WILD TROUT TRUST
wildtrout.org

Advisory Visit
River Slea, Lincolnshire
November 2022

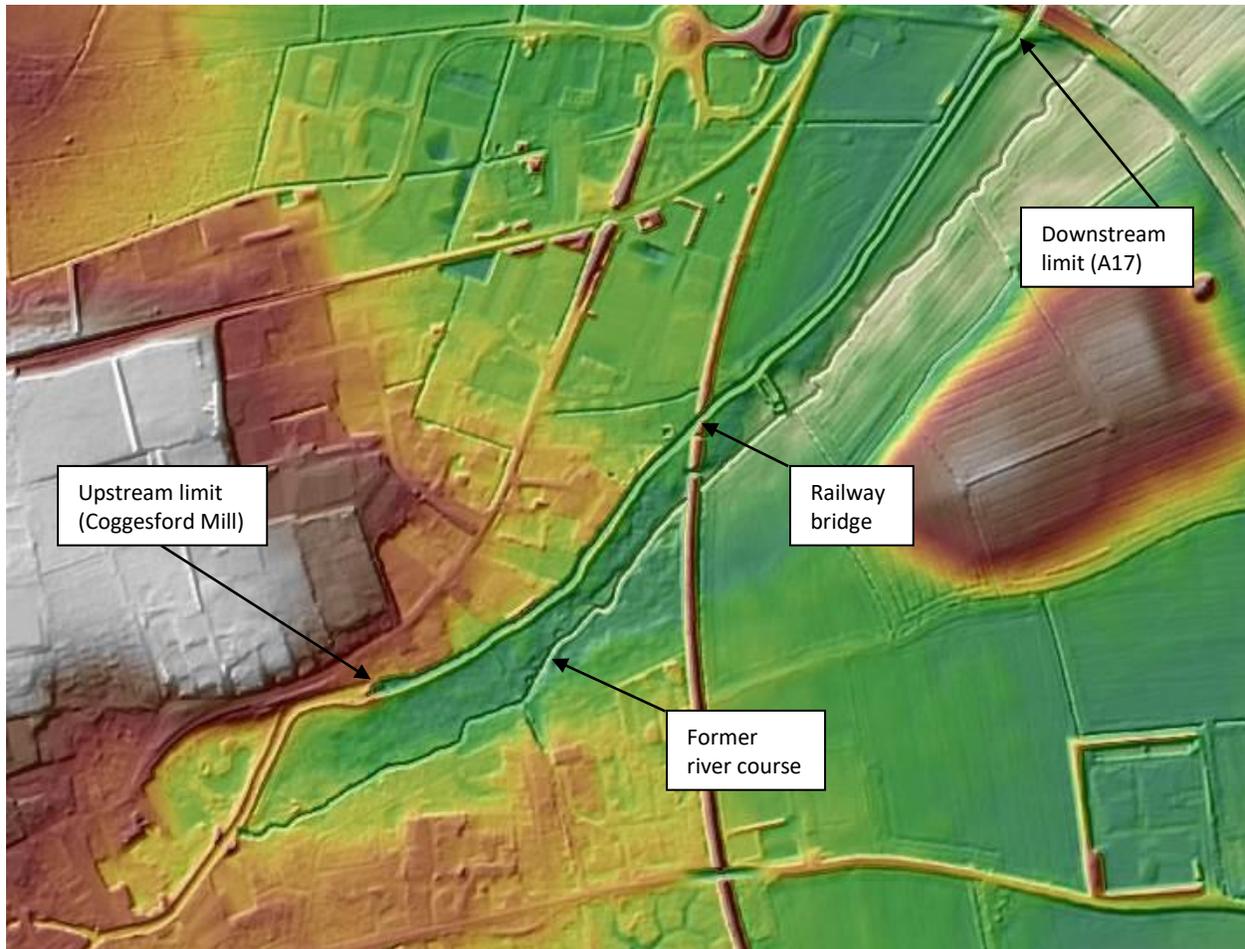
Figure 1 LiDAR map (1m DTM) of the reach inspected (<https://www.arcgis.com/apps/webappviewer/index.htm>)

The channel has a low gradient with the fall concentrated at the former navigation lock structures mentioned above; between these there is a fall of approximately 0.75m over the 1400m reach (from LiDAR 1m DTM data; Figure 1). The low gradient, combined with the perennially low flows experienced on the Slea, provides very little flow energy, which is evident from the lack of scour around such features as submerged pipe crossings (Photo 3). The little gradient there is along the reach is concentrated around

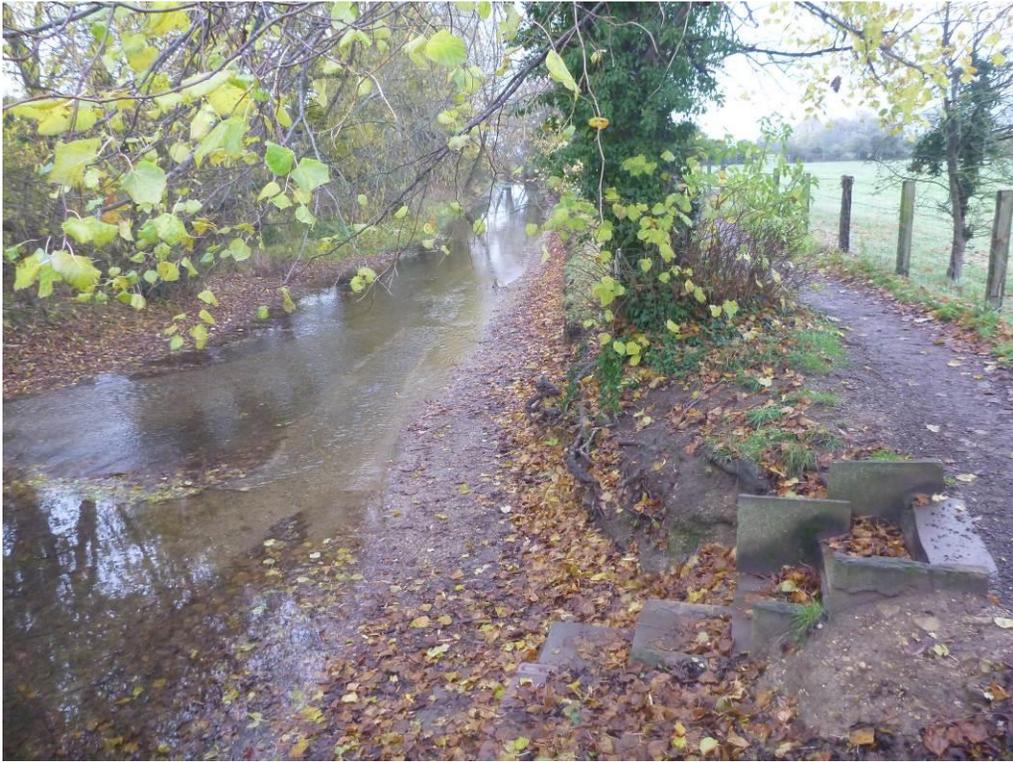
At the upstream end of the reach, the river is shaded by mature trees and the relatively faster flows from the mill and lock structures keep the river bed free of silt (Photo 1). Progressing downstream, the river is less shaded which allows emergent vegetation to colonise the full width of the channel (Photo 2).

Photo 1 Upstream end of the reach, immediately below Cogglesford Mill. Some channel gradient is present here, along with clean (relatively) gravel. Note the exposed margins as a result of very low flows following a drought summer.

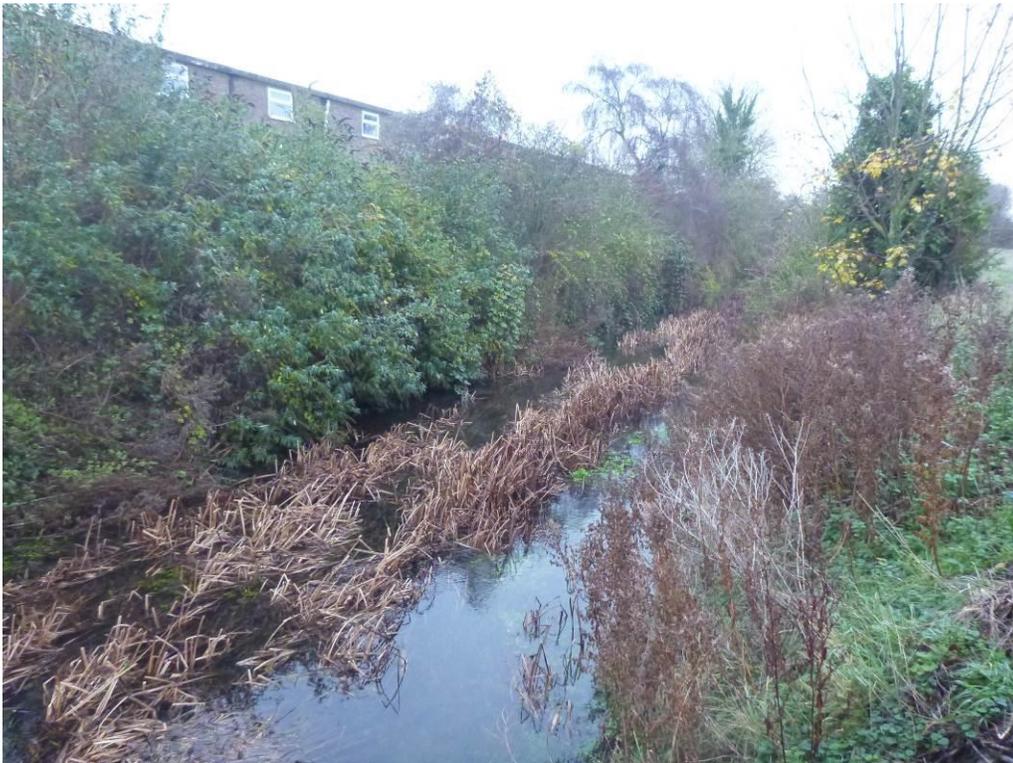
During the visit, the First Witham IDB delivered to site an excavator with weed cutting bucket to remove this vegetation on behalf of the EA as the Slea is designated main river. This type of in-channel work should not be taking place at this time of year because it is during the spawning period for

brown trout (spawning trout were observed upstream of the reach inspected) and risks the illegal disturbance of spawning fish and smothering of eggs with mobilised fine sediment. Such works should not take place later than 30th October (start of trout angling close season) nor earlier than 16th June (end of coarse fish close season).

Photo 2 Approximately halfway between Cogglesford Mill and the railway bridge – a low gradient, depositional environment choked with emergent vegetation. This section was about to be weed-cut by First Witham IDB on the day of the visit.

- Ensure robust screening processes are in place to prevent in-channel maintenance operations such as weed cutting taking place during fish spawning seasons.
- Liaise with weed-cutting contractors to carry out a pattern of cutting which maximises fishery benefit. For example, cutting a meandering central channel would concentrate flows, scour fine sediment and provide better angling opportunities.

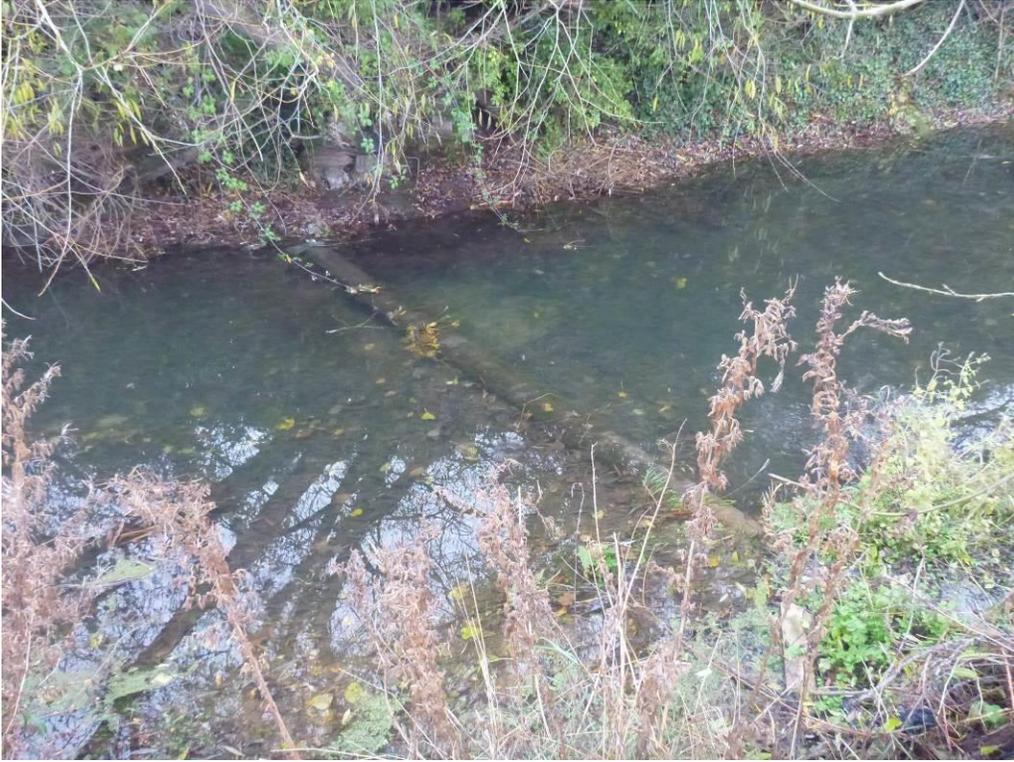
Photo 3 Submerged pipe crossing showing no signs of scour.

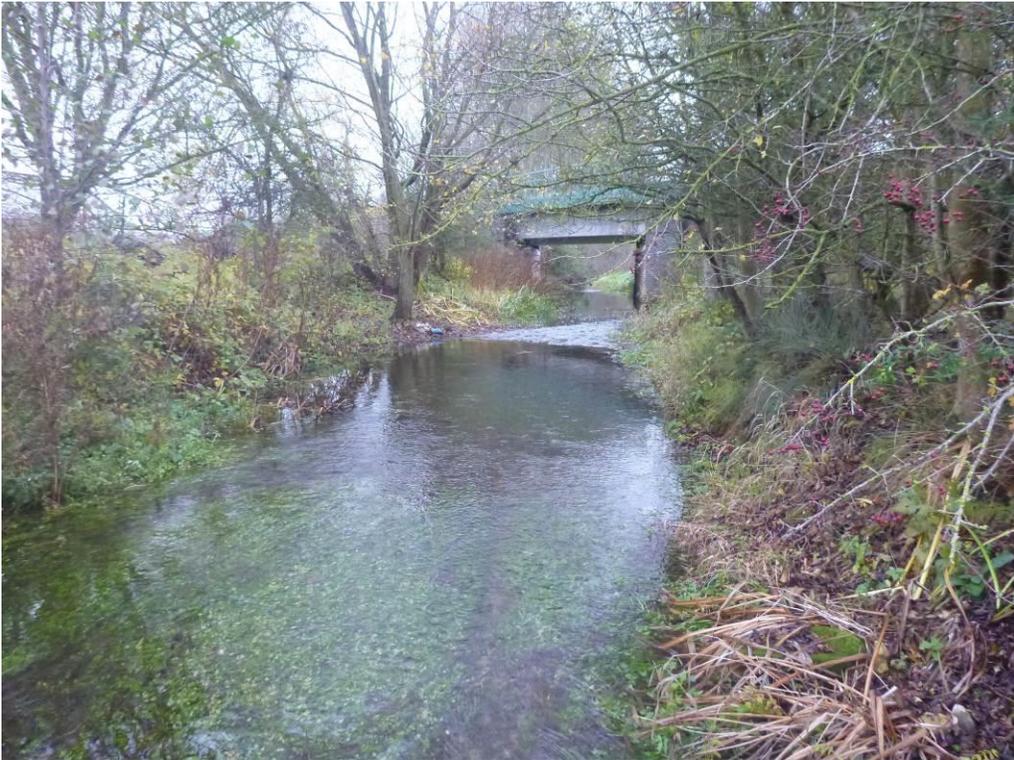
the railway bridge about halfway along (Photo 4, Photo 5). Here there are riffles upstream and downstream of the bridge and a lateral scour pool against the bridge footings; this was about the sum total of good trout habitat seen.

Photo 4 An increase in channel gradient at the railway bridge allows some riffle and pool habitat to exist.

As mentioned above, a short length of improved habitat is present immediately upstream and downstream of the railway bridge where there is a localised increase in river bed gradient. Riffles with coarse substrate are present along with a scour pool under the bridge. This area provides a limited amount of suitable trout spawning habitat.

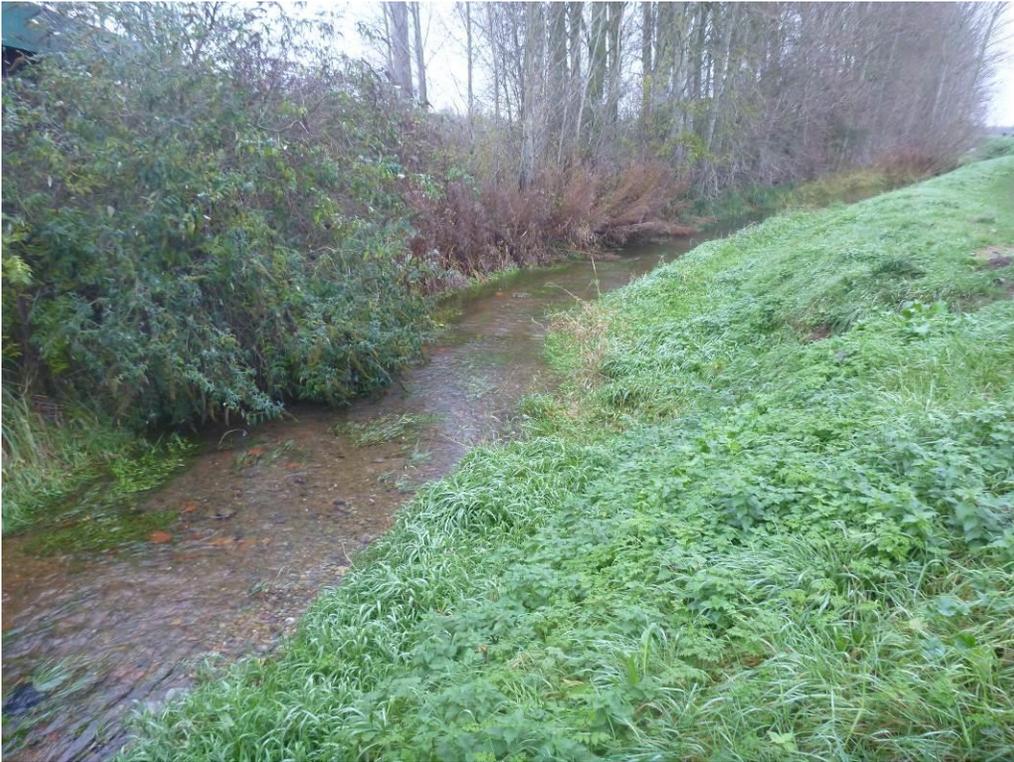
Photo 5 Faster flows and clean gravels downstream of the railway bridge.

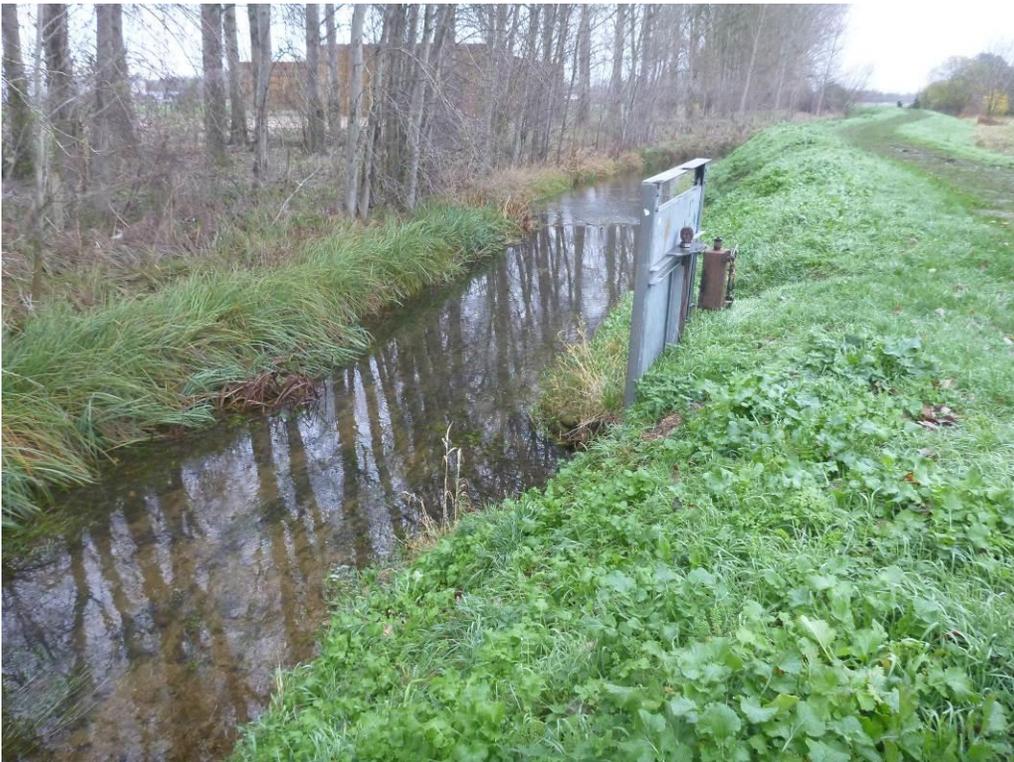
Photo 6 Abstraction point for an irrigation reservoir (winter storage).

Further downstream, the habitat type reverts to a steady glide impounded by the weir at Bonemill Bridge. The river bed substrate is dominated by fine sediment and vegetation is typical of still/slow-flowing water (marginal sedges, submerged broad-leaved pond weed *Potamogeton natans*). This section is evidently maintained by mechanical weed cutting to prevent emergent vegetation encroachment. An abstraction point is located on the right bank, apparently supplying an irrigation storage reservoir. (Photo 6 - Photo 8).

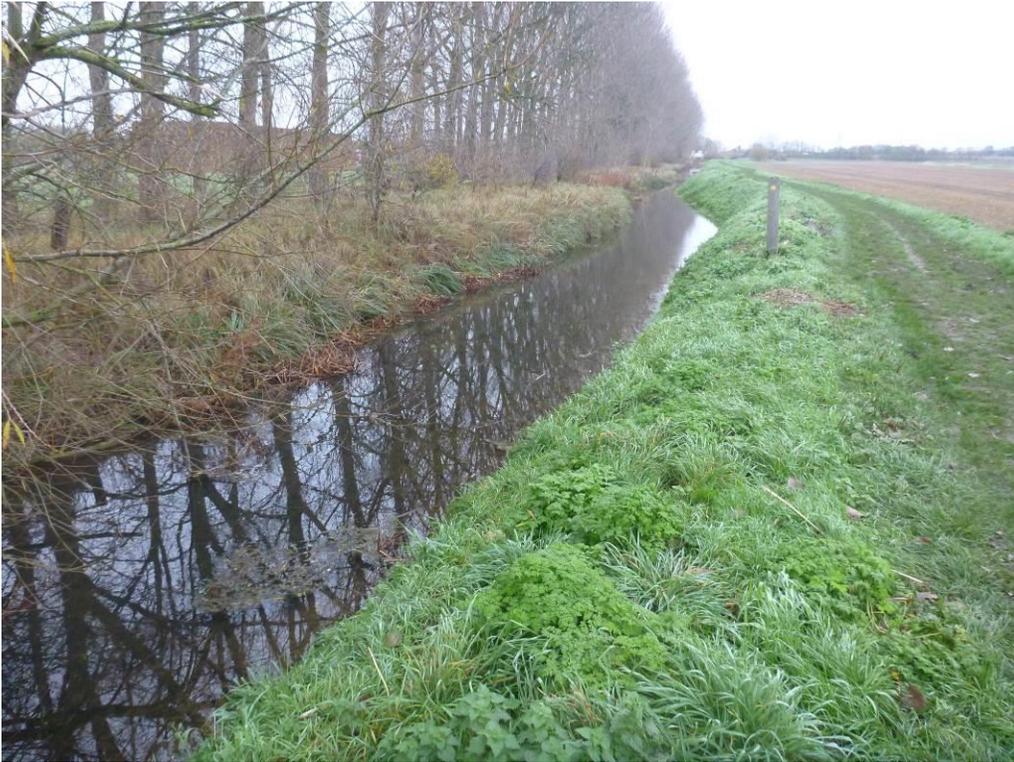
Photo 7 Typical habitat on the lower section of the reach, maintained as a drainage channel.

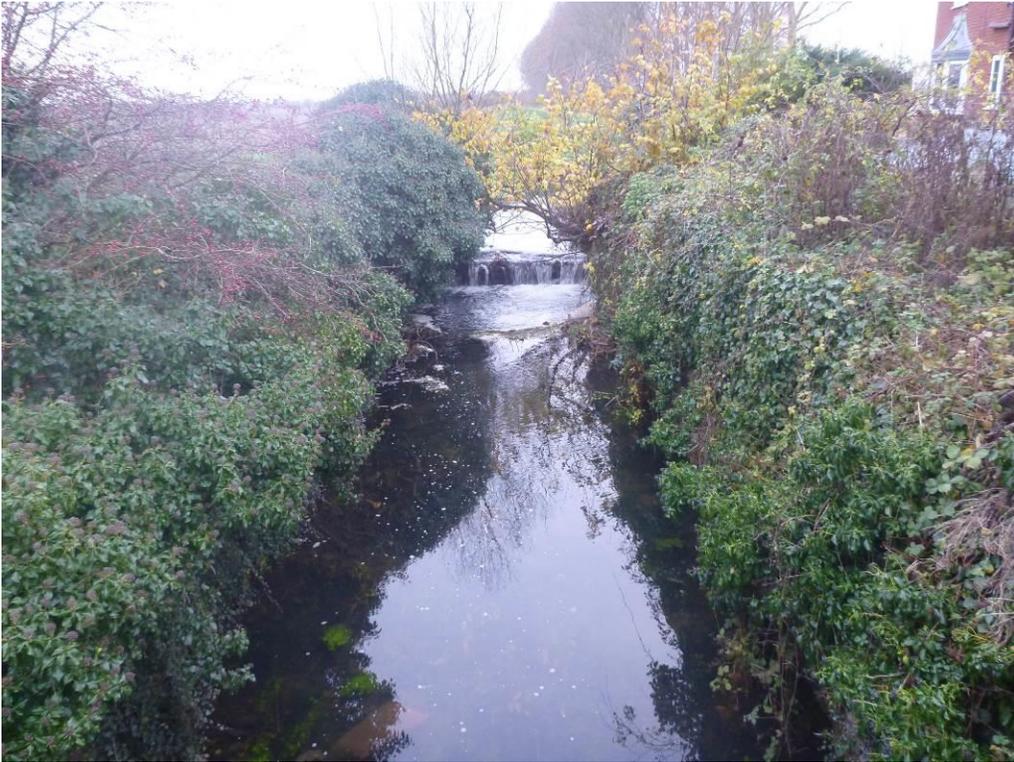
Photo 8 Upstream view from Bonemill Bridge showing weir at the lower end of the reach.

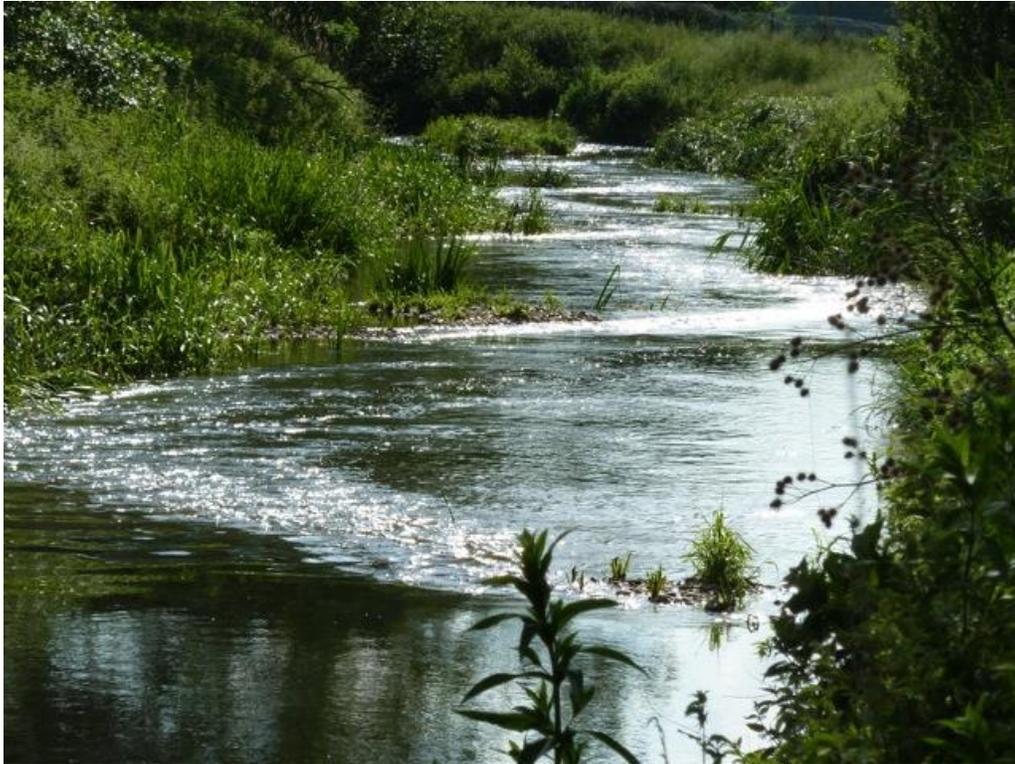
This technique is applicable on heavily-modified channels and involves re-shaping of the river bed with an excavator to create pools and use of the resulting material to construct alternating or opposing berms to pinch the flow, create scour and maintain pool depths. The technique relies on there being sufficient gradient (and hence flow energy) over the long-section of

the reach – any high points in the bed further downstream can frustrate the objective, for example an un-dredged section of river beneath a bridge, or a weir; this could well be the case on the Slea with the railway bridge and former locks.

Photo 9 River Lark, Suffolk, following re-shaping of the river bed (“dig-and-dump”), Credit: Ian Hawkins.

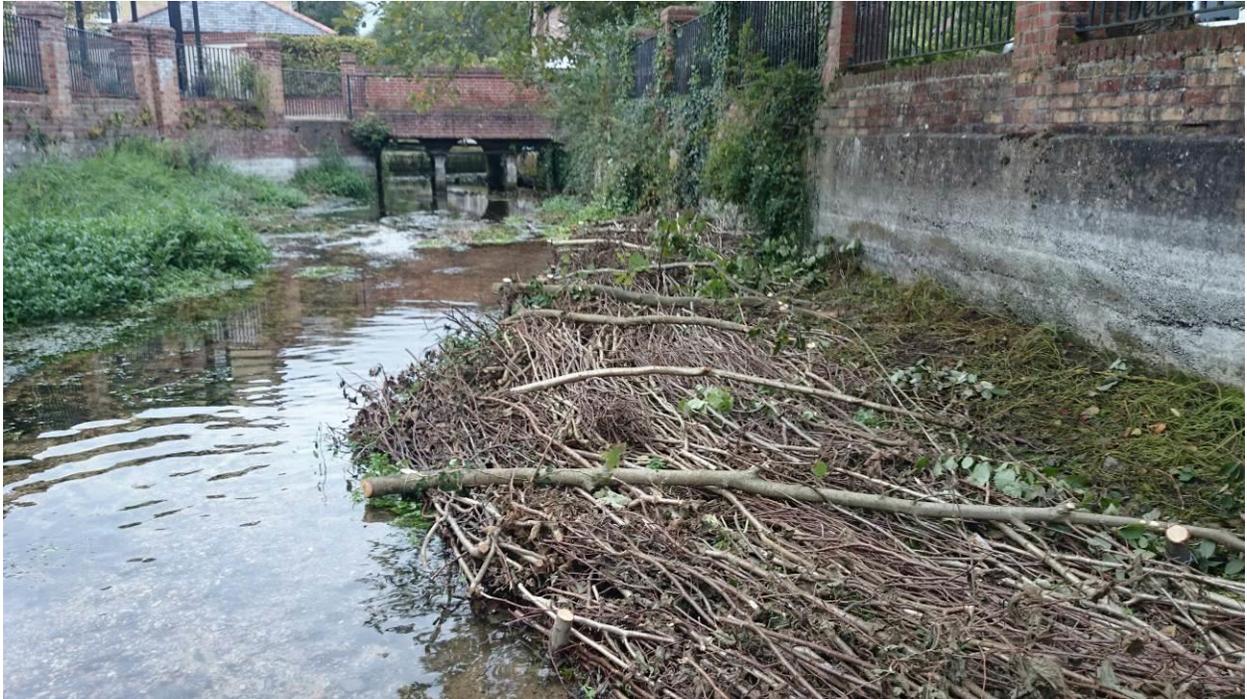
Photo 10

Structures such as brushwood berms ((Photo 10) and log flow deflectors can be used to pinch the channel and concentrate flows, creating scour, depth variation and sorting of river bed substrate. However, this is unlikely to be the case on the Slea given the evidence of little scour occurring around existing in-channel structures and the minimum 14-ft channel width required by the landowners.

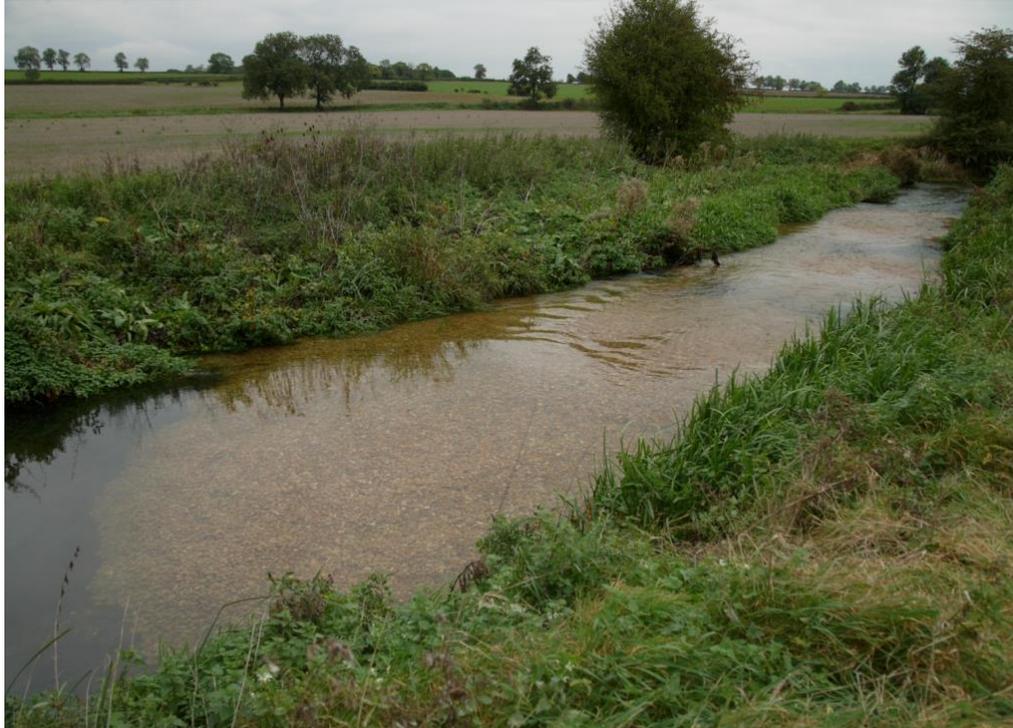
Coarse substrate could be used to construct 'riffles' within the channel. These provide improved spawning habitat and may create scour pools at the downstream side. However, upstream they have an impounding effect which can promote settling out of fine sediment and encroachment of emergent vegetation, so their level must be set so as not to create an impoundment.

Photo 11 Introduced gravel, Willow brook, Northants.

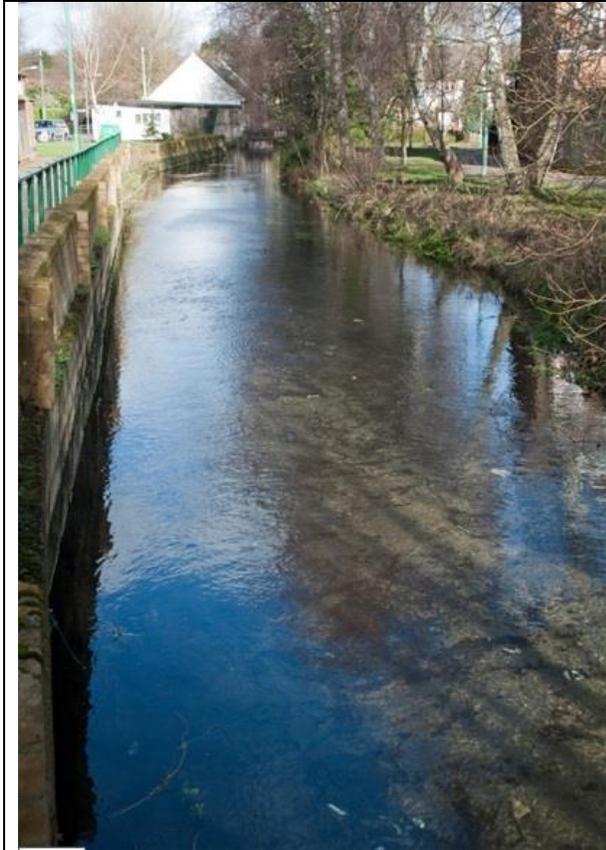
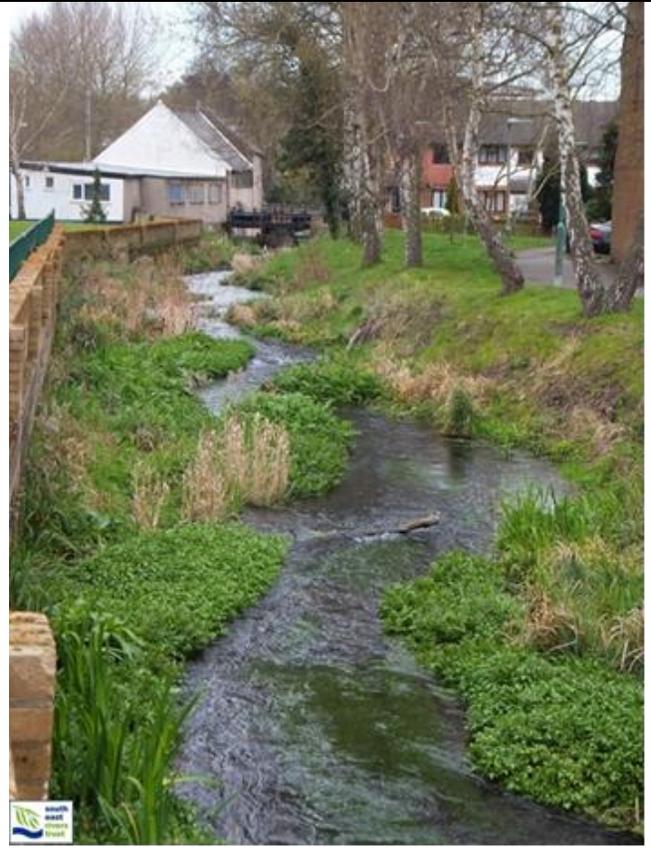
Photo 12

Removal of existing impoundments would restore gradient to the channel which would allow many of the above techniques to operate effectively. However, this would conflict with the ambition to restore the navigation.

River Wandle, London, before (left) and after (right) weir removal. Credit: South East Rivers Trust
