Taunton Fly Fishing Club (TFFC), Wellisford, River Tone

**An Advisory Visit by the Wild Trout Trust
May 2021**

**Nick Lawrence
nlawrence@wildtrout.org**

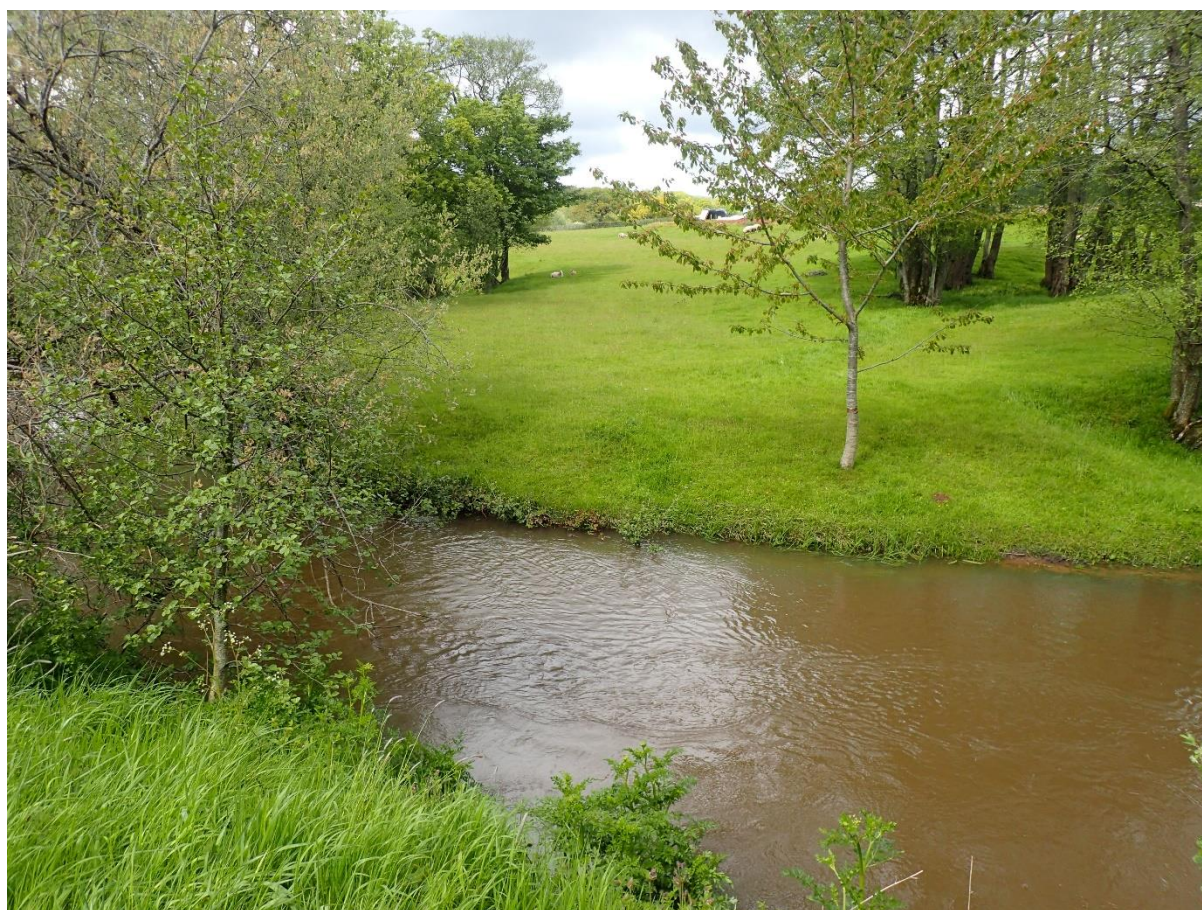
On the day of the visit the river was notably high and coloured from recent rainfall (photo 1), with sediment loading very apparent in water of the same colour as the soil of the local area. On the way to the location of the visit, it was noted that some contour ploughing had been undertaken on a hill that was draining directly into the river (photo 2). This was not within the site visited, but it is an indication of some of the agricultural pressures the river system faces.

Photo 1: High sediment content within the floodwaters; livestock exclusion on the LB would be beneficial

Photo 1 also illustrates how uninterrupted grazing can suppress the marginal plant communities and tree growth, reducing the bankside cover within this reach on the LB: a fence here would be beneficial.

- Engage with farmers in a proactive way, to attempt to co-exist without conflict: this could include applying for some fisheries improvement funding (FIP) to fence or refence sufficient buffer strips, including cattle drinking areas, which could benefit both parties.

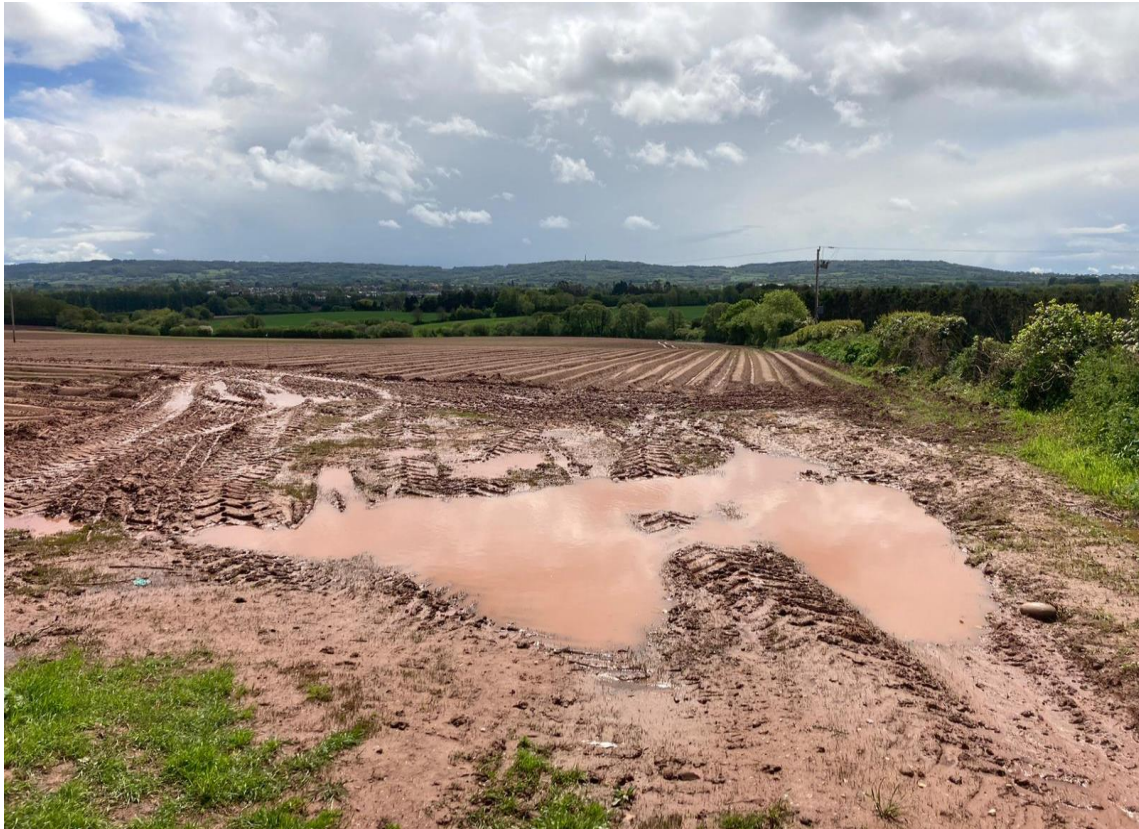
Photo 2: Inappropriate contour ploughing where the rainfall is eroding the soil directly into the river

- Encourage work aimed at improving water quality: this could involve the Westcountry Rivers Trust (WRT) undertaking some wet weather walks to map sediment ingress from unsustainable farming practices. Also report any incident that involves a breach in the farming rules for water (https://assets.publishing.service.gov.uk/government/uploads/system/uploads/attachment_data/file/695598/farming-rules-for-water-policy-paper-v2.pdf) to the EA pollution hotline 0800 80 70 60.

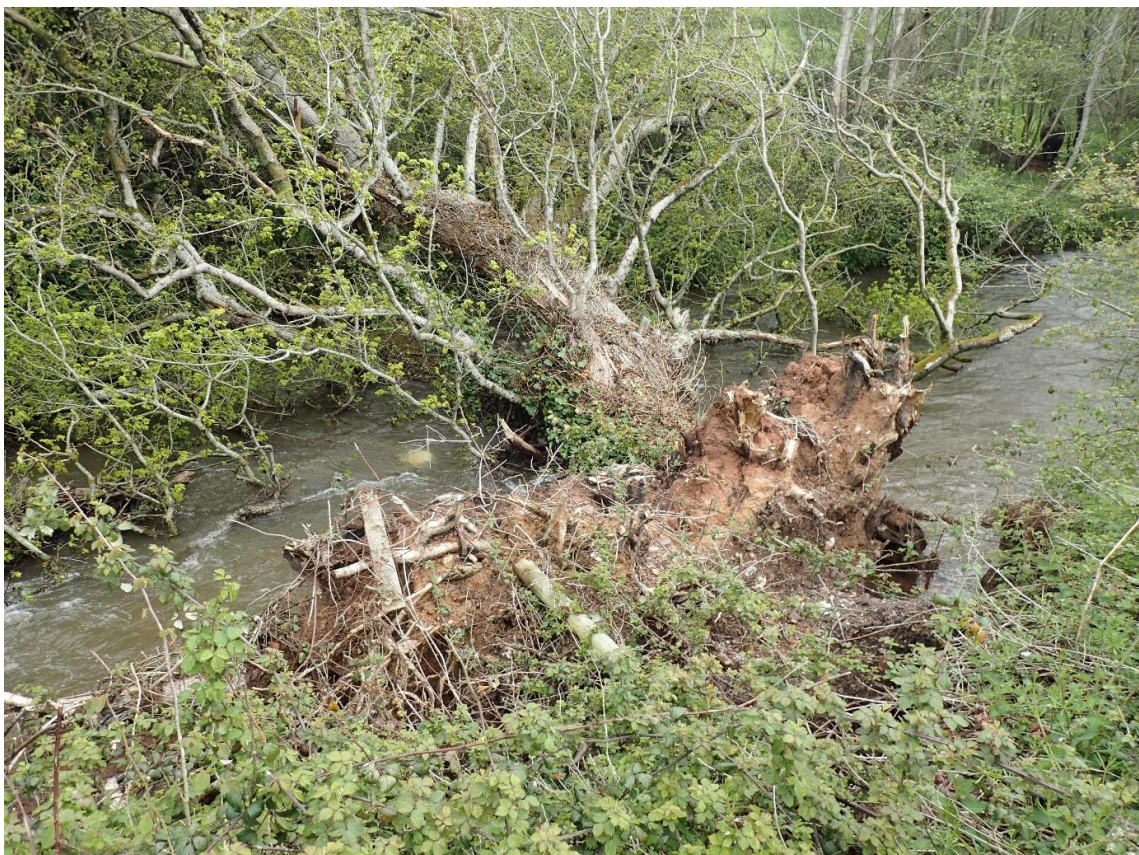
Photo 3: Large tree wedged in the channel providing good undershot scour and cleaning gravels.

Moving down the reach, a large tree had succumbed to recent floods, and is now providing some quality undershot scour, cleaning gravels and driving the bed down. This will provide good opportunities for trout spawning, and in time create a feature to fish to. Gifts from nature should be seen as a blessing and left unaltered if the farmer is amenable. If the farmer has concerns a few branches on the LB could be removed, to allow the river to flow around and under the tree. The majority of the tree should be left in situ to retain the habitat benefits.

- Continue to employ light touch management, e.g. leave fallen trees in the river. If a tree does fall in a place where it might cause a problem, give it a couple of floods to see how it settles. After this, and if the tree is problematical, move it into a more favourable position and secure it with steel cable to retain the ecological (and fishery) benefit.

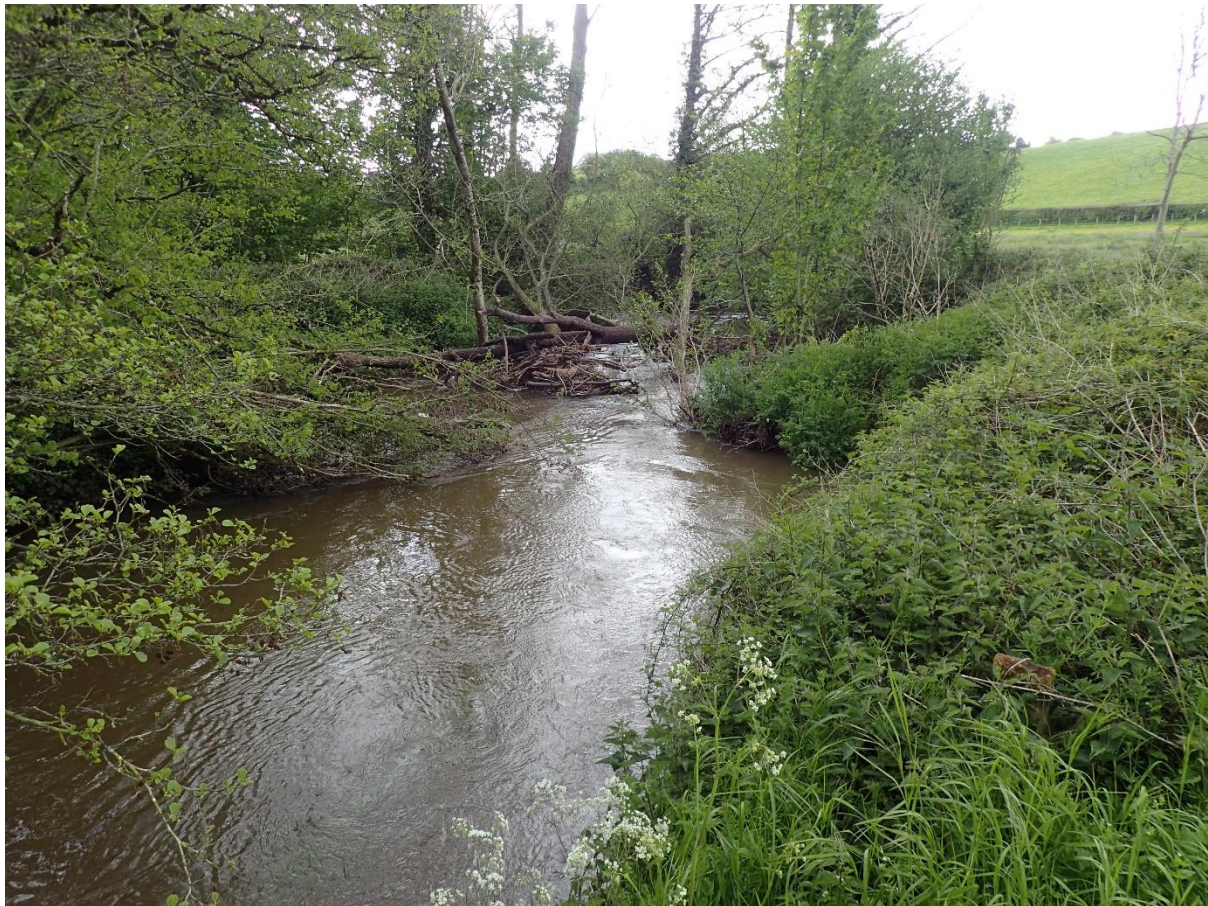
Further down the reach more benefits can be viewed (photo 4) due to the TFFC's light touch management policy, with naturally fallen large woody material (LWM) which is hugely beneficial in terms of gravel scour as the river cuts underneath it. Features such as this should be conserved, and never removed: the variation in habitat that such natural features provide is very hard to replicate.

Photo 4: Large woody material collecting up and creating a pinch point, where gravel scour will be increased, top quality trout feature

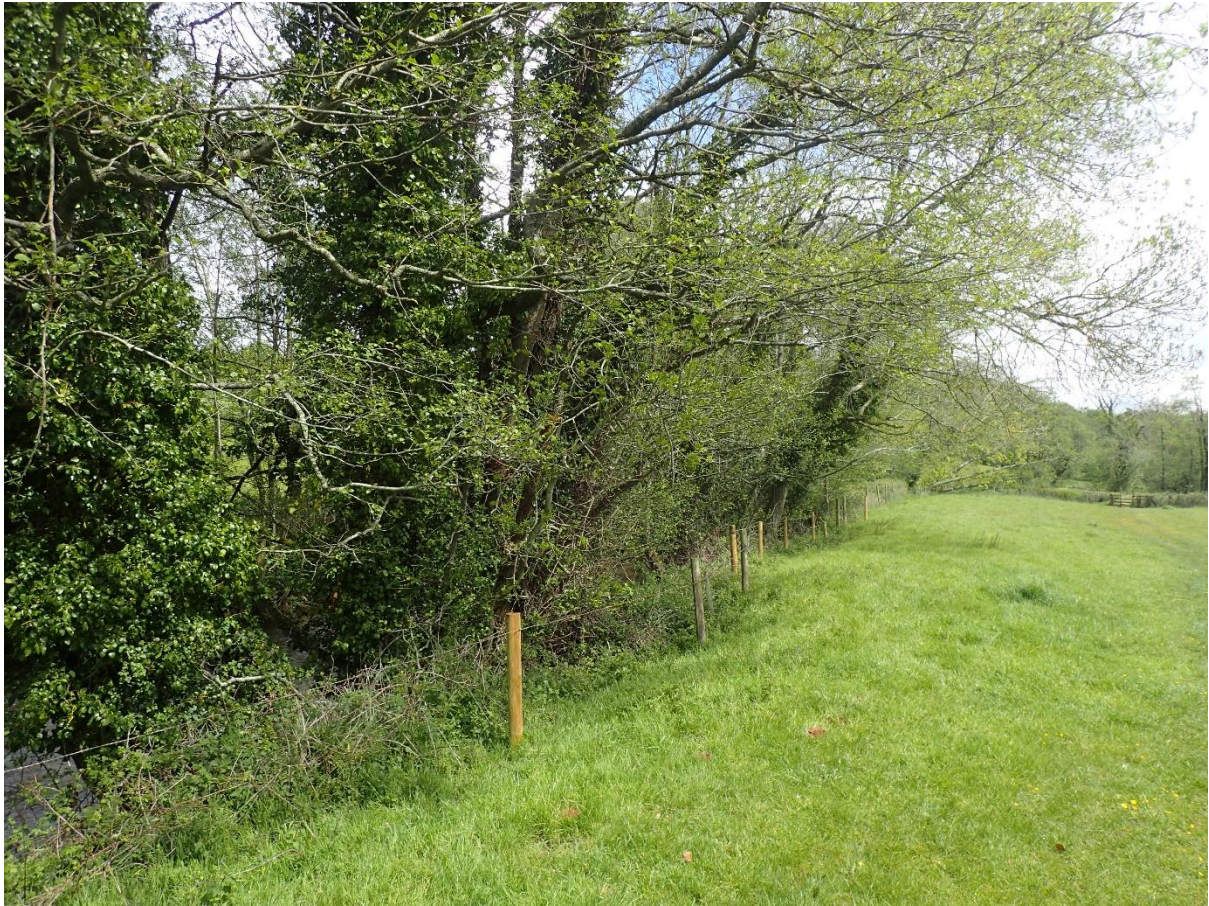
Before moving into the lower section which includes the nature reserve, large stands of trees are growing uniformly within the fenced-off buffer strip on the RB (photo 5). There are instances where it would be beneficial to light the channel by selectively felling a couple of these trees. The arisings from this skylighting activity could be tethered within the channel using steel cable or using adjacent trees to lodge the wood in place: see the appendix for examples.

Photo 5: Uniform tree growth behind buffer fencing: targeted felling could benefit riverine habitats

- Where tree cover is very dense and the river is over-shaded (indicated by a noticeable absence of aquatic vegetation), instigate light tree works to open up some occasional skylights in the canopy (mainly in upper section). The arisings from these works could be installed as habitat features within the channel, either cabled or lodged as viewed in appendix photos 9-11. More information on trees and rivers can be seen here [Trees and Rivers | Wild Trout Trust](#)

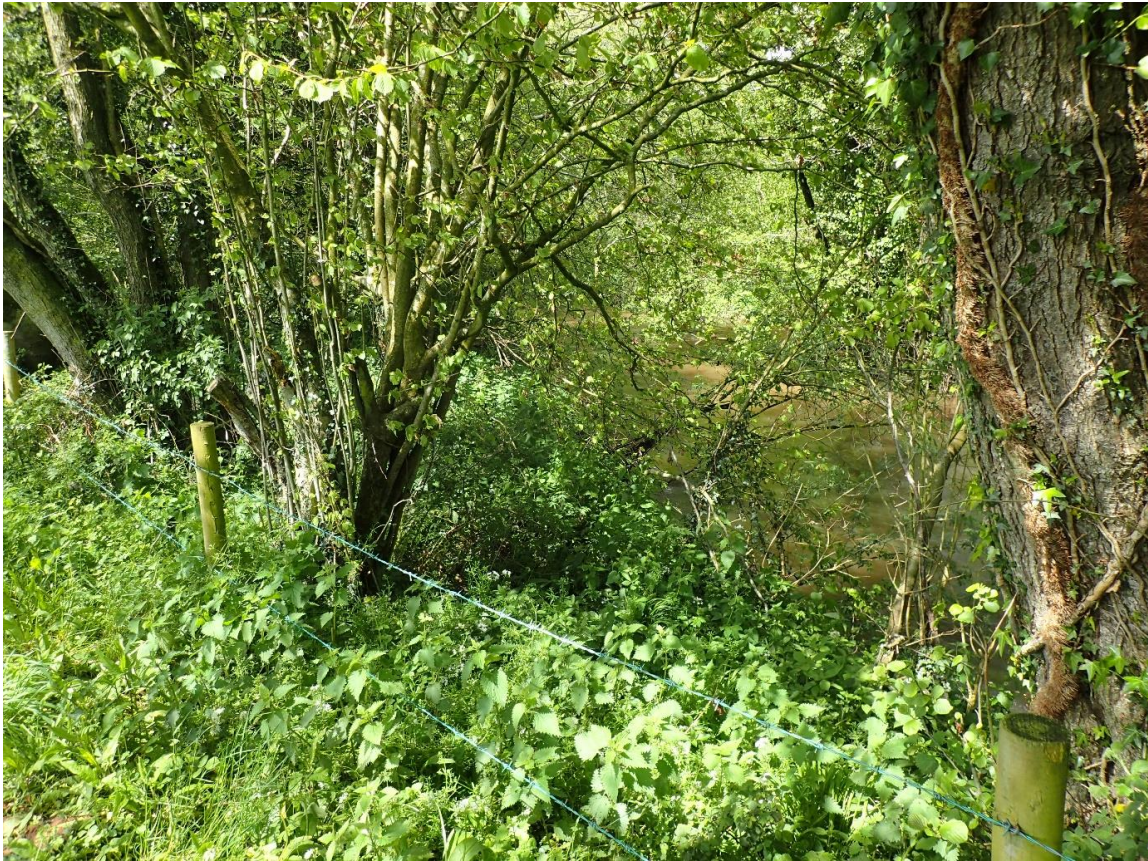
The lower section of the river adjacent to the nature reserve was considerably more overgrown than the rest of the fishery (photos 6 & 7)., Although general wildness is beneficial to the river in most instances, as seen in the upper reaches, and some shade is necessary to keep the river cool, excessive tunnelling by trees as noted in the lower reach can be detrimental to the river's habitat. Much of this tunnelling could be addressed with strategic coppicing or hinging, to carefully provide some dappled light to the channel. This will also benefit other wildlife – a desirable outcome for the nature reserve run by SWT.

Photo 6: Hazel could be coppiced and / or hinged to increase light in the channel

- If agreed with SWT a programme of rotation of coppicing works focussing on the southern banks, with the aim of introducing light over shallow, faster-flowing sections. Try to retain as much low-lying cover as possible, especially over good pools. This activity is likely to be focused on the lower end of the reach within the nature reserve: engage with SWT so the activities can be used to benefit both parties.

- The coppicing works (mostly hazel) could be used some to boost habitat instream by hinging (see appendix photo 12) into the channel in a downstream direction. Such trees should be carefully selected for optimal benefit, in consultation with WTT to select the best opportunities.

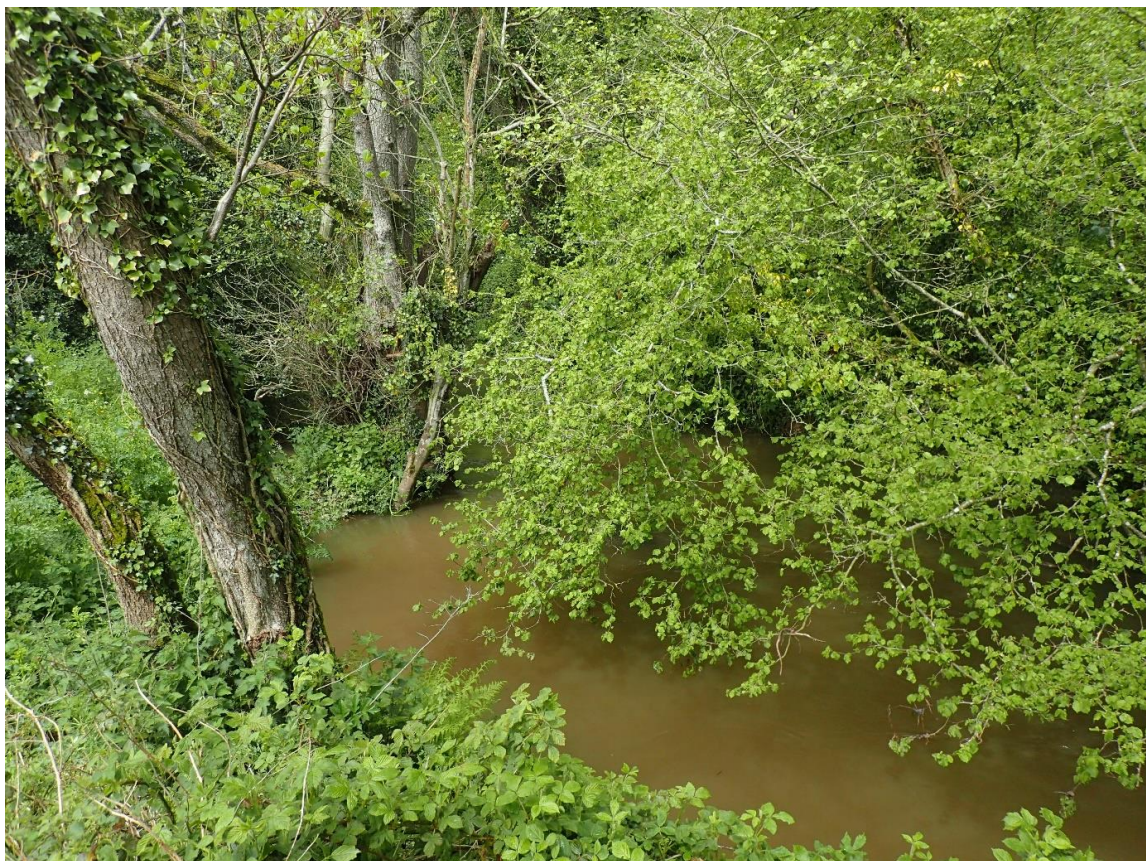
Photo 7: Much of the lower section has overstood hazel coppice, reducing light penetration.

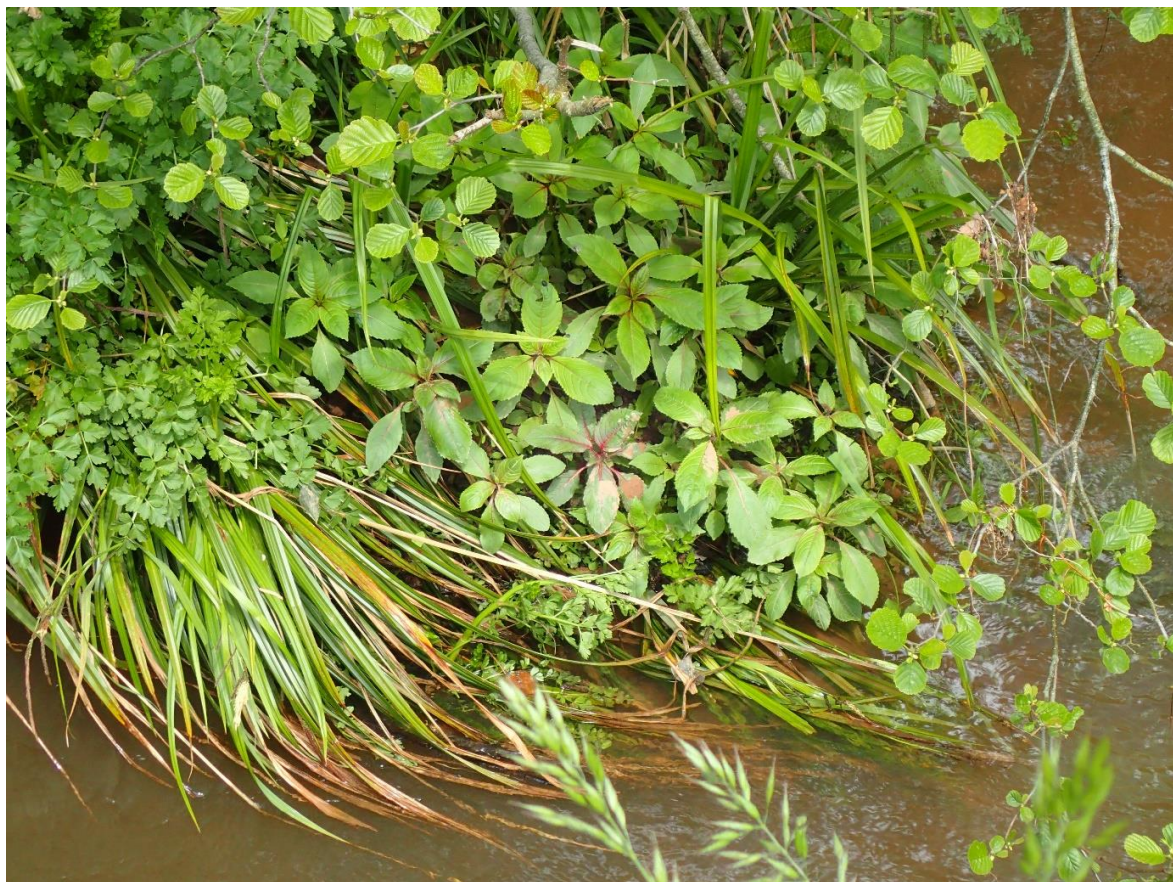
On closer inspection of the marginal plants it was noticeable that there are considerable amounts of potentially very damaging Himalayan balsam (photo 8) mixed with the native plant communities.

Himalayan balsam will increase sediment loading within a river as the plants die back in the autumn and banks are left exposed to erosion: combined with some of the farming practices observed, this leaves the river vulnerable to sediment pollution and the impacts of silt on spawning gravels. The balsam problem will not be localised to this area: it will almost certainly be originating from upstream in the headwaters, and the club should seriously consider becoming part of a catchment-wide effort to eradicate it from the headwaters downstream.

Photo 8: Invasion by Himalayan balsam plants can reduce biodiversity dramatically.

- Find out if there are any schemes to control Himalayan balsam within the catchment, possibly through the SWT or the WRT, and work with other landowners, fishing clubs and community organisations to clear this invasive species strategically from the top of the catchment downstream. Targeted 'balsam bashes' on the reach may also help to protect particular areas of value but should not be seen as a substitute for a top-down, catchment-scale strategy. There are examples elsewhere of near eradication of balsam (e.g. on the River Monnow), though the approach must be strategic and persistent. The SWT should be engaged as this would no doubt benefit their nature reserve.

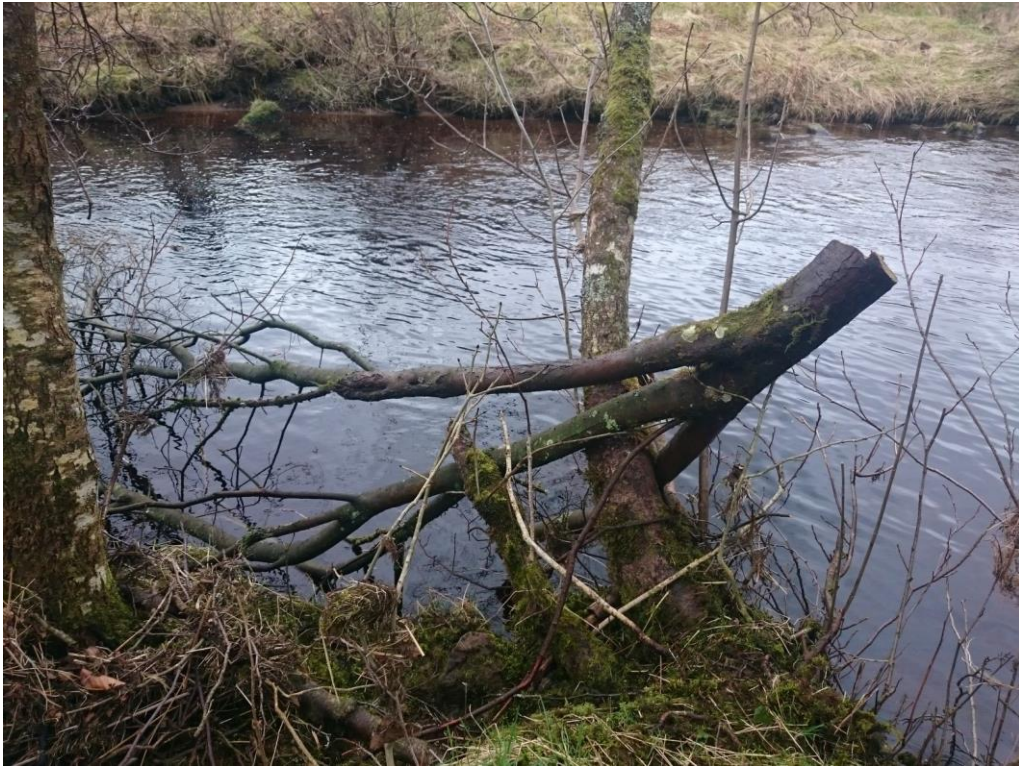
Photo 9: Lodged woody material, the most natural of methods to mimic naturally fallen trees, wedged in another tree to secure it with no other materials required.

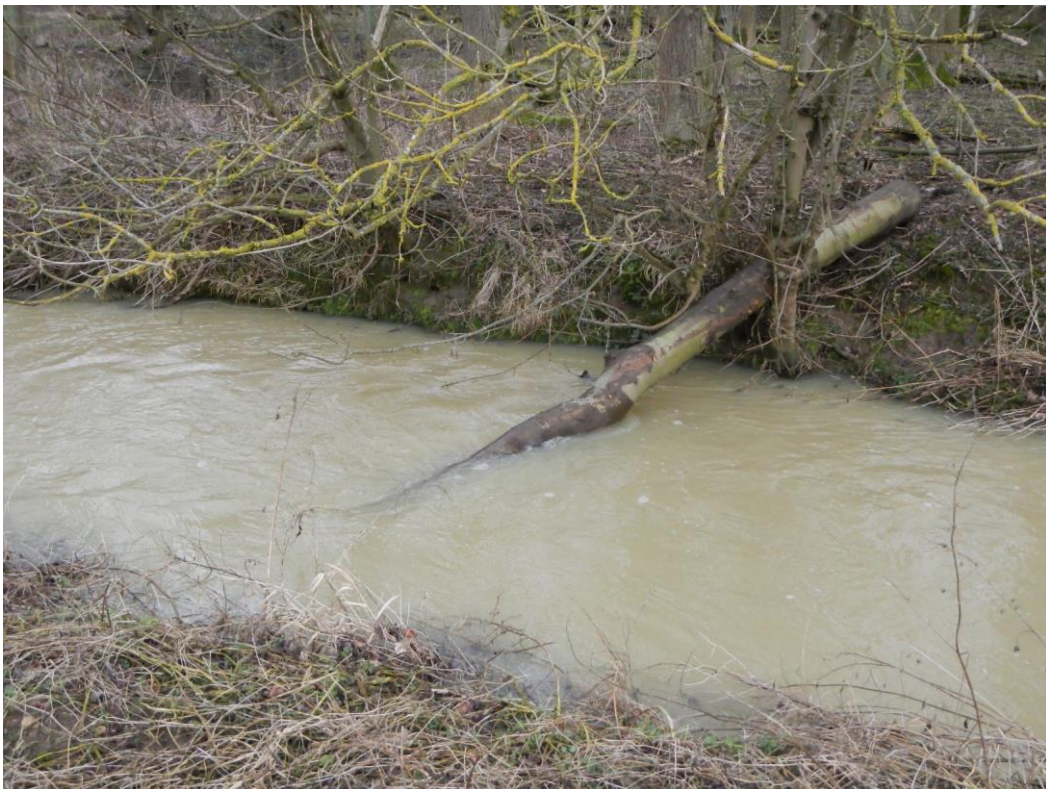
Photo 10: Another example of lodged woody material wedged between tree trunks to brace it against flows, as secure as any posts and wire or cabling.

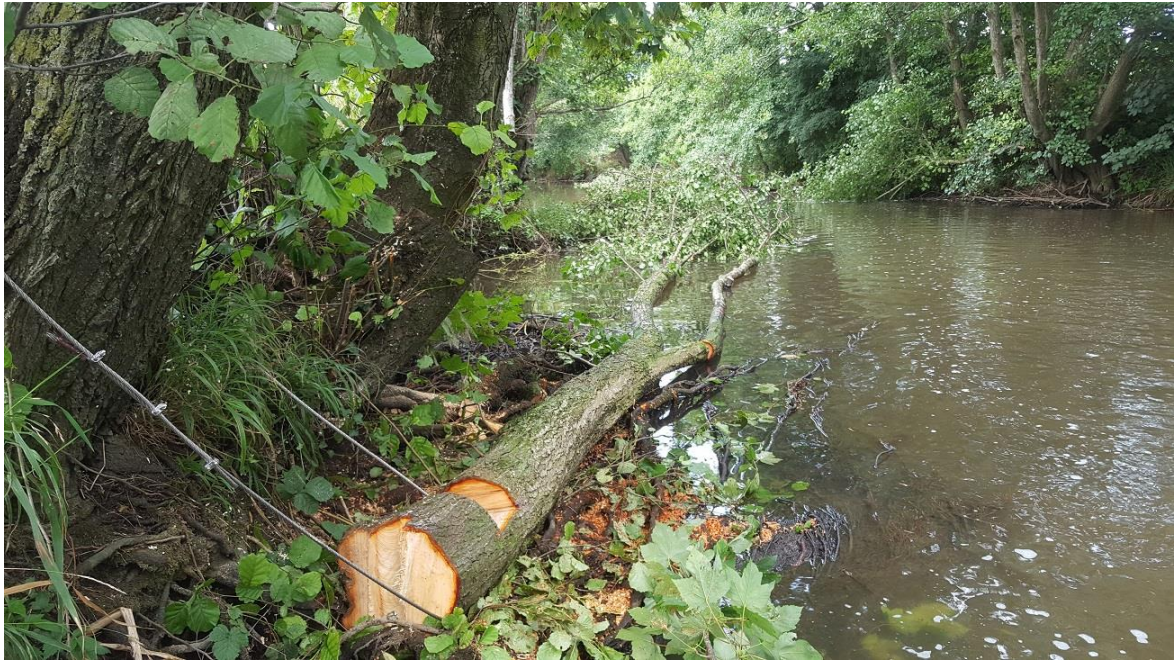
Photo 11: A tree kicker cabled to an existing tree stump on the River Yeo. Kicker tethers should be as short as can be realistically achieved: apart from too much metal cable being unsightly and unnatural, the risks of the trees being stranded on the banks in floods are significantly increased. Hiring or investing in a hand winch would allow the kickers to be winched back toward the stump, reducing the amount of cable needed, which in turn will reduce the likelihood of the kicker being stranded on the bank after high flows.

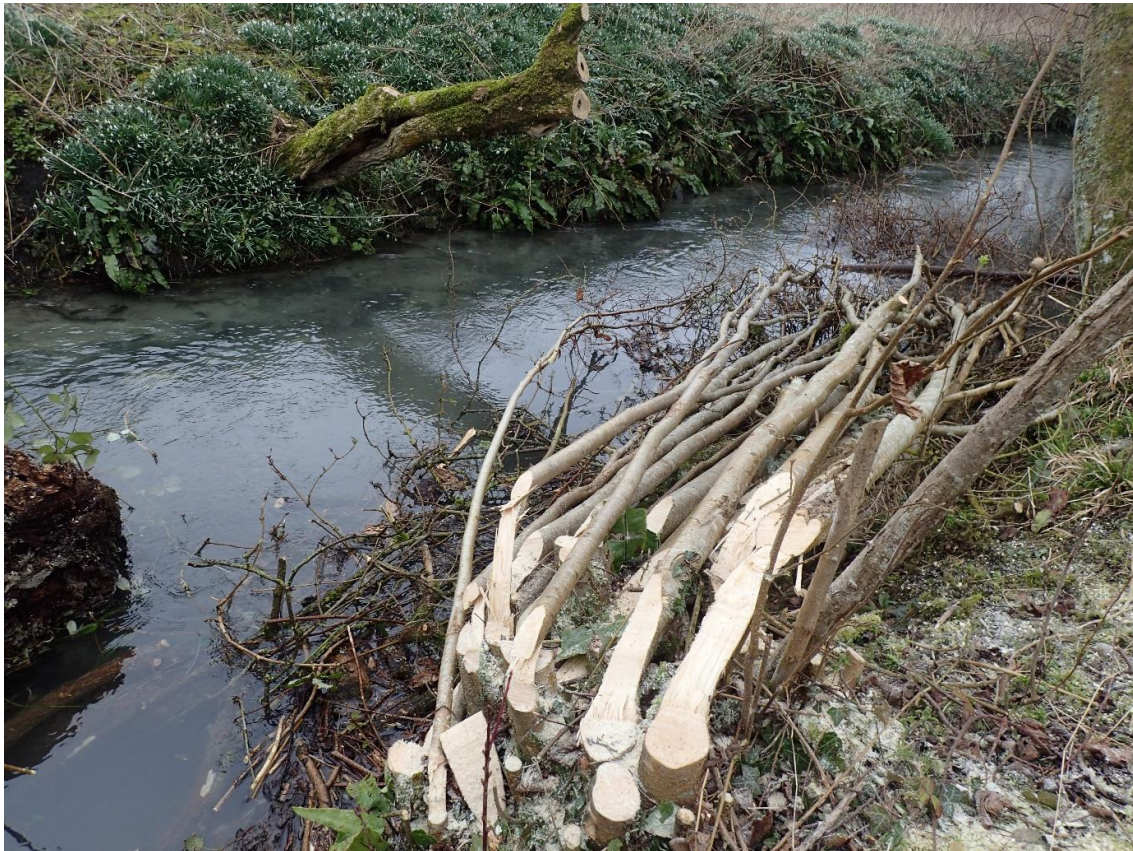
Photo 12: Hinged hazel can be a good method for lighting the channel and improving habitat
