River Sheppey, Shepton Mallet, Somerset

Wild Trout Trust report on walkover surveys carried out on 13 February and 5 March 2021

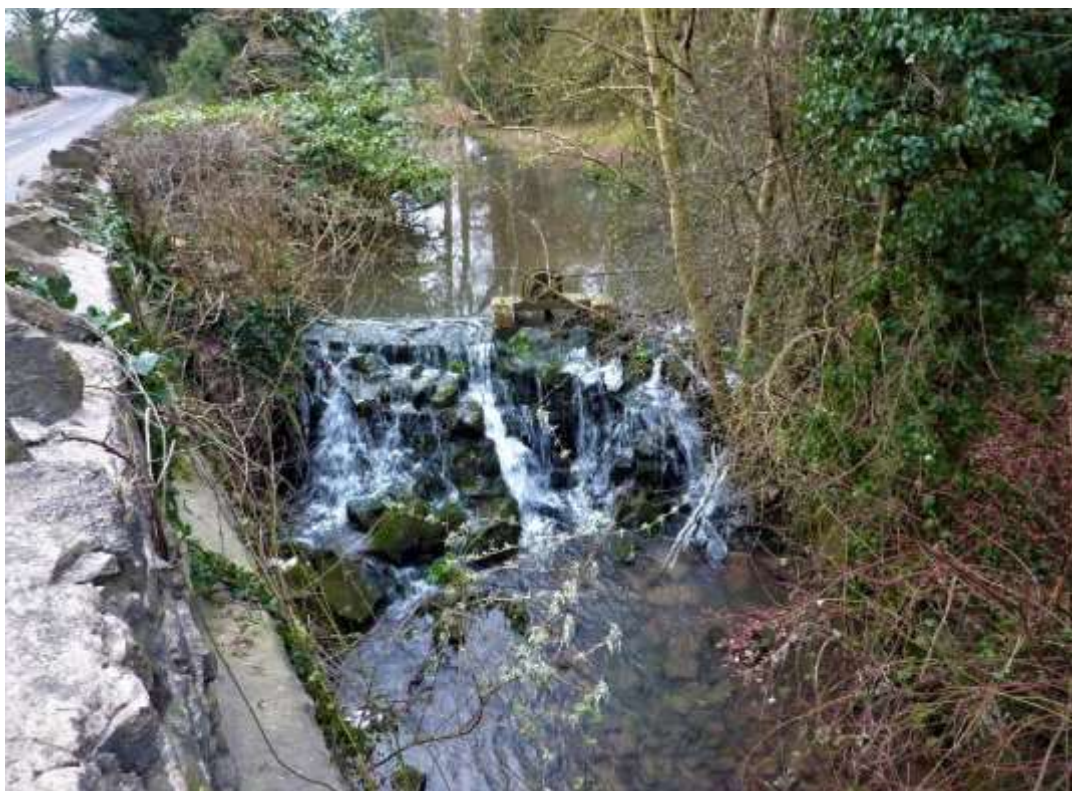
Figure 3: A redundant weir impounding c 120 m of the River Sheppey at Charlton

As discussed in *Appendix 3: Weirs and their impacts*, structures like this weir interrupt the river's longitudinal connectivity and strangle its natural sediment transport processes, causing fine silt to drop out of suspension, and creating a uniform and degraded habitat. In the case of this lake, the main flow appears to follow the RB, with higher levels of sedimentation on the LB, some of which has become partially consolidated by a reed bed. Although the reed bed does offer some habitat benefits, the rest of the lake is dark, swampy, and ecologically and visually unappealing. Despite some tree shade, water quality in this large, shallow impoundment may also be affected by solar thermal heating, particularly in the summer months, leading in turn to elevated temperatures and reduced dissolved oxygen further down the river – a factor which will also apply to other impoundments further downstream.

On the LB between the weir and the road bridge, a constant flow of water was noted from a rough hole in the rock revetment at a point just above water level. Very close inspection was not possible, but since this outflow is not visibly formalised with a pipe or headwall, it may be an early indication that the river's flow is starting to bypass the weir within the revetment, raising the possibility of sudden structural failure.

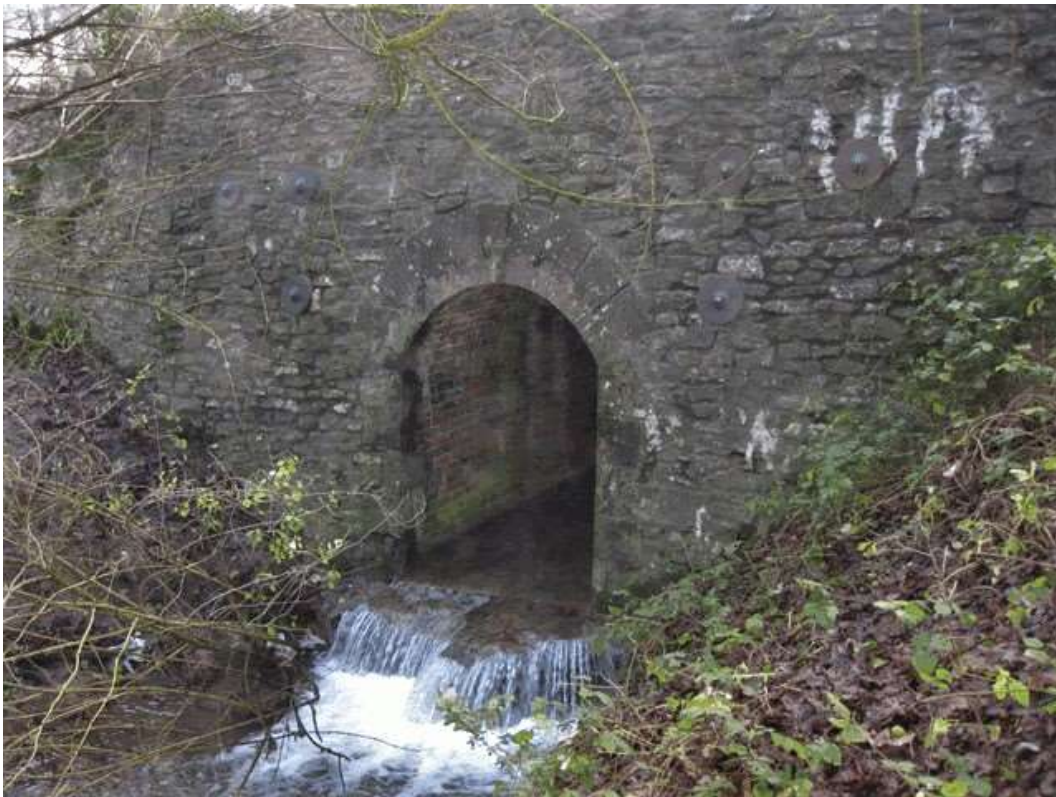
Figure 4: Shallow, impassable flow through the narrow bridge culvert under the A361 Charlton Road (Photo: Somerset Rivers: www.somersetivers.uk)

The River Sheppey flows under the A361 road bridge through a small arched culvert, which could not be easily accessed for closer inspection. However, a photograph found on the Somerset Rivers website (www.somersetivers.uk) suggests that it is likely to be impassable for fish in most flows, due to the step up to shallow, high velocity water over a smooth concrete bed (as shown in Figure 4 above).

Pre-barraging the bridge to drown out the step and the fast, shallow flow within the culvert, perhaps with a small rock ramp or an oak board easement, would allow fish to pass more freely into future restored stretches of river upstream.

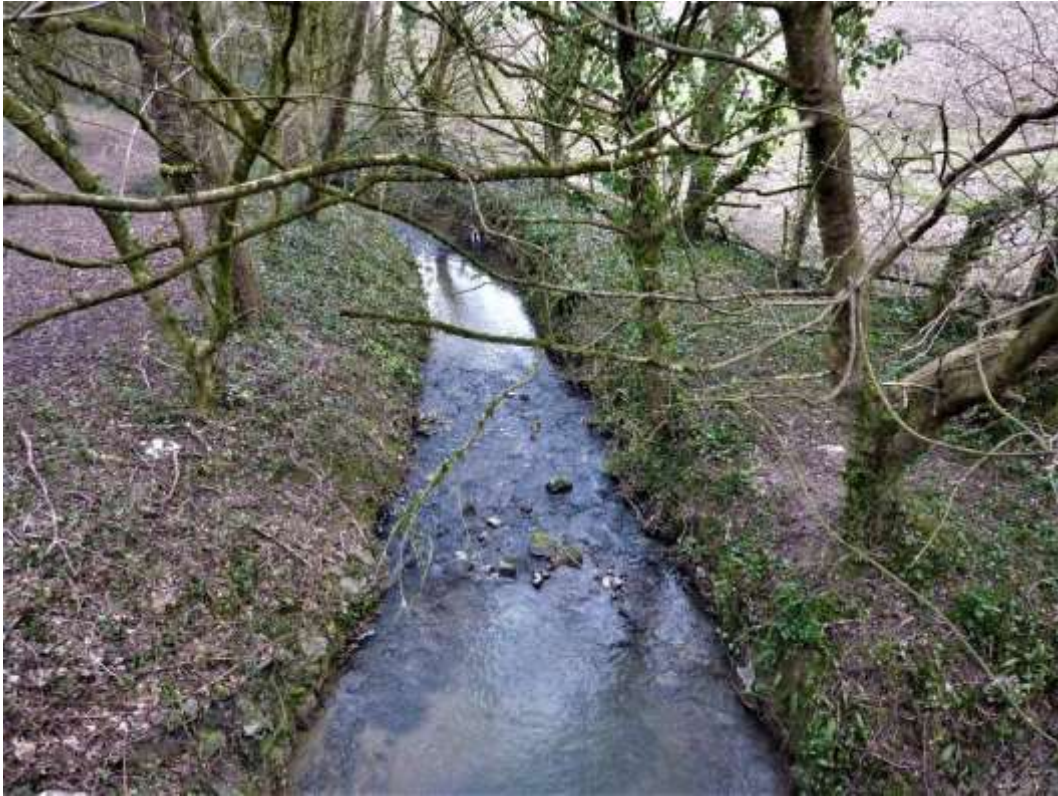
Figure 5: Looking downstream from the A361 Charlton Road bridge

Downstream from the road bridge, the river appears to become progressively more incised and disconnected from its floodplain – although, as shown in Figure 5 above, there is also a recognisable pool and riffle sequence at its upstream end. Adding one or two pieces of Large Woody Material (LWM) at the tail of each pool would help to 'sort' the substrate, creating well-scoured areas of fine gravel favoured by trout for spawning. Extra LWM in the pools would also increase hydrological roughness and habitat complexity for all life stages of fish.

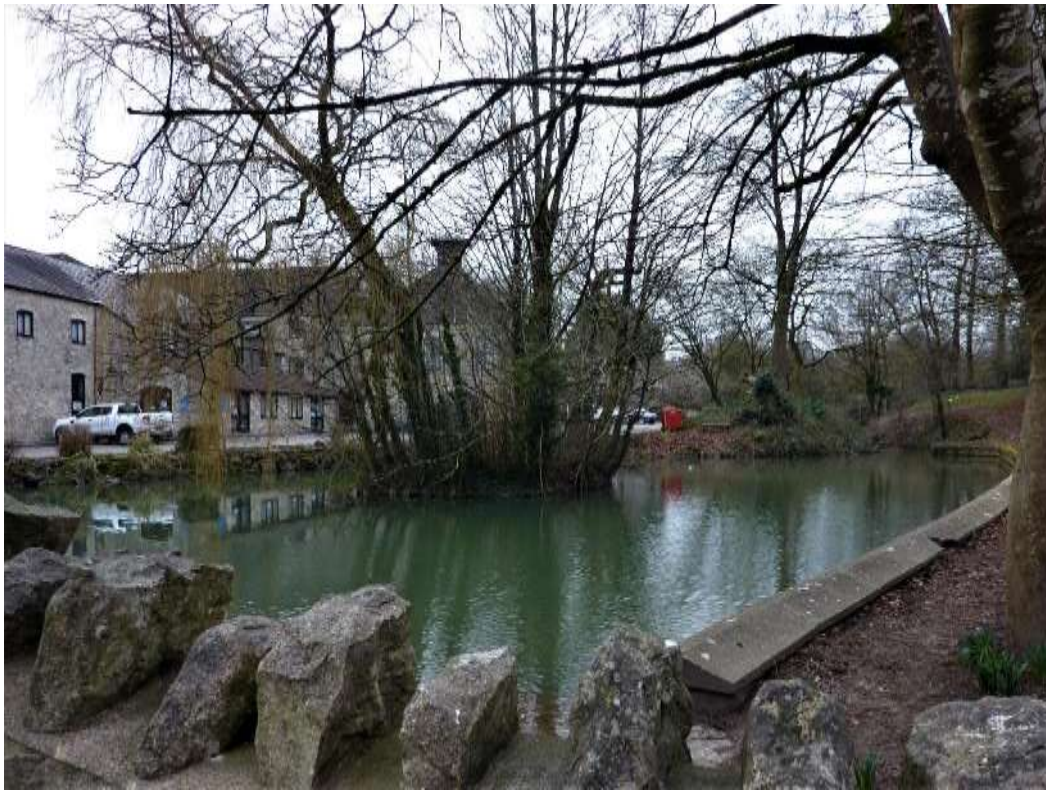
Figure 6: A mill pond adjacent to Martin's Lane

To optimise habitat gains, an important part of the functionality of this concept would be to minimise the throttle on the downstream end, so that the SuDS fills only on the highest flows. Too much of a throttle could result in excessive deposition of fine sediment, leading to maintenance and habitat issues, particularly if subsequent flushing of that sediment occurs (including algal blooms downstream in following years). As part of this project, full fish passage through this area should also be restored.

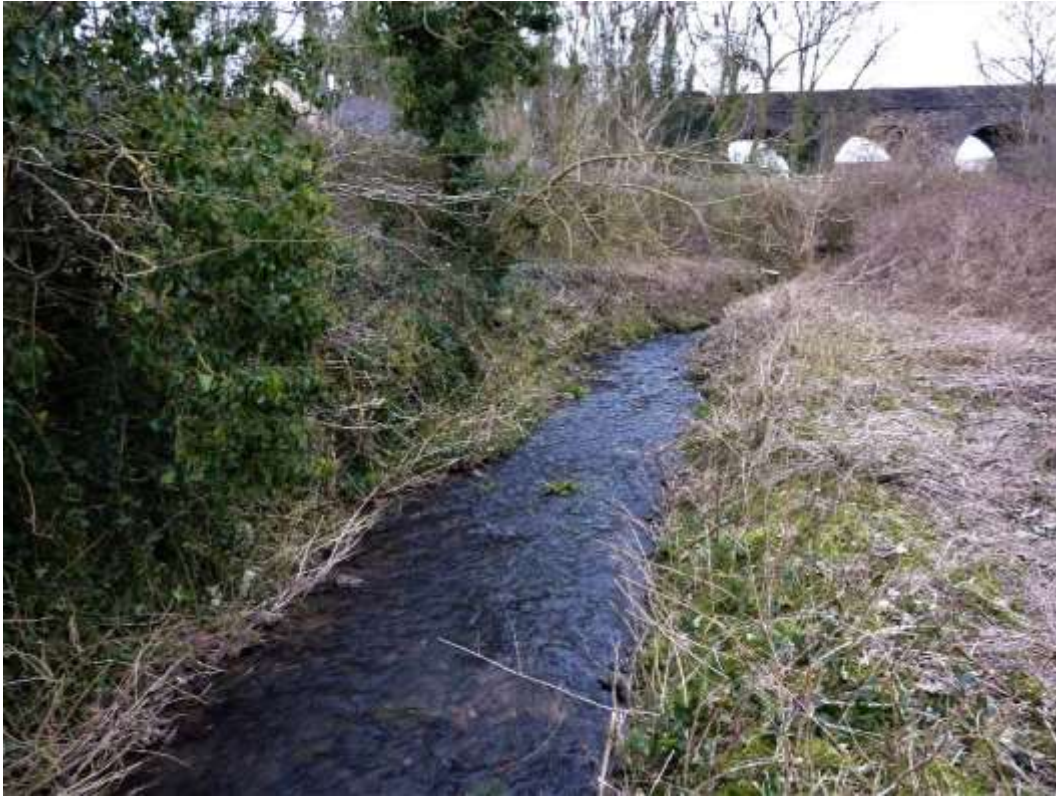
Figure 7: The river is fast, straight and shallow as it flows towards the Charlton Viaduct

With landowner permission, easy access to the river at this point could make it a suitable location for riverfly monitoring by members of the local community. It should also be noted that Wessex Water's Fosse Lane pumping station is consented to discharge a little further downstream at ST 62856 43417 (approx.). The duration of any such discharges is not currently monitored, and it would be useful to gain better understanding of these incidents (potentially also including kick sampling up and down stream of the outfall). It is important to monitor CSOs and ensure that they only discharge during or shortly after excessive rainfall, when the sewage treatment network is unavoidably overloaded (and, importantly, the excess water in the watercourse can dilute the effluent). Any discharges outside of those times are likely to be illegal and constitute pollution events.

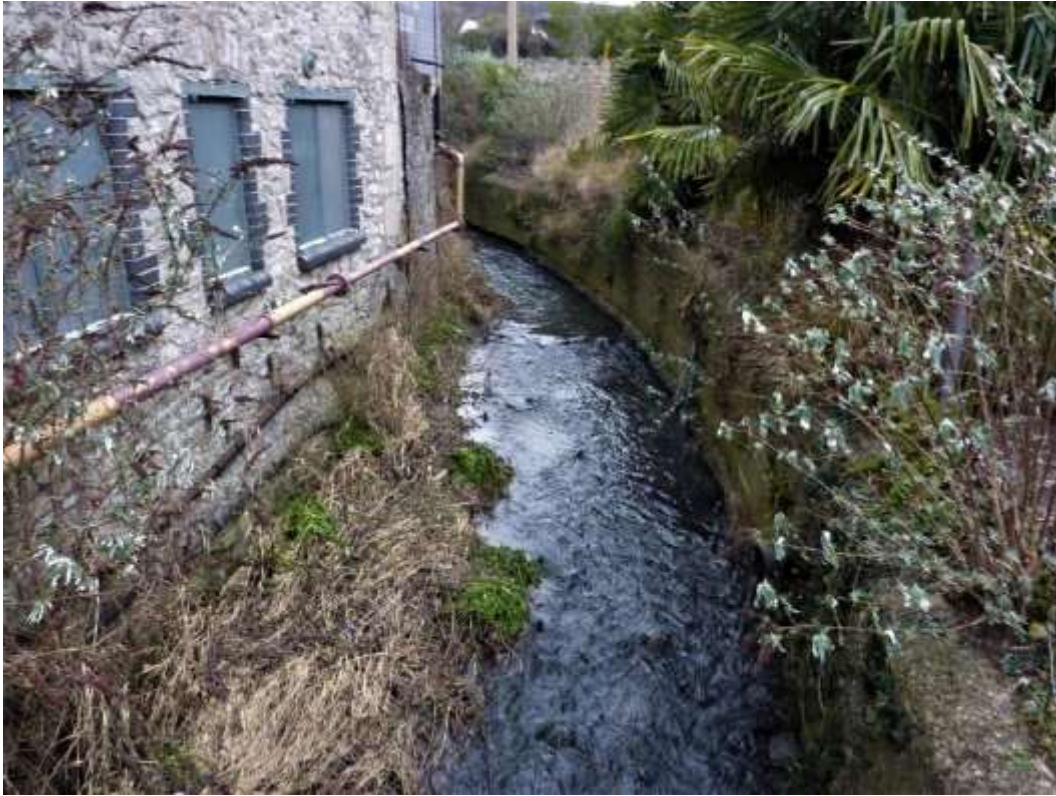
Figure 8: Looking upstream into the short stretch of open channel at Kilver Court, with a valuable vegetated depositional area forming on the inside of the bend

In the longer term, strong consideration should be given to breaking out the culvert and establishing a soft, sloping natural margin on the LB – a measure which could also increase flood storage in this area and reduce flood risk downstream, as well as providing community access to the river. In the meantime, a few depositional areas have accumulated silt and vegetation on the inside of bends (as shown on the RB in Figure 8 above): these valuable softer areas should be retained and even formalised with brush bundles along the toe, before incorporation into the more ambitious project. Small flow deflectors could help to promote localised scour and deposition, creating pockets of habitat in what is mainly a single fast riffle. Supplementary planting of attractive native streamside species such as purple loosestrife, hemp agrimony and water forget-me-not would also help to change perceptions and draw attention to the river as a positive local asset, instead of an overlooked and under-appreciated space.

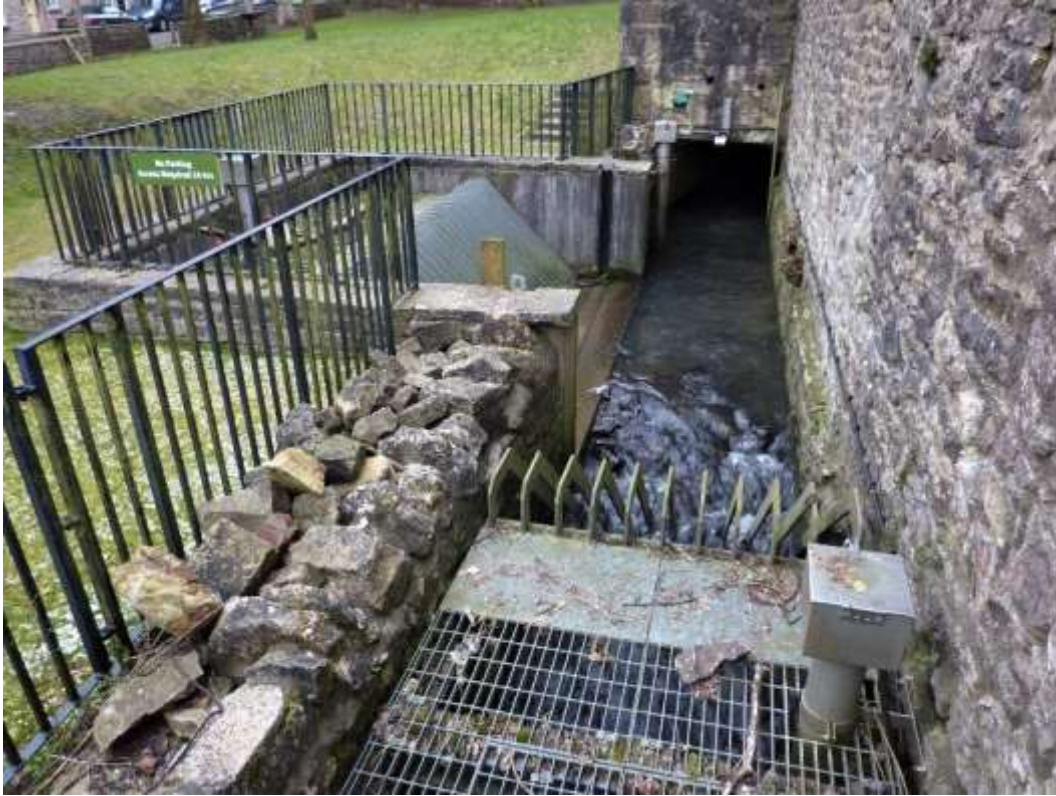
Figure 9: One of three short open culverts in the green space at the western end of Garston Street, which could be broken out as a pocket park for flood storage and social amenity

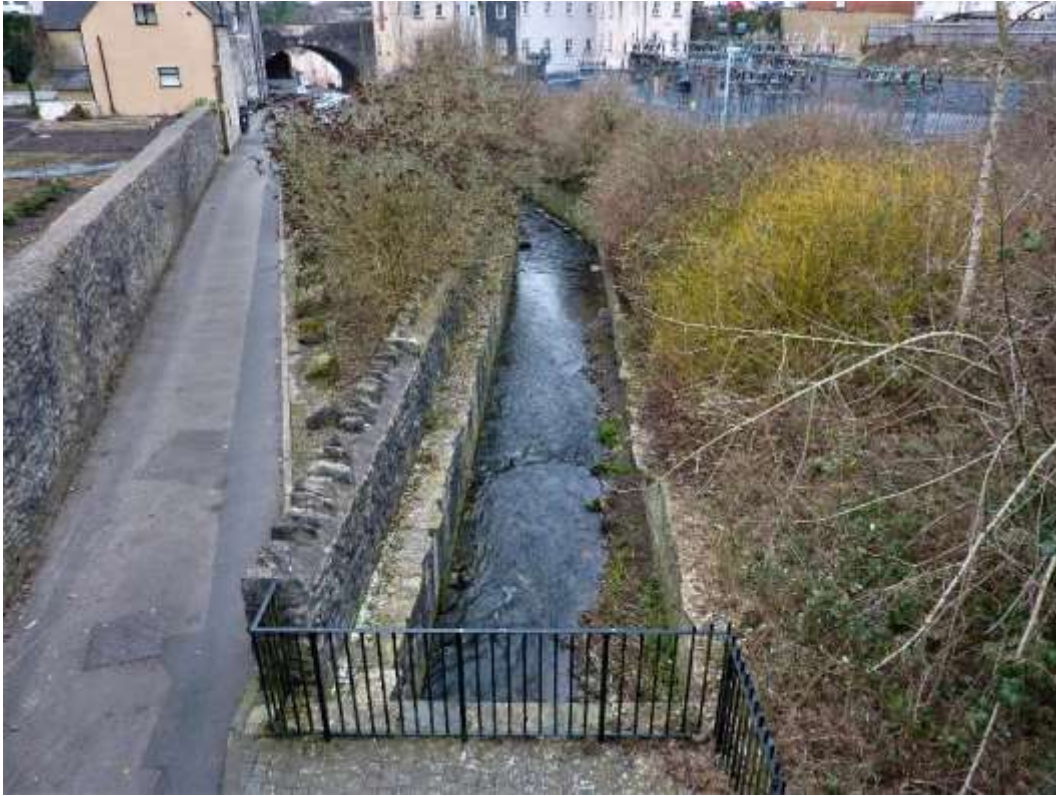
Figure 10: Looking downstream from the high footbridge over the River Sheppey and Lower Lane, with an unsightly transformer station on the RB, and the site of a potential pocket park on the LB

climate change, relocating important electrical infrastructure away from the floor of a flood-prone urban valley should surely be a strategic priority).

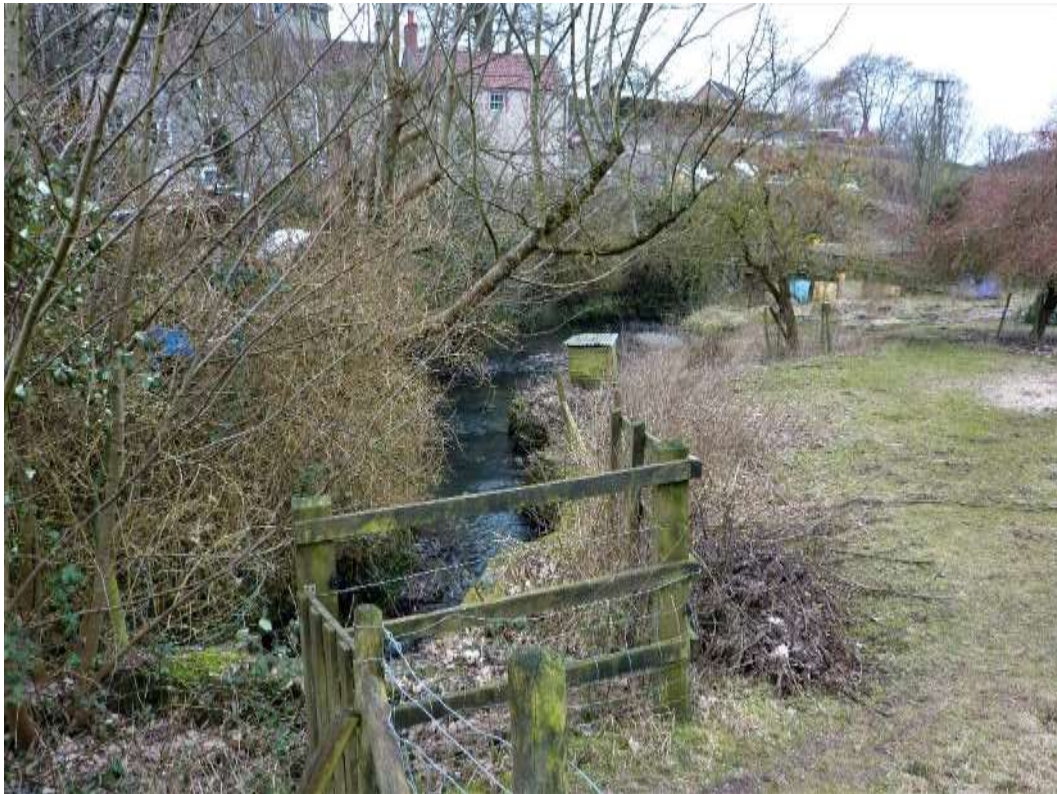
Figure 11: Active geomorphology in the channel beyond Draycott Road

A more ambitious vision for this this area could include meandering the river further out into the fields, with a much more sinuous course. Increasing the overall length of the channel, and reconnecting it with its floodplain, could help to 'slow the flow' and reduce flood risk at pinch points (such as bridges and undersized culverts) further downstream, as well as boosting aquifer recharge and maintaining flows during dryer periods.

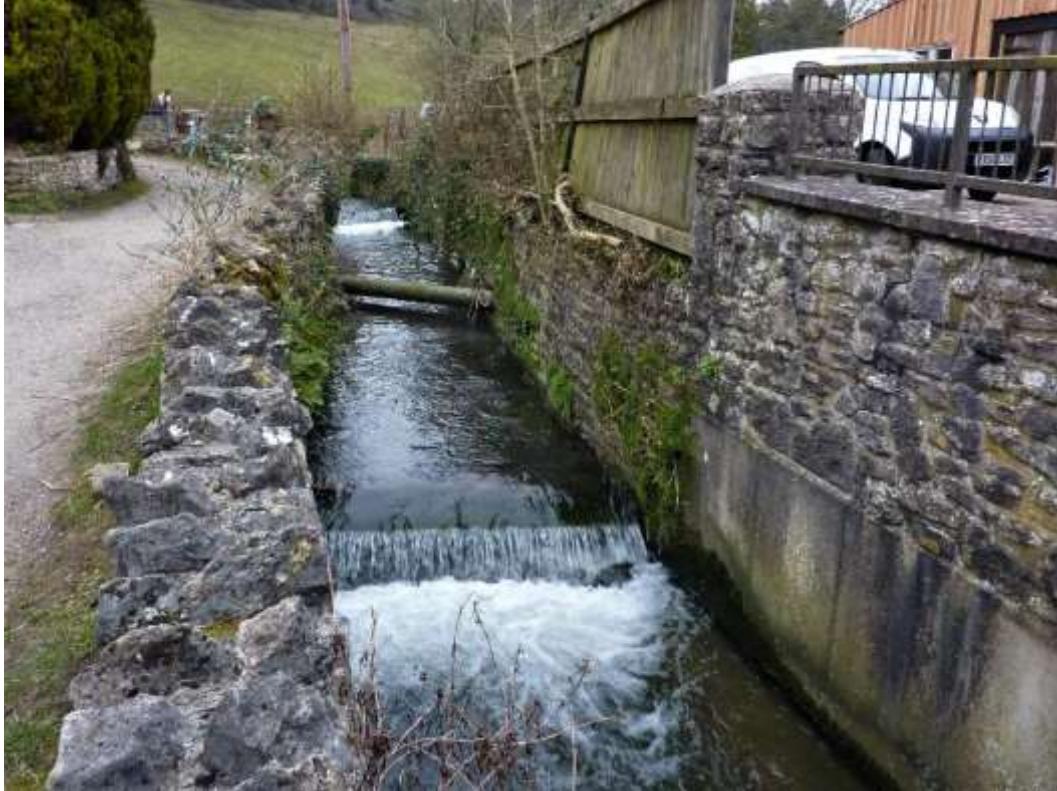
Figure 12: Two weirs at Forum Lane in Bowlish

upstream. Both weirs now appear to be redundant, but are likely to be obstructions to fish passage in many flows, and should be removed.

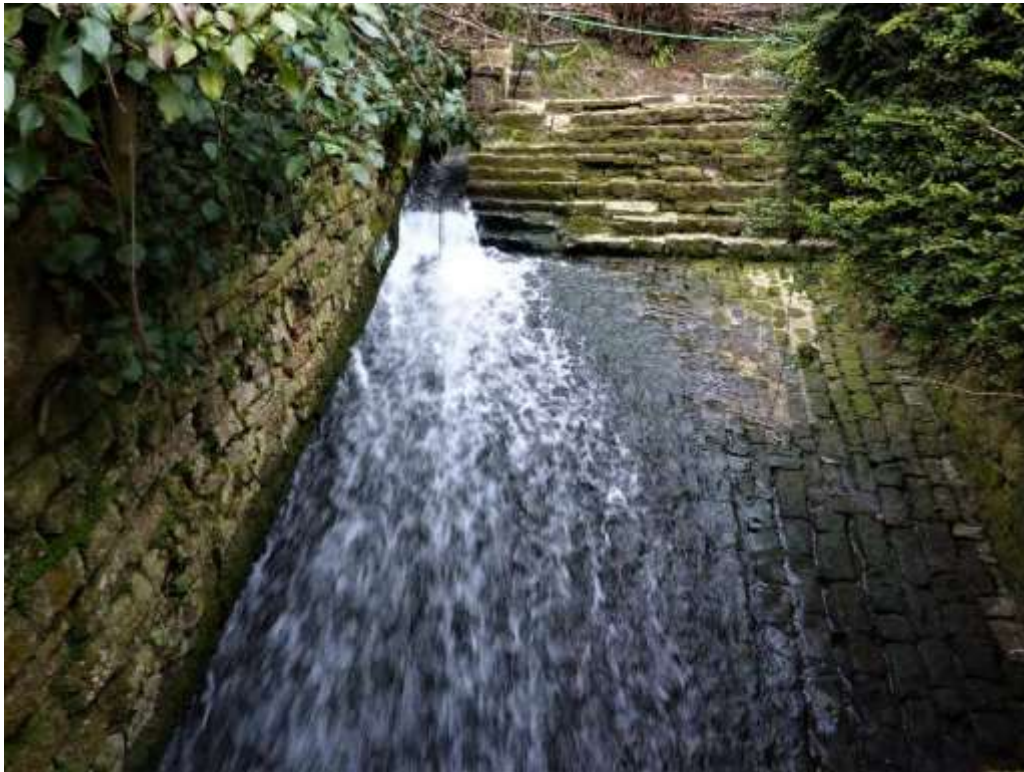
Figure 13: Shallow, impassable flow down Ham Mill weir

In addition to fish passage issues caused by the weir, the straight high-level leat which once provided a steady flow of water to the mill is probably also now a flood risk issue for residential properties in this area. As such, the best combined solution for flood risk management, sediment transport and fish passage improvements alike would be removing the weir completely. If this is not possible for any reason, other options for enhancing fish passage should certainly be investigated.

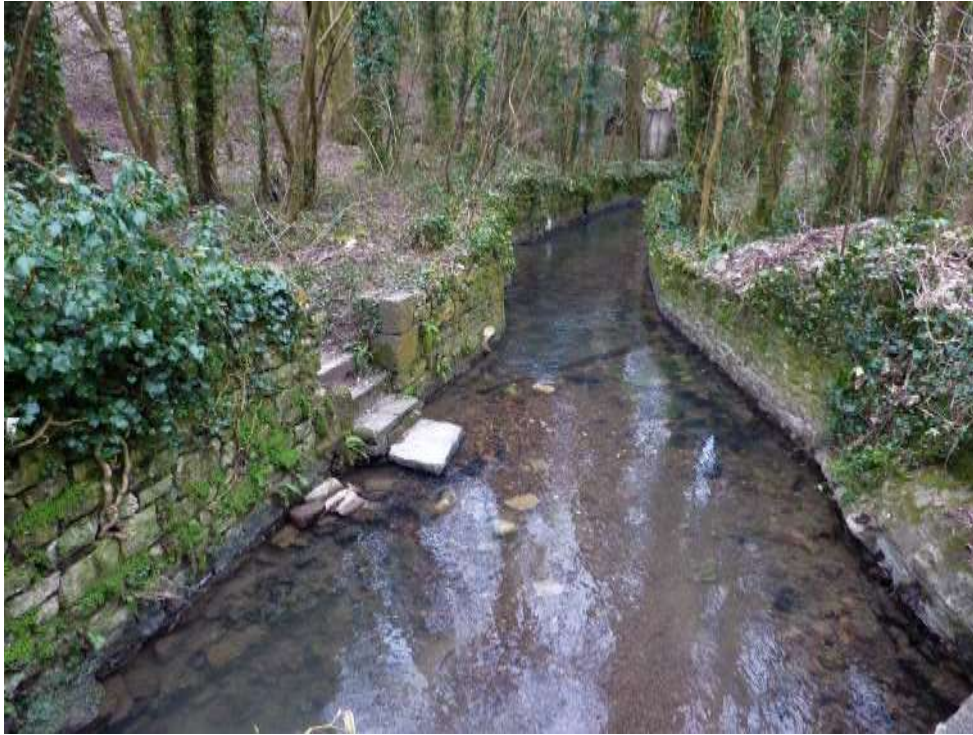
Figure 14: The River Sheppey downstream of Ham Mill

Adding LWM to this stretch of constrained, stone-walled channel would help to accelerate natural processes of scour and deposition – including ‘sorting’ and desilting the cobble and gravel substrate, thus providing better spawning conditions for fish. Some of this LWM could be locally won through selective tree thinning or skylighting, letting more light into the channel and helping beneficial macrophytes such as water crowfoot to become established. Such beds of water crowfoot would increase localised scour and deposition, and provide excellent habitat for many insect and fish species.

As shown in Figure 14 above, a convenient flight of steps provides unusually easy access to the river at this point: with landowner permission, it could be a suitable location for riverfly monitoring by members of the local community.

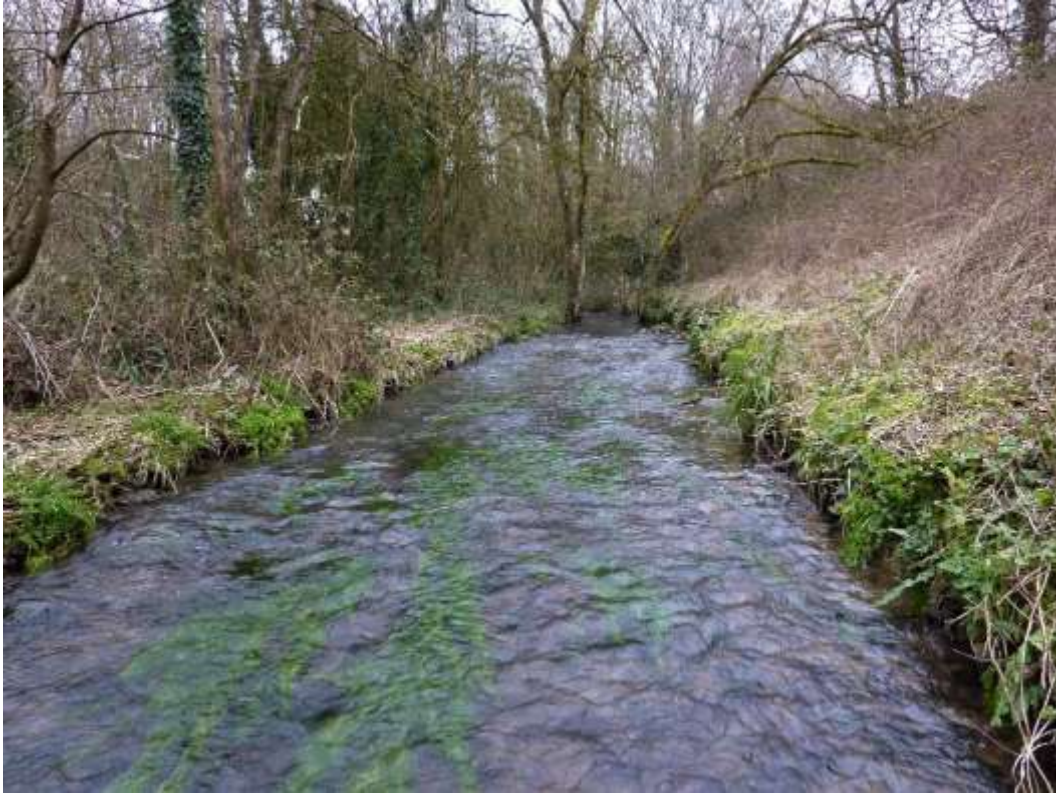
Figure 15: A more open, naturalistic stretch of river, with abundant water crowfoot

In this area of naturalistic soft banks (rarely seen in the course of this survey), it was unfortunate to note clear signs of infestation by invasive American signal crayfish, whose distinctive half-moon burrows undermine banks and dump large quantities of silt into affected rivers. At present there is no known method of eradicating signal crayfish, but they can be discouraged from burrowing into vertical banks by regrading to a very shallow batter and re-lining with cobbles. This makes the margins undesirable for crayfish, without restricting a vegetated fringe from redeveloping - an approach which could usefully be implemented here.

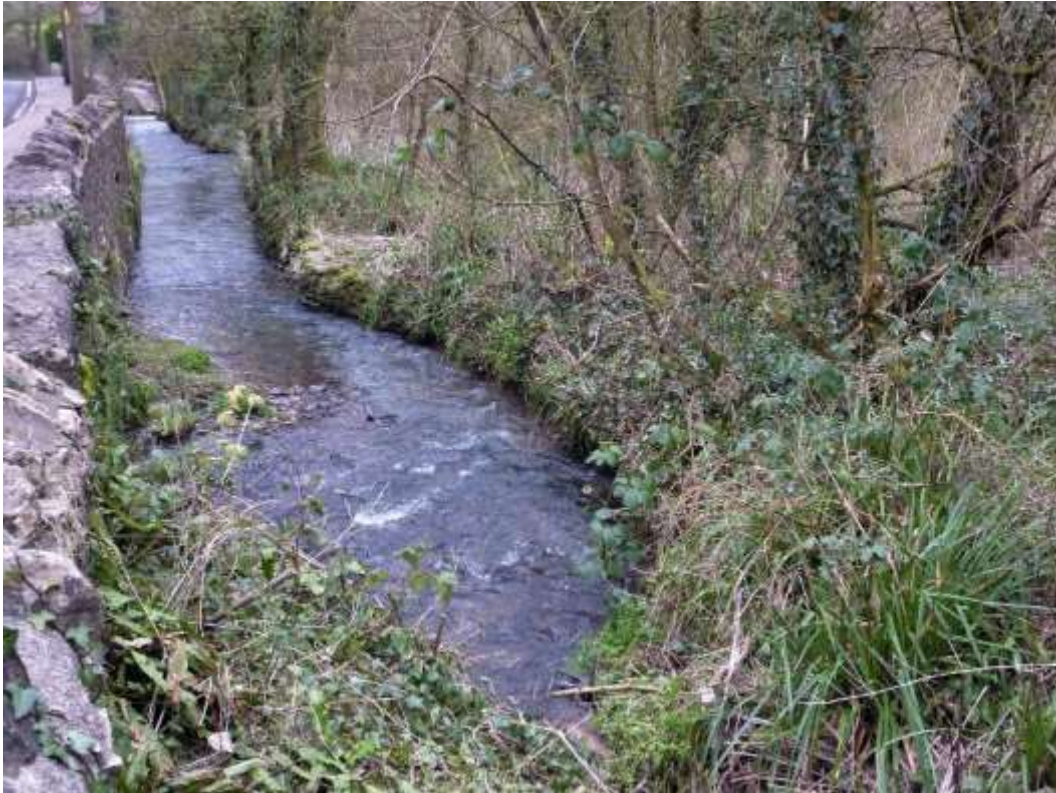
Figure 16: The River Sheppey in the renaturalised Darshill Mill pond

After flowing under the A371 Wells Road again, the River Sheppey emerges into the old mill pond of what was once Darshill Lower Silk Mill. This pond has been very successfully renaturalised as an area of wet woodland: the river runs close beside the road, while the rest of the former impoundment is braided with channels supplied by the nearby Orledge spring. The whole area is now owned and maintained by the Darshill and Bowlish Conservation Society (D&BSC).

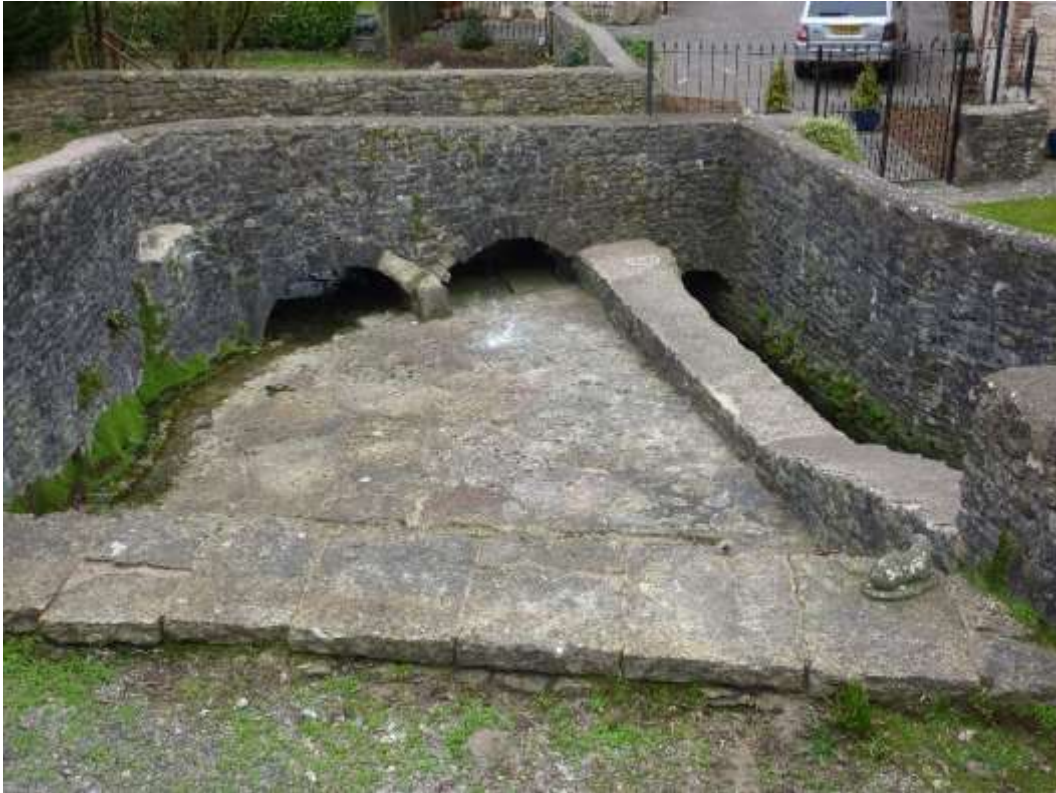
Figure 17: The complex weir structure at Darshill Mill: lower flows are presently channelled down the steep chute on the right hand side of this photo

At Darshill Mill (ST 60731 43886) the River Sheppey pours down into a culvert through a system of sluices and overflow channels (on the right hand side of Figure 17 above). Due to the height and complexity of this structure, it is considered to be impassable to fish in all conditions of flow. Due to the pinch point that it creates, it is also very likely to be adding to flood risk in the immediate area.

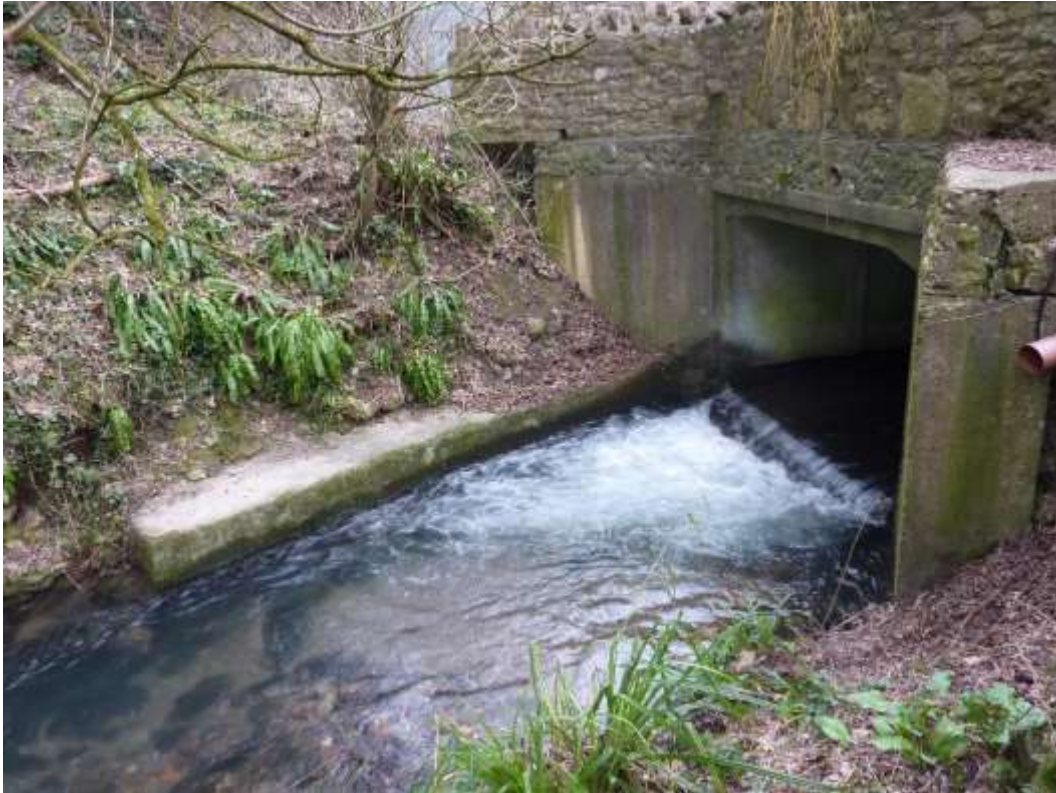
Figure 18: The culvert pool at the Darshill Mill access bridge

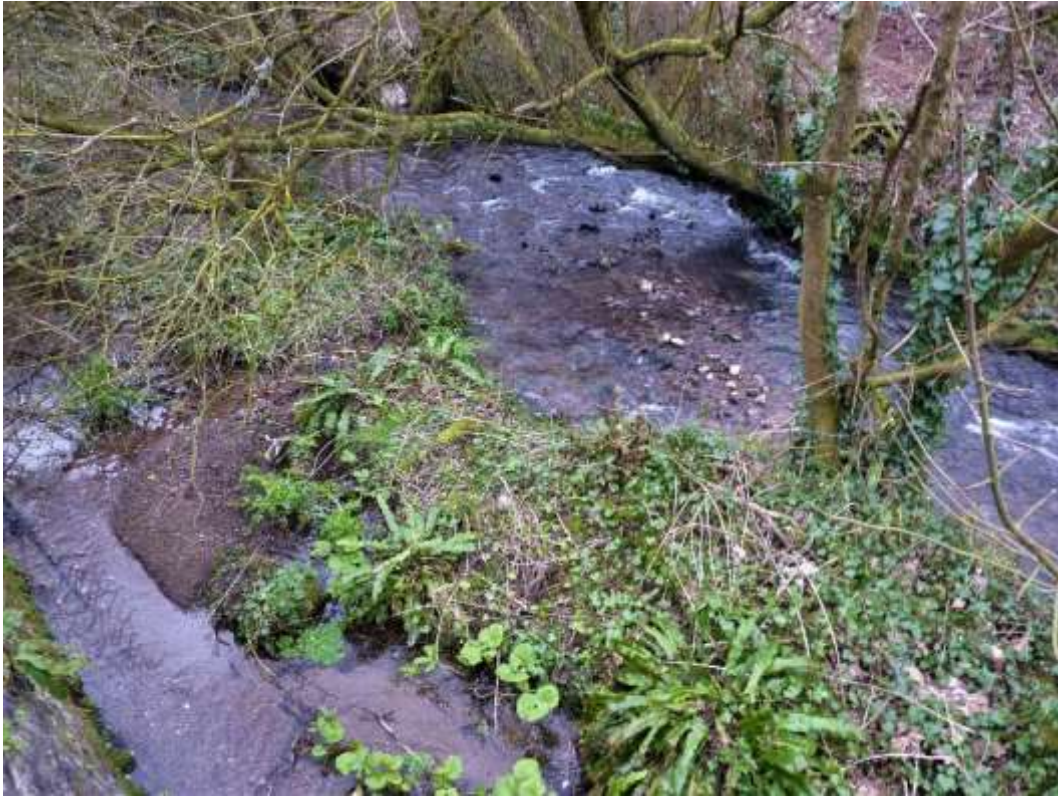
Figure 19: Steep but getting more complex: the River Sheppey approaching Darshill Middle Mill

Although still fairly straight and steep, the channel seems hydromorphologically active, with the beginnings of mid-channel bars (as shown in Figure 19 above) and even braids where the flow from a small tributary joins from the RB. In this area, it would be beneficial to hinge a few small trees into the edges of the channel to promote localised scour, deposition and sorting of the gravel and cobble substrate, as well as providing low, complex cover for fish.

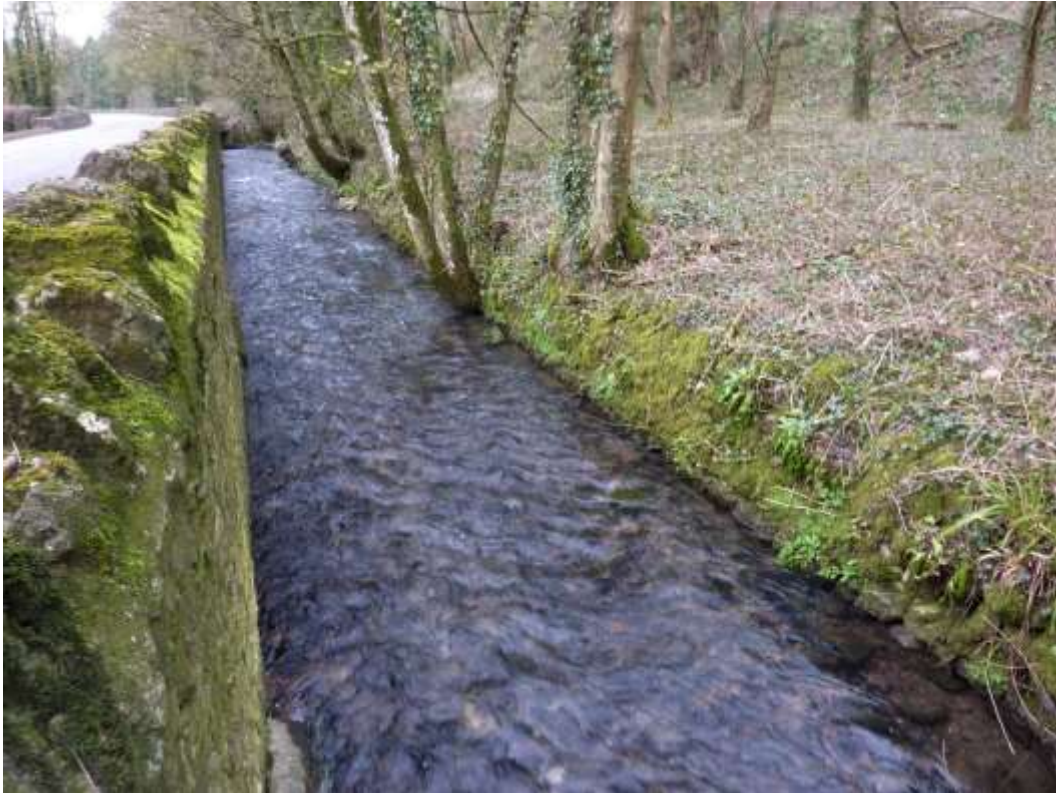
Figure 20: Approaching the Shepton Mallet STW, the river channel would benefit from added LWM for diversity and hydraulic roughness

It should also be noted that a CSO from the Shepton Mallet STW is located about halfway down this reach: this is not currently monitored by Wessex Water, so studying its impact on the river with riverfly monitoring and other citizen science projects would be interesting.

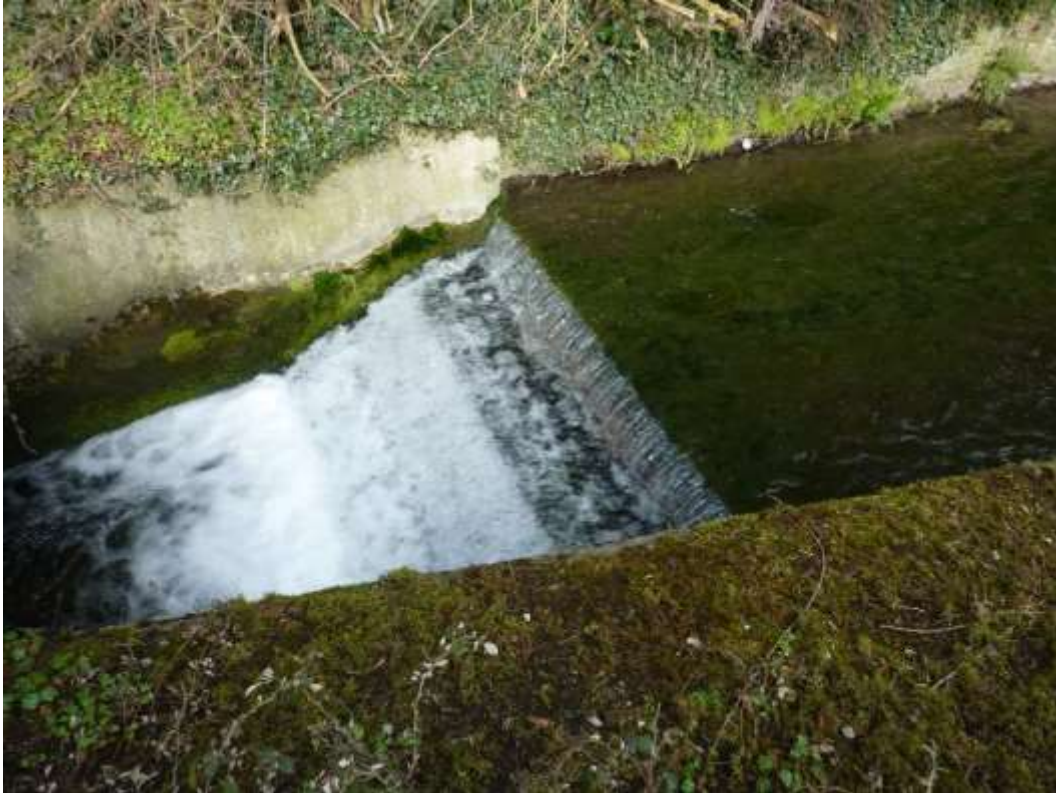
Figure 21: A weir just upstream of the entrance to Shepton Mallet STW

The weir is considered to be impassable to all fish, and complete removal is recommended, re-grading the channel accordingly through this reach.

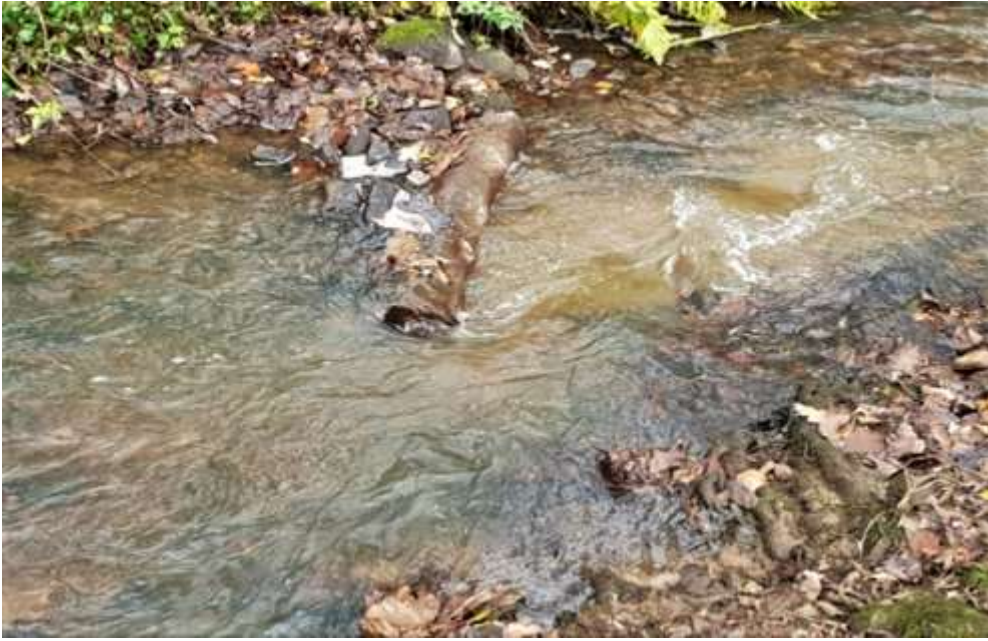
Figure 22: A flow deflector log pinned at an angle, using rebar stakes, partially across the stream (split chestnut stakes can also be used). In order to create scour in the centre of the channel, the log is angled upstream. At lower flows, the stream width is reduced, keeping the gravels clean and helping to move mobile sediment downstream. Higher flows can run over the top with little impediment.

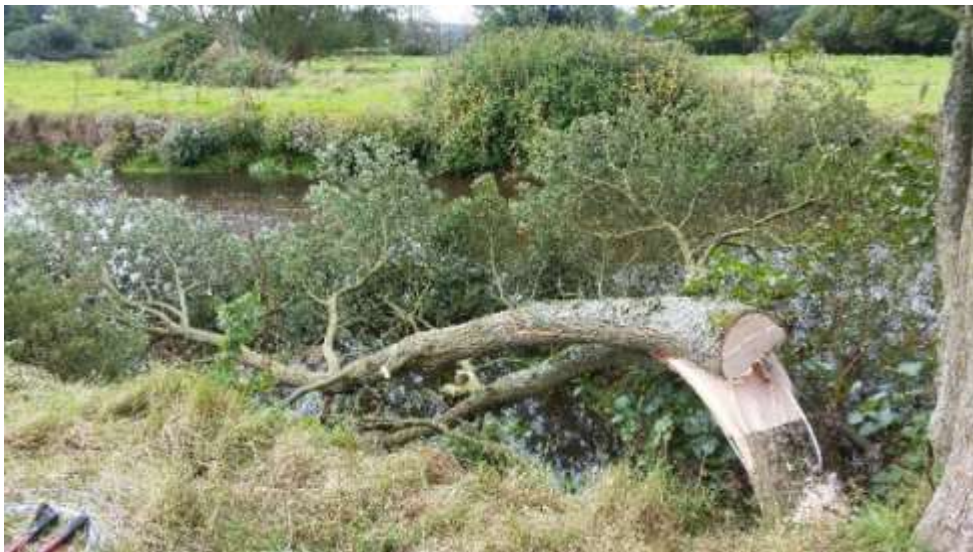
Figure 23: To reduce overshading and increase habitat, bankside trees can be hinged into the edge of a river so that they can continue to grow (depending on species) and provide low-level cover for fish, insects and birds. For extra security, the branches can be staked, or the trunk can be cabled back to the stump.

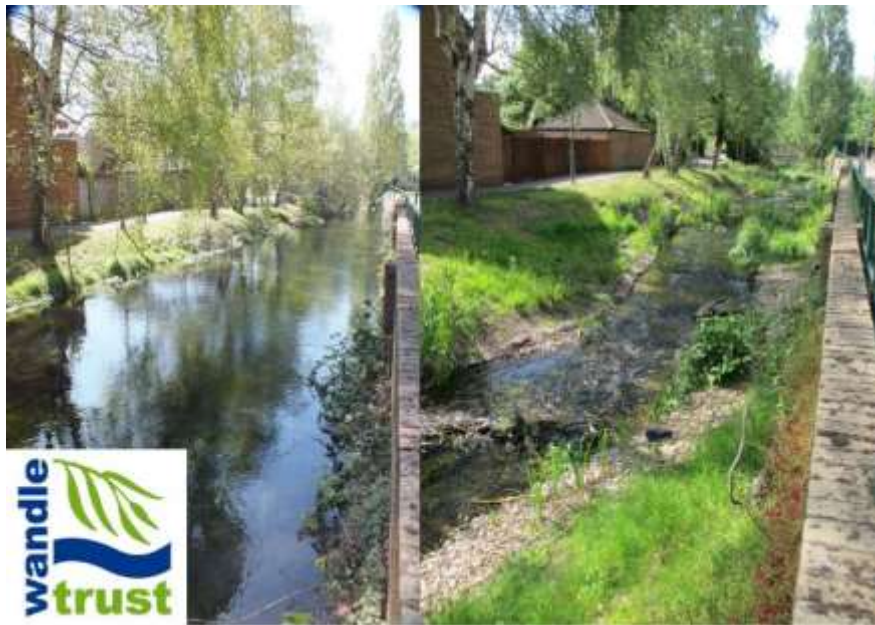
Figure 24: Before and after: an impounded and ecologically impoverished stretch of river (left) can be renaturalised by removing the weir, and then re-grading and re-meandering the channel through the site (right). Connectivity, sinuosity and natural processes have all been restored to this stretch of the River Wandle in Carshalton, south London.

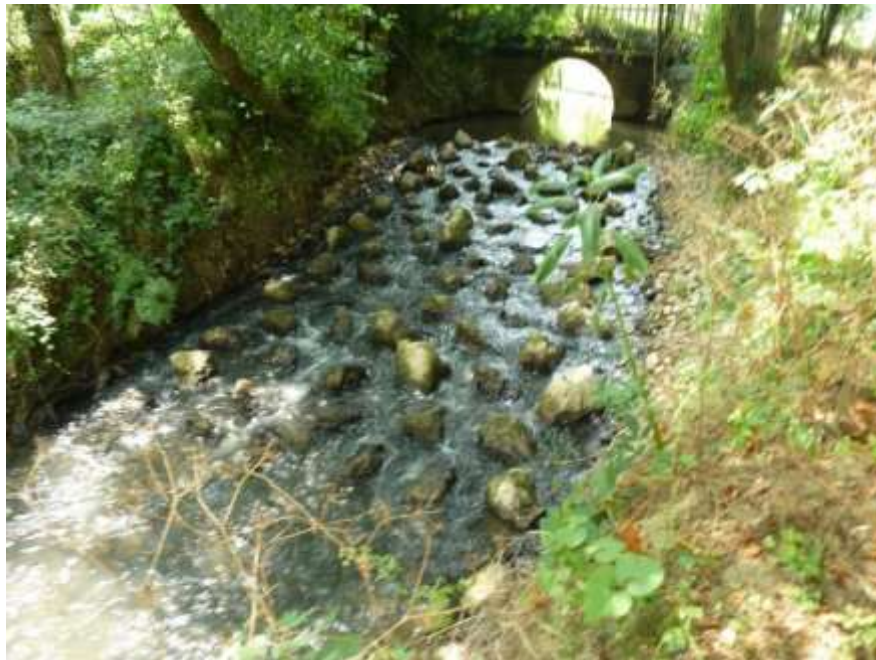
Figure 25: A rock ramp is an effective fish passage solution when a culvert cannot be modified with baffles or other easements, and a step up into it may need to be 'drowned out'. This example uses a series of erratic perturbation boulders to baffle the flow and ease fish passage.

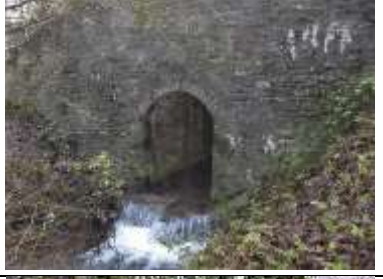
1	ST 63170 43038	Fish passage: restore fish passage with rock ramp or oak board easement
Channel beside flood attenuation basin

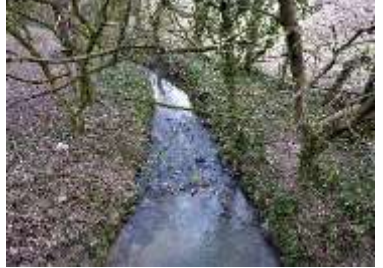
1	ST 63179 43070 (approx.)	Habitat: introduce LWM deflectors or tree kickers to create more sinuous flow, increasing channel roughness and habitat pockets

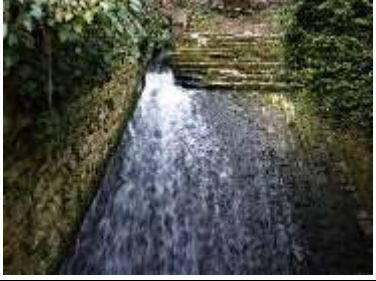
Ham Mill weir

2	ST 61039 43960	Flood risk, fish passage and habitat: investigate options for removal or other fish passage enhancement
Channel downstream from Ham Mill

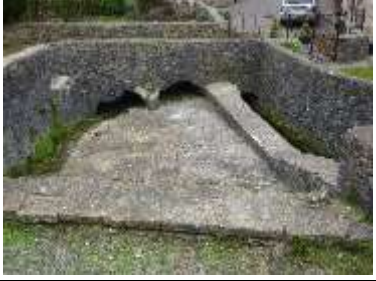
Darshill Mill weir complex

1	ST 60728 43887	Flood risk, fish passage and habitat: investigate options for removal of weir or other fish passage enhancement
Darshill Mill access bridge footings

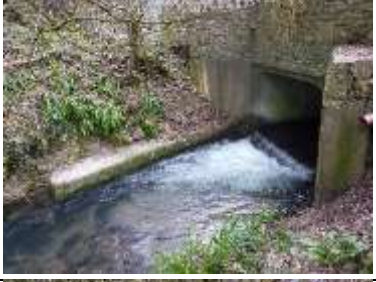
2	ST 60579 43918	Fish passage: chisel notch into downstream sill and add low cost baffles for depth and turbulence over flat concrete footings
Channel approaching Darshill Middle Mill

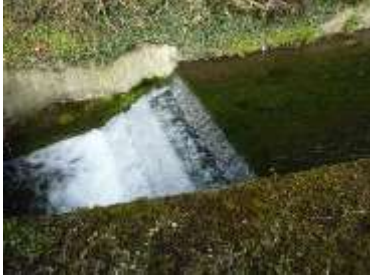
Weir adjacent to Shepton Mallet STW, plus culvert just downstream

1	ST 60066 43968	Fish passage and habitat: remove weir and regrade river through this stretch; also address fish passage through culvert under bridges just downstream
---	---	---	---------------------------	---
