River Sheppey, Shepton Mallet, Somerset

Wild Trout Trust report on walkover surveys carried out on 13 February and 5 March 2021

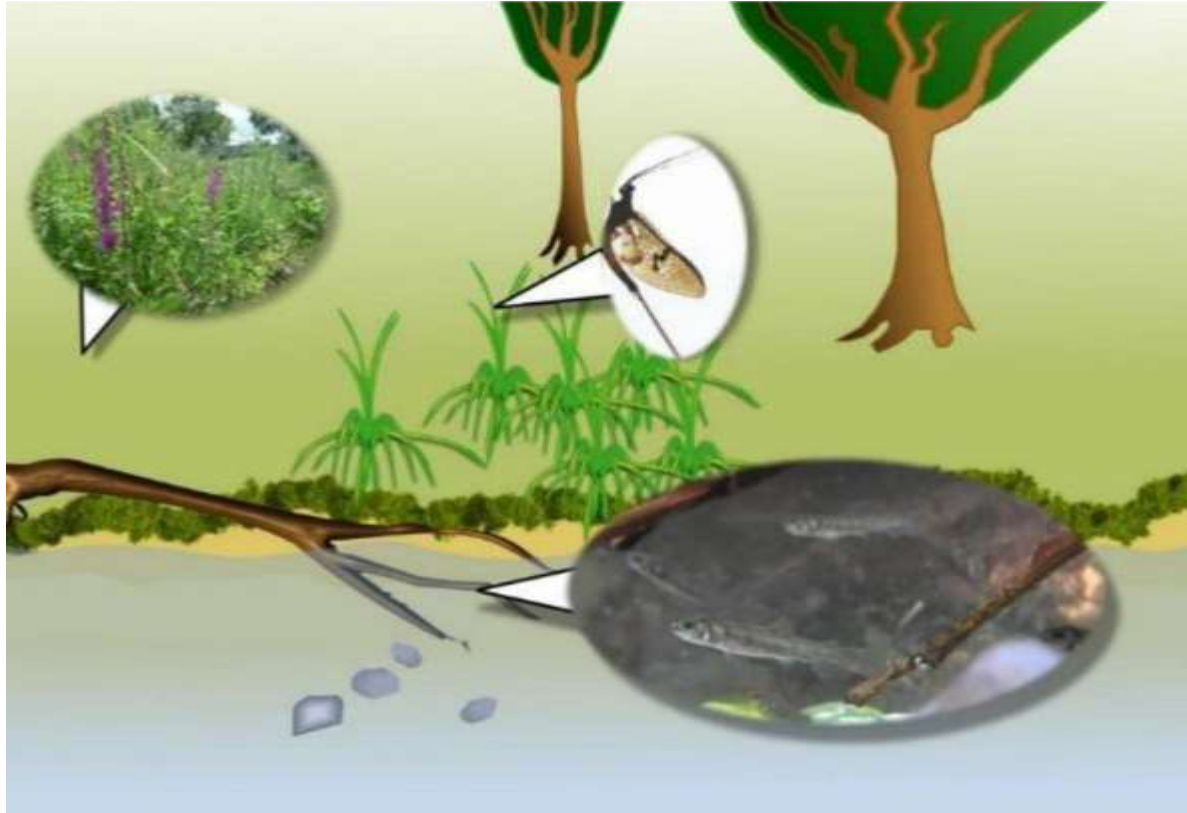
Figure 29: Larger cobbles and submerged 'brashy' cover and/or exposed fronds of tree roots provide vital cover from predation and spate flows for tiny juvenile fish in shallower water (<30cm deep). Trailing, overhanging vegetation also provides a similar function, and has many benefits for invertebrate populations (some of which will provide a ready food supply for the juvenile fish).

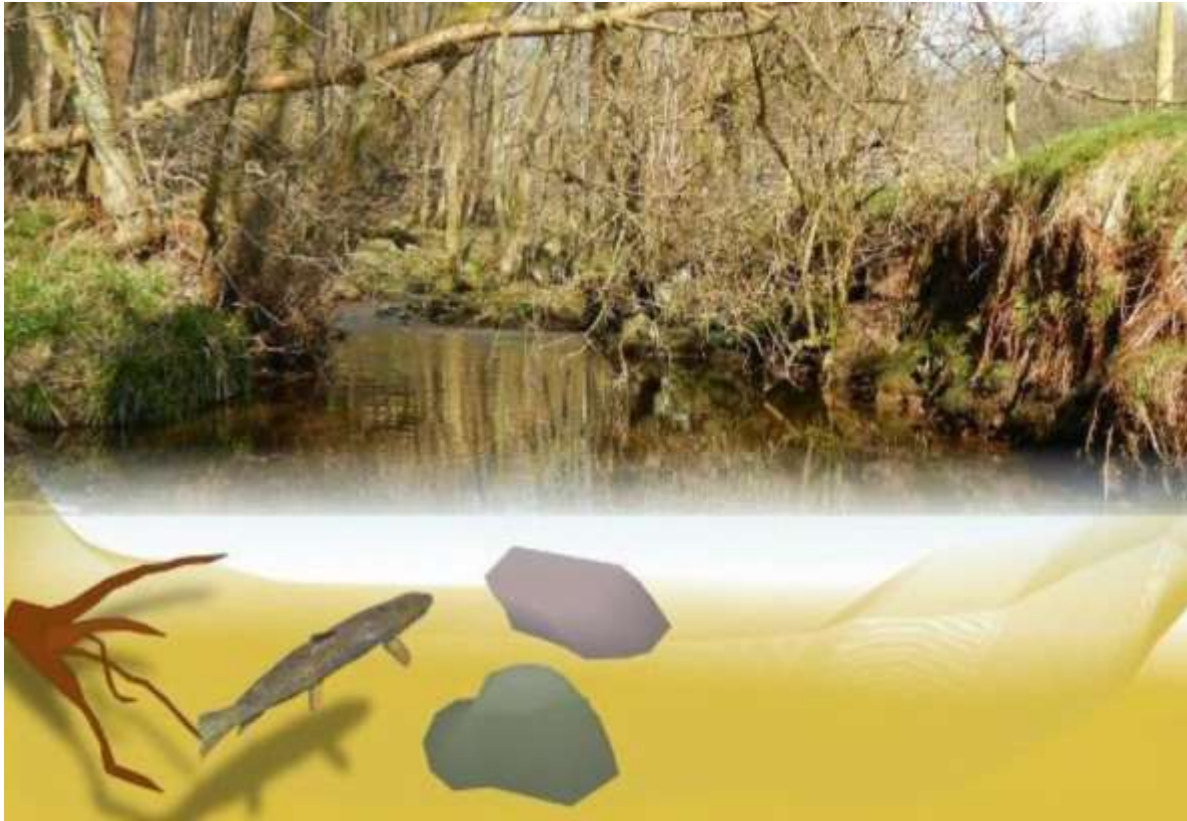
Figure 30: The availability of deeper water bolt holes (>30cm), low overhanging cover and/or larger submerged structures such as boulders, fallen trees, large root-wads etc. close to a good food supply (e.g. below a riffle in this case) are all strong components of adult trout habitat requirements.
