WILD TROUT TRUST

Advisory Visit Report

River Dikler

February 2026

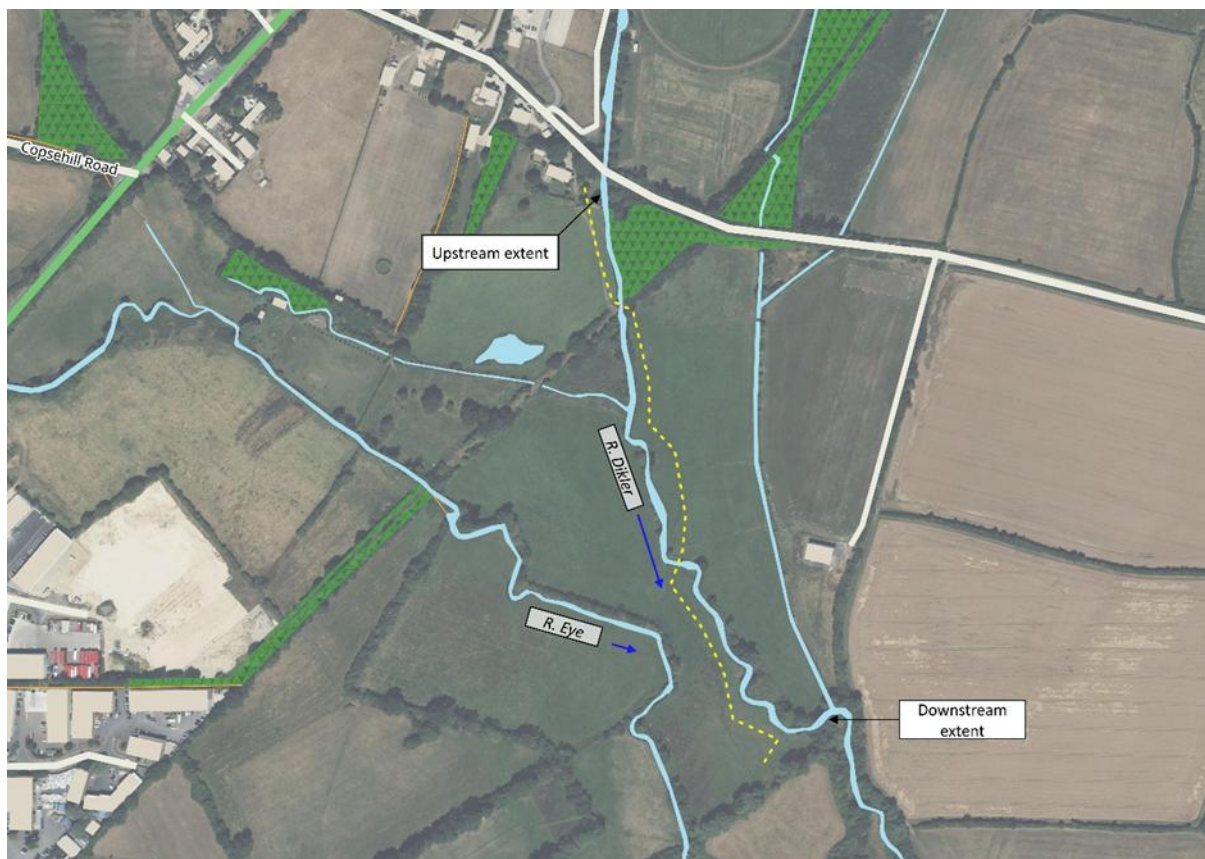
*Map 2 Showing the route taken during the visit (yellow dashed line) and River Eye location on the western side of the property.*

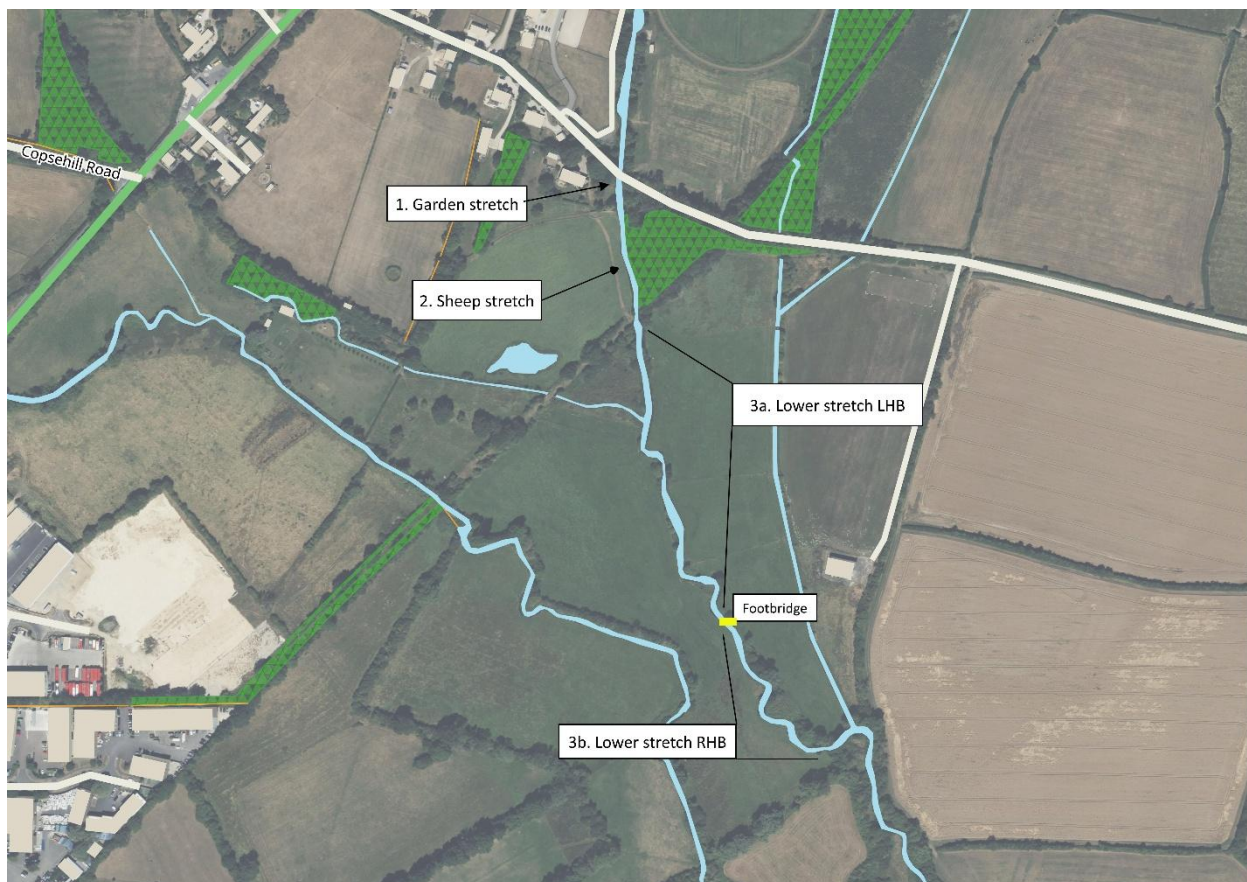
*Map 3 The separate sections of watercourse, as described in the CRT and WTT reports.*

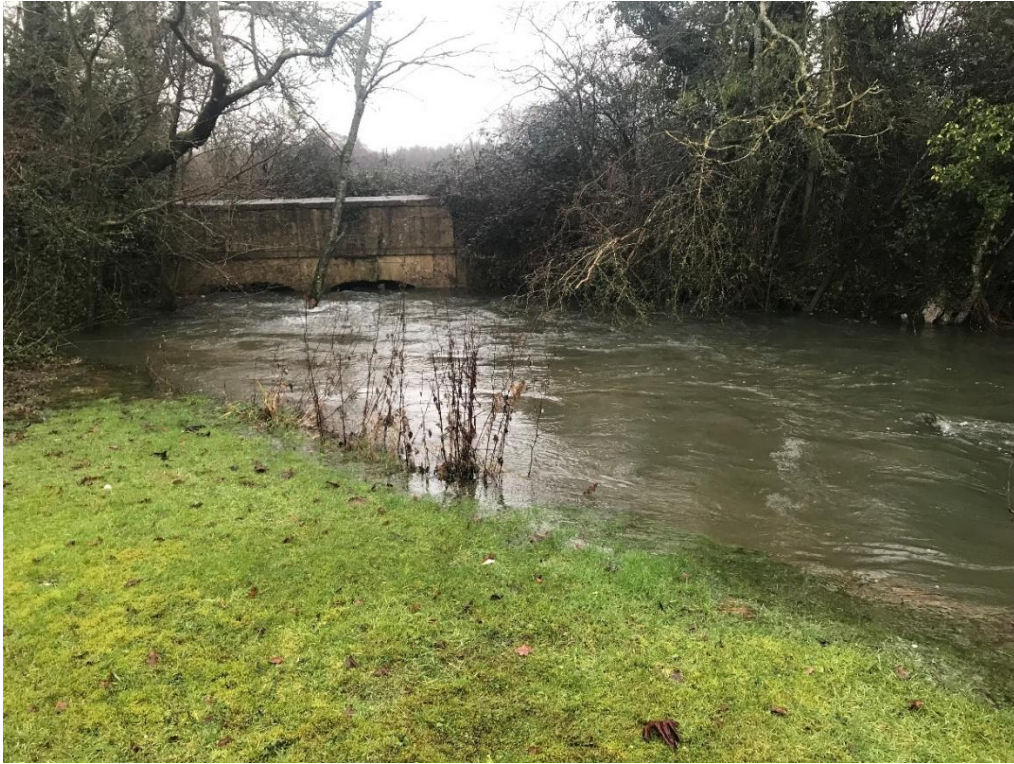
*Photo 1 51.899431 , -1.7440592 The Dikler entering the garden section from under the road bridge. The height of the water made it difficult to assess habitats in the channel, but it is beneficial to view the river at this height to judge the influence the energetic high winter flows will have on habitat formation. The lawned section could be vulnerable to back eddying and erosion due to the lack of protection from mature vegetation and complex root systems that bind the bank together and armour it against flows.*

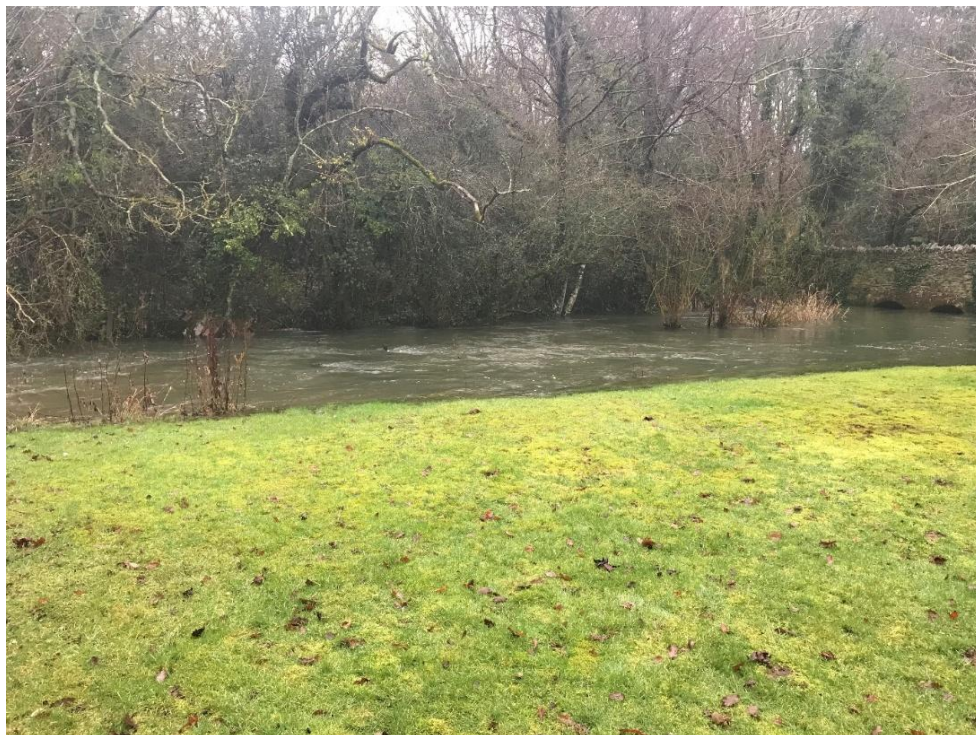
*Photo 2 A wider view of the lawn edge. Allowing a marginal fringe – a section maybe 1m-2m wide between the edge of the river and the lawn which isn't mowed*

*will make some delightful habitat for many insects and mammals. However, this is less critical given the presence of the mature woodland on the far bank (but still good to help protect the lawn from erosion). The woodland will also provide an excellent source of large woody material that can be used to enhance river habitats in the channel potentially, once levels drop in the summer to fully assess where this could benefit in-channel habitat creation.*

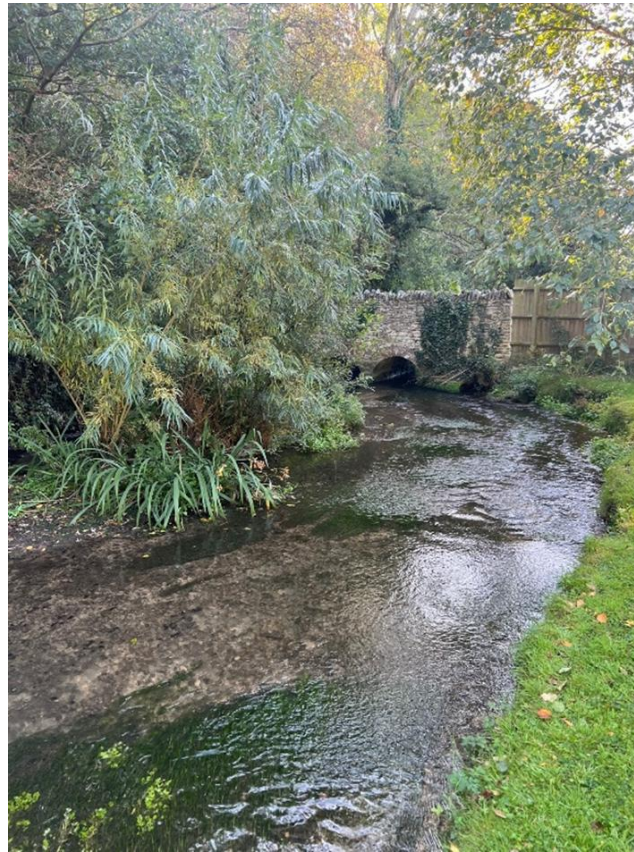
*Photo 3 (Courtesy of Cotswold Rivers Trust) The Garden Section during normal summer flows, looking good with marginal and overhanging vegetation on the far bank and submerged aquatic plants manipulating depths and flow velocities; very trout and aquatic insect friendly due to the variety of depths, flows and appropriate physical 'cover' available. This would be transformed further by a tall fringe of native plant life along the edge of the lawn and trailing in the water.*

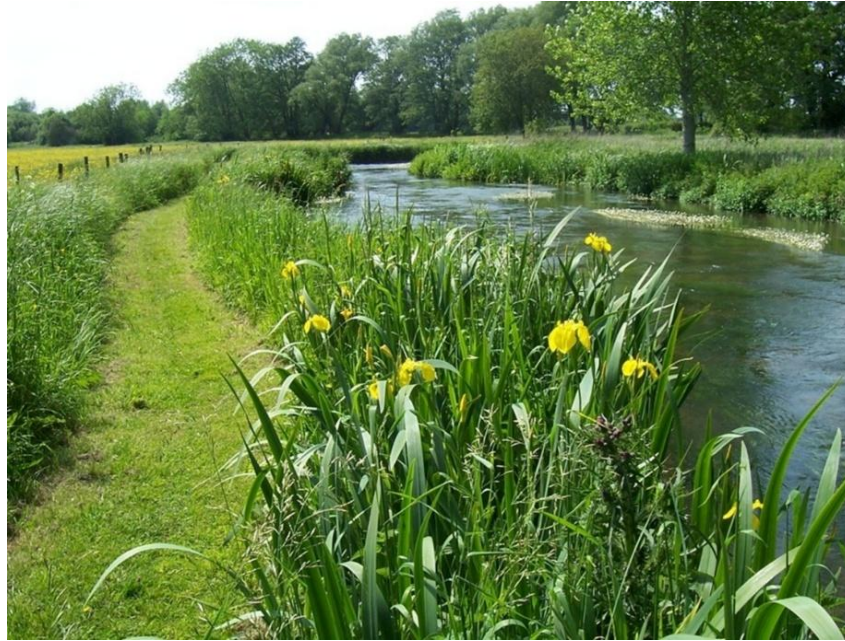
*Photo 4 Example of a narrow marginal fringe between mown grass (in this case a pathway) and a river providing an excellent habitat buffer between the two with multiple biodiversity benefits.*

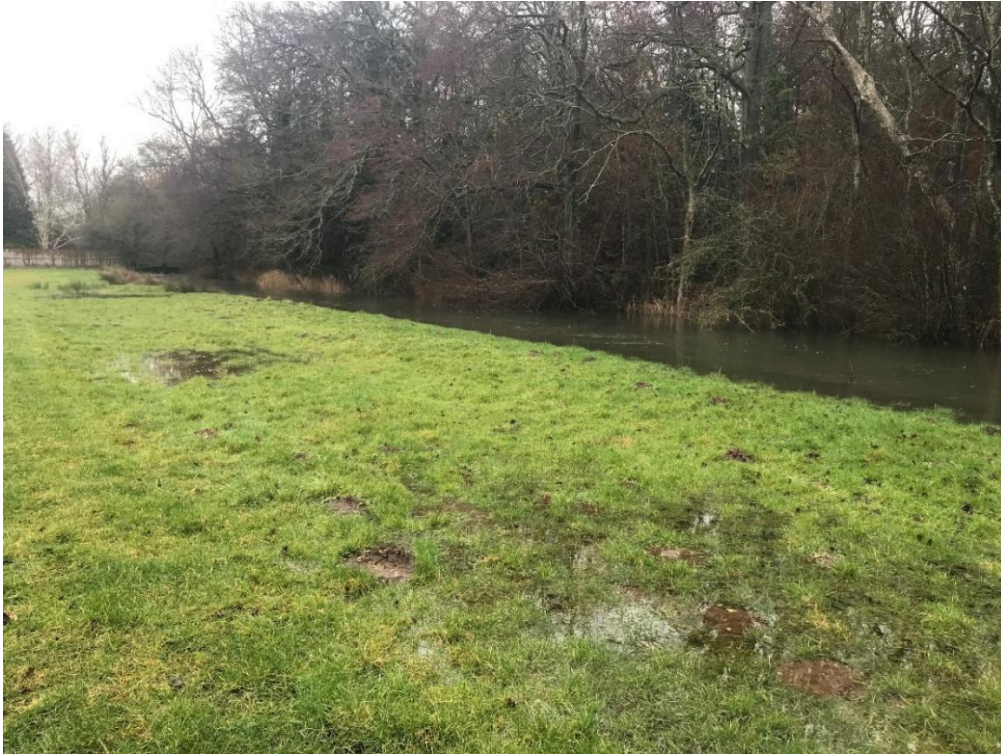
*Photo 5 51.898990 , -1.7439975 Looking upstream from the middle of the Sheep Field. Fencing this whole section of river, well back from the water's edge to keep grazing livestock out will allow riparian vegetation to establish and mature, providing habitat for terrestrial wildlife as well as adult aquatic invertebrates. Developing vegetation in the marginal area will provide important physical habitat for fish, providing cover from predators and especially important for juvenile trout in the shallow water areas.*

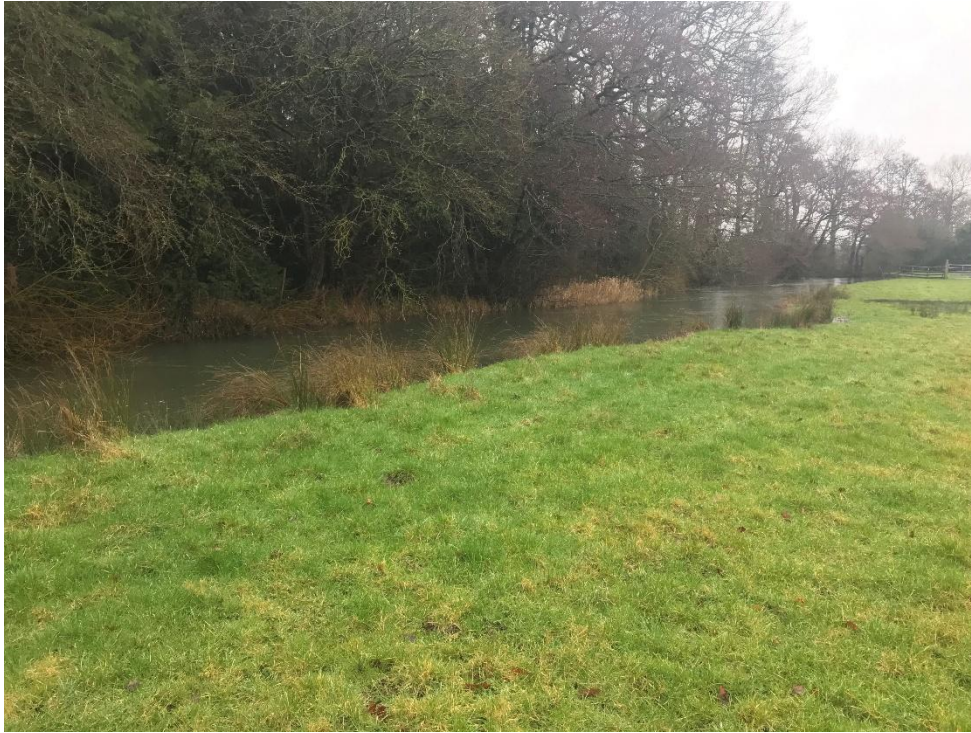
*Photo 6 51.898727 , -1.7438875 An abundance of standing timber on the far bank will provide plenty of material for introducing beneficial large woody material features to the channel. Locating timber in the channel correctly will work with the erosive and depositional processes between high and low flows to drive variation in bed level and diversity in areas of flow velocity required by fish and aquatic invertebrates. Ideally, this is carried out by first looking at how the watercourse is developing during low flows and then creating sinuous flow pathways and constrictions in the channel between LWD installations to maintain both flow velocity and areas of flow diversity. Depositional areas behind LWD will help to form and consolidate minor meanders in the wetted channel, to help mitigate the effect of the straightened channel. Natural, large pieces of timber are preferred over built brushwood structures, as they mimic natural introductions of wood to the channel and allow the river to work around them and adjust them as naturally as possible during floods. Figure 1 shows the concept in the Recommendations section.*

- Install a selection of large woody material features in the channel from the top boundary of the fishery down to the old railway line, as appropriate – see Figure 1 below for the concept.

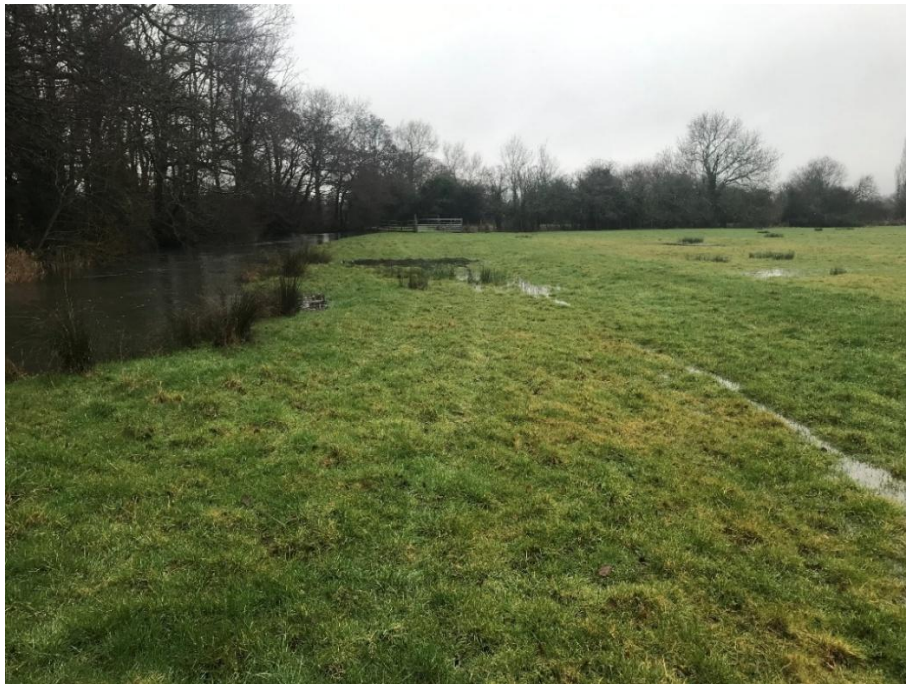
*Photo 7 The lower end of the Sheep Field stretch, showing the perched channel. It is likely the channel was sat somewhere to the right of its current location due to the difference in height of ground, although there is nothing to show this on available historic maps. This still needs fencing all the way back down to the old railway line in the distance to create all the benefits a buffer zone can create.*  
*Buffer Zones | Wild Trout Trust*

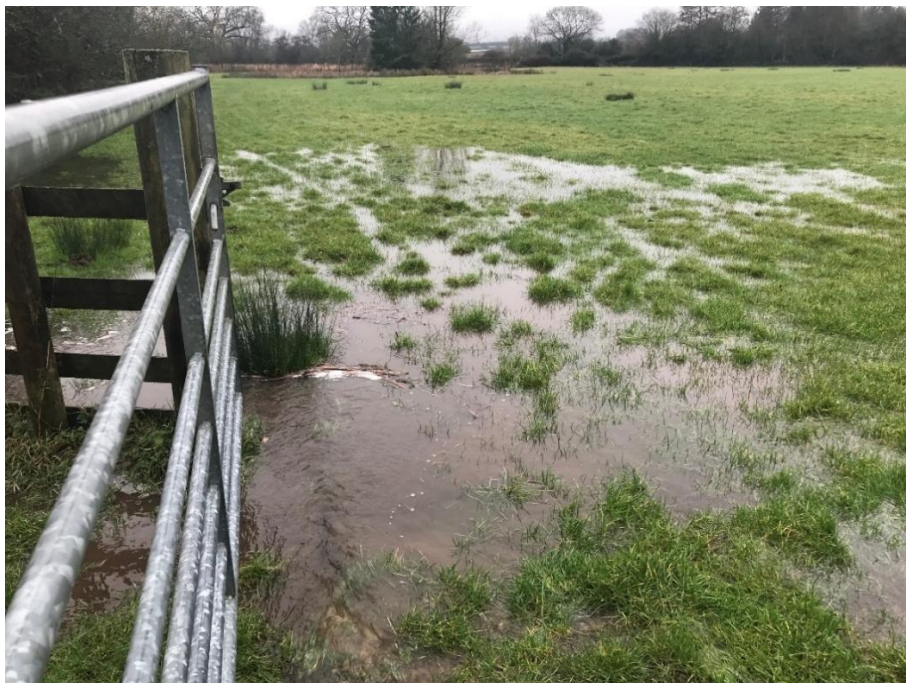
*Photo 8 51.898494 , -1.7438661 A breach in the perched bank due to the river being elevated above the surrounding land. As this is just floodwater from the channel at high flow, it is not a huge issue for the river, simply creating wet meadow conditions of limited wildlife value. However, worth keeping an eye on as erosion could develop this into something more substantial over time.*

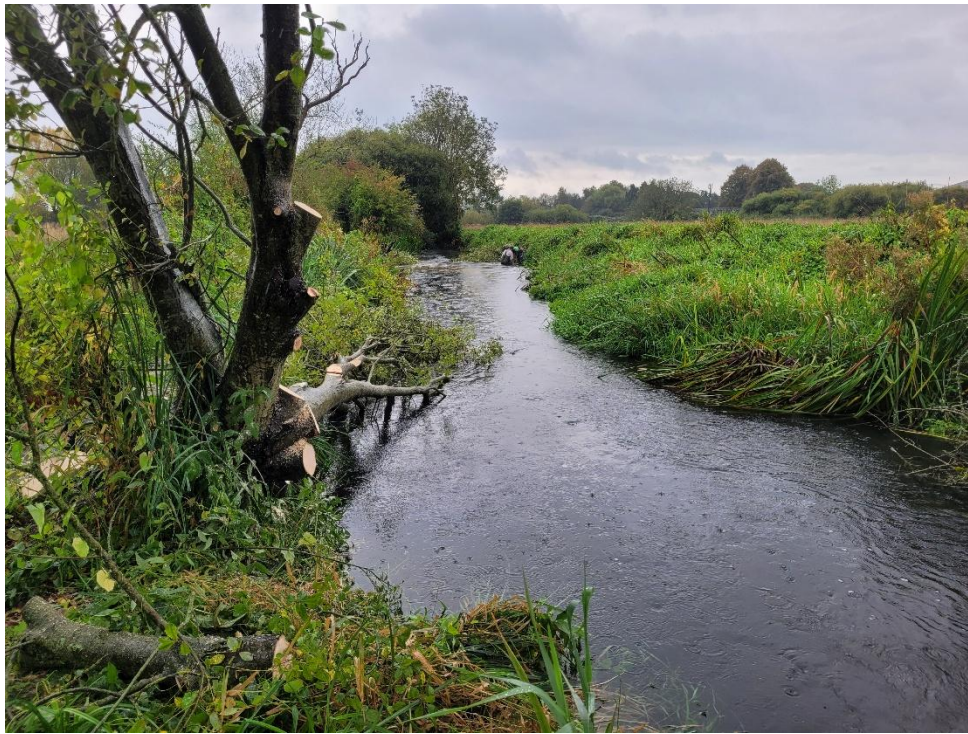
*Photo 9 While a larger channel than the Dikler at Snipe Moss, this is an example of a large marginal fringe transitioning from the bank top and terrestrial plant community, down to an emergent aquatic plant community which is naturally narrowing the river to maintain water depths and flow velocities. Great for all river fish species and invertebrates, it is also very good habitat for other creatures, such as water voles. River habitat enhancements have included hinging a tree into the river on the LHB so add further complex physical structure, and pinching the channel to further diversify flow patterns through this section of watercourse.*

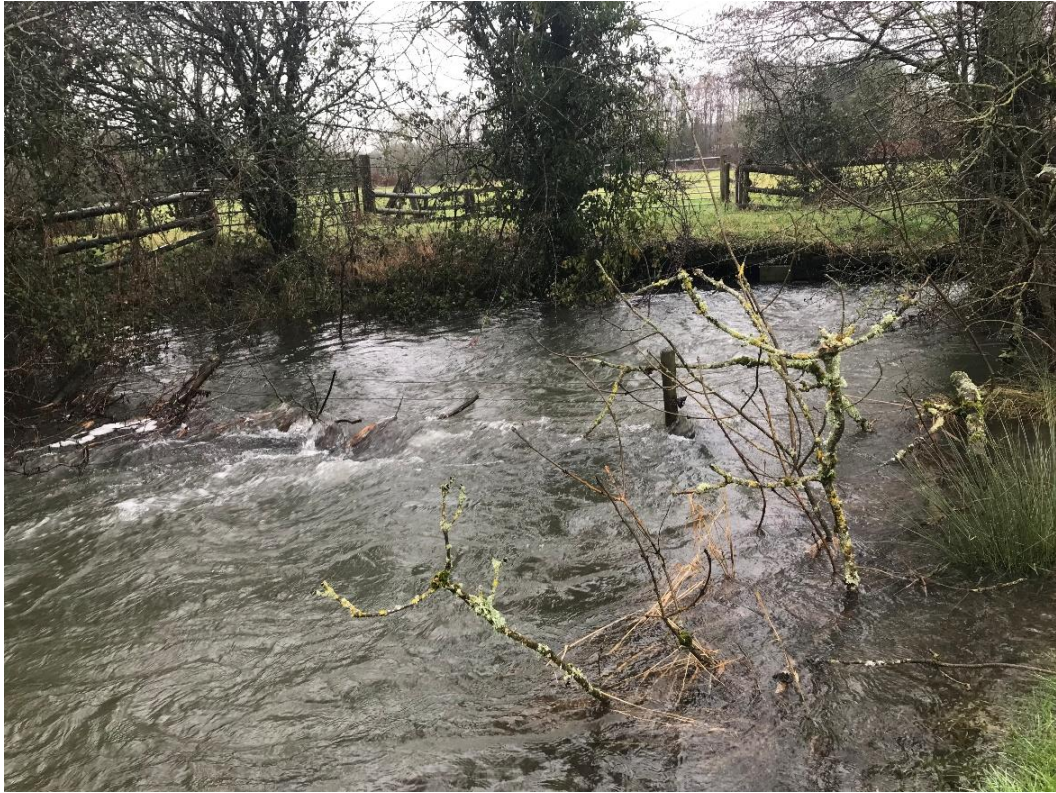
*Photo 10 51.898347 , -1.7437481 The Dikler exiting from under the railway embankment. The bridge culvert allows fish passage during lower flows according to CRT. The high energy flow is balanced with a backwater slack on the far (RH) bank and some brashy woody material against the near (LH) bank. This provides important refugia from high velocity flows for all aquatic life; the physical structure dissipates flow energy and provides physical cover for fish and invertebrates. The fence over the river looks ineffective for discouraging cattle. It will also hang up lots of debris in water levels that are any higher than those seen on the day.*

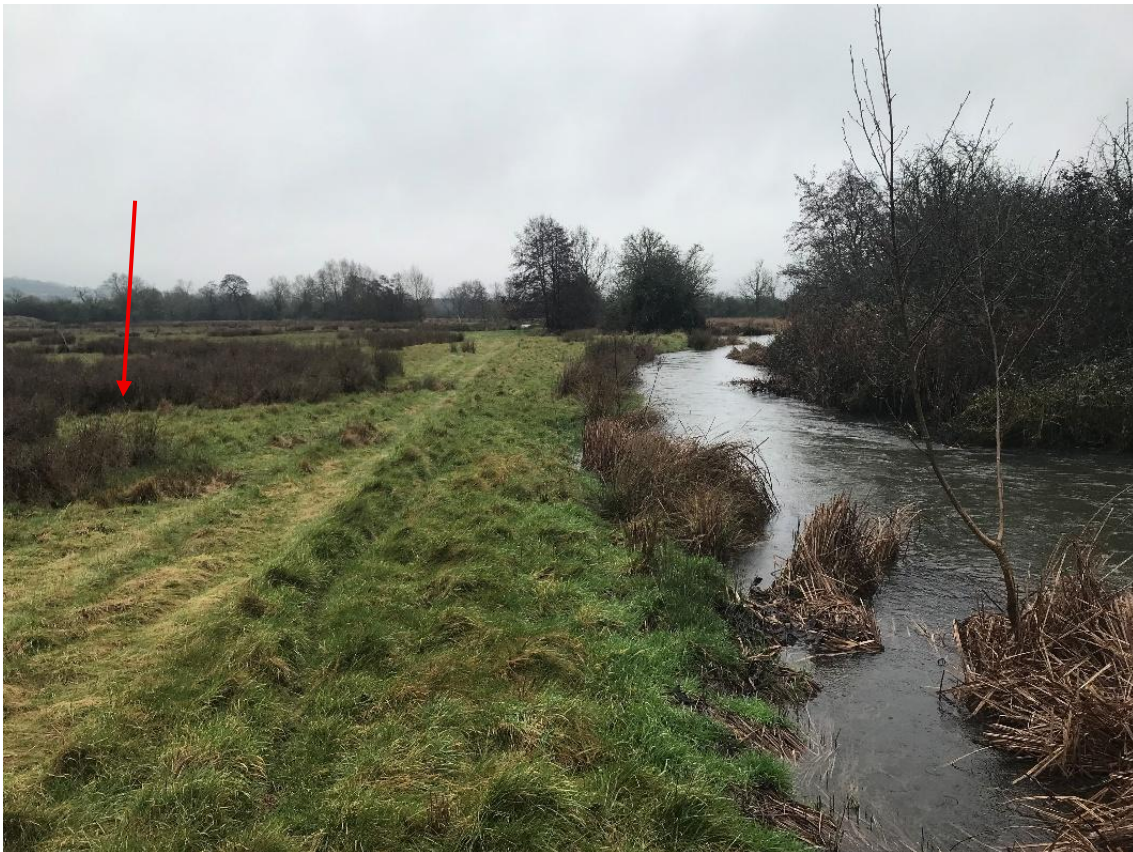
*Photo 11 The nature of the marginal habitat, riparian zone and wider land use, along this whole section of the Dikler. It is assumed the LHB is grazed by cattle looking at the nature of the grassland sward. The vegetative habitat is likely suppressed due to the time of year, but possible impacted by grazing, too. Depending on cattle stocking density, fencing could be used to develop marginal habitats along the watercourse. However, if fully fenced off (using other unmanaged banks as reference), vegetation is likely to develop into a tall, rank sward of grasses, rushes and reeds, and trees and shrubs establish. Worth considering, as this would need managing to maintain viable access for fishing and diversity in vegetation to benefit wildlife. Fencing well back from the river to the left of the grassy access track (red arrow) would allow space to seasonally graze cattle within the fence to disturb vegetation development, coupled with a gravity fed drinking system for stock back in the field. If grazing is intensive to the number of cattle being grazed, limiting damage to the riverbank is critical, as bare earth introduces damaging fine sediment to the watercourse (smothers river gravels) and limits plant diversity. If a smaller head of cattle are grazed (e.g. light stocking density), leaving the river open to grazing for a suitable period of time can be highly beneficial, as the light poaching and disturbance of the ground drives plant diversity and helps limit succession in the river and wet grassland habitats.*

*GWT suggests not planting trees extensively along this bank as they create 'predator perches' for birds (especially carrion crows), limiting the value of the wet grassland for nesting wetland birds. Developing mature vegetation along the margins of the river will help create some shading for keeping the water course cool, and some excellent physical habitat along the margins of the river.*

- Work with conservation partners to identify the best plan of action for developing riparian vegetation in 3a Lower section LHB. This may include a physical fence set well back from the river that cattle can be periodically grazed inside, or simply lightly grazing the field with no fences. The Sustainable Farming Initiative may be worth investigating for Snipe Moss here [SFI26: details, definitions and what to expect – The Farming Blog](#)

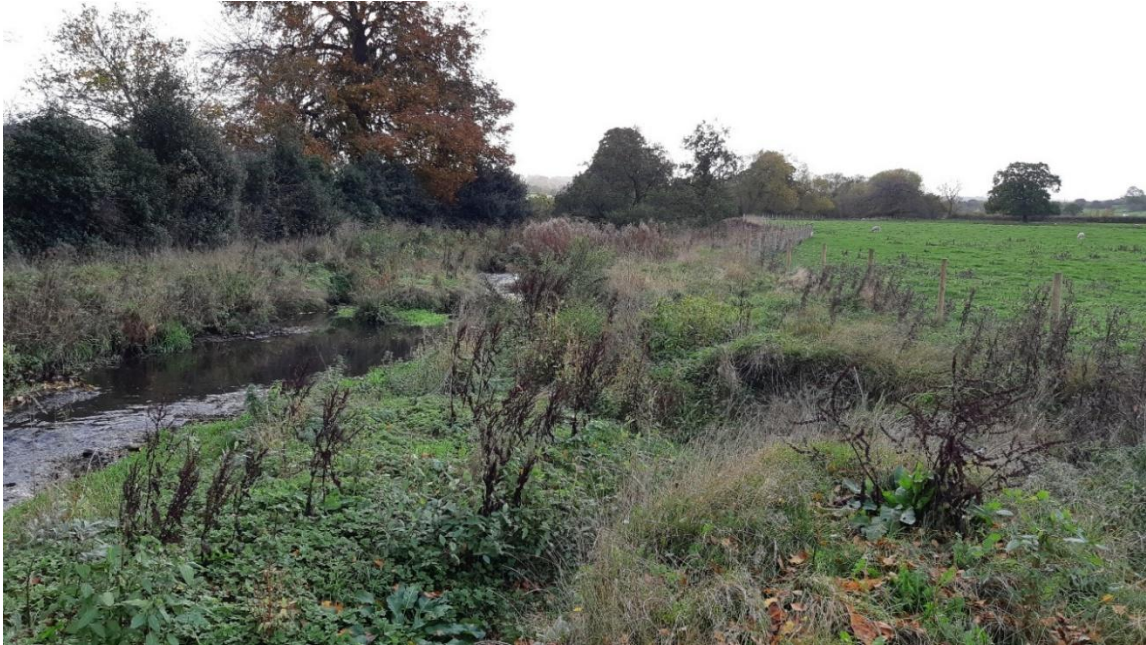
*Photo 12 Example of a well buffered river, using a fence to keep stock away from the watercourse (Upper River Dearne).*

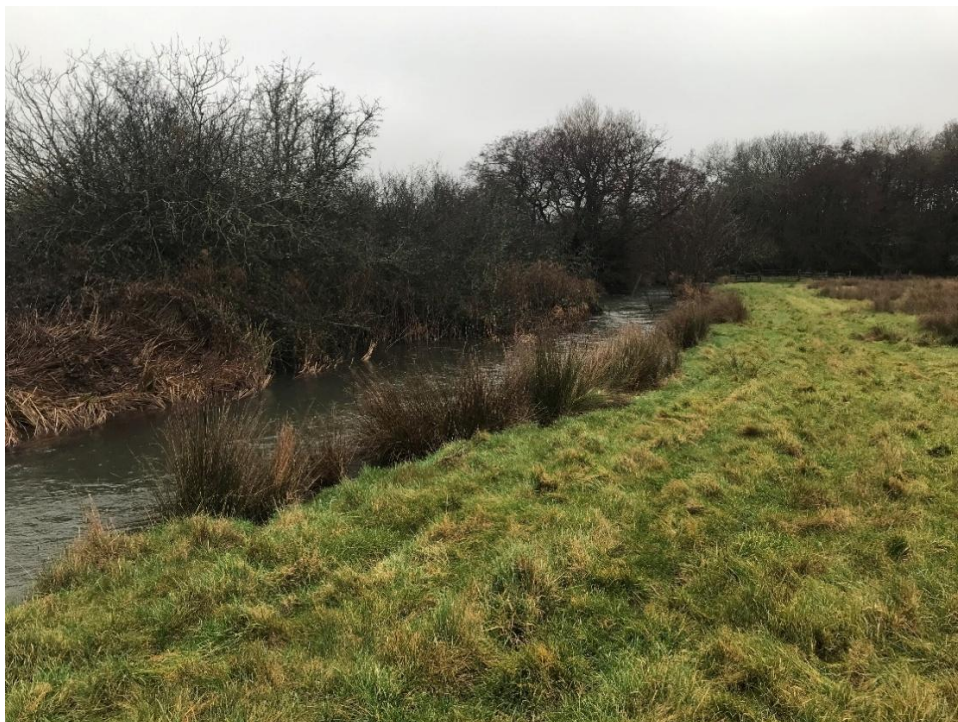
*Photo 13 51.898035 , -1.7436381 Looking back upstream to the railway embankment. The unmanaged far RH bank creates some excellent habitat. The complex tangle of reeds, roots and trailing branches in the water provides critical physical cover for all fish and invertebrates. The transition into mature shrubs with branches overhanging the watercourse provides both shade to the channel and a potential food resource for trout as terrestrial (land based) insects fall or get blown into the water. Replicating this along the watercourse helps create a mature habitat corridor along the river on one side, while retaining an element of 'openness' for fishing purposes on the other.*

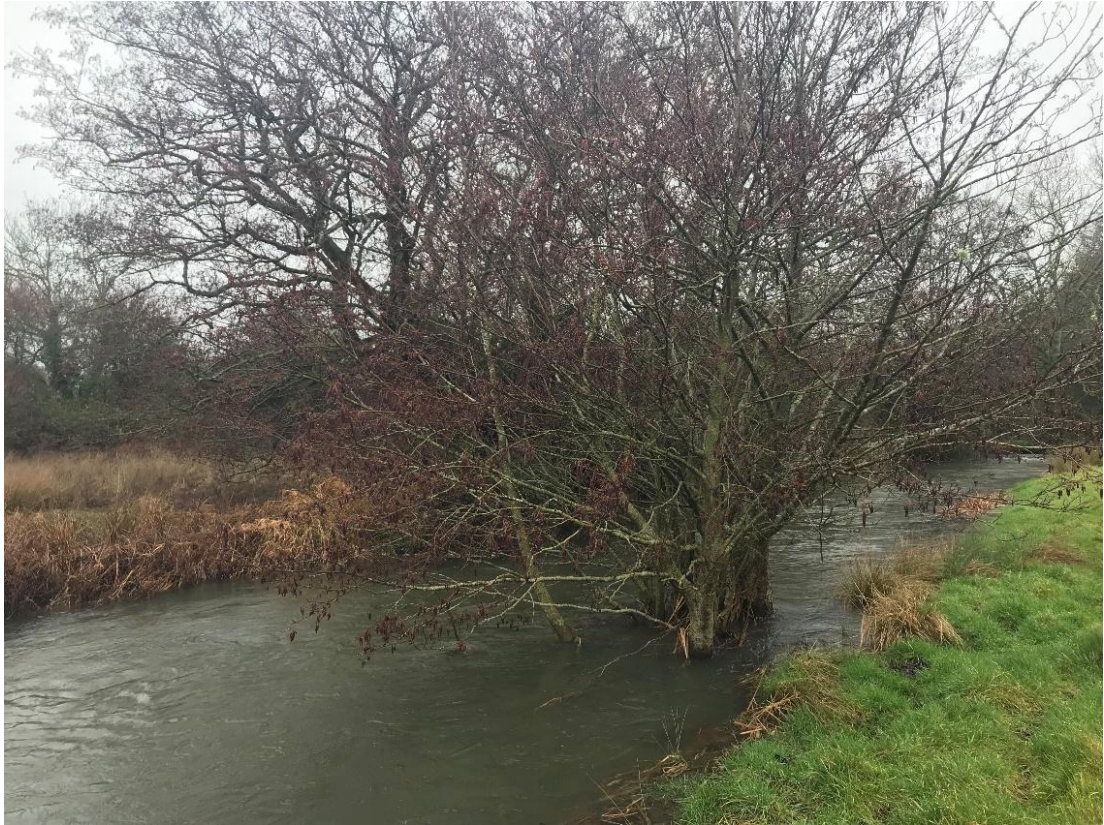
*Photo 14 51.897400 , -1.7436488 A nice alder bringing several benefits to the river at this point, especially coupled with the open reed habitat on the far bank. The unseen root system is likely to be providing high quality messy structure under the water, always a prime location for holding trout. This can be further enhanced by hinging over some of the alder stems ([Habitat-Sheet-Hinging.pdf](#)) or anchoring and pinning along the margins of the channel. This provides further complex structural refugia for fish, plus habitat and feeding opportunities for a range of invertebrates. Alternatively, rotational coppicing with other trees present in the reach will create a diversity in tree growth and limit physical size making them manageable and limiting predator perches for the adjacent wet grassland, while providing materials that can be used in river habitat interventions.*

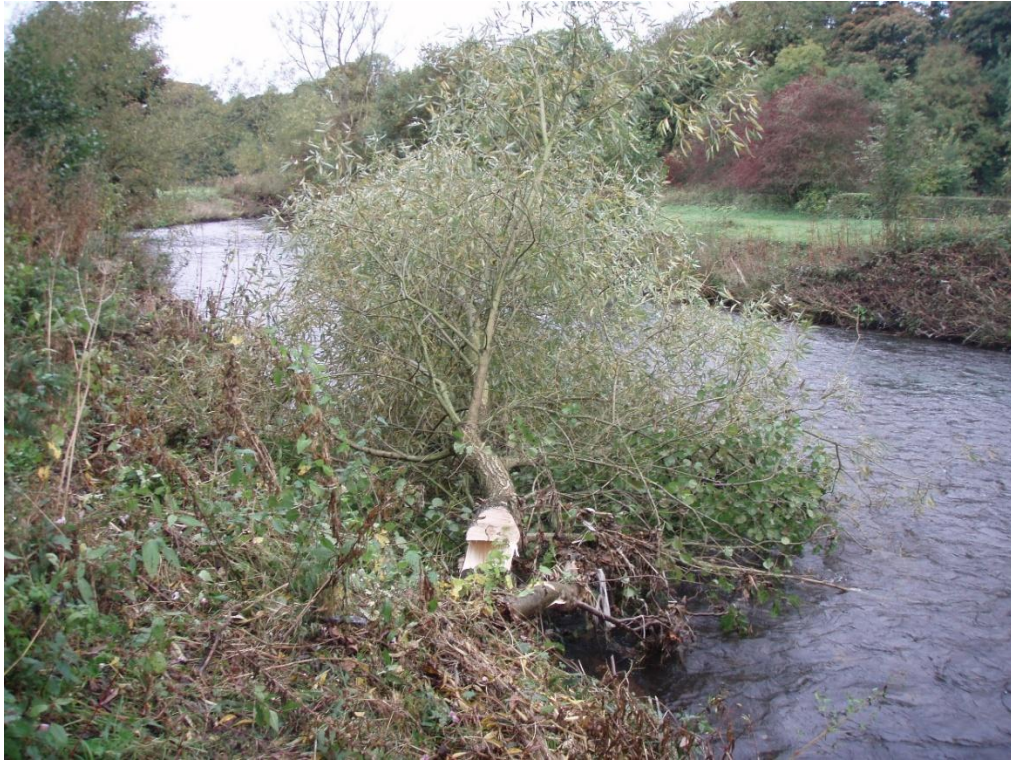
*Photo 15 Example of a tree hinged into a river, providing excellent cover, pinching flows, creating flow diversity and sinuosity in the channel.*

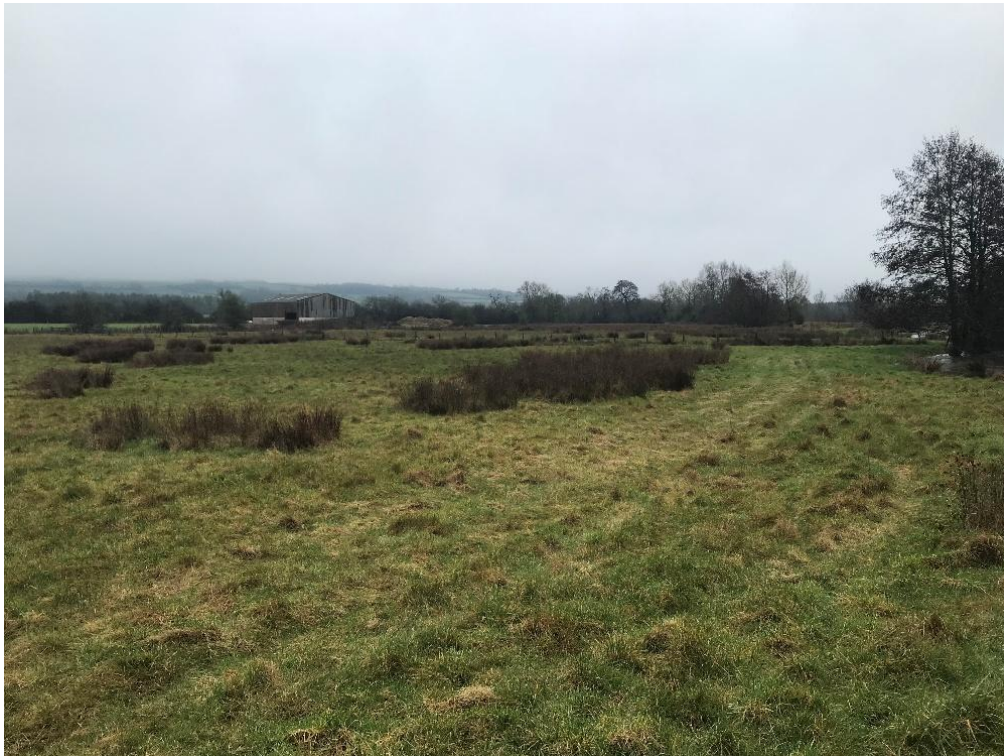
*Photo 16 The wet grassland, looking towards the downstream boundary. The perched channel will be keeping the meadow damp; competing conservation requirements can work together to achieve required outcomes, such as managing breaches in the bank and how well they supply the grassland with water during high river levels. The marginal vegetation fringe is particularly limited in this photo.*

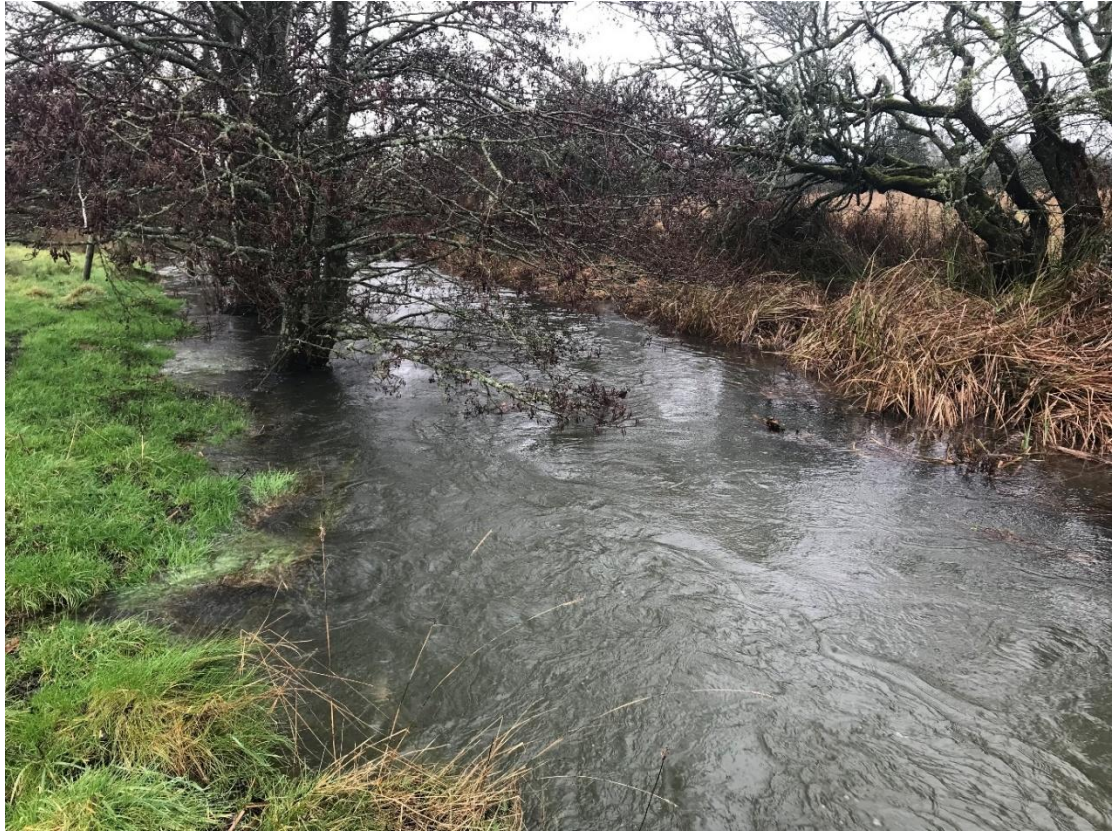
*Photo 17 51.897228 , -1.7434112 Improving river habitat along the banks here. The low, overhanging branches from the mature alder on the LHB provide a key habitat feature for trout when the river is low and clear. Equally, the trailing reed growth on the RHB will provide excellent physical cover for fish and invertebrates. Opportunities to use some of the alder stems by hinging or pinning in the channel are an option [Habitat-Sheet-Pinned-Woody-Material.pdf](#)*

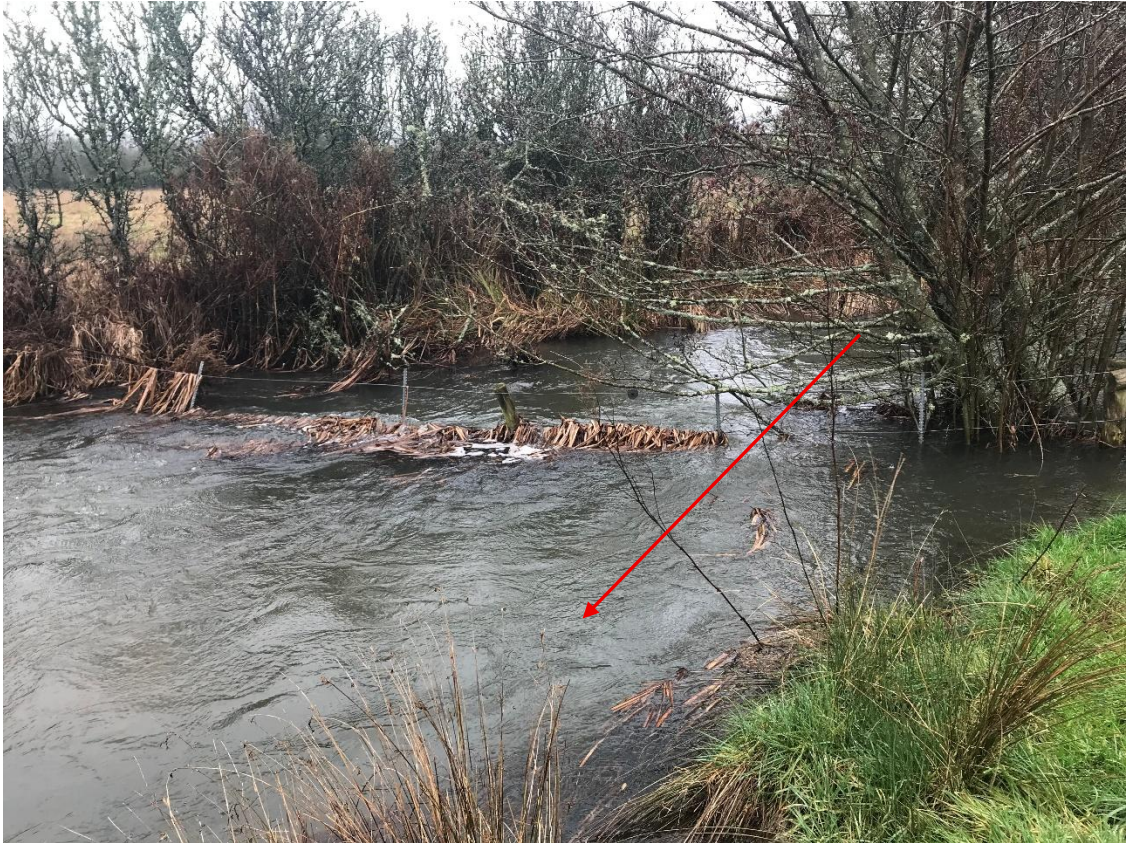
*Photo 18 51.897099 , -1.7434005 The matured RHB fringe with well-established shrubs and small trees on the LHB provides some good physical habitat complexity here. The root systems and trailing reed vegetation will be providing cover and structural habitat for trout and invertebrates. The low overhanging branches provide excellent overhead cover, creating an attractive lie for trout. It is a good idea to leave parts of the river 'messier' than others as this is where the best quality habitat for trout will exist, providing refuge from flood waters and predators, too. While difficult to fish, trout that utilise these areas for survival will dissipate out to the fishery at some point, where they can then be targeted by anglers. Alternatively, the brashy willow in the foreground is ripe for hinging into the margins of the river here (red arrow). The wire across the river does not look particularly robust for keeping stock out and is accumulating debris. Alternatives could be considered here, such as a formalised water gate or if fencing stock away from the river, as part of wider interventions on this stretch.*

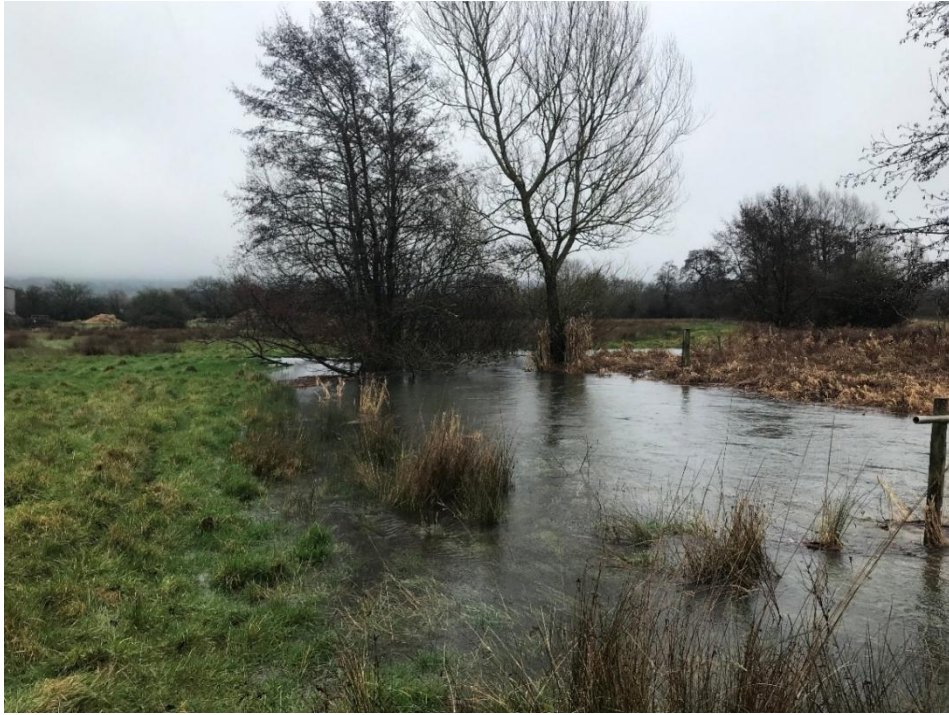
*Photo 19 51.896852 , -1.7432312 The end of the section reviewed from the LHB. Limited marginal and riparian continues to be an issue. The large alder could definitely be used for felling and pinning stems into the apex of the bend (red arrow), to provide excellent habitat complexity, erosion control and limit a predator perch overlooking the adjacent wetland.*

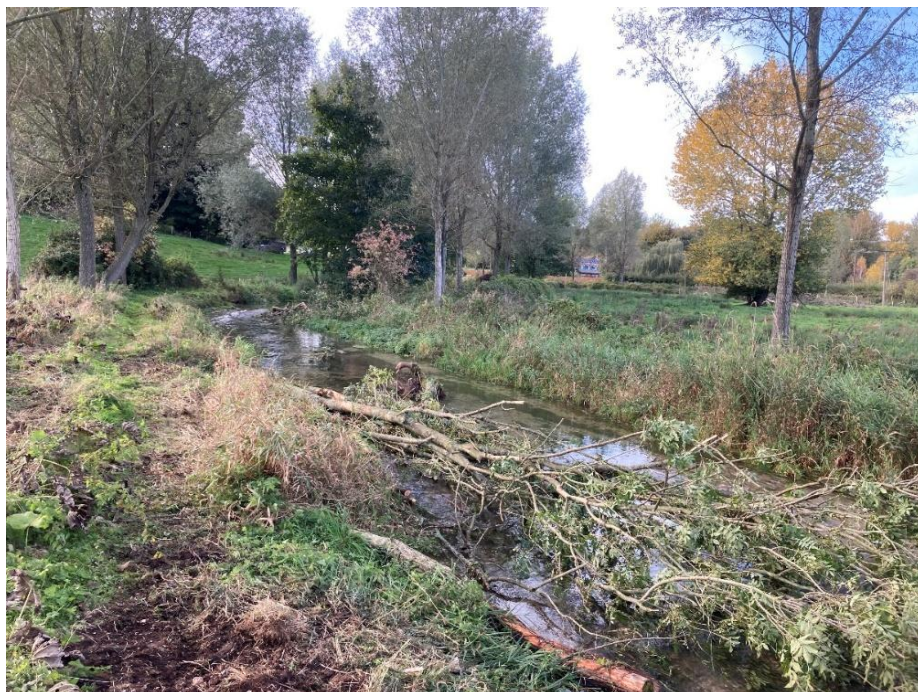
*Photo 20 An example of pinned large woody material providing multiple benefits to this channel. The complex structure provides excellent refuge for trout and a host of habitat and feeding opportunities for invertebrates. Pinned material helps pinch the channel to create beneficial depth and flow velocity diversity, also protecting the bank from erosion during periods of high water or powerful flows.*

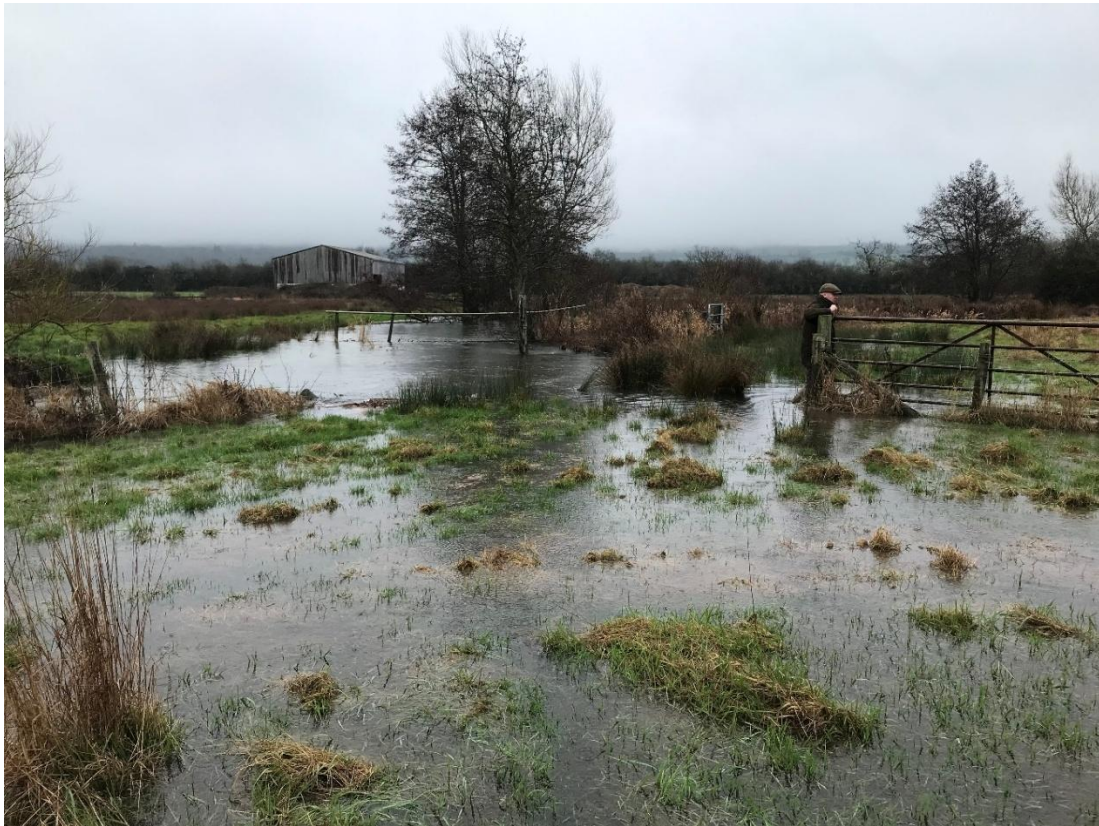
*Photo 21 51.896470 , -1.7432899 Extent of water flowing into the field at the top end of the RHB section. The footbridge was holding surface flows back and raising the level slightly upstream. Changing this to a simple 'arched' bridge design will help alleviate this.*

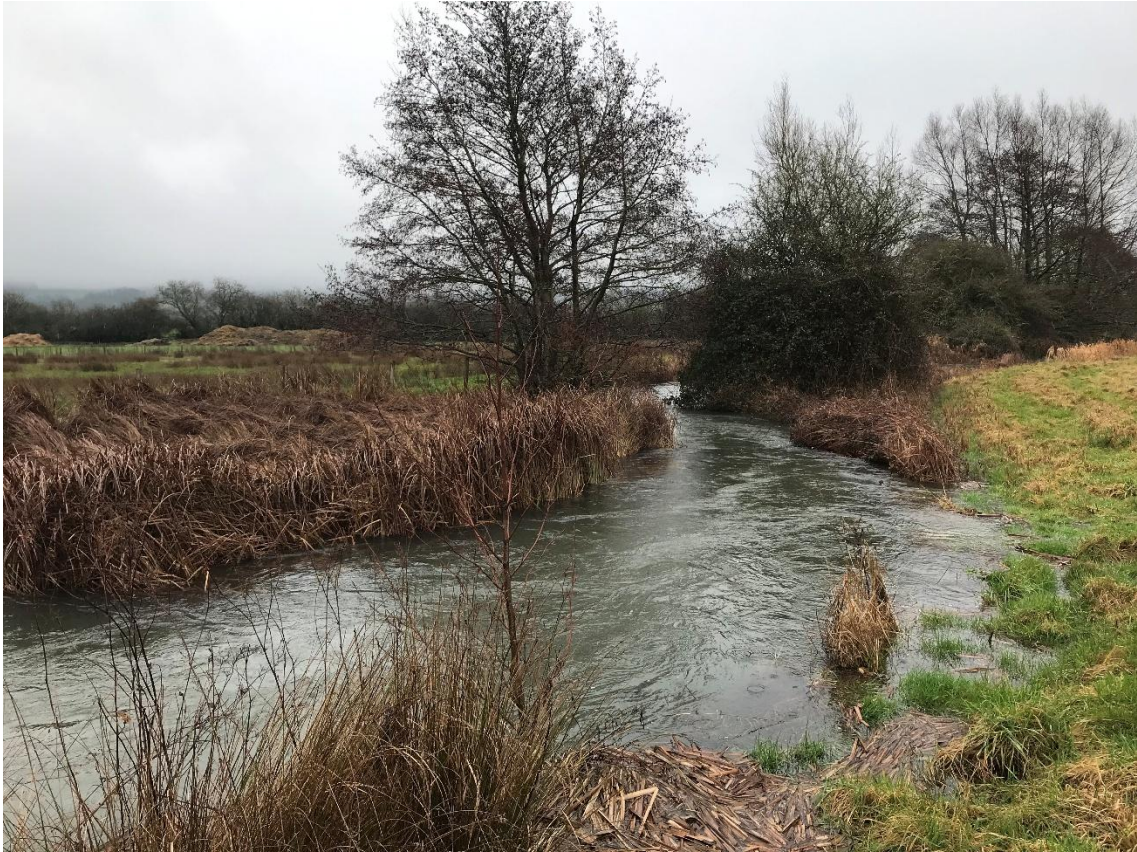
*Photo 22 51.896301 , -1.7429177 This section is reported to suffer from emergent vegetation choking the channel in the summer. Propagating some low, bushy shrubs in the reedbed on the LHB will increase shade to help limit plant growth. Equally, maintaining depths and flow velocity through the bend will help keep emergent plant growth in check. Harvesting stems from the alder on the LHB and pinning them in to pinch the channel to maintain depth and flow speed will be a useful here.*
