WILD TROUT TRUST

Advisory Visit Report

River Dikler

February 2026

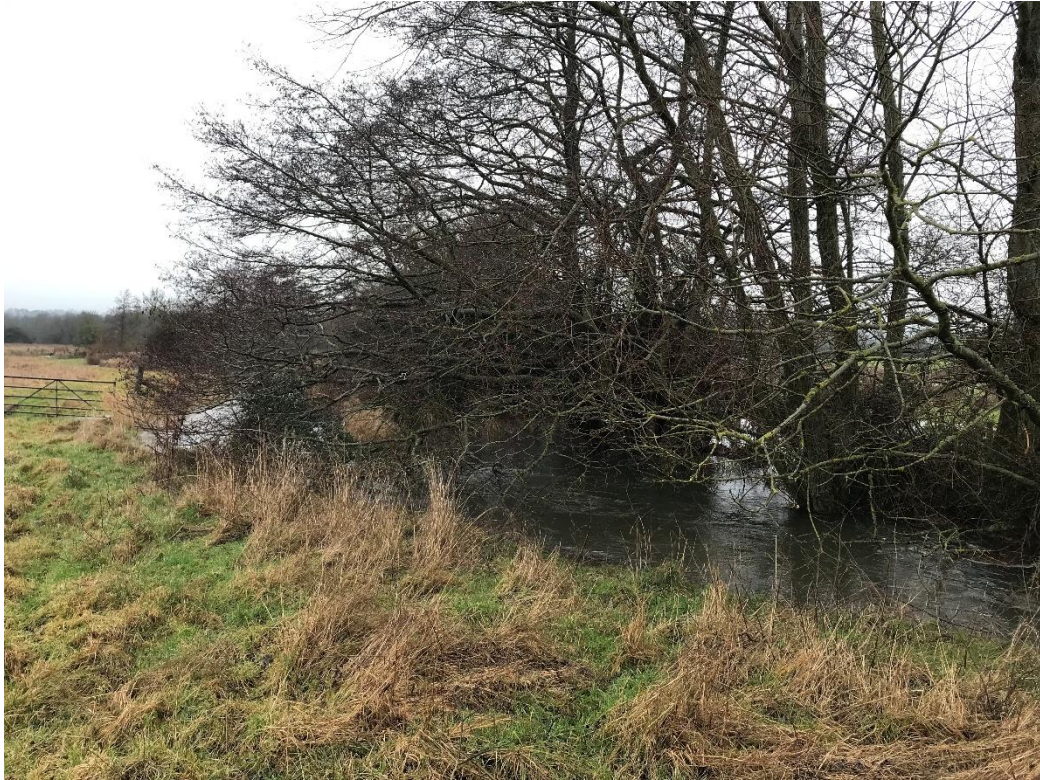
*Photo 23 51.895535 , -1.7422729 Overhanging alder branches provide a superb habitat feature that will attract trout. The proximity of the alder trunks to the channel means extensive root systems are likely exposed under the water, adding further high-quality complex structure and cover for trout. Clearly this is a tricky place to fish, so the decision needs to be taken to either just leave it as a sanctuary for trout or manage some branches. If this happens, sensitive and very selective removal of the minimum amount of branches from the lower canopy to essentially 'lift' the canopy from the waters surface could make space for a side cast. However, no habitat equals no trout, so care would be required to not degrade the quality of the feature by removing too many low and trailing branches here.*

- Plan any sensitive and selective management of branches for fishing. Removing occasional and individual branches to create gaps, or a slightly higher canopy above the water where there are low hanging branches, can retain habitat features while allowing just enough space for fly fishing.

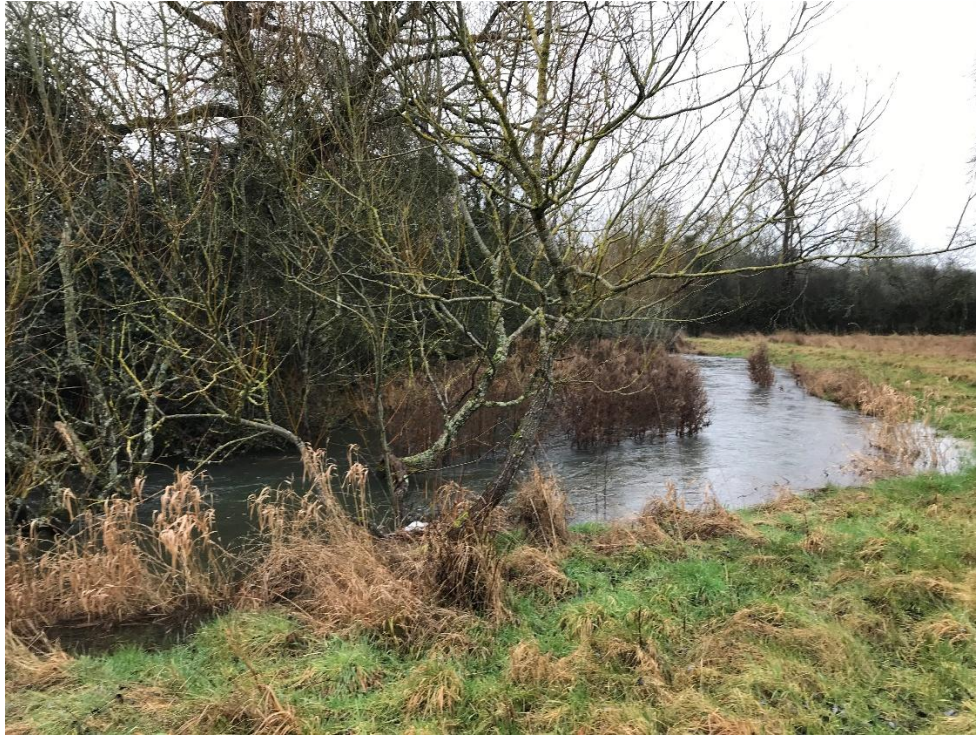
*Photo 24 51.895152 , -1.7417804 Further down river, a good combination of large woody material and open water exists. Trout will occupy such areas where good quality refuge (the large woody material) exists close to open water (feeding locations) downstream. Replicating this throughout the fishery will assist with maintaining a well-structured and abundant trout population.*

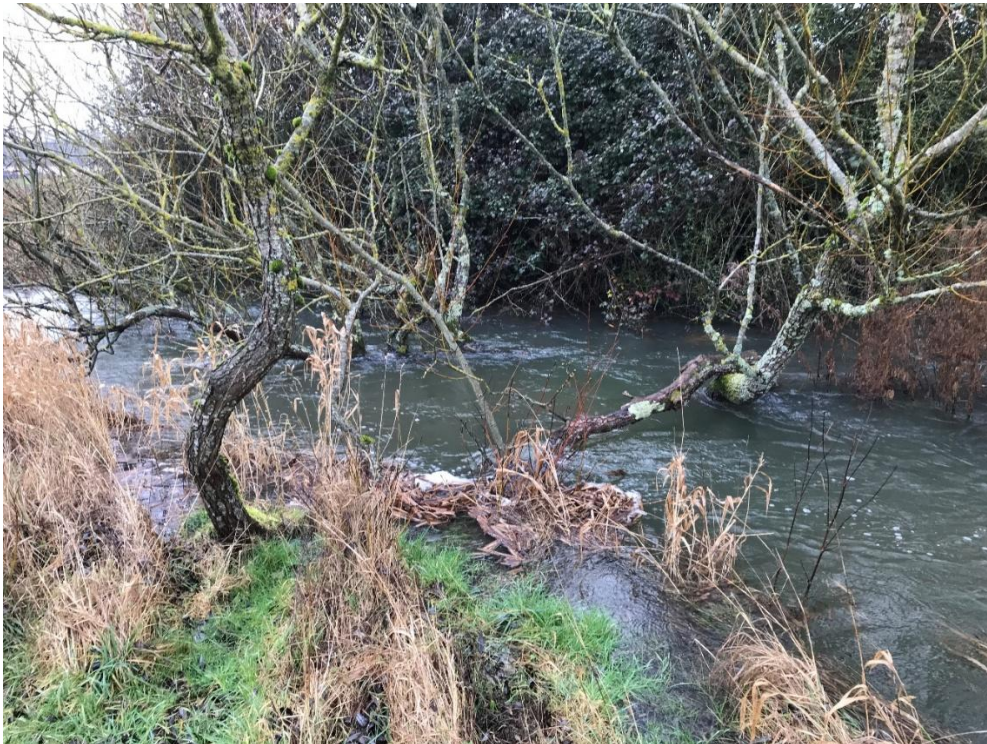
*Photo 25 The complex physical structure under the water will attract trout of all ages and sizes. This type of large woody feature should be retained and replicated across the fishery.*

- Retain some very 'messy' locations where large woody material with lots of brash is already in the channel. This will create relatively inaccessible and quiet places that trout will thrive in.

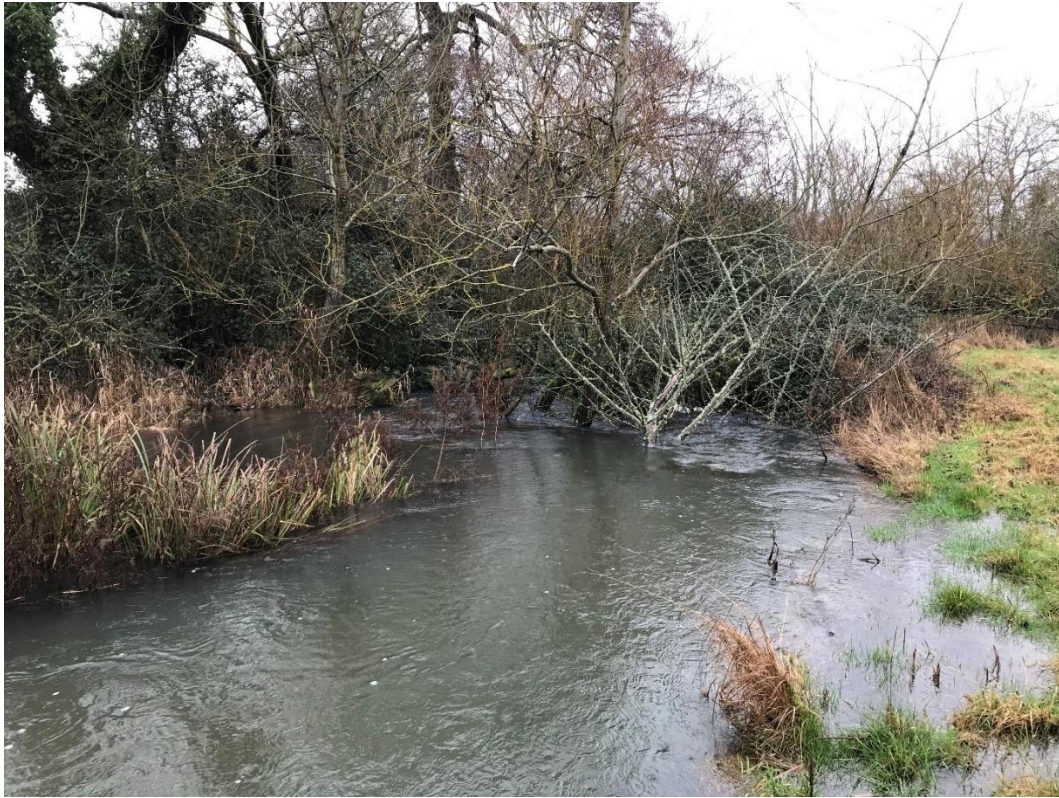
*Photo 26 51.894828 , -1.7411796 Another example of good quality habitat where fish can avoid being disturbed, on the lower boundary of the fishery. This complex and tangled arrangement of brashy woody material over shallower water is particularly good for juvenile trout.*
