WILD TROUT TRUST

Stanley Ghyll Beck

River Esk Catchment

06/10/2020

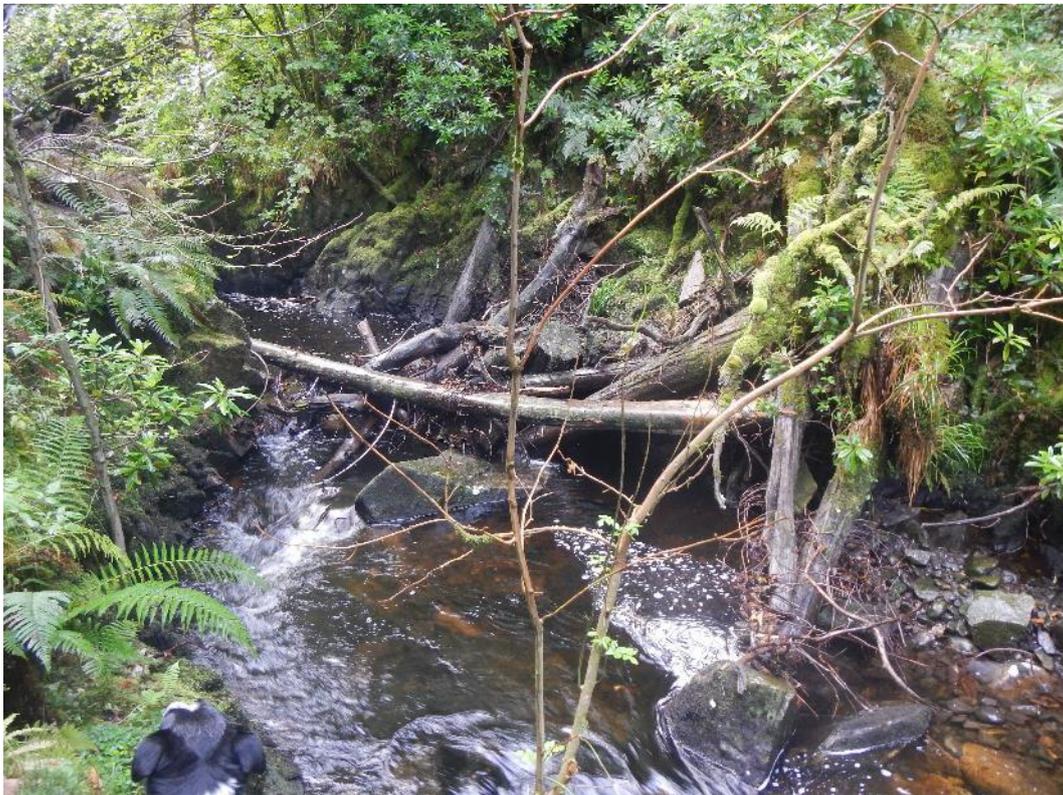
Figure 1. Towards the upstream end of the reach, the channel is steep and relatively straight, constrained within a bedrock gorge. The habitat is a combination of small pools and pockets of slack water, interspersed by chutes and falls, with the occasional larger pool in which larger adult trout are likely to reside. Areas of potential spawning substrate are present in the tails of the larger pools, but the high energy and coarse substrate of the beck means that potential is limited, and juvenile dispersal from other areas is likely to play a large part in populating the reach. Rhododendron shrubs create a negative impact upon riparian habitat and the broader woodland, overshadowing and outcompeting native species. Their leaves are slow to degrade and less palatable to invertebrates than those of native species, so there is also likely to be a localised impact upon productivity. It is therefore encouraging that the LDNPA are attempting to eradicate the issue through cutting and treating with herbicide plugs.

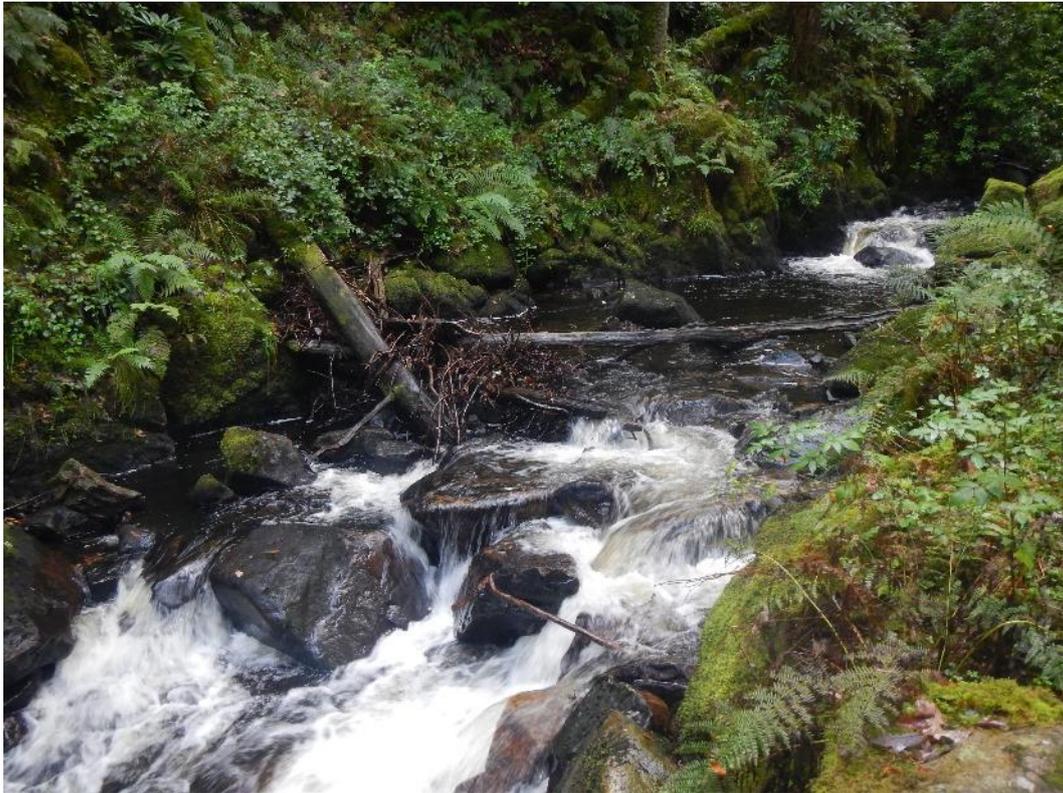
Figure 2. The majority of the bed material in the upper section is coarse, creating plenty of niches for flow-loving invertebrates and juvenile fish at low flow, but a hostile channel in high flow, when woody material provides an important source of cover and shelter.

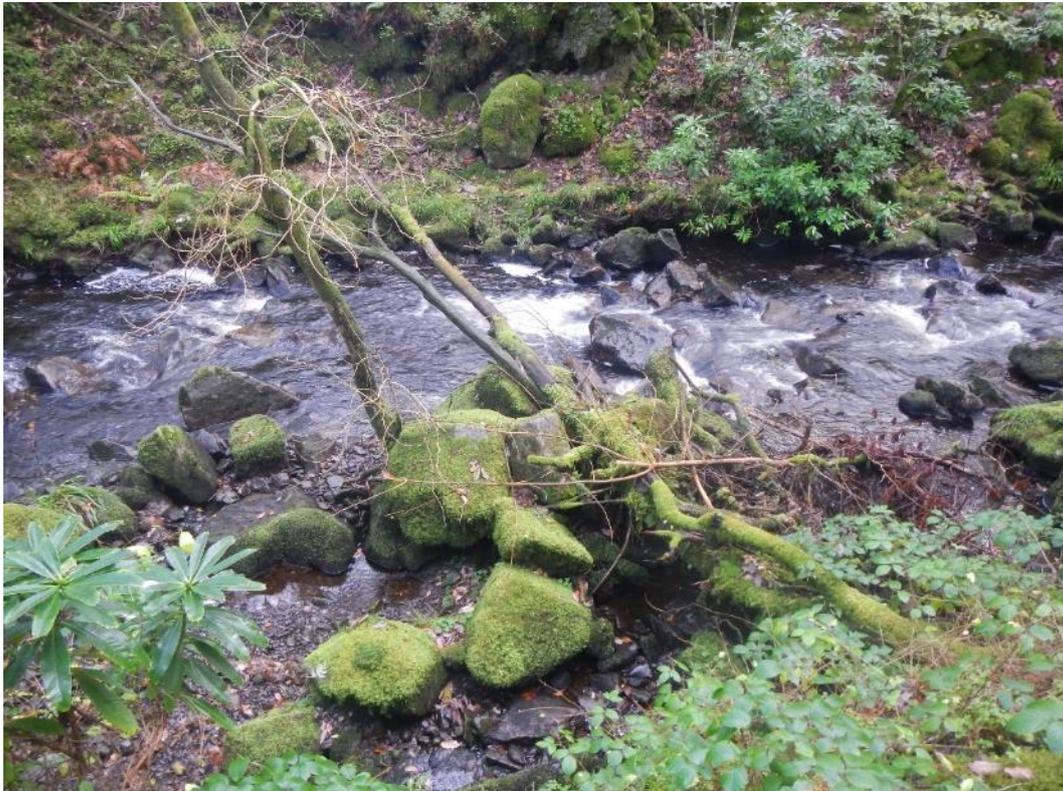
Figure 3. Branches and woody material within the channel help to retain other organic material, like leaves, providing an important source of nutrients and productivity as food for invertebrates. In a deep, wooded and shaded gorge where reduced light penetration limits primary production, the importance of this material should not be overlooked.

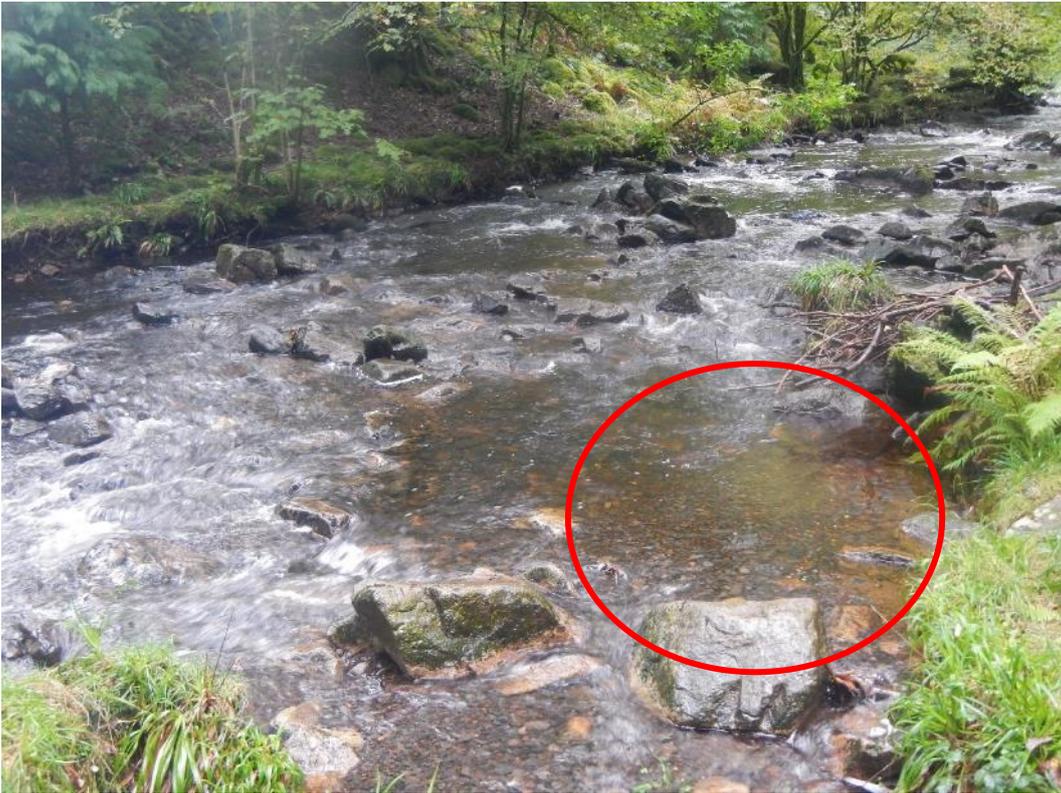
Figure 4. As the valley gradient reduces the associated reduction in stream power facilitates a wider and more sinuous channel, where a greater diversity of substrate is retained (red circle).

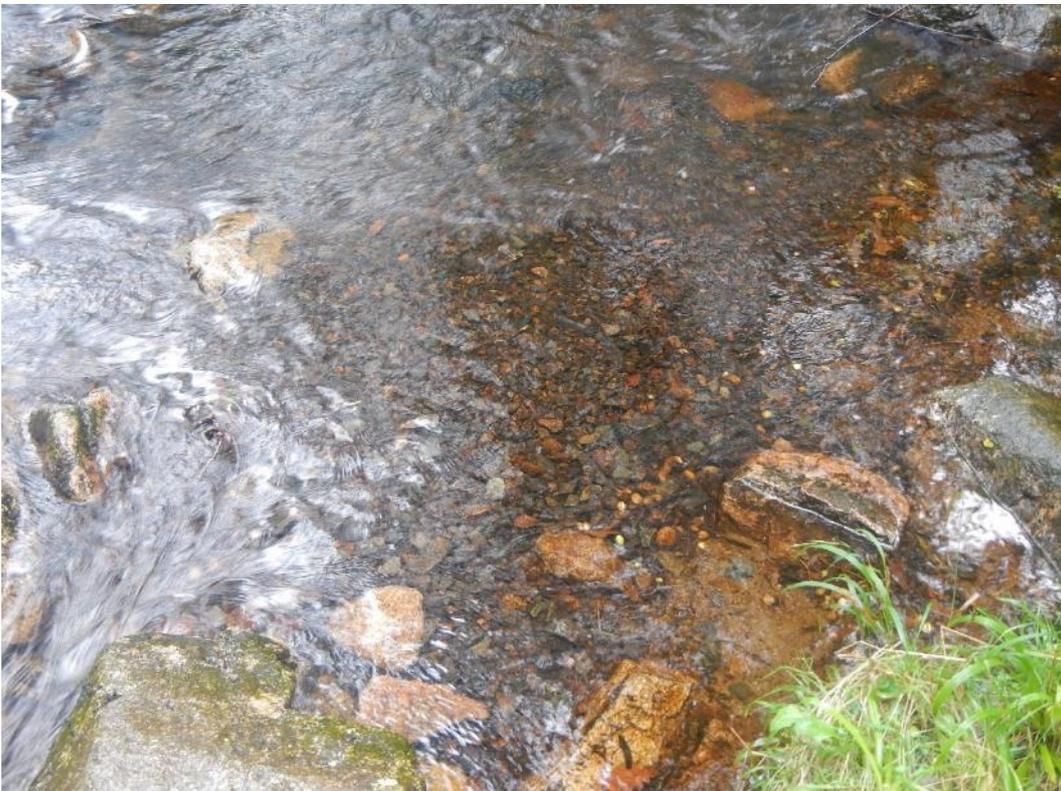
Figure 5. The slower flowing area depicted in Figure 4. As the valley gradient reduces the associated reduction in stream power facilitates a wider and more sinuous channel, where a greater diversity of substrate is retained (red circle). : much smaller gravel substrate can be seen in this area, suitable for resident trout spawning. This substrate diversity also provides habitat for a range of native invertebrates.

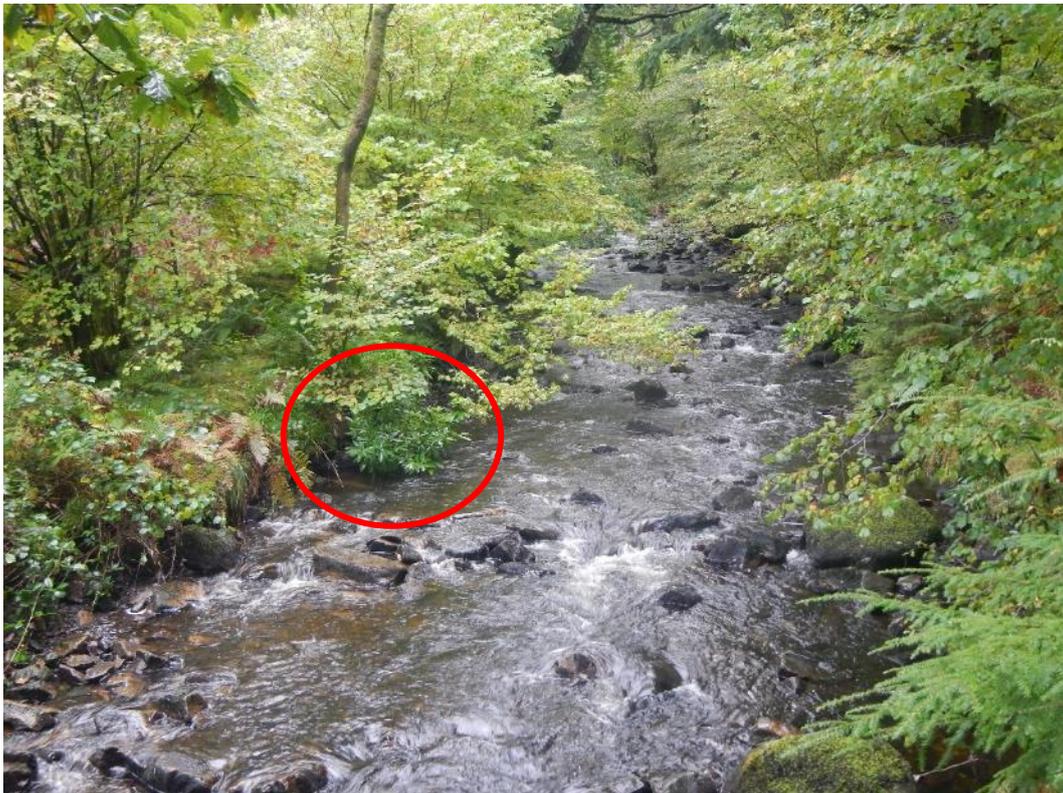
Figure 6. The varied canopy of the woodland creates a natural balance of light and shade, with the low cover provided by smaller shrubs and understory complementing the taller mature canopy, but without the overshading that can occur where uniform age class/height canopies develop. However, note the continued presence of rhododendron (red circle) which could ultimately take over and disrupt the natural balance, if left unchecked.

eradicated wherever possible to allow native species to flourish. As such, the great work already being undertaken by the LDNPA, contractors and volunteers to eradicate rhododendron should continue, with other non-native species also tackled. Some of the material generated from this work could be utilised to increase the availability of in-channel woody material and cover (see recommendations).

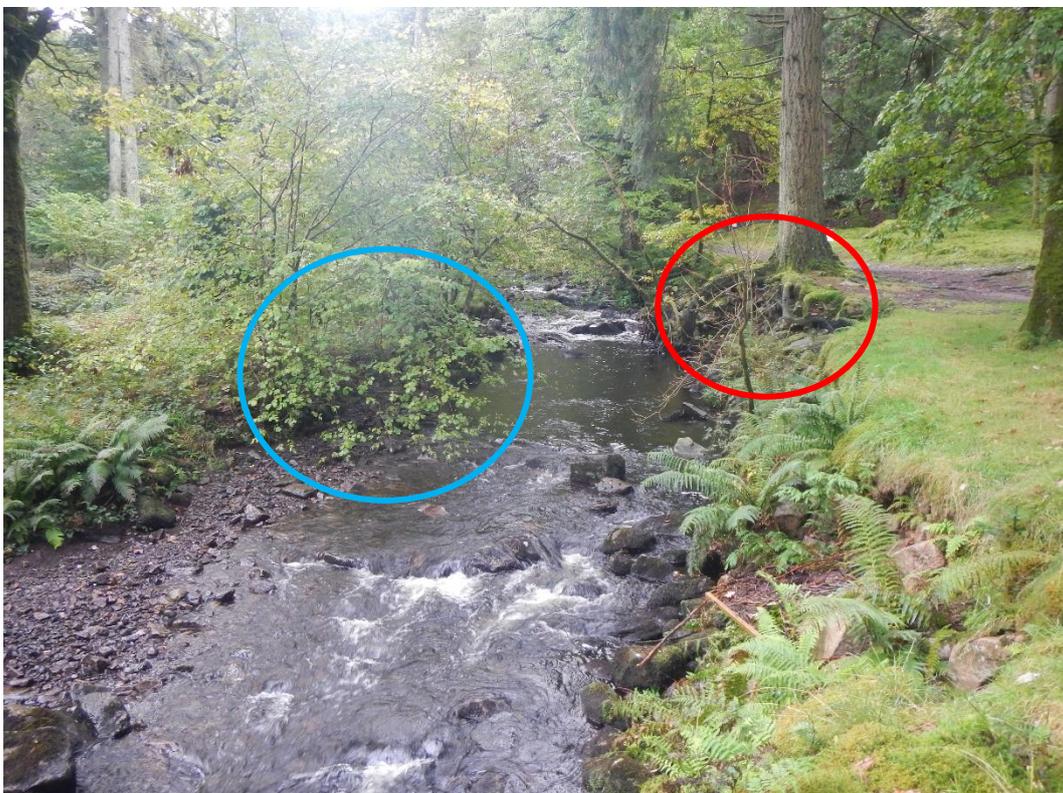
Figure 7. Looking upstream, on the RB (blue circle), some of the overhanging hazel could be laid down into or along the channel. On the LB (red circle), erosion threatens the mature conifer on the bank top. If possible, this should ultimately be allowed to fall naturally into the channel. The footpath may need to be re-routed further away from the watercourse but facilitating natural input of trees to the beck would be greatly beneficial.

- Lay selected hazels along the bank of the beck to introduce additional low cover. N.B. This may not be necessary if similar habitat can be produced with the non-native species brash.

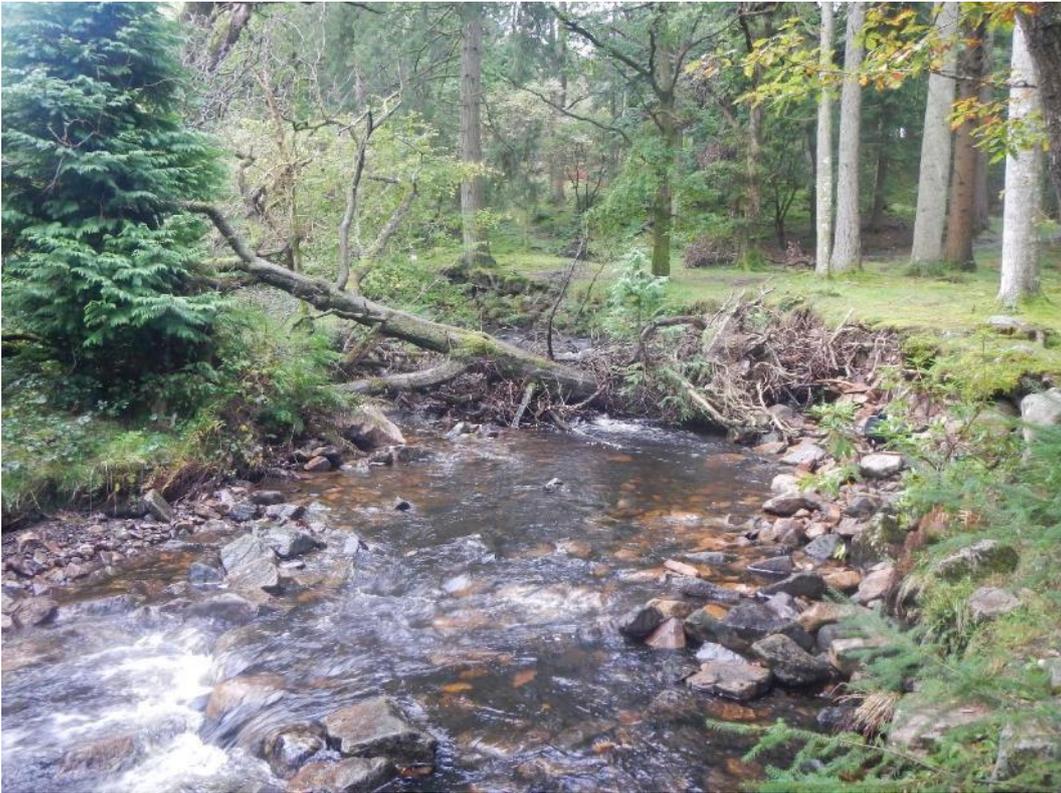
Figure 8. Just downstream, it was encouraging to see that treefall and the vital input of large woody material is already being allowed to occur and remain in situ. This tree may eventually slew round, or become outflanked by lateral erosion but, in the process further beneficial habitat will result.

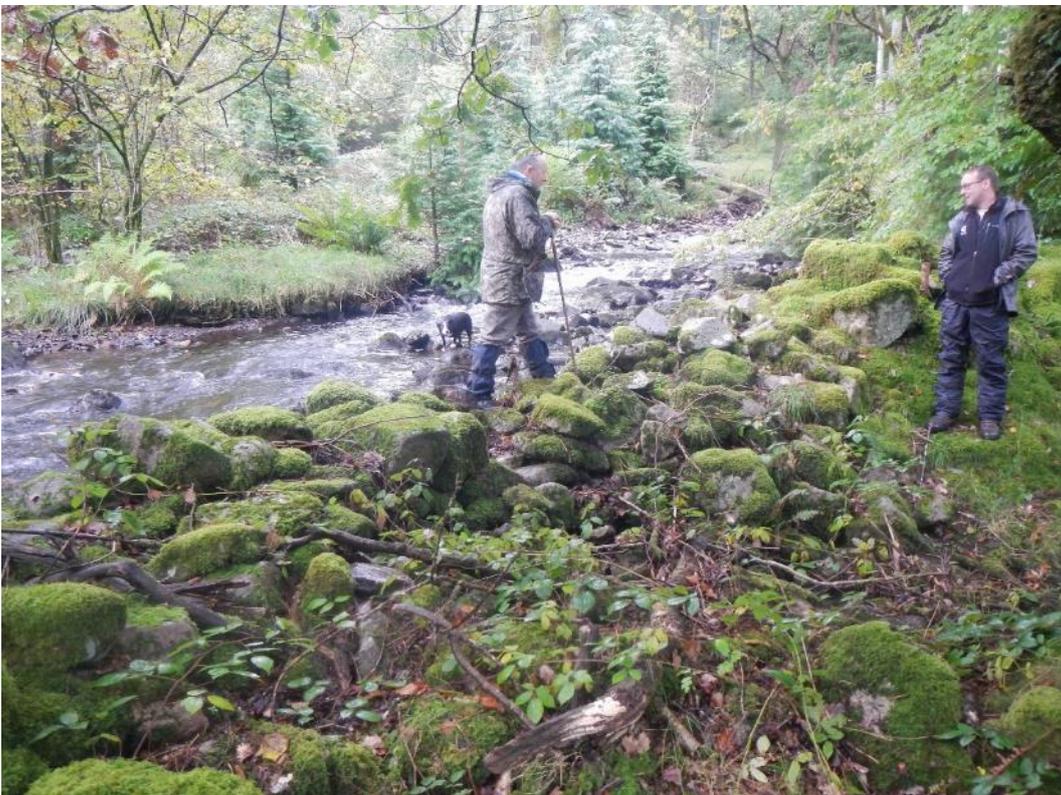
Figure 9. Boulders appear to have been used historically to prevent high flow shortcutting a bend (NY 17382 00110). These high flow pathways are a natural feature of woodland watercourses and should not be prevented. The boulder bund is already breaching, and it would be beneficial to accelerate that process. Doing so would reduce the peak flow energy in the channel downstream through the meander and take pressure off the RB at the bend downstream, which is close to the edge of the woodland and adjacent agricultural land.

- Remove the bund of boulders that restricts high flows bypassing the large bend.

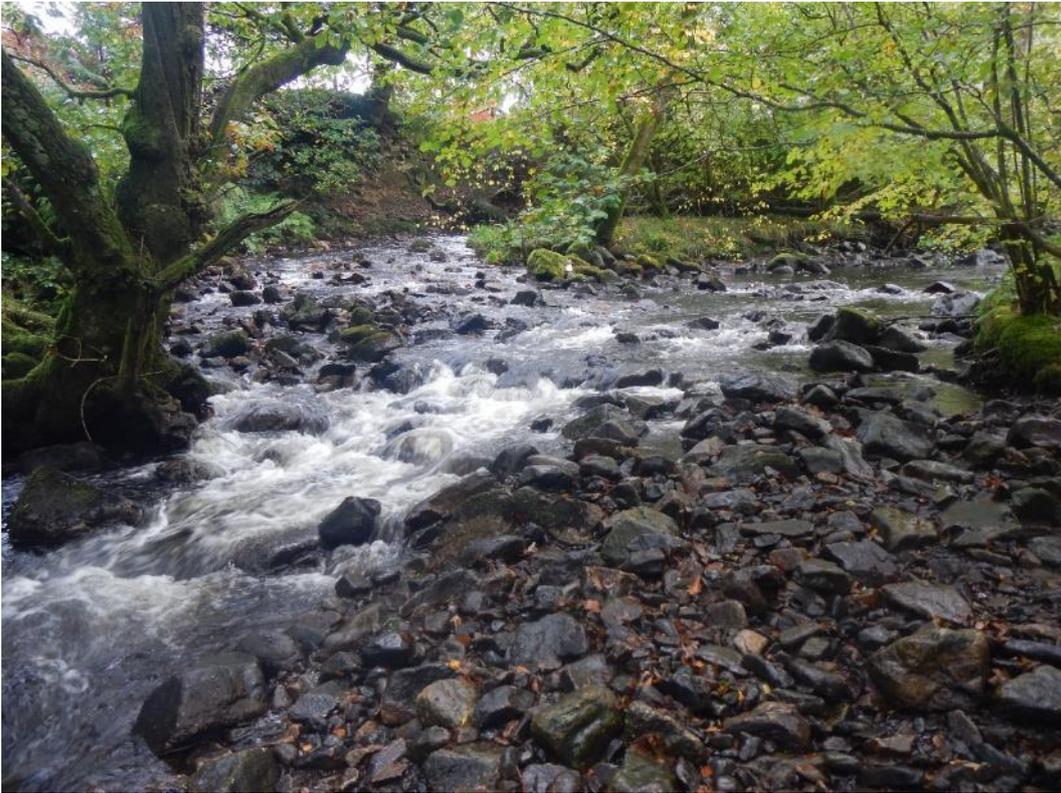
Figure 10. A small island in the channel on the outside meander bend downstream. Note how the varied channel structure facilitates a range of flows and bed levels, contributing to a diverse wooded watercourse environment.

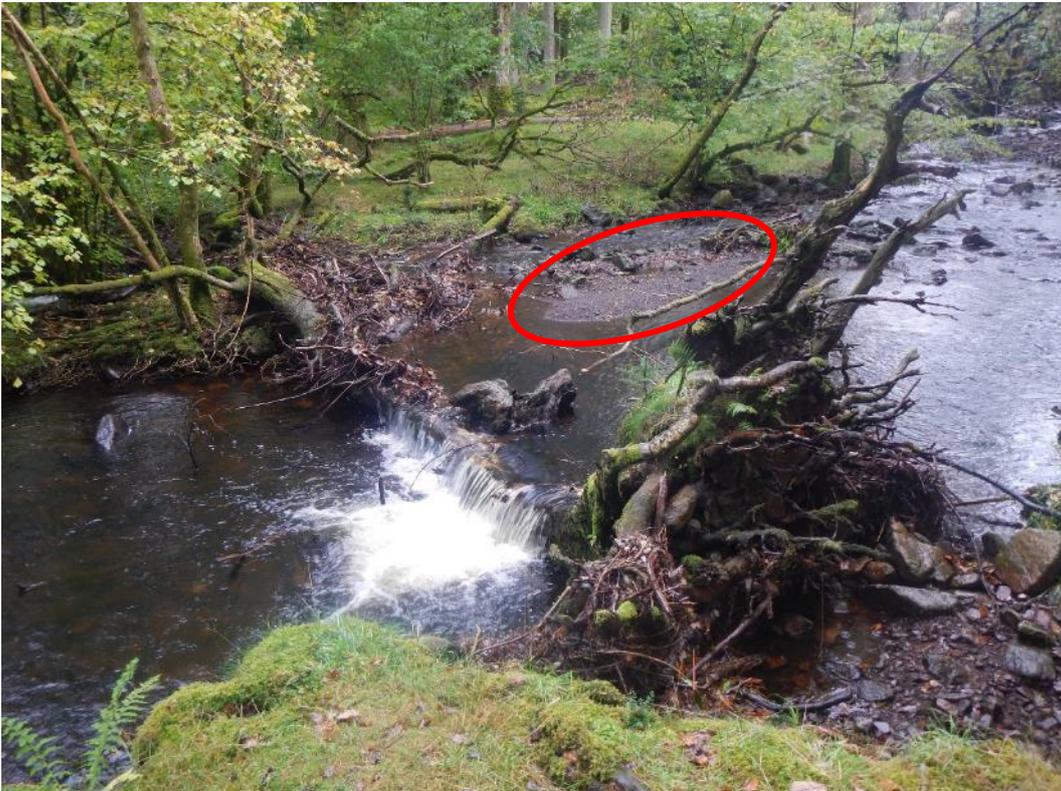
Figure 11. Another fallen tree creates increased water depth upstream and downstream, increased gravel deposition within the impoundment (red circle) and increased lateral erosion around the stump that will facilitate a more varied/sinuous course. Unlike the negative and long-lasting issues of man-made impoundments, the impact of this semi-permeable structure will be short-lived, providing various beneficial habitat as it adjusts, before eventually washing out. The transitional nature of the structure avoids the infiltration with fine sediment and bed compaction that occurs with fixed, artificial weirs.

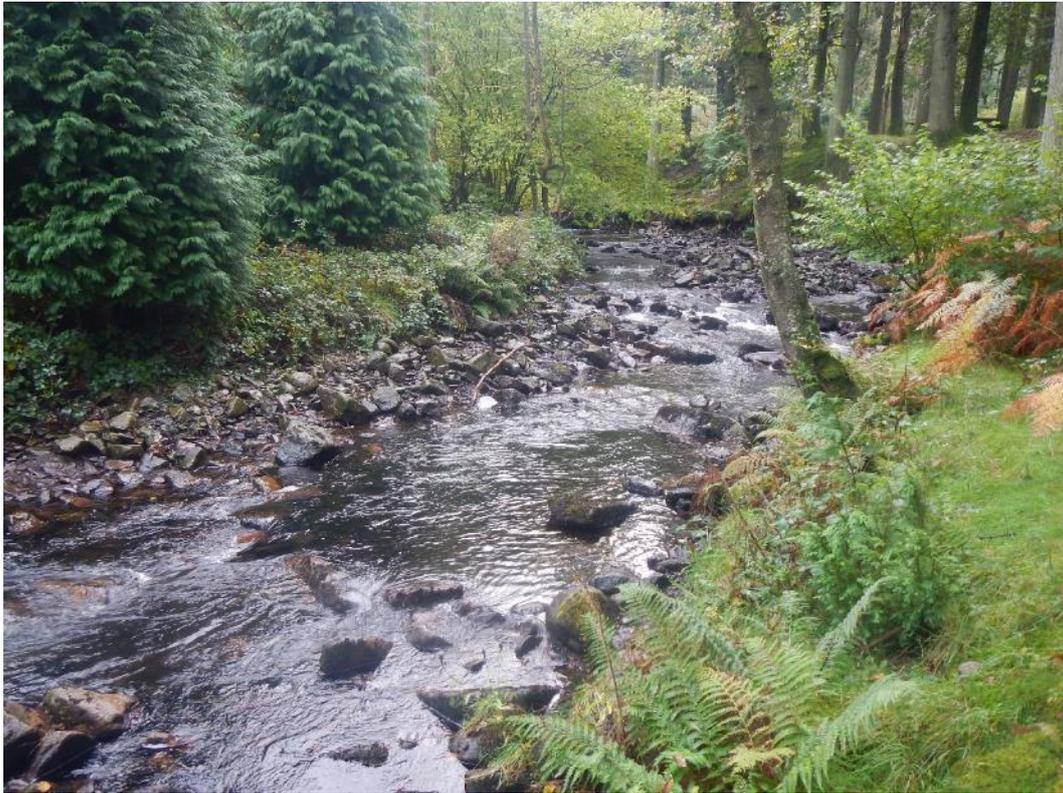
Figure 12. More non-native species were observed in the lower reaches of the beck , where what is thought to be Leyland cypress was observed (left of shot). Felling these trees to allow replacement with native species could also generate additional material for introduction to the channel.

- Eradicate the non-native species that have become established within the woodland.
- Utilise some of the material generated through non-native tree/shrub eradication for in-channel woody material. Larger non-native conifers could be lodged with the channel to replicate natural treefall (see lodged woody material). Owing to the comparatively slow decomposition and low nutrient accessibility of rhododendron leaves, it might be beneficial to allow the leaves to wilt and fall from the stems before they are introduced to the channel (then ideally also removing or mulching the leaves).

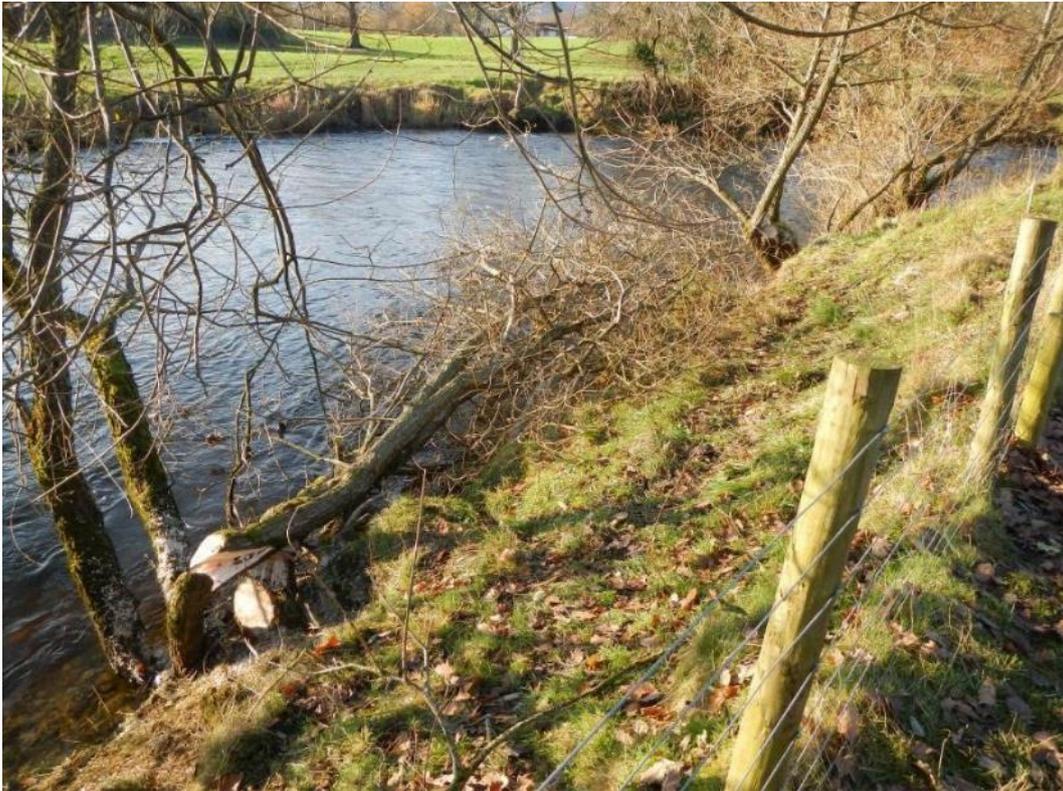
Figure 13. Willow hinged into the river margin to increase cover and structure. The method involves cutting part way through the branch, quickly through the first two thirds, then continuing until it collapses down over the river. The depth of the cut should be limited to only that which is required to bend the limb over, as this will maintain maximum size and strength of the hinge and the health of the tree/shrub.

Where multiple trees are present, the occasional trunk can be used to create a habitat enhancement feature, with no significant detriment to the overall habitat. This could entail partially cutting through trunk, as you would when laying a hedge, so that the trunk/branch remains attached (Figure 13). This technique works well with hazel and willow.

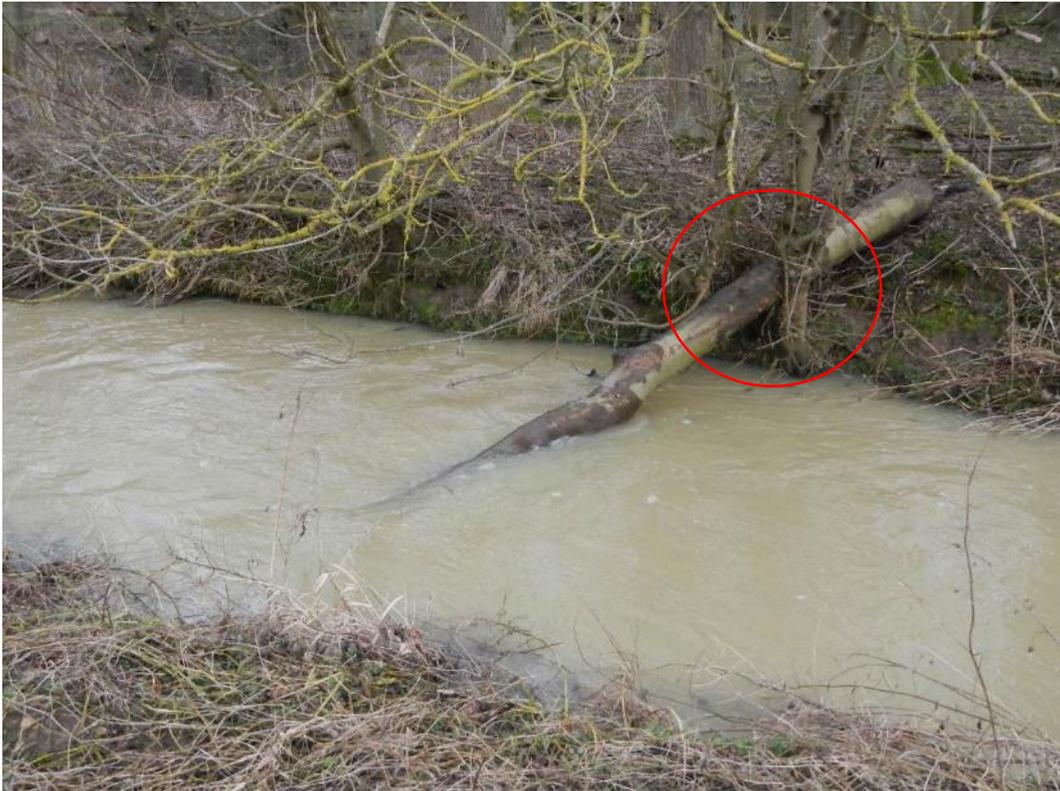
Figure 14. A lodged flow deflector securely but naturally lodged in place between to upright trees (red circle). The technique can utilise a single pole (primarily to increase scour) or a branched limb (to create greater flow dissipation). The elevated butt end (bank end) reduces the potential detrimental bank score usually associated with d/s deflectors as a through-flow is maintained along the bank.

Alternatively, a trunk can be felled to create a coppice, encouraging low-level regrowth from the stool and providing material that can be lodged between two or more standing trunks (Figure 14), or hung over another tree if a 'V' branch is available (Figure 15).

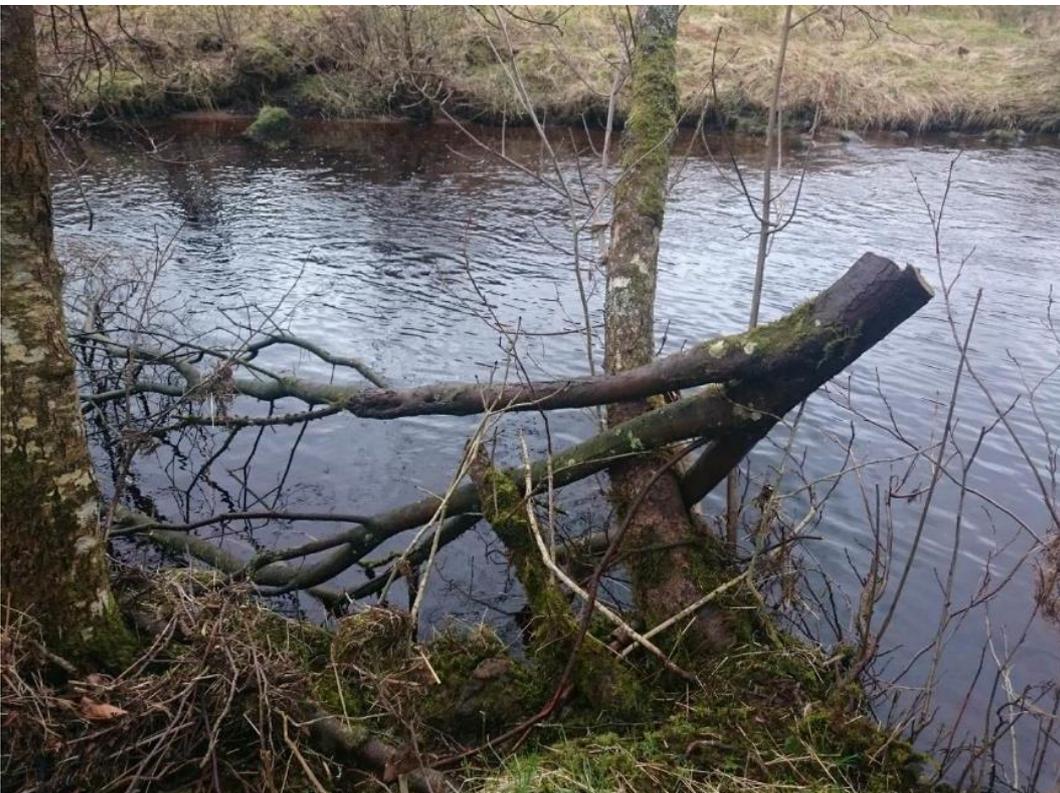
Figure 15. Medium-sized, lodged woody material, securely anchored by the 'V' of the branches against an upright tree.
