River Hooke, Waterside, Hooke, Dorset

An Advisory Visit by Nick Lawrence of the Wild Trout Trust

July 2022

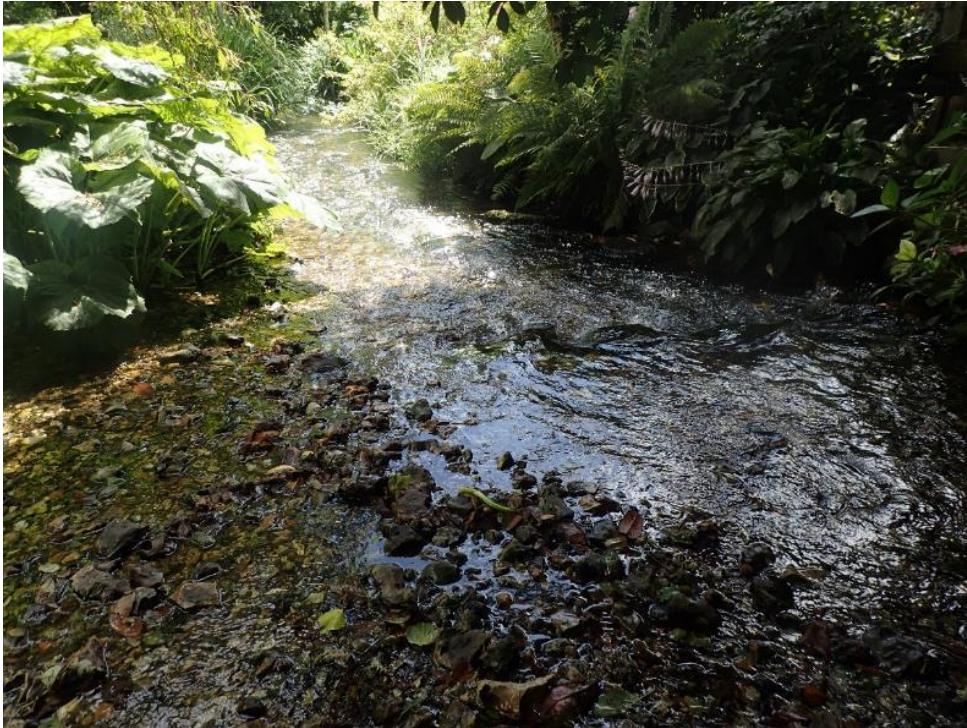
Photo 1 Upper most section visited, the river here exhibits a good gradient and clean graded gravels. Water crowfoot would be expected here as it grows downstream, so some planting of it in well lighted areas could be beneficial. Exemplary management of shaggy overhanging fringes and trees provide high quality habitats for insects and fish.

- Consider translocation of water crowfoot to the fast flowing well-lit areas.
- Notch the centre out of the rock weir and cut a small notch in the wooden planked weir adjacent to the pond.

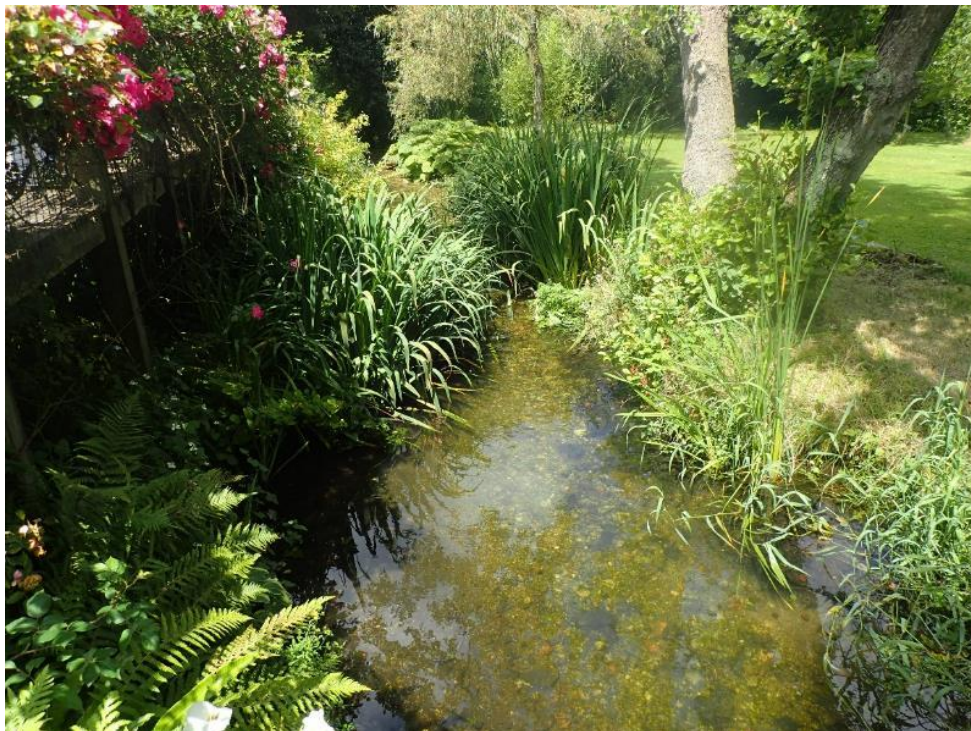
Photo 2 High quality marginal habitats, providing refuge for insects and fish: 5 trout were sighted within this area.

- Continue to encourage lush and thick vegetated fringes, ensuring cover for small fish and invertebrates at the river's edge: Avoid strimming bankside plants as this reduces cover for wintering invertebrates.

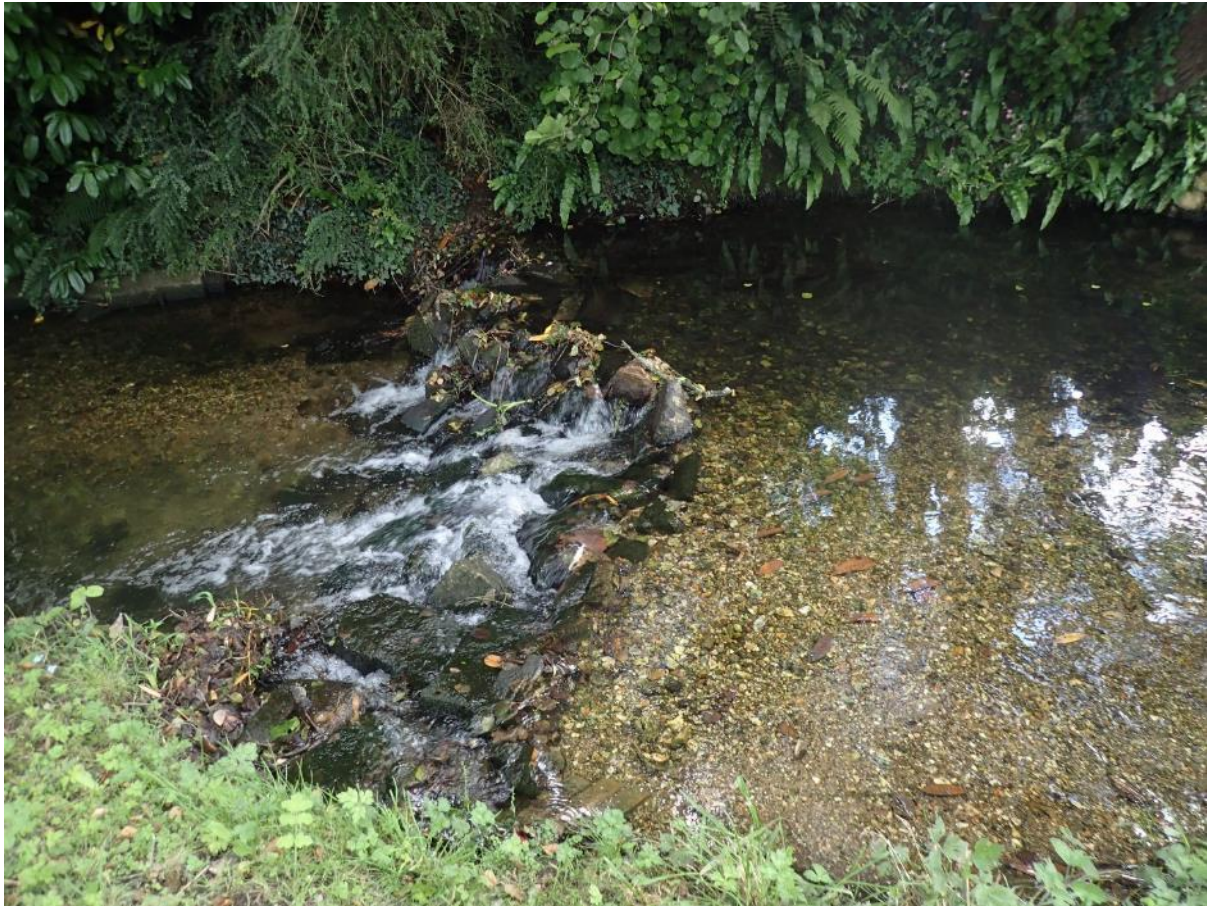
Photo 3 Small boulder weir is interrupting gravel and fine sediment transport downstream, and increasing bank erosion downstream on the LB. This should be modified to improve in channel habitats. Removing the central stones and rolling them into the edges of the river will improve fish passage, sediment transport and reduce erosion.

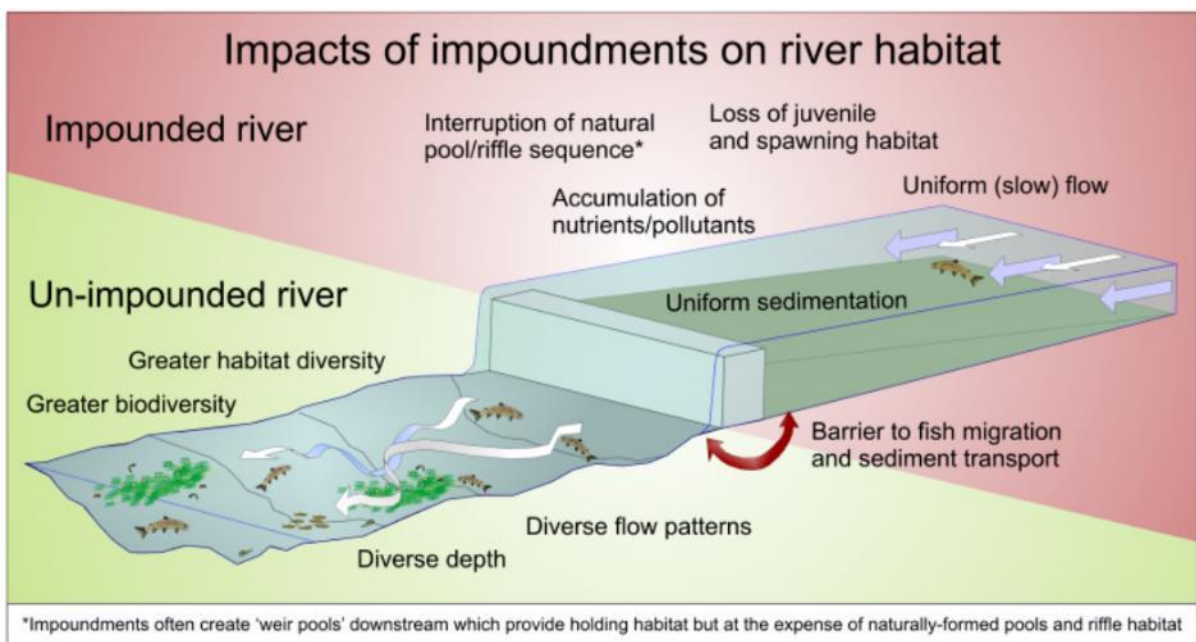
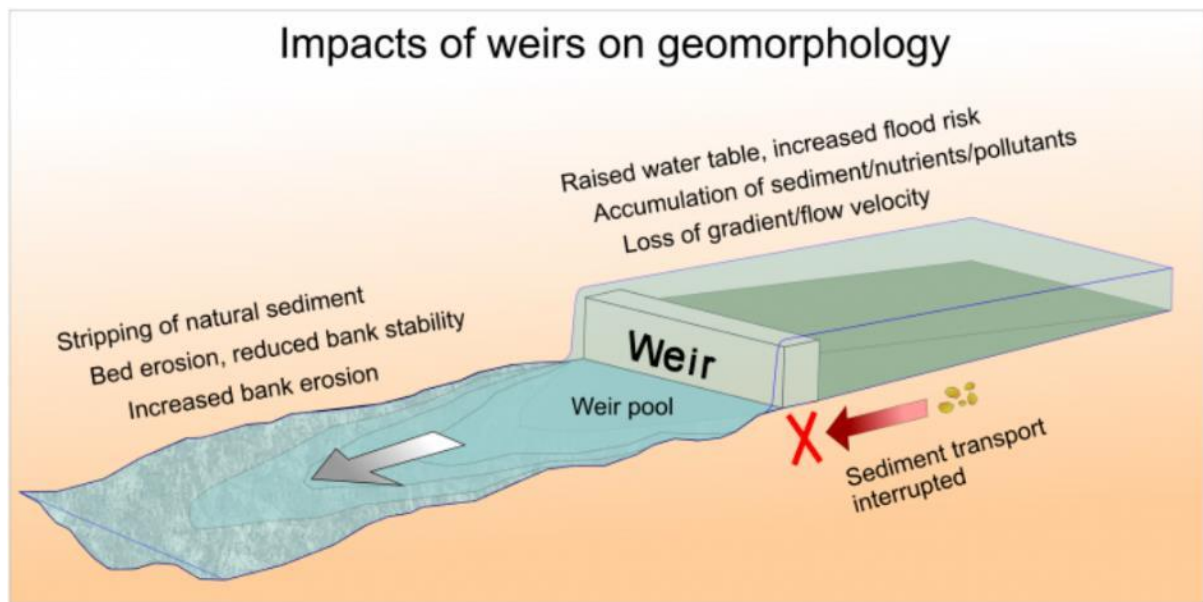
Diagrams 1 & 2 show the effects a weir can have on a river, and is relevant to even the small weir at Waterside. More information on weirs can be found at [Weirs, barriers and hydropower | Wild Trout Trust](#).

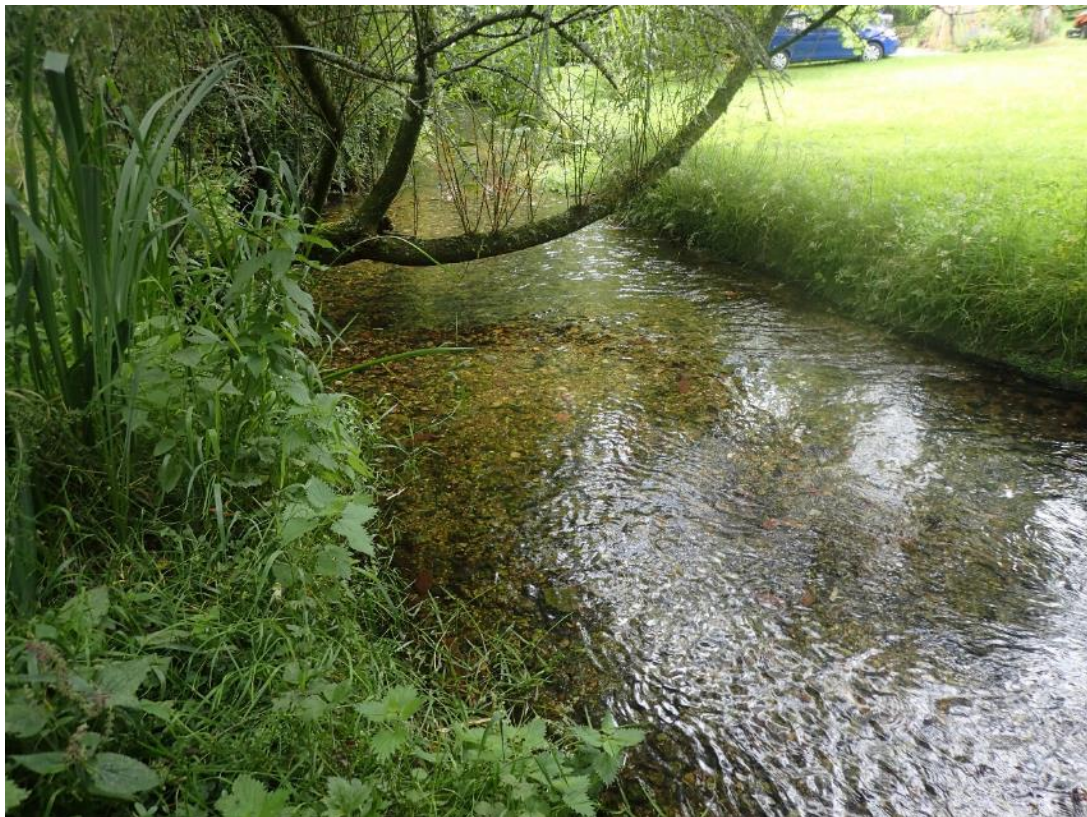
Photo 4 Looking downstream to a well-shaded channel which aids water temperature regulation in hot periods. The LB has favourable habitat management with trailing vegetation to water level. On the RB (under different ownership) habitat development is impeded by block stone at the bank toe. The block stone would be best removed and replaced with a natural sloping gravel edge or faggot bundles could be installed to aid the establishment of native marginal plants.

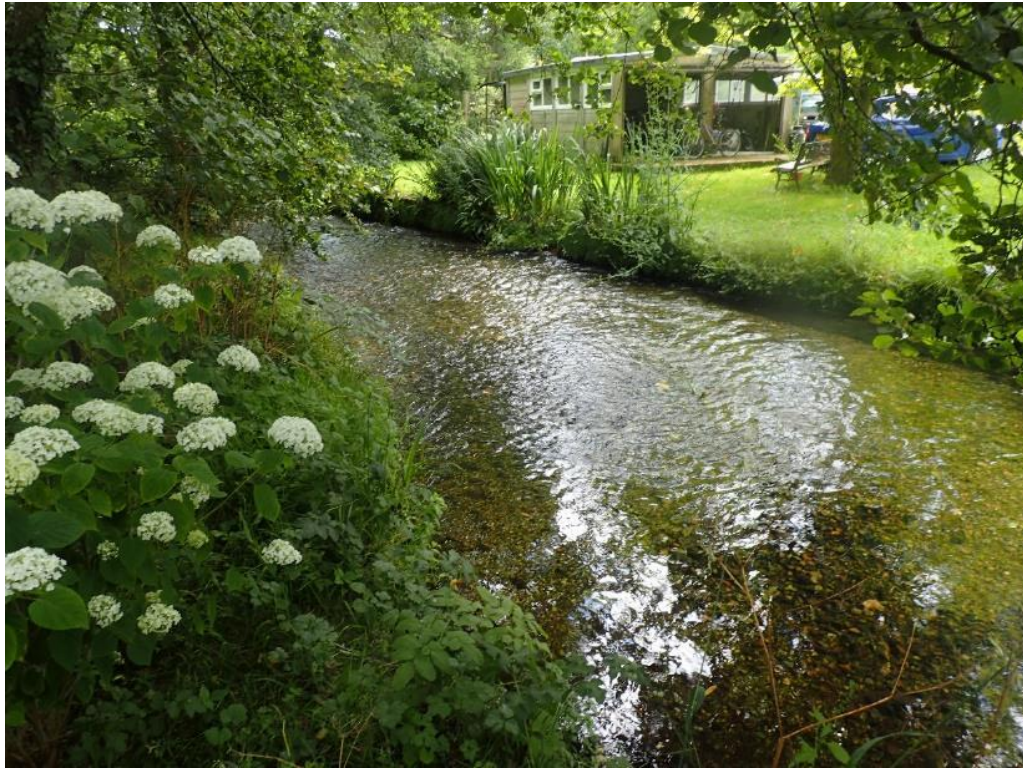
Photo 5 Further downstream a wide shallow riffle could provide spawning habitat. It could be diversified further with woody material placed on the LB to increase local bed scour and flow diversity to generate a wider range of micro-habitats.

- Add some woody material into the channel to create pinch points to help diversify the flow and to initiate bed local bed scour. See example below.
- Speak to the EA to understand if their gauging weir is underperforming, which could mean it is due for removal.

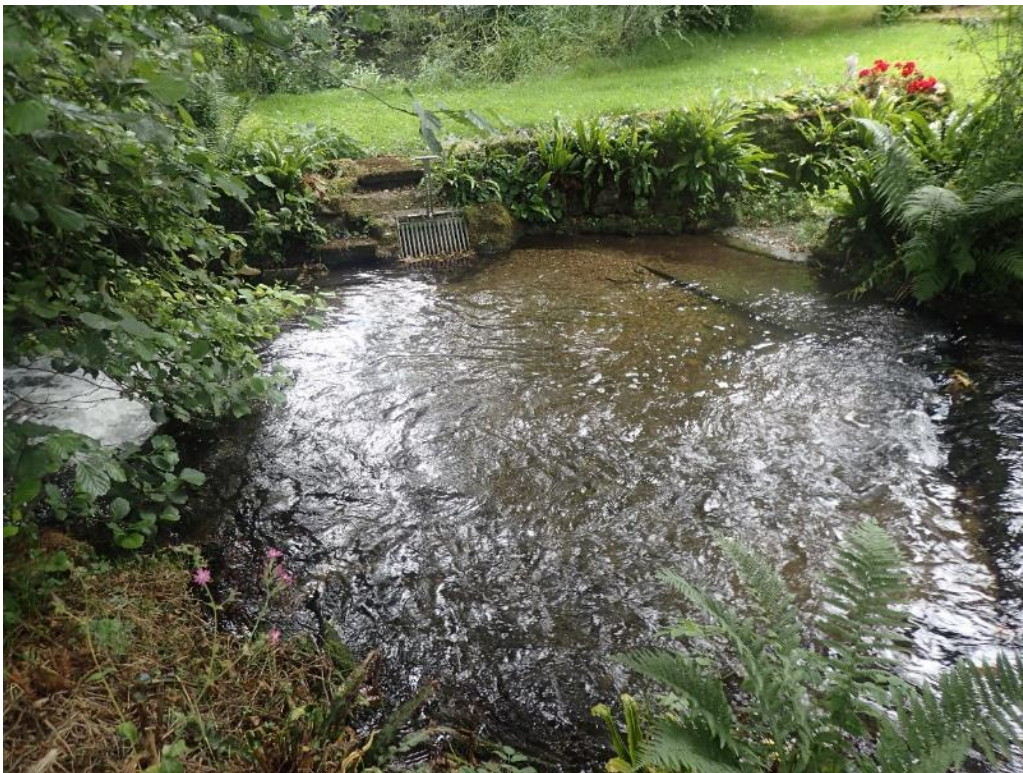
Photo 6 Another small weir made of wood planks (left of shot) is designed to divert a sweetening flow to an online pond on the RB. The weir should be notched further to improve fish passage and habitat connectivity, whilst still providing flow to the lake.

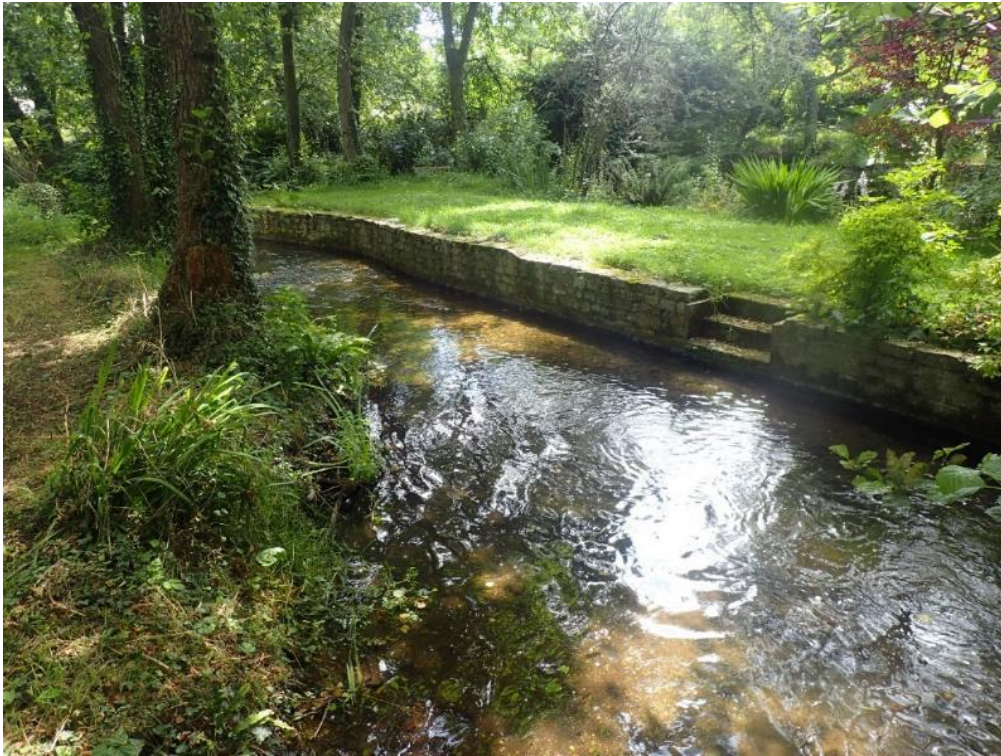
Photo 7 Nice mature woodland providing good, dappled shade keeping the river cool. The stone wall (RB), (under different ownership), is preventing marginal plant growth and offers no habitat cover for trout. Its impact could be mitigated by the introduction of a gravel bar at the base of the wall. A gravel bar would enable shade tolerant plants (such as pendulous sedge and ferns) to establish.

- Consider installing a new low-toe to the RB against the vertical wall, to enhance the aesthetic and biological quality of the defended bank: The gravel would also provide further protection to the wall against erosion.

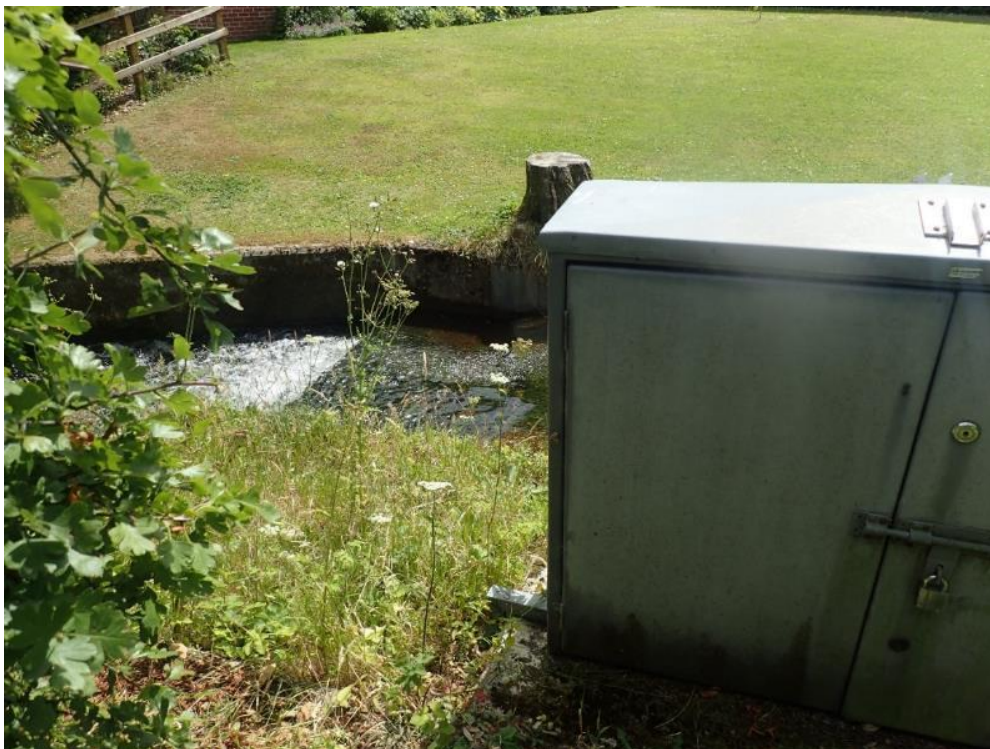
Photo 8 At the most downstream point visited, the Environment Agency (EA) gauging station [River Hooke level at Hooke - GOV.UK \(check-for-flooding.service.gov.uk\)](https://check-for-flooding.service.gov.uk). The shallow water over the concrete sill prevents, fish passage except in high flows.

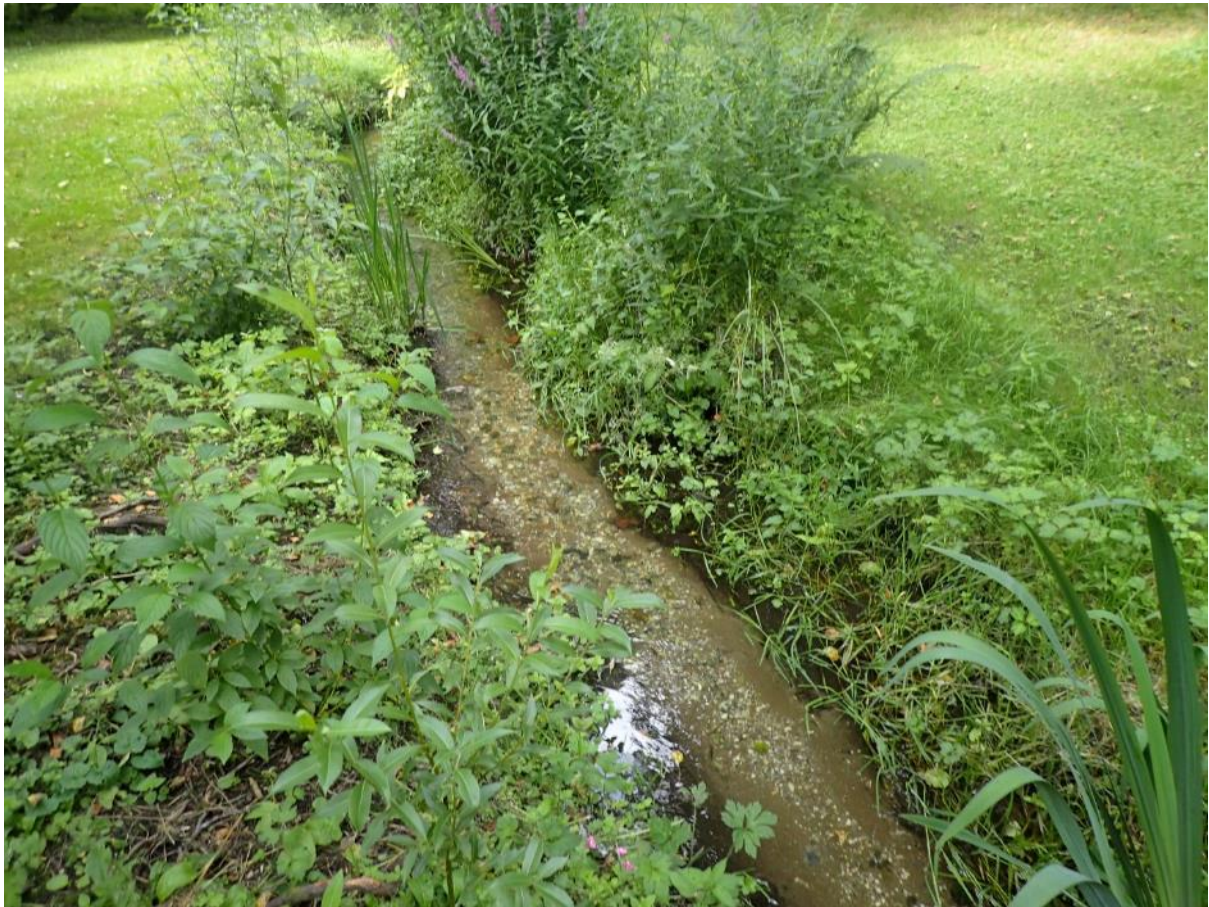
Photo 9 Adjacent to the main River Hooke was a small stream that is fed from the main river, which, rejoins at the lower end of the reach. The stream is managed sensitively and provides habitat for a wide array of aquatic invertebrates (as demonstrated by some cursory stone turning).

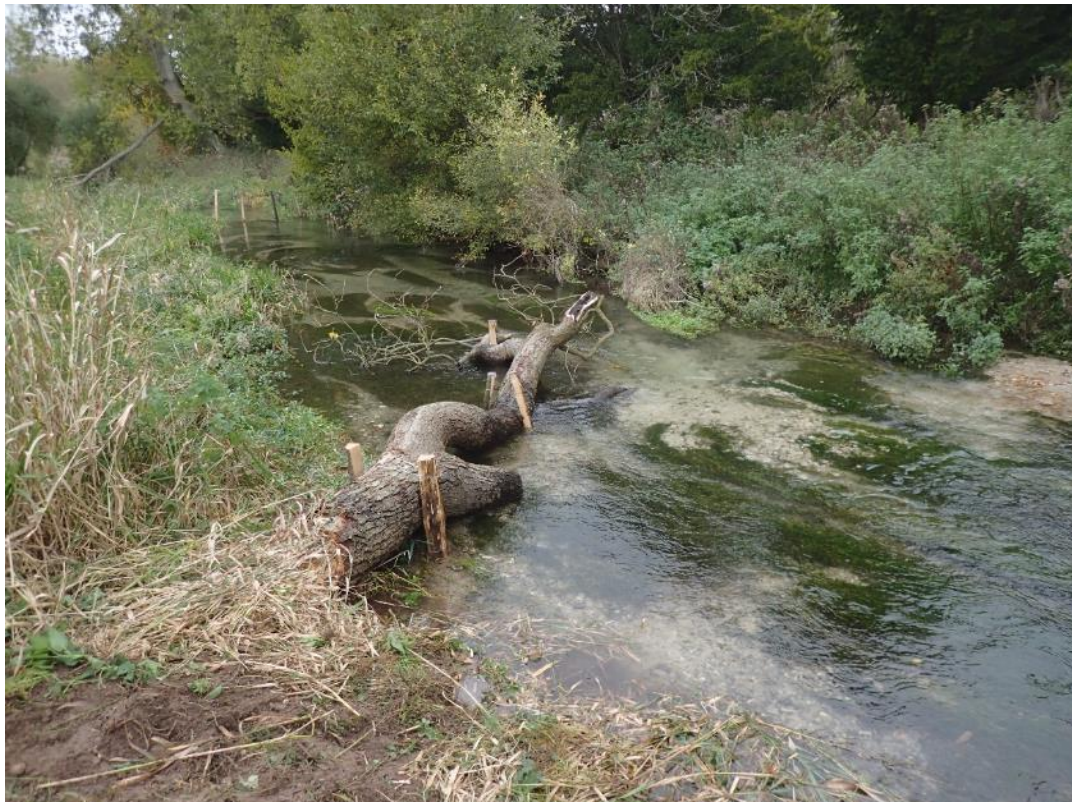
Photo 10 A misshapen piece of woody material, scouring the riverbed and diversifying flows.
