Weston Farm (River Lambourn) – Advisory Visit

An advisory visit by Nick Lawrence & Rupert Kelton of the Wild Trout Trust

11th January 2022

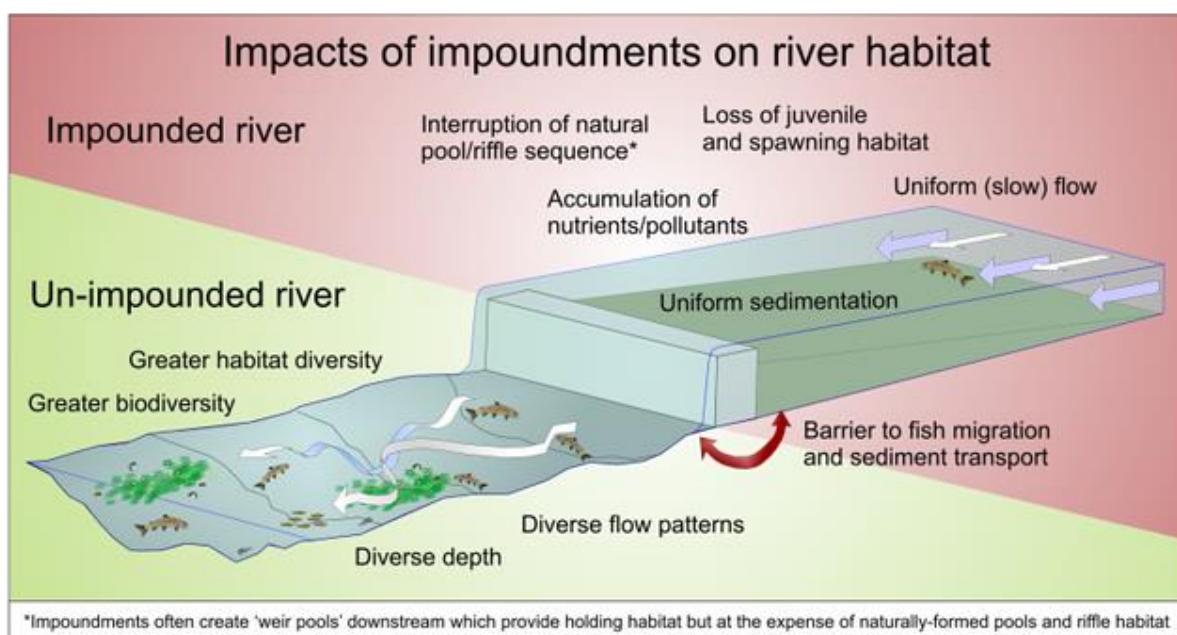
Figure 1: Illustration of impacts of impoundments on river habitat

The channel here is slightly uniform with a laminar flow which indicates that the river is impounded.

Looking at the [Kennet & Lambourn SSSI Restoration Plan \(2011\)](#) it appears there is a weir and a large cascade downstream at Welford Park. The large cascade is described as 'having a significant impounding effect on approximately 150m of river' and it suggests that fish passage is unlikely up any of the structures.

The current status of the structures at Welford Park is unknown but it is possible that these structures are the cause of the slower flows and increased levels of sedimentation that are present at the lower end of the fishery at Weston. Chalk stream reaches that have more variety in channel shape and form (pools, riffles and glides) provide more valuable wild trout habitat than long sections of impounded channel, like there is here and downstream to Welford.

Further investigations with the Environment Agency would be worthwhile to establish what changes have been made or are planned for the structures at Welford Park.

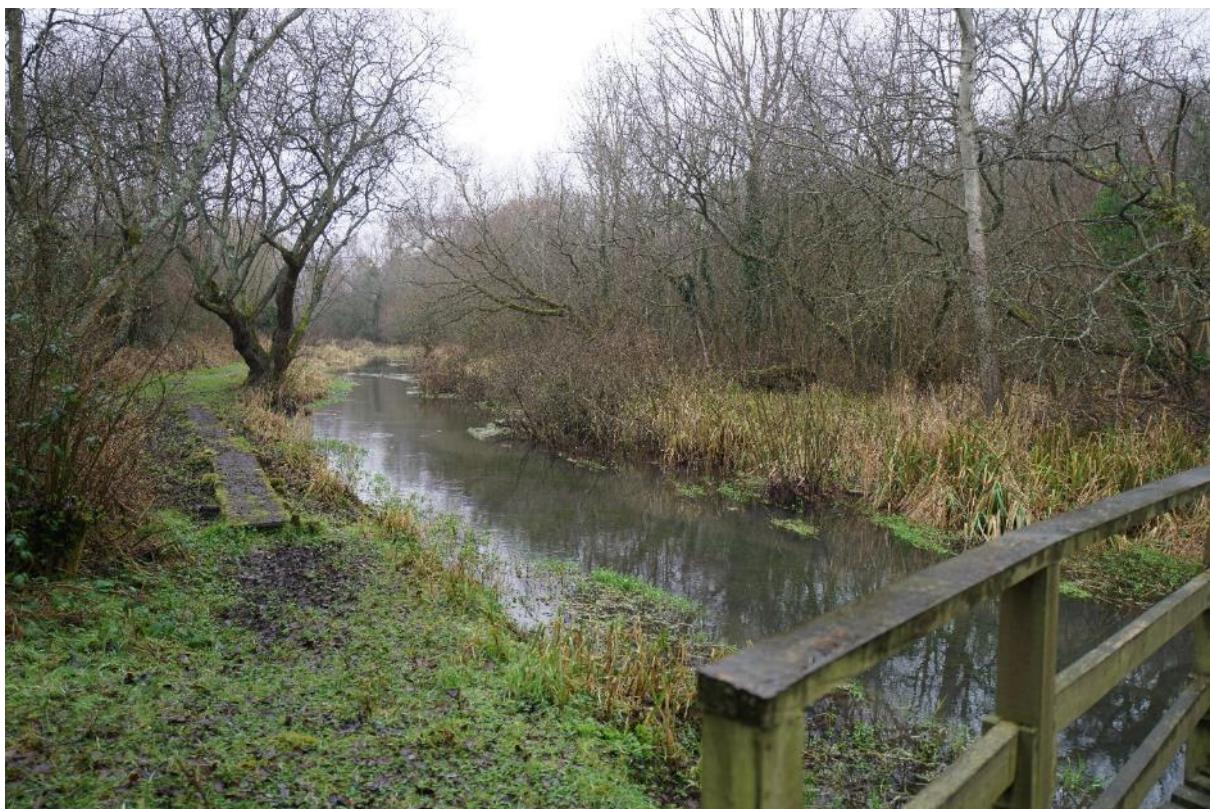
Despite the impoundment there is good marginal habitat along this reach with plenty of overhanging branches and willow scrub along the unmanaged LB, as well as signs of a marginal fringe on the RB.

Photo 1: View upstream from the lower limit of the fishery.

Continued 'light touch' management of the marginal fringe on the RB will be beneficial and, generally speaking, the thicker and more diverse the fringe is allowed to become the better for providing refuge and cover for juvenile fish and adults alike. Similarly, the habitat along the bank edges, where the aquatic and terrestrial communities meet and integrate, can be a hugely valuable source of food. Managed correctly, the margins will benefit the river's fish by providing a terrestrial subsidy of invertebrates falling in the river.

Whilst an unbroken marginal fringe would be considered optimal from a habitat perspective it can make sense, for the management of the fishery, to cut a few small gaps (<1m wide) in the areas where you would like to encourage rods to access the river, rather than entering and exiting at any given point and disturbing or potentially damaging the margin.

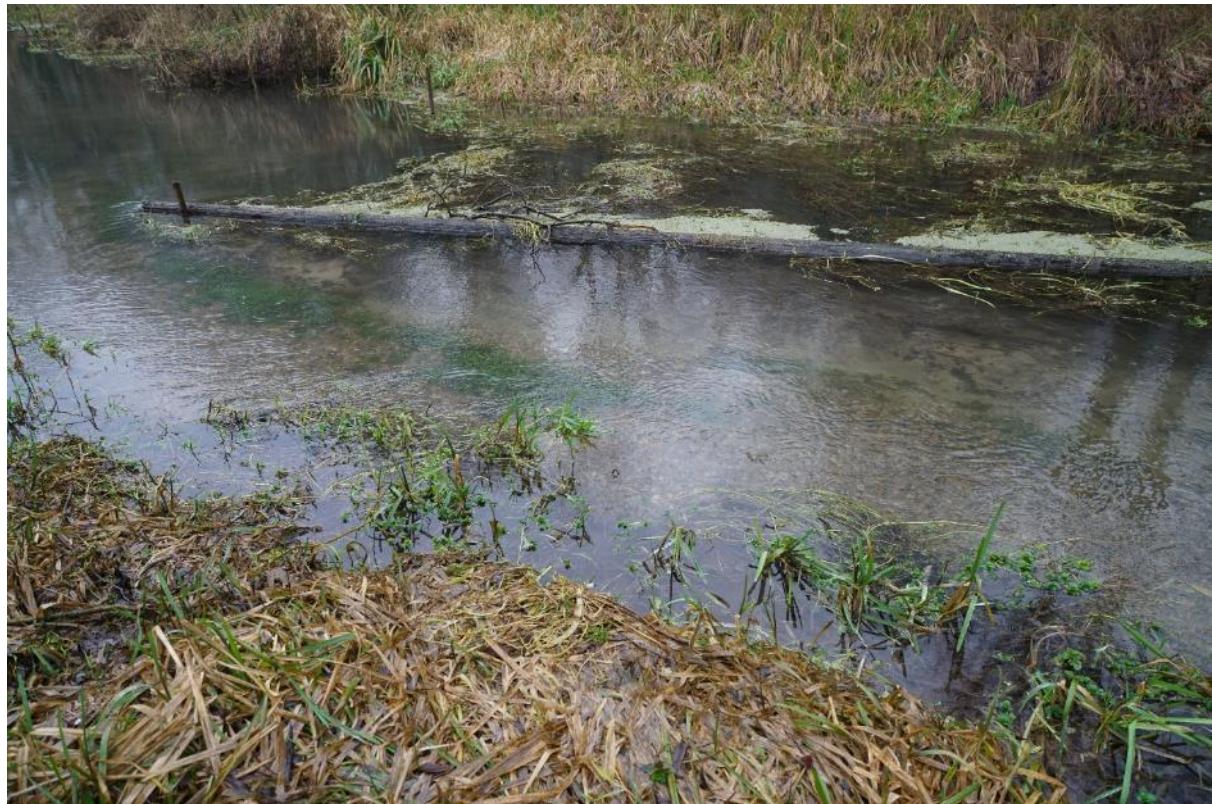
Upstream of the footbridge, the small section of channel adjacent to the weed rack highlights the impounding effect of the river. By contrast, where the weed rack has narrowed the channel the increased flow velocity has allowed the river to maintain a clear gravel bed as seen in **Photo 2**.

Photo 2: A section of clear gravel bed where the weed rack has pinched the channel and increased flow velocity.

Where silt is collecting on the riverbed, particularly in the central channel, it is often a sign the river wants to be narrower. Strategically adding course woody material to the channel can improve flow diversity, clearing or scouring the bed, as seen here, which will improve the quality and range of habitats, helping to increase spawning opportunities.

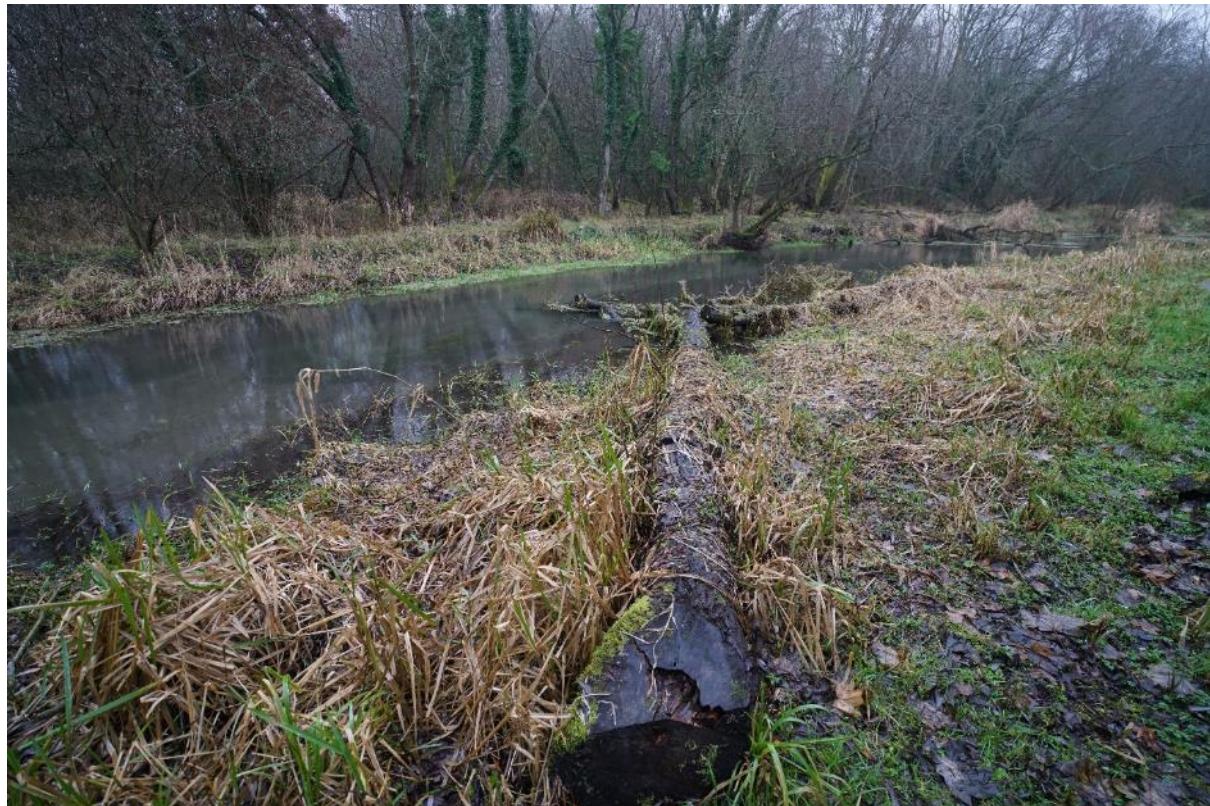
Upstream of the weed rack there are some good examples of where this has been done in the past. The tree limb placed in the channel from the RB, shown in **Photo 3**, is not only helping provide the sort of complex habitat and cover that will favour trout, it has also helped to speed-up the flow in the central channel, whilst slowing the flow along the right-hand margin, encouraging sediment deposition and, over-time, collecting silt and marginal plants. The overall effect of this has created a new bank edge, further narrowing the channel and restoring a more natural flow regime. Likewise, downstream, there is another section of woody material on the LB which is doing a similar job and working in tandem with the tree limb upstream to help add sinuosity to an otherwise fairly uniform channel.

Photo 3: Example of woody material previously installed to help improve the flow regime and provide instream habitat.

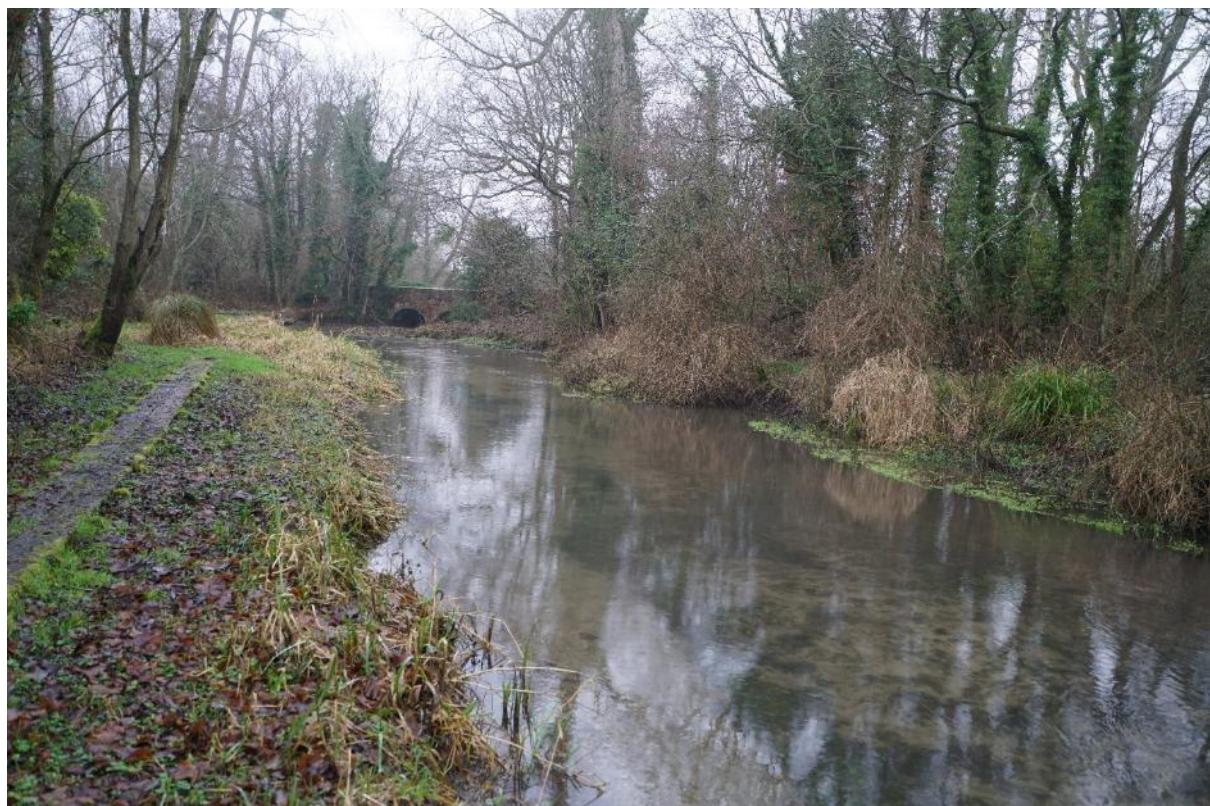
Photo 4: Opportunity here for the addition of more woody material.

There is scope to add more woody material to the channel in the section, shown in **Photo 4**, upstream towards the road bridge. Below the bridge, the impoundment caused by the structures at Welford Park is no longer evident and there is some good riffle habitat with evidence of several redds during the visit.

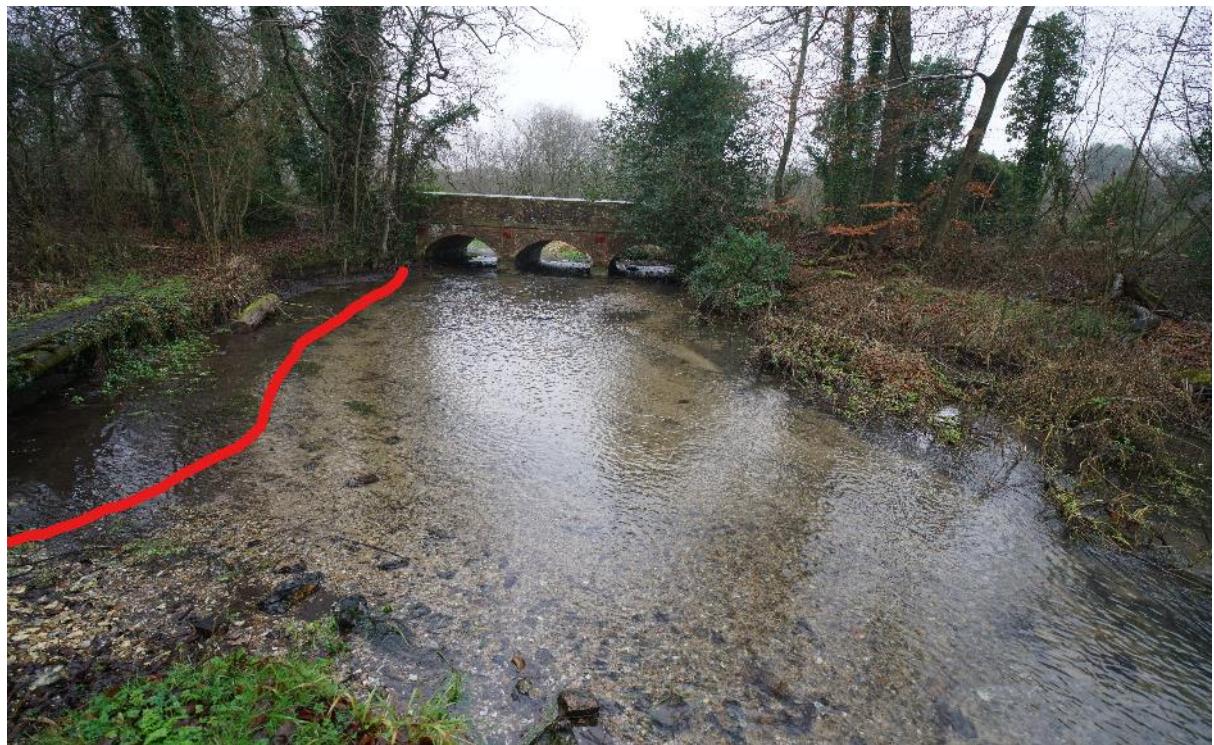
Photo 5: Gravel riffle providing good spawning habitat + scope for brushwood berm on RB.

Immediately below the road bridge there is potential to enhance the gravel riffle by creating a brushwood mattress along the RB (**Photo 5**). This should help concentrate flow over the riffle and provide accessible refuge for juvenile fish. Some siding-up of the overhanging branches and limbs from the trees above this area will allow more light onto the structure, enabling the growth of marginal plants which should help stabilise the structure. Translocating some flag-iris and sedge from nearby will also help speed-up this process.

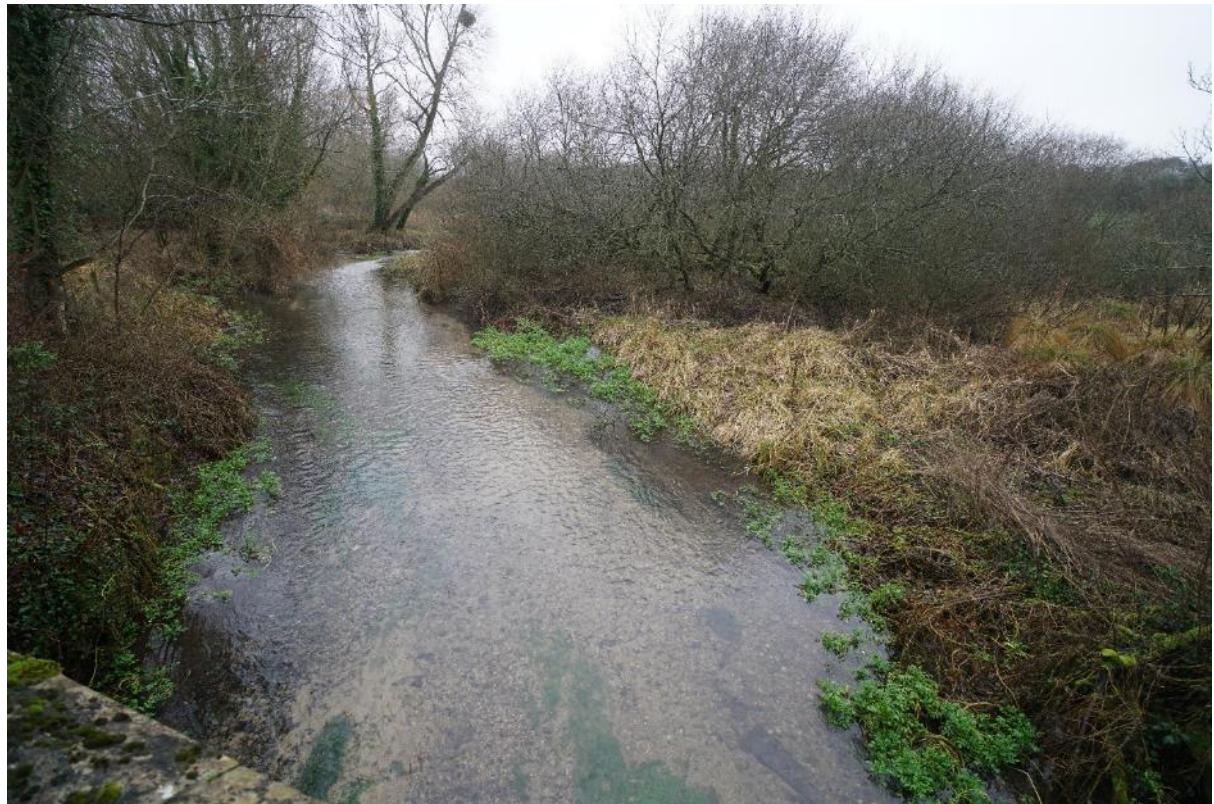
Upstream of the road bridge, there is an area on the LB known to provide important habitat for the Desmoulin's whorl snail, *Vertigo moulinsiana*. This rare wetland snail lives on the leaves of tall wetland plants, such as the reed sweet-grass and tussock sedge found on this part of the reach. Cutting or mowing should be avoided as this will remove the tall vegetation that the snail requires. Tidy riverbanks or heavy trampling will eradicate the snail. Allowing this area to remain as relatively swampy, unshaded ground with tall waterside plants should help to maintain a healthy population of snails whilst also providing good marginal habitat for fish and invertebrates.

Photo 6: Desmoulin's whorl snail habitat on LB and opportunity to add woody material to the channel on the RB.

There is also further scope to add woody material along the RB above the road bridge. Winning timber from the Goat Willow *Salix caprea*, seen on the LB in **Photo 6**, could help reduce shading to the snail habitat and provide good material that can be used to enhance sinuosity and habitat in this part of the channel.

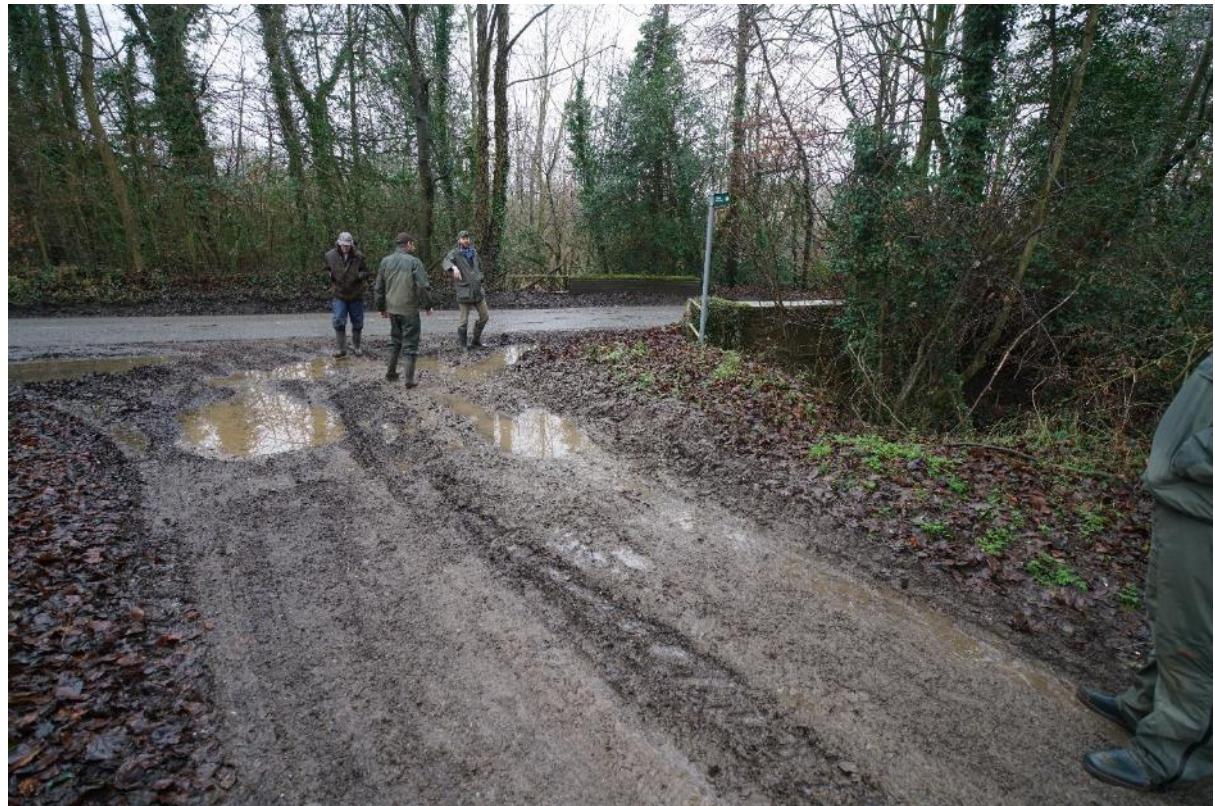
Approximately 100m to the east of the road bridge, along the Newbury Road, there is a farm track leading to pony paddocks and arable land to the north. Where the track meets the Newbury Road (51°27'37"N , 001°25'13"W) there are a couple of grips where water from the track drains into the river. During heavy rainfall events this track is likely to be a source of sediment pollution into the River Lambourn.

Photo 7: Farm-track acting as a source and pathway for sediment pollution

Simple solutions such as installing a cross-drain and sediment trap on the track (**Photo 8**), resurfacing or relocating the access to the pony paddocks (**Photo 9**) and investigation of other measures to take water away from the track, further to the north, would make an important contribution to reducing sediment pollution in the river and the wider catchment.

- Talk to the owners of the farm track (NGR: SU 40381 73638) off the Newbury Road about interventions to prevent sediment pollution. Contact Karen Davis at Catchment Sensitive Farming for advice and help with funding. WTT will share contact details.
- Explore options for fencing and managing the grazing pressure in the meadow at the top of the upper beat. Again, Catchment Sensitive Farming can help with funding and advice.
- Continue to monitor and report the storm overflow from the East Shefford STW and contact Action for the River Kennet regarding options for volunteers to help with riverfly monitoring. WTT will share contact details.

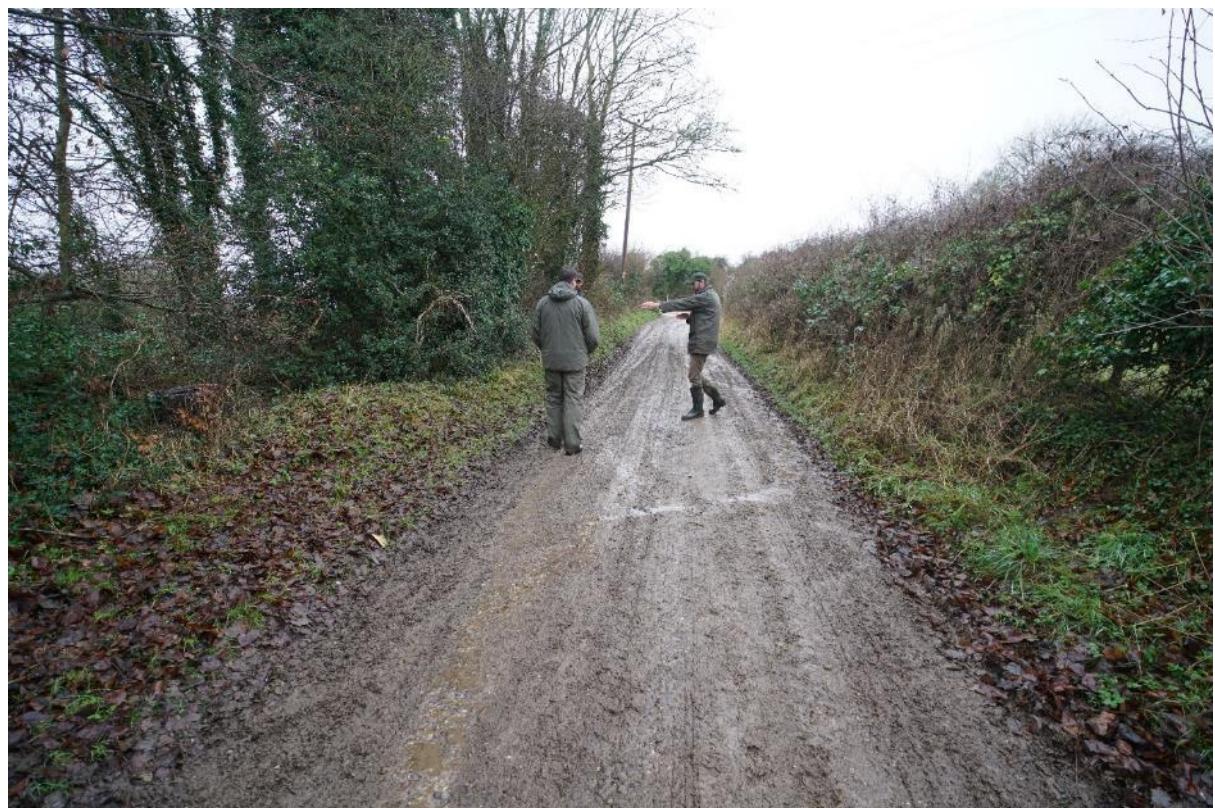
Photo 8: Opportunity for cross-drain and sediment trap

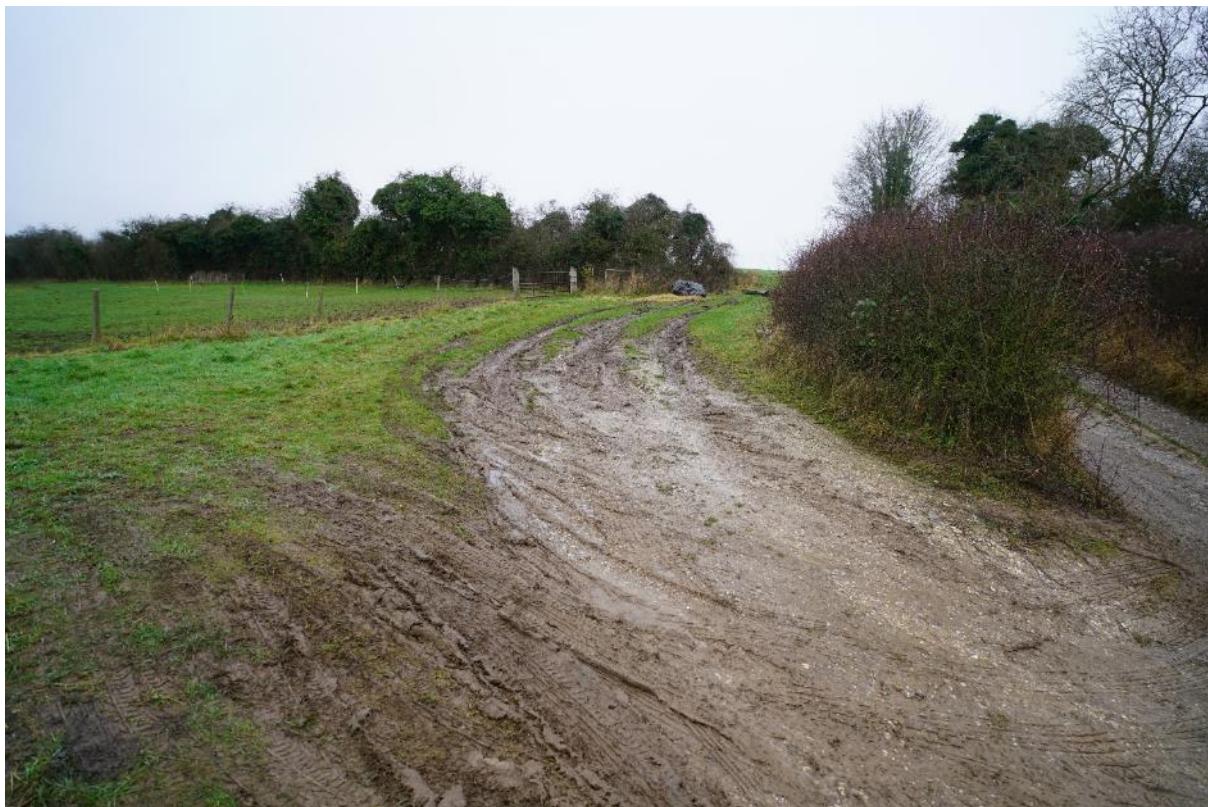
Photo 9: Opportunity to resurface access or relocate gateway

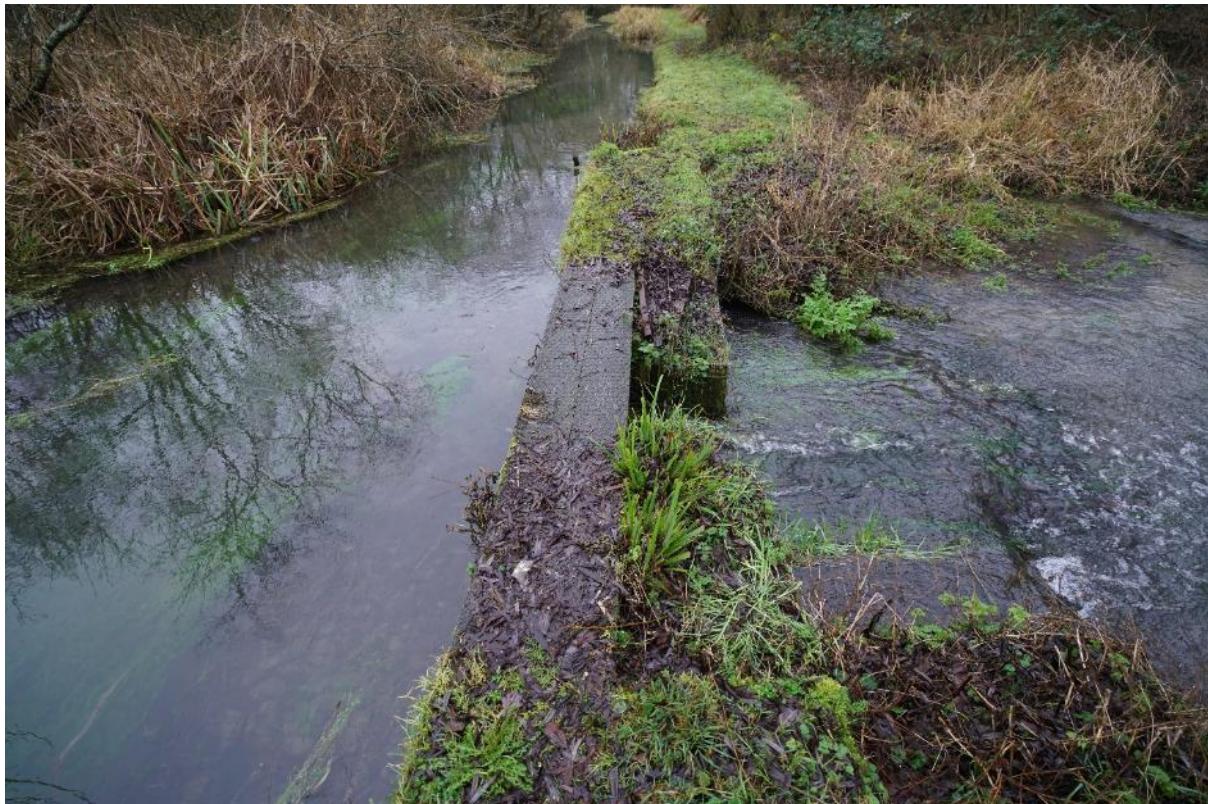
The river here, however, has historically been altered and is a legacy of the old water mill structure upstream. The channel along this section is perched and there is a sluice, mid-way along the reach, on the RB, which has apparently had issues with breaches in the past and is understood to have been repaired approximately 10 years ago with funding from Natural England.

Photo 10: Sluice on the RB of the perched mill leat ($51^{\circ}27'39''N$, $001^{\circ}25'20''W$)

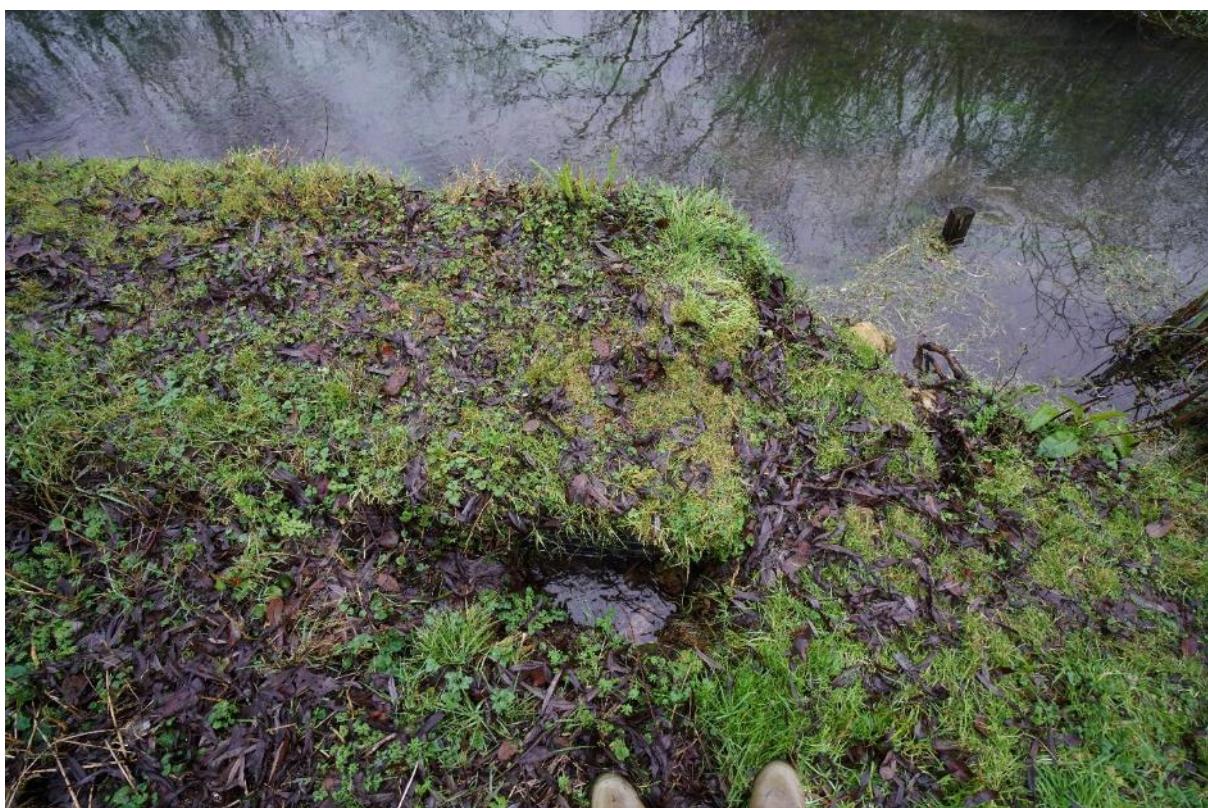
During the visit, there was evidence of the beginnings of another breach at this structure, as seen in **Photo 11**. Infilling the breach with stone and chalk and creating a small brushwood berm could help in the short-term to prevent the breach from worsening but WTT would recommend the fishery undertake their own investigations into a longer-term solution.

Photo 11: Breach at the downstream end of the structure

- Investigate the breached structure seen in **Photo 11** (51°27'39"N , 001°25'20"W) on the lower beat and identify best solutions for repairing the breach. Natural England might have a record of previous works and could help provide funding to contribute towards the repair. WTT will share contact details.

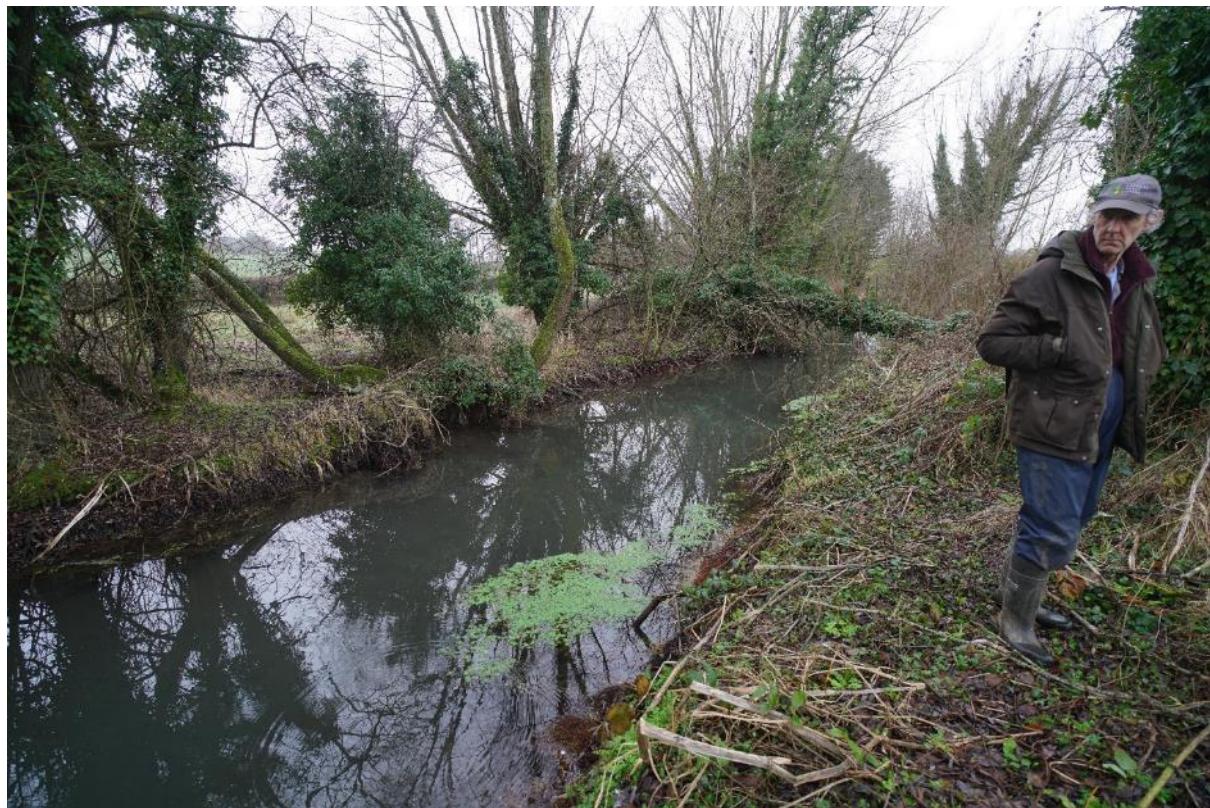
Another legacy of the historic alterations to the River Lambourn, most likely a result of dredging work carried out by the National Rivers Authority, is the heavily degraded / partially destroyed section of channel in the reach below the mill ($51^{\circ}27'39''N$, $001^{\circ}25'22''W$). The river here has been robbed of all the natural characteristics you would expect from a classic chalk stream and left as an over-wide, over-deep, canal-like waterbody, as seen in **Photo 12**. In its current state this section of river is not favourable for supporting healthy populations of wild trout. However, it would be possible to restore this reach by reintroducing clean gravel into the channel to raise the level of the bed and restore the natural gradient.

Photo 12: Dredged and heavily degraded section of channel below the mill.

This would be a worthwhile aspiration for the fishery in the longer-term, both by way of providing a decent length of additional fishing and helping to restore a valuable section of chalk stream habitat. The Wild Trout Trust and / or the local Rivers Trust (Action for the River Kennet) would be able to help source funding and provide support with a restoration project of this nature.

- Explore options with WTT and Action for the River Kennet for a restoration project in the dredged section of the lower beat, downstream of the mill ($51^{\circ}27'39''N$, $001^{\circ}25'22''W$).

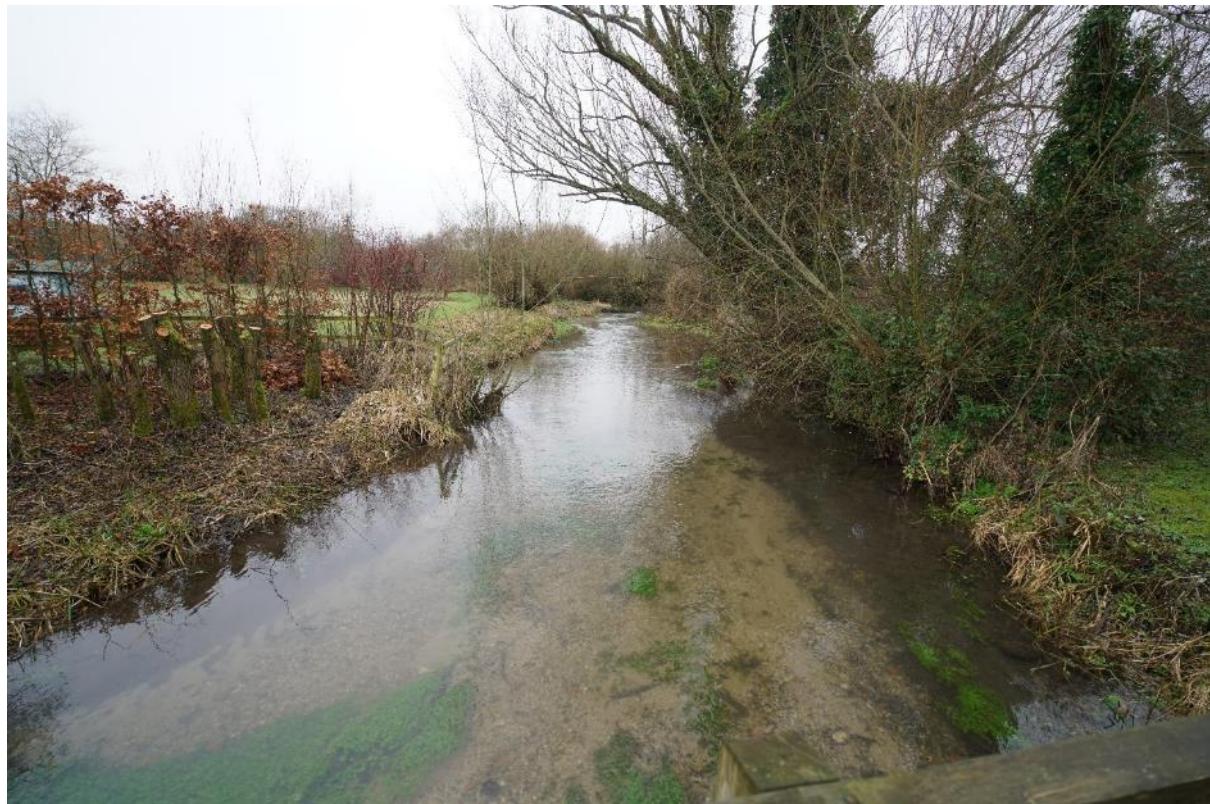
There is more quality habitat on up through the start of the middle beat (**Photo 13**), towards the mill hatch pool (**Photo 15**), with good gradient, clean gravel and signs of a range of emergent plants. A brushwood mattress in the space shown on the LB in **Photo 14** could be used to enhance marginal plant encroachment and broaden the margin to exaggerate the sinuosity of the channel.

Photo 13: Looking up-stream from the footbridge at the lower limit of the middle beat (51°27'40"N , 001°25'27"W).

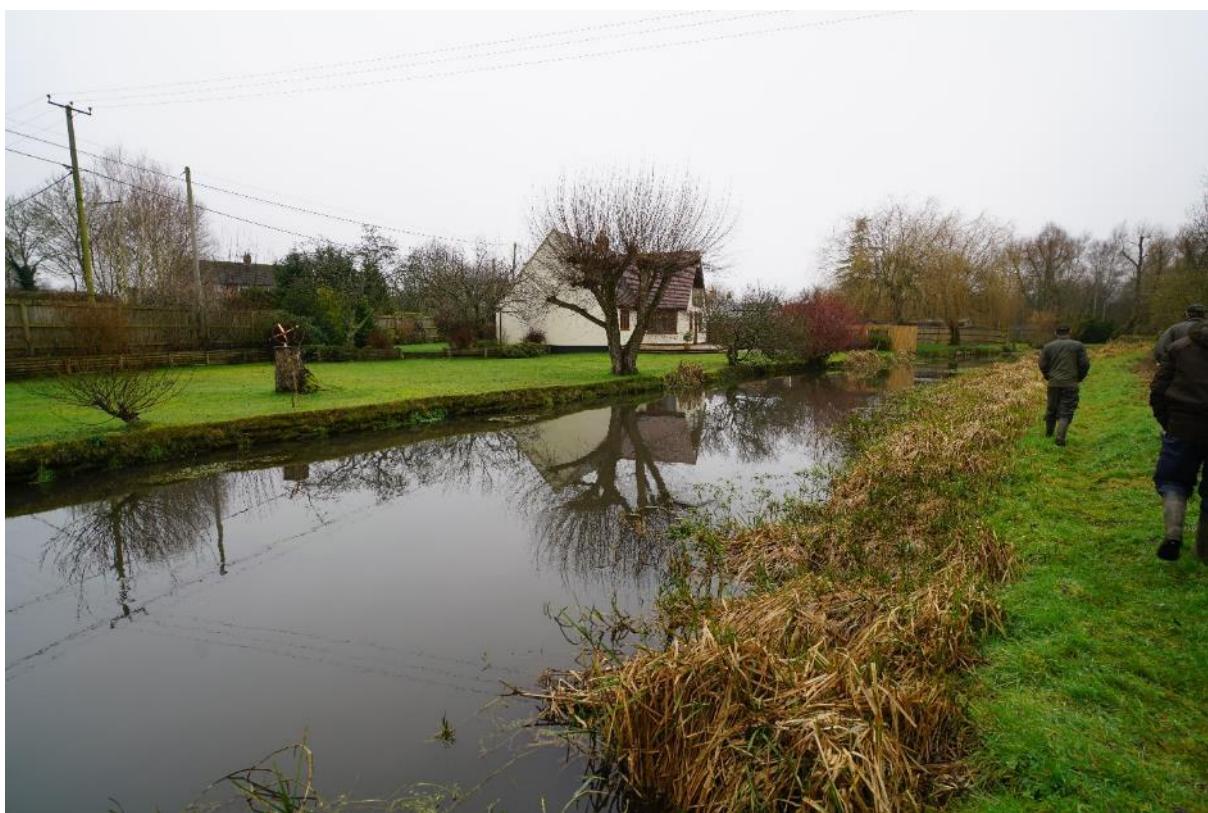
Upstream of the mill, the river is impounded by the mill structure and the flow is slow and uniform. The 'light touch' management of the marginal fringe on the LB, owned by the fishery, is contrasted with the solid vertical revetment on the RB with a garden lawn that is mown right to edge of the bank. When a riverbank is poorly managed like this, it can rob the river, (and the owner's garden) of all the benefits of a marginal fringe and ecologically disconnect the river from the land around it. In comparison the LB will be providing habitat for fish, insects and other wildlife. Water voles, in particular, rely on access to the banks for their burrows and plenty of tall vegetation to provide them with food and cover from predation.

Photo 16: Solid vertical revetment on the RB, contrasting with the thick marginal fringe on the LB, allowing far more biodiverse habitat.

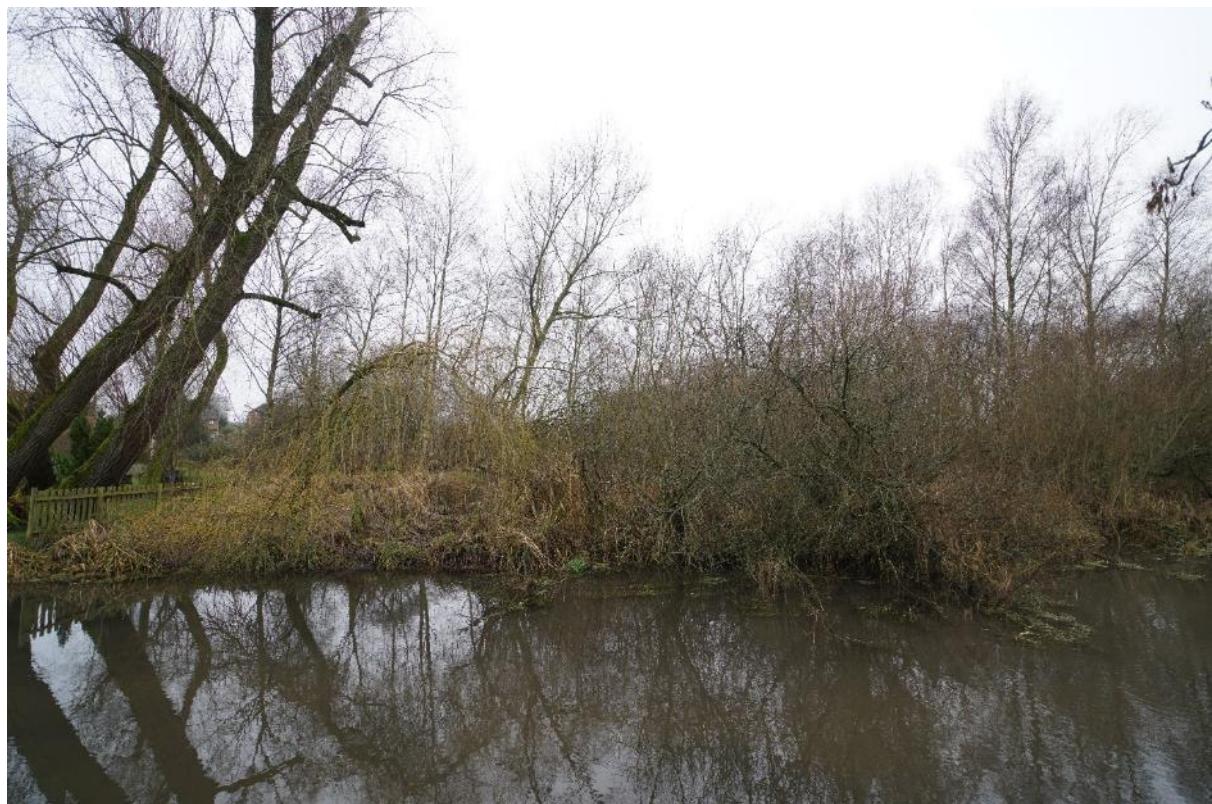
Upstream of the gardens, on the RB, there is an area that historically has had issues with Himalayan Balsam. This is a non-native invasive species with a red stem and characteristic purplish-pink slipper-shaped flowers which appear in June. Himalayan balsam plants grow in dense stands that suppress the growth of native flora so that when the plants die back, in the autumn, they can leave banks bare of vegetation and liable to erosion. The seeds are easily dispersed and balsam can quickly colonise a reach of river, which left unchecked, can cause problems downstream in the catchment.

Photo 17: Area on RB where Himalayan balsam has been an issue in the past.

It would be worthwhile keeping an eye out for any Himalayan balsam growth in the spring and removing it before the plants set seed. If there is a large stand of balsam then contacting the local Rivers Trust (Action for

the River Kennet) to arrange help from their volunteers, can make this a more manageable task.

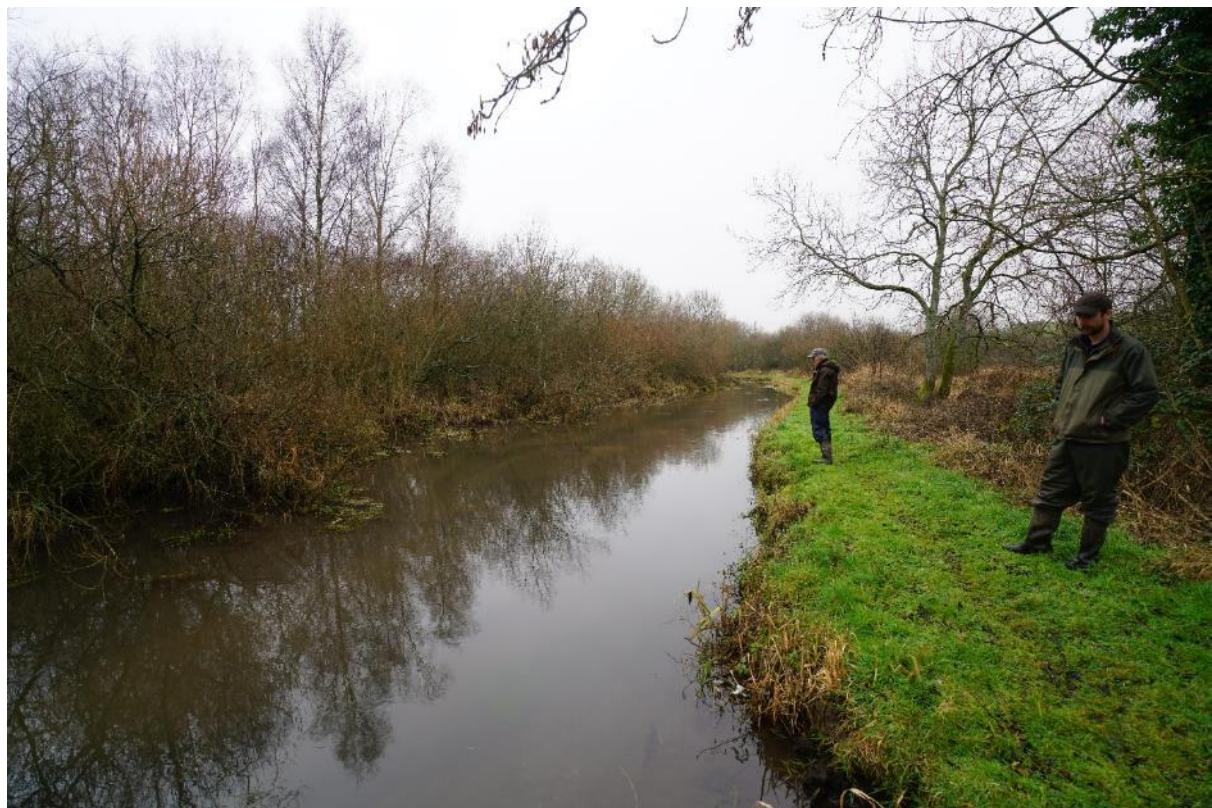
Upstream (**Photo 18**), there is some very good-looking margin on the RB with plenty of scrub and low hanging cover providing complex habitat and refuge for fish. At the time of the visit this reach appeared to be suffering from low flows, on the back of a dry autumn, and not representative of how it would typically look when the springs rise later in the year. To help provide this reach with more resilience against low flows and the effects of climate change it would be worth looking to add some strategically placed woody material from the LB and encouraging a thicker margin to develop.

Photo 18: Reach suffering from low flows, could be enhanced with woody material in the channel and encouraging the development of a thicker fringe on LB.

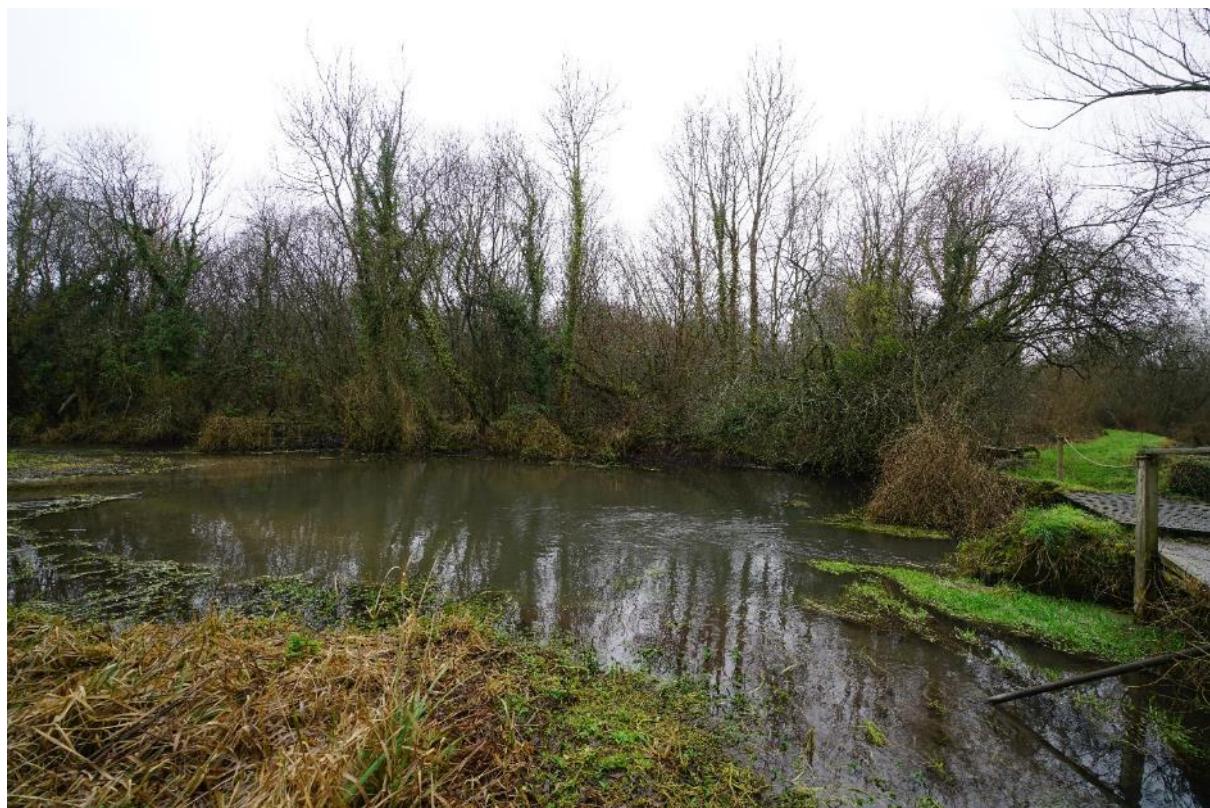
Further upstream is the Elton Lane hatch pool (**Photo 20** / 51°27'48"N , 001°25'40"W) which provides a large pool area with good holding habitat for larger adult fish. At the tail of the pool there is a nice section of riffle, offering quality spawning habitat. The LB here, adjacent to the old fishing hut, has gradually been eroded and the river has become slightly overwide. A brushwood berm could help protect the bank from further erosion and as it consolidates with sediment and plants it will help concentrate flow over the main riffle in the central channel.

The hatch at the top of the pool has been breached, with some of the flow seeping around the left-hand side of the structure. This breach is not a particular cause for concern in the short-term but would be worth keeping an eye on.

Photo 20: Hatch pool providing area of deeper water for adult fish.

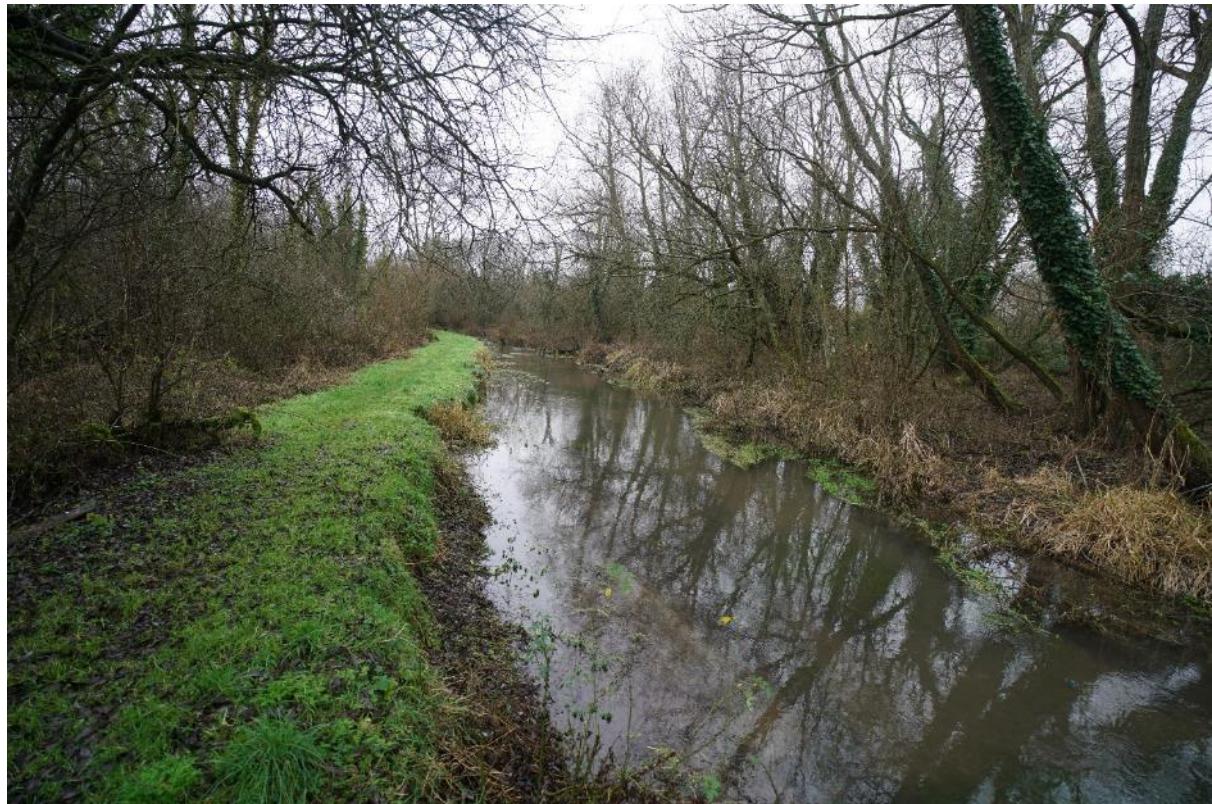
Upstream to the road bridge there is more good quality marginal habitat on the LB. Encouraging a thicker more diverse margin on the RB (**Photo 21**) would help stabilise this section of vertical bank and reduce the opportunity for erosion during higher flows.

Photo 21: Vertical bank along RB at the top of the middle beat, between Elton Lane and Elton Lane hatch pool.
