Weston Farm (River Lambourn) – Advisory Visit

An advisory visit by Nick Lawrence & Rupert Kelton of the Wild Trout Trust

11th January 2022

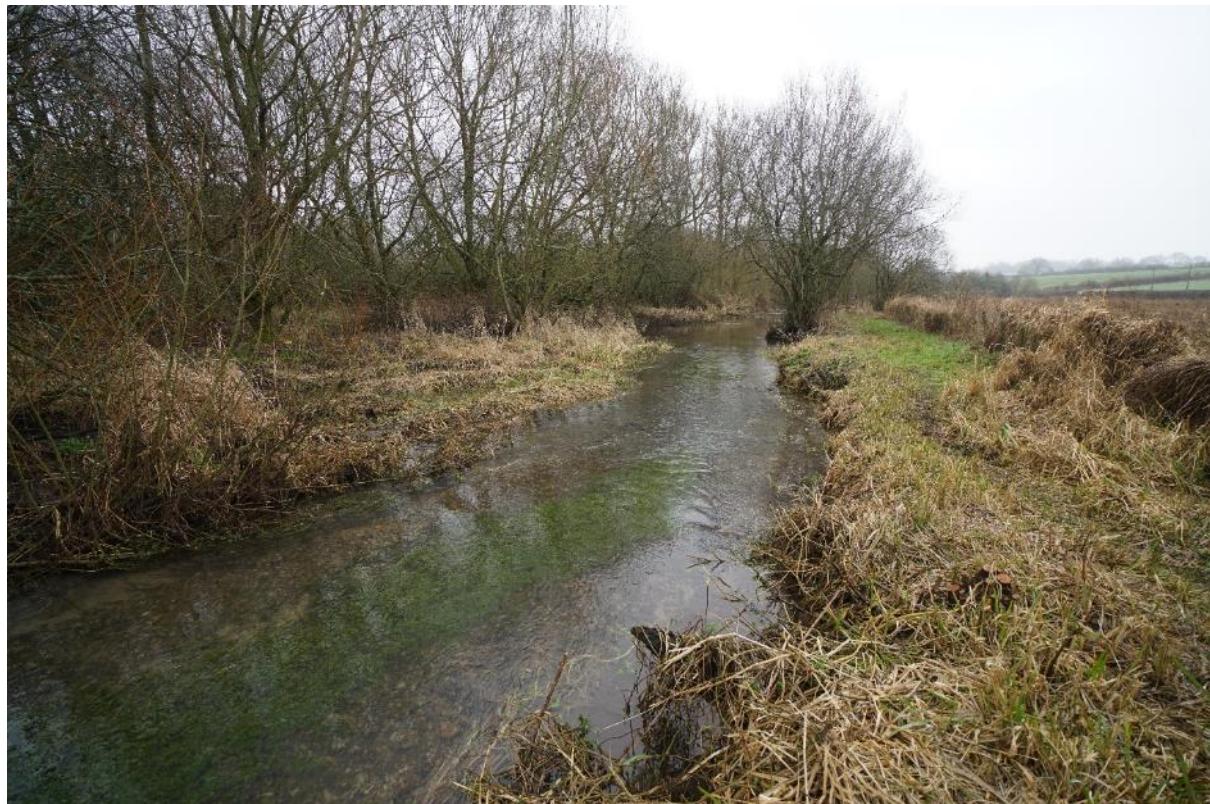
The upper beat begins at Elton Lane ($51^{\circ}27'48''N$, $001^{\circ}25'46''W$) and moving upstream from the lane, the river is buffered by a good expanse of relatively unmanaged meadow on the RB (**Photo 22**).

This reach is a lovely example of a classic chalk stream with good gradient, variation in channel form and depth, excellent sections of loose gravel and growth of water crowfoot, starwort and water parsnip. It is a great demonstration of how 'less' can equal 'more' in the management of a fishery and the benefits that 'light-touch' maintenance can have for a river; enabling good habitats to flourish naturally with minimal intervention.

Photo 22: Great example of a 'natural' chalk stream on the upper beat.

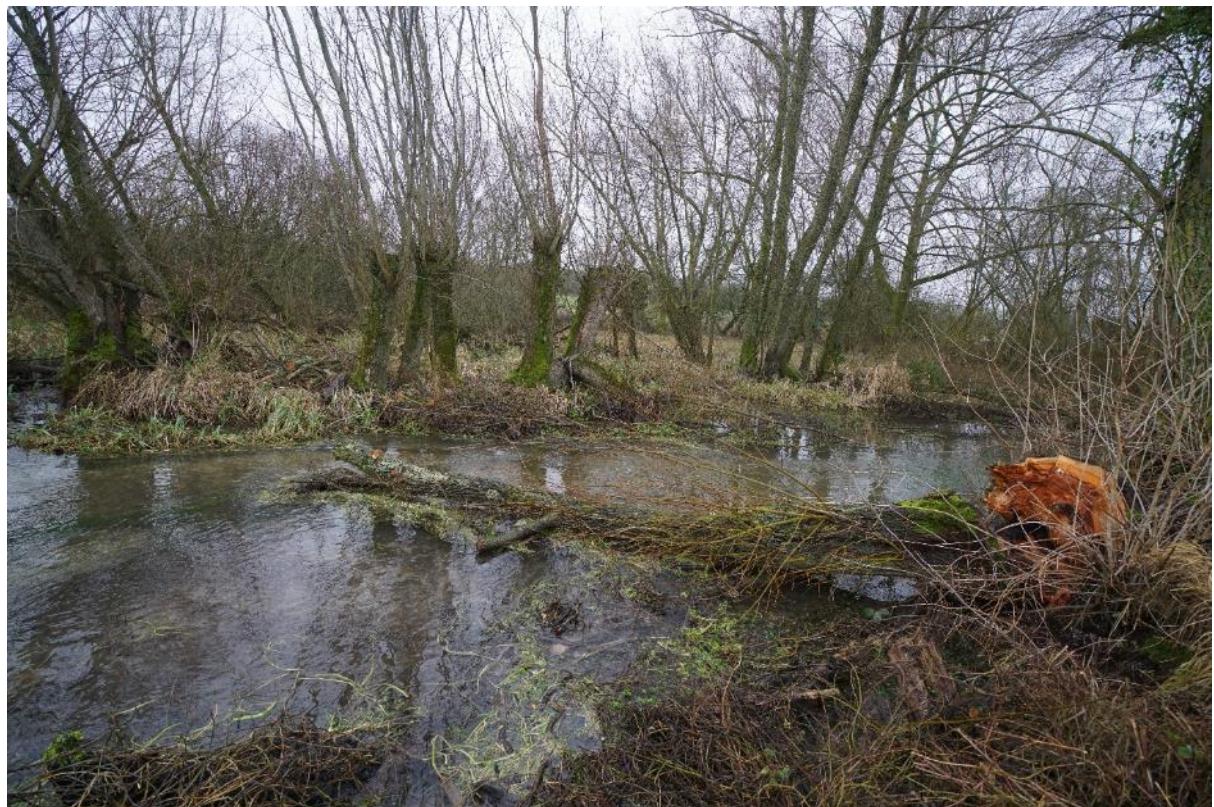
There are lots of good examples on the upper beat where woody material has been added to the channel, creating habitat diversity and more opportunities to support a greater number of fish (e.g. **Photo 23**). Over time, the fishery can seek to add to these or where trees and limbs naturally fall into the river, either to leave them in place or suitably adjust them and secure them into position with chestnut posts and wire or coir rope.

Photo 23: Exemplar management, harnessing what nature gives the river.

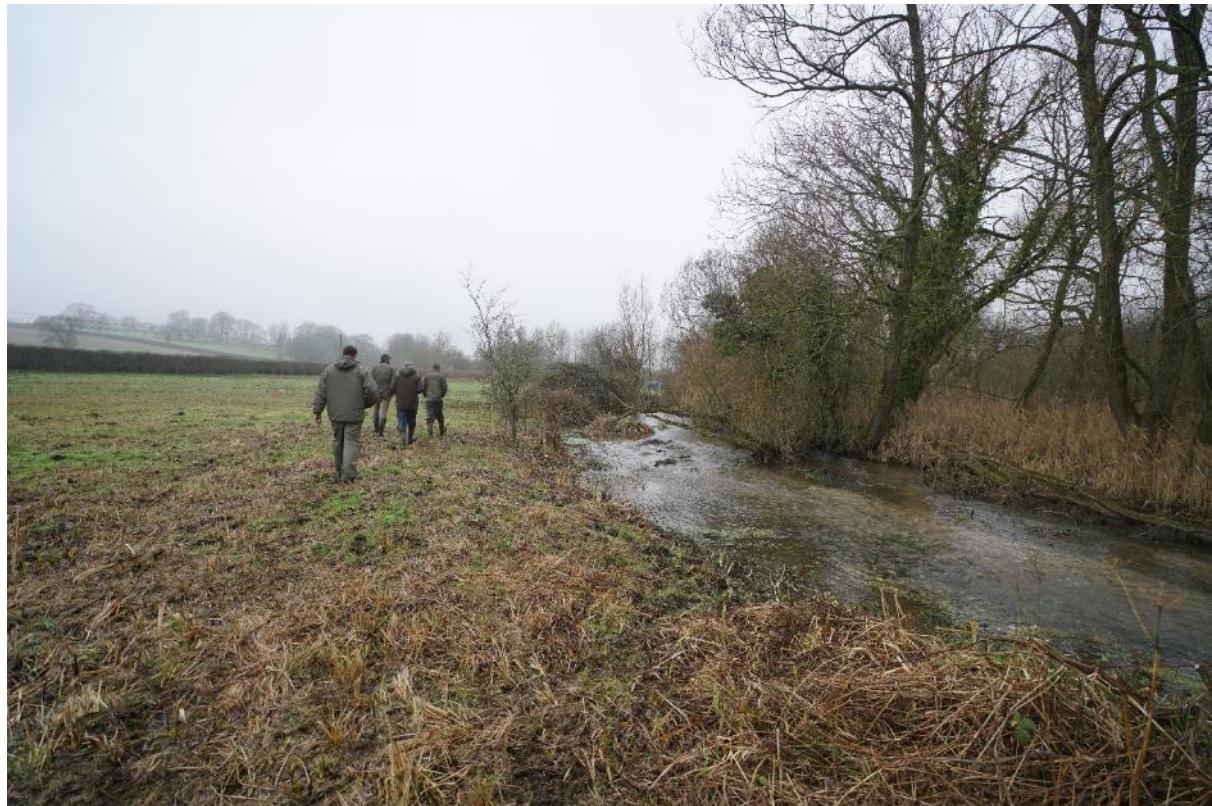
At the top end of the reach, the management of the meadow on the RB changes, with horses being grazed in a large paddock. It looks to be over grazed and heavily poached, with unrestricted access to the watercourse causing damage to parts of the bank (**Photos 24 & 25**).

Photo 24: Overgrazed section of meadow. Consider options for fencing and reducing grazing pressure.

It would be worthwhile talking to the grazier about options for reducing grazing pressure as well as fencing this part of the meadow to restrict access for the horses to the river, which will help protect the banks from erosion. There are a few alternatives for providing drinking water for the horses e.g. solar powered pump or pasture pump connecting to a water trough or fencing a designated drinking area in the backwater / pond that extends out from the riparian corridor into the field.

Again, there should be opportunities available to fund this work through the Countryside Stewardship Capital Grants Scheme, options might include:

- FG1: Fencing @ £4.00 per metre
- LV5: Pasture pumps and associated pipework @ £220 per pump

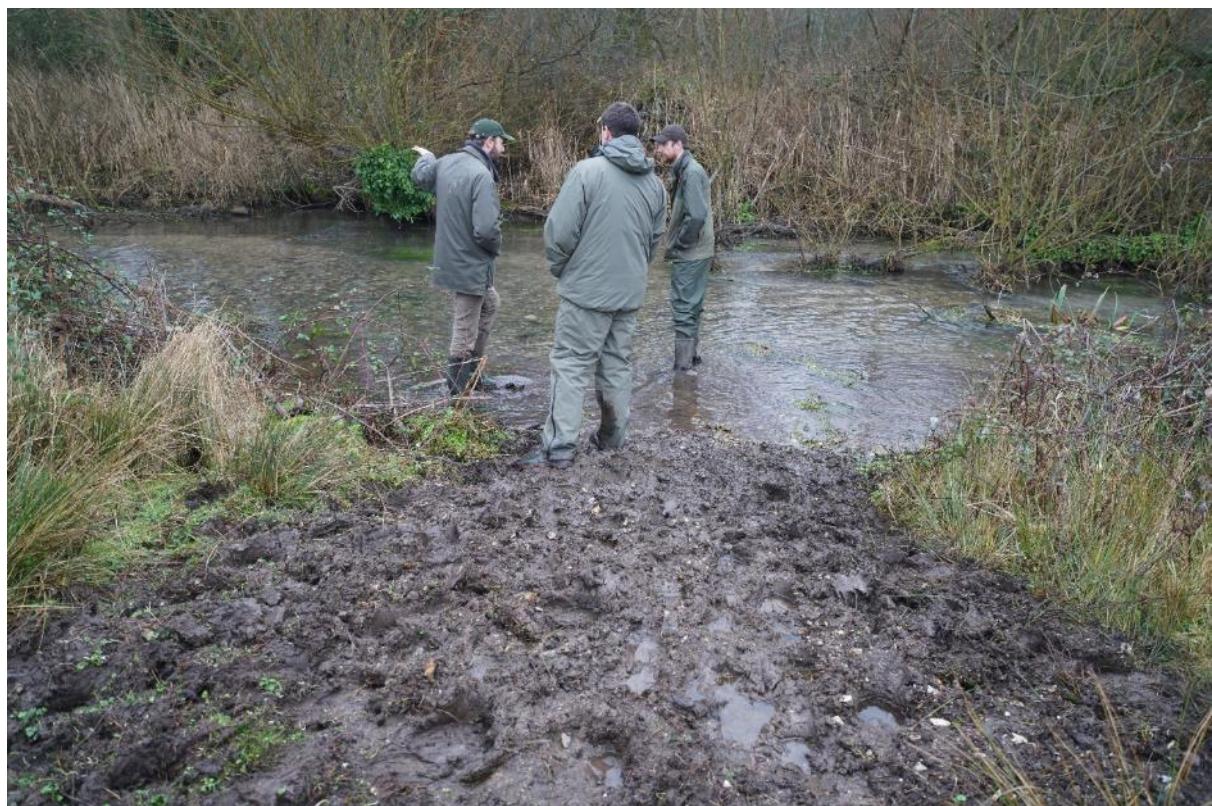
Photo 25: Heavily poached bank contributing sediment pollution.

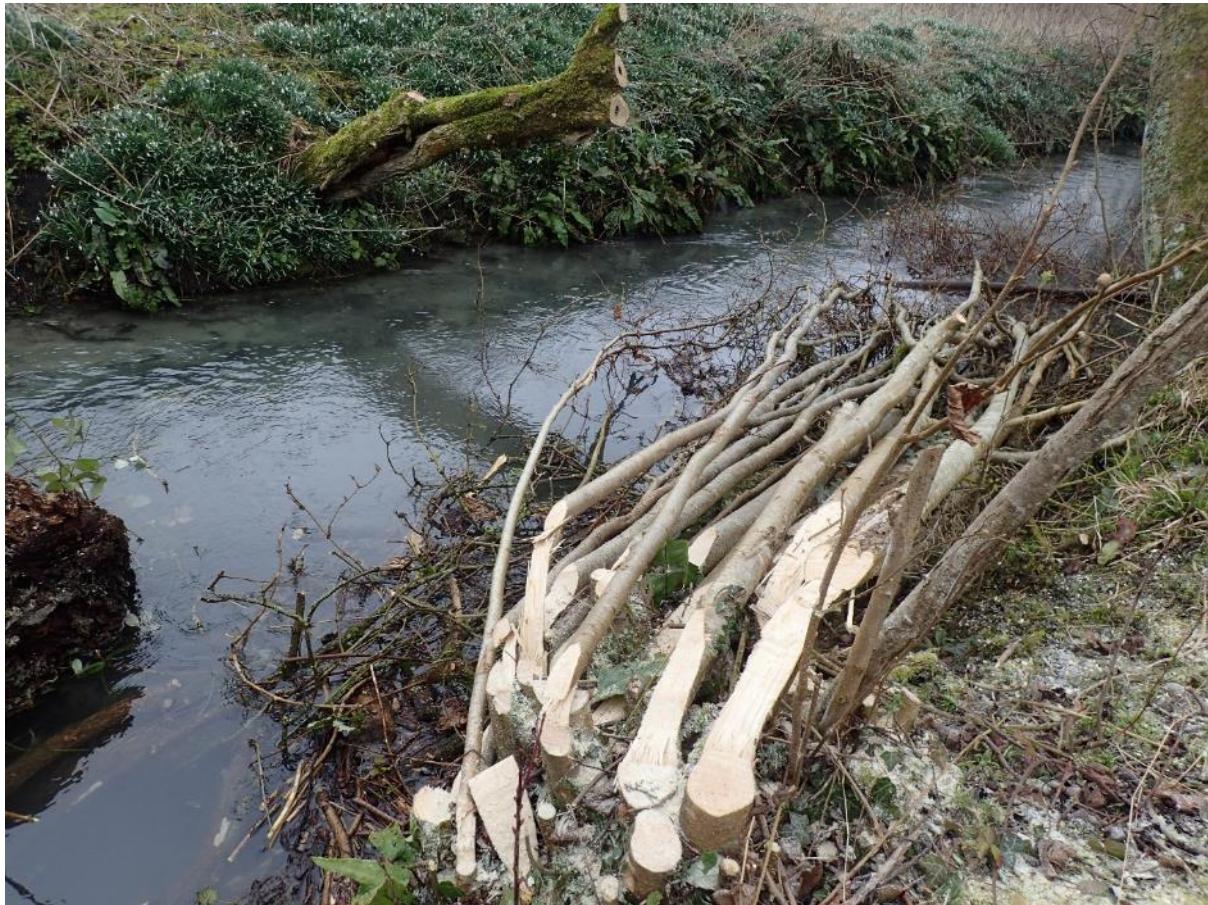
Photo 27: Hinged hazel on the River Shalbourne. Hazel, small willows and small alders can be hinged into a river, creating diversity of flow and instream cover for fish. The trees are hinged in a similar manner to hedge laying, where the tree is partially cut through at the base and laid into the margins. Chestnut stakes and fencing wire (or sisal rope) can be used to secure the trees in place. Willow will survive perfectly well even with 70% of the branches submerged; however, hazel and alder should be laid to retain much of the structure above water level.

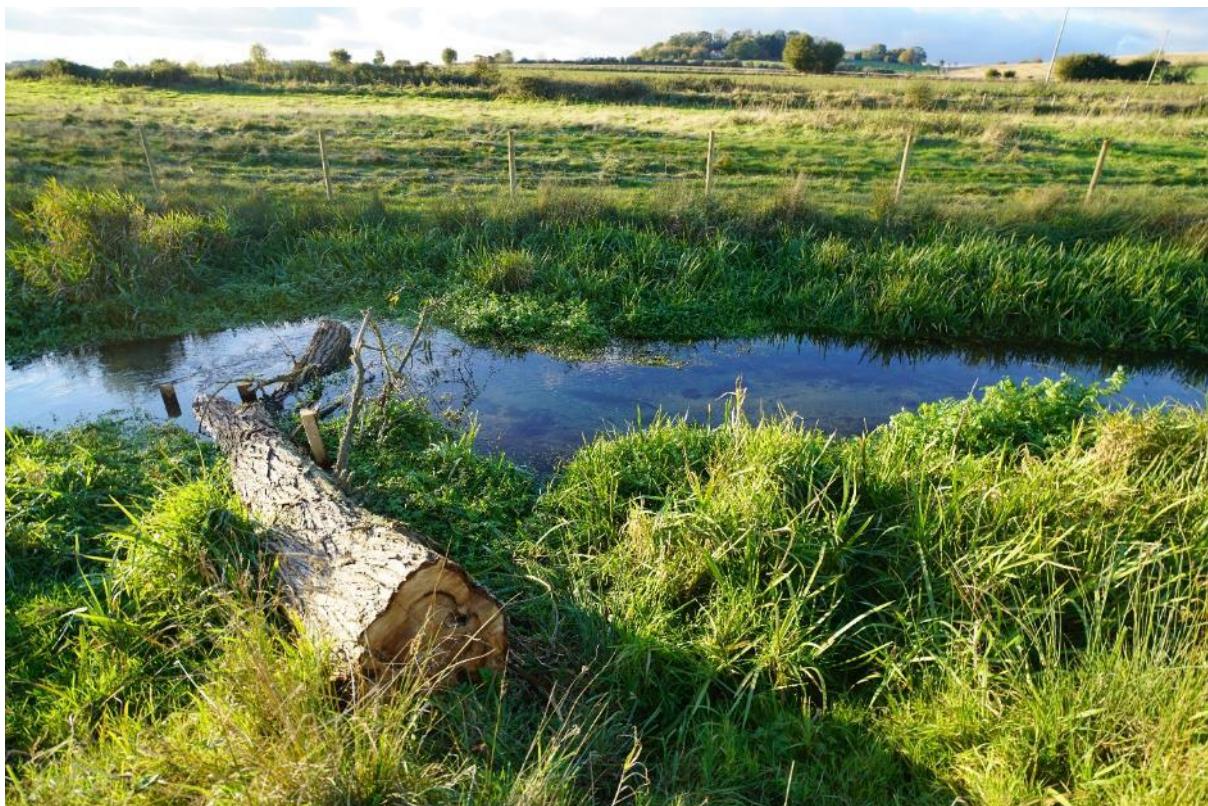
Photo 28: Another example of a tree successfully hinged into the margins of a river to improve habitat diversity.

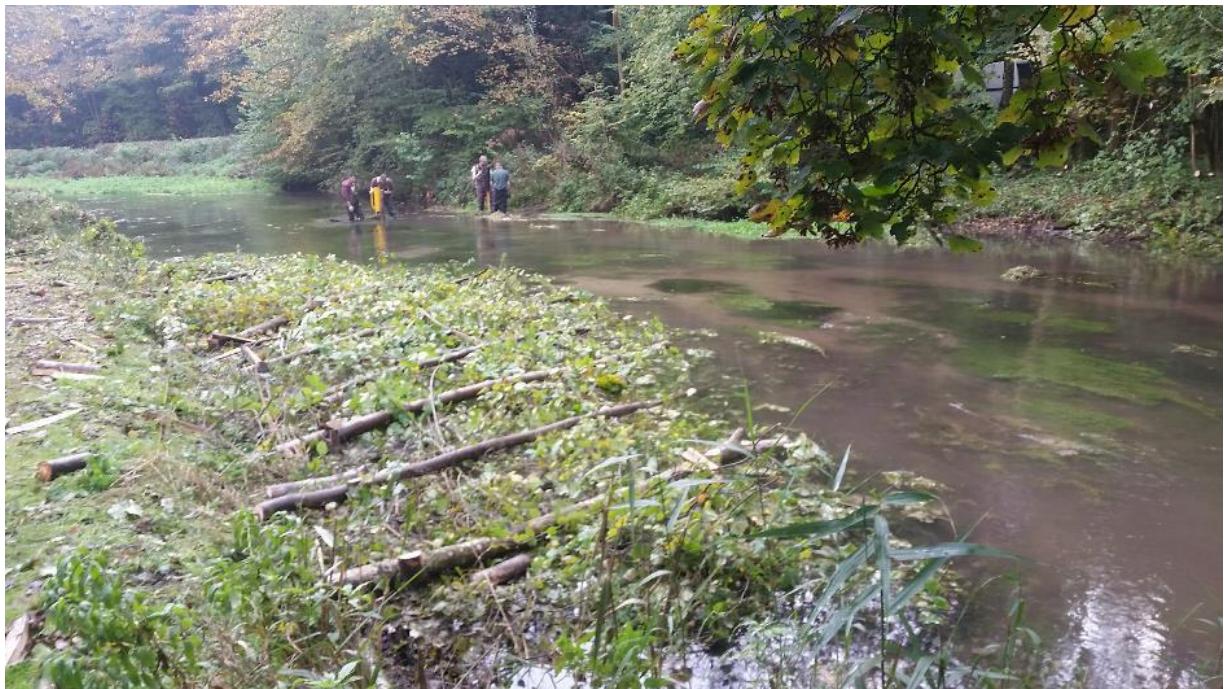
Photo 29: Simple flow deflector on another chalk stream, the Dun: these help to diversify flow regimes and scour pools which helps to clean gravels for spawning.

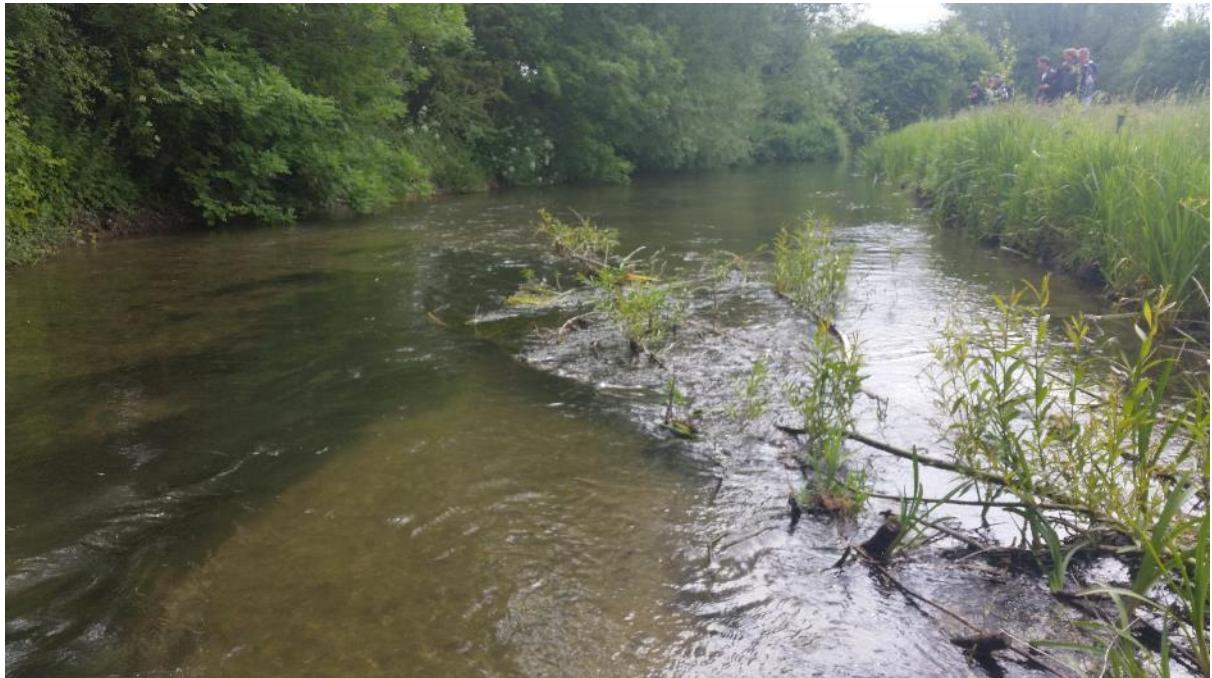
Photo 30: Brushwood mattress in another chalkstream, the Dever, on an overwide section to allow marginal plants to encroach, pinching the river.
