**Witchampton Mill (River Allen) – Advisory Visit**

**An advisory visit by Nick Lawrence of the Wild Trout Trust**

**February 2020**

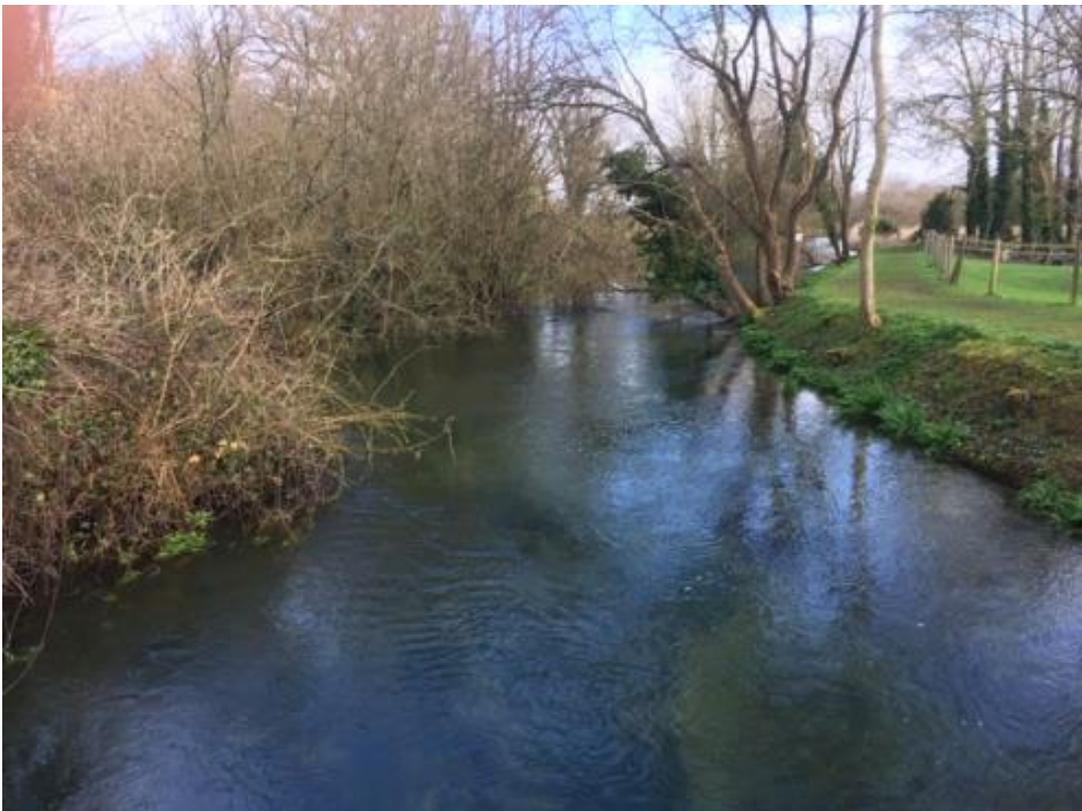
Photo 2: Impounded reach above the Mill with fantastic low cover on the RB, ideal habitat for both fish and invertebrates

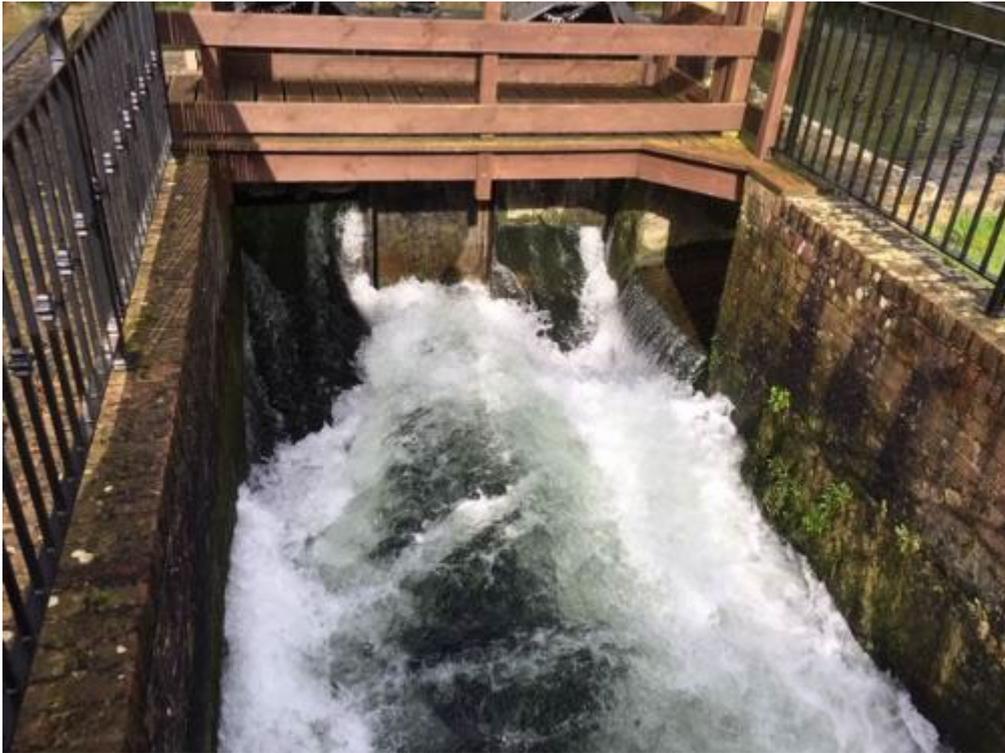
Under high flow conditions, as those observed on the day of the site visit, it is highly likely that fish on an upstream migration would be attracted into the Garden Carrier, as opposed to the main Mill Channel due to attraction flow. This would result in at best a delay in migration but possibly also in fish being forced to use spawning habitat within the Garden Carrier. Although good quality spawning habitat is available in this stream, it is limited in extent and has poor connectivity to any nearby nursery habitat (shallow, well covered margins). It is highly likely that all available spawning sites within the Garden Carrier will be fully utilised and any delay or block for upstream migrants may well result in overcutting of favourable spawning sites and an overall loss of natural production within the system. Overcutting in fish species like salmon and trout happens when suitable areas for spawning are limited and females inadvertently disturb nests dug by other females, killing the first-laid, incubating eggs.

Photo 2: The side hatches that feed the Garden Carrier. Upstream water levels are controlled using these hatches and under high flow conditions fish are likely to be attracted into the carrier where upstream progress is impossible

- Inspect the flow split, especially in low flow conditions to give priority to the Mill Channel. This will ensure fish are directed towards the passable route during autumn migrations, when flows are just beginning to build.

- Experiment with the tilting gate on the main channel to see if it can be used to prioritise flow into the Main Channel without compromising fish pass efficiency. Lowering the gate will increase the attractant flow and could be used in conjunction with throttling the Garden Carrier.

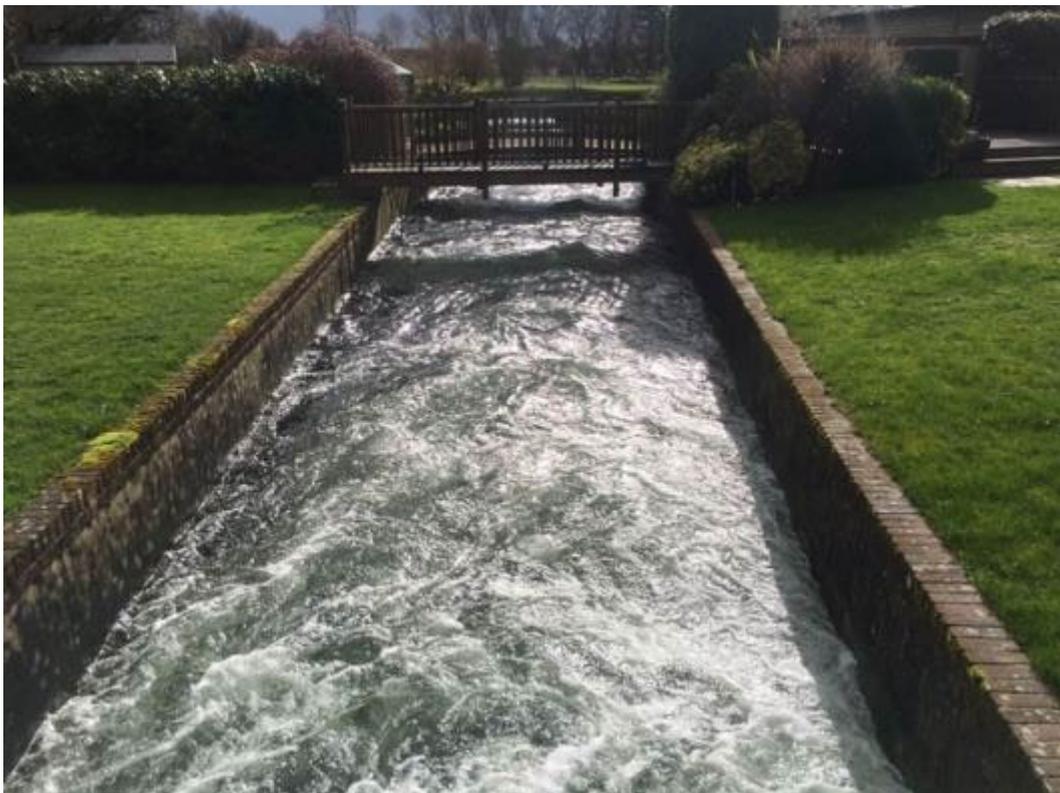
Photo 3: The Garden Carrier downstream of the hatches, fast flowing, very turbulent and with hostile, hard vertical revetment

- In line with recommendations made in the previous WTT report, vertical revetments should be softened to improve the marginal interface between the river and the riverbank. These can be replaced with faggot bundles which will improve the connectivity between the bank, margin and river, and act as a medium for plants to colonise or be planted.

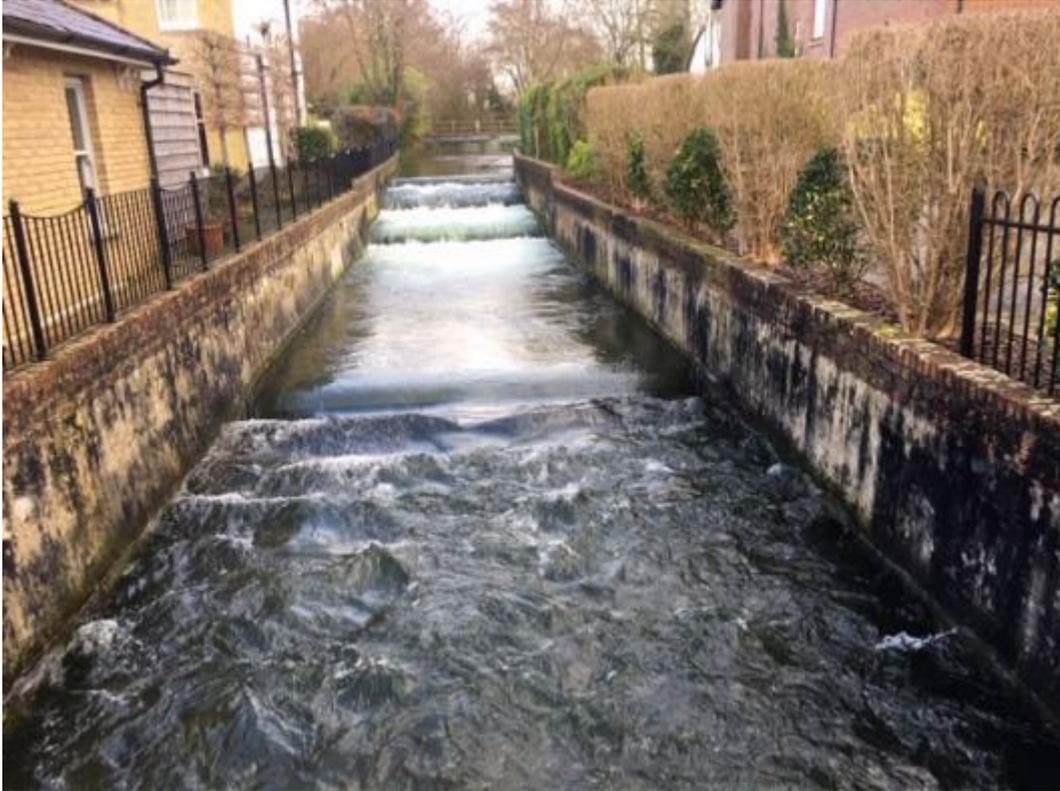
Those fish that migrate into the Mill Channel should find navigating through the series of notched weirs and pools relatively straightforward although turbulence within the second chamber down was considered to be excessive. Flows at the time of the visit are likely to be considerably greater than those which might be expected to lift an autumn run of salmonids on spawning migration, so the turbulence may not be such an issue under lower flow conditions. At some stage, if and when future maintenance is required, it would help if size of the second chamber could be extended by moving the retaining impoundment downstream of its current location. This would reduce the amount of upwelling within the chamber and provide improved migration opportunities. An alternative and much more desirable outcome would be to reduce the overall head-loss at each structure by reducing the height of all the impoundments.

Photo 4: The fish pass is a series of notched pools and weirs; note the pools are different lengths, with the first two pools being quite short and as a result, very turbulent, potentially impacting on pass efficiency

- If the water levels are retained at their current height then consider extending the length of the chambers to reduce the amount of flow energy and upwelling, particularly in the second chamber.

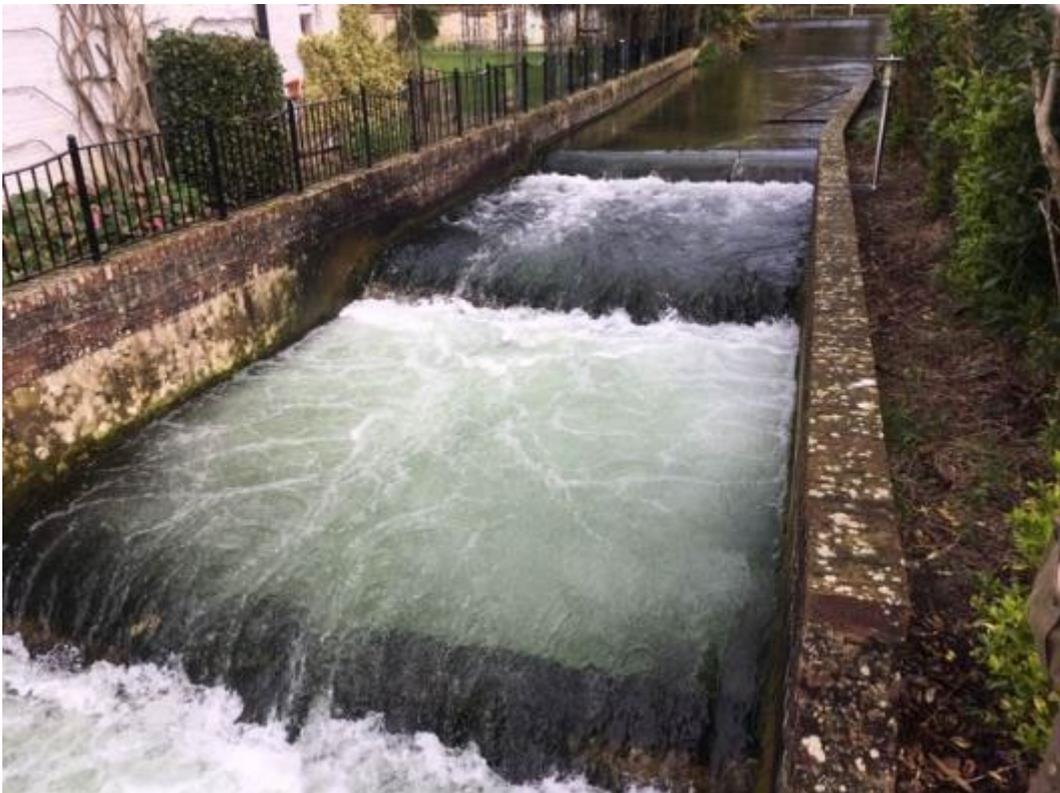
It was noted that the top impounding wall incorporated a cable-operated tilting gate adjacent to the LB. It might be possible to use the gate under high flow

conditions without compromising fish passage through the adjacent notch, increasing the amount of attractant flow down the main Mill Channel. Conveying a greater proportion of the available flow through the main Mill Channel would also take some pressure off the Garden Carrier, which was flowing near to full capacity, despite the side hatches not being fully drawn.

Photo 5: Close up of the first 3 weirs on the fish pass; note the steel gantry above the top weir supporting the tilting gate. The second pool down is extremely turbulent which may well reduce the efficiency of the notched pass and result in excessive scour to the adjacent wall haunch.

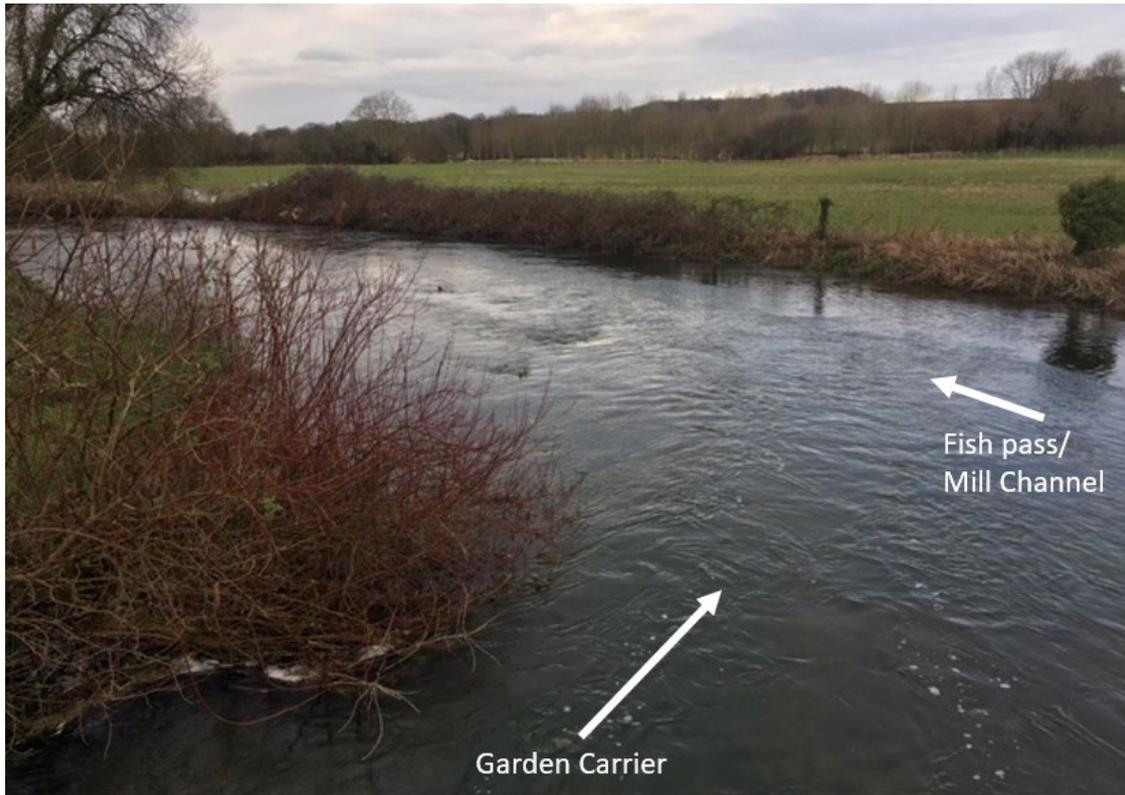
On the day of the site visit it was not possible to assess whether or not fish would be able to ascend via the under-shot hatches at the head of the reach but it is assumed that a combination of excessive flow velocities, the anti-erosion apron/hatch invert and lack of available water depth immediately below the hatch gates would make this route impassable under virtually all flow conditions. It is essential therefore that downstream, where the two channels meet, fish are encouraged to keep to the RB and make progress via the main Mill Channel.

Photo 6: Confluence of both channels with the main attractant flow velocities appearing to be in favour of the Garden Carrier

- To encourage fish to find the main Mill Channel, it is possible to build a naturalistic woody flow deflector out from the LB of the Milling Channel to flume elevate flow velocities down the RB at the very confluence of the two streams. The deflector must be located either at right angles to the Mill Channel bank or laid in at a slight angle pointing upstream to avoid any elevated risk of bank erosion. The deflector should be keyed into the bank and firmly secured to the river bed and should be high enough to kiss the surface during high flow conditions and squeeze the existing channel width by at least a third of the existing channel width to be effective. An existing willow sits on the LB and this could be hinged into the channel for a similar effect.

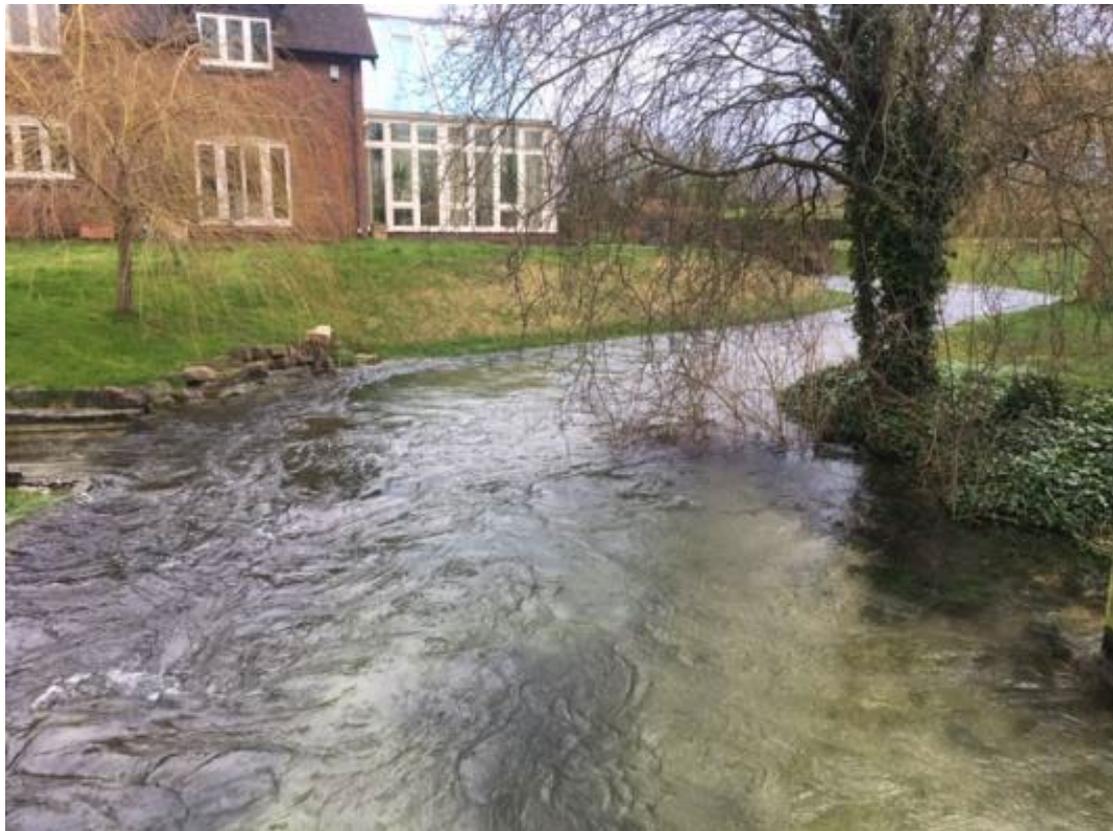
Photo 7: Looking upstream on the Garden Carrier, fantastic gradient and gravels but hugely lacking in bankside diversity. The trimmed/ mown margin is a monoculture of grass and vulnerable to erosion

- Installation of eel bristle-brush passes should be made adjacent to the margins of all structures.
- Due to traditional garden maintenance, the banks are not rich in plant growth which can be 'reservoirs' for biodiversity and can offer excellent complex habitat for many species of aquatic invertebrates and even fish. It is essential to recognise that however 'messy' unmanicured banks may appear at first glance, this 'messiness' provides many more habitat niches for different species, and is far more beneficial for birds, fish and insects, than hard banksides or tightly mown lawn turf extending right to the water's edge. Supplementary planting of attractive and iconic native plants such as marsh marigold, purple loosestrife, water forget-me-not, water mint, flowering rush, meadowsweet, hemp agrimony and gypsywort, if these are not already present, could also add extra visual appeal for the gardens at Witchampton.

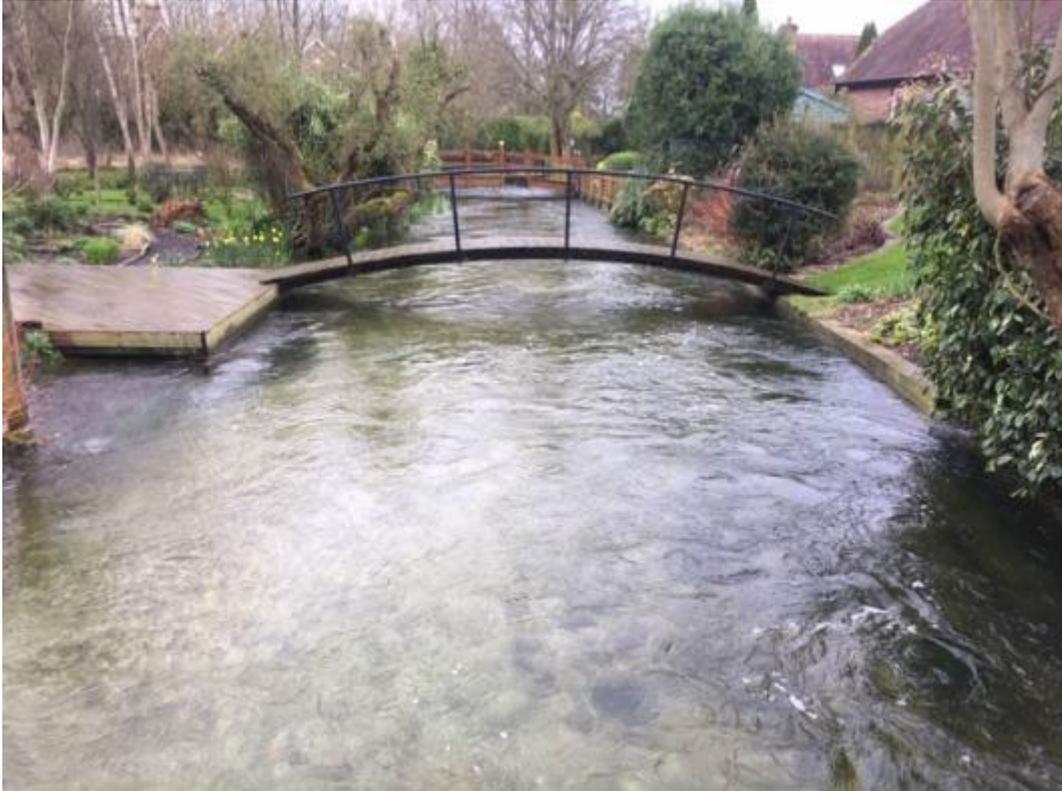
Photo 8: Looking downstream on the Garden Carrier: again, fantastic gradient and gravels but note vertical revetments on both banks, impeding the development of any marginal fringes

- In the previous WTT project proposal, many opportunities for woody berms were highlighted, some in places where the vertical revetments are. This would improve the marginal interface between the river and the bank, see example below (previous habitat works at Witchampton). An example of an unmanicured chalkstream margin can be seen in the appendix; the scope for improving the habitat within the gardens remains a good opportunity.

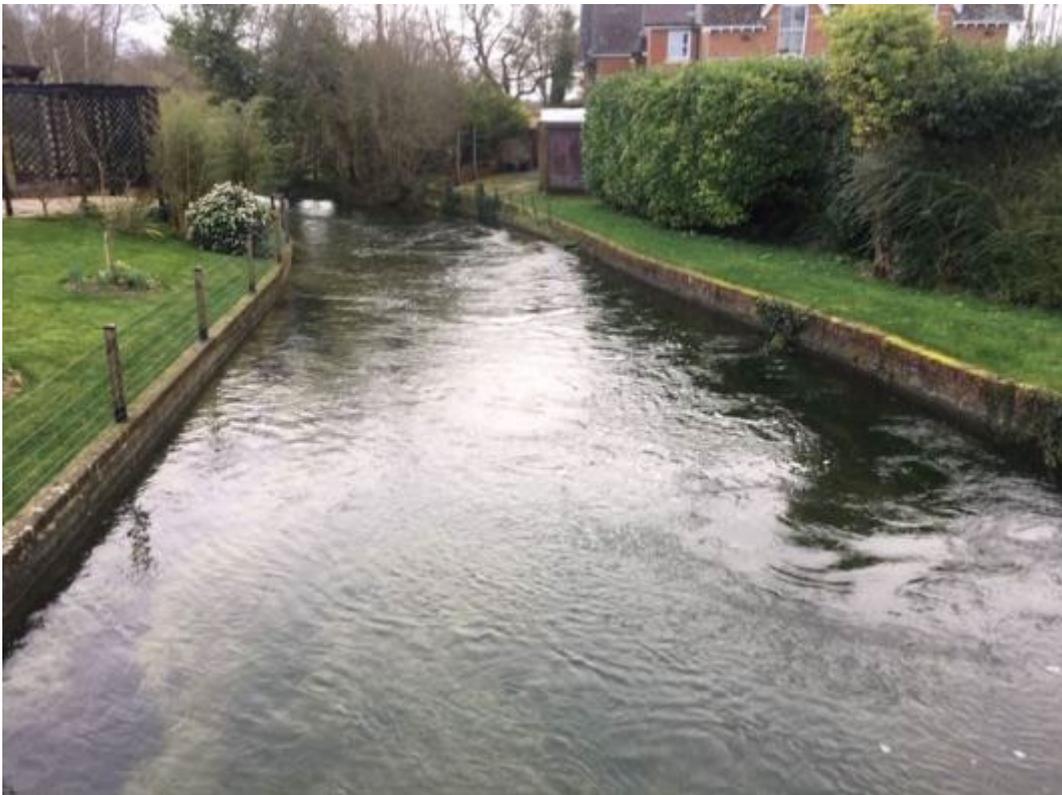
Photo 9: Looking upstream from bottom boundary on the Garden Carrier, another example of both banks being vertically revetted and lacking cover that would provide habitat for small fish

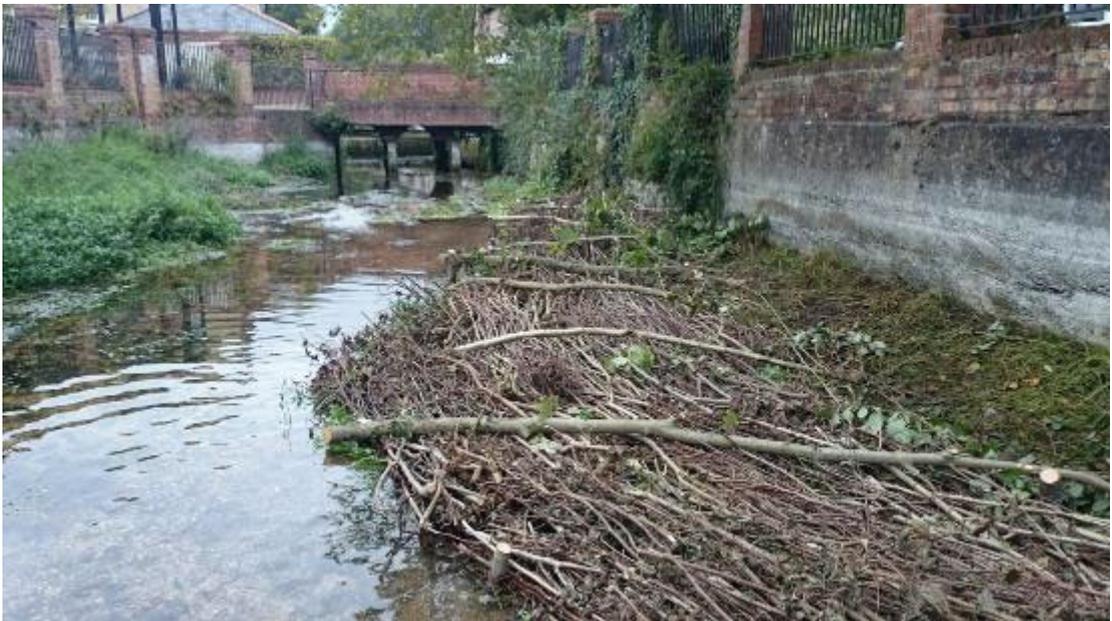
Photo 10: a woody berm, created during previous habitat works at Witchampton
