The Upper Tillingbourne

Advisory Visit March 2022

By A. Thomas, athomas@wildtrout.org

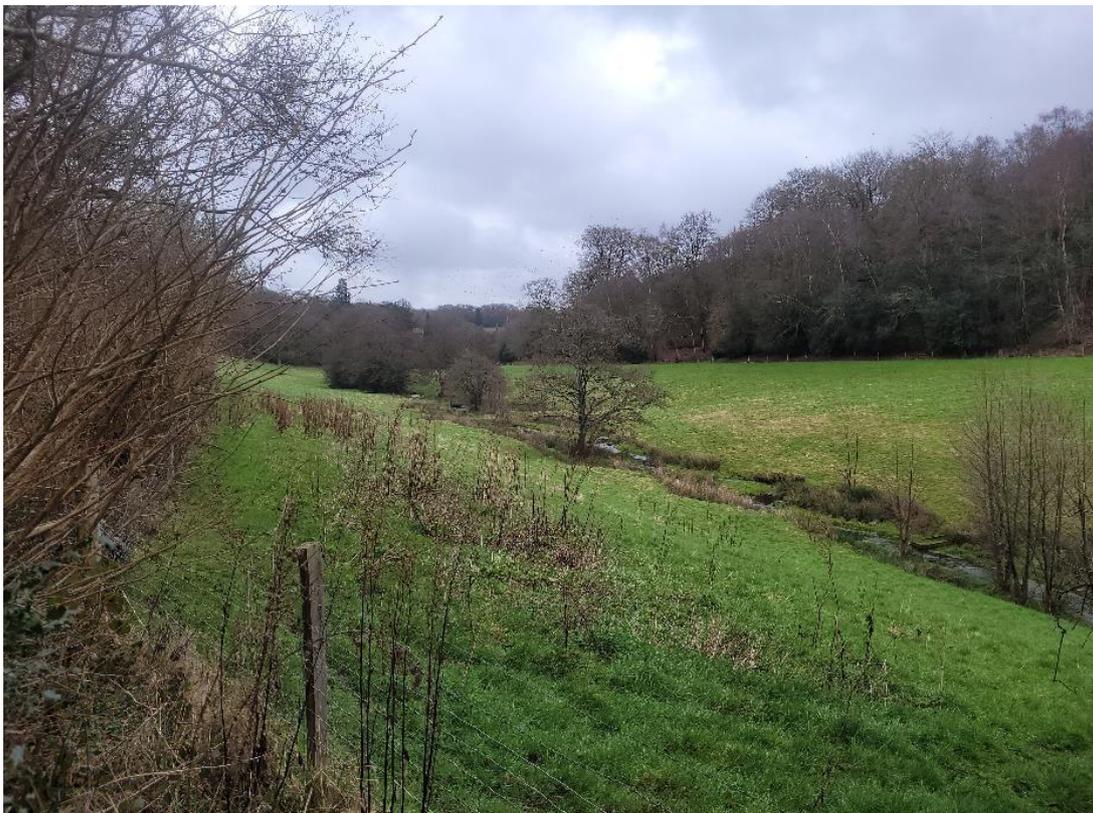
Much of the upper Tillingbourne sits within relatively steep sided valleys (Photo 1) which in theory should restrict natural meandering, and results in a legacy of long shallow runs and only occasional deeper pools. However, the reach here has a relatively steep gradient, promoting vigorous flow velocities and despite the narrow nature of the valley floor, the river has a very active morphology, with a series of meander bends (photo 2) and valuable pools, riffles and glides (photo 3). With little shading, the reach also supports beds of submerged weeds, mainly starwort *Calatriche sp.*

Photo 1. Steep sided valley and extremely narrow flood plain.

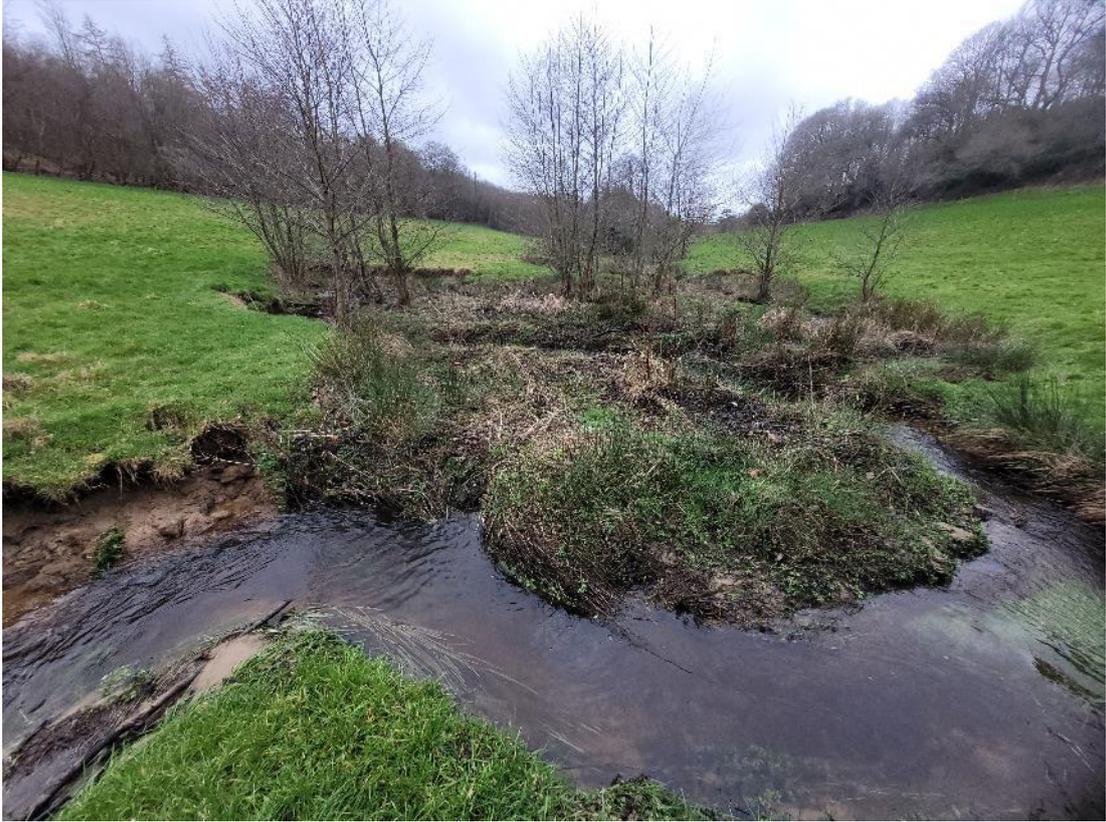
Photo 2. The series of tight meander bends looks to be barely possible in such a narrow valley floor.

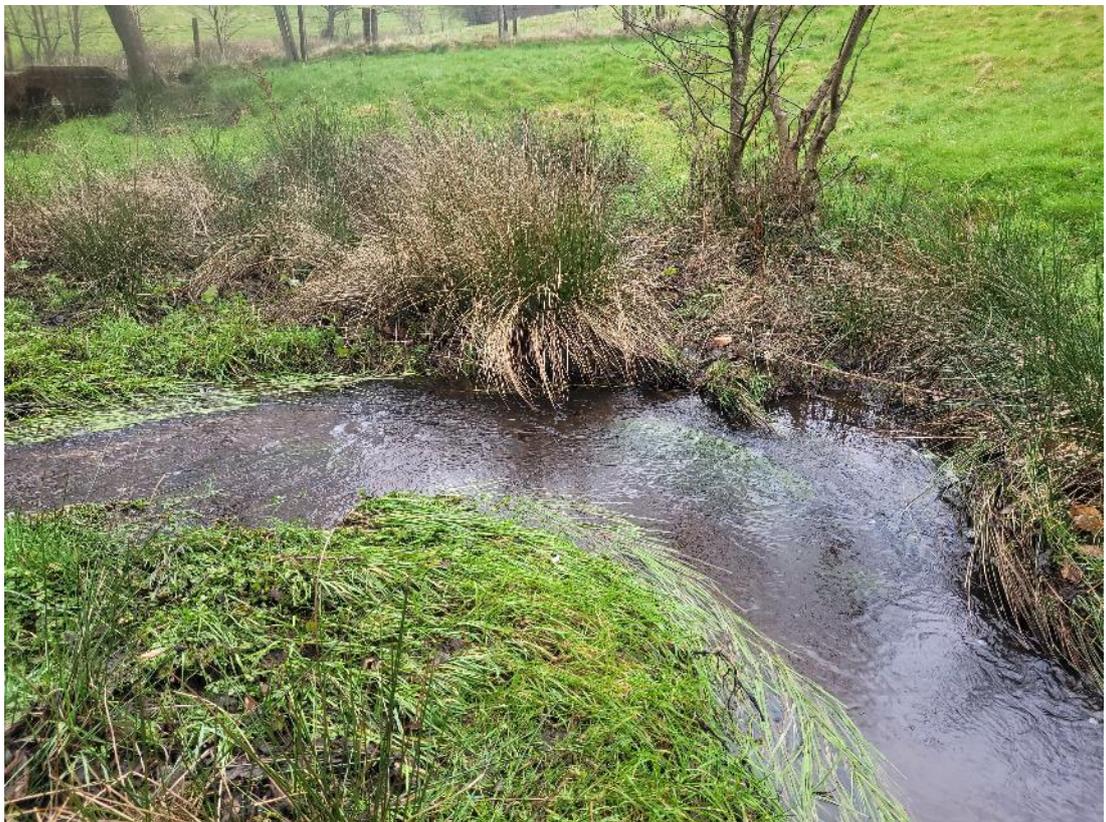
Photo 3 The sinuous characteristics of this lower reach promote valuable diversity in the shape of the channel, forming pools, glides and broken riffles.

The meanders are extremely valuable in helping to increase the overall channel path length and thus reduce peak flow velocities. The banks' soils here are a mix of friable sands and clays and there was evidence of significant bank erosion and bank slumping in several locations. Tree cover was considered to be sparse on this lower section and there was considerable scope for tree planting for improved bank protection, especially on the outside of meander bends, which are invariably the areas that should support deeper water and opportunities for adult trout to safely lie up. Any new trees planted will require protection from grazing livestock.

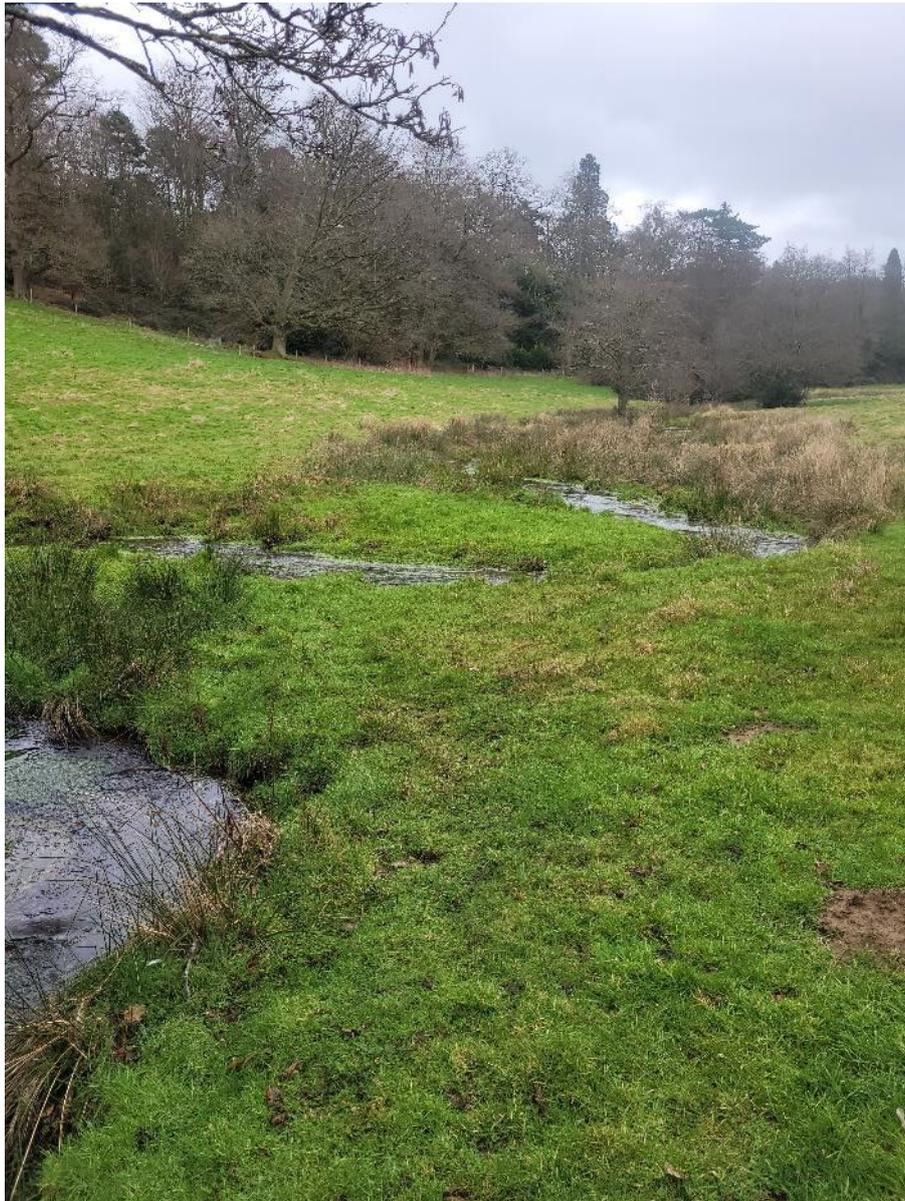
Photo 4. The outside of the meander bends would benefit from tree planting to provide cover for trout and reduce bank erosion pressures.

- The lower section would benefit from the provision of increased low, overhanging tree cover through tree planting (such as goat willows), particularly over pools and on the outside of bends.

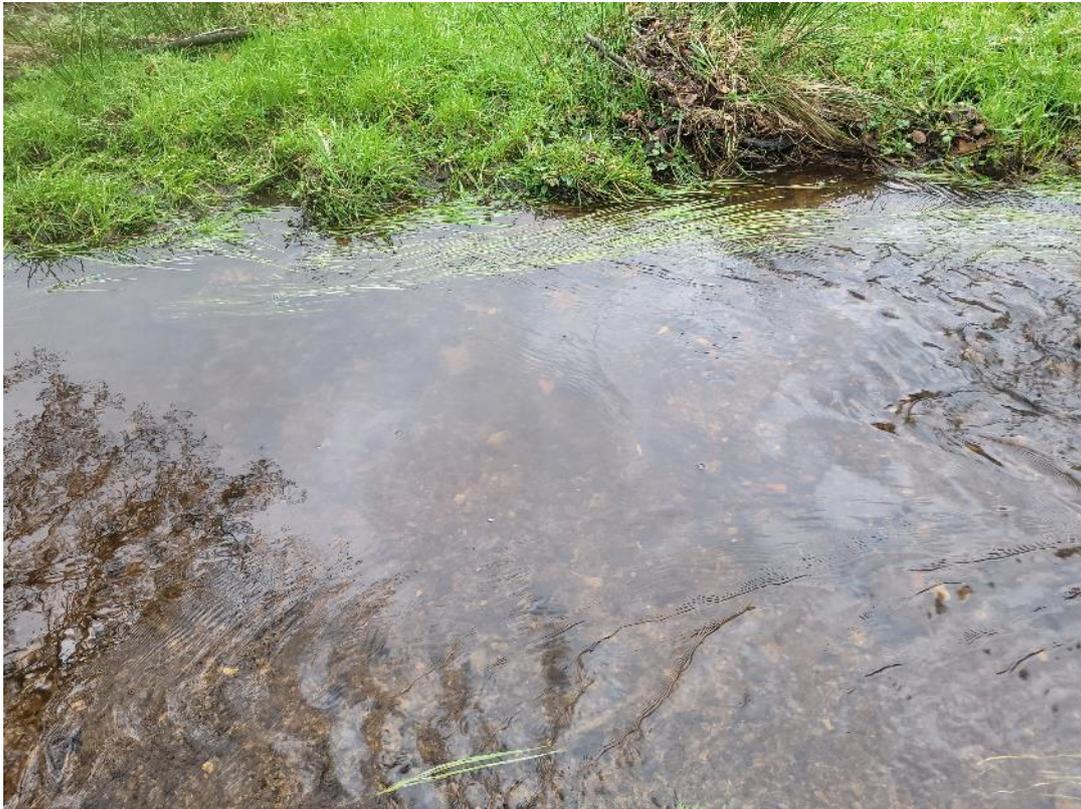
Between the bends, there were numerous riffles, where bed and bank material has been eroded from pools and bends and deposited onto pool tails to form shallow ramps of clean, loose gravel. These areas provide excellent habitat and

the whole reach provided numerous examples of high-quality trout spawning and nursery areas. (Photo 5).

Photo 5. The tail of a gravel-bottomed glide leading into broken riffle provides good quality habitat for trout to spawn on. The provision of more low, overhanging cover, complex root systems and fallen woody material could make sections like this highly productive for trout recruitment and fry/parr survival.

- Install woody material adjacent to areas where there are natural outcrops of gravel or sandstone to promote scour and free up valuable spawning material.

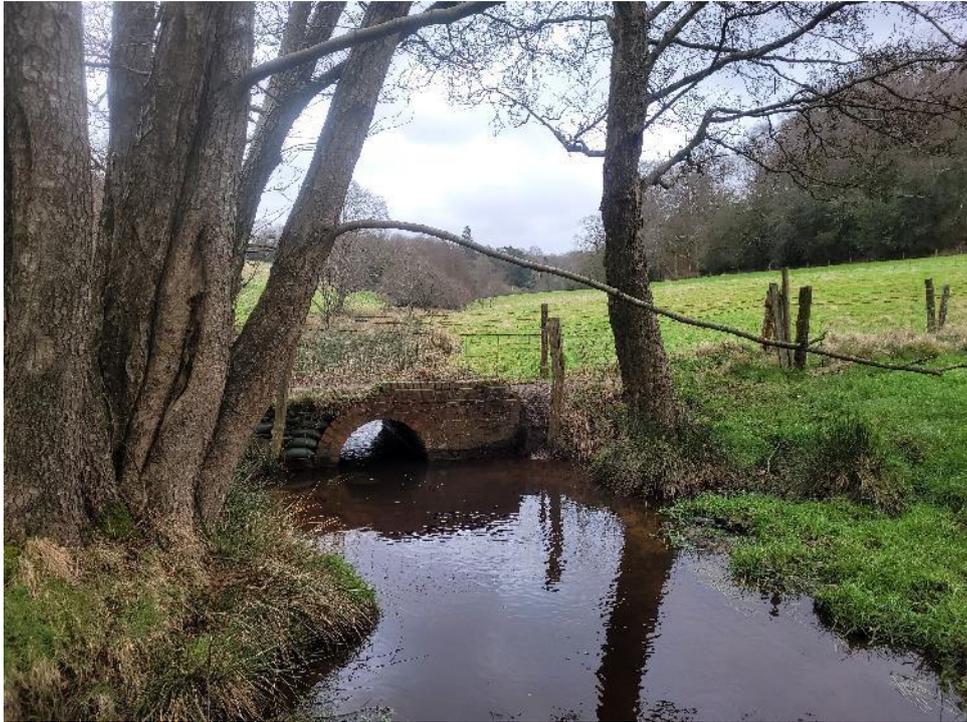
In a few locations there are culverts. The example in (photo 6) is for a path crossing. The capacity of this culvert is modest but on a positive note, all those that were seen have been set down well below the local bed depth, so none are considered to be an issue for fish migration or trapping sediment. The increased flow velocities generated through the culvert in photo 6 has blown out a deep pool that is likely to be an attractive holding water for an adult trout. Squeezing the channel cross section with large piece of tree trunk, or root wads can have a similar effect, where increased flow velocities can be concentrated through a narrow slot to blast away bed sediment and leave attractive holding lies.

Photo 6. Bridge culvert with deep holding pool below.

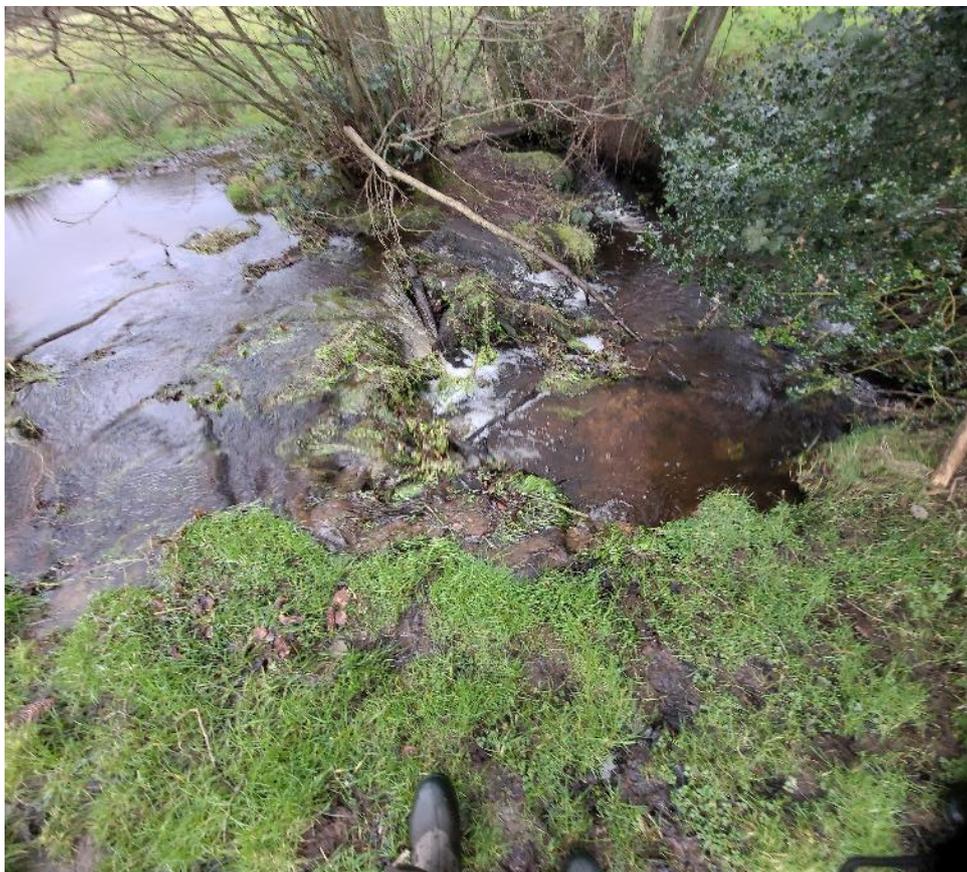
Near the top of this reach, the root systems of mature alder trees have joined and spanned the width of the stream bed, forming a natural impoundment (photo 7). The head differential between the upstream and downstream water levels is significant and may impact on upstream fish migration during low flow conditions. As the length of channel above this natural structure up to the first of many on-line pools is modest, no intervention is recommended.

Photo 9. A natural impoundment caused by a large tree root system

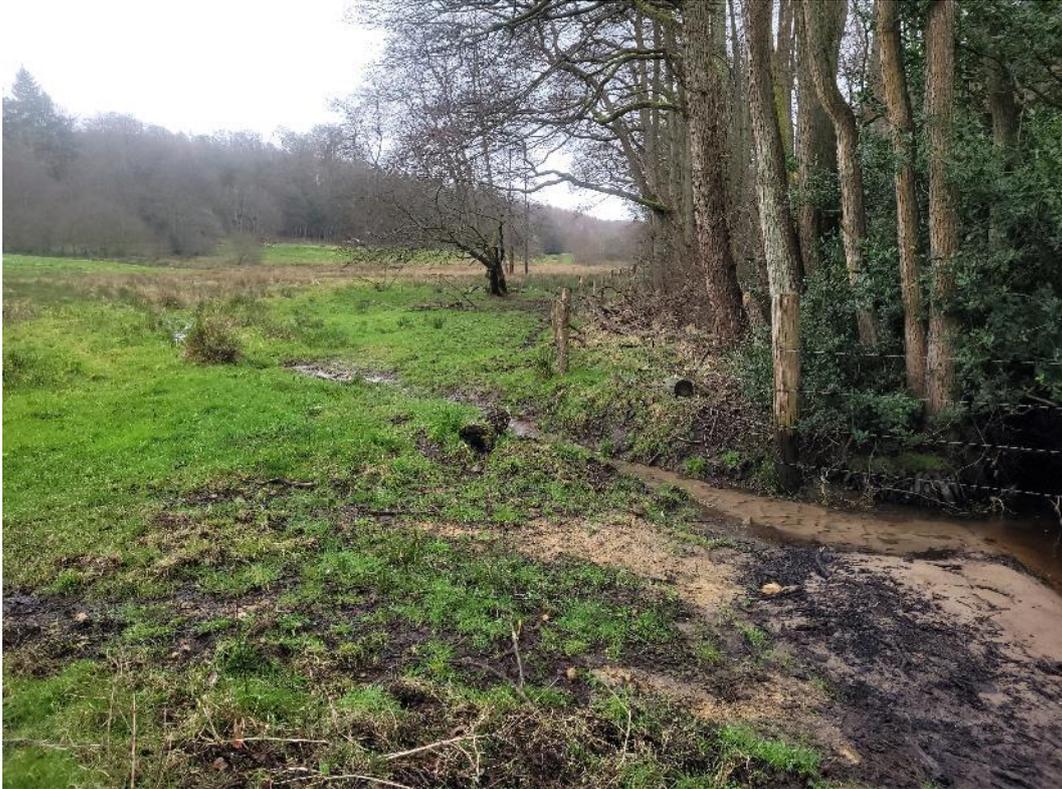
Photo 10. Wide valley floor and heavily shaded stream channel

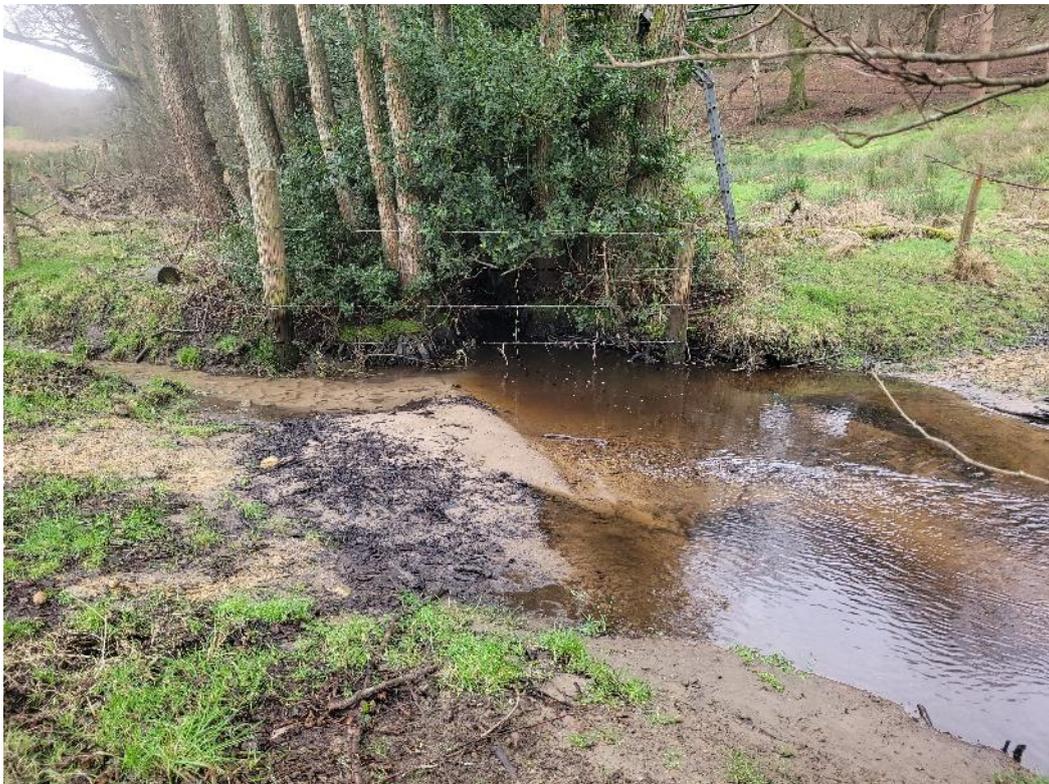
The reduced gradient, coupled with the impounded nature of the channel, results in significant fine sediment deposits within the reach (photo 11). The difference between this section and the lower reach is stark, and it is highly likely that the chain of pools intercepts huge volumes of mobilised sediment, that might otherwise deposit in the downstream section and beyond. Overall, the reach is also much more heavily shaded via mainly mature alder trees and as a result, very little aquatic weed growth was observed.

Photo 11 Sand and fine silt deposits were much more evident in the upstream reach.

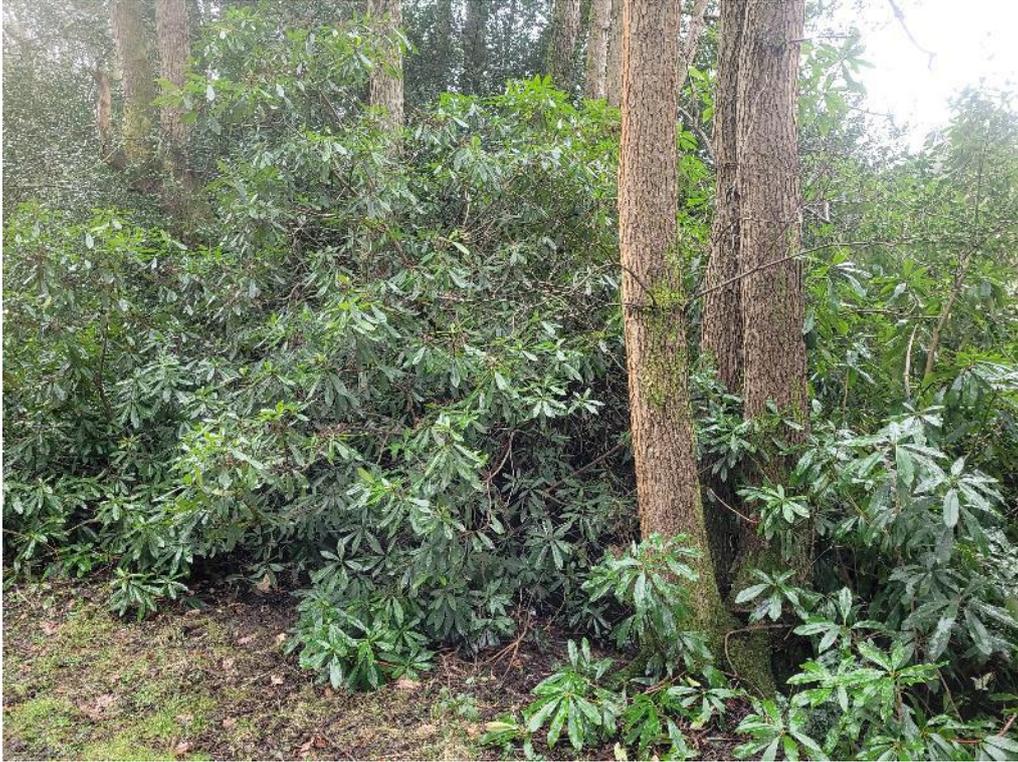
In a few locations there were significant stands of cherry laurel, or rhododendron (photo 12). Laurel can be highly toxic to aquatic organisms and both plants are highly undesirable stream-side plants that should be removed. Great care should be taken when managing these shrubs and any freshly cut leaves and branches should be kept well away from the stream to avoid damage to local invertebrate and fish communities.

Photo 12. Cherry laurel or rhododendron are undesirable stream side plants that will seriously limit productivity.

- Work on the top reach should be focused on protecting water quality. The removal of non-native shrubs that acidify the local environment and adversely impact on water quality is highly recommended: rhododendron is highly invasive on a landscape scale, and the club should engage with the landowner to arrange removal as soon as possible.

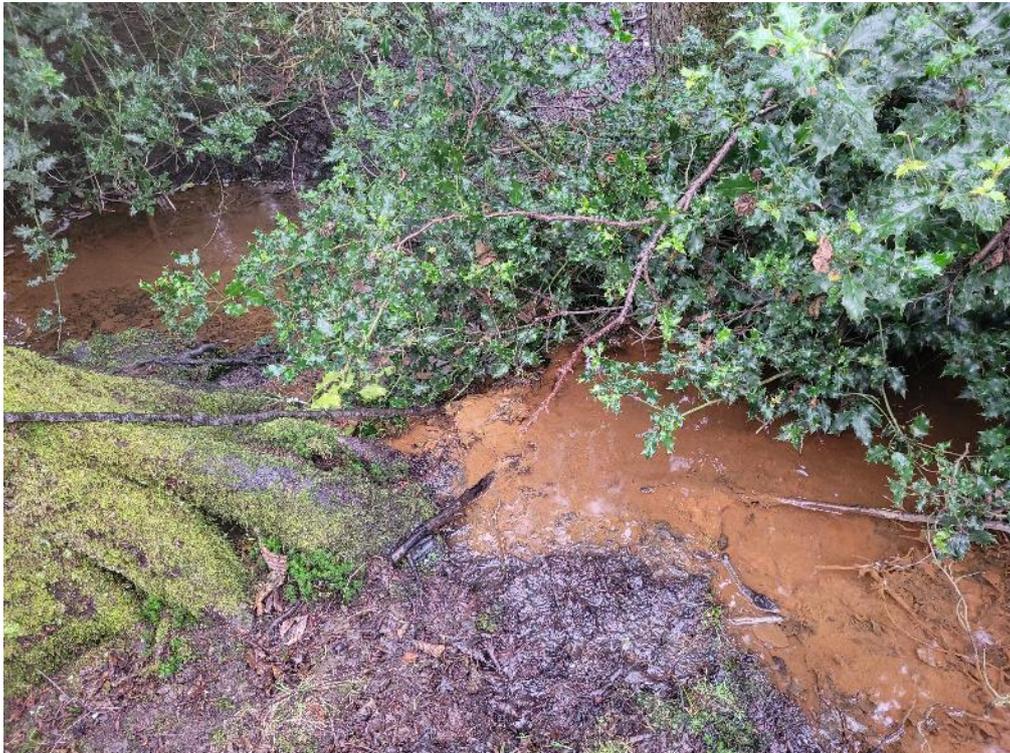
In contrast to the bottom reach, the influence of adjacent iron-rich springs was more evident (photo 13), imparting a tea-coloured tinge of colour to the stream. Iron rich water will be slightly acidic, and it is possible that the combination of the heavy shade and the naturally acidic water is limiting natural productivity. As discussed earlier, the shade and cooling properties of river-side trees is critically important but ideally the reach should have access to more direct sunlight to help promote in-stream primary productivity. A good ration to aim for is a 60:40 ratio of direct shade to available sunlight.

Photo 13. Upwelling iron-rich springs will be acidic in nature and will limit stream productivity

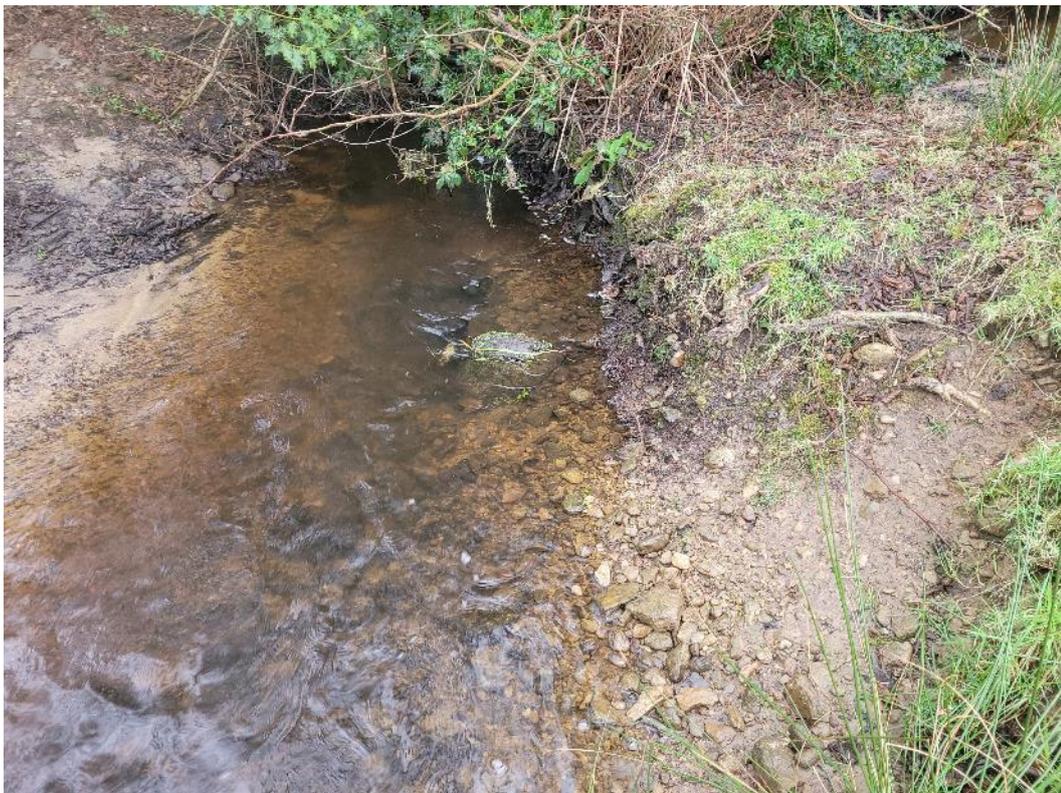
Spawning opportunities were much more limited in this reach, other than the occasional outcrop of sandstone (photo 13). Any natural trout production in this

Photo 13. Spawning opportunities were limited to occasional outcrops of eroded sandstone chips.

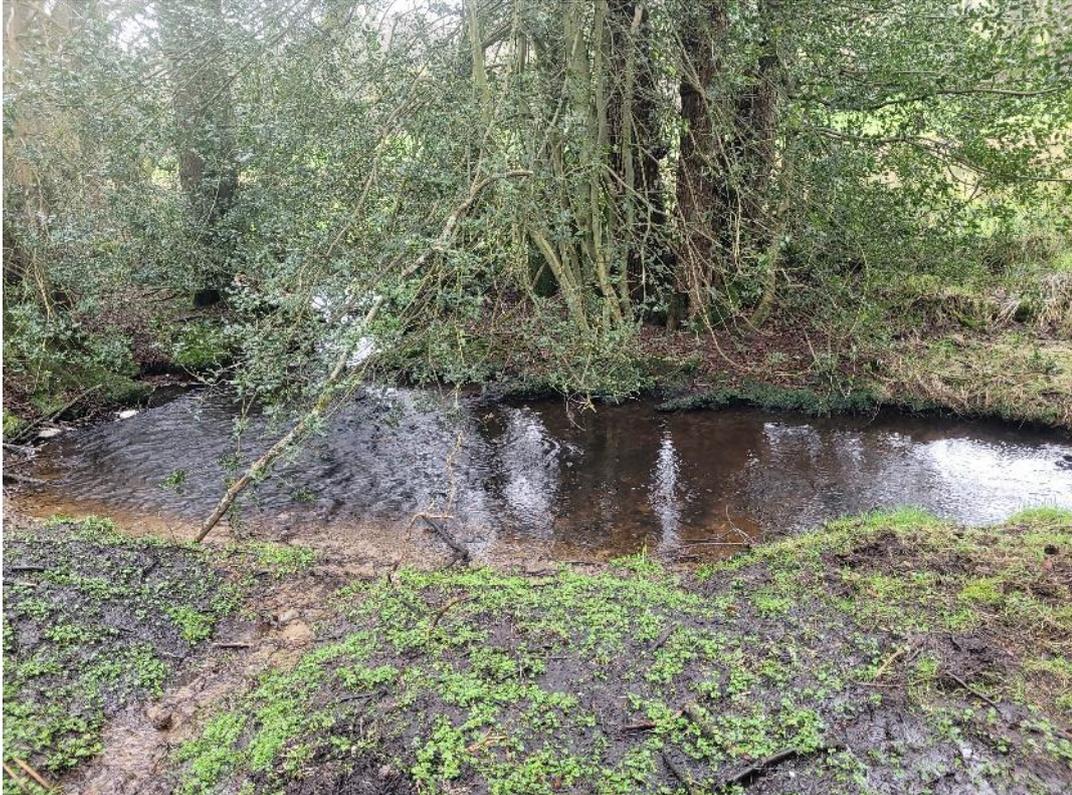
Overall, the reach supports some reasonably good habitat for brown trout (photo 14). However, the natural water chemistry, when coupled with the local geology and streamside flora may be limiting productivity in this reach. Access for upstream migrating trout may also be limited by the on-line ponds located downstream of this reach.

Photo 14. Good quality habitat for trout but potential for trout growth may well be naturally limited by the stream's water chemistry and local ecology.
