Advisory Visit

Colne Brook, Iver, Buckinghamshire

August 2018

Undertaken by Rob Mungovan

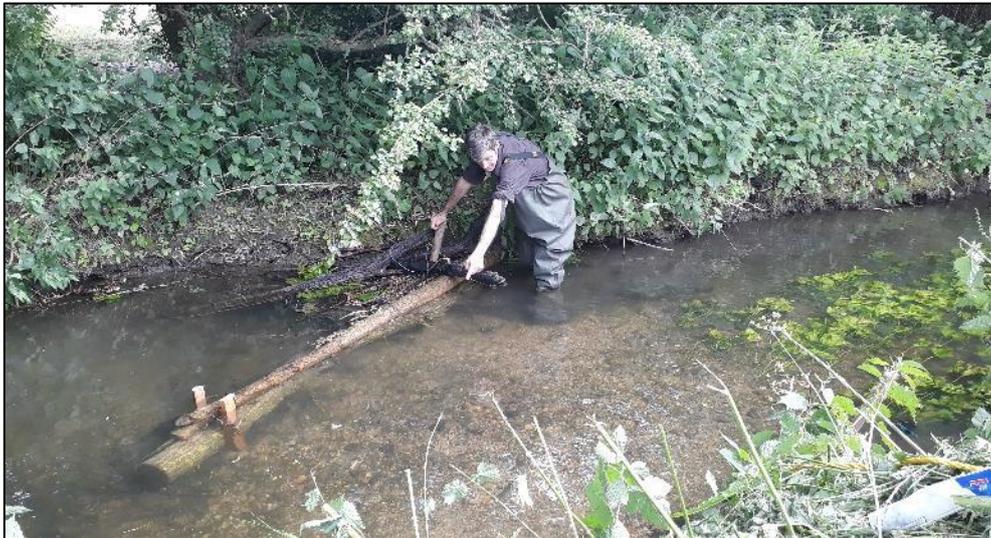
Pic 29 – A flow deflector used to focus flow and scour into the centre of the channel.

The river is limited in juvenile brown trout habitat. The shallow glides and riffles present an opportunity for safe in-channel working. It would be possible to conceive a habitat enhancement scheme to increase the juvenile trout holding potential of the river through the application of approaches such as flow deflectors (pic 29), brushwood berms (pic 30) and the fixing of LWM to the riverbed (pic 31). Additionally, in gravel rich rivers that are subject to poor flow and depth diversity, a technique known as dig and dump can be used. This sees an excavator working from within the river to locally re-distribute bed material to create pools. The material excavated from the pools is used to pinch in the channel to locally increase water velocity upstream of a pool (pic 32), thus keeping it energised and cleansed of silt. The WTT would be able to provide further support on this issue. These habitat enhancement approaches alone cannot bring about true river restoration.

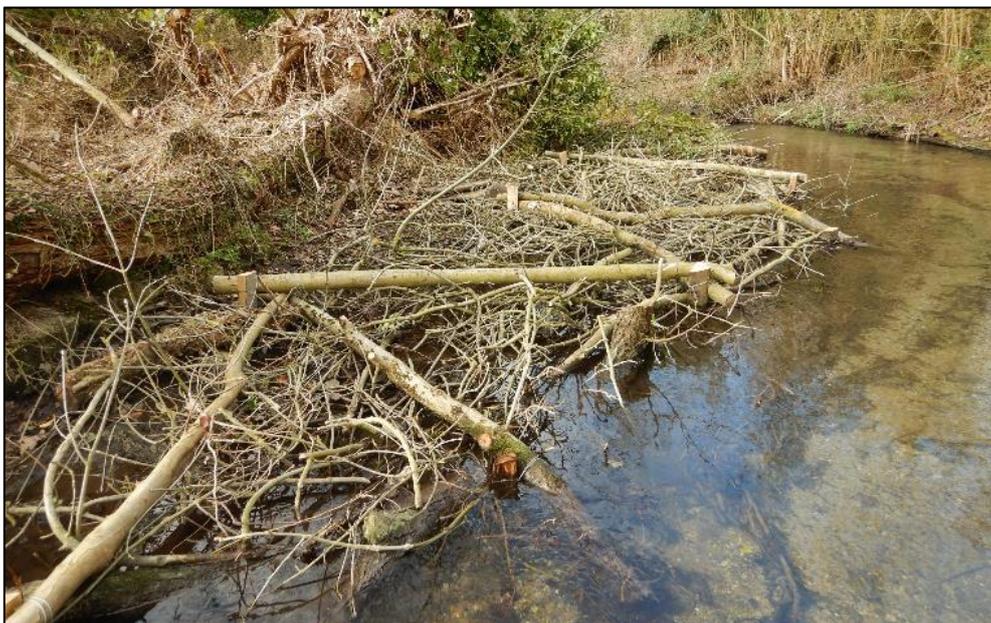
Pic 30 – A brushwood berm used to encourage marginal deposition, which in turn will become a rooting a substrate for plants and is also excellent cover for fry.

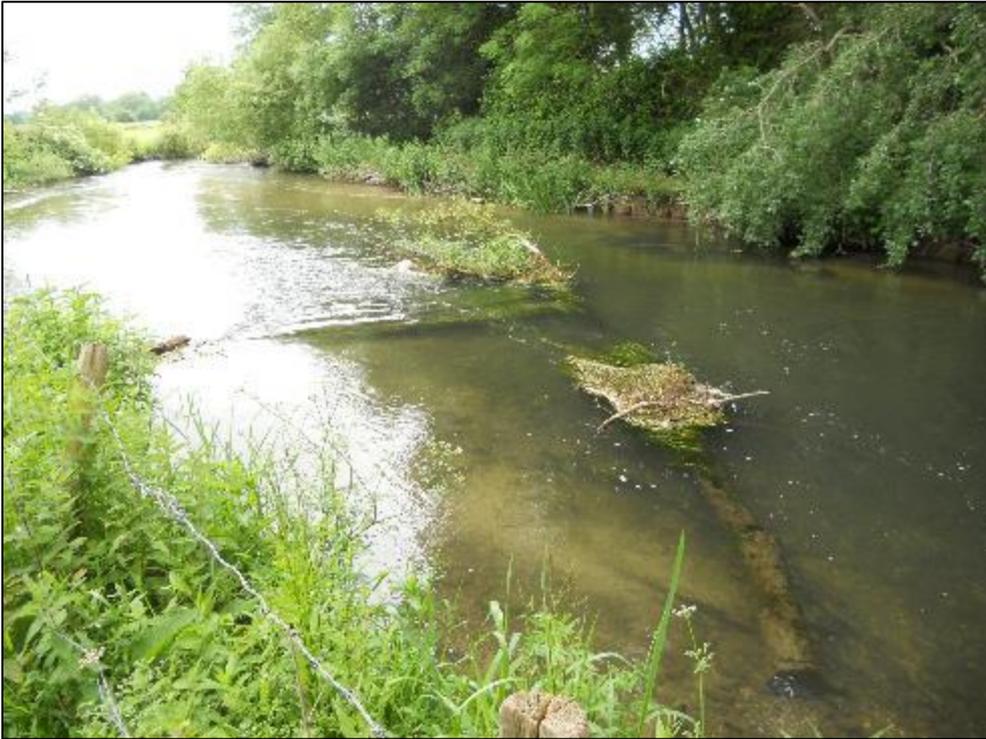
Pic 31 – LWM fixed to the riverbed to create areas of local scour and in-channel cover.

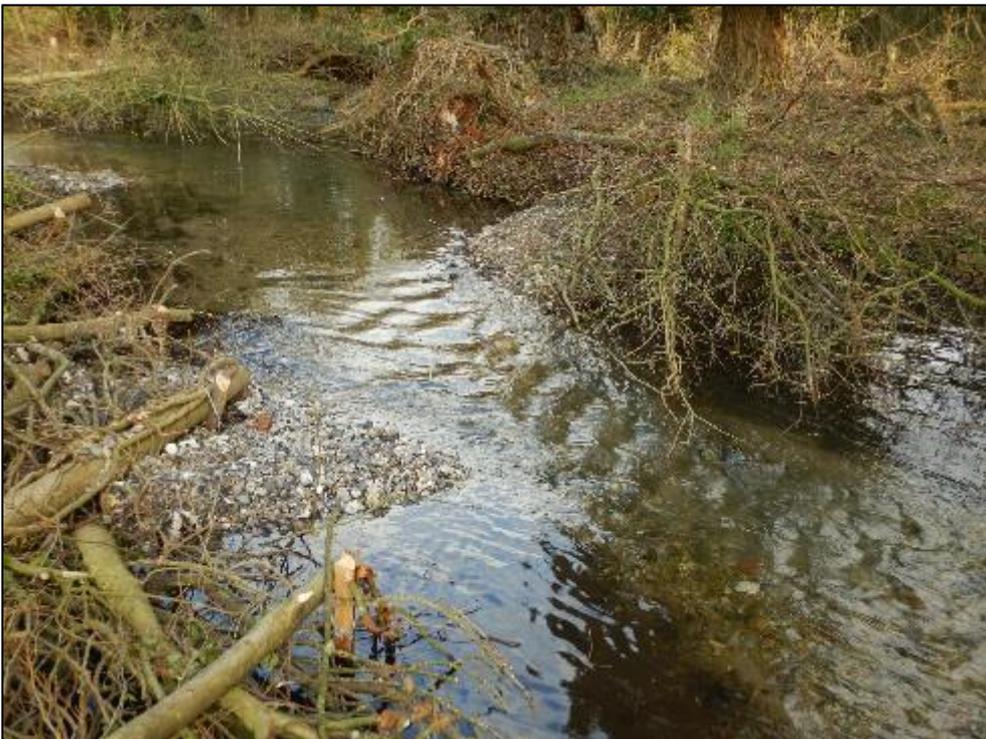
Pic 32 – The technique of dig and dump can be used in shallow gravel-rich rivers where the gradient will allow the formation of new pools and riffles. The excavated bed material is used to narrow the channel leading into a pool.

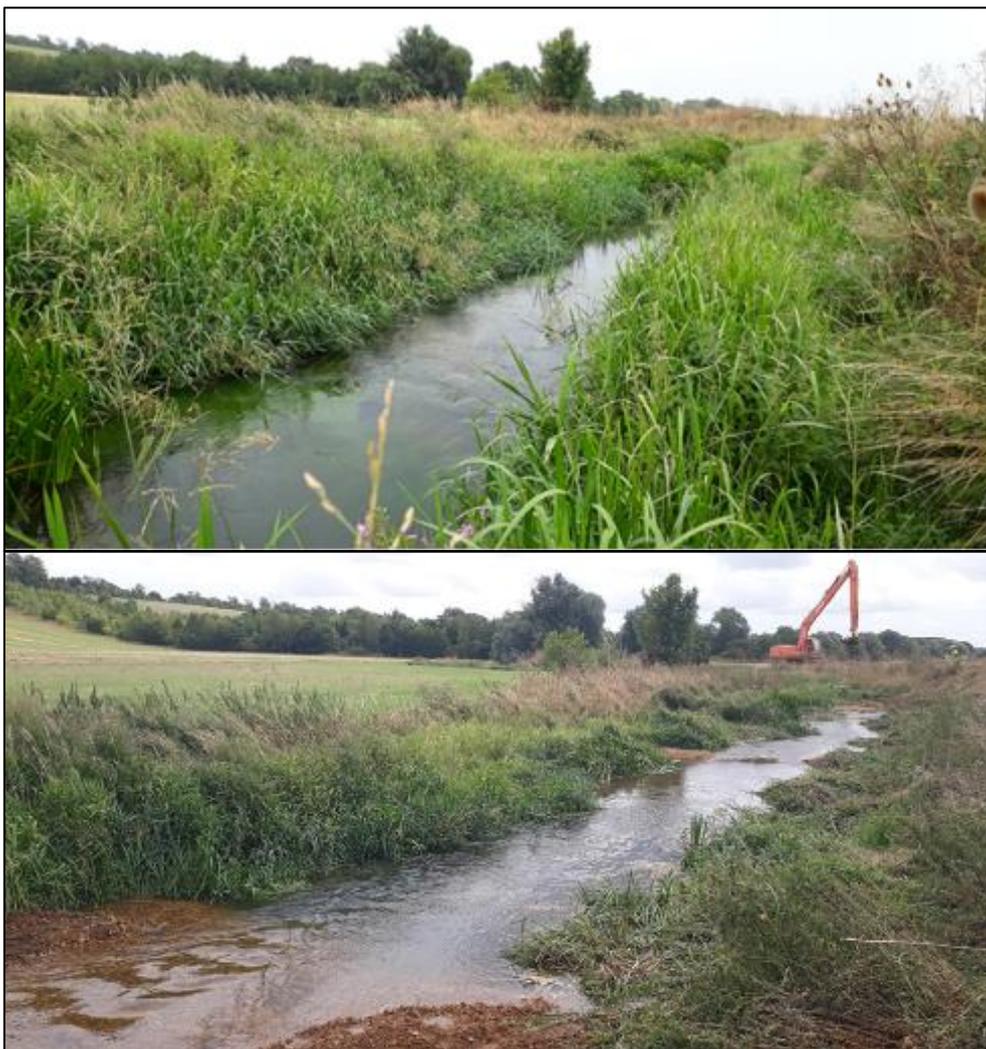
Pics 33 – Raising the riverbed to the form that it was pre-dredging restores sediment transfer, flow diversity and hugely increases the range of aquatic niches. Bed raising on the River Gwash used 300T of mixed grade stone to raise the bed ~0.5m over ~100m (at ~5m width).

The river has been over-dredged in many locations and it would appear that there is little downstream transfer of coarse sediment. The river is unable to restore its proper riverbed profile without significant intervention. The usual approach to addressing historic dredging is to undertake riverbed restoration through the placement of gravel and stone.

The reach of river immediately upstream of the railway line to the WWTW access road, provides a discrete area (~30m) in which to undertake riverbed raising with no residential properties in the vicinity nor any requirement for tree removal. It is also assumed that Affinity Water control the land, this should be clarified.

Riverbed restoration should increase water velocity which in turn should aid fine sediment transfer leaving a clean gravel bed. This approach is likely to reduce the dominance of bur reeds, and to a lesser extent yellow water lily.

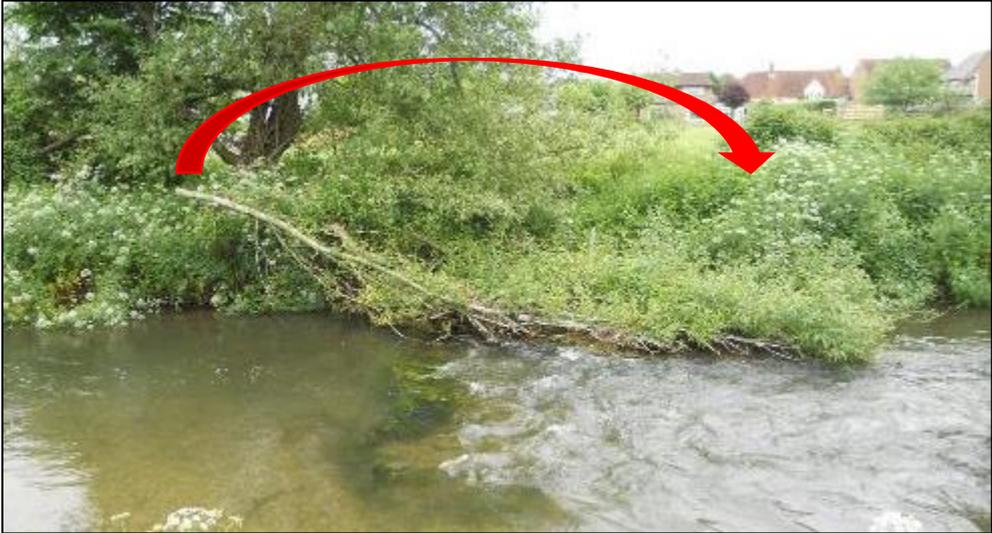
Pic 34 – An example of tree hinging, a simple and effective technique for increasing cover and scour in a river.

Some reaches have become over-shaded. Shallow reaches have the greatest capacity to self-restore once light is let in again. Such reaches should be mapped and a tree management plan drawn-up. Tree hinging into the shallow reaches would speed-up self-recovery as LWM kick-starts the processes of scour, sediment transfer and deposition.

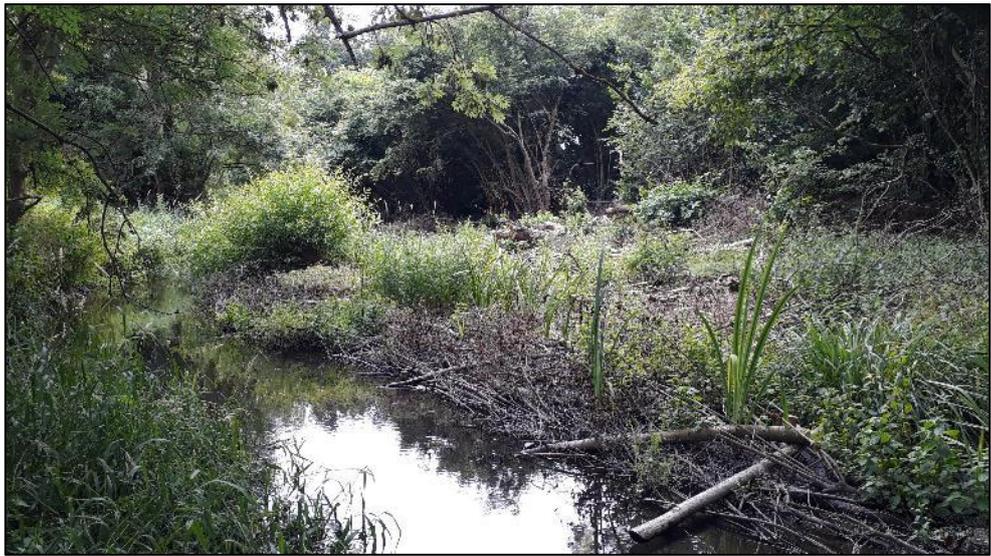
Pic 35 – Removal of the shade-casting canopy has allowed the native marginal plants to grow. Once the marginals become established they consolidate silt and bring about further channel narrowing (in this pic brushwood ledges have been used to accelerate the process).

Tree management should also have regard to the need to retain trees, particularly over pools, for their shade to aid summer cooling and for controlling vegetation growth. Trailing branches at water level should not be removed unless absolutely necessary as trailing branches will increase the holding capacity for fish.
