WILD TROUT TRUST
wildtrout.org

Advisory Visit
River Erme, Devon
October 11, 2021

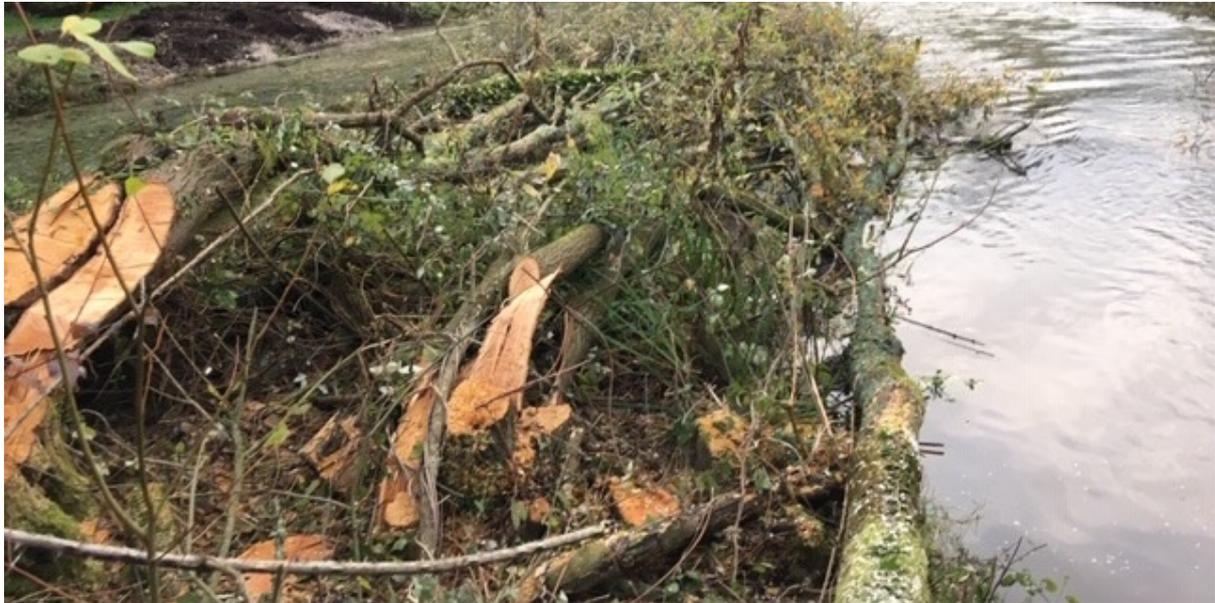
Figure 15 Hinged willow on the River Test. Hazel, small willows and small alders can be hinged into a river, creating diversity of flow and in-stream cover for fish. The trees are hinged in a similar manor to hedge laying, where the tree is partially cut through at the base and laid into the margins. Chestnut stakes and fencing wire can be used to secure the trees in place. Willow will survive perfectly well even with 70% of the branches submerged; however, hazel and alder should be laid to retain much of the structure above water level.

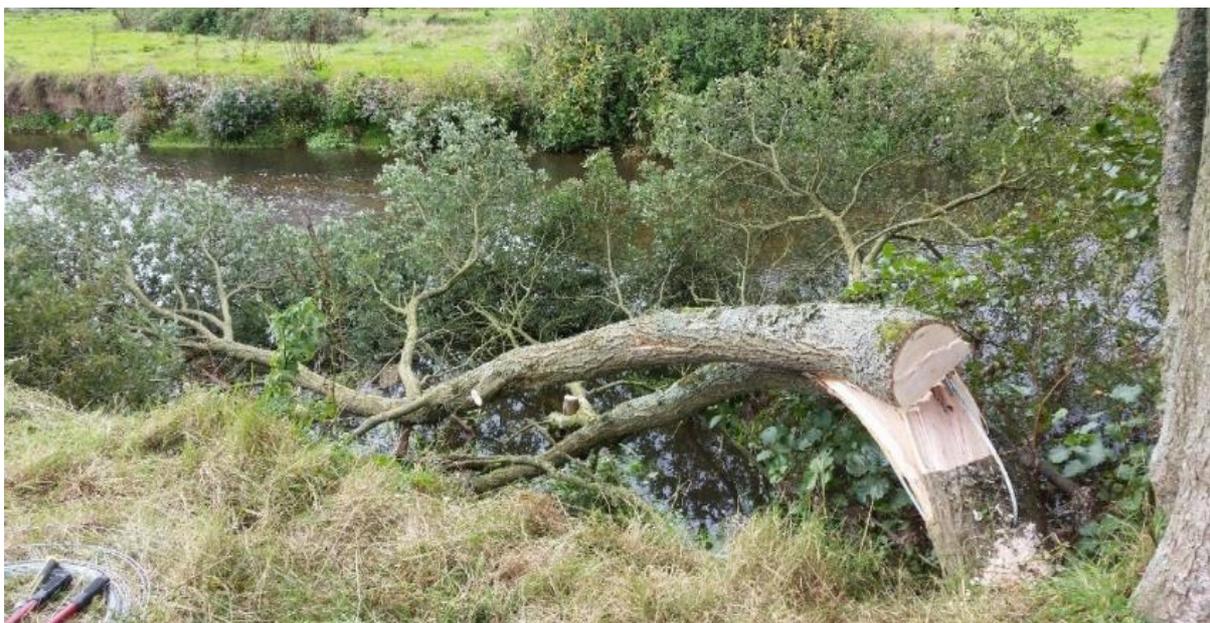
Figure 16 Another example of a tree successfully hinged into the margins of a river to improve habitat diversity.

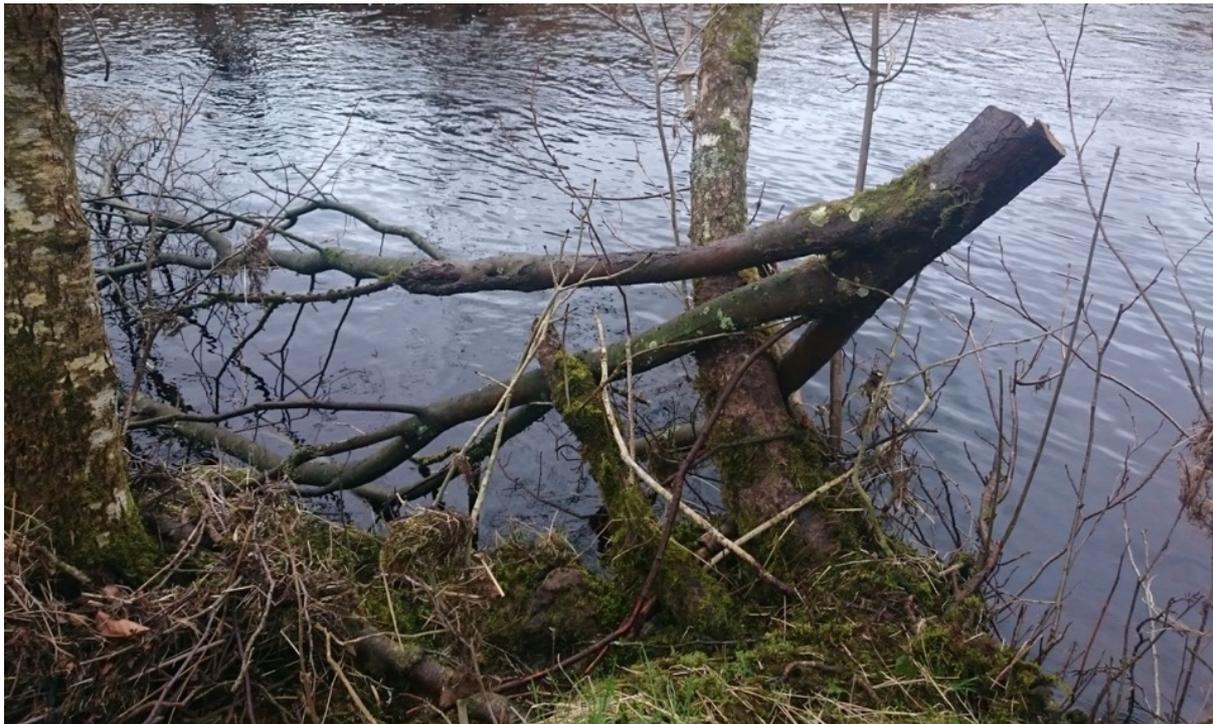
Figure 17 Lodged woody material, the most natural of methods to mimic naturally fallen trees, wedged in another tree to secure it with no other materials required.

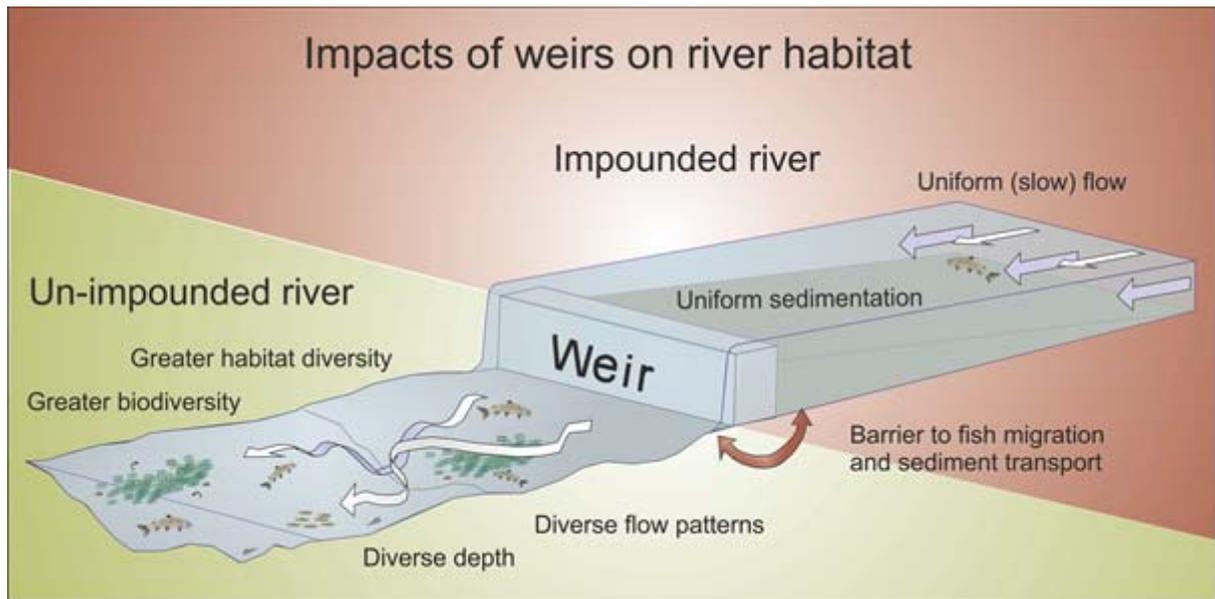
Figure 18: An illustration showing the impacts of weirs on habitat quality

Within the reduced energy and gradient of an impounded reach, fine sediment carried in suspension drops out of the water column uniformly across the stream bed, where habitat quality and diversity become severely degraded (Figure 18).

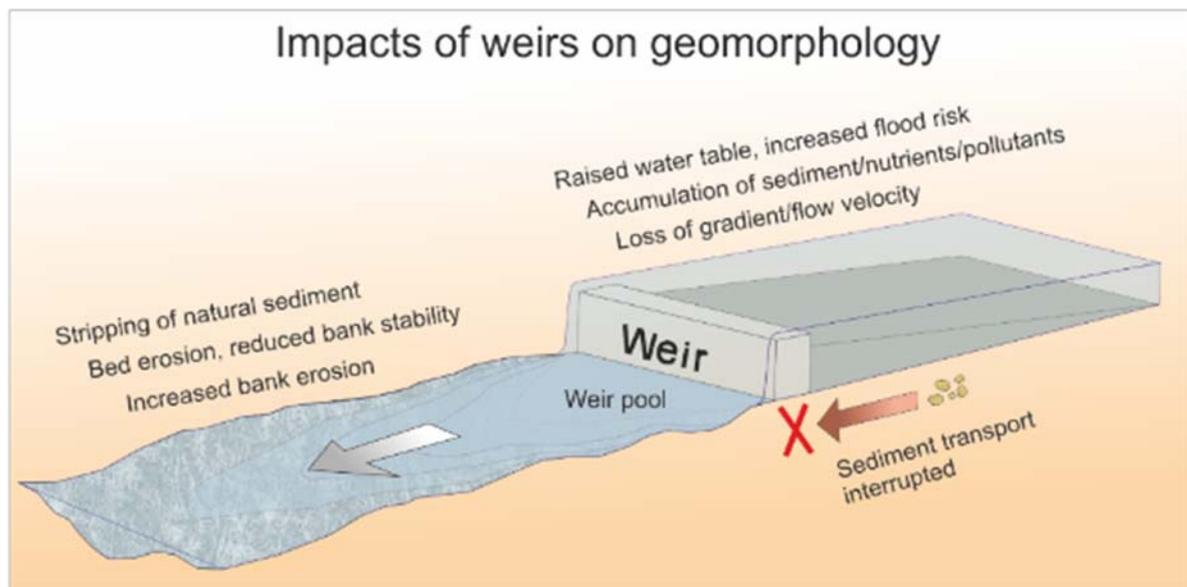
Weirs also interrupt the natural transport of coarse river material like gravel and cobble (Figure 19). This can cause the river downstream to become depleted of sediment, and can increase bed and bank erosion downstream as the supply of gravel and cobbles from upstream is interrupted.

Figure 19: An illustration showing the impacts of weirs on river geomorphology
