Walkover Assessment
Badsey Brook (Warwickshire Avon) catchment
14-15/06/2017

Undertaken by Gareth Pedley

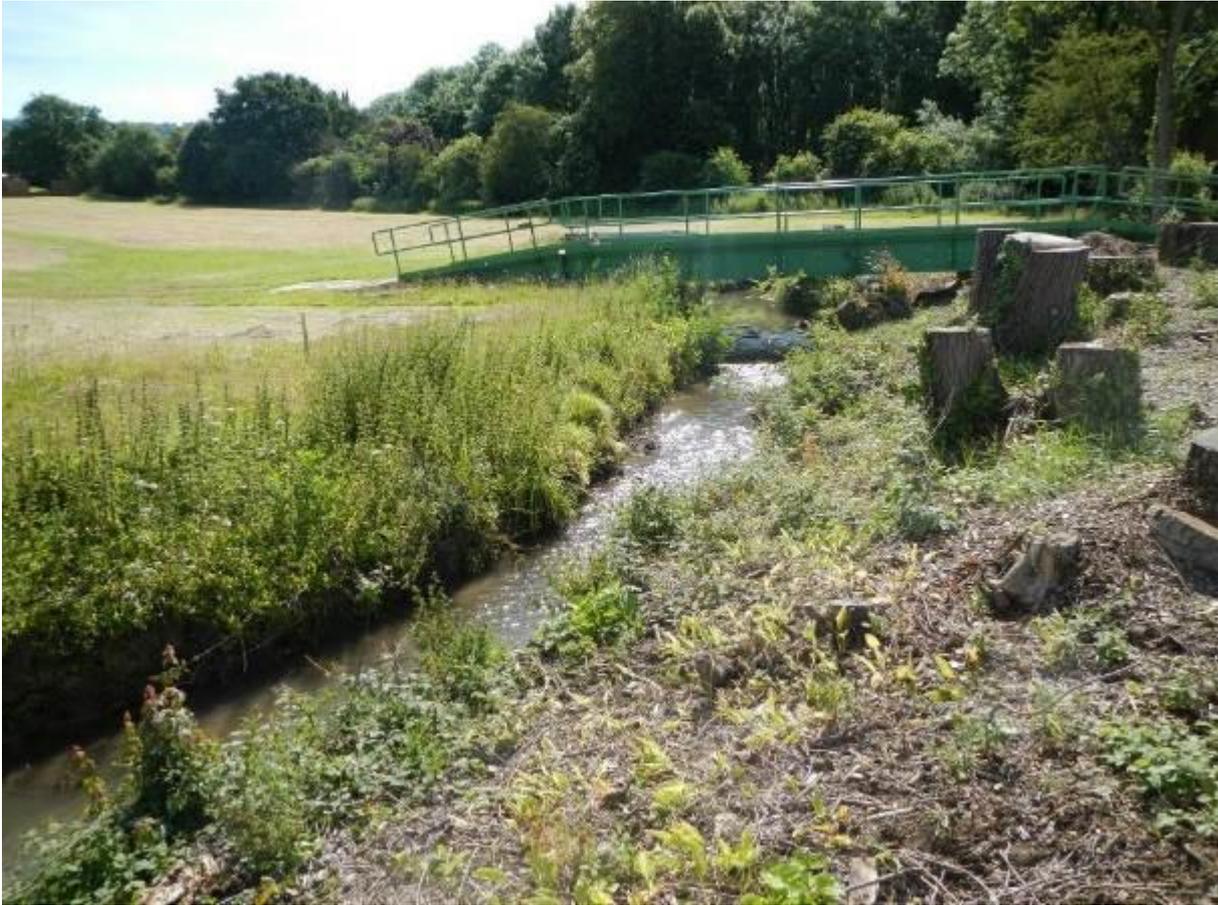
Figure 3. Some potential spawning and juvenile habitat is available in the straight section u/s of Broadway Weir (u/s of the impounded reach). However, the channel is uniform, straightened and of an artificially low gradient (owing to the weir) and would clearly benefit restoration to a more natural gradient and more sinuous planform, with pool and riffle habitat variation. Note the tree and bank clearance work that has already been undertaken, creating just part of the requirement for environmental mitigation associated with the flood alleviation scheme; it is not clear why all these trees were removed.

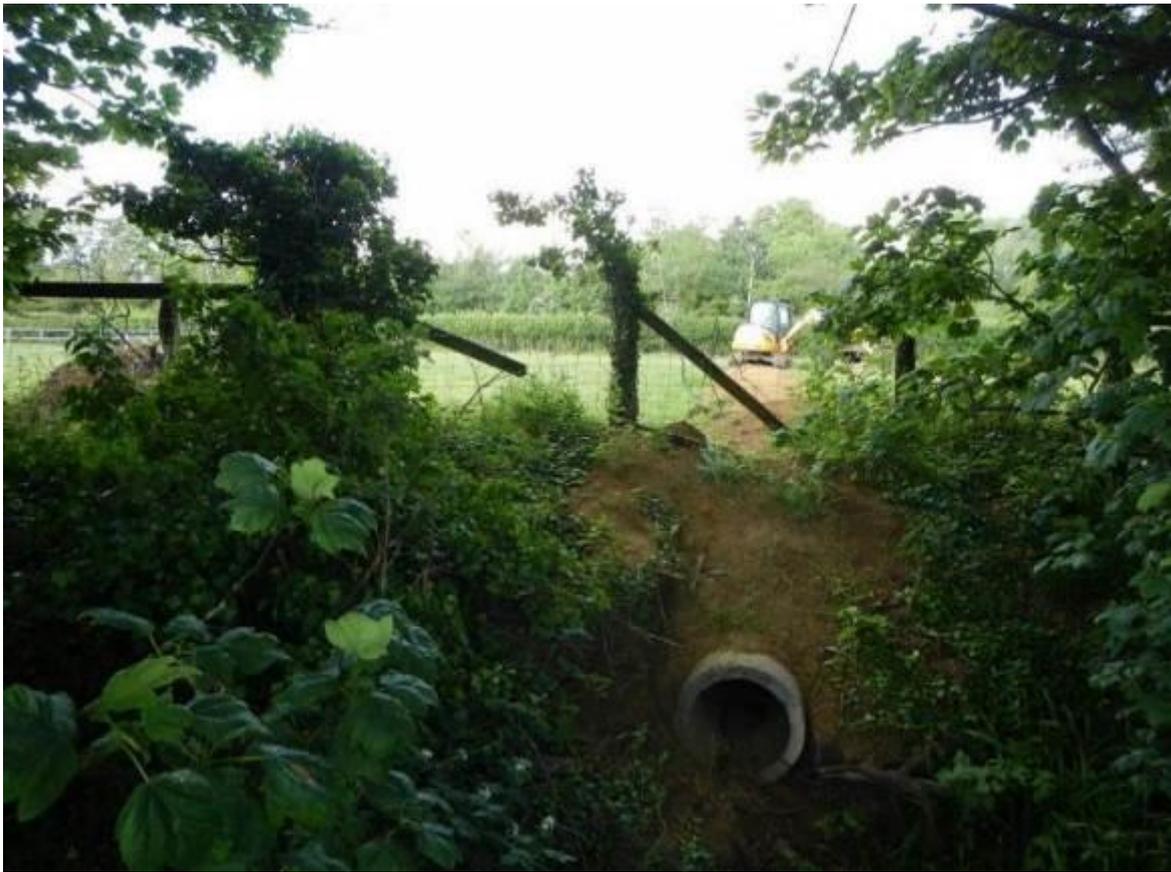
Figure 7. At SP 08610 37850, suspected unconsented (EA staff on the visit were unaware) drainage work appeared to be underway which should be investigated. Strangely, this work also appears on aerial photography, so may be ongoing.

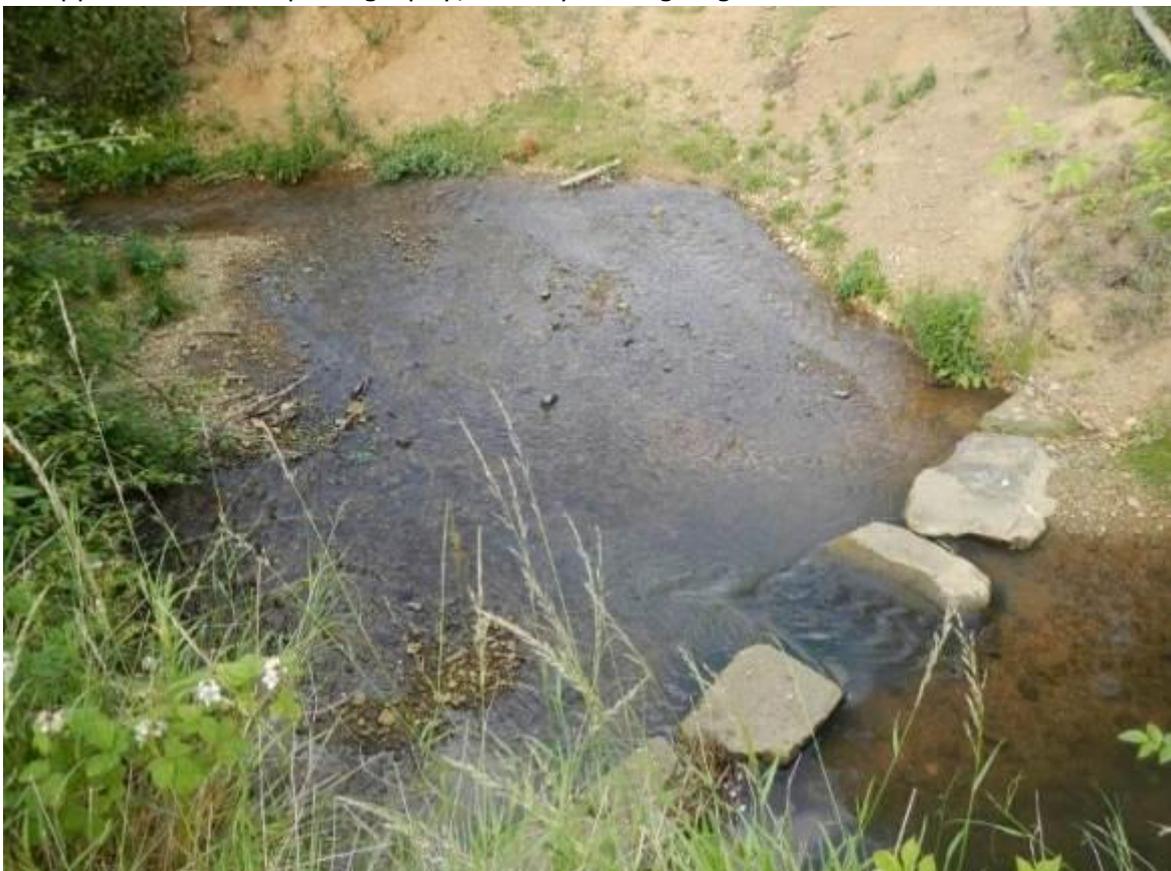
Figure 8. At SP 08560 37878, a weir comprising large stone blocks creates a small impoundment. This almost certainly unconsented structure appears unnecessary and interrupts sediment transport. Man-made obstructions like this should ideally be removed.

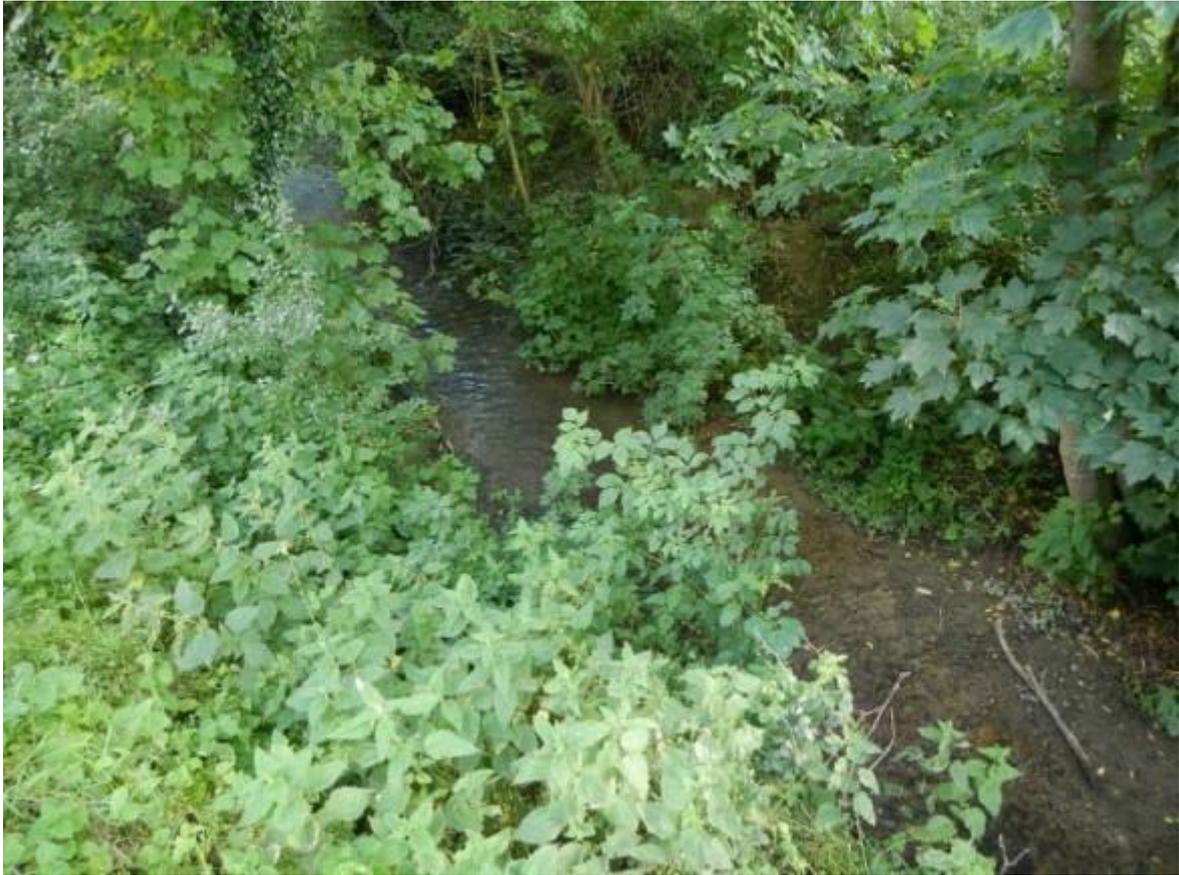
Figure 11. The physical habitat quality between Broadway and Leedon's Holiday Park is generally as good as can be expected within an often straightened channel which limits the development of geomorphological features (discrete pools and riffles).

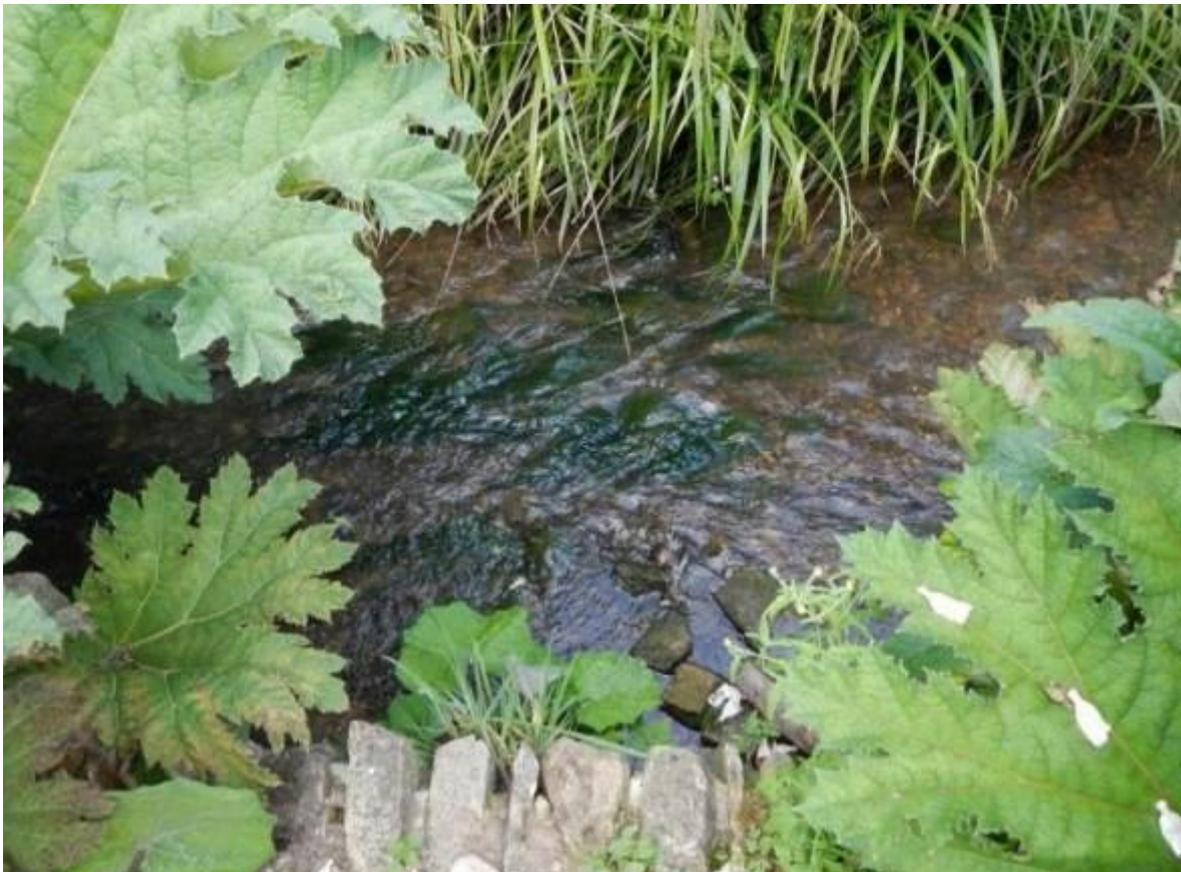
Figure 12. Continued occasional signs of excess nutrient input are apparent through excess algal growth. Not all potential sources could be identified and field drainage/diffuse pollution is likely to be a contributor, along with septic tank discharges.

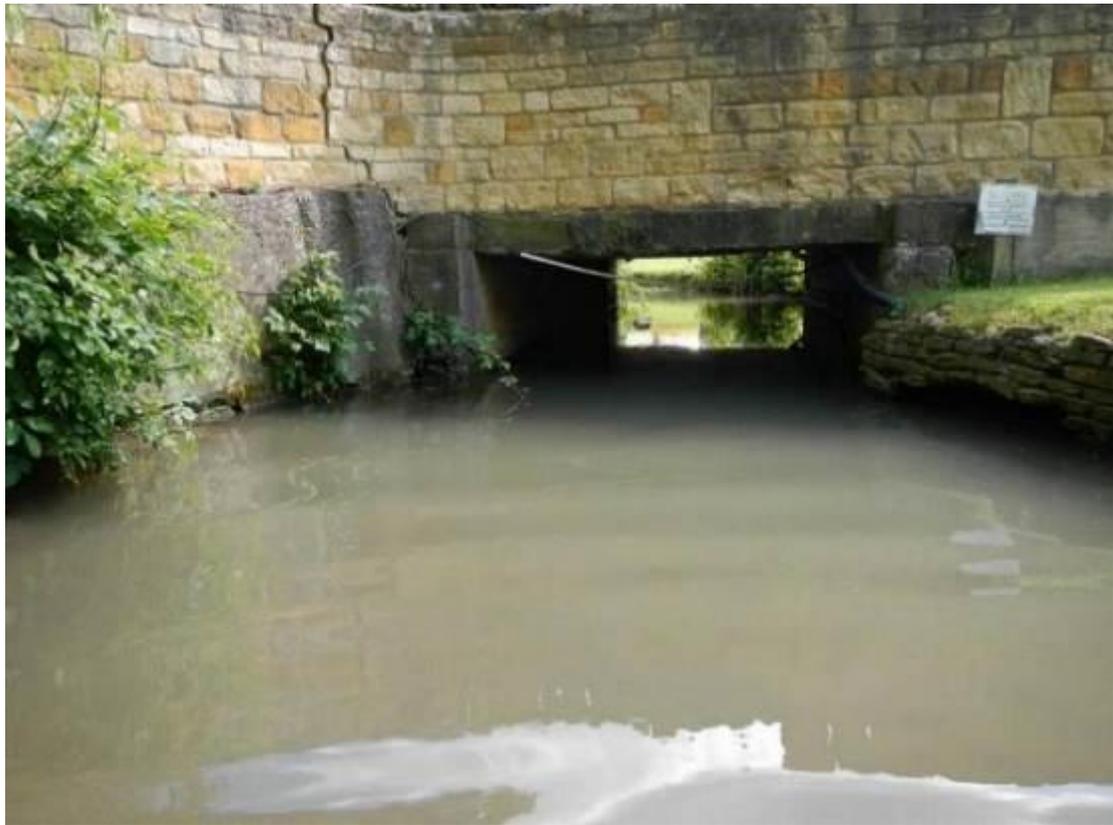
Figure 15. The culvert at the main entrance to Leedon's Holiday Park (SP 08175 38345) is sufficiently sunken to pose no issue to fish or sediment movement; however, the water here is currently impounded by a weir a short distance d/s.

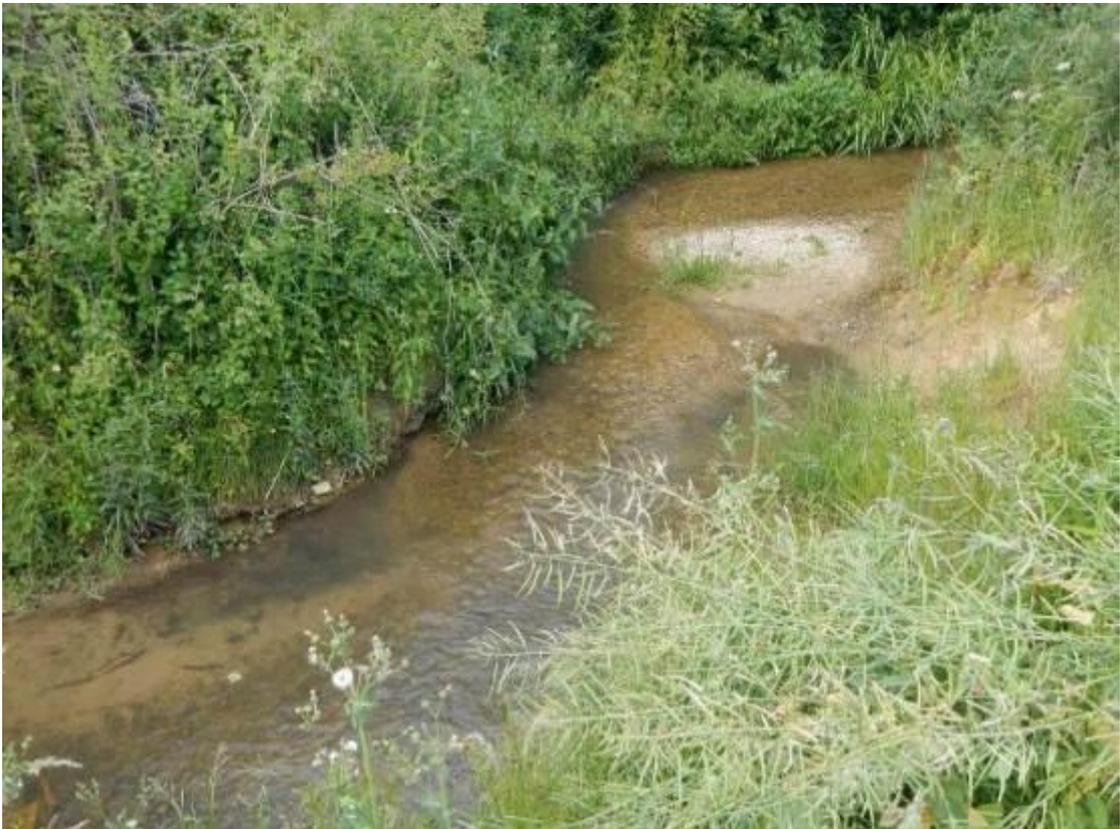
Figure 22. A short section of more natural planform/recovering channel and improved, mobile substrate d/s of the garden offers better habitat and potential salmonid spawning; however, clear signs of relatively recent dredging were apparent from spoil heaps on the bank. The possibility for restoration extends through this section u/s of Childswickham.

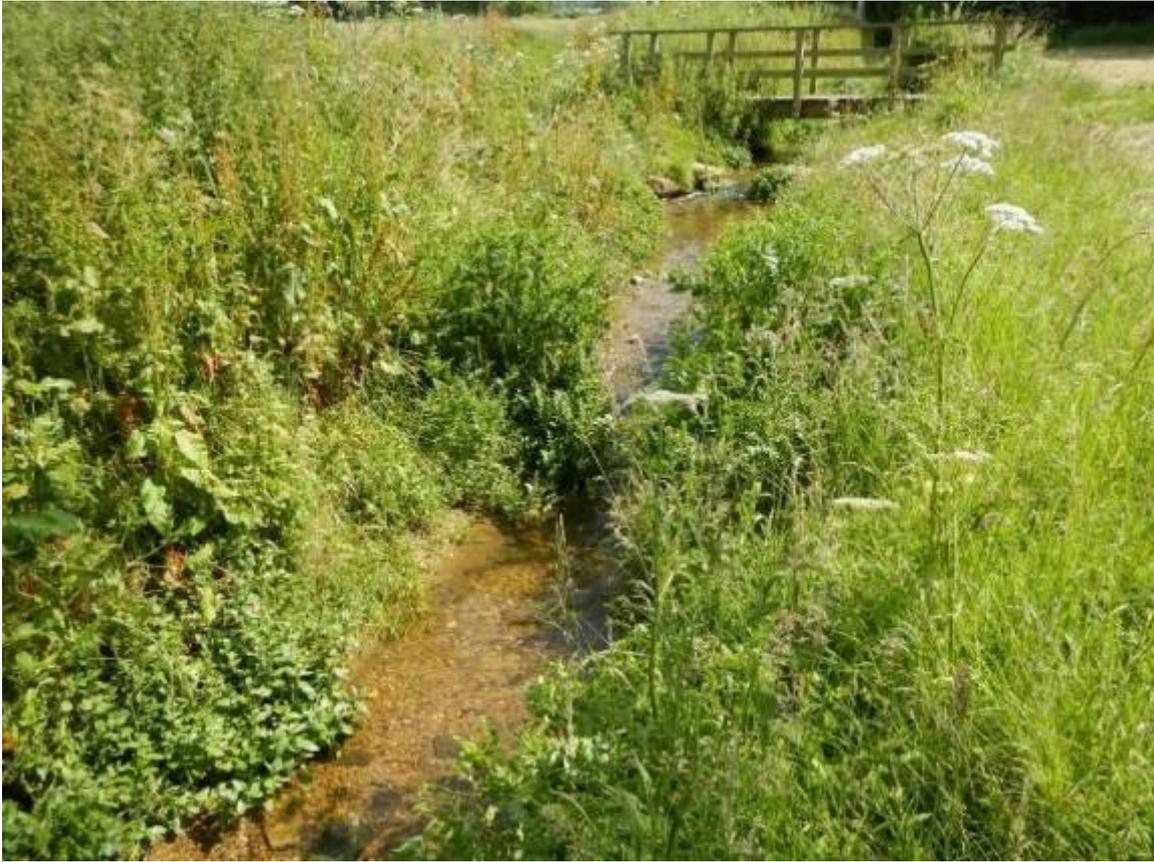
Figure 23. A straightened but naturally improving tributary joins the brook at SP 07583 38469, providing better invertebrate habitat and potential for salmonid spawning.

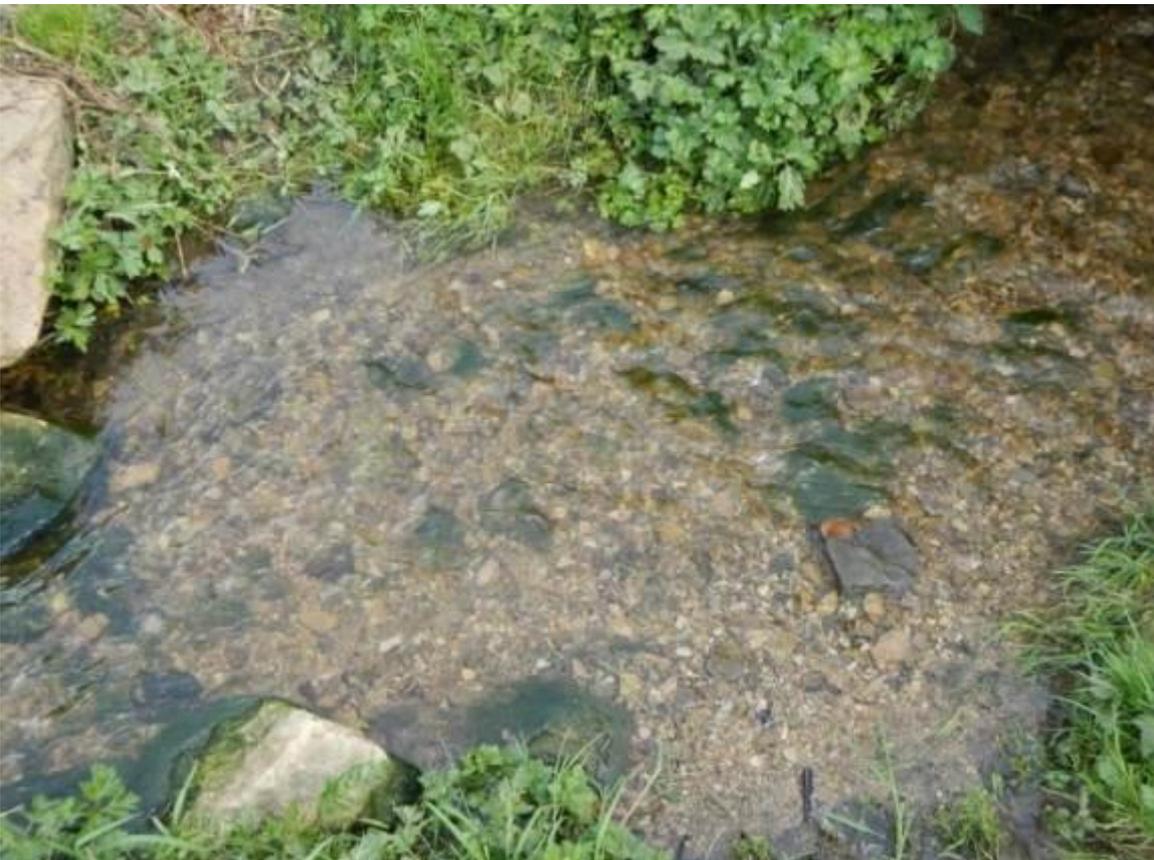
Figure 24. Signs of elevated nutrient input/eutrophication were evident on the tributary in the form of excess algal growth but it was crystal-clear, unlike the main brook which becomes gradually clearer d/s but remains turbid (previous and subsequent Figs). Further investigation suggests the local STW (SP 08146 37755) discharges to this watercourse u/s and could be contributing excess nutrients, as could the adjacent land use.

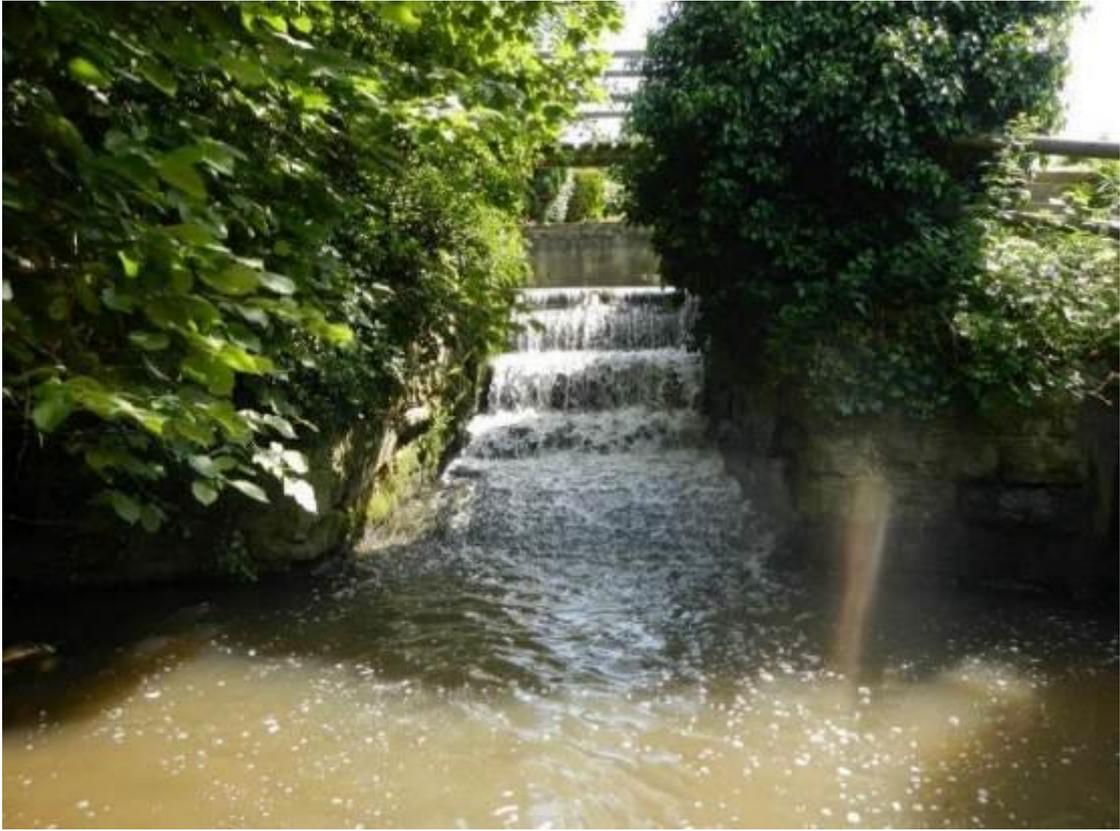
Figure 25. The brook flows through private gardens as it enters the southern edge of Childswickam, where a previously unknown, complete barrier to fish and sediment movement was identified at SP 07456 38486. This is an ornamental feature within the gardens but may also increase flood risk locally which could assist a case for removal. Note the turbidity, which is more obvious in the occasional deeper areas.

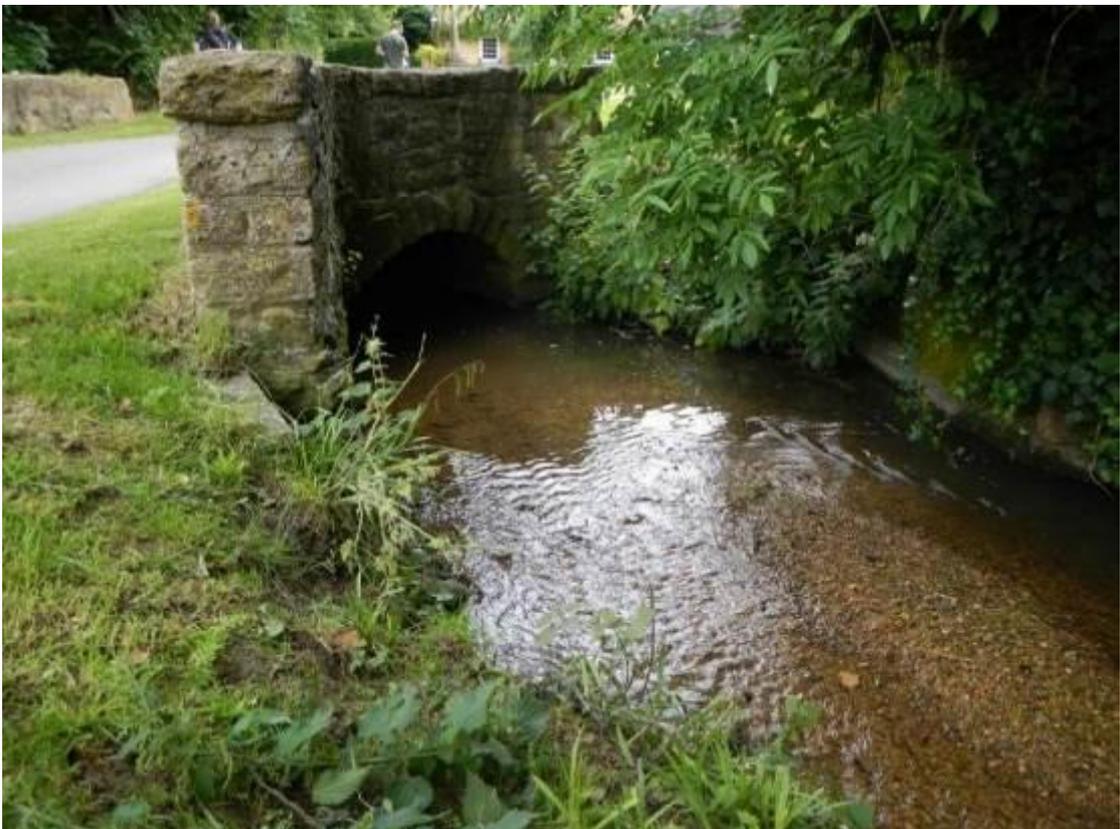
Figure 26. At SP 07387 38557 a road crossing of the brook poses no major issue for fish or sediment movement, although sediment is accumulating on the d/s side, possibly due to dredging/widening of that area in the past.

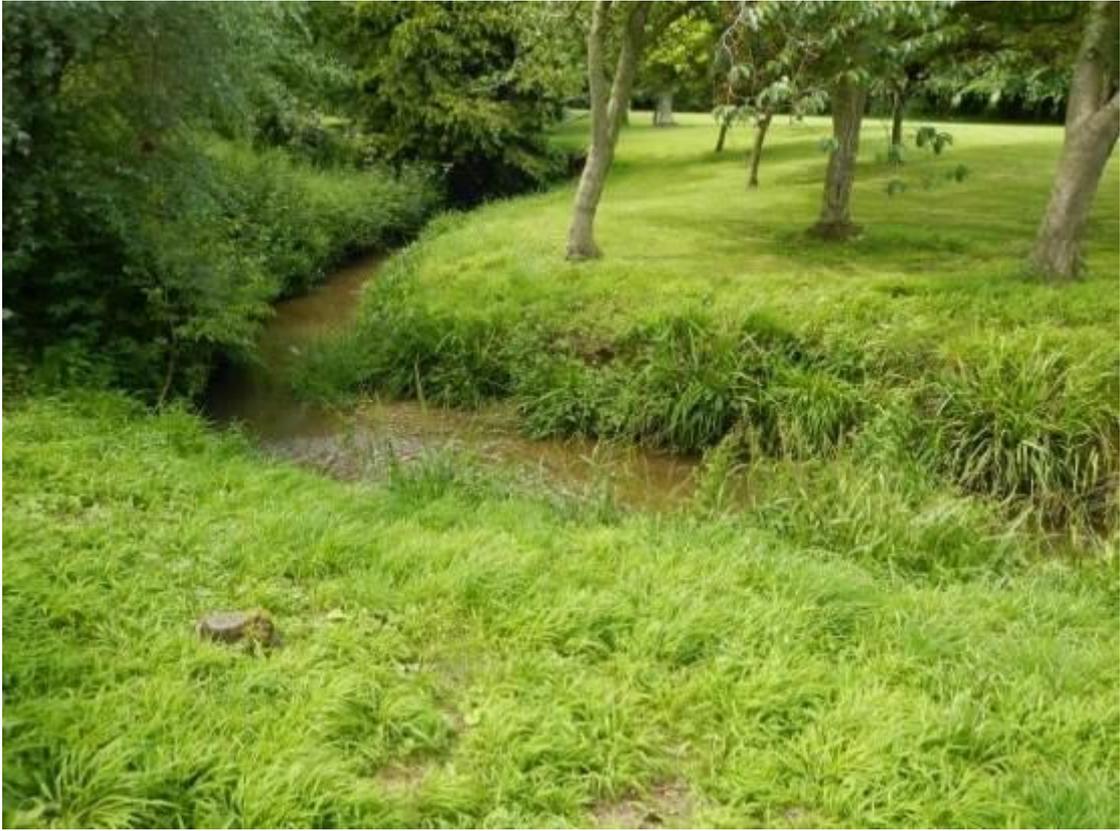
Figure 31. At the western, d/s side of the village, the brook regains some sinuosity and, correspondingly, habitat quality improves, with deeper pool habitat available where bends allow areas of bed scouring and deposition elsewhere.

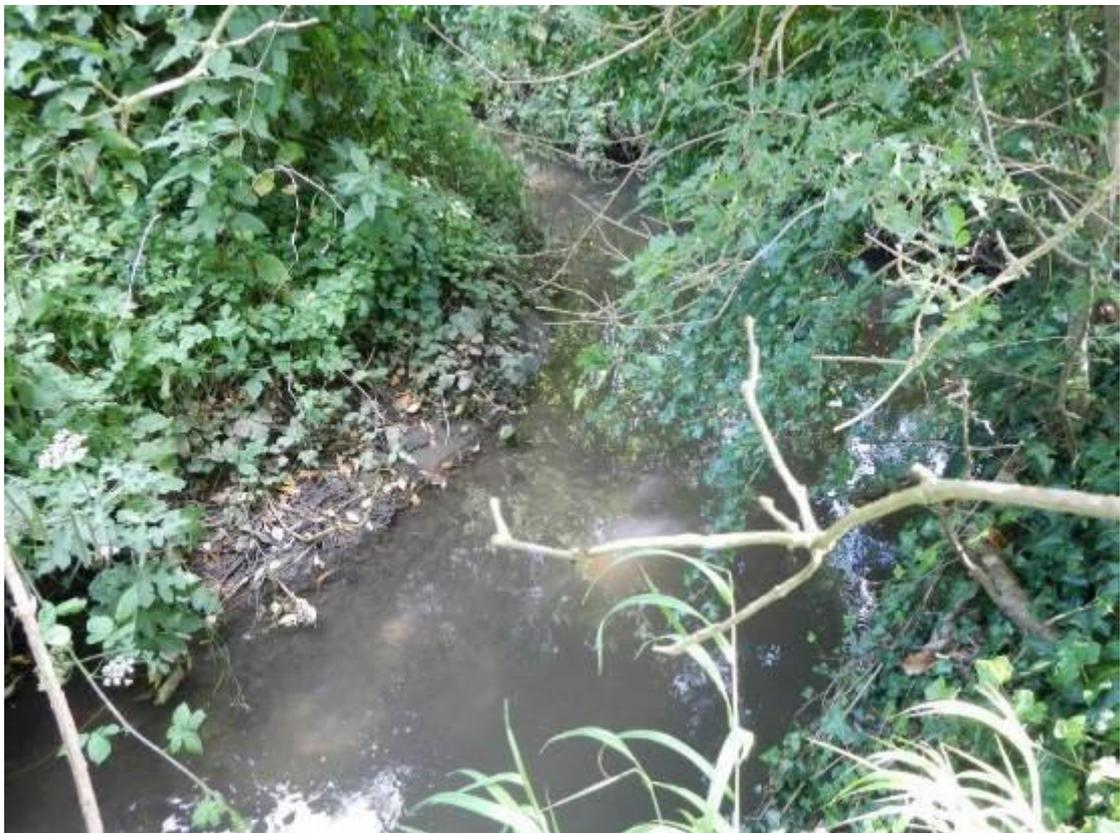
Figure 32. The more sinuous tree-lined section d/s of the garden (SP 06912 38751 - SP 06463 39034) provides habitat variation, with trailing vegetation and branches further assisting natural enhancement. However, maintenance and removal of overhanging and trailing vegetation was being undertaken which will negatively impact upon habitat quality.

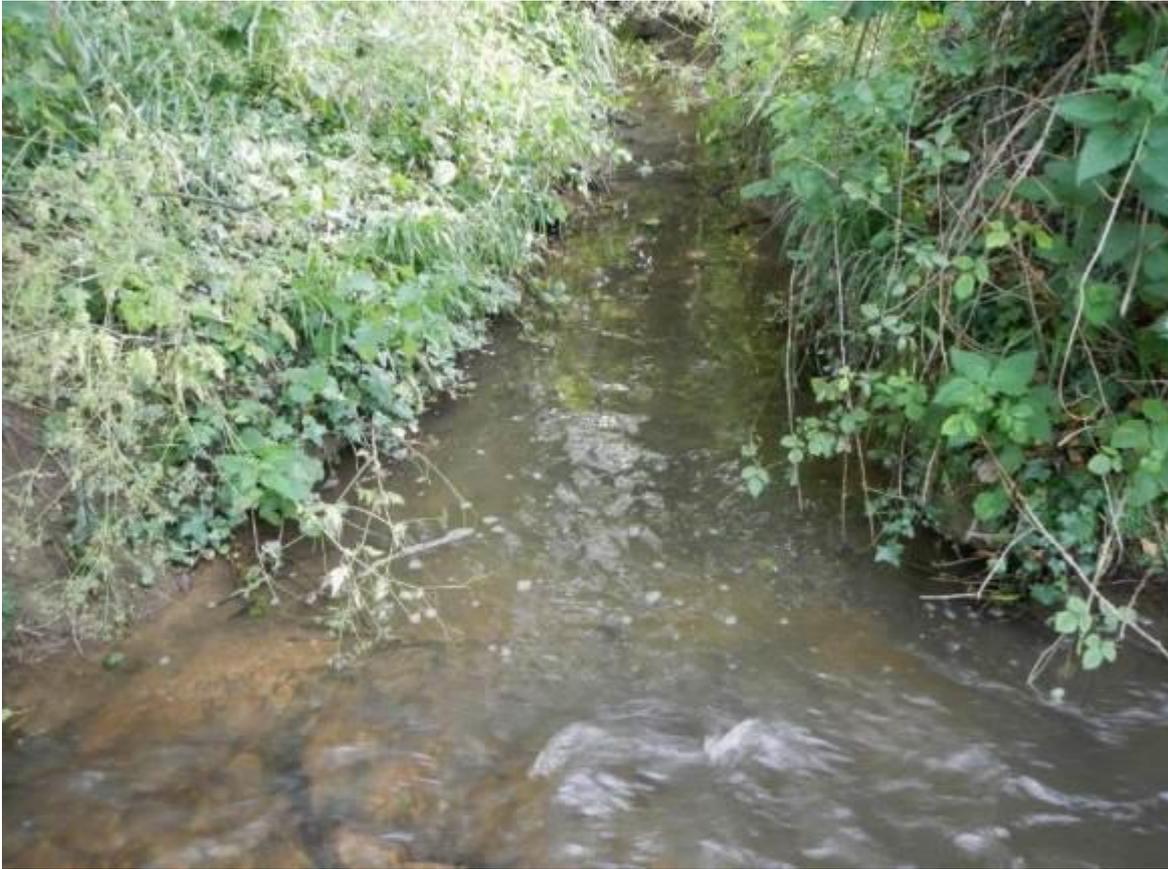
Figure 33. The confluence of the much smaller Badsey Brook and the larger Bunches Brook (foreground). Badsey Brook upstream of the confluence appears little more than a straightened field drain.

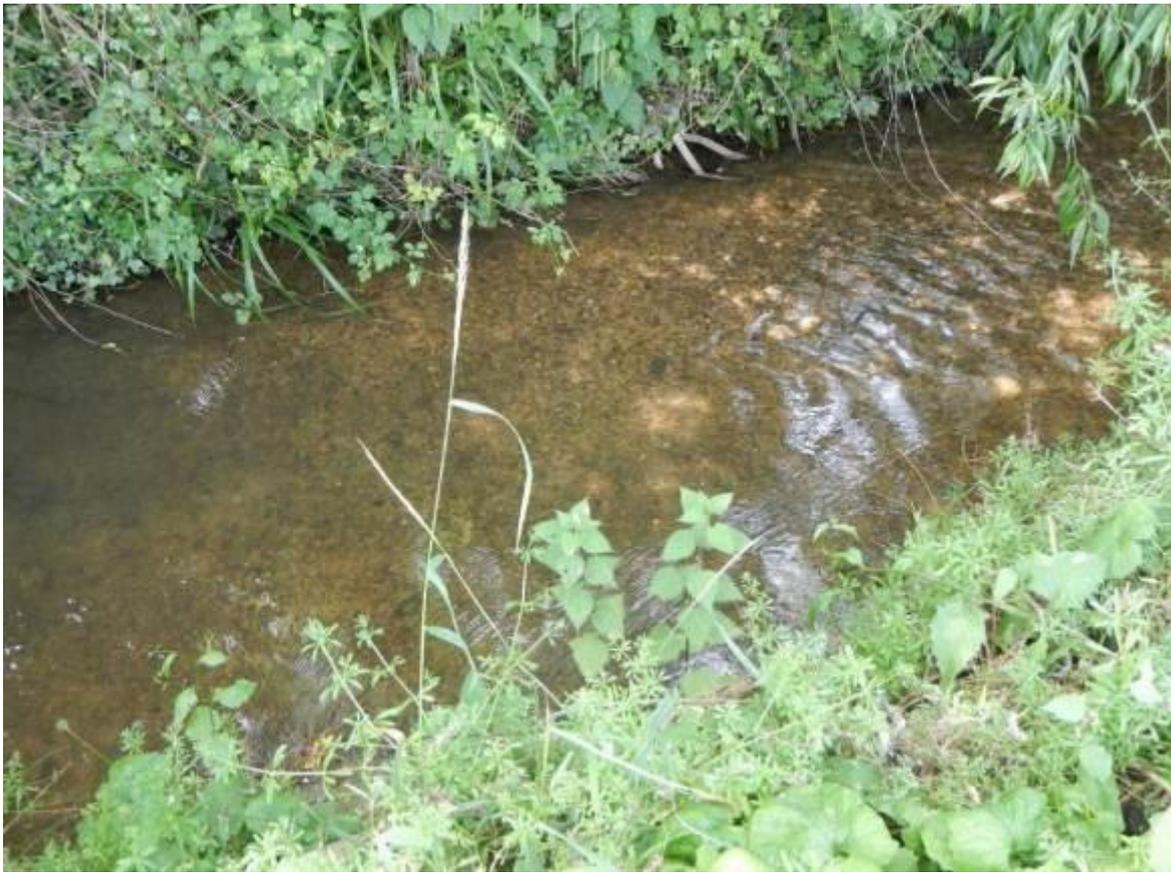
Figure 34. Badsey Brook d/s of the confluence is again subject to straightening and dredging, with obvious signs of paleo-channels in the fields on the RB (Fig. 35).

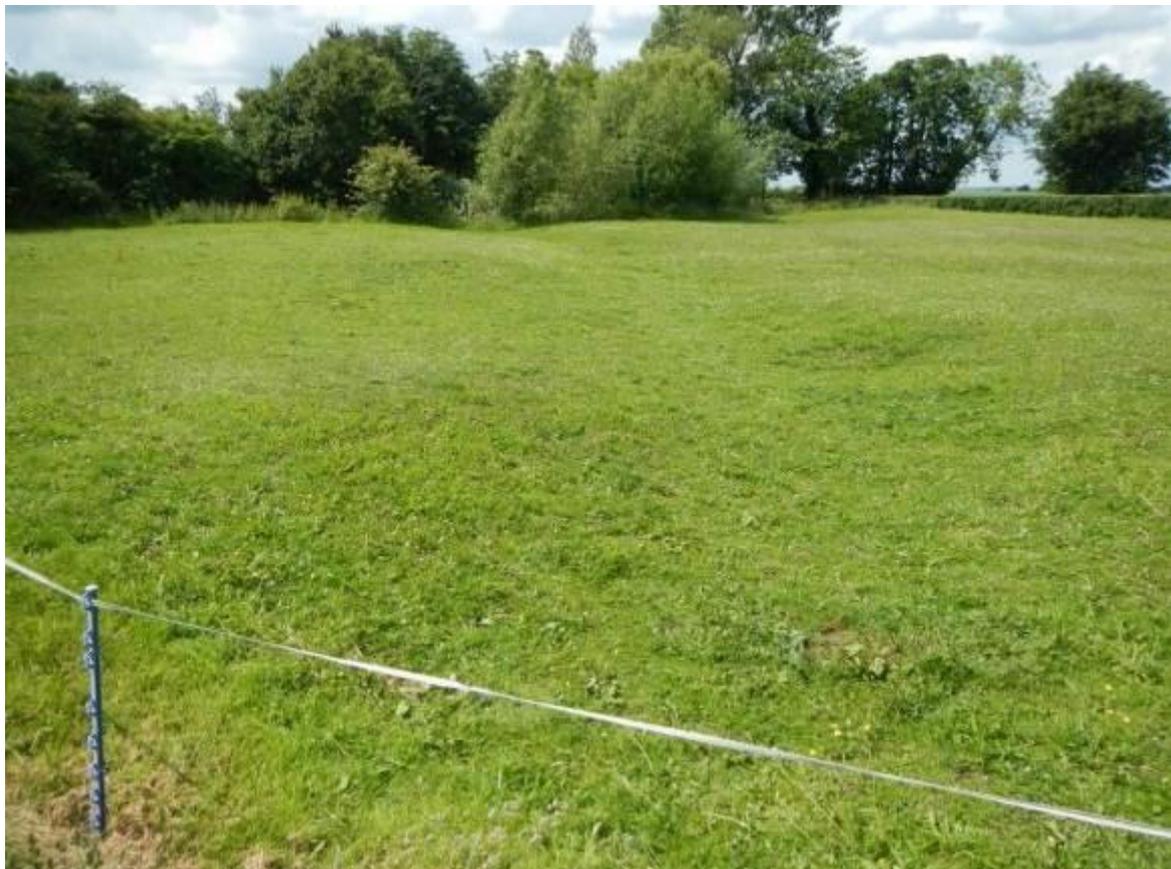
Figure 35. Paleo-channels of the brook were clearly evident within the adjacent horse field (SP 06551 38960 - SP 06456 39114). It is likely that the use of this land for grazing has helped preserve the contours of the channel better than occurs in the more heavily cultivated, adjacent arable fields.

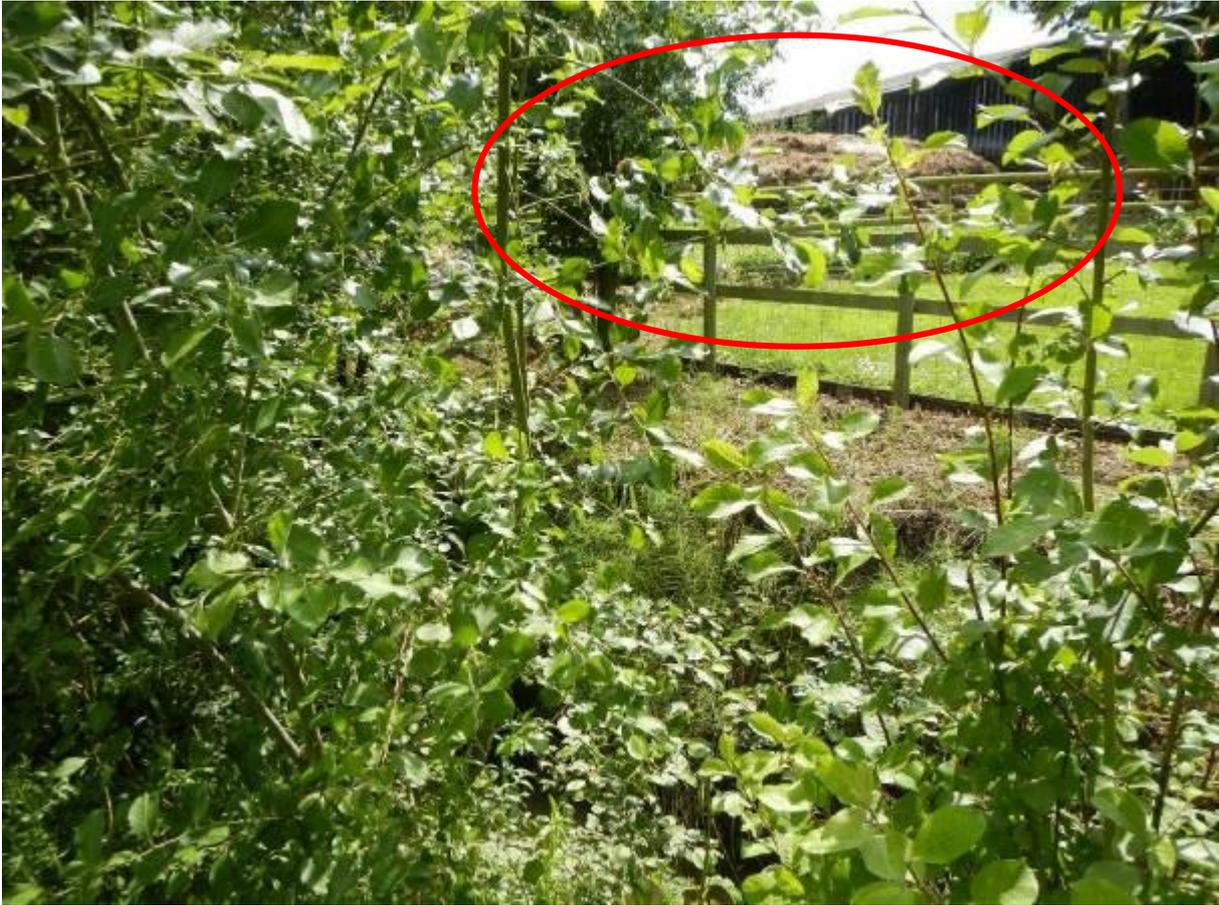
Figure 36. On the opposite bank to the horse field, a manure midden was located within 10m of the watercourse.

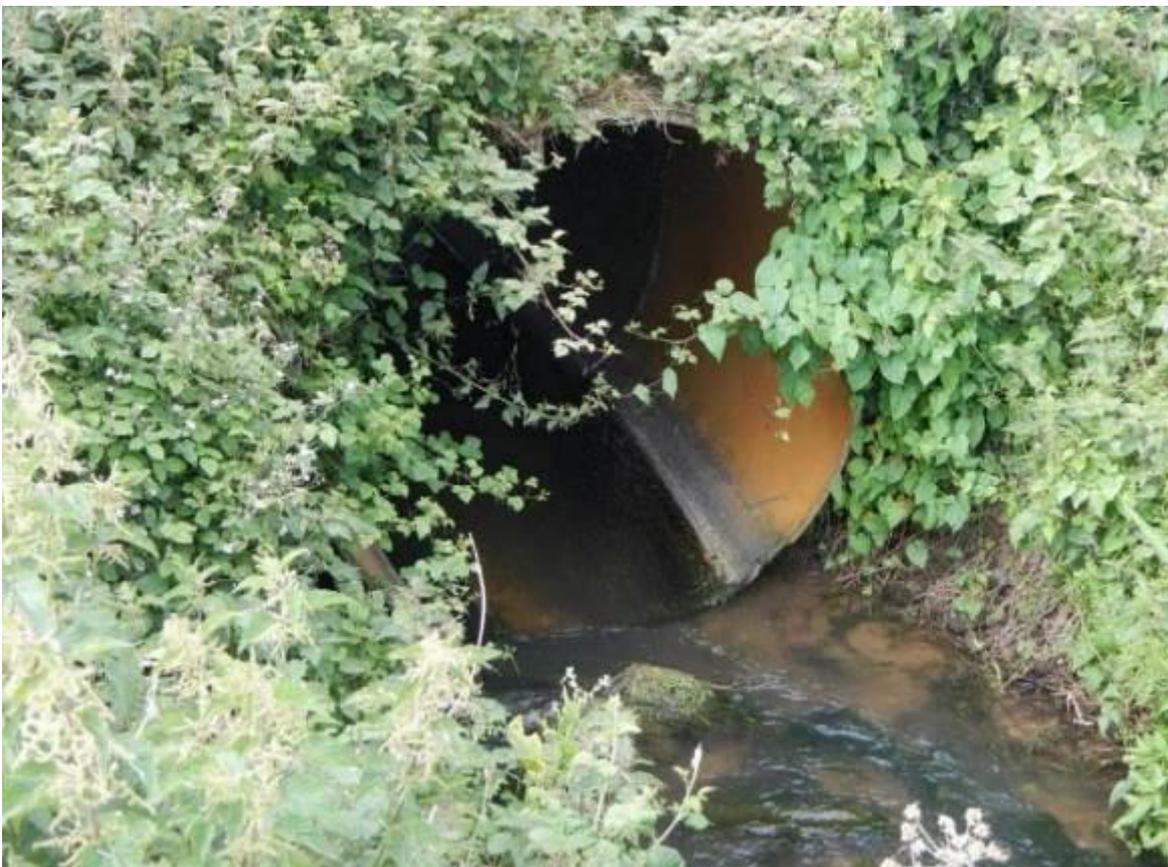
Figure 41. At SP 06457 39218 a large pipe culvert poses a minor obstruction but it is large and sunken enough to be passable by most fish.

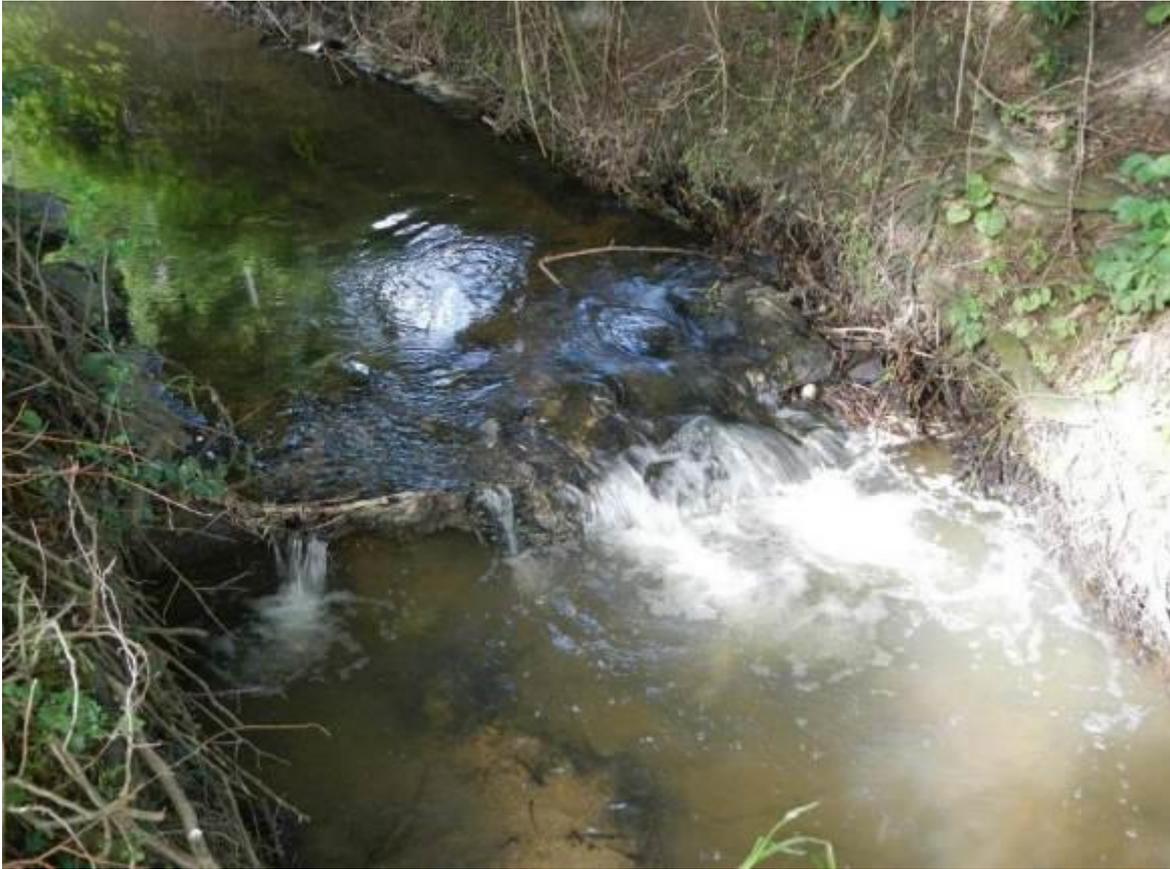
Figure 42. At SP 06477 39508, unsympathetic armouring of the bed at a gas pipe crossing creates an impoundment, obstruction to sediment transport and small obstacle to fish.

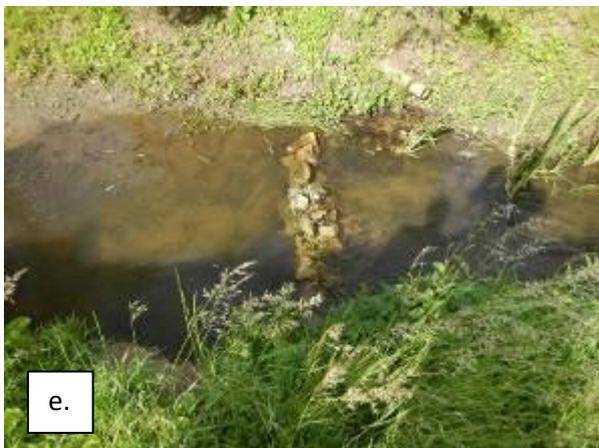
Figure 46a-f. Six small weirs d/s of Murcot Mill (at, SP 06334 40098, SP 06327 40126, SP 06305 40161, SP 06292 40208, SP 06286 40223 and SP 06274 40246, respectively) create minor, passable obstructions, but greatly degrade the habitat quality in the area and, although small, interrupt sediment transport/natural geomorphological processes.

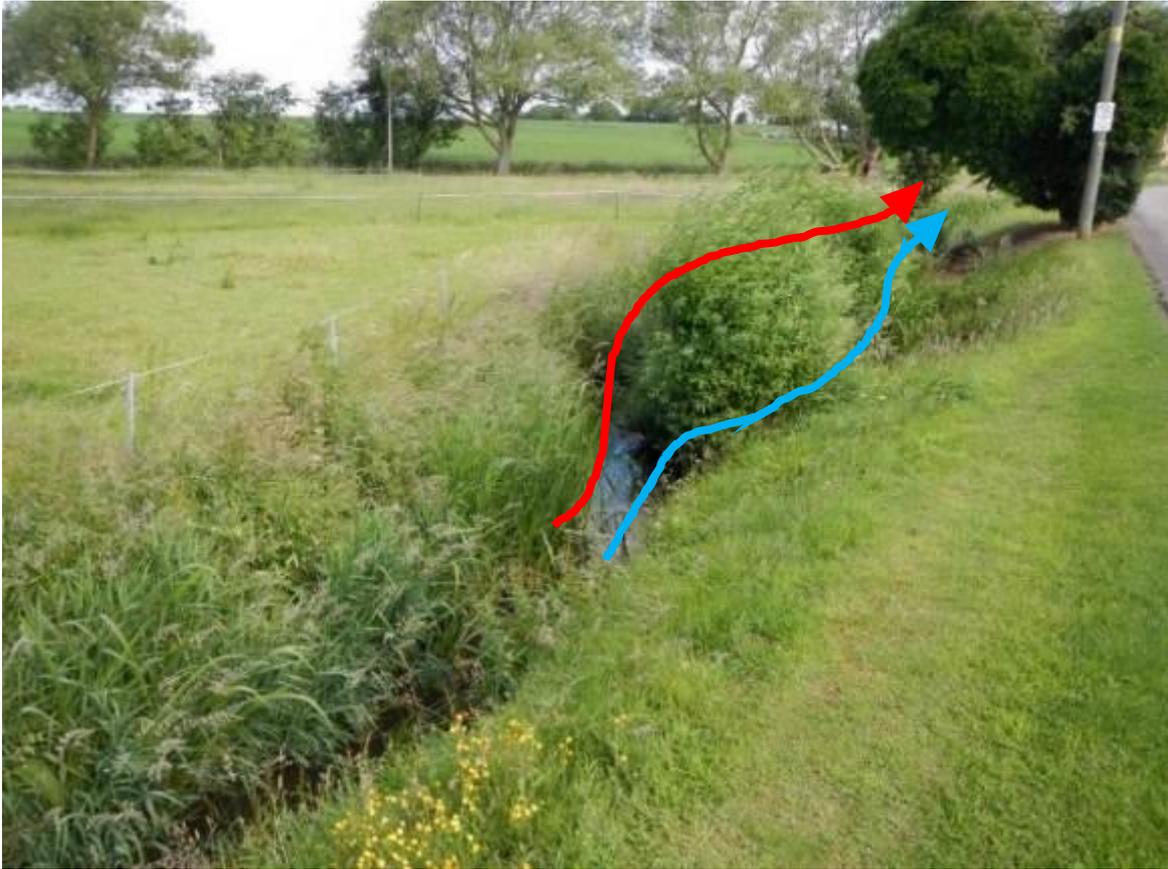
Figure 49. The channel does appear to be naturally adjusting here, but is being artificially maintained, as evident by a side channel that has been dug through an area of slumped bank/deposition that that was pushing the channel towards the road, which has now created a small island.

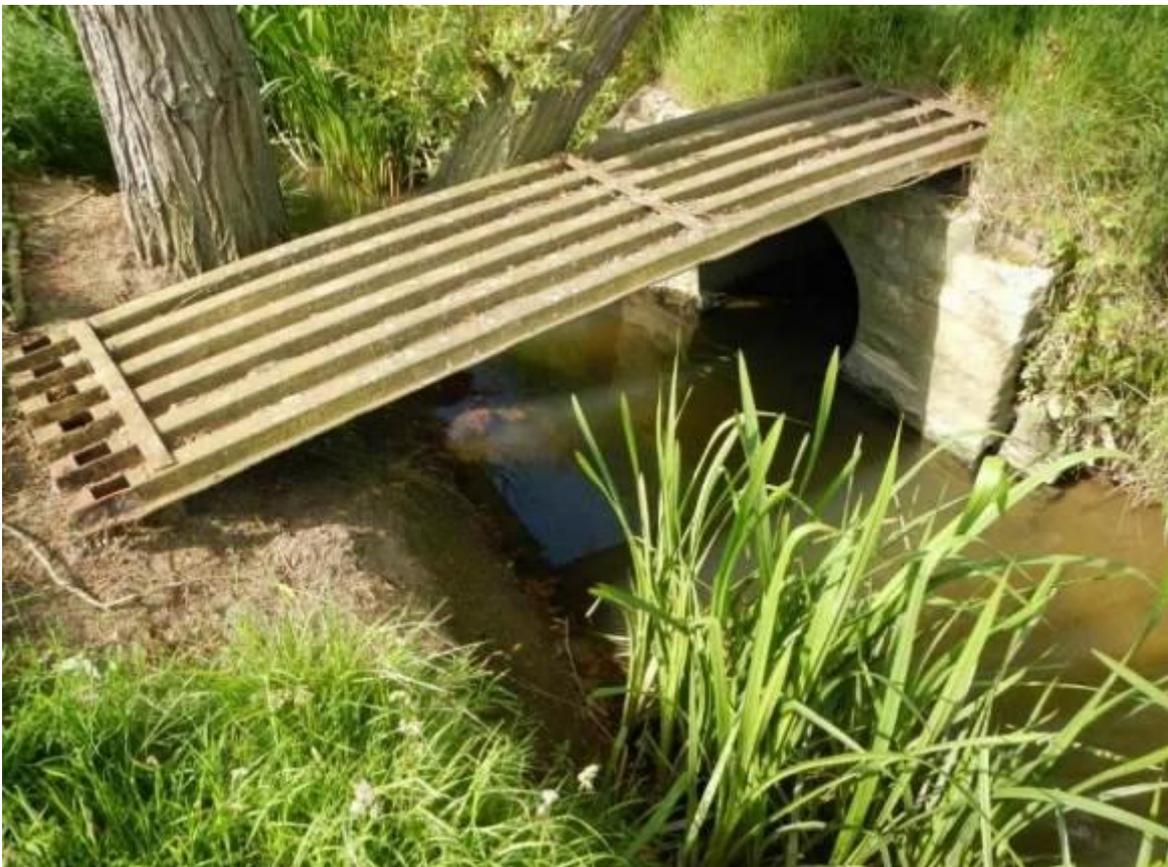
Figure 50. A small ditch joins the brook via a large pipe culvert at SP 06238 40395, but was almost dry on the day of inspection.
