Walkover Assessment
Badsey Brook (Warwickshire Avon) catchment
14-15/06/2017

Undertaken by Gareth Pedley

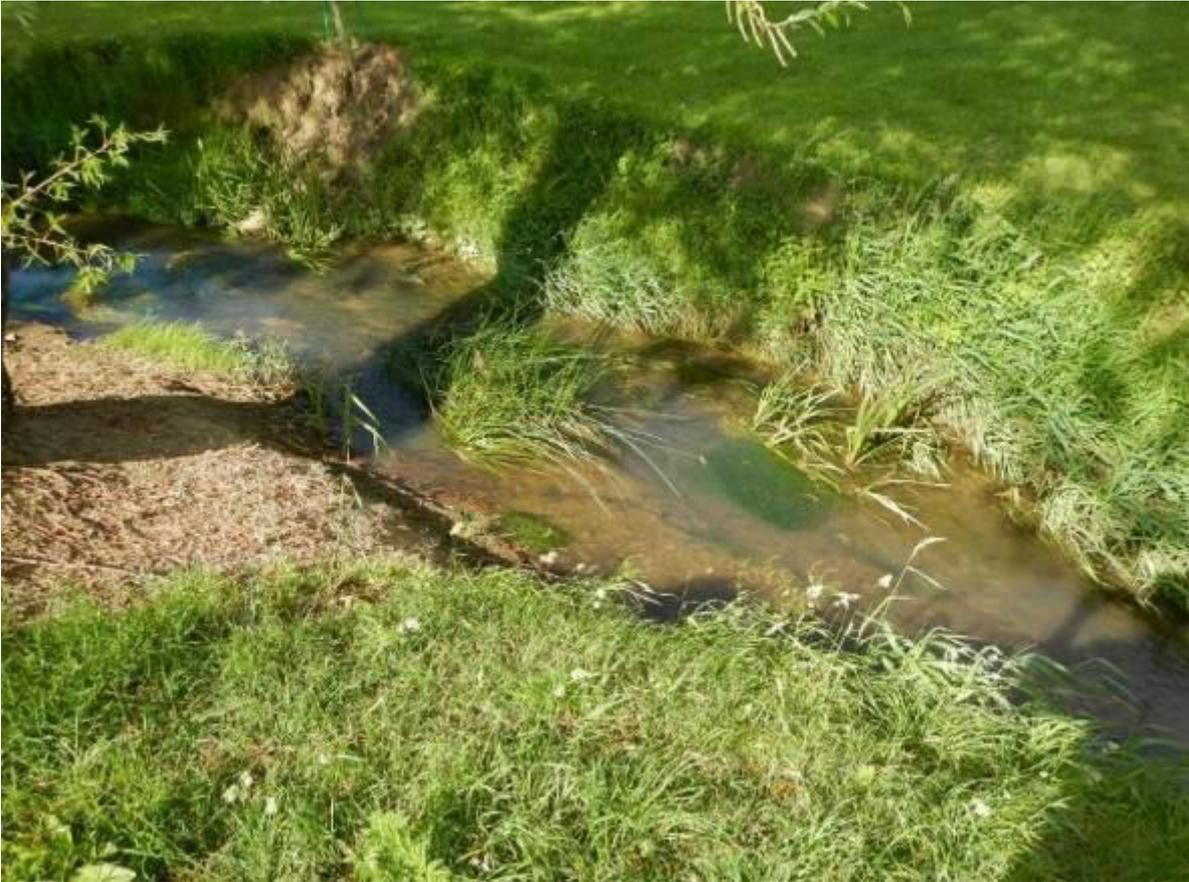
Figure 53. Further examples of emergent and aquatic vegetation taking advantage of inappropriately maintained channel sections and encroaching in to the excess capacity channel.

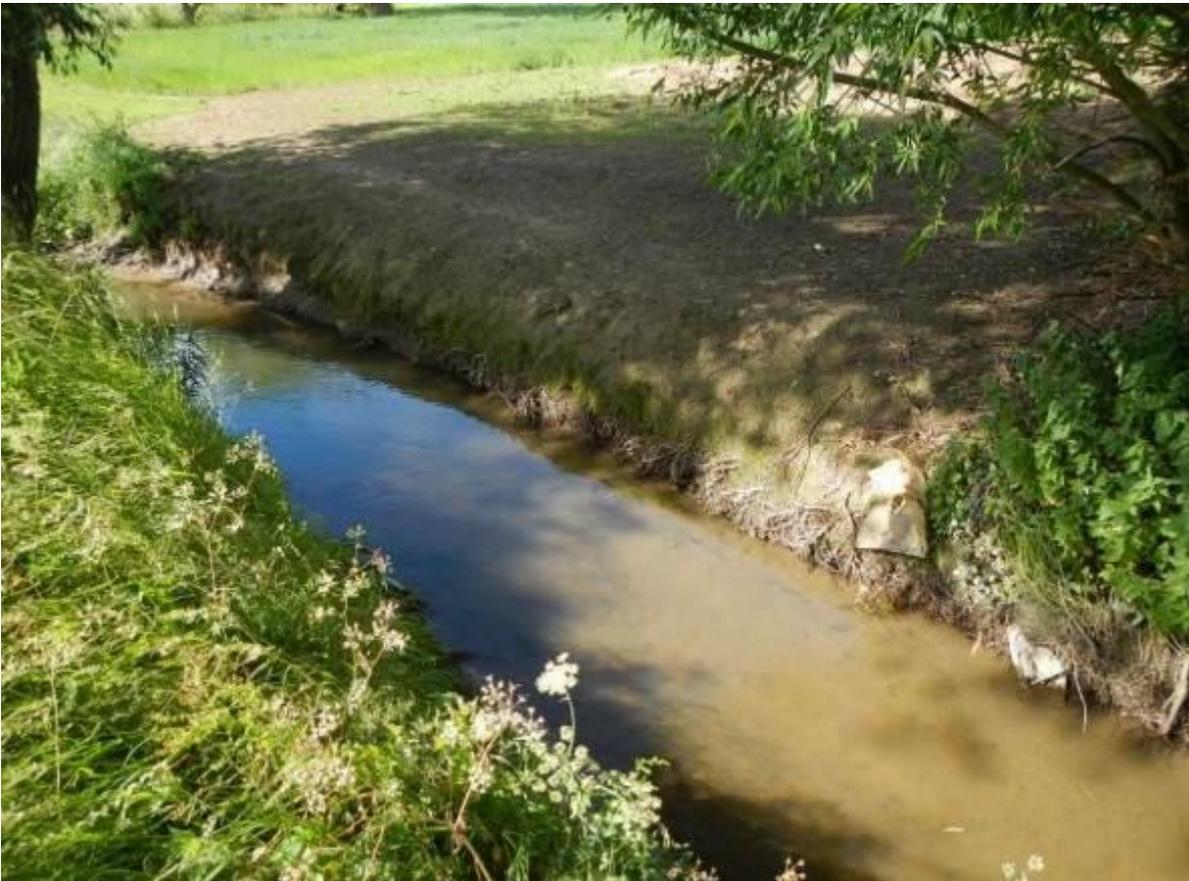
Figure 54. More recent channel maintenance and suspected herbicide spraying along the banks (SP 06266 40622).

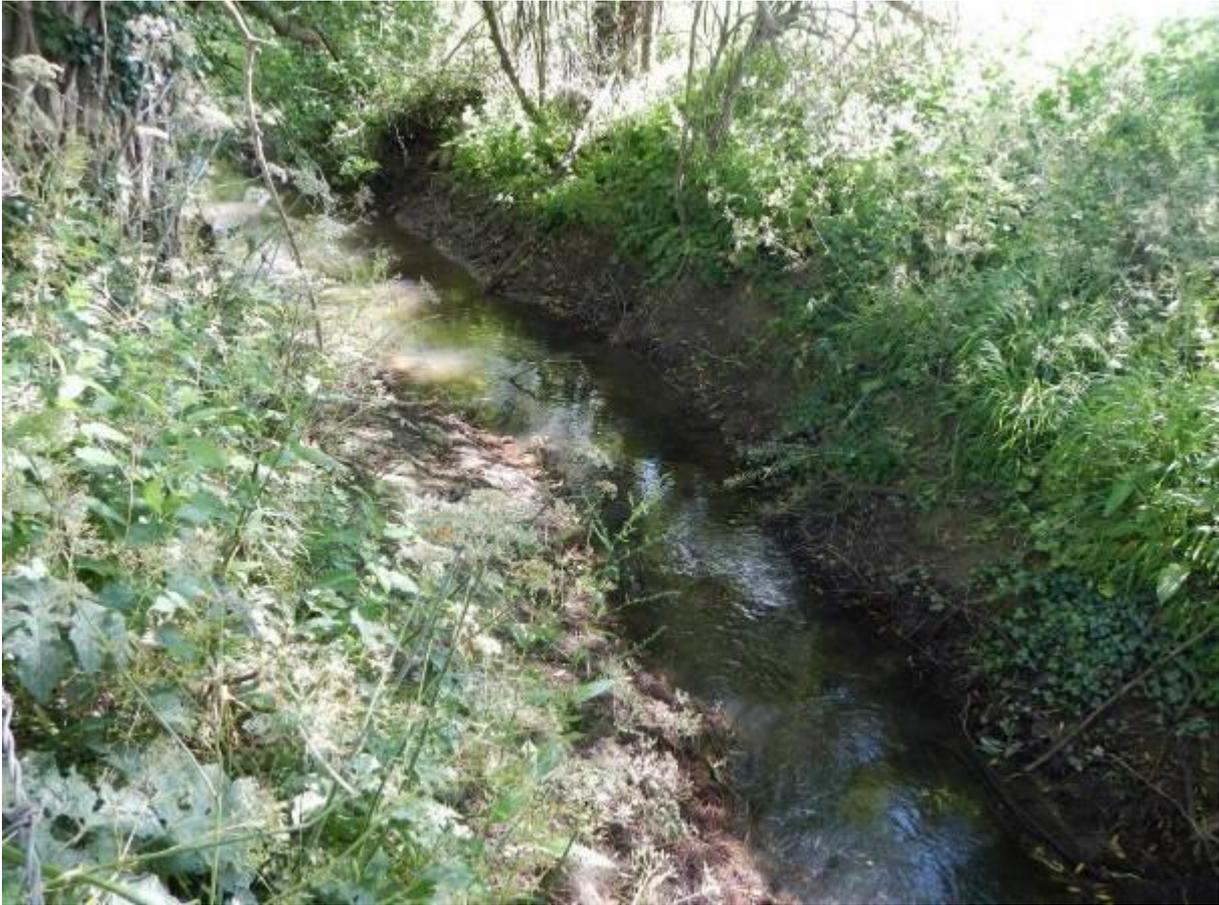
Figure 55. Moving d/s, the river regains a small deciduous tree buffer but the impact of previous dredging activity creates very poor quality habitat.

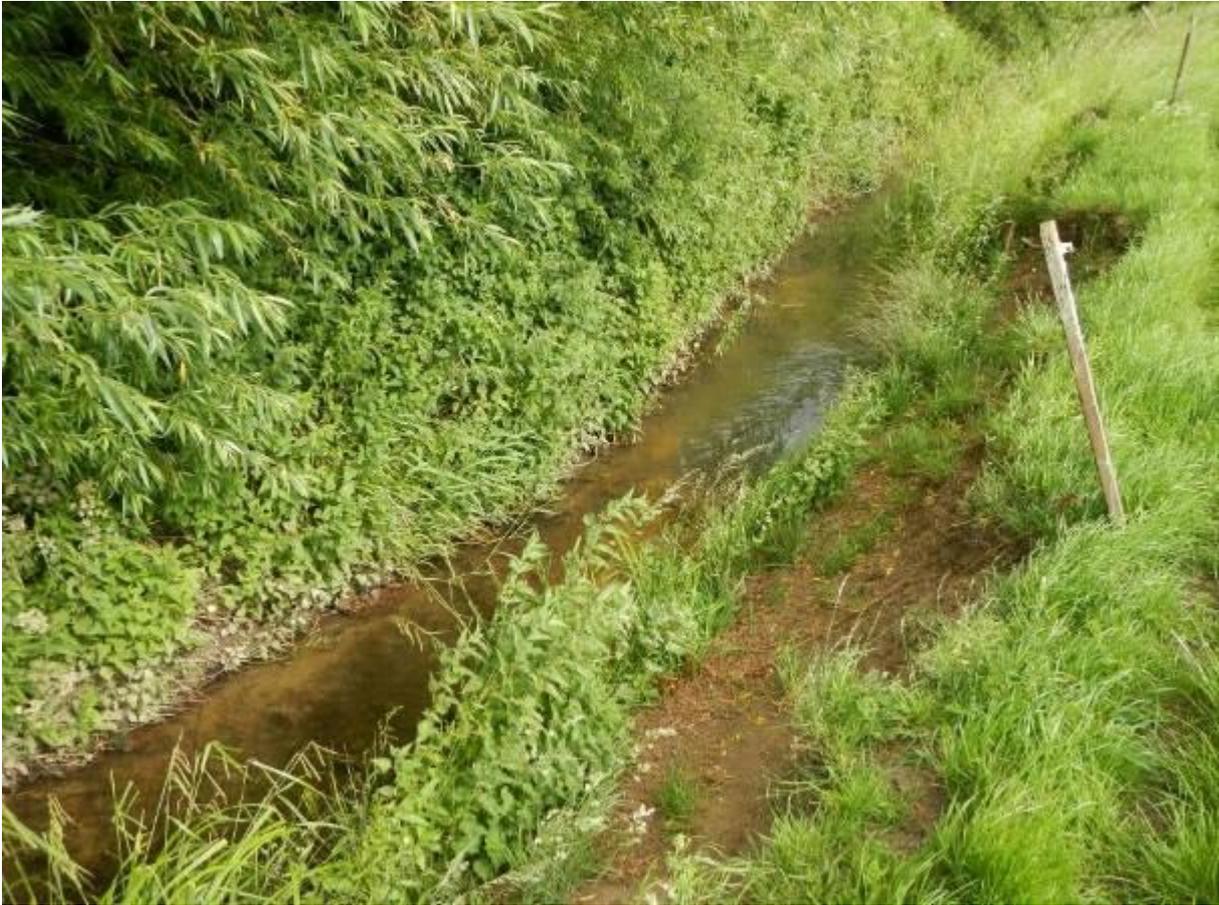
Figure 56. The section u/s of Mill House Farm remains straightened and poor quality habitat, becoming impounded towards the mill weir. Livestock also have access on the RB.

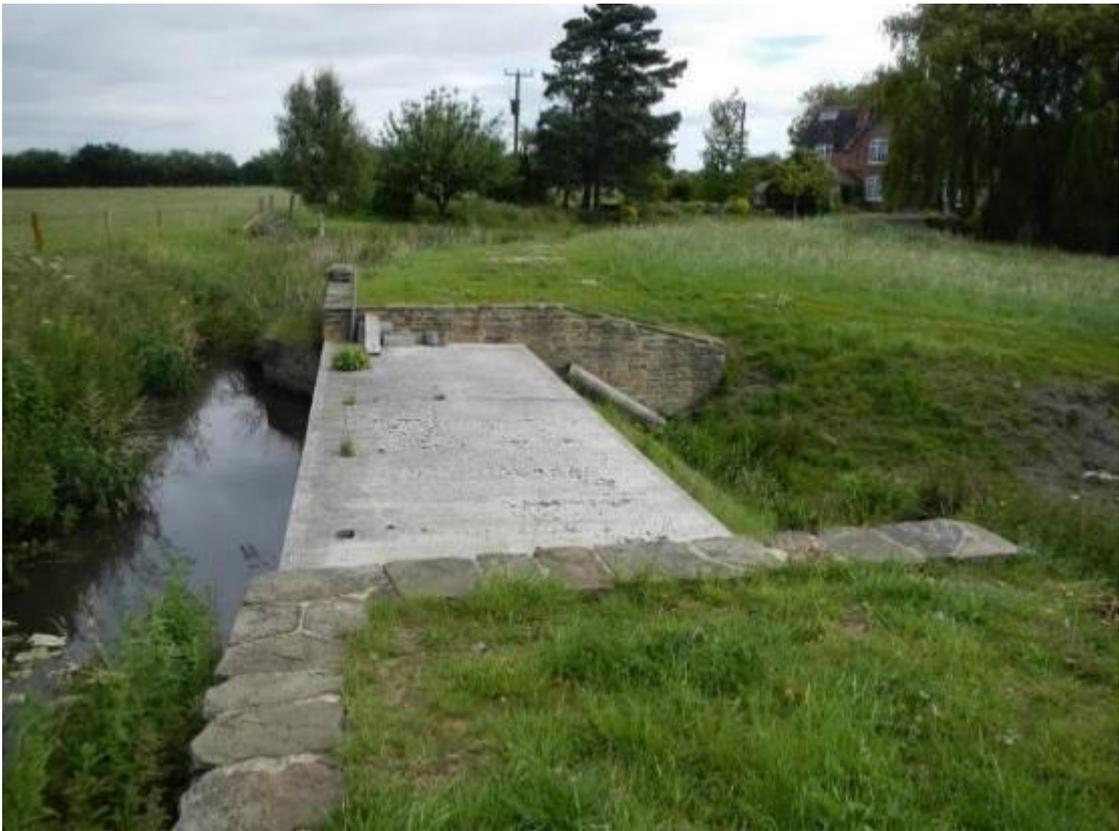
Figure 57. Mill House Farm weir (SP 06381 41089) is a renovated structure with a sluice (and overspill) that currently takes most of the flow (Fig. 58), but is designed to control water to the mill, which can then either flow through a second sluice/spillway (Fig. 59) or through the mill (Fig. 60).

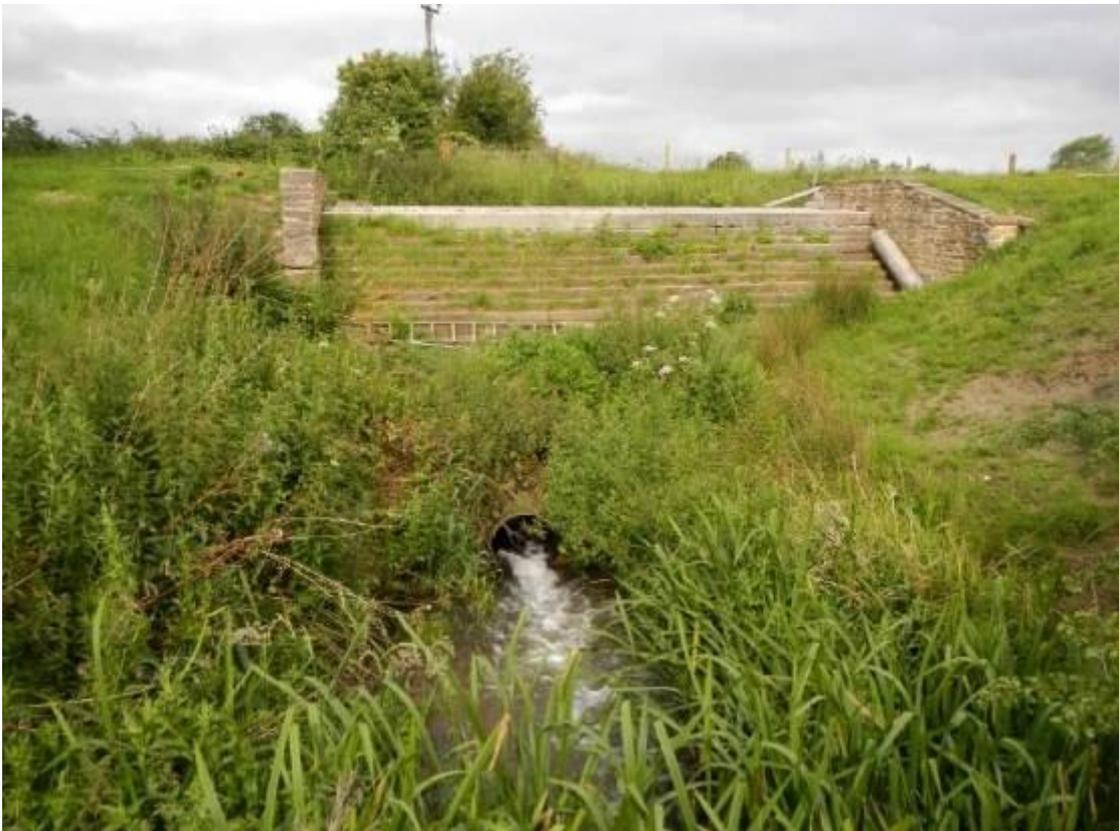
Figure 58. On the day of the visit, almost all of the brook's flow was bypassing the overspill weir, via a sluice. While the sluice is at an accessible height for fish, the head of water above the pipe (>3m) and associated high velocities within the pipe will render it impassable to fish. Even with flow over-spilling the weir it would be completely impassable.

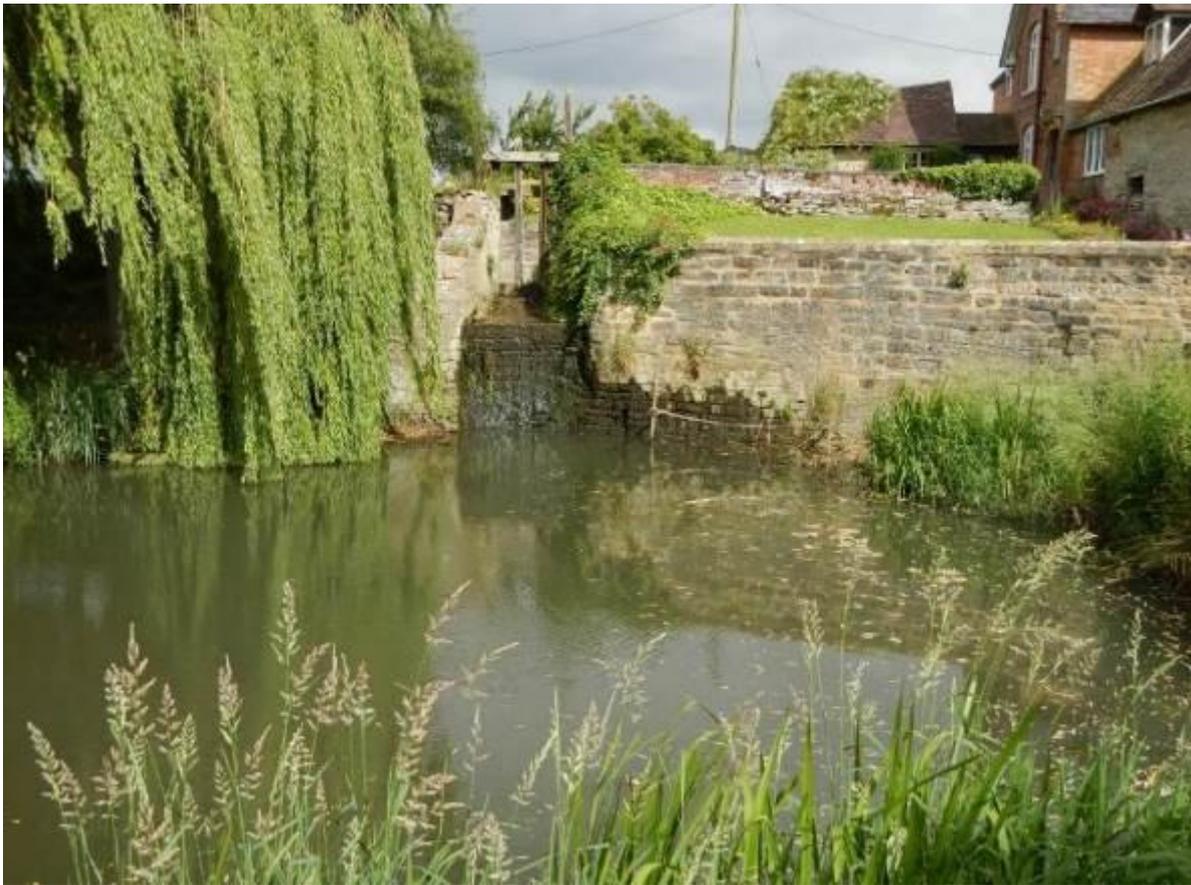
Figure 59. A second spillway, just u/s of the mill, is also completely impassable to fish and was receiving no flow at the time of the visit.

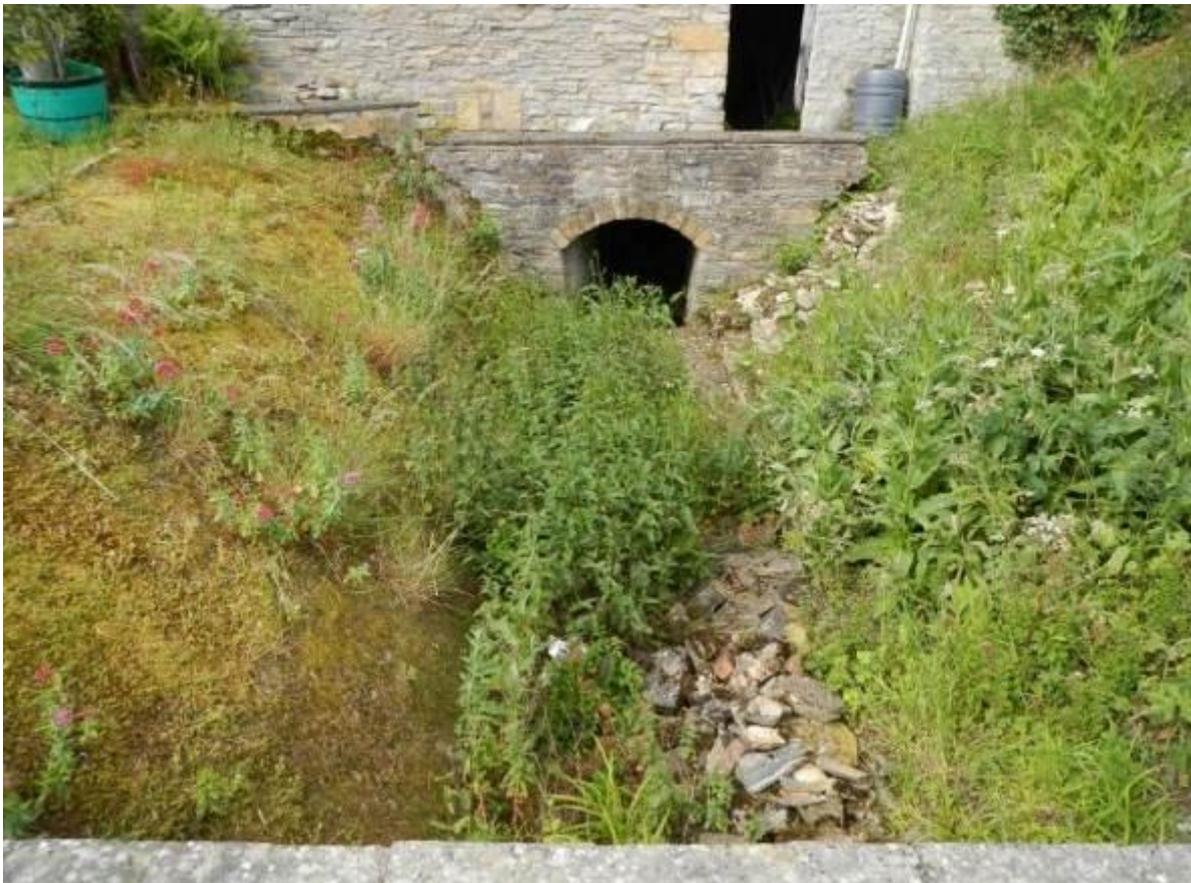
Figure 60. The channel beneath the mill was dry. The weir and infrastructure associated with Mill House Farm creates another complete obstruction to fish and sediment movement and again, disconnects habitats u/s and d/s.

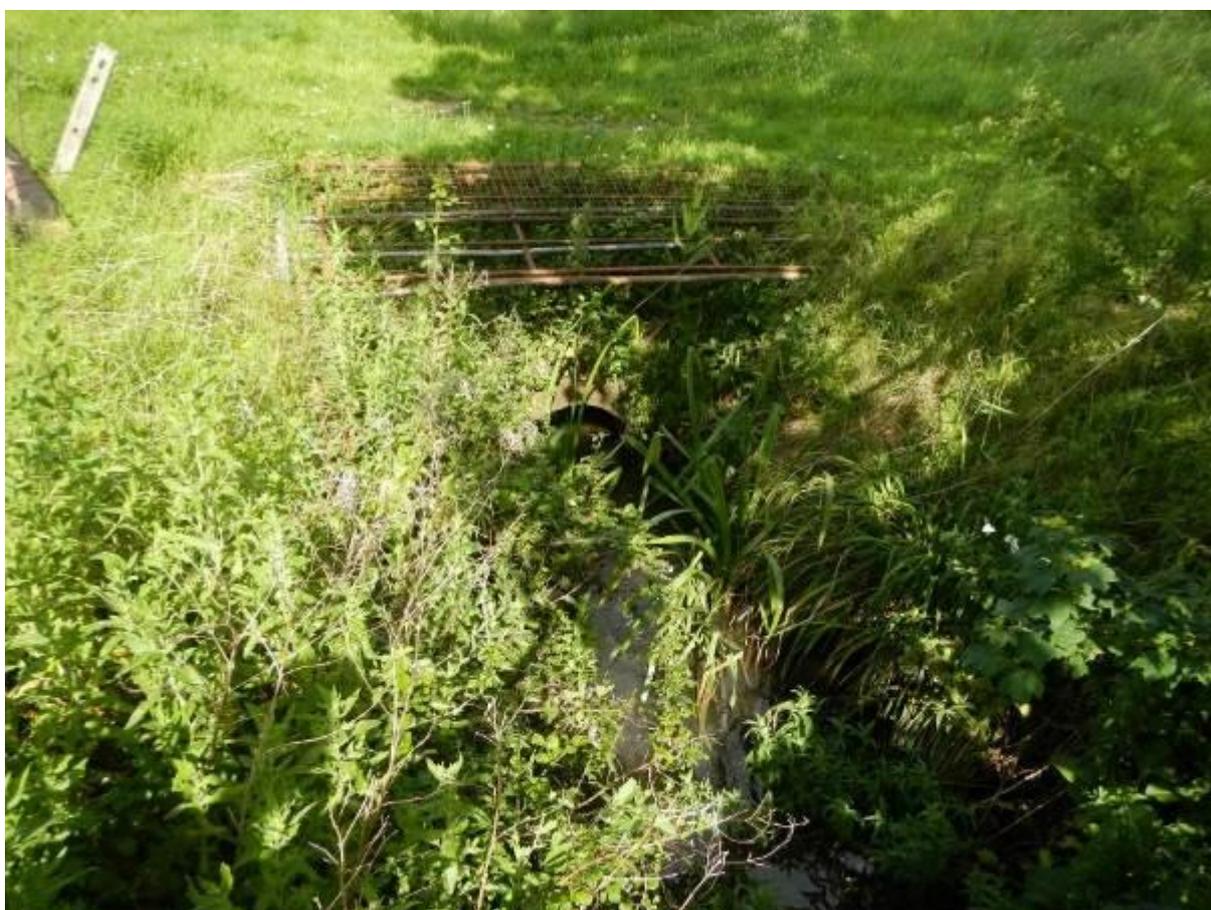
Figure 62. At SP 06399 41085, a crossing of the main channel d/s of the weir poses no issues for fish or sediment movement.

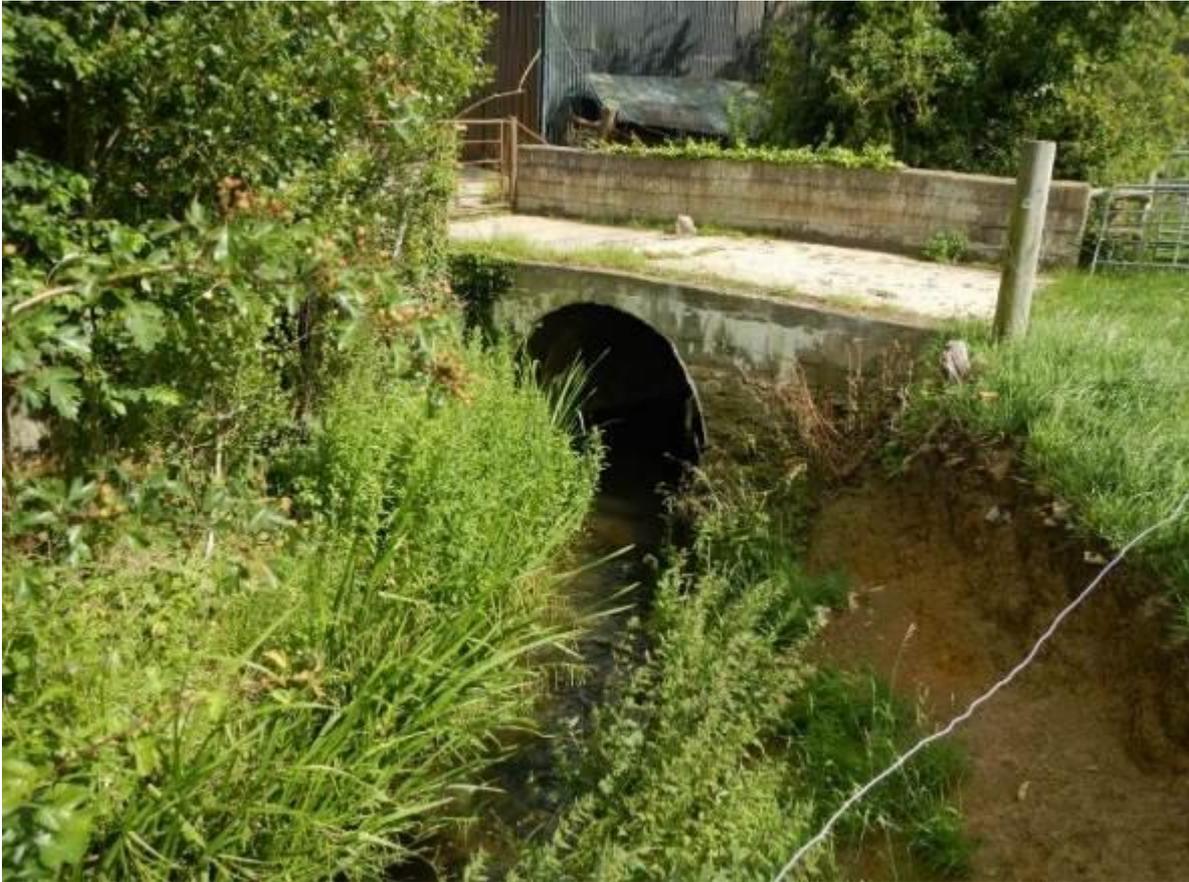
Figure 63. Crossing at SP 06472 41113 poses no issues for fish or sediment movement.

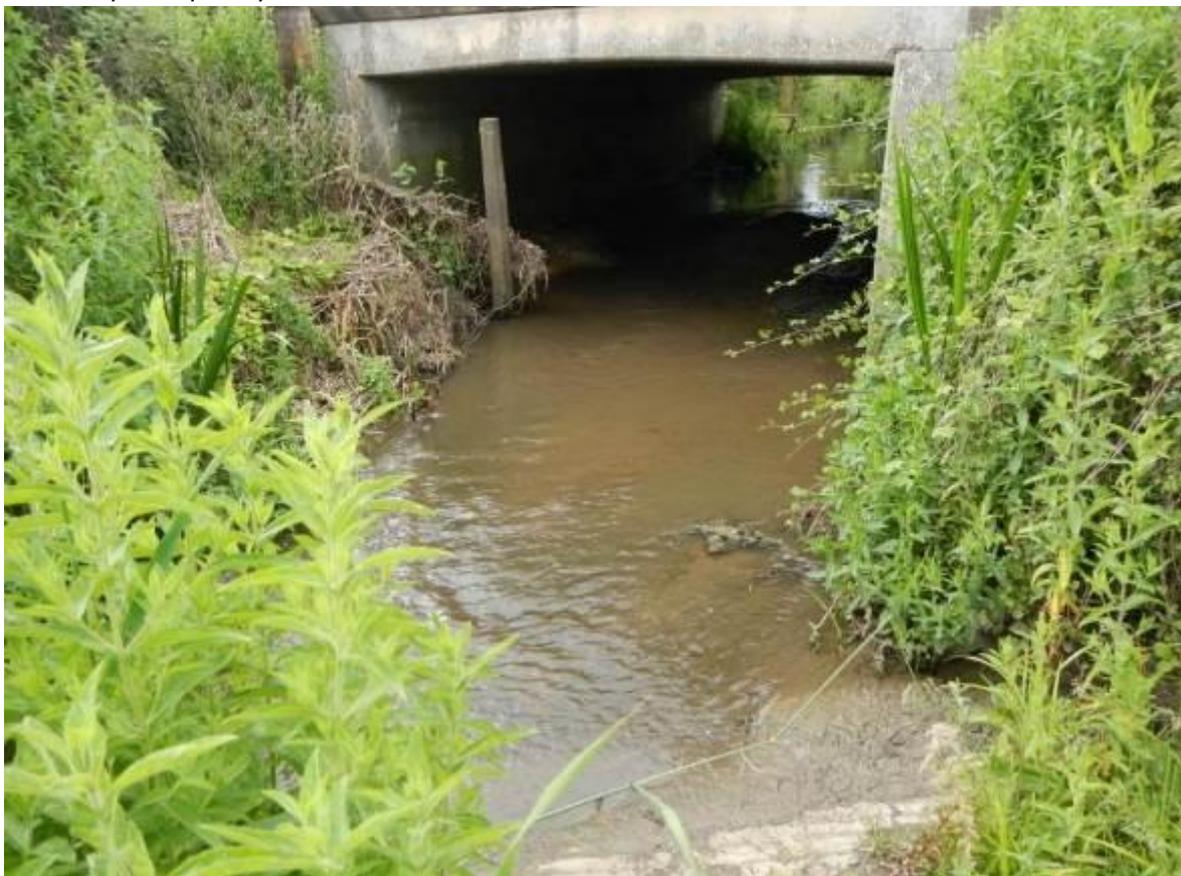
Figure 66. The A44 road bridge culvert (SP 06550 41356) has been built greatly over-capacity to double as an access ford. This creates a shallow-water channel and has encouraged fine sediment deposition across the bed but the structure poses no significant issues or fish or sediment movement.

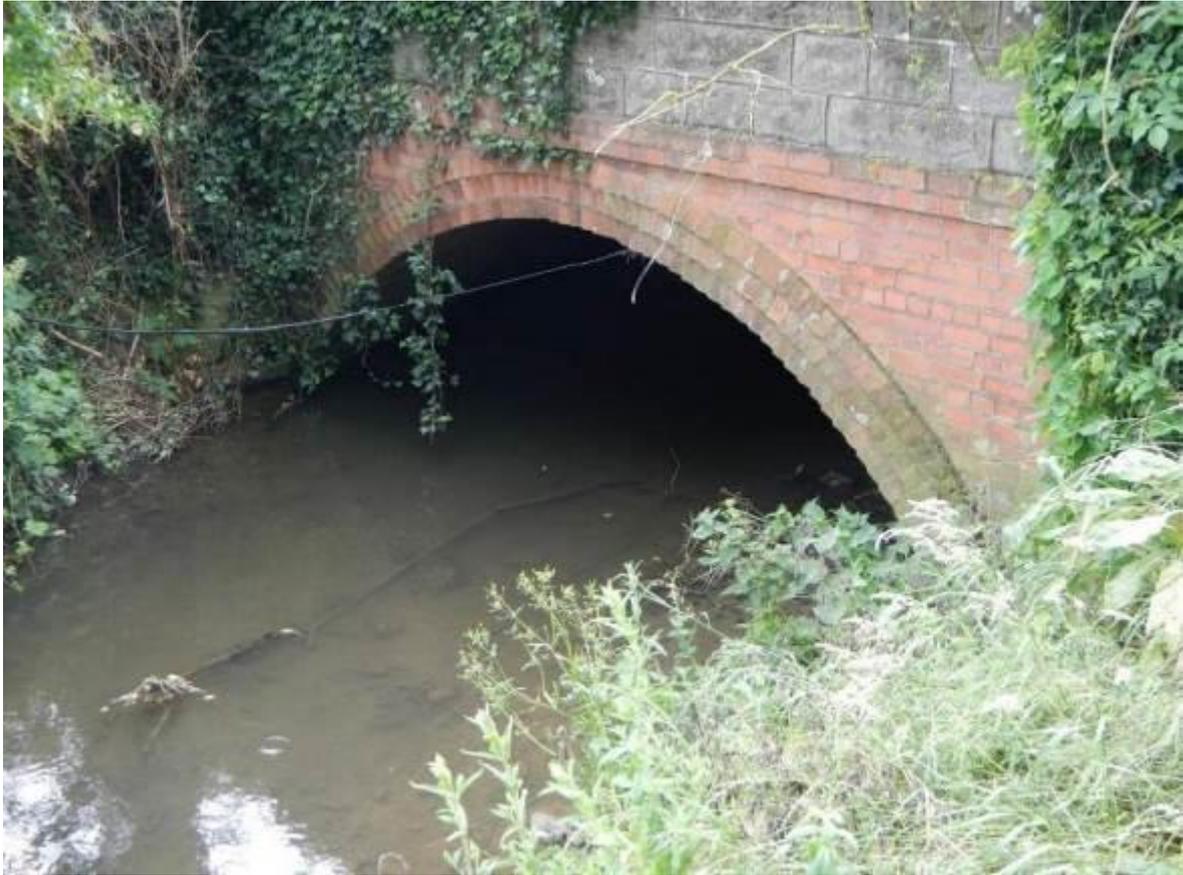
Figure 67. At SP 06529 41468, Longdon Hill road crossing is also of ample capacity and supports natural substrate throughout, posing no issues for fish passage.

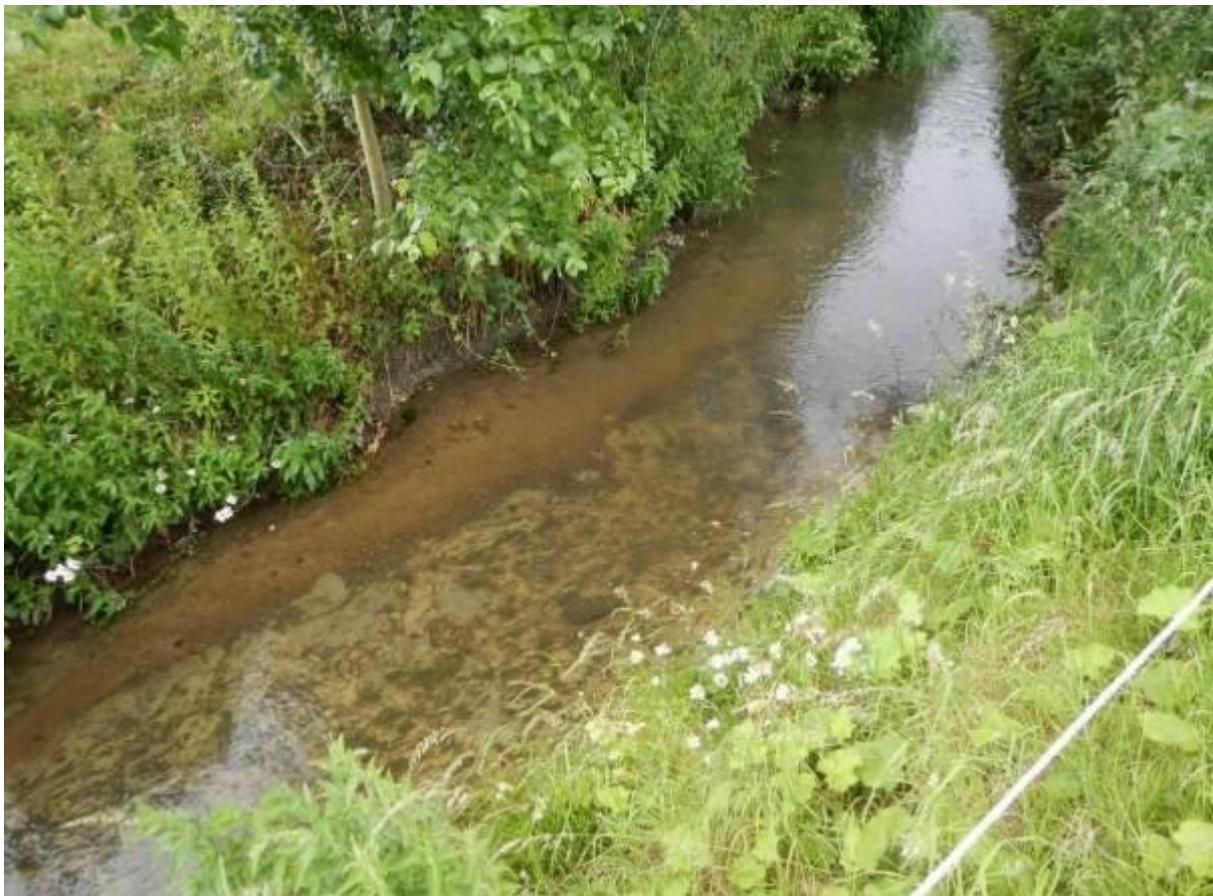
Figure 68. Past channel realignment/dredging has clearly been conducted d/s of Longdon Hill road, as evident by exposed boulder clay in the bed and a lack of coarse substrate.

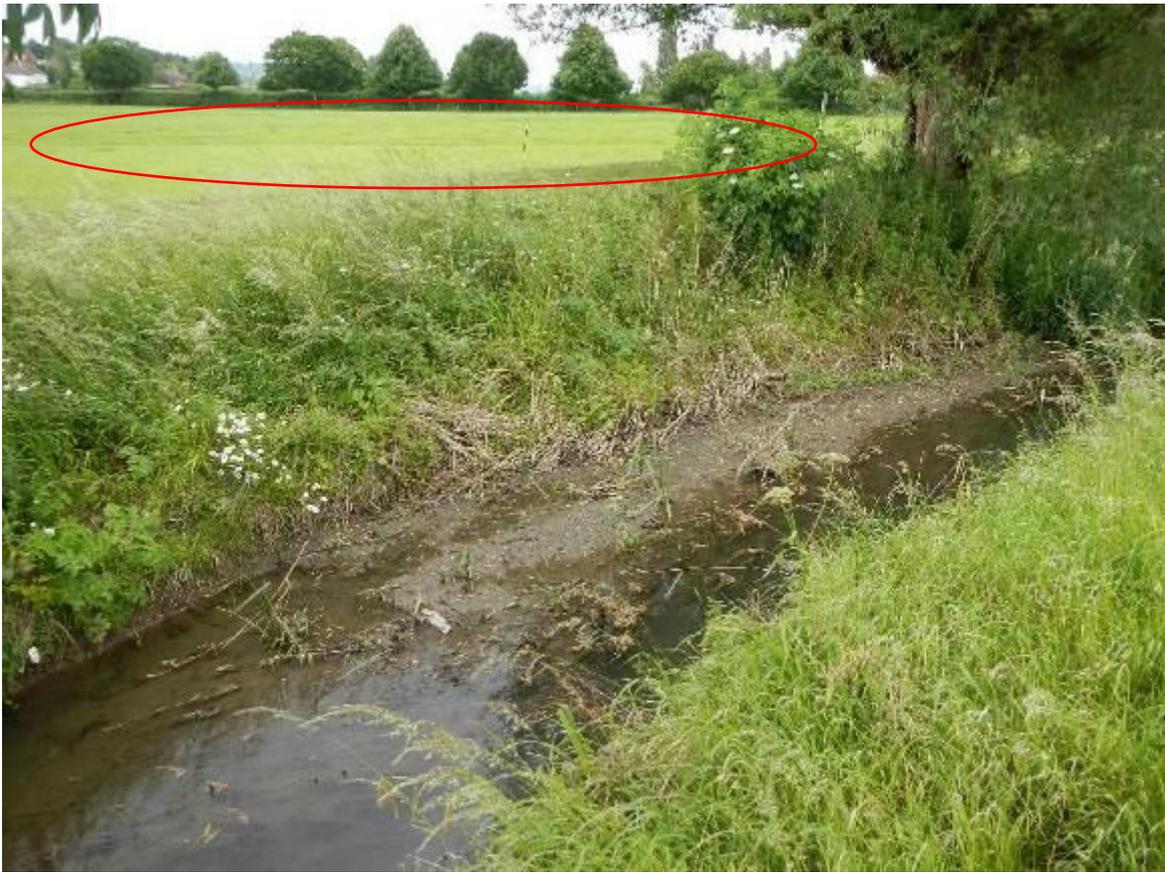
Figure 69. The canal-like, straightened channel d/s, provides poor quality trout habitat, better suited to coarse fish. The excess capacity of the channel is clearly unable to self-maintain its dimensions and is becoming choked with vegetation and fine sediment. Suspected paleo-channels were evident in the floodplain around this location (red ellipse).

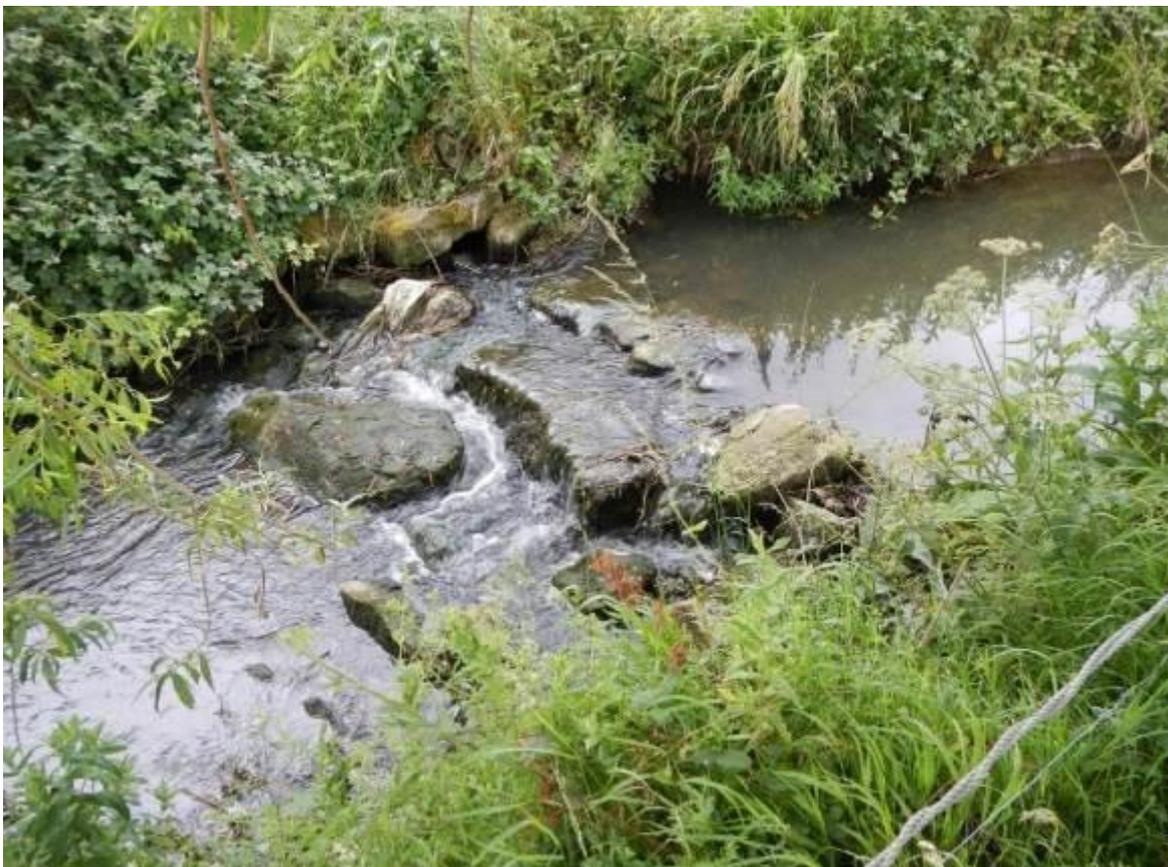
Figure 70. At Whickham Farm, an armoured bed section/possible pipe crossing at SP 06587 41687 poses a small obstacle to fish and sediment movement.

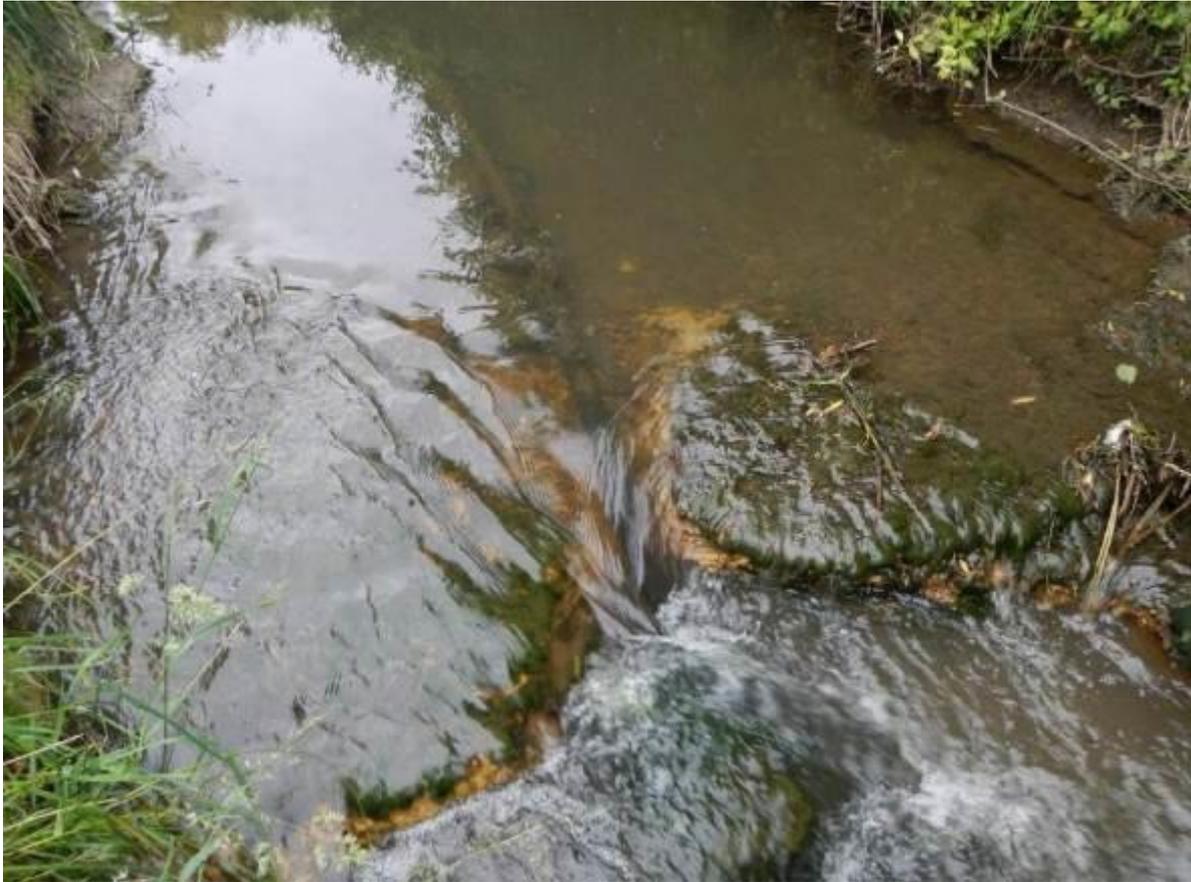
Figure 71. Another structure a few metres d/s (SP 06584 41695) also creates a small obstruction and appeared to be associated with a pipe (centre of shot).

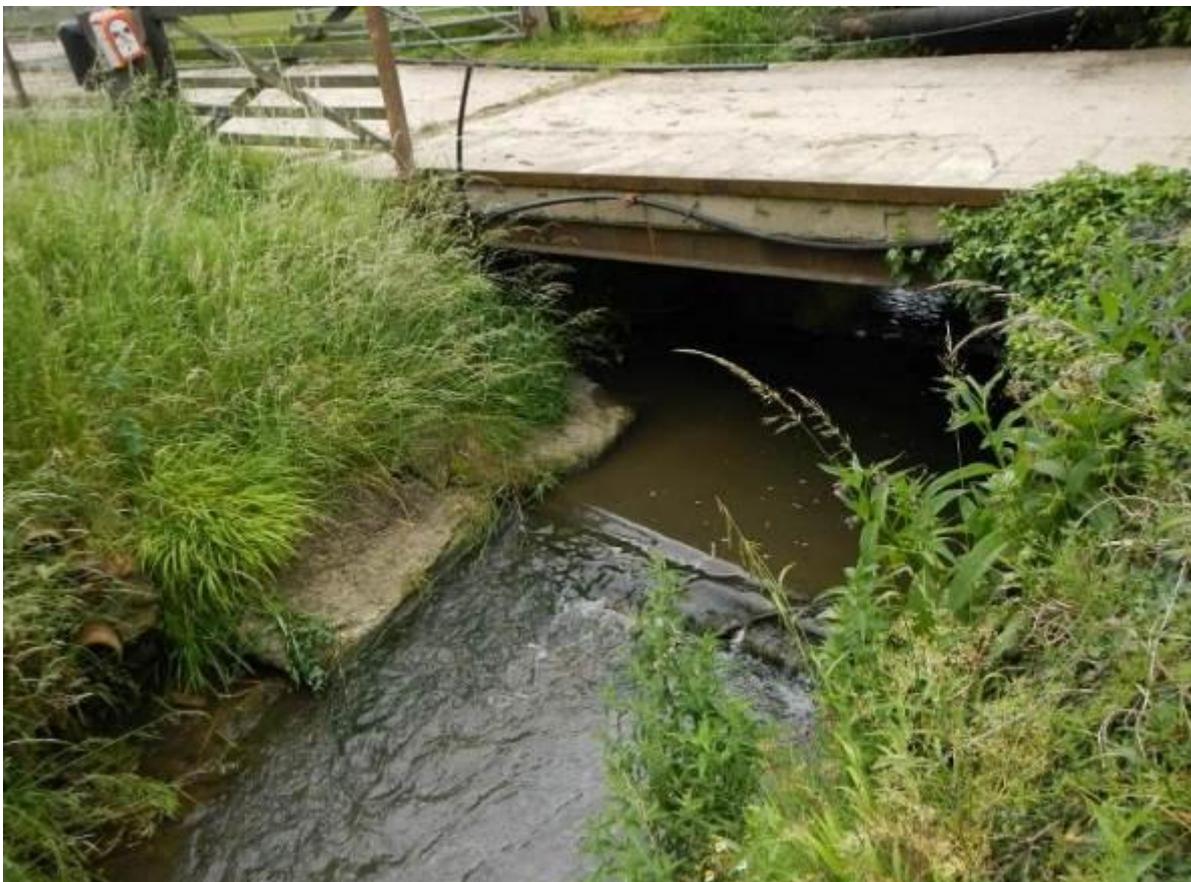
Figure 72. The deck of the farm access track (SP 06587 41708) poses no issues but the inappropriately installed structure with armoured bed and associated step create a small and unnecessary issue for fish and sediment movement.

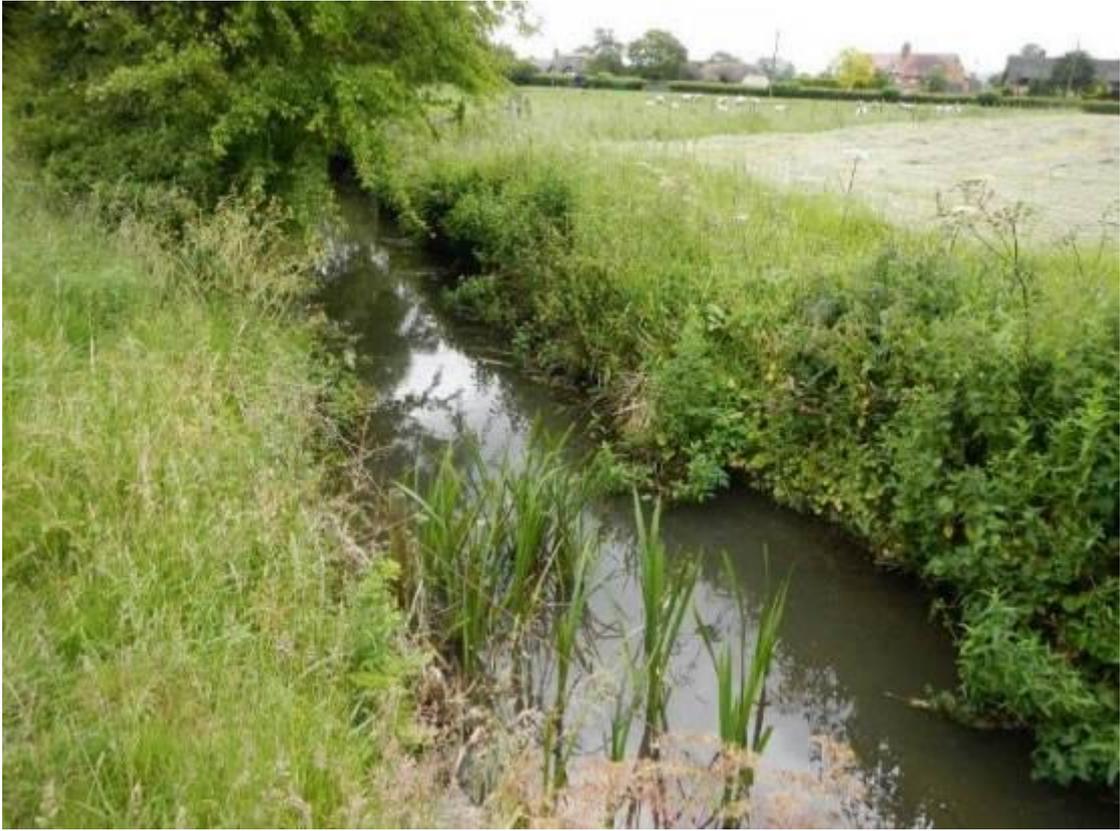
Figure 75. The improved section is, however, very limited, with the channel being dredged, straightened and uniformly over-capacity a short distance d/s. Note the emergent vegetation is more characteristic of canals and stillwaters.

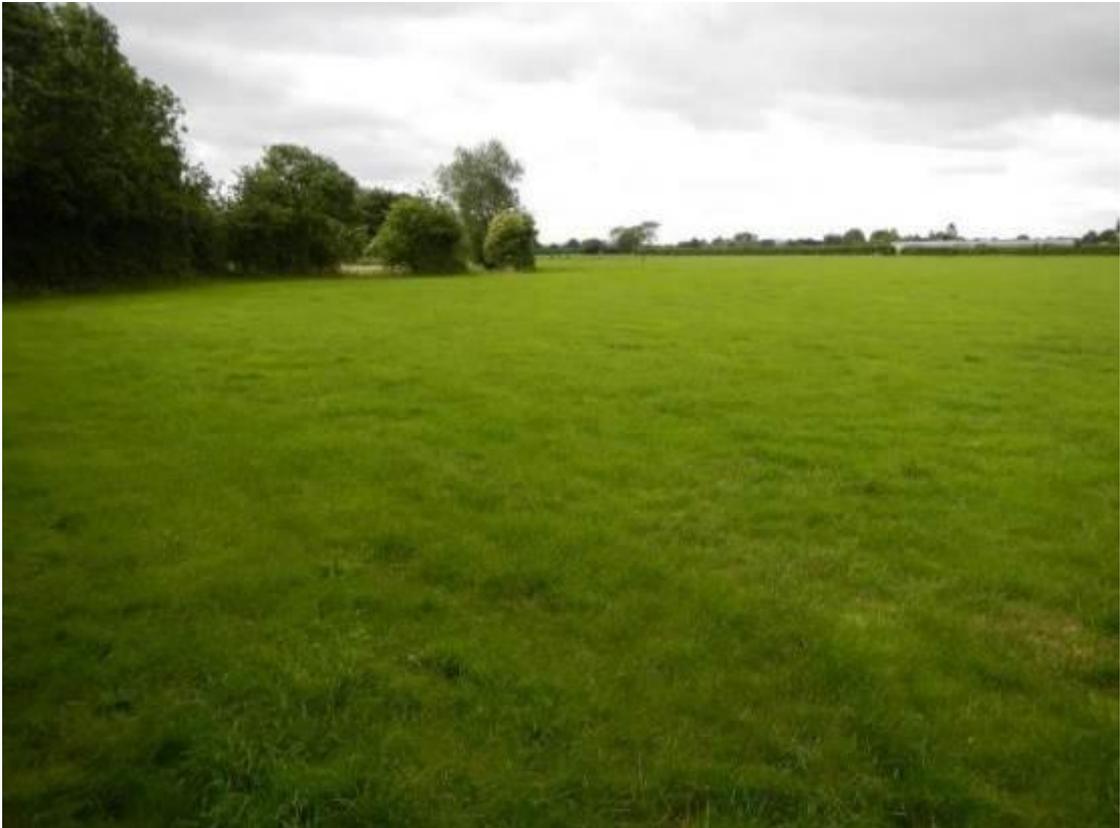
Figure 76. The pasture land at either side of the channel in this area could offer potential for a river restoration scheme if the funding were available e.g. if grazing land would be less impacted by a reinstated meandering channel than arable land use (particularly if the land ownership/tenancy is the same on both banks).

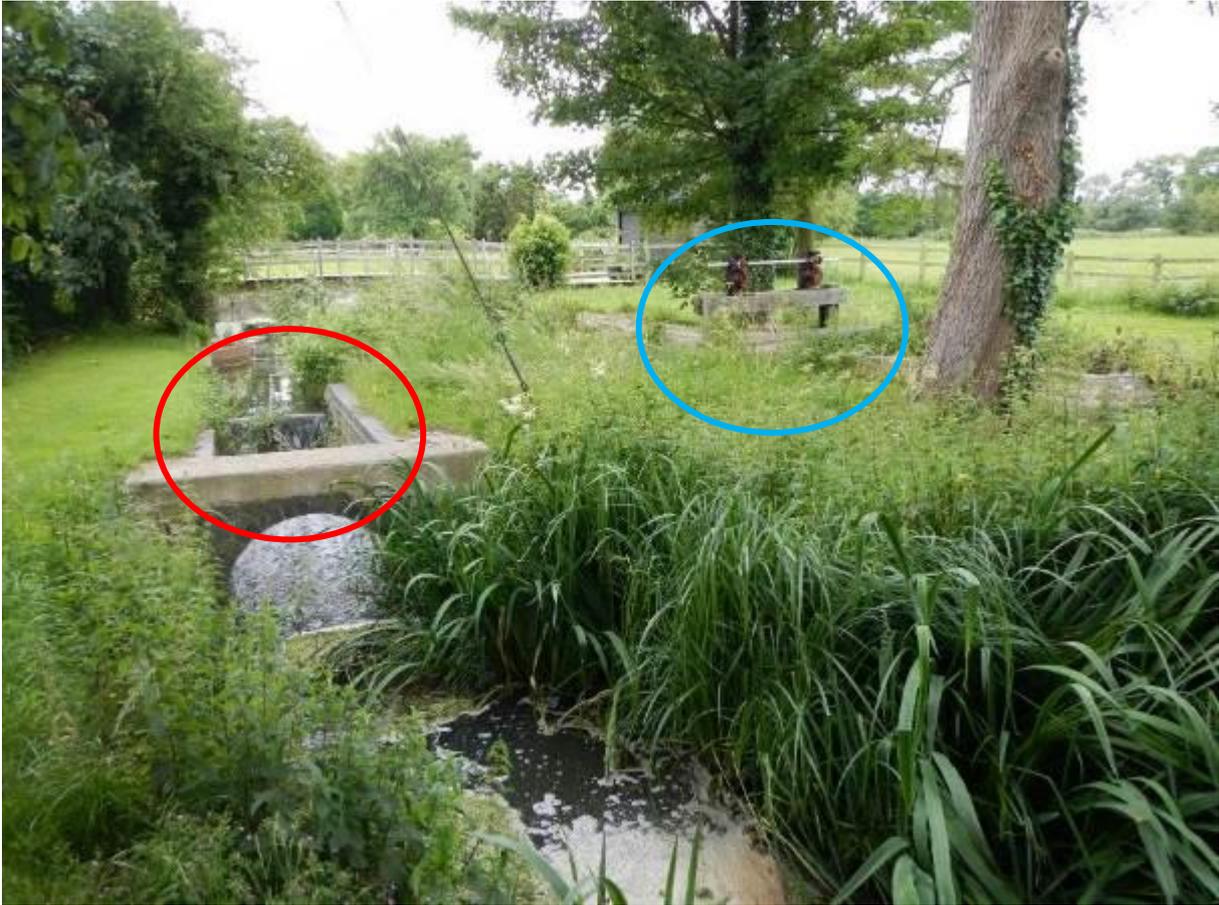
Figure 79. The impoundment is created with sluices on two channels at the d/s end of the pond (red and blue circles, figures 81 & 82, respectively).

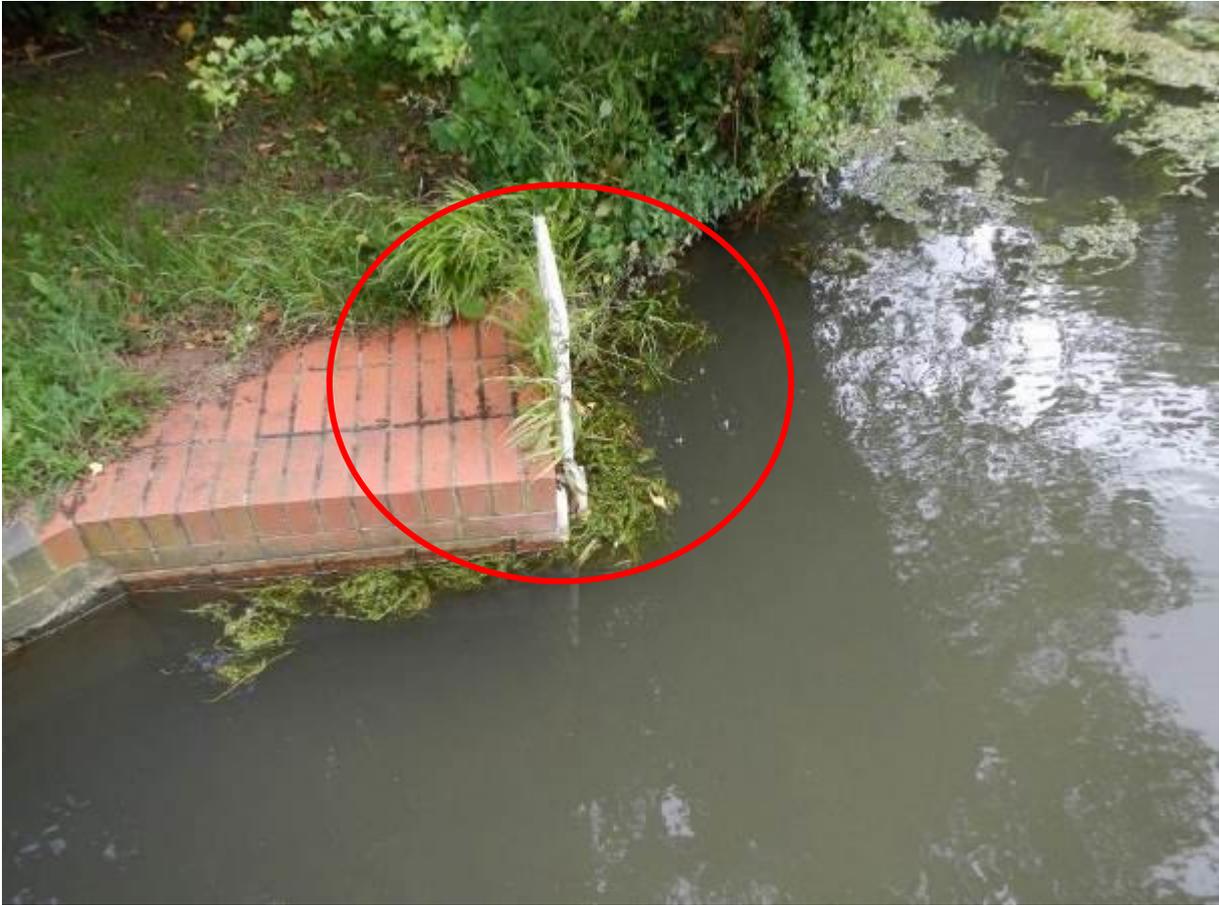
Figure 80. The purpose of the impoundment now appears to be primarily the supply of water to ornamental features within Manor House garden, via a small sluice (red circle).
