Walkover Assessment
Badsey Brook (Warwickshire Avon) catchment
14-15/06/2017

Undertaken by Gareth Pedley

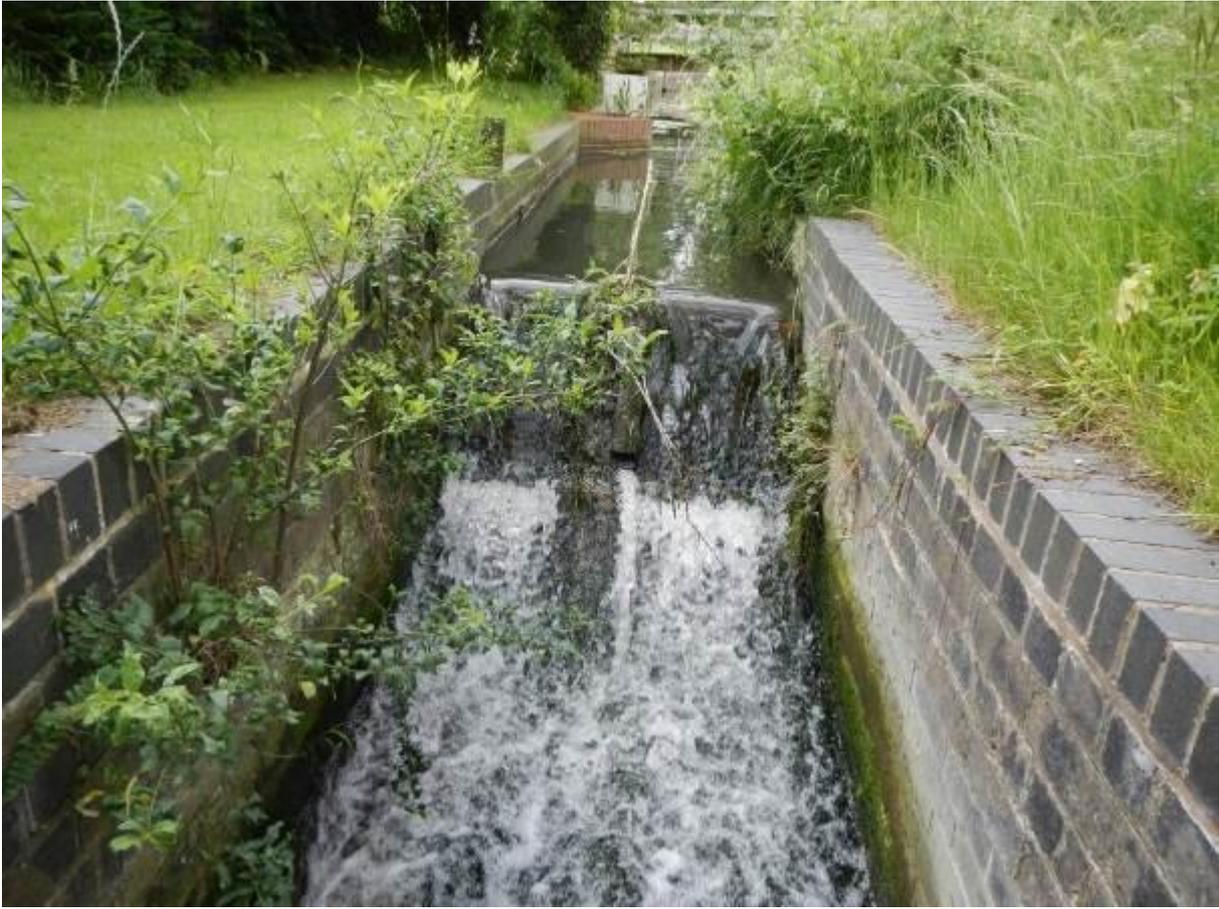
Figure 81. The RB side overspill (SP 06788 42159) – the steep, c. 45° slope, steepening towards the crest, is effectively impassable by fish or sediment.

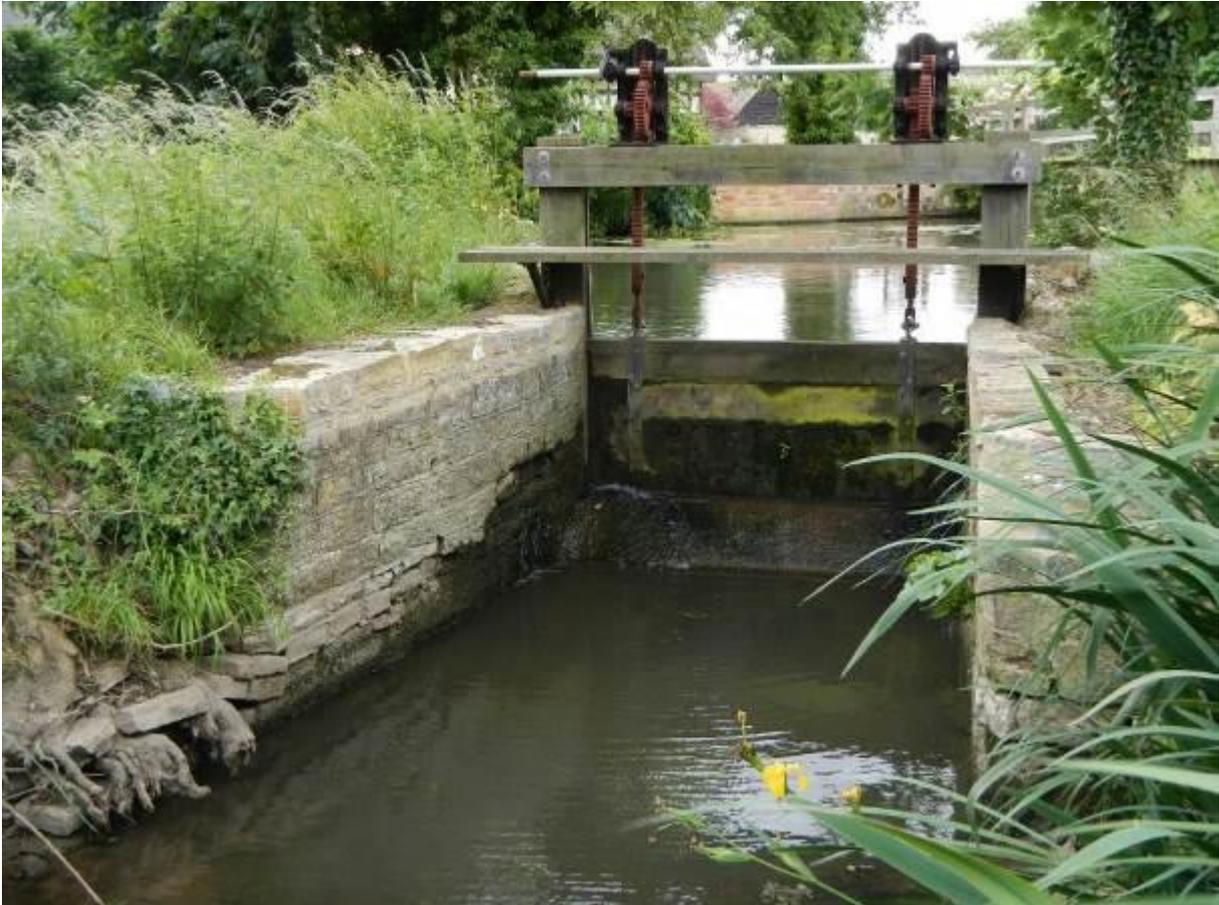
Figure 82. The LB side sluice (SP 06782 42158) – a vertical board sluice, impassable to fish or sediment when shut.

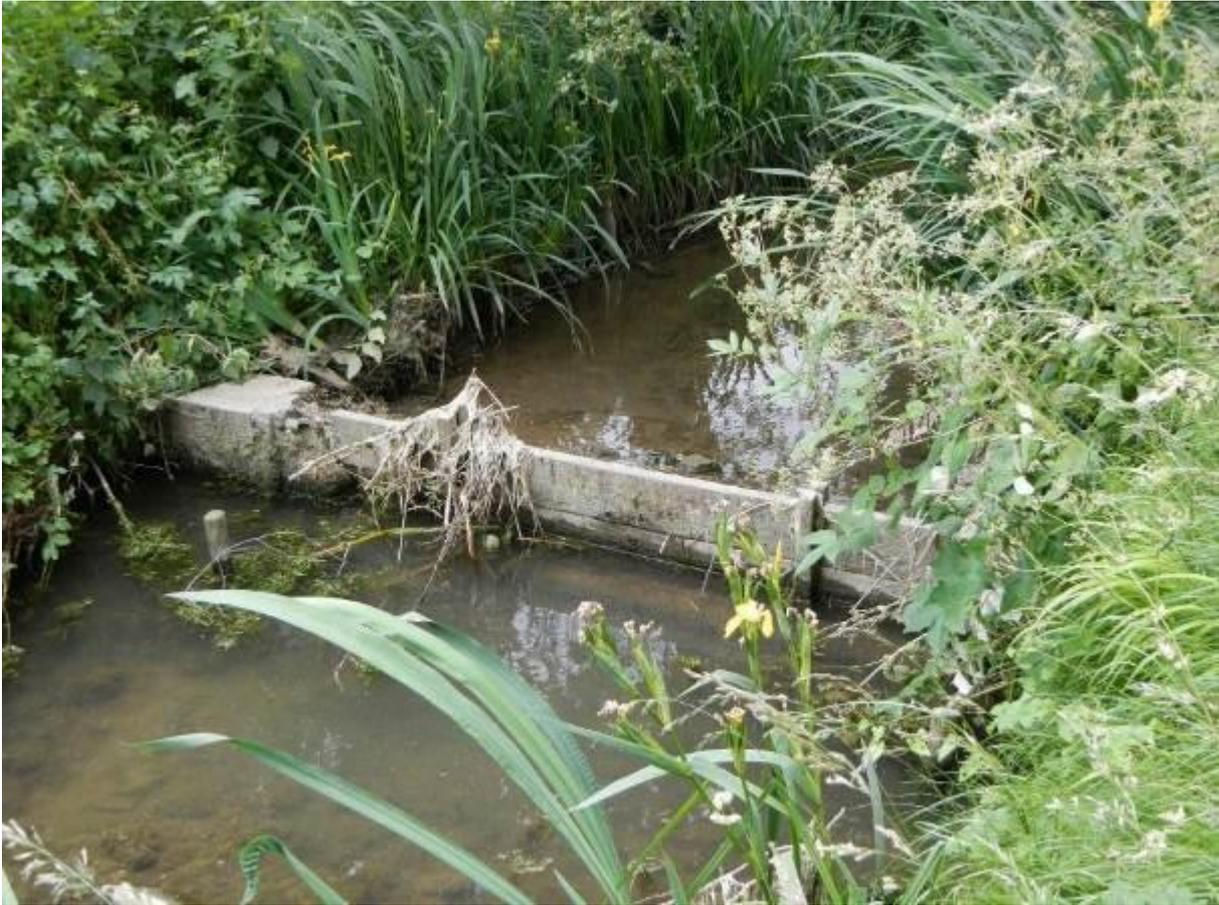
Figure 83. A small board weir in the channel d/s of the sluice (SP 06775 42171) creates an obstruction even if the sluice were open/raised.

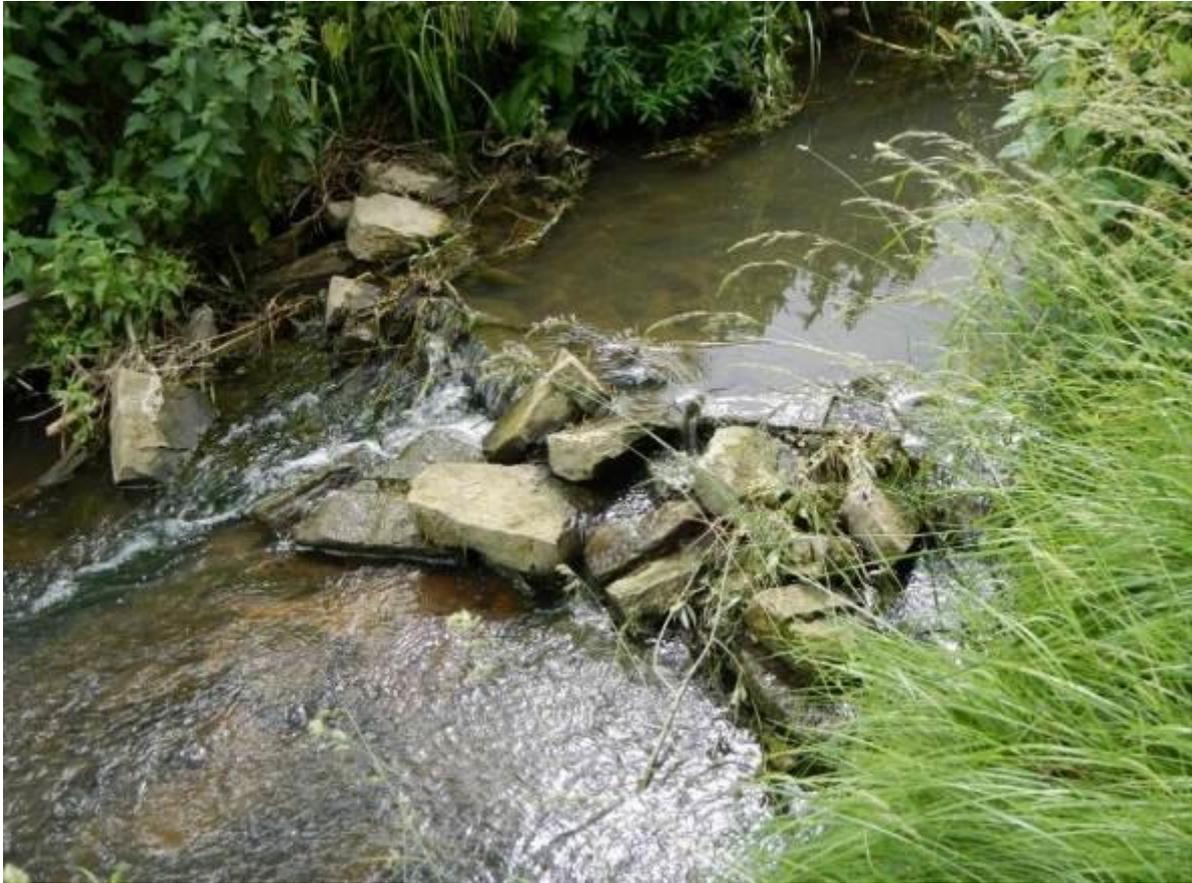
Figure 84. Just d/s of the board weir, a crudely constructed stone weir (SP 06761 42189) also creates yet another obstacle.

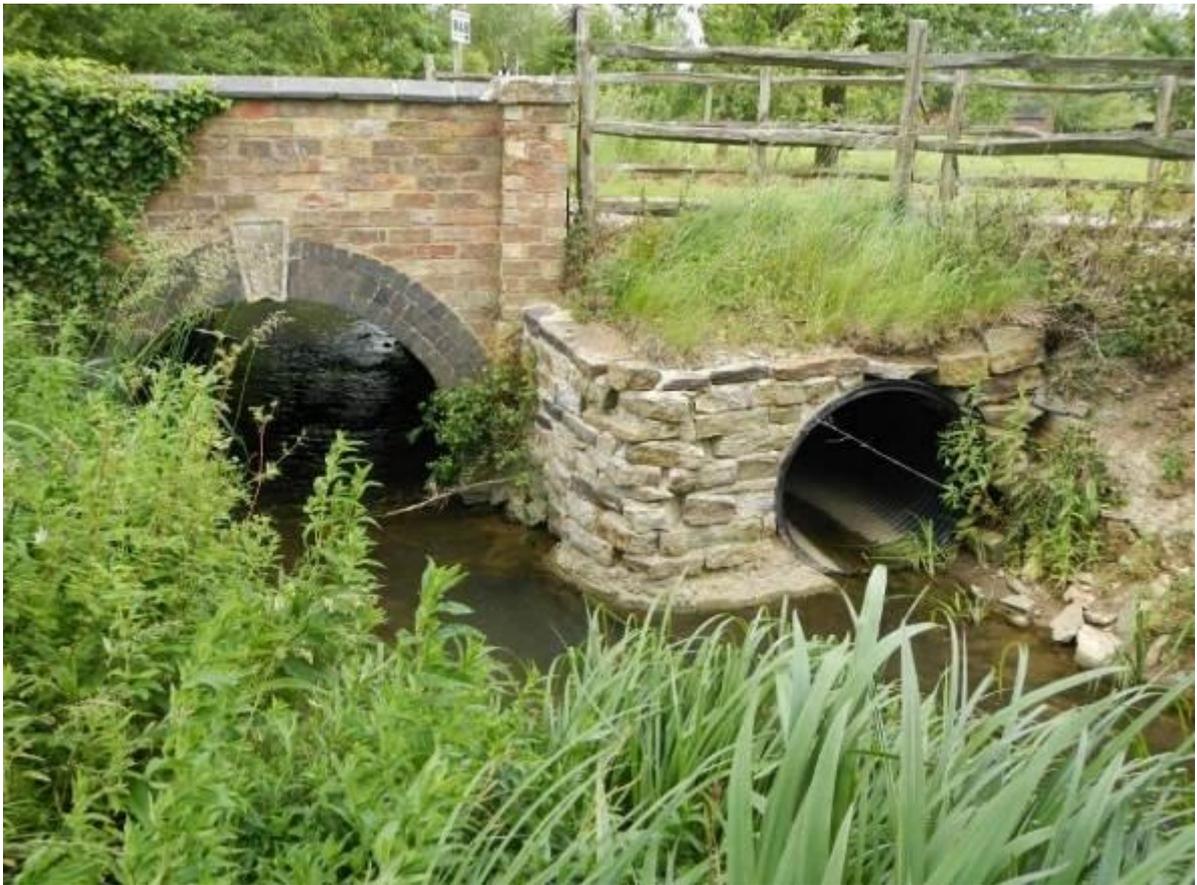
Figure 85. The overflow channel and the sluice channels join c. 35m d/s of the pond, before flowing through a double culvert that supports the access track/road to the houses. While the RB culvert is perched, free passage is afforded through the main, LB channel.

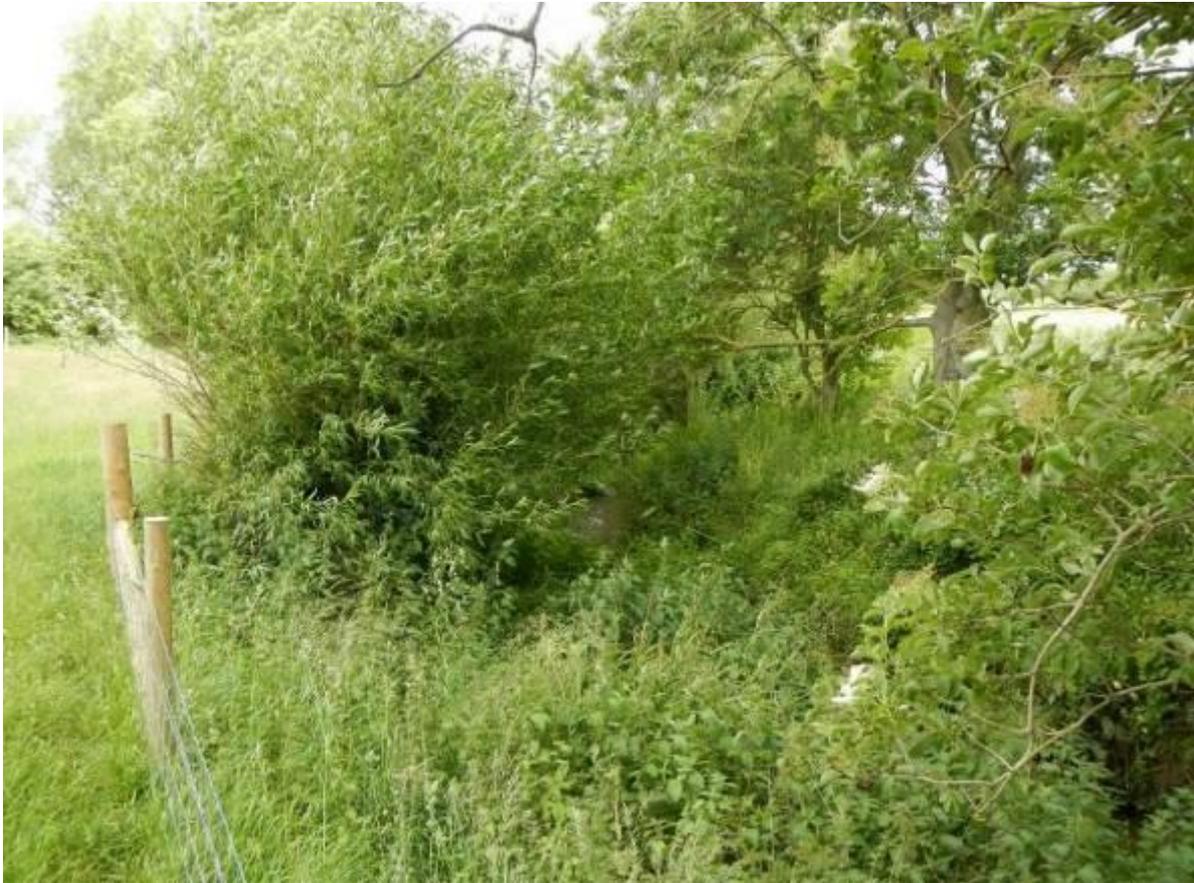
Figure 88. The adjacent land use remains as grazing, with a buffer fence on the LB and livestock access on the RB (although access appeared minimal).

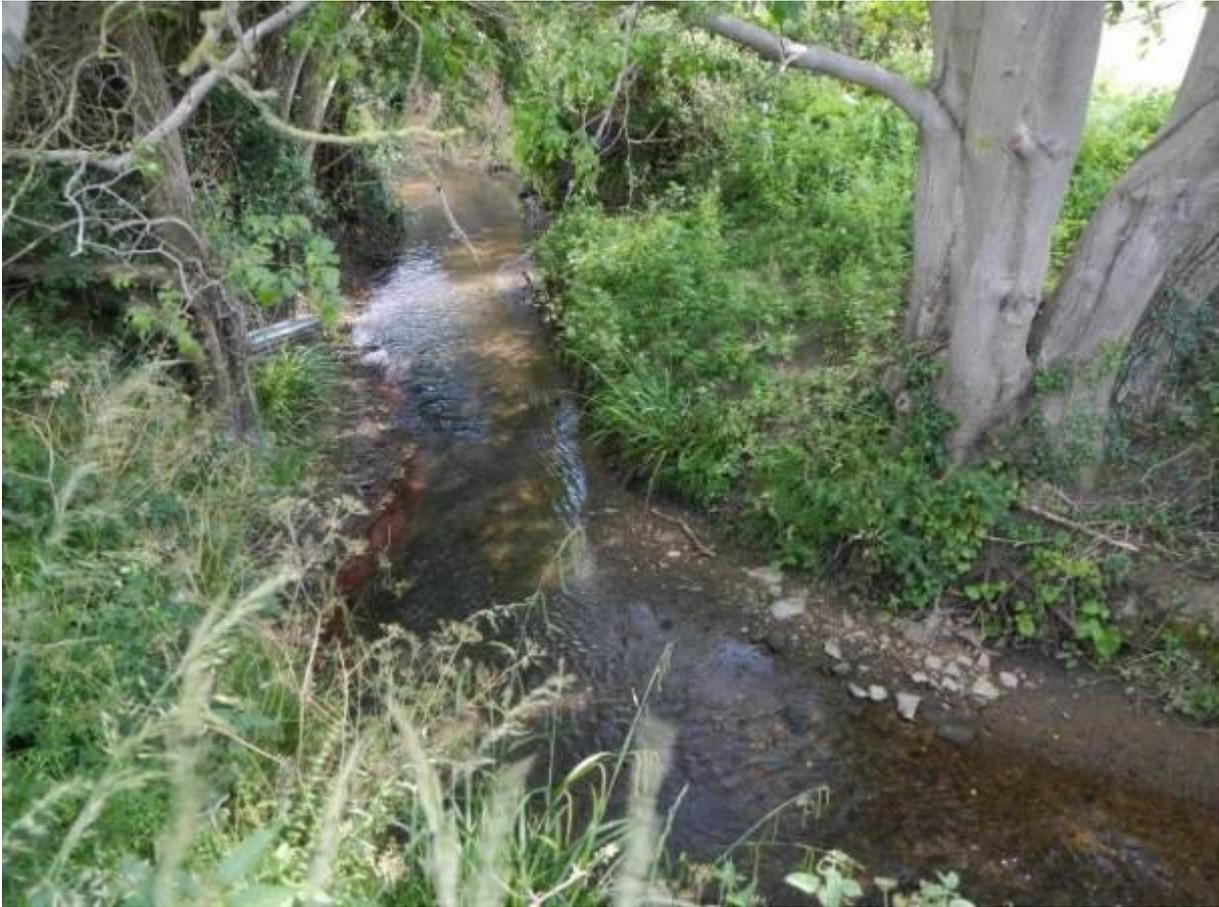
Figure 89. Clear signs of past channel modification but active sediment transport and potential salmonid spawning habitat was apparent.

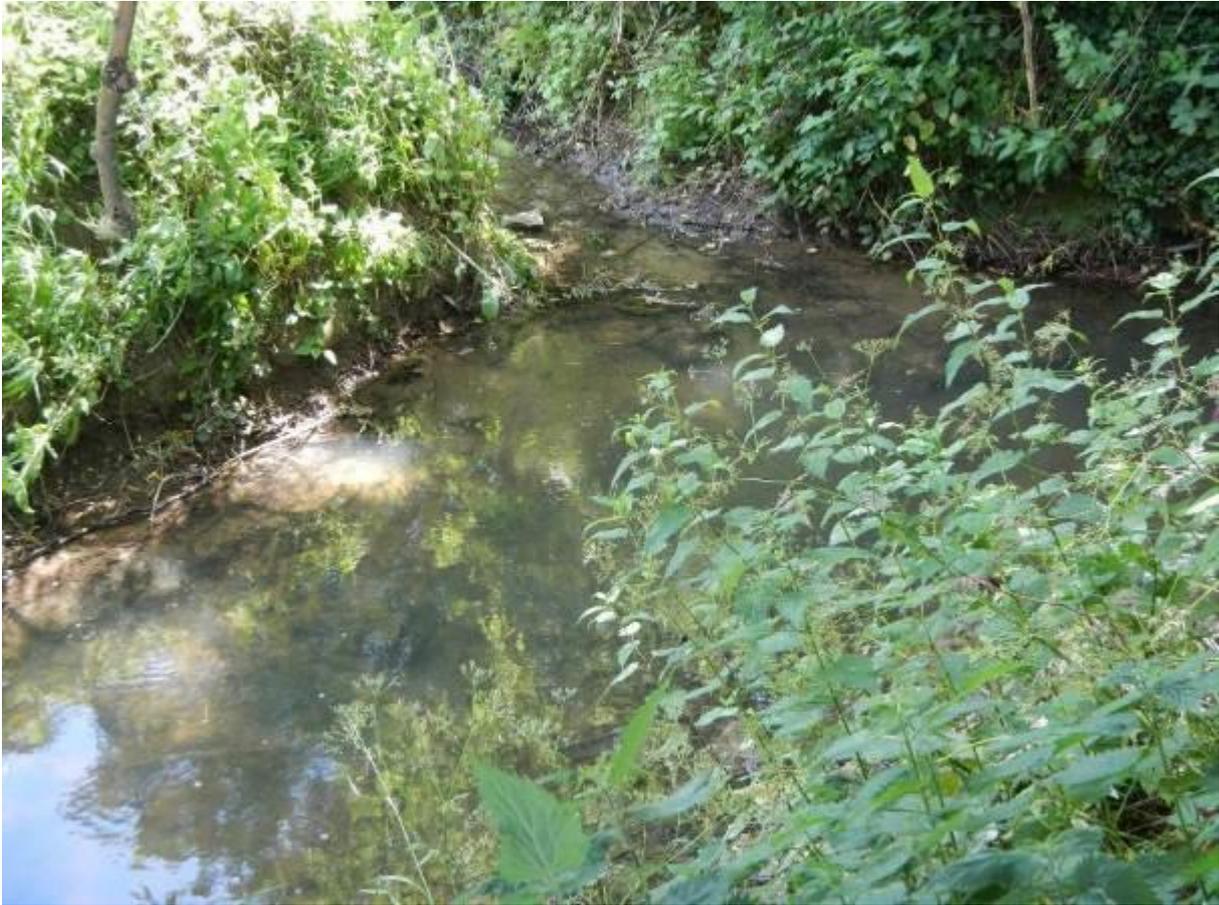
Figure 90. A small tributary joining at SP 06847 42807 appeared little more than a ditch and created no visible impact upon the brook.

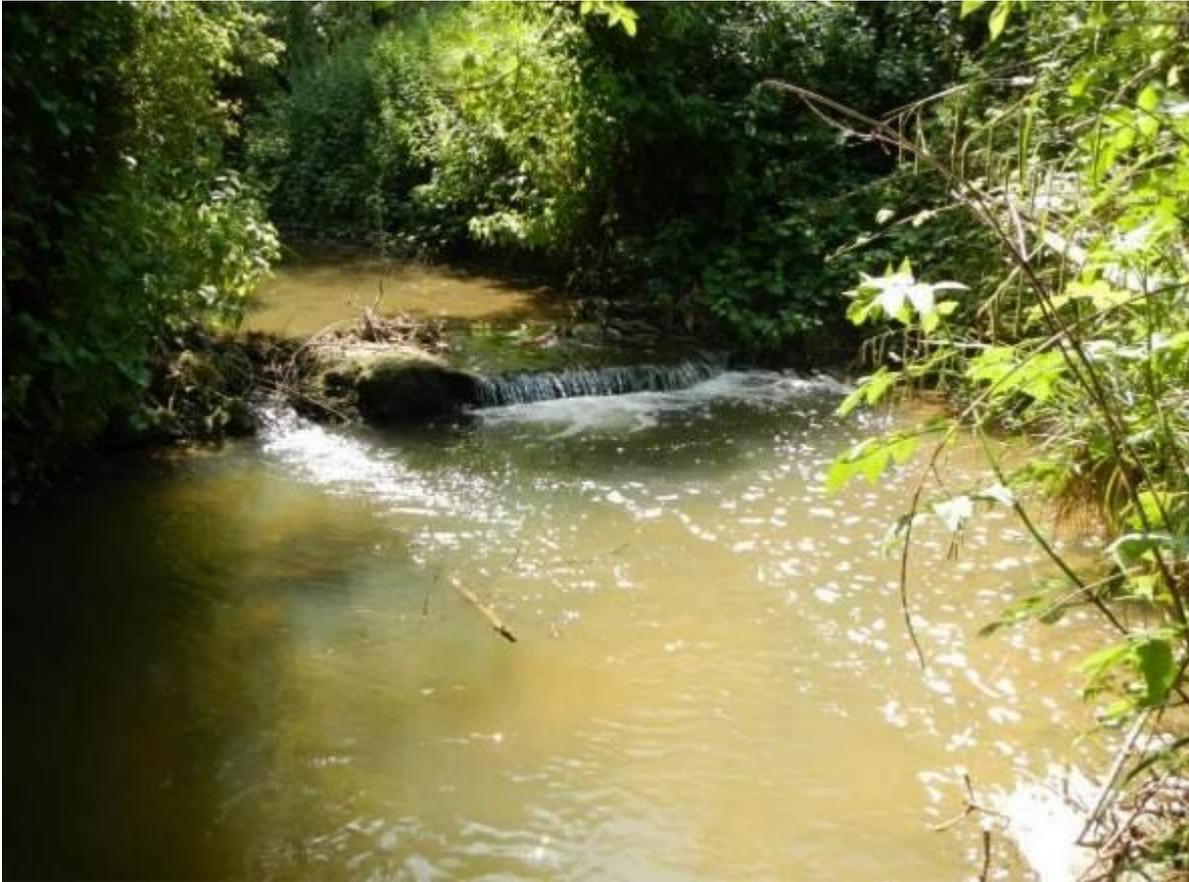
Figure 91. A small weir at SP 06818 42875 creates an impoundment and inhibits fish and sediment movement. The scour pool d/s has also increased erosion of the LB.

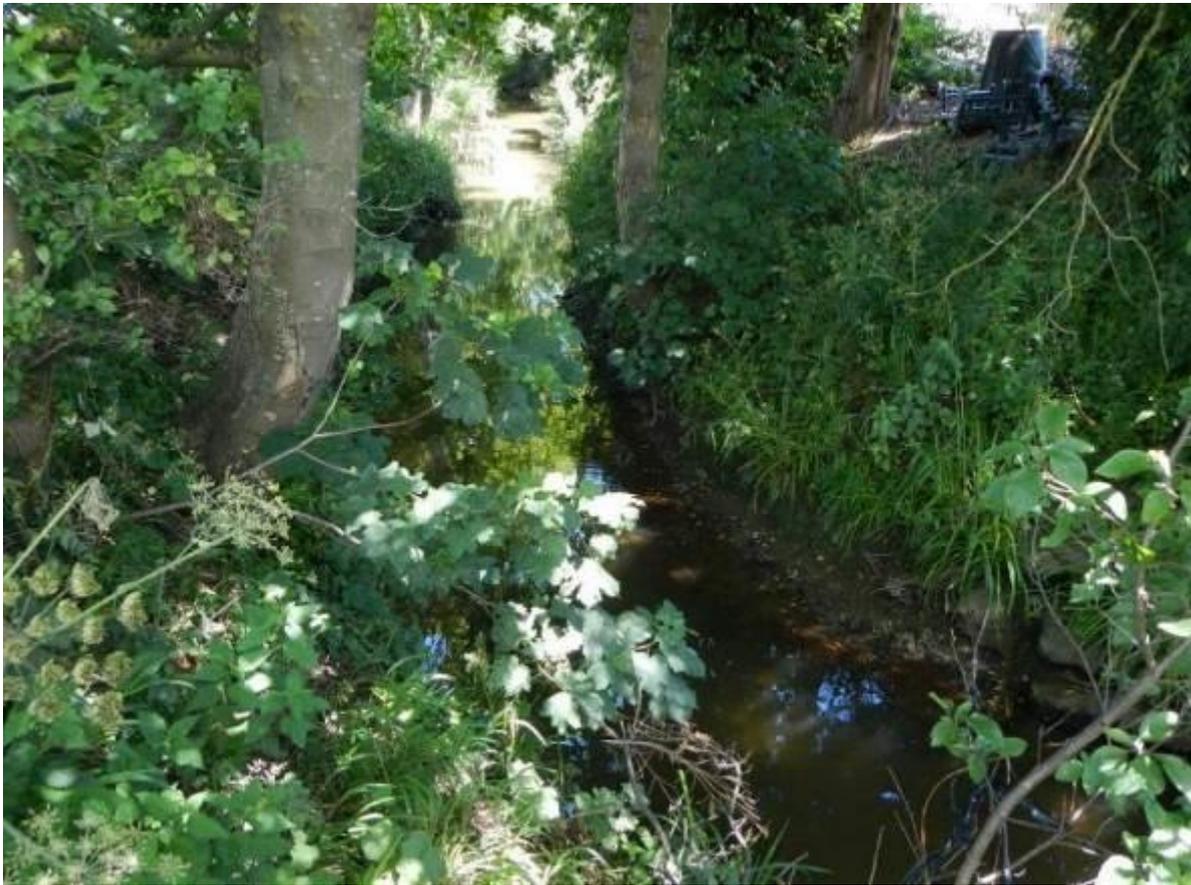
Figure 94. Where sufficient buffer is allowed between the channel and adjacent land use, the riparian habitat is relatively good but past realignment/dredging remains the issue.

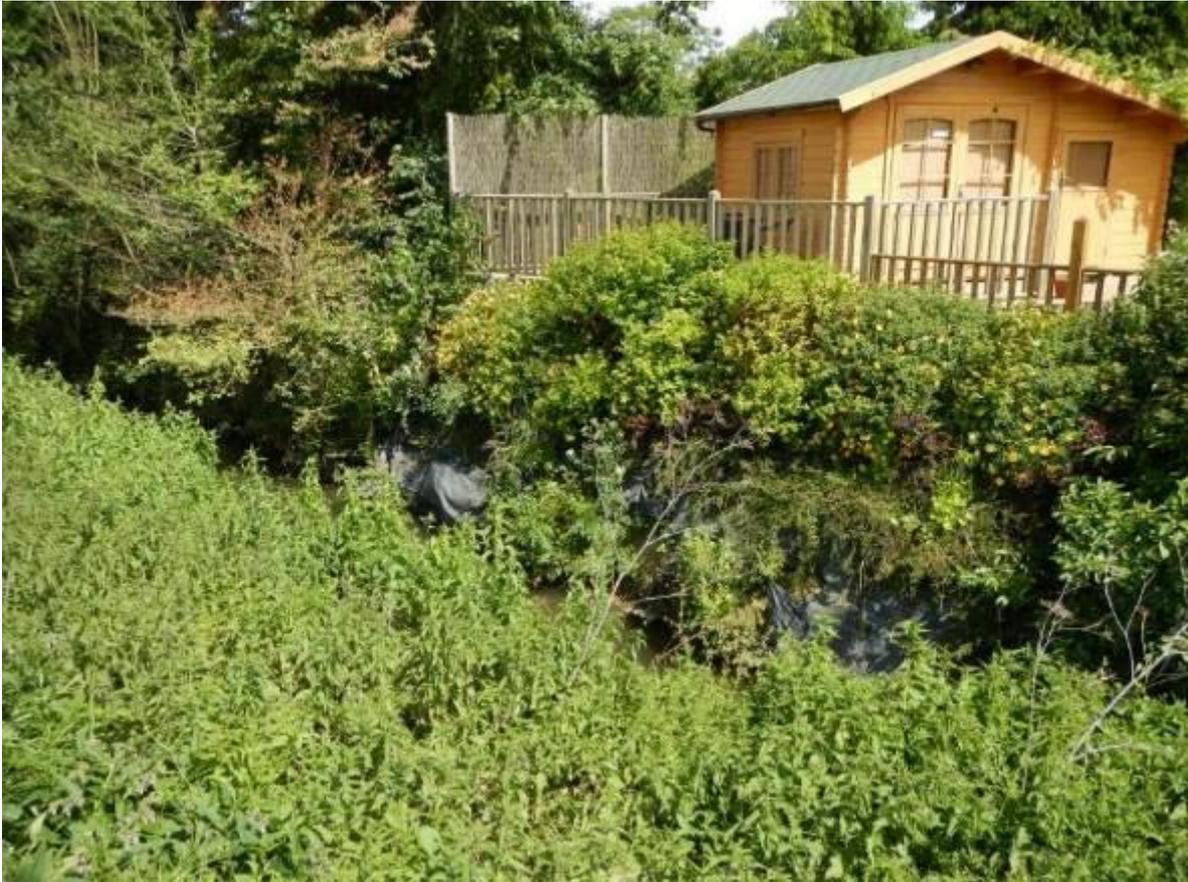
Figure 95. At SP 06856 43229, the bank is covered with geotextile, presumably as ill-advised bank protection, which is having the opposite effect by preventing vegetation growth, leaving it unconsolidated and actually more susceptible to erosion.

95	SP 06856 43229	Geotextile	Remove geotextile that is preventing vegetation growth on bank.	2
106	SP 06626 44157	Dredged channel	This work would not be required if the river were restored to its natural course.	3
120	SP 06277 44922	Gauging weir	Ideally this structure should be replaced with more modern, less intrusive flow gauging technology but in the short-term, a fish pass/easements should be installed. Eel passes should already be installed on EA weirs.	1

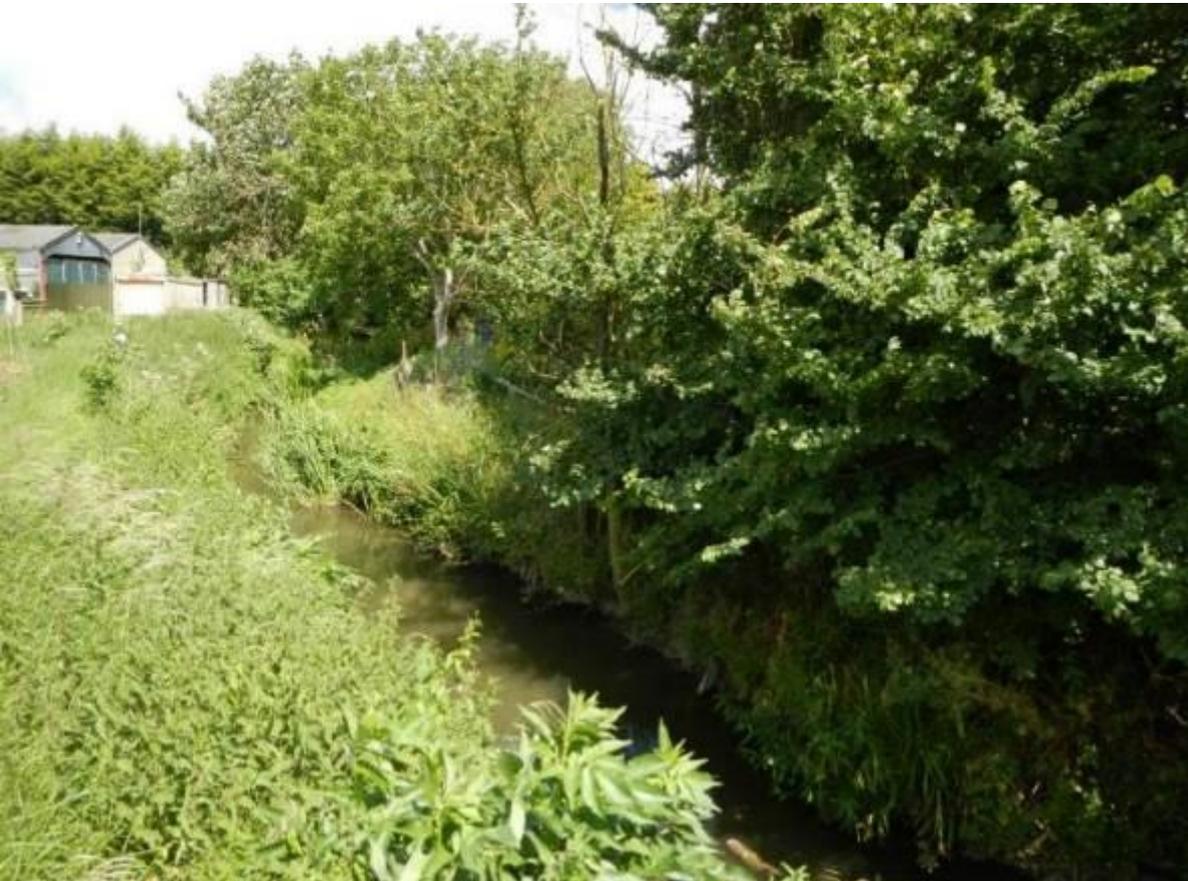
Figure 96. Straightened, featureless channel, typical in much of the section from Badsey Lane down to the B4035, between the gardens and market gardens.

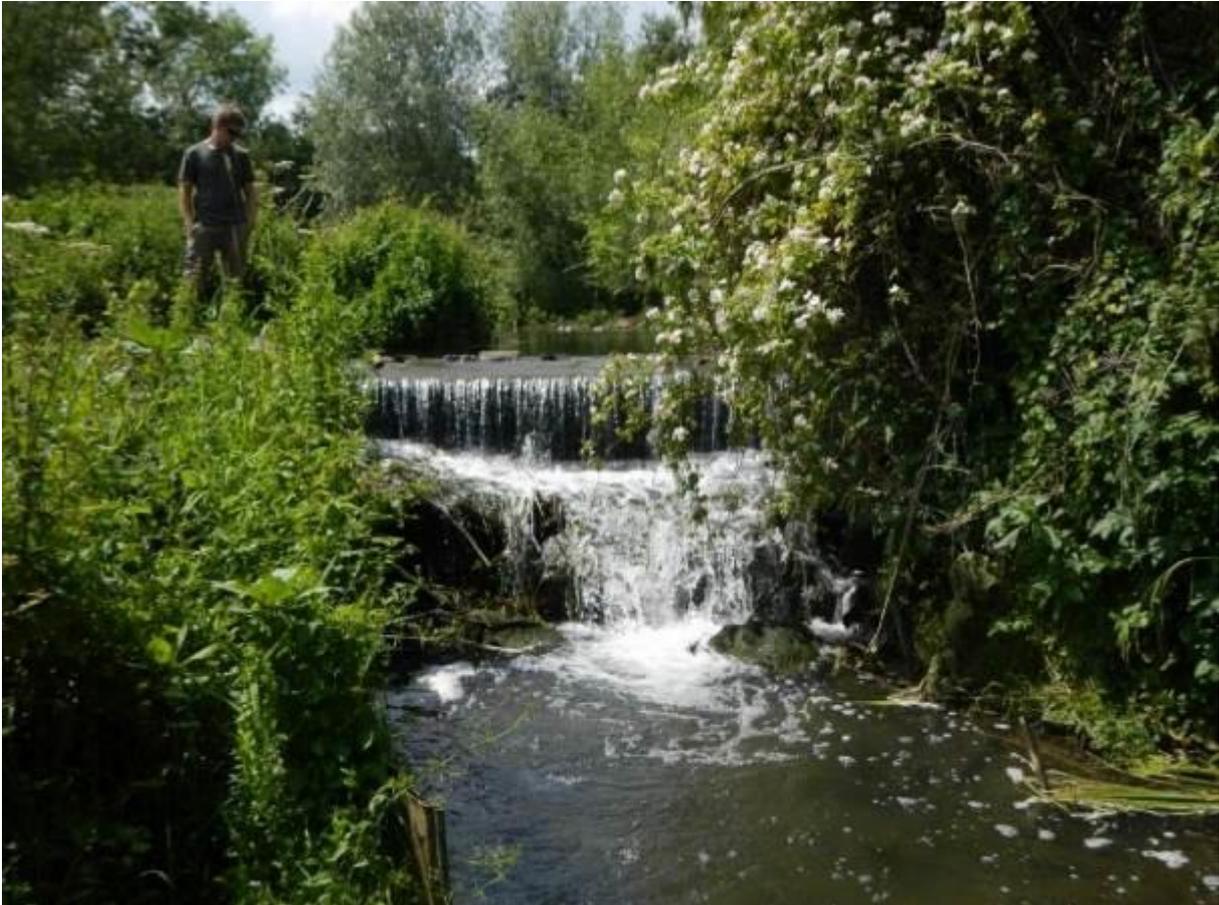
Figure 102. The >1.5m weir (SP 06543 43998) creates a complete barrier to fish and sediment and may increase flood risk locally through artificial elevation of the bed level. The majority of flow passes down the weir on the RB side – there is a sluice on the LB.

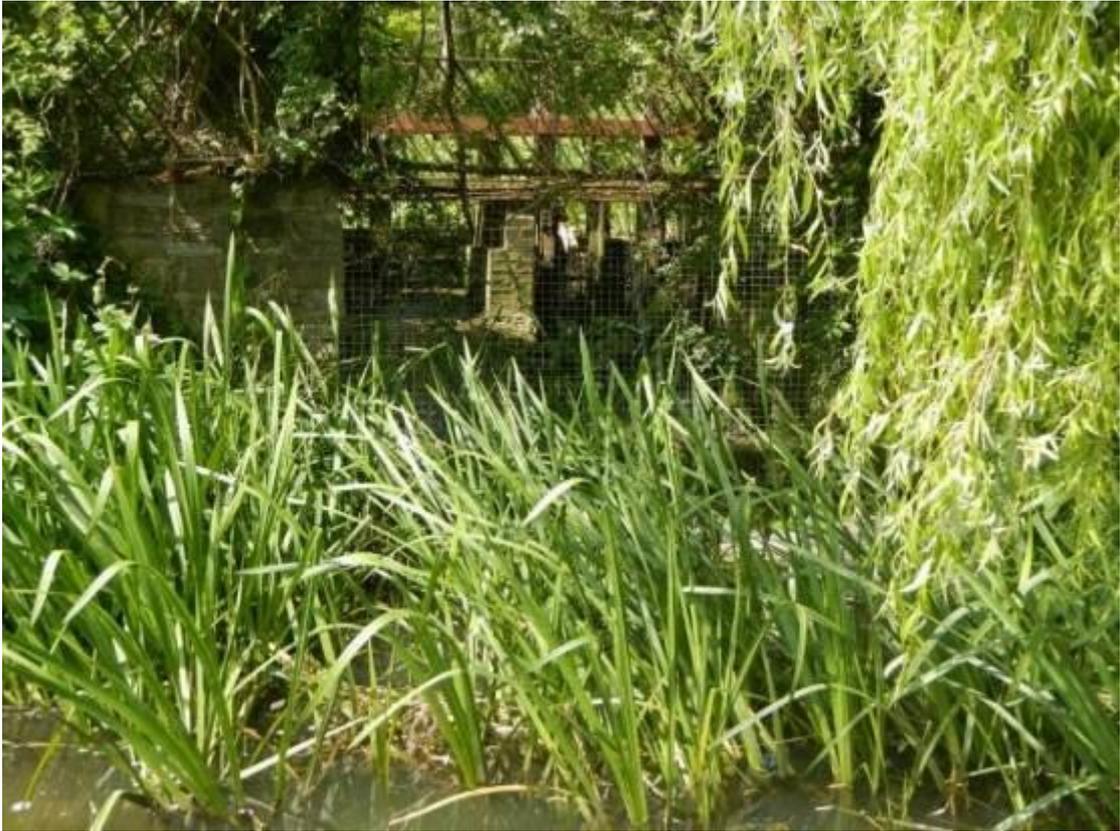
Figure 102. To the LB side of the weir is a set of decrepit sluices which, by the emergent plants choking the channel d/s, do not appear to be in regular use or taking much flow but may offer potential for a bypass route if agreement were gained to lower the river level.

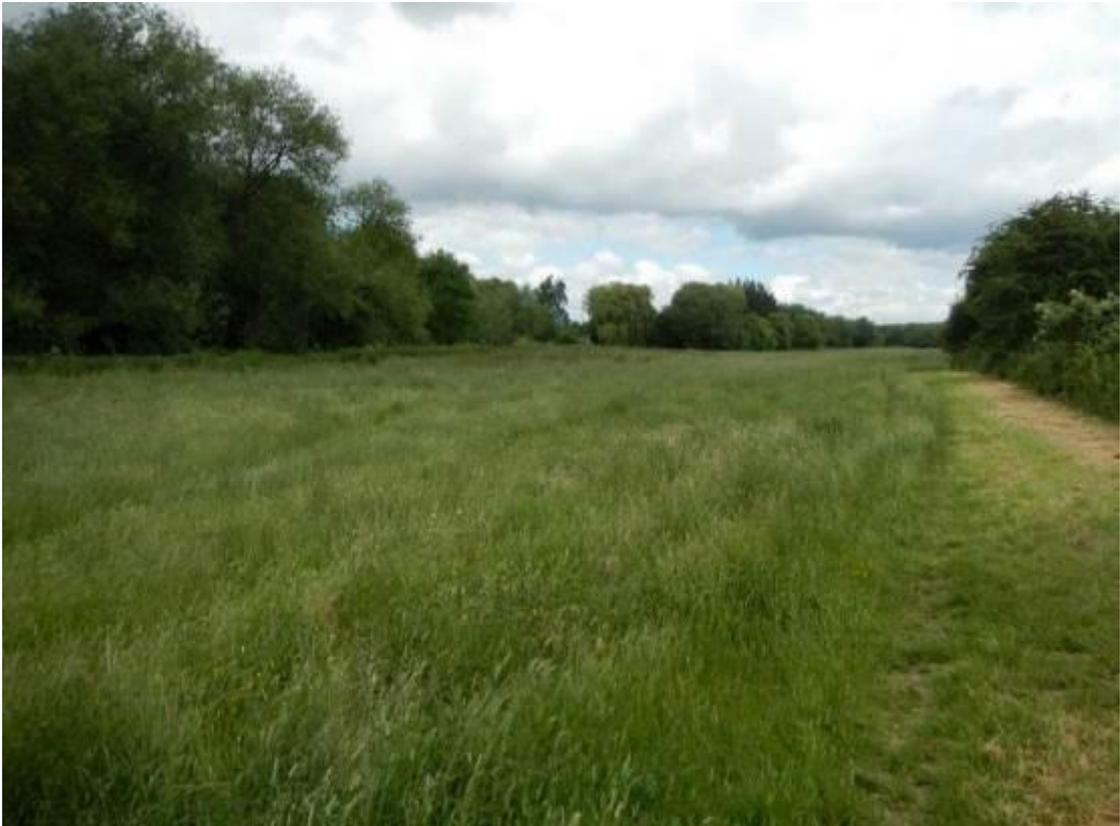
Figure 103. The channel around the weir is clearly perched to the side of the valley bottom (left of shot), offering an opportunity to bypass the weir and restore the brook to a more natural channel in the valley bottom (centre of shot), potentially reducing flood risk to properties on the LB and restoring habitat quality and passage fish – providing tenant and / or landowner agreement can be gained. This may be a difficult sale on a hay/silage field.

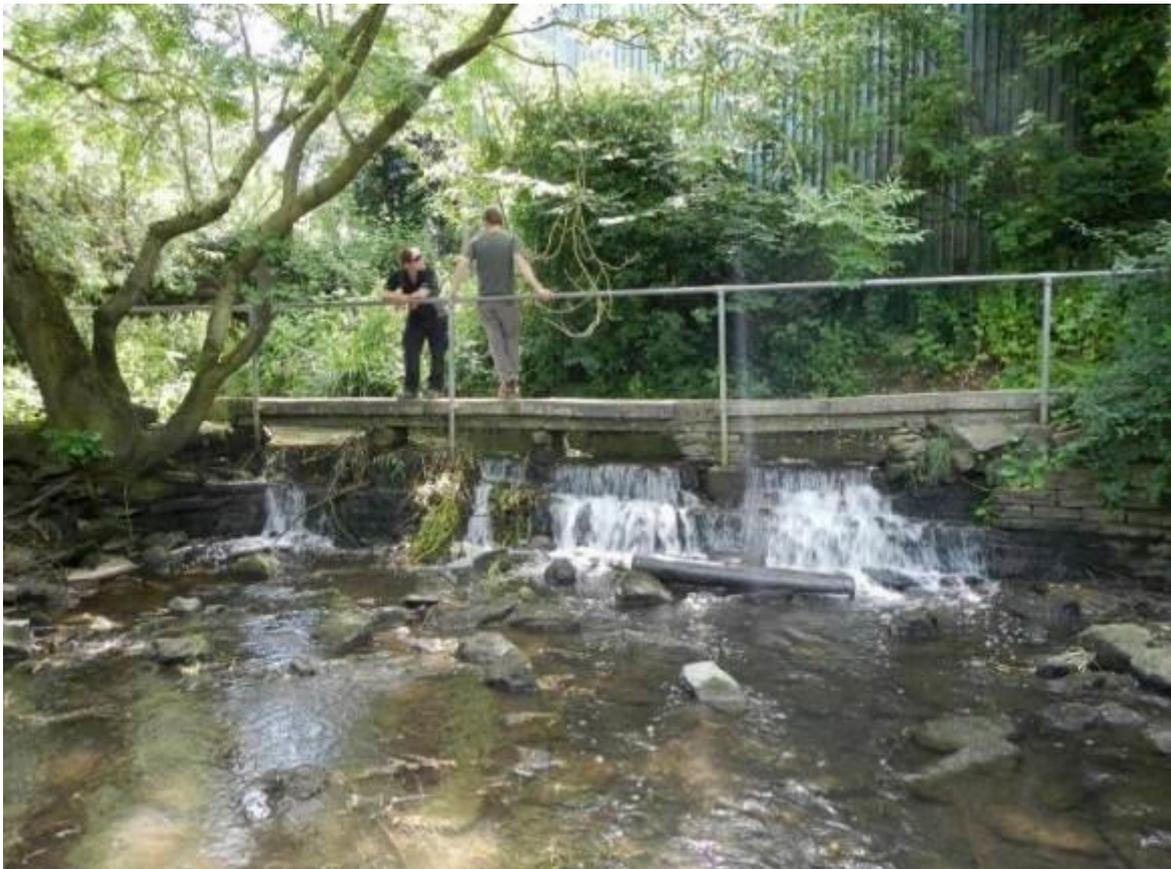
Figure 104. At SP 06586 44069 (c. 100m d/s of the main weir), an old ford further disconnects habitat and artificially elevates the bed. This too could be bypassed with a river restoration scheme, but the associated footpath would require a bridge.

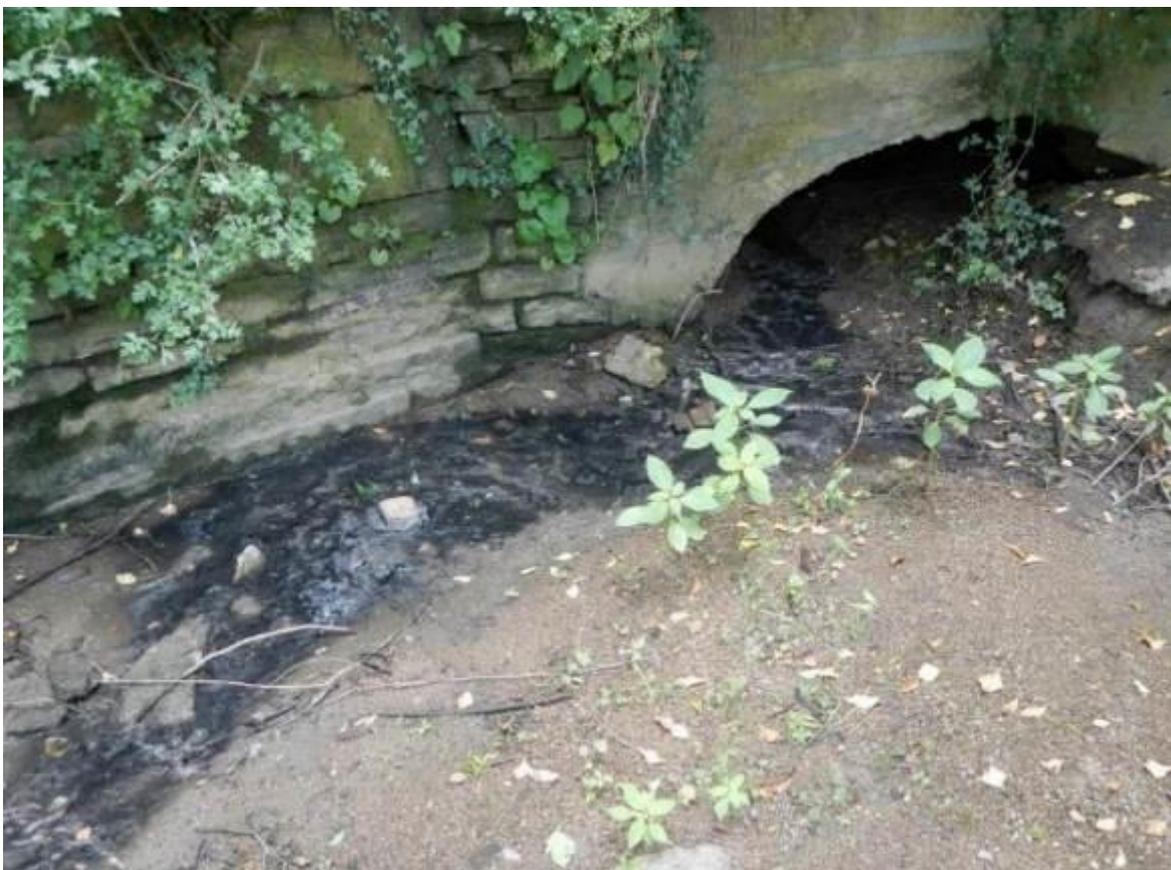
Figure 105. Emanating from an arch under the footings of the ford was a foul smelling high nutrient discharge (possibly septic tank or misconnection). This undoubtedly pollutes and enriches the watercourse.

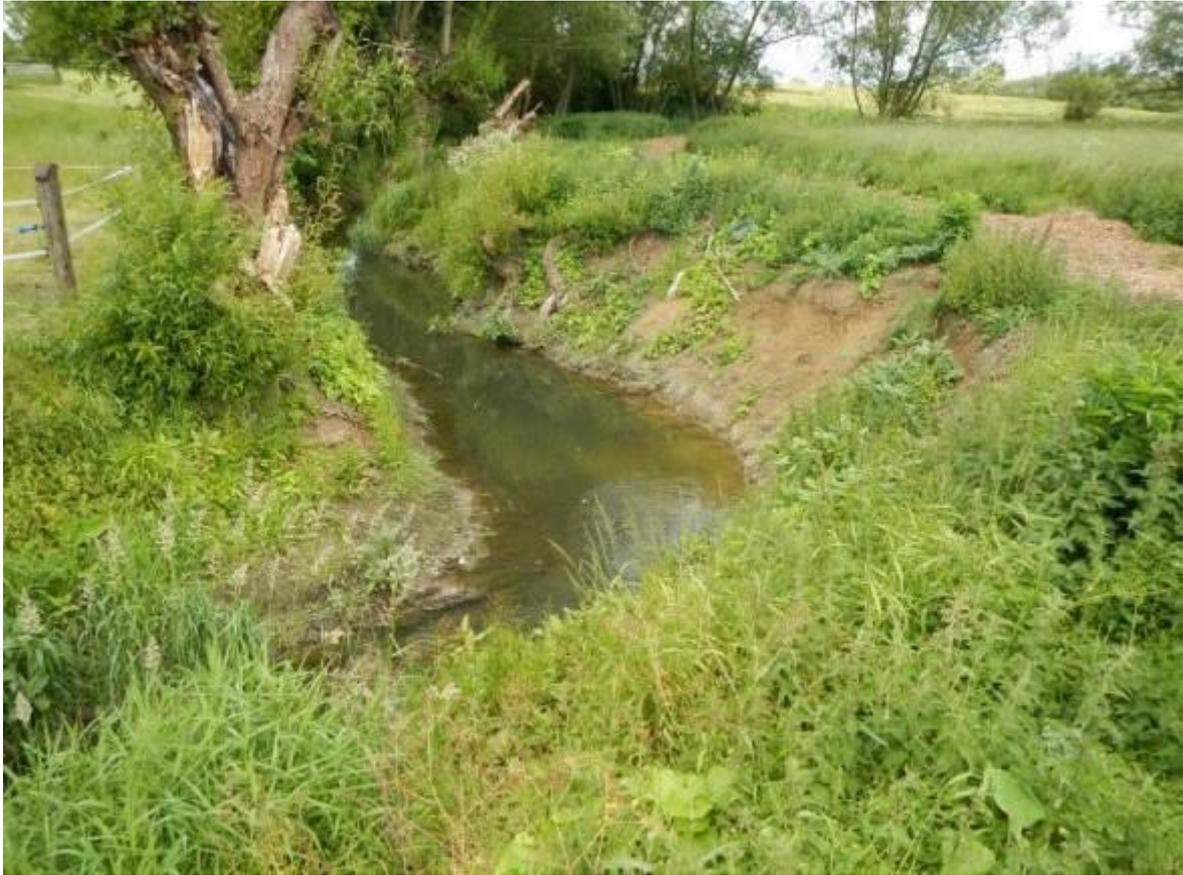
Figure 106. Recent dredging and tree maintenance had been undertaken on the channel d/s of the ford (SP 06626 44157). Removal of/bypassing the ford and weir would reduce the inundation and waterlogging of adjacent land more effectively than channel dredging.

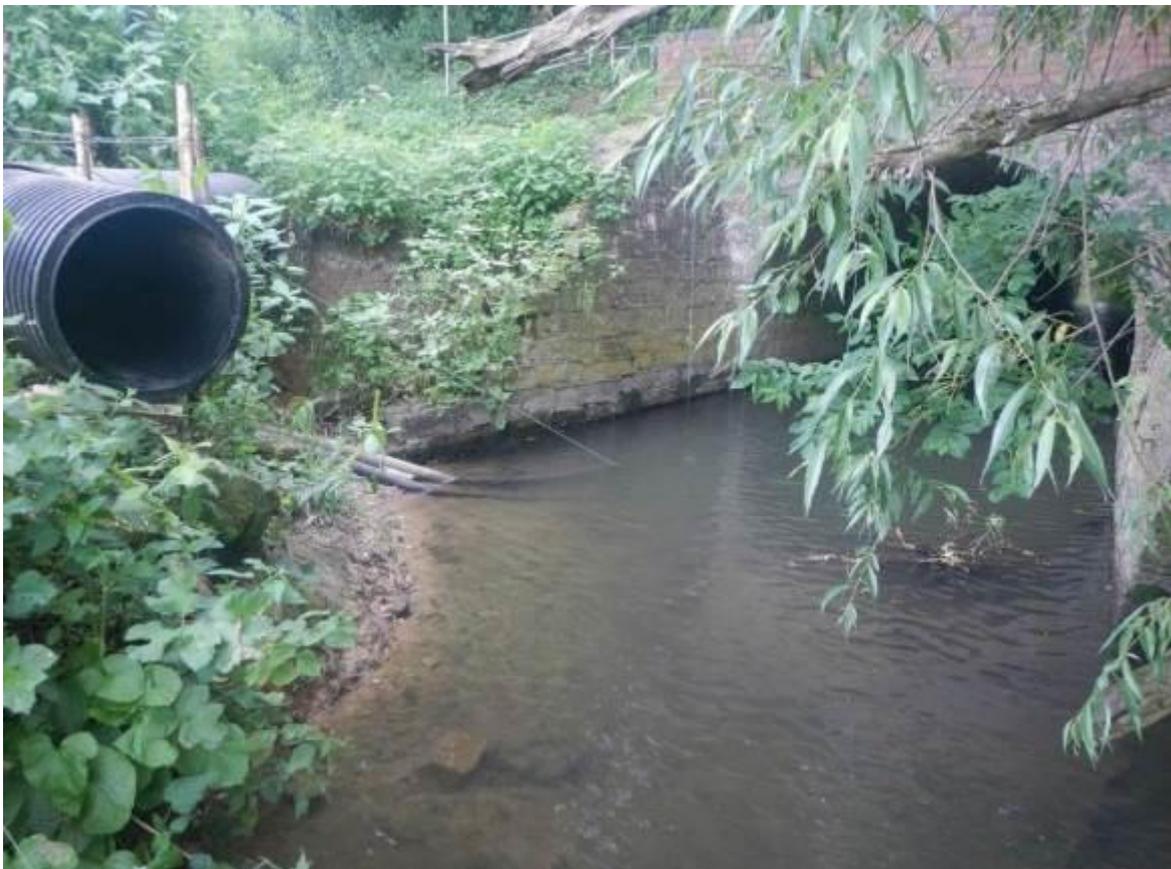
Figure 113. Immediately d/s of the railway culvert (SP 06453 44836), a series of large, piped-discharges that appear to be associated with the market gardening operation, along with suspected abstractions from the brook. Although hard to ascertain, the bed of the brook still appears relatively clear of algae immediately u/s of the pipes.

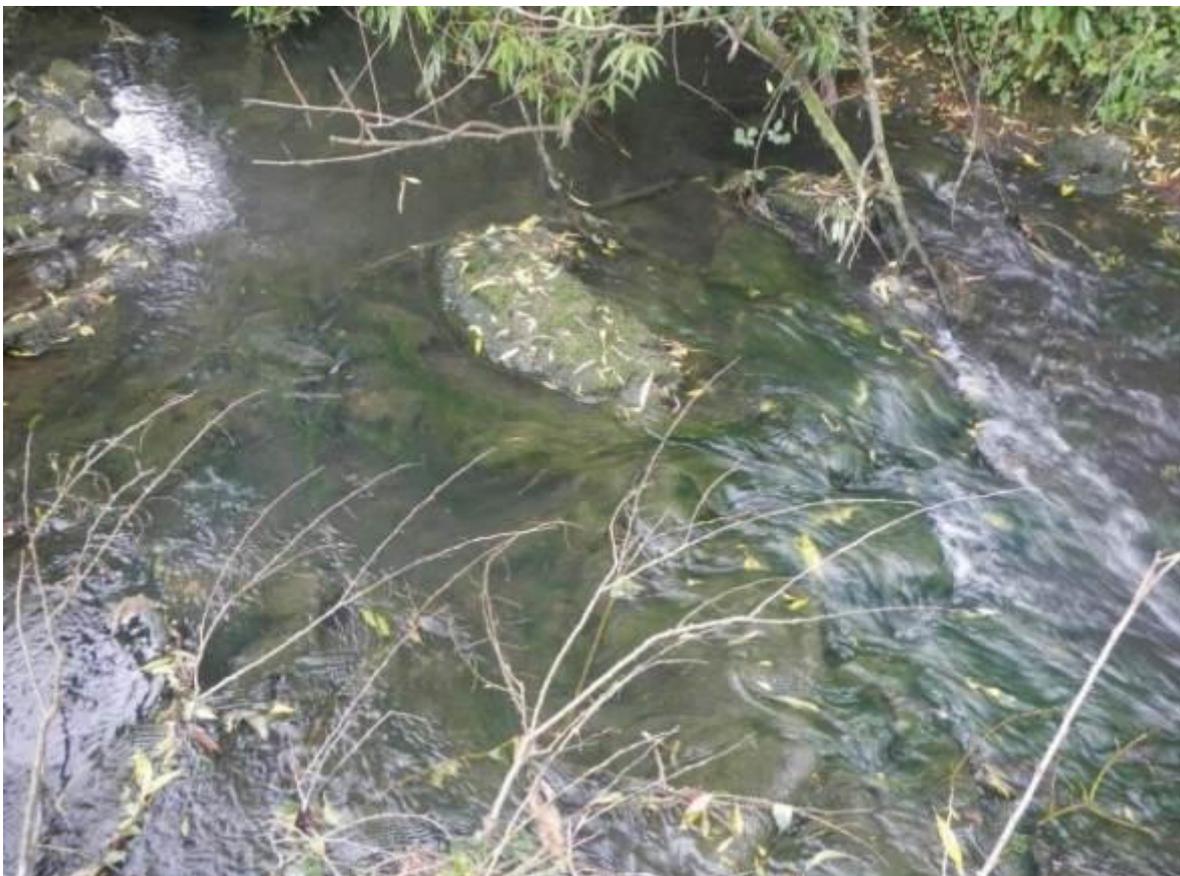
Figure 117. The bed around the discharge/pipes becomes smothered with algae and appears highly eutrophic. This provides poor invertebrate habitat. Detailed investigation of the discharges d/s of the railway line and from the STW would be beneficial.
