Walkover Assessment
Badsey Brook (Warwickshire Avon) catchment
14-15/06/2017

Undertaken by Gareth Pedley

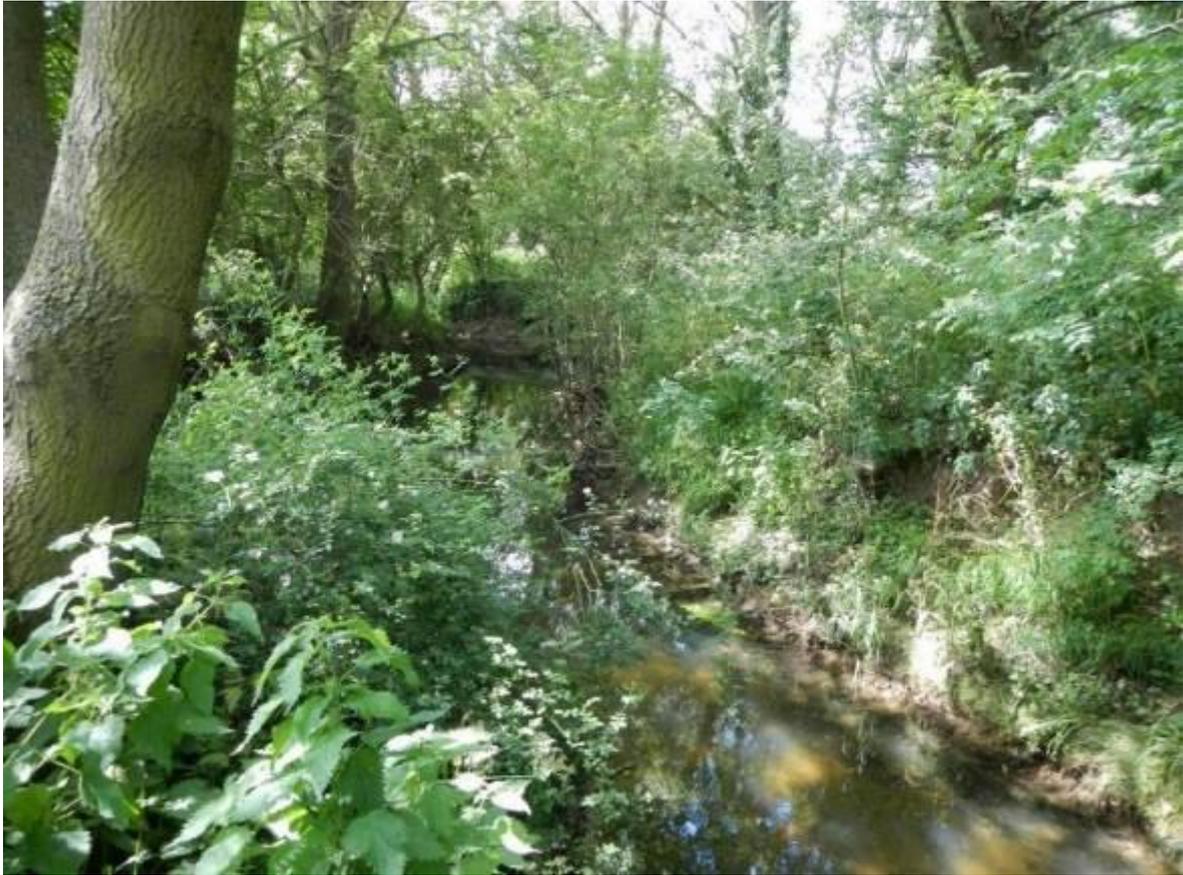
Figure 121. The general habitat d/s of the gauging station is naturalising with cover and structure available although, as with other sections, past channel maintenance has left a greatly over-capacity channel.

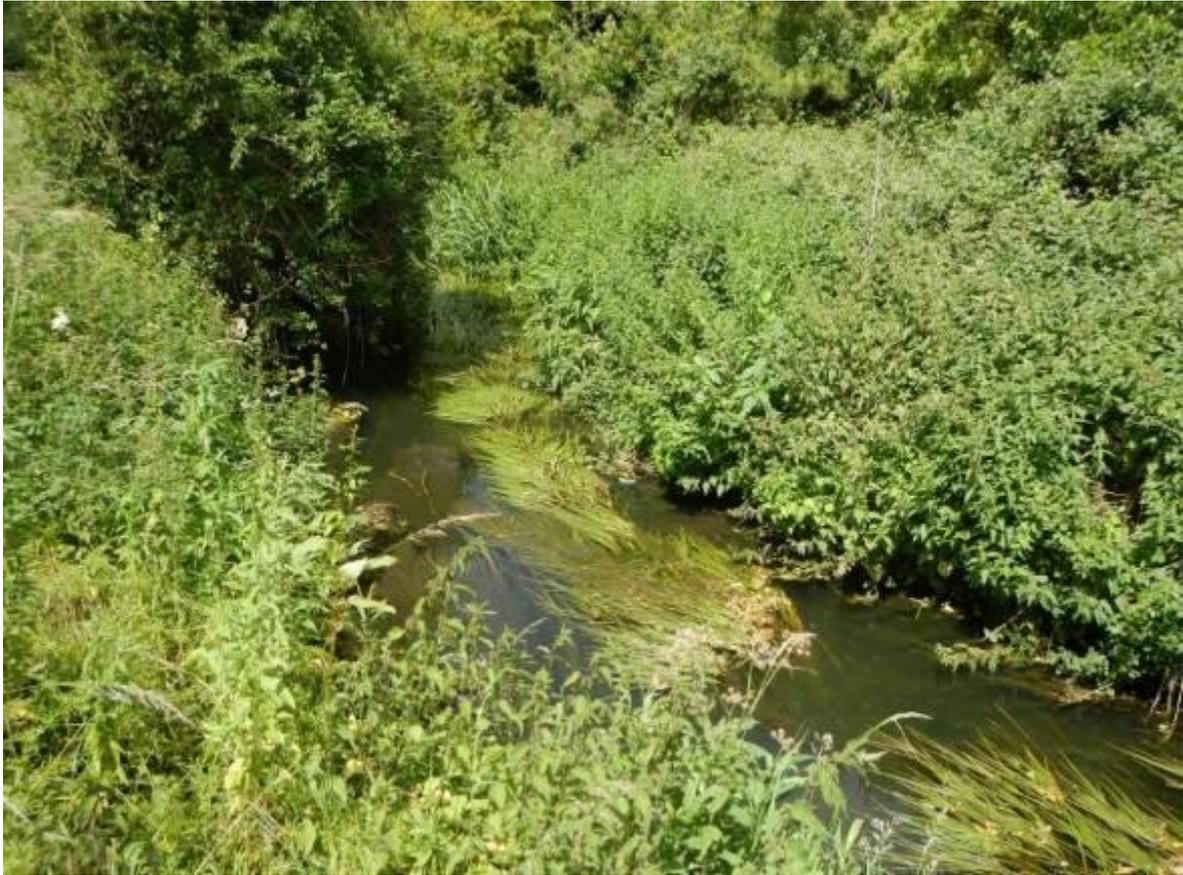
Figure 123. For the remainder of the brook d/s to the Avon, the channel is tree-lined, punctuated by small open areas, but is buffered in most areas. The predominance of nettles among the buffer may suggest nutrient seepage from the adjacent fields.

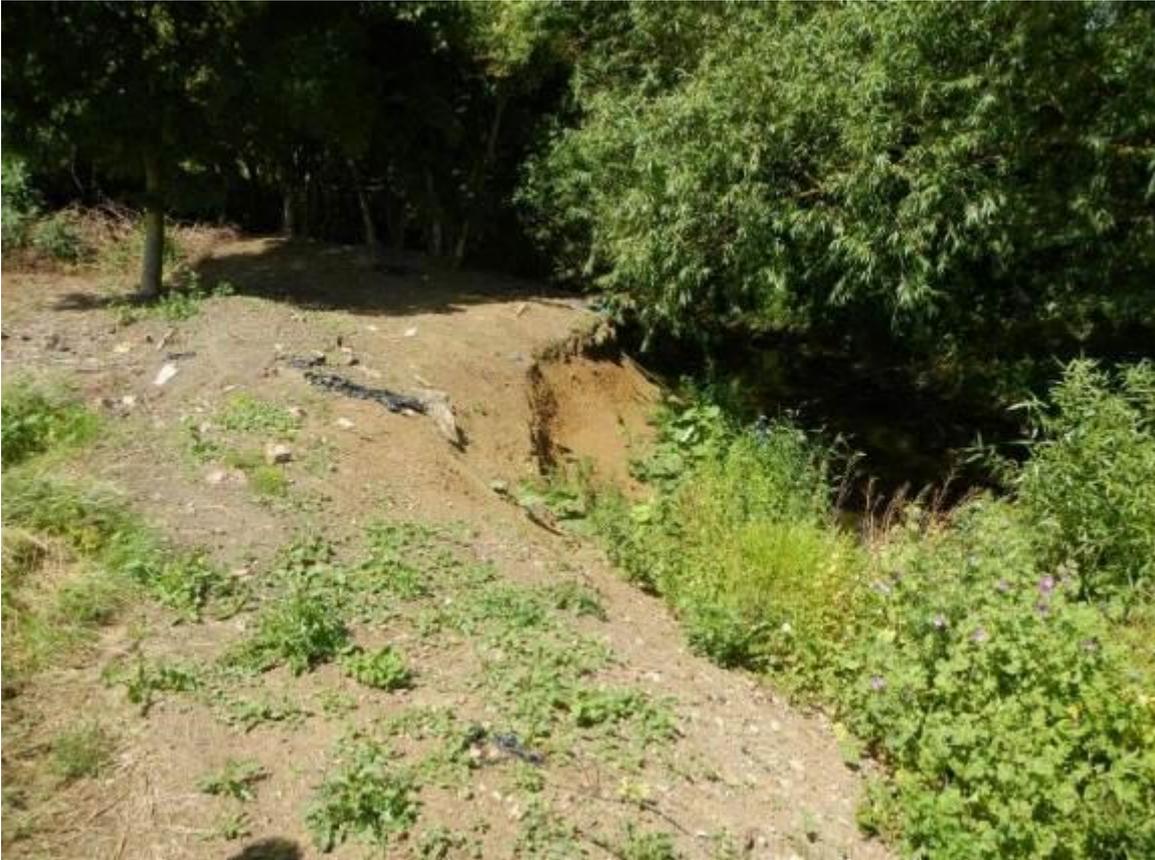
Figure 126. A larger area of bank appears to have been sprayed with herbicide at SP 05569 45328. A small buffer has been left/re-established at the bank toe that should help consolidate the area. Usage of herbicide this close to a watercourse requires written agreement from the EA.

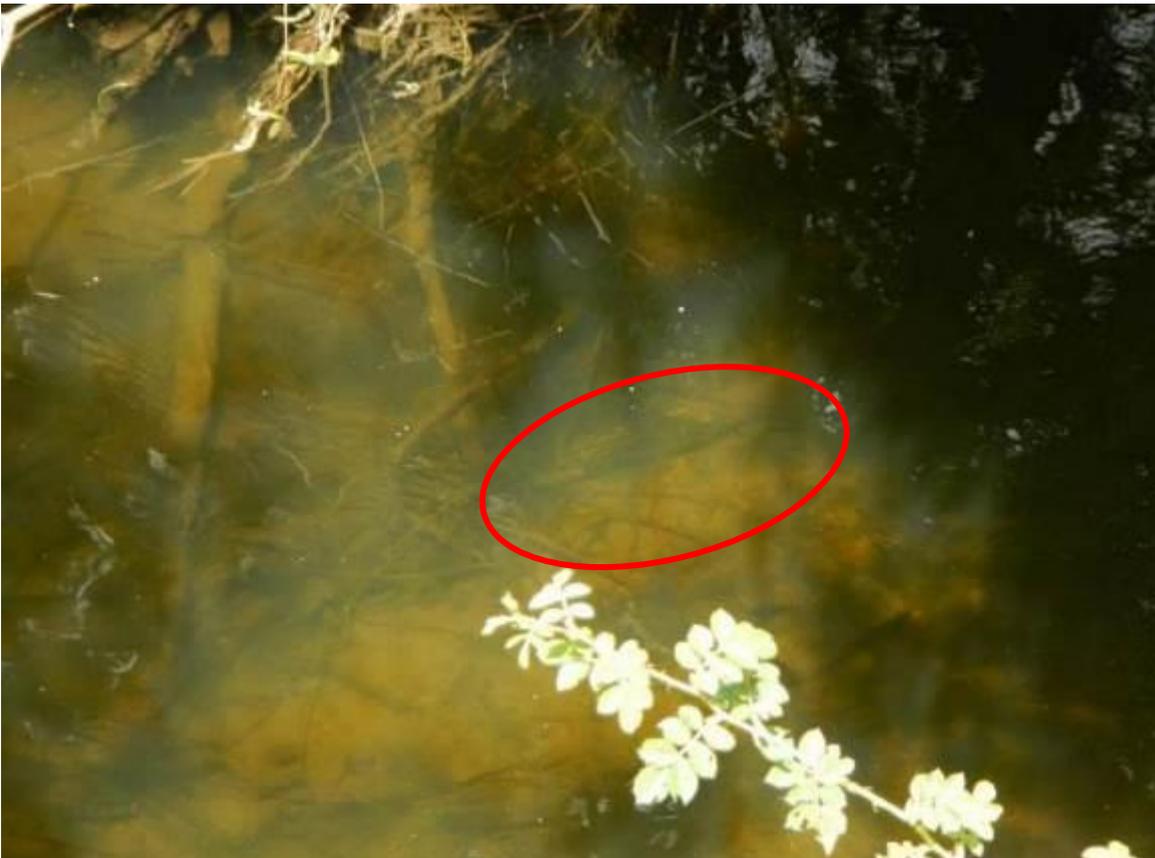
Figure 127. Past dredging has left much of the lower channel featureless and lacking flow diversity (as with many sections u/s) and the lack of discernible bed features/riffles has allowed slower flow species to colonise the area, such as pike (red circle), roach and perch.

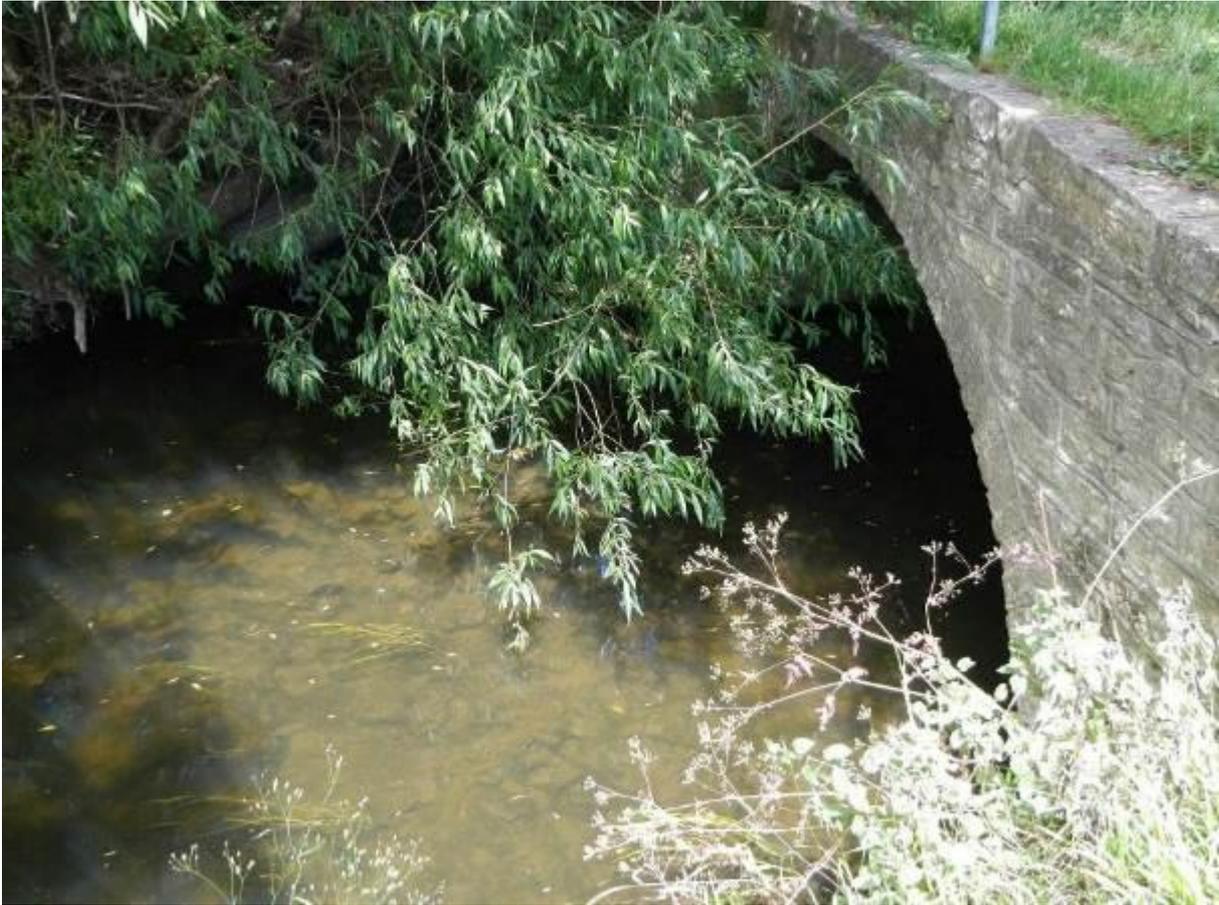
Figure 129. The bridge on Mill Lane poses no issues.

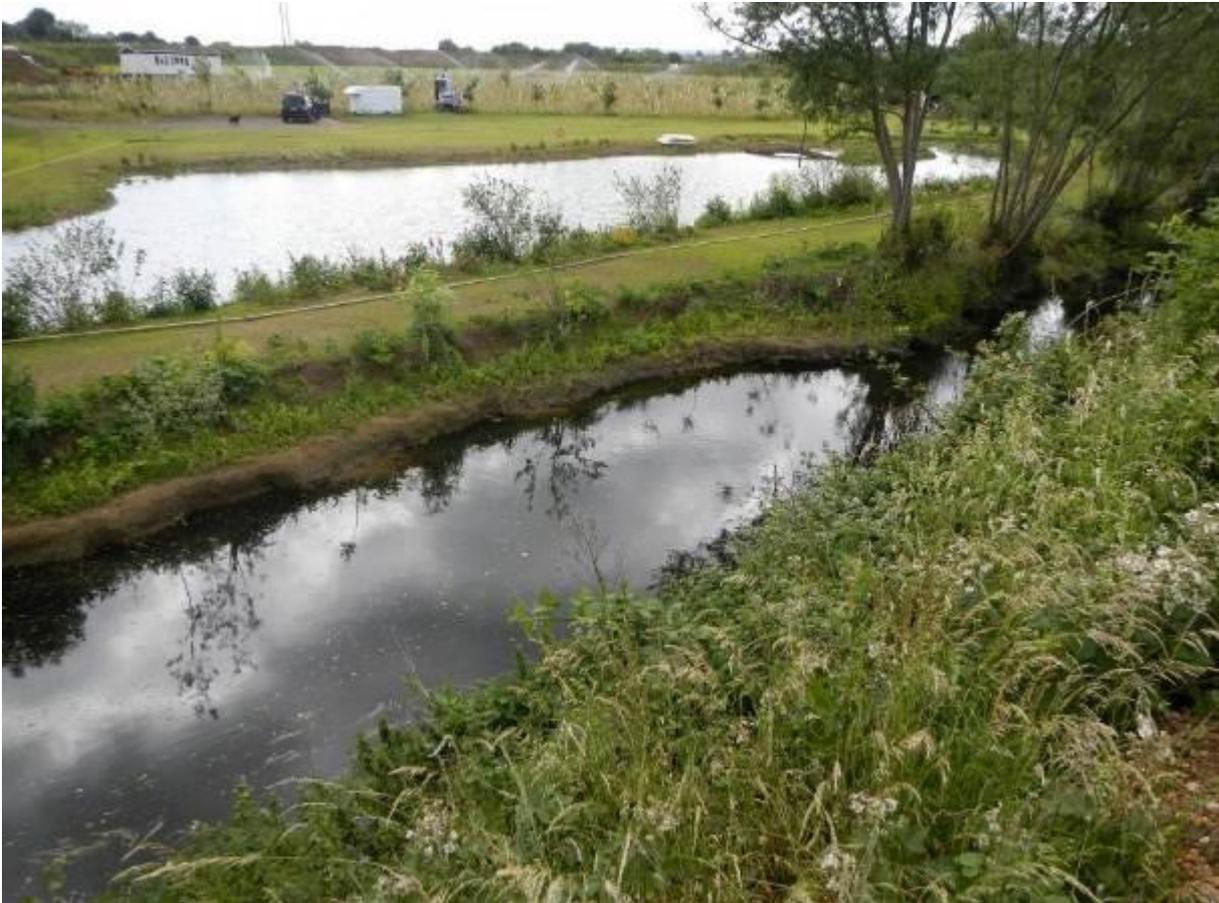
Figure 130. At SP 05313 45452, a recent pond and wetland development has been undertaken, apparently in consultation with the EA (according to the tenant/landowner).

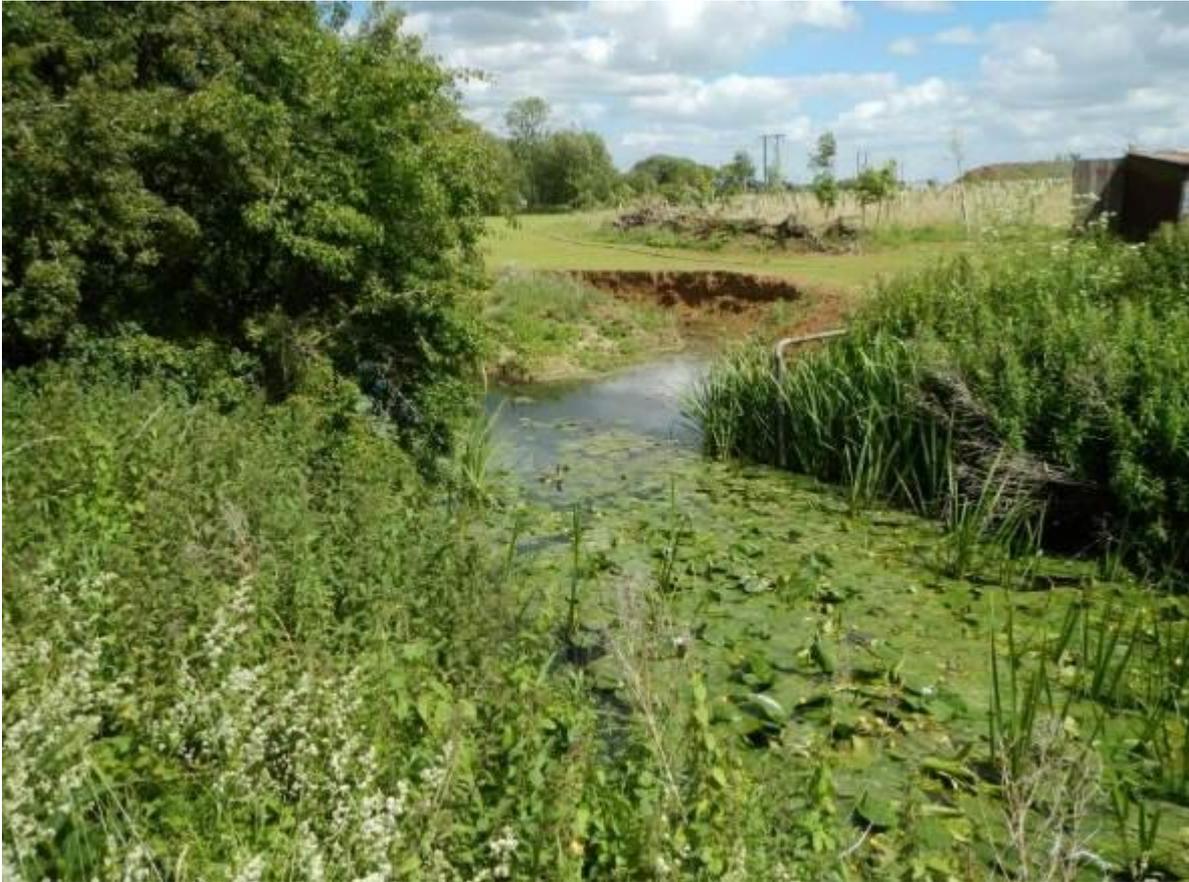
Figure 131. The development includes a small online loop, just u/s of an abstraction point that was being used to irrigate a small tree plantation further up the bank. Note the almost static flow of the brook, as evident by stillwater emergent and floating-leaved vegetation.

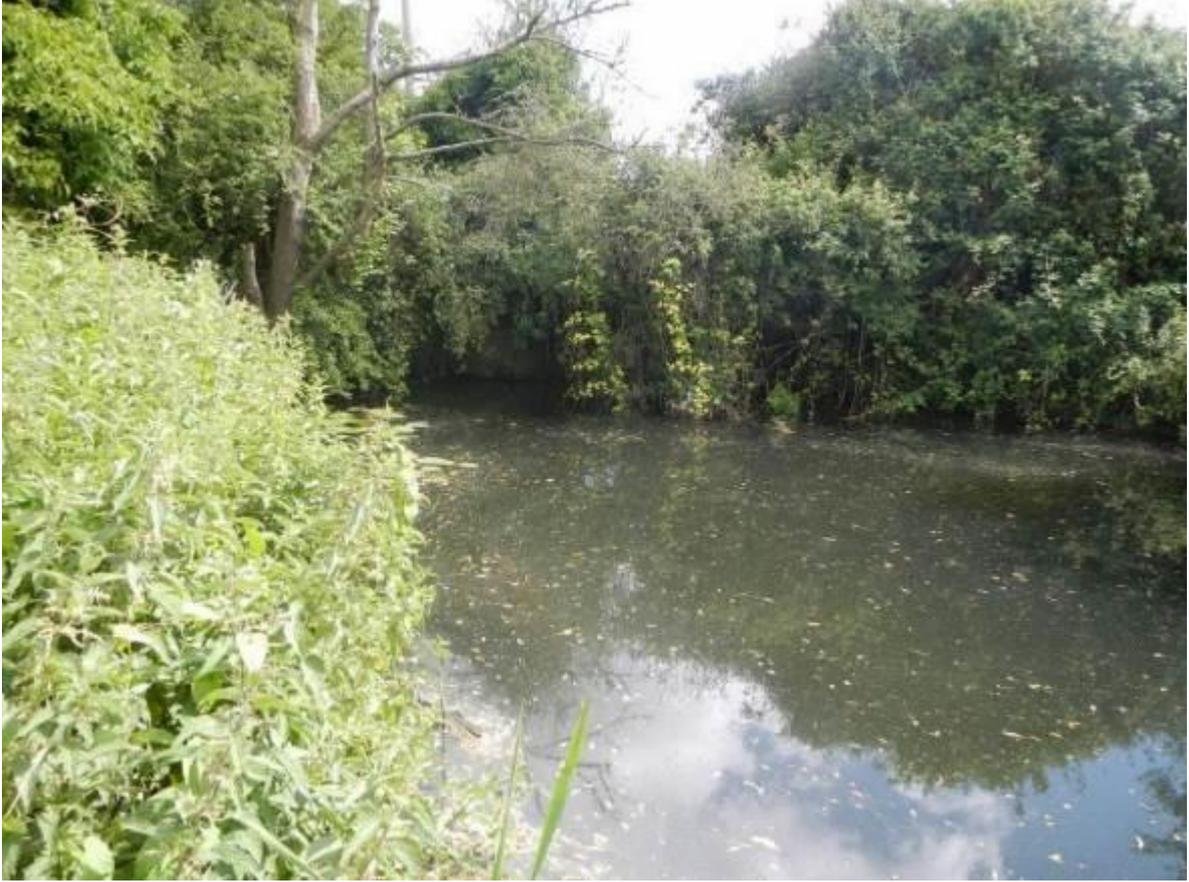
Figure 132. A small, clear-span stone bridge within the vegetation (left of shot) at SP 05068 45429 poses no issues.

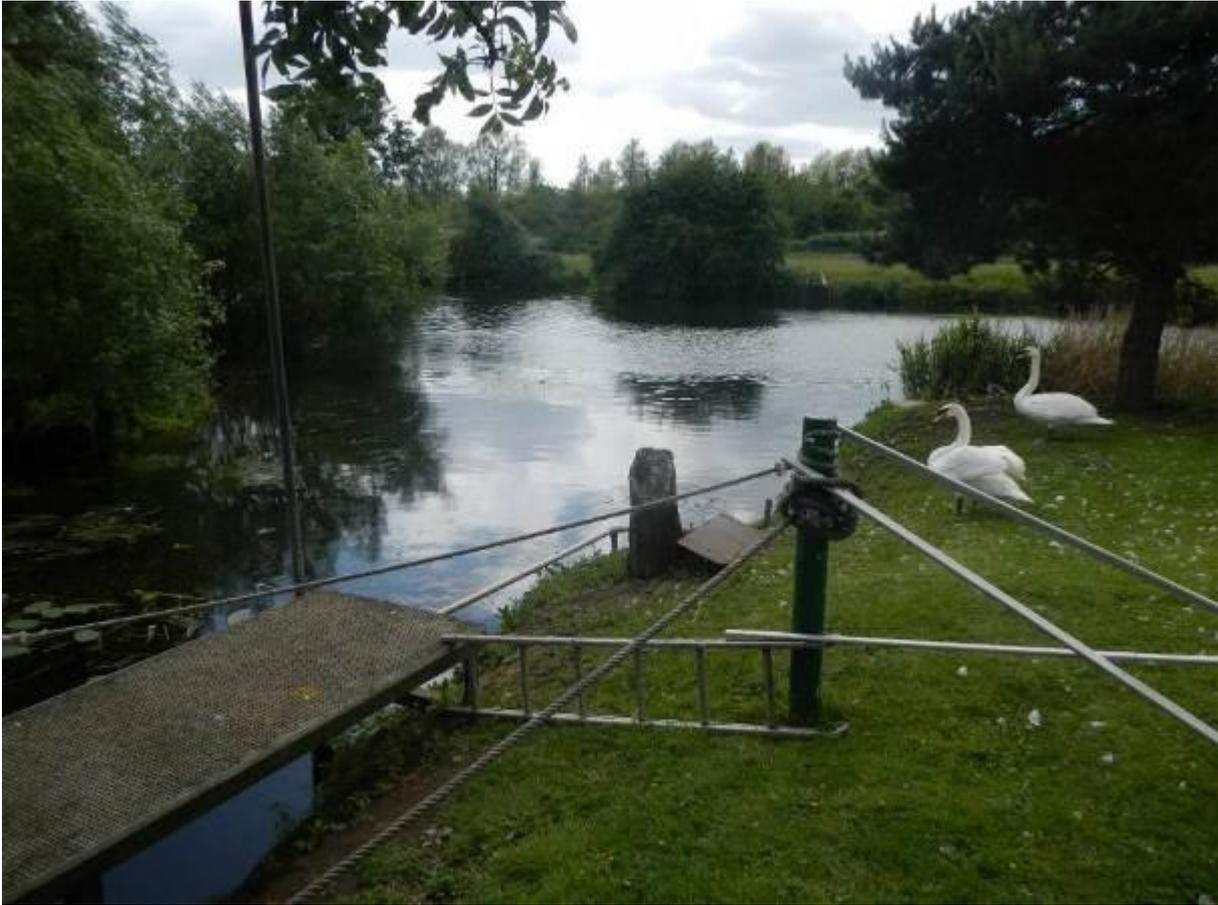
Figure 133. There are no obstructions to fish accessing the brook from the River Avon.
