WILD TROUT TRUST

Bentley Brook (aka Bradbourne Brook)

Derbyshire

February 2024

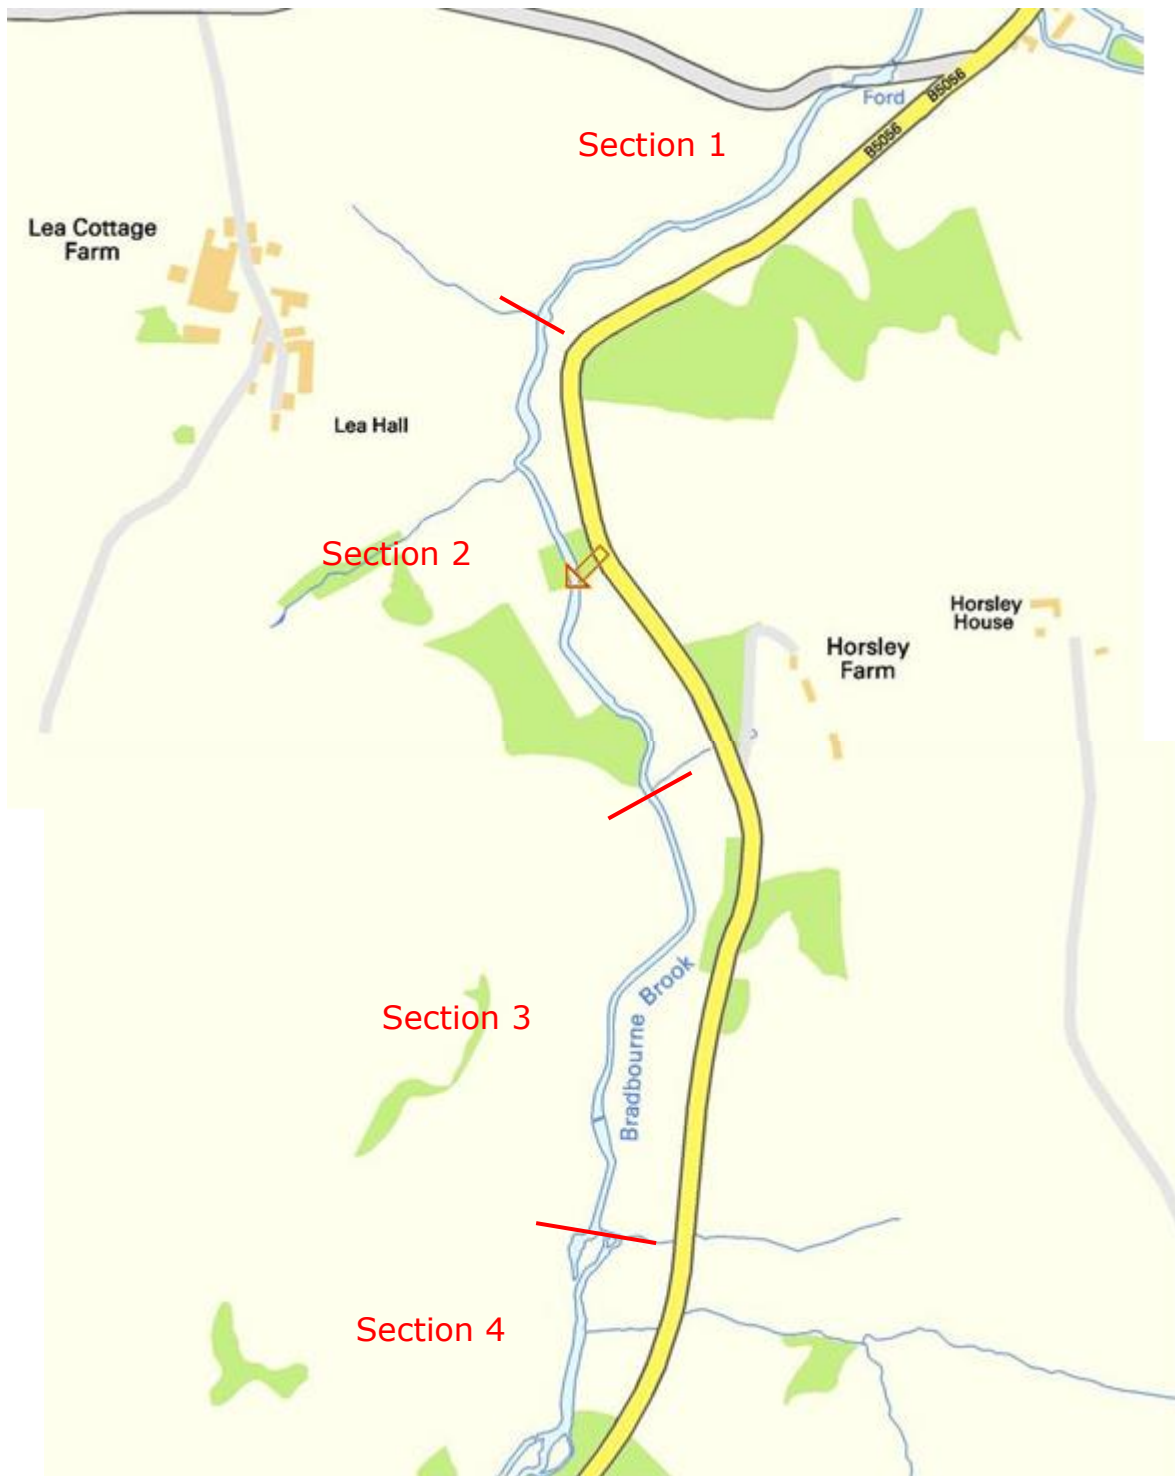
Figure 1 LADFFA waters on the Bentley Brook, split into sections referred to in the text.

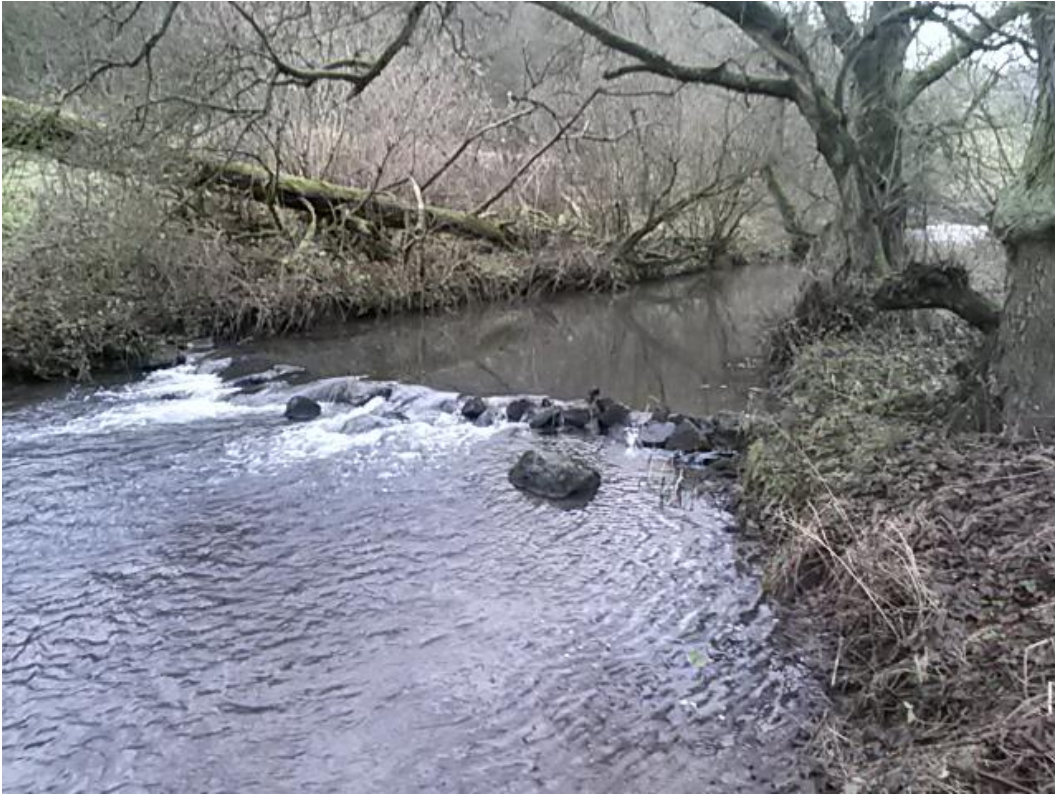
Towards the downstream end of this section is an area where habitat improvement work was carried out previously by WTT in 2015. Figure 14 - Figure 16 show the changes in this area and give an indication of the lifespan of this type of habitat improvement in the Bentley Brook. The coppice re-growth on the RB should be hinged into the brook margins here to create some dense cover; this will improve survival rates of juvenile trout.

Figure 14 Nov 2014 pre-works.

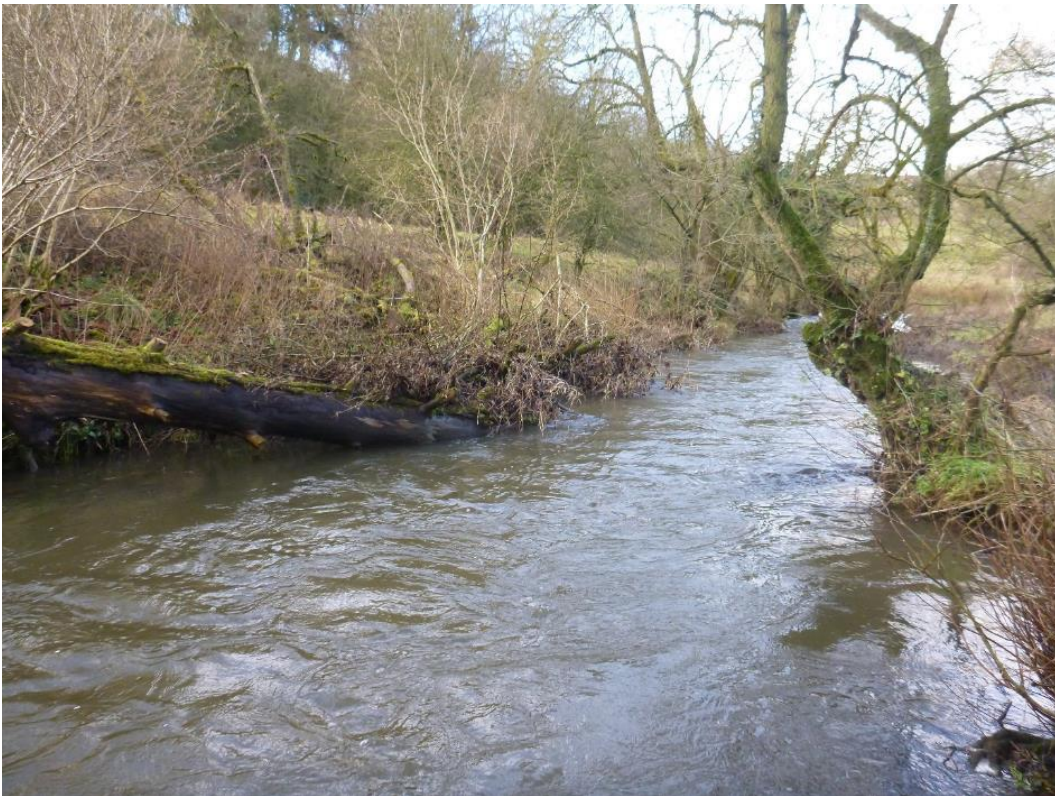
Figure 15 Jan 2016 post-works (completed March 2015). Large trunk winched into the channel and willow & alder trees hinged over to form dense marginal cover.
