WILD TROUT TRUST  
wildtrout.org

Advisory Visit  
River Camel and tribs, Cornwall  
February 24 & March 22, 2022

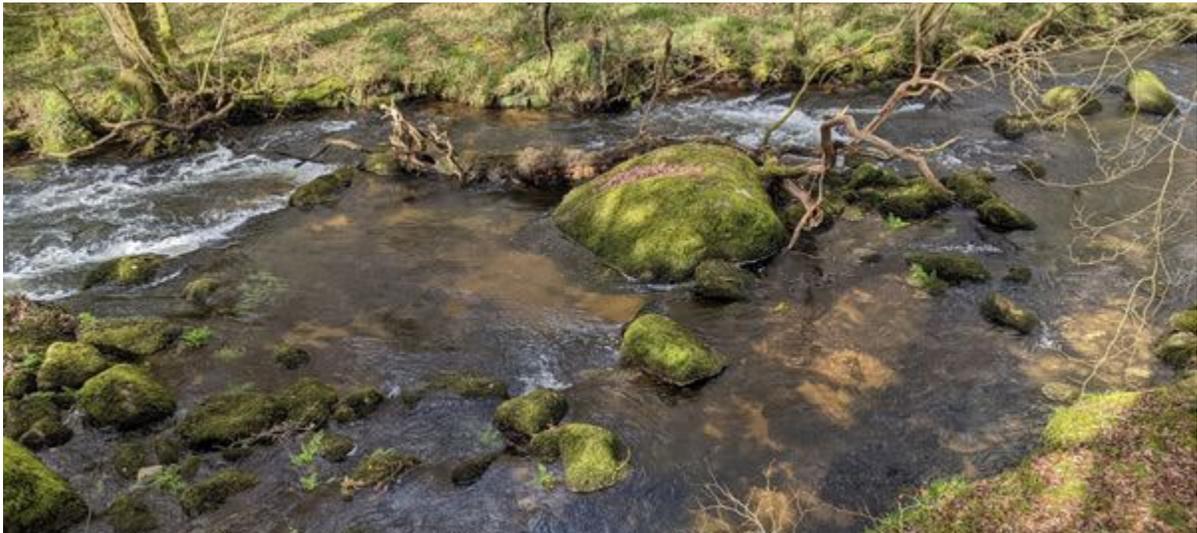
Figure 20 A lodged fallen tree diverts flows over part of a natural fall, creating greater depth and hence passability combined with an upstream resting pool. To remove this tree would average out the depth across the fall and so make them less easy to navigate. -4.6915509 50.540177

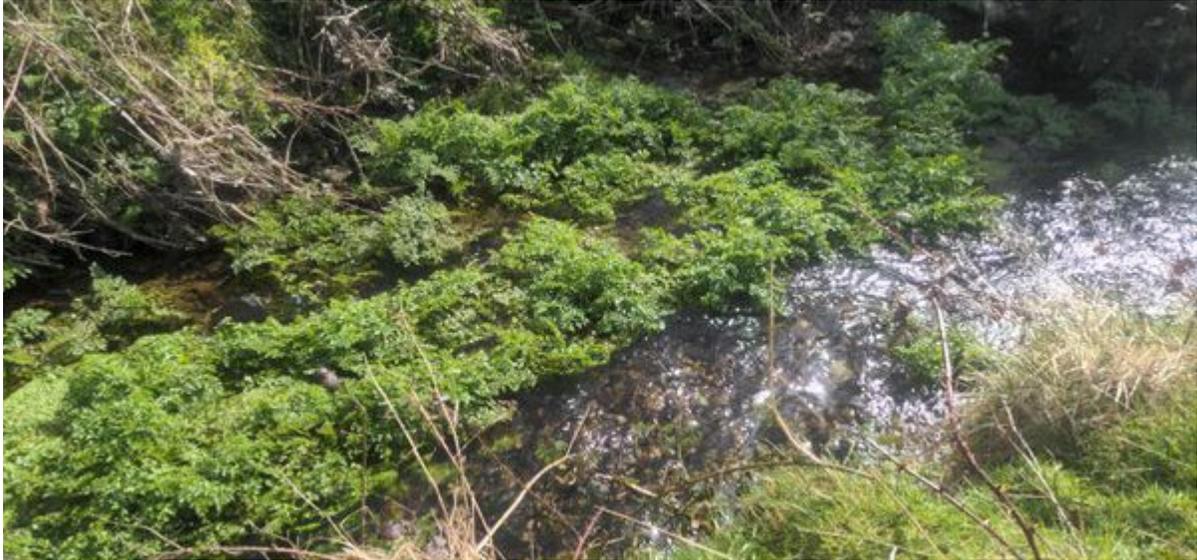
Figure 37 Large stands of hemlock were already established. Note the faster flow on the near side preventing the plant from succeeding. As an in-channel feature, hemlock can provide much needed flow diversity and habitat structure. Where it is deemed out of control, shading and increased flows can re-establish a better balance without the need for labour intensive removal and disposal. -4.673115 50.6459873

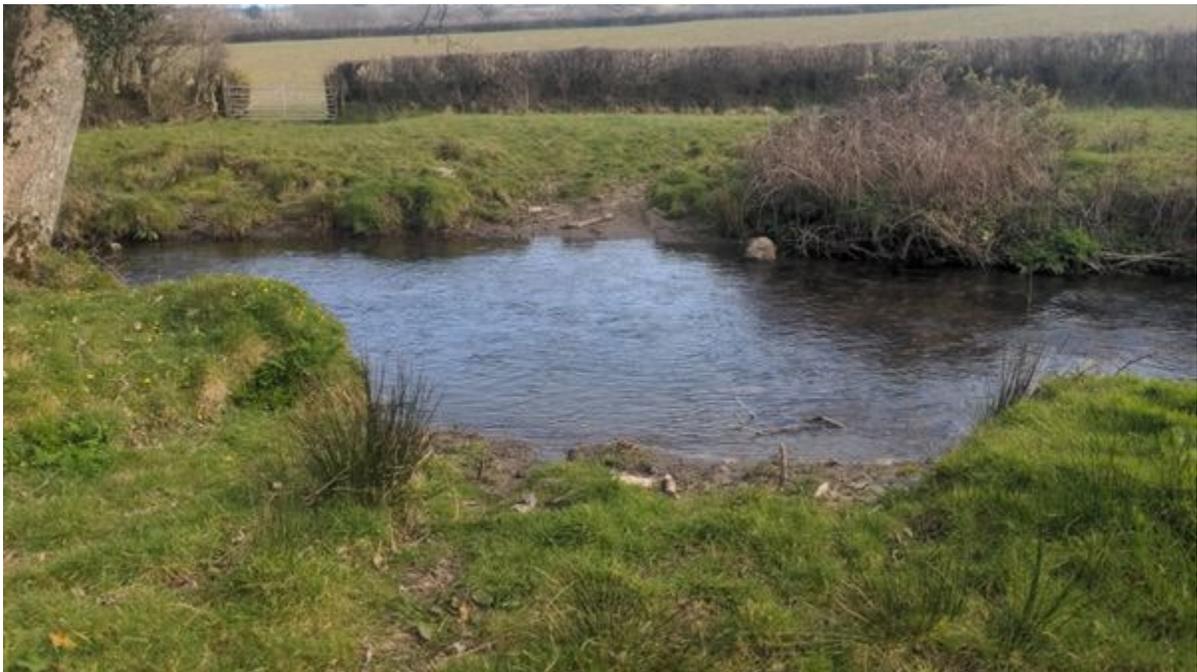
Figure 57 A poorly designed ford. This will be increasing fine sediment inputs. Considering the road bridge is 50m upstream, and this ford appeared to be used by 4 wheeled vehicles, there should be a question of its need before thoughts of better design. -4.6894292 50.5973617

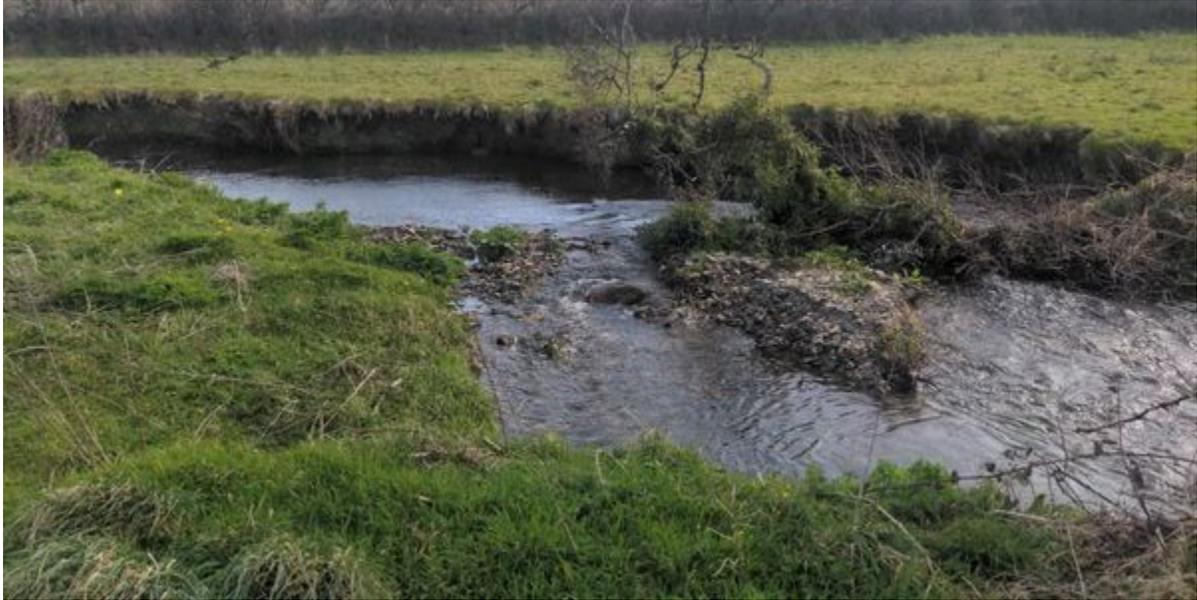
Figure 58 Lack of fencing on the LB is causing faster erosion and land loss. Grass, especially short cropped, does not grow the deep roots of other native plants. This leaves the bank soils untied and easily erodible. Stock fencing, a wide buffer strip and a natural regeneration of shrubs, bramble and ground cover are required. Some tree planting could be employed as well. -4.6898251 50.5971698

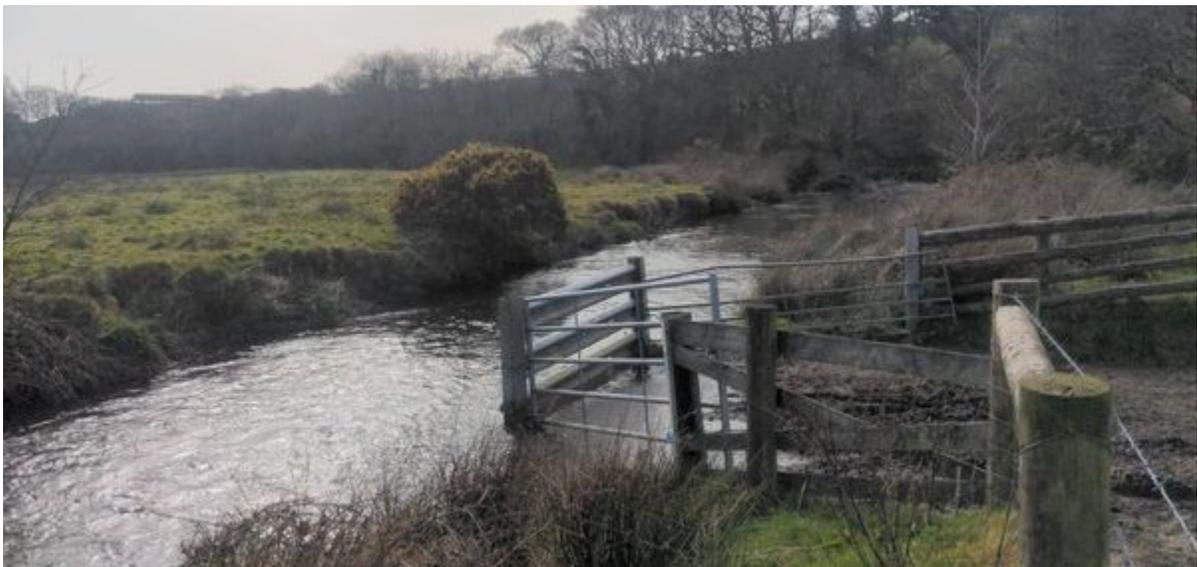
Figure 59 A substantial drinking bay. However, stock entry to the river should be discouraged and other means of watering such as pasture or solar pumps are preferable. In this case, the recent investment is unlikely to be undone, so better cobble standing, running further into the field should be laid. Stock use has turned over the ground and is creating fine sediment pathways to the river. The river here is unnaturally straight and is pushed to the edge of the floodplain. -4.6902015 50.597004

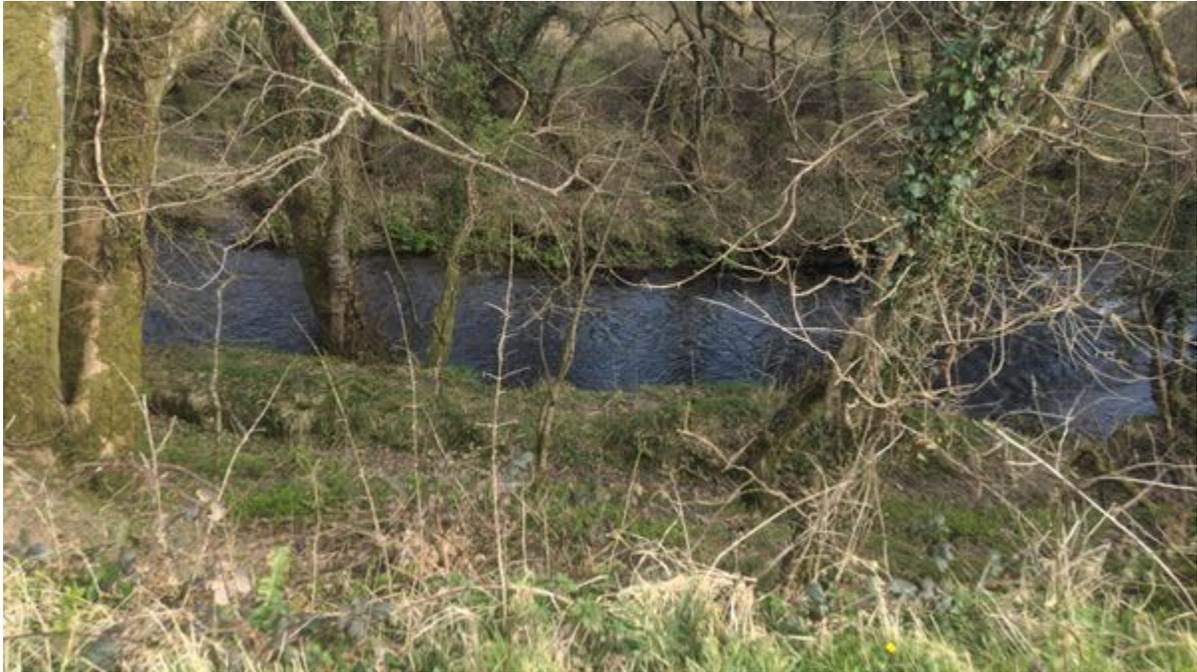
Figure 60 Though well-wooded, the river is straight, shallow and homogenous. No visible channel diversity or in-channel structure was seen. This stretch is not providing good adult habitat and as an angled stretch, could be improved greatly with the introduction of large woody material to provide structure and improve the bed morphology. -4.6919854 50.5954169

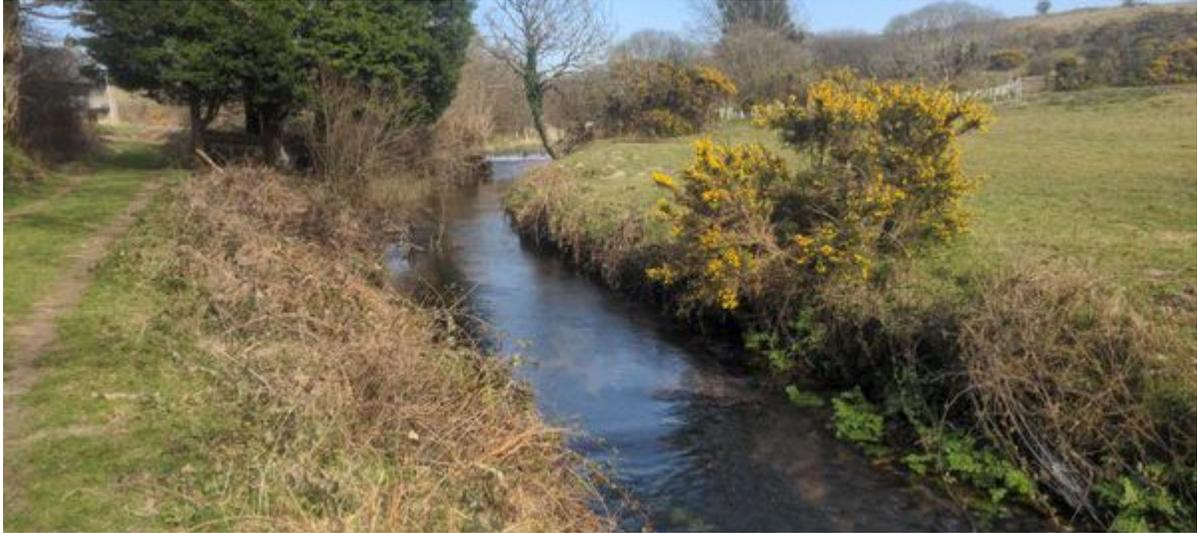
Figure 62 Looking upstream: the LB is occasionally holds cattle, the RB is solely a track. Fencing and a buffer strip on the LB would allow a better marginal fringe to develop, holding the banks together and making room for potential tree planting. The RB could be developed without fencing, but some tree planting would be beneficial. -4.6716676 50.5886926

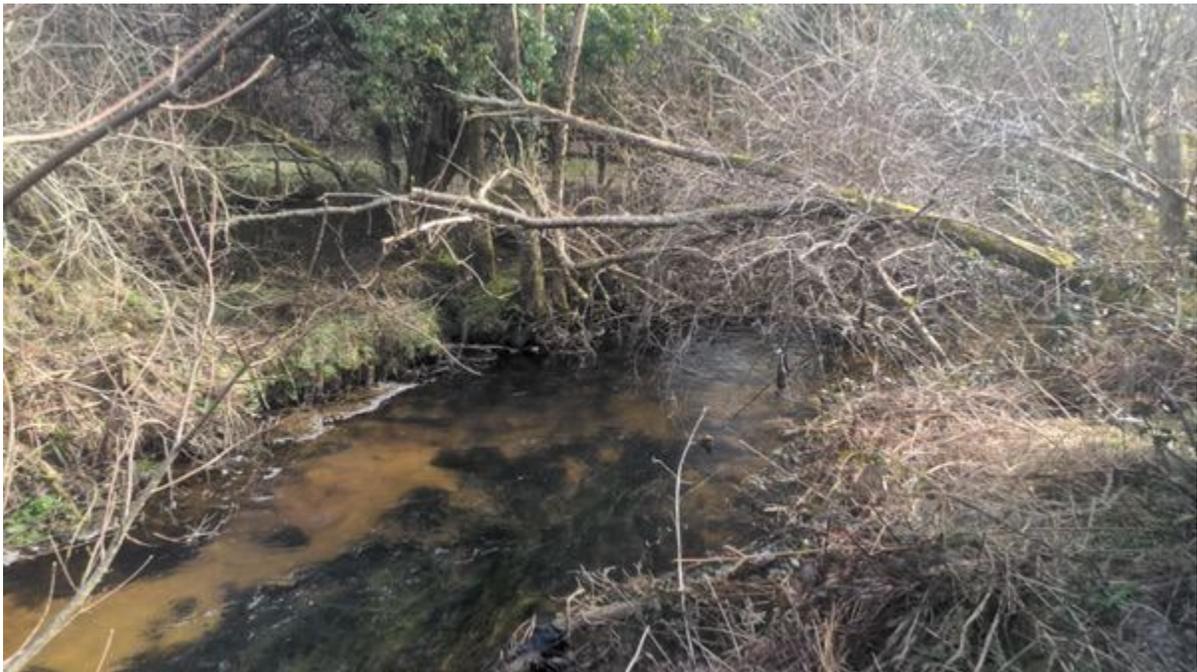
Figure 63 The stream was nicely unmanaged, and this should continue as common practice. Fallen wood like this is beneficial for photophobic trout, giving them shade from the sun. It will have a positive effect on slowing peak flows and provide food for detritivores. -4.6715955 50.588029

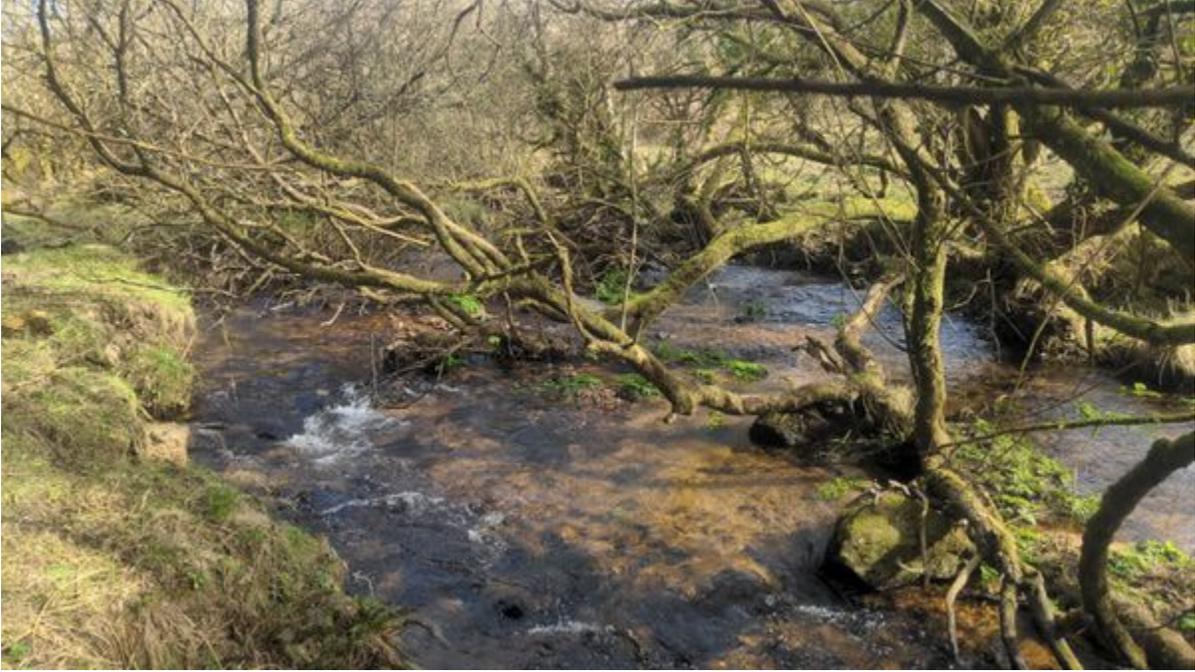
Figure 64 Though the channel appears to be over wide, the bridging trees have displaced the channel and increased velocities, causing beneficial lateral erosion to accommodate the river. This process has created numerous different flow paths, complete with associated habitat niches. Clean gravel was also indicative of the healthy nature of this section. This is an excellent example of prime salmonid habitat.  
-4.672788 50.5871464
