Advisory Visit

R Wharfe & tributaries, Bolton Abbey Estate, Sept 2019

Prof J Grey: jgrey@wildtrout.org

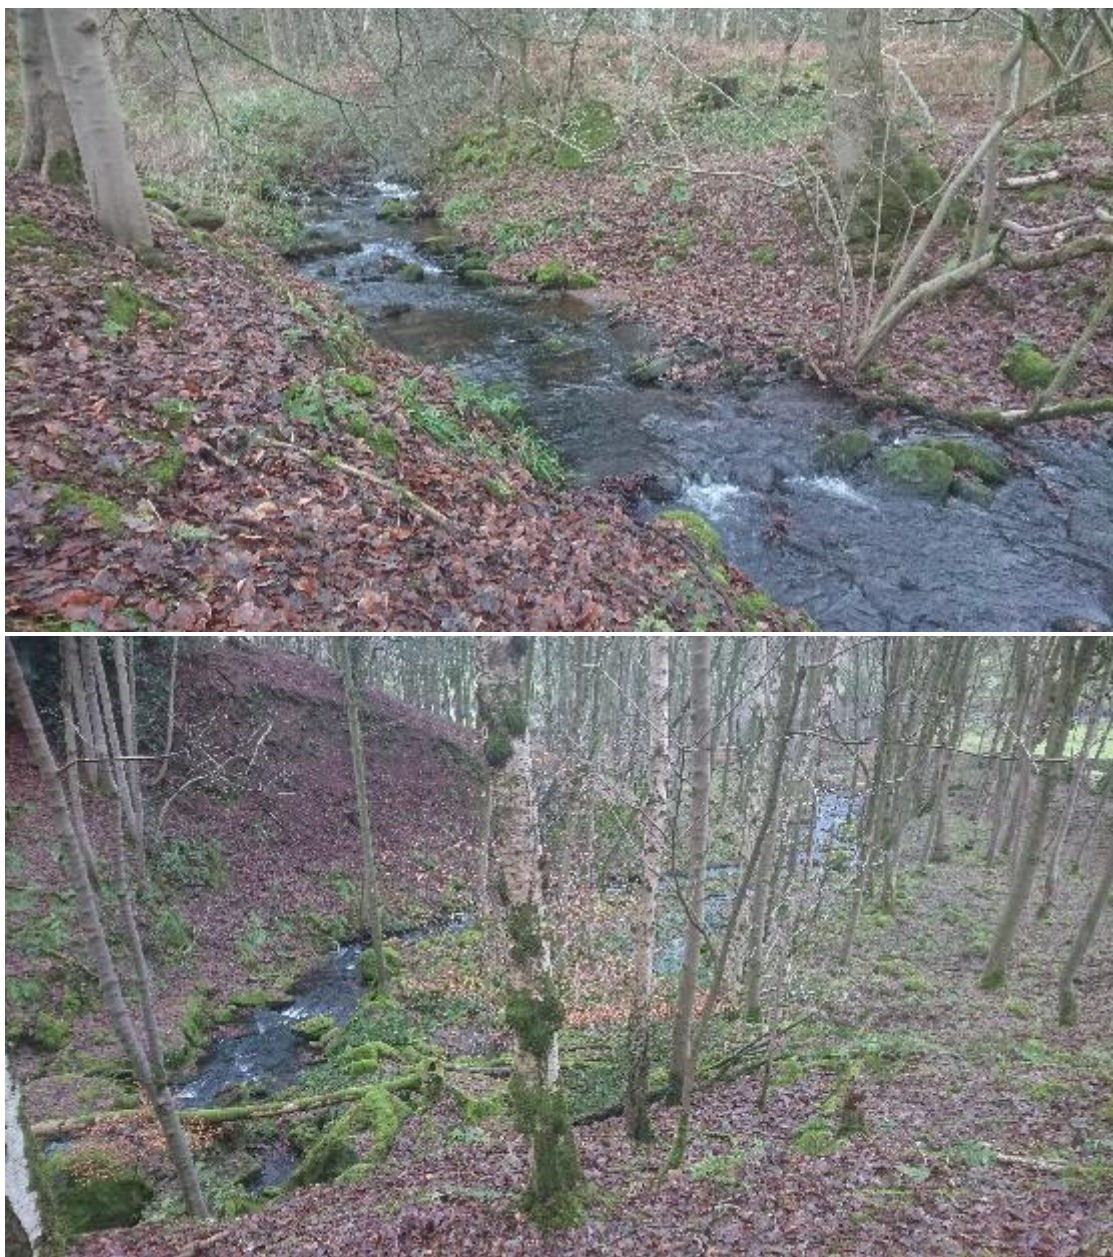
The lower reaches of the beck within the walled wood were also subject to an extremely high canopy and hence understory was sparse except for where trees had been felled for the path of powerlines (Fig 52). The overabundance of tall whippy trunks could be used to improve habitat; felling several in clumps to introduce

Fig 52. The lower reaches of Gill Beck flowed through very tall mixed deciduous trees; only where powerlines passed through the wood was any low cover notable (top left of the upper image).

gaps and thereby encouraging new low understory growth near to the channel while leaving the felled trunks strewn around the channel to mimic natural wood fall and introduce channel diversity (Figs 52 & 53). Keeping more wood in the channel helps to retain and sort the smaller gravel fractions required for spawning, and also further retain leaf litter which underpins much of the macroinvertebrate production. Gill Beck would thus appear a low risk / high reward site for some management interventions (see Recommendations).

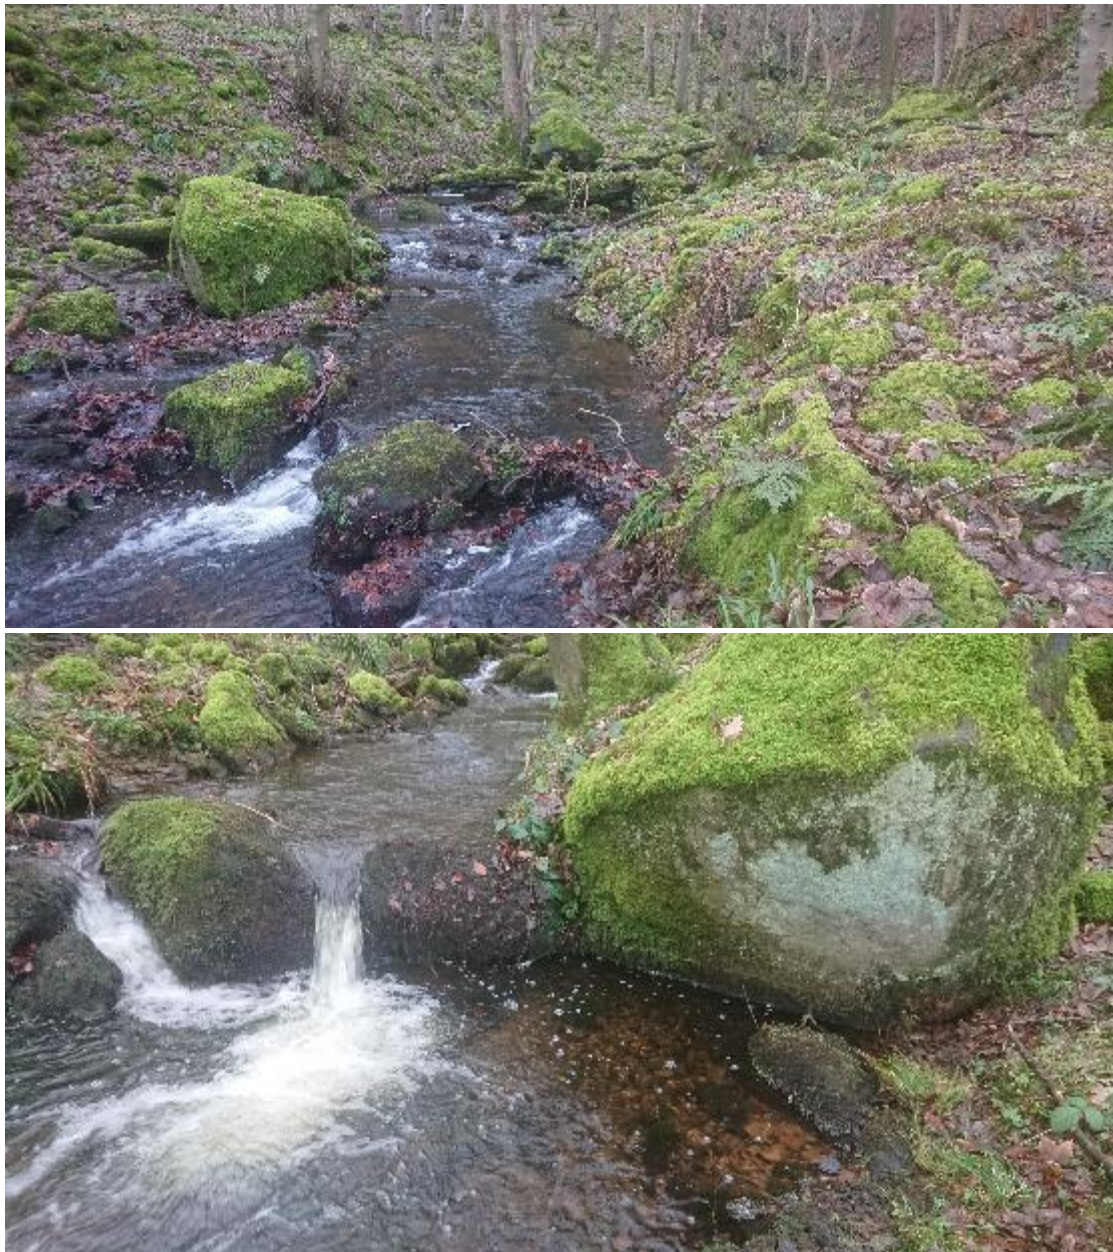
Fig 52. As the valley narrowed and steepened, the character changed to boulders, pools and cascades. Retention of leaf packs and small gravel pockets was notable (upper & lower panels, respectively).
