**WILD TROUT TRUST**  
wildtrout.org

**Advisory Visit**

**Brailsford / Spinneyford Brook, Derbyshire**

**January 2026**

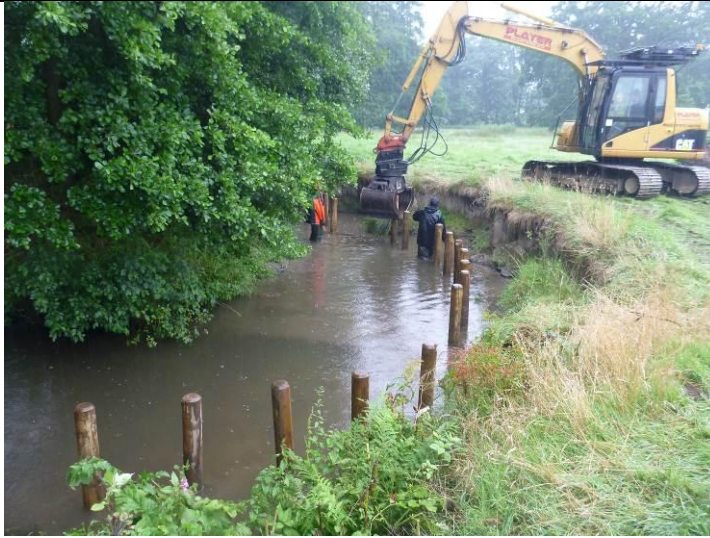
**Photo 7 July 2017**

The works carried out to stabilise the eroding bank in 2017 using posts and alder root plates has prevented further erosion, but has not colonised with self-seeded trees as anticipated ([Photo 7 - Photo 10](#)). As mentioned above, allowing a strip of coarser vegetation and trees to develop along the right bank will contribute to its longer-term stability. The protruding posts at this location could be cut off at water level to improve the aesthetics, with one or two retained as anchor points for lodged woody material (see [Appendices](#)).

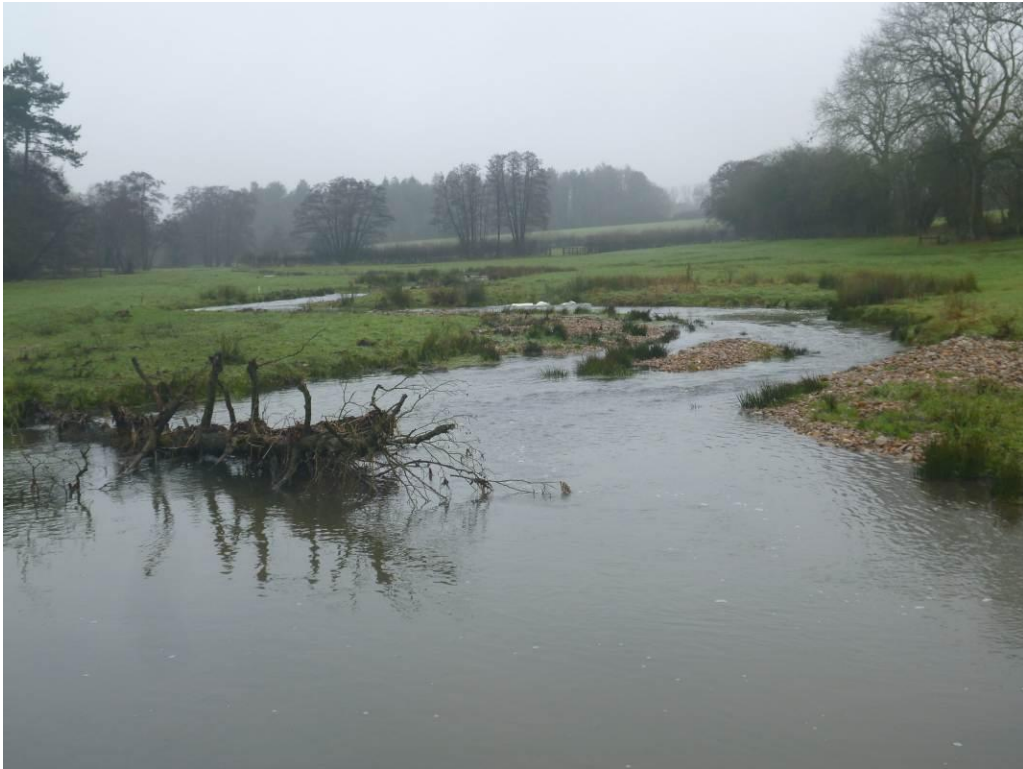
Longmeadow is the location of the restoration project carried out by the Estate in 2025 involving realignment of the channel to the valley bottom east of its previous course. The lower part of the restoration ([Photo 14](#)) was constrained by the historic impoundment to feed the mill leat (as described above) and hence is relatively low gradient compared with the upper section ([Photo 15](#)). The project has created some excellent habitat and restored natural processes, including a pool-riffle sequence, well-connected floodplain, and large woody structures. The key to maximising these benefits will be encouraging the development of a treelined watercourse with diverse marginal and riparian vegetation to provide plentiful shade and cover for all trout life stages.

**Photo 14 Upstream view of restoration project, Longmeadow.**

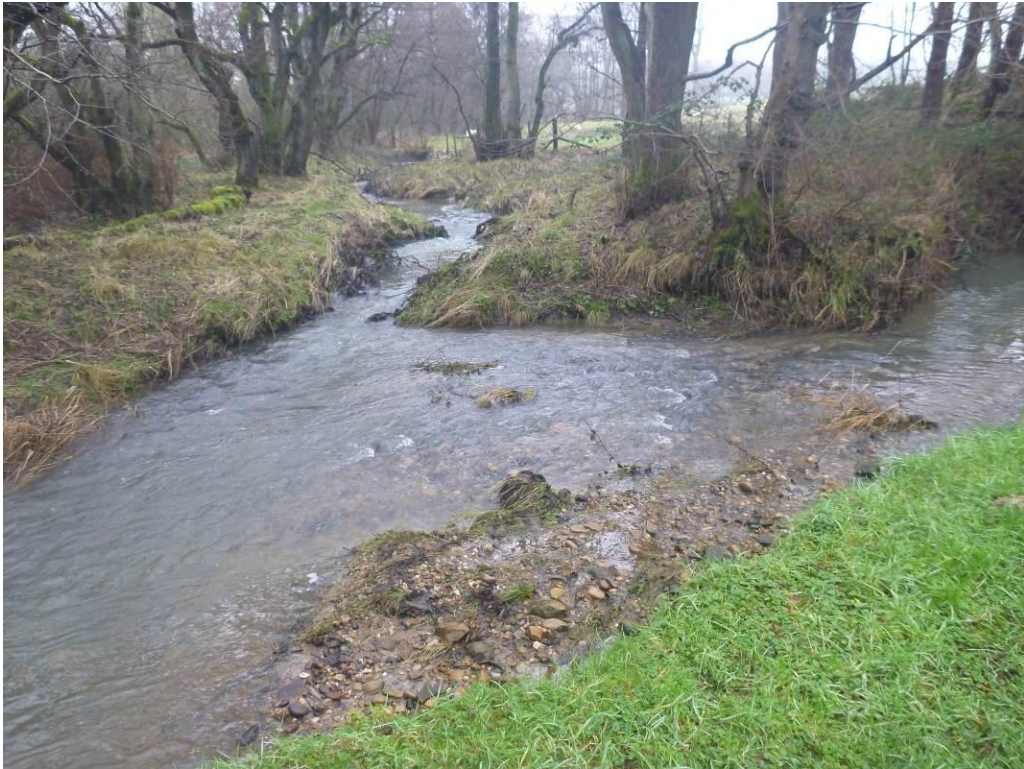
**Photo 26 Confluence of Bradley Brook (left) and Spinneyford Brook (right).**

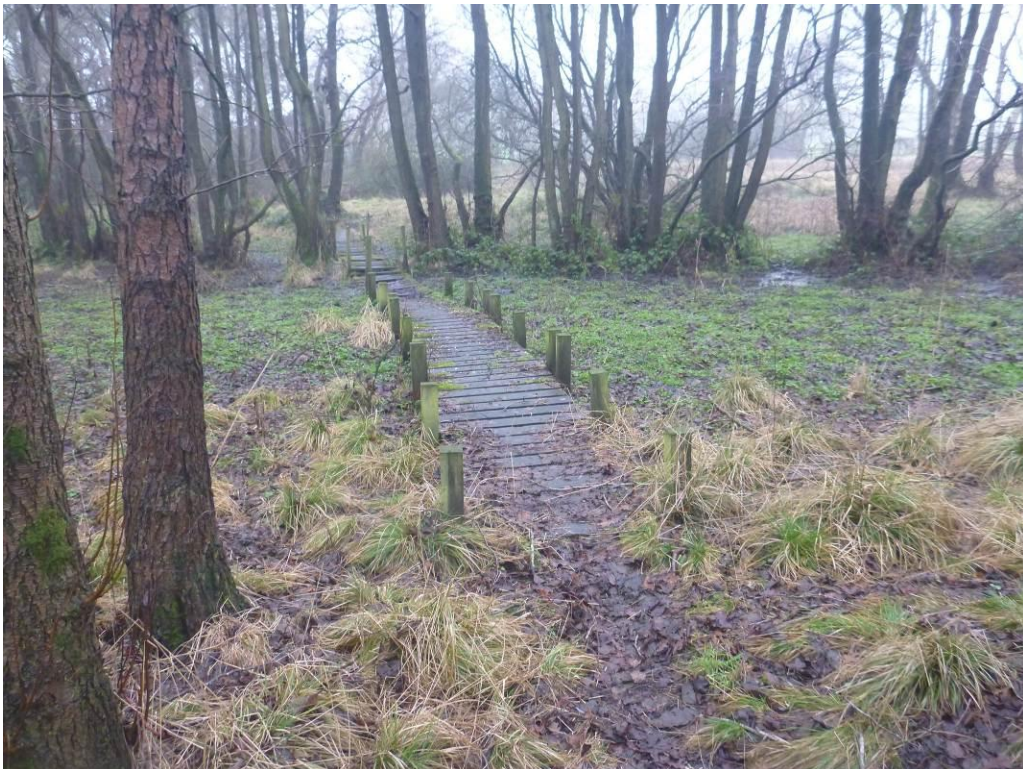
**Photo 51 Well-connected, high quality floodplain habitat (lowland fen). Public footpath on raised walkway.**

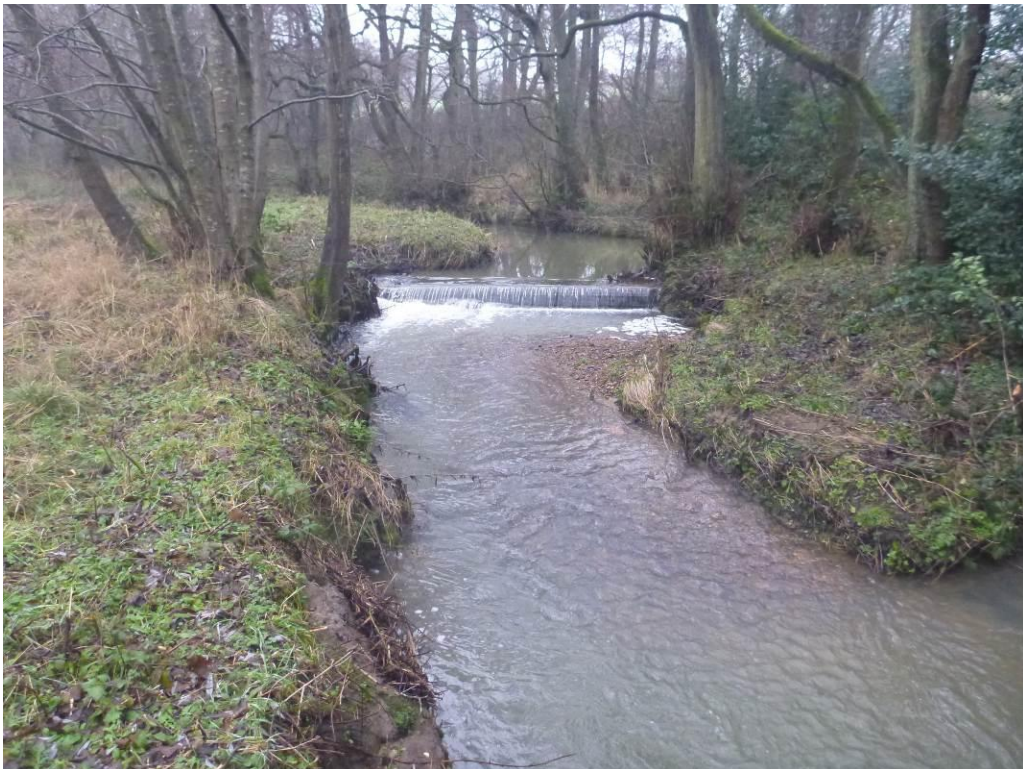
Beyond the impounded reach above Secret Lake (Photo 50), the brook has generally good in-stream habitat which is compromised by the presence of multiple low weirs. The weirs are in various states of repair, of similar construction (hollow concrete panels) to those found elsewhere on the Estate and now largely removed (Photo 52 - Photo 53). The brook is bordered by high quality riparian habitats as recognised above (Photo 51) and crossed by a public footpath which includes wooden walkways and a footbridge.

**Photo 53 Typical weir within this section, constructed from hollow concrete beams.**

It is recommended that the weirs are removed to reinstate natural river processes and realise the potential for excellent in-stream habitat here. This must be done with proper regard to the Local Wildlife Site (LWS) and its irreplaceable habitats, and it is recommended that a method statement is developed in consultation with interested parties – Derbyshire County Council is responsible for both the Local Nature Recovery Strategy (LNRS) and issuing the Ordinary Watercourse Consent which is required for weir removals. Derbyshire Wildlife Trust are a partner in the LNRS and would be a good starting point for consultation.

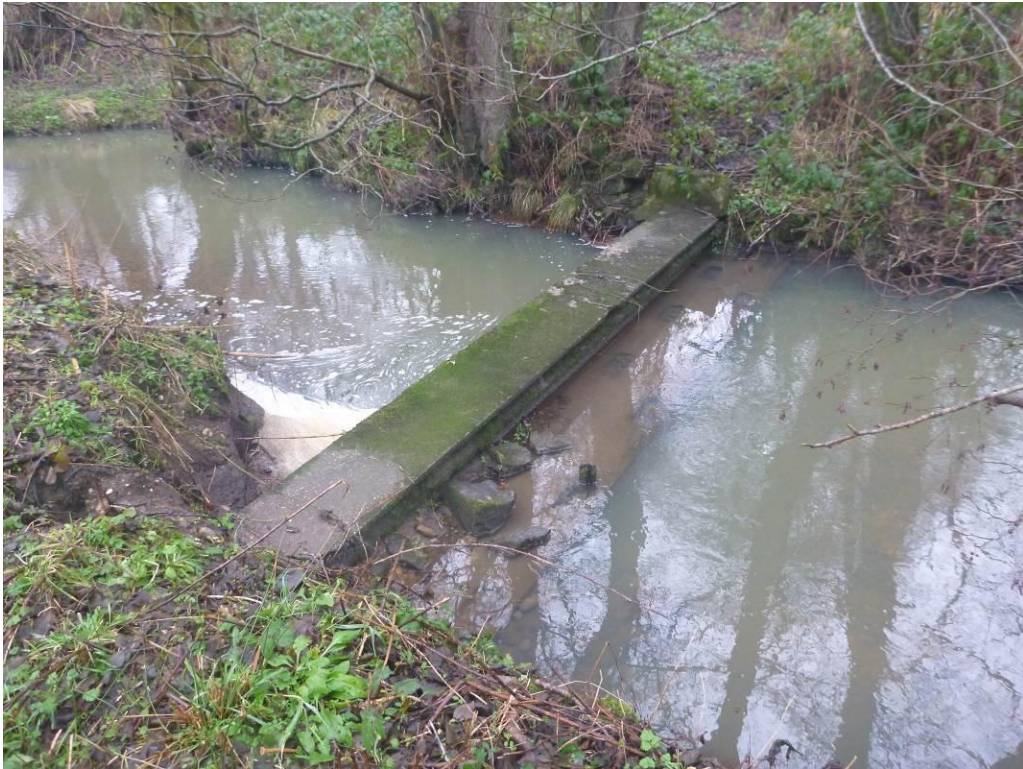
**Photo 54 Partially breached weir.**

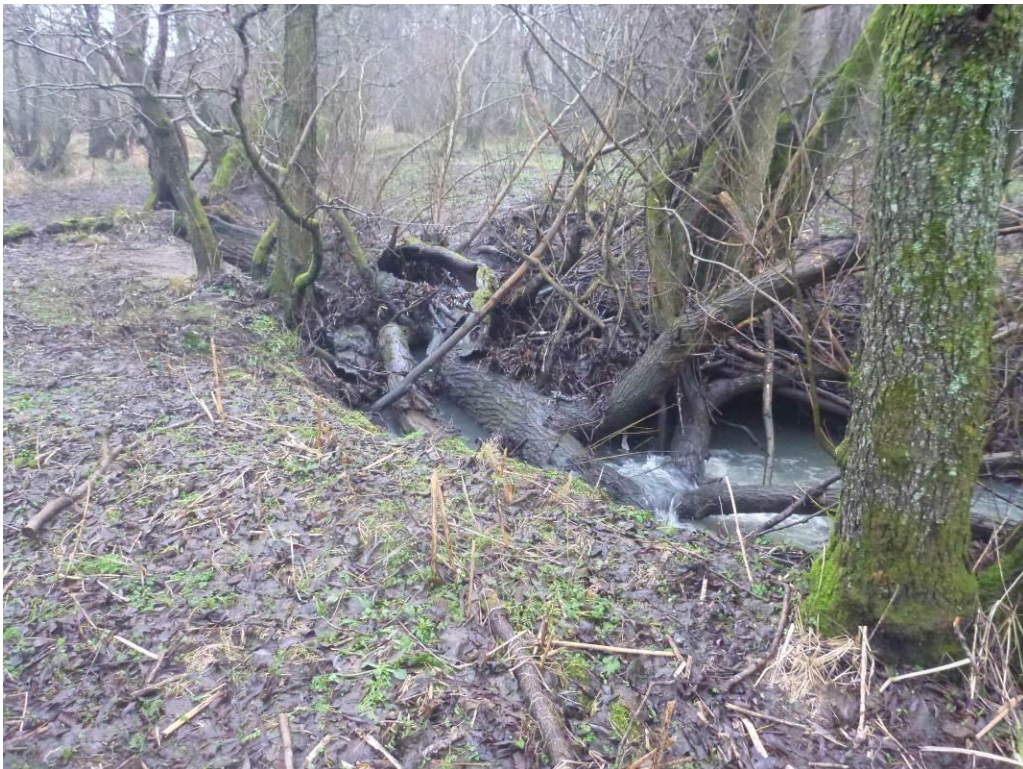
A good example of a natural LWM accumulation is shown in Photo 55. Naturally occurring features such as this should be retained.

**Photo 55 Natural accumulation of woody material, providing multiple habitat benefits and promoting floodplain connection. This structure appeared passable to fish at the time of the visit.**
