## WILD TROUT TRUST

### **Advisory Visit**

**Gilling Beck, R. Swale, Gilling West Fly Fishers, April 2021**

**Prof J Grey: [jgrey@wildtrout.org](mailto:jgrey@wildtrout.org)**

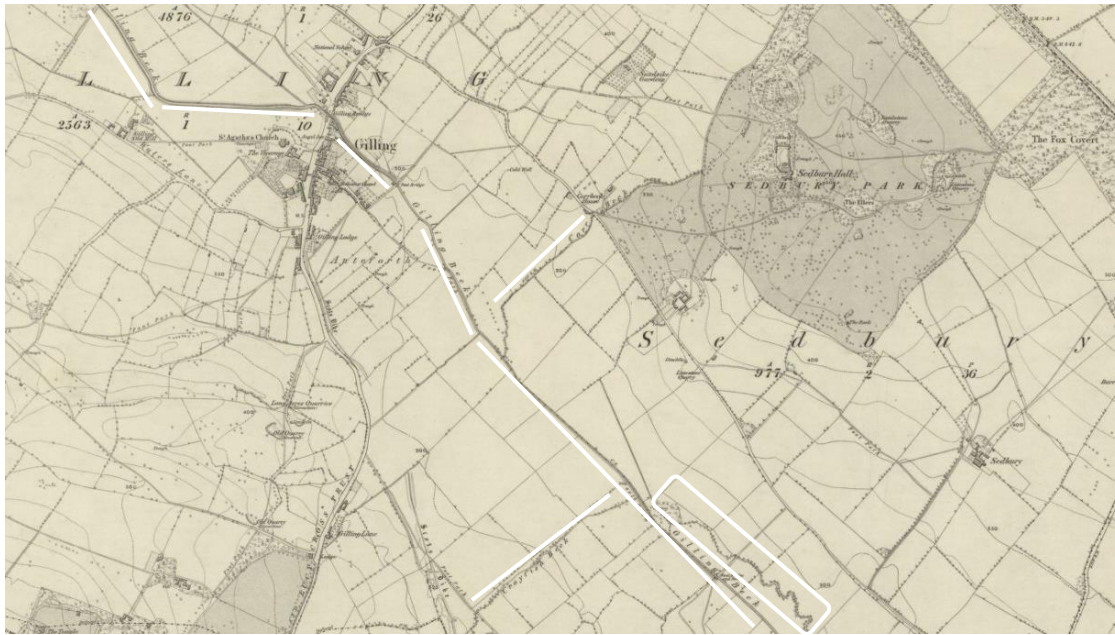
Earliest mapping of the river clearly showed extensive straightening before the 1850s (Map 3).

**Map 3. From the Ordnance Survey of 1848, Gilling Beck and its various tributaries had already been realigned and straightened to promote agriculture (highlighted by white lines). A small section of the original dynamic and meandering channel was still visible then but already bypassed (white rectangle). Reproduced with the permission of the National Library of Scotland.**
