The River North Wey

Venue: Lower Neatham Mill, GU34 4NP.

Advisory Visit, 26th June 2025

By David Oakley, Conservation Officer, WTT doakley@wildtrout.org

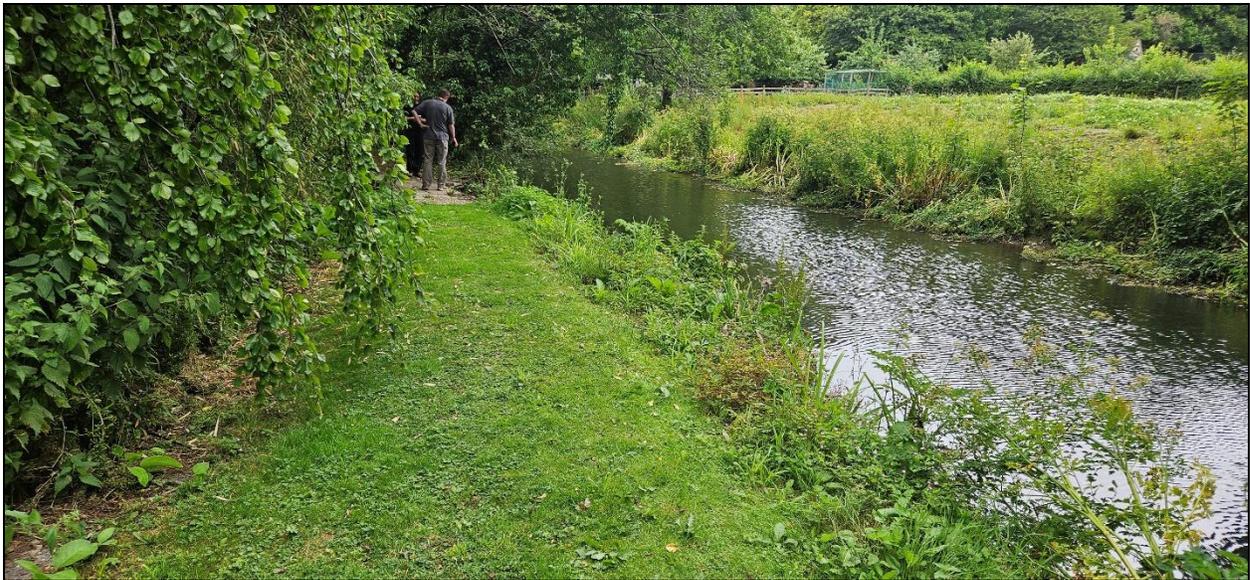
The left bank was managed by the owner and regularly mown to create a grass path alongside a narrow strip of marginal growth by the river, see front page photograph. The right bank was in different ownership. At the d/s end, opposite the mill, the whole bank formed part of a garden. It was regularly mown and any marginal growth removed. See Fig 6

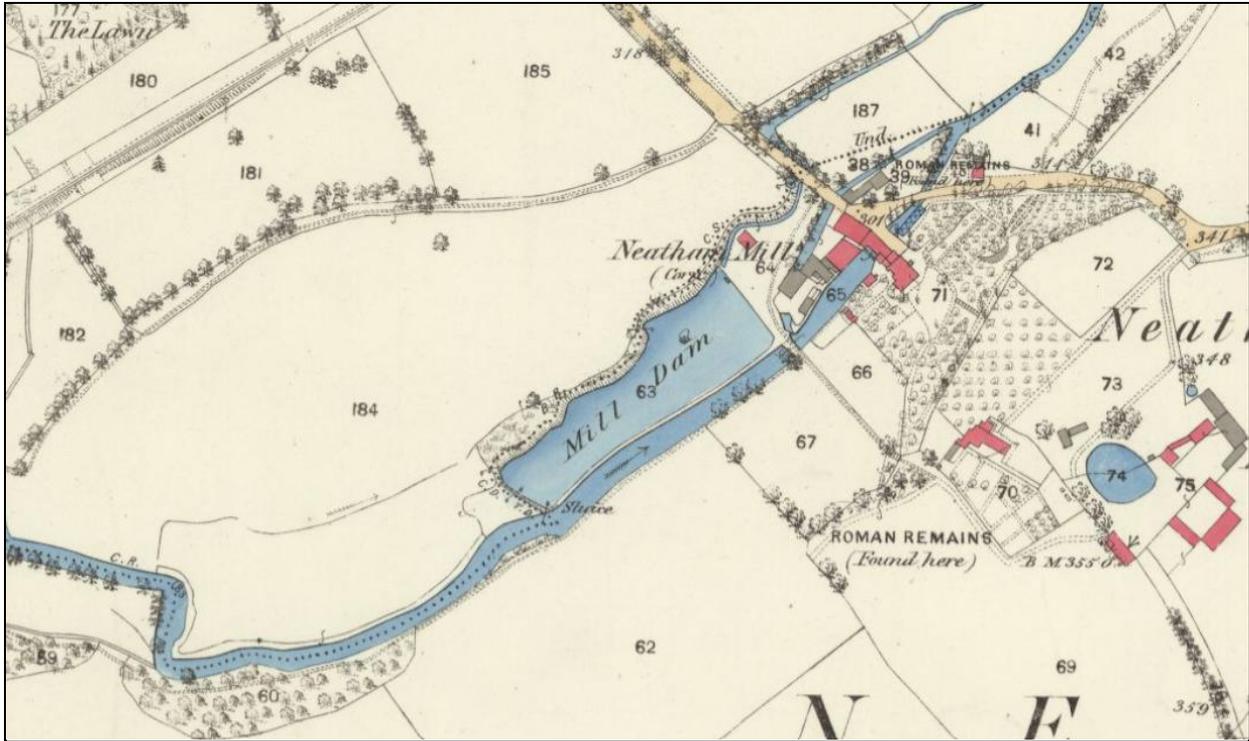
Map 2 OS extract from 1871

In order to ascertain what alterations can be made to improve the current river habitat, we need to understand what has happened to the river in its past. The oldest available OS map is from 1871, see Map 2. It clearly shows a large mill lake, alongside the impounded leat. This feature is present on all subsequent OS editions up to 1946, see Map 3. Here the mill lake appears to be filling up with silt and becoming more of a marshy area. It is not present at all in later editions, only featuring as a residual pond and drainage system. See Map 1. This drainage system has subsequently been connected into the main river channel to form the BPCs, (not shown on the map). This implies the ground below the BPCs will be very silty and possibly made up. Also, the take offs are likely to be of a nonstandard construction see fig 5.

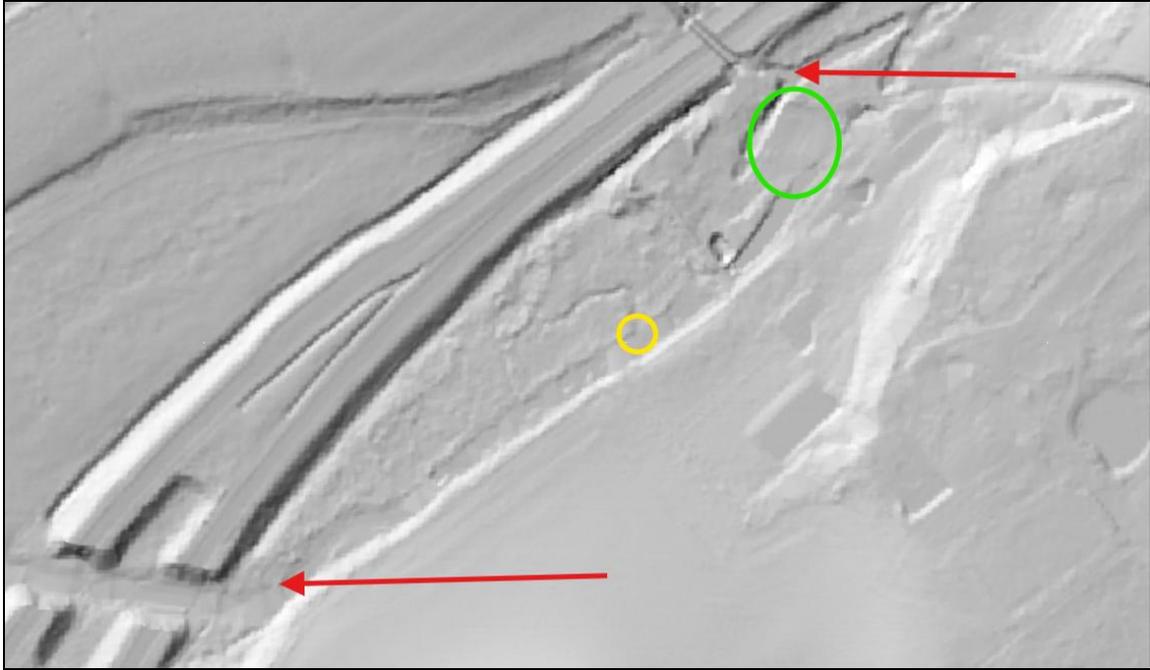
Map 4 LIDAR image of the area inspected.

Ground penetrating radar images, Laser Imaging, Detection, and Ranging (LIDAR) of the area reveal very little detail, see Map 4. The poor imaging is probably due to the made-up nature of the ground, however the mill buildings are circled in green and the BPC off-take in yellow. A smaller scale plan of the area, see Map 5, demonstrates how clearly the river channel is visible d/s (the area within the blue line) due to the river being more natural, pools, riffles and glides with riverbanks to match, rather than a perched channel.

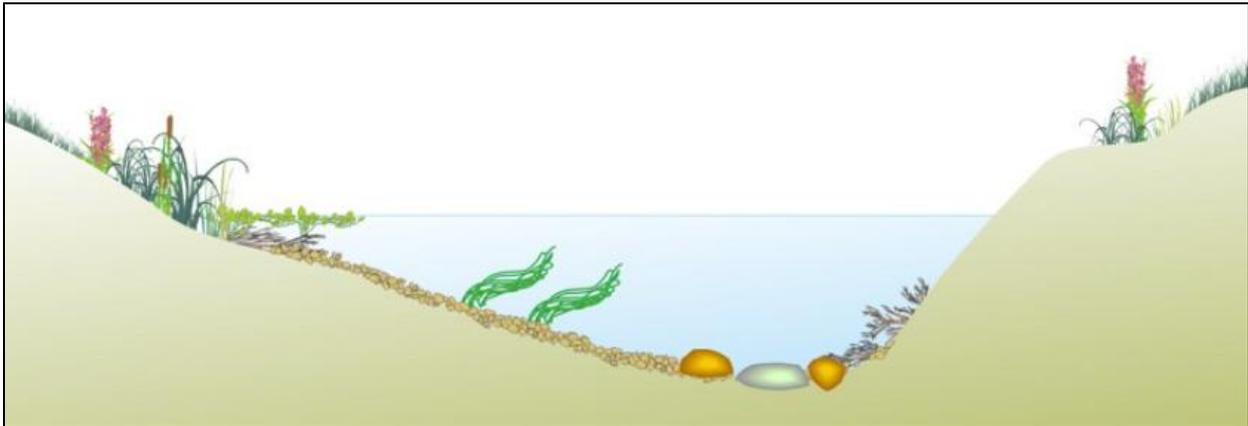
Dia 2 A natural riverbed with varied cross section, providing numerous habitat niches.

The perched and artificially created channel has steeper, deeper banks, without the usual gradual sloped banks required to allow a healthy mix of riparian plants to establish. See Diagram 1. A cross section of a naturally flowing river is shown in Diagram 2. This would be achievable if the river were to be relocated.

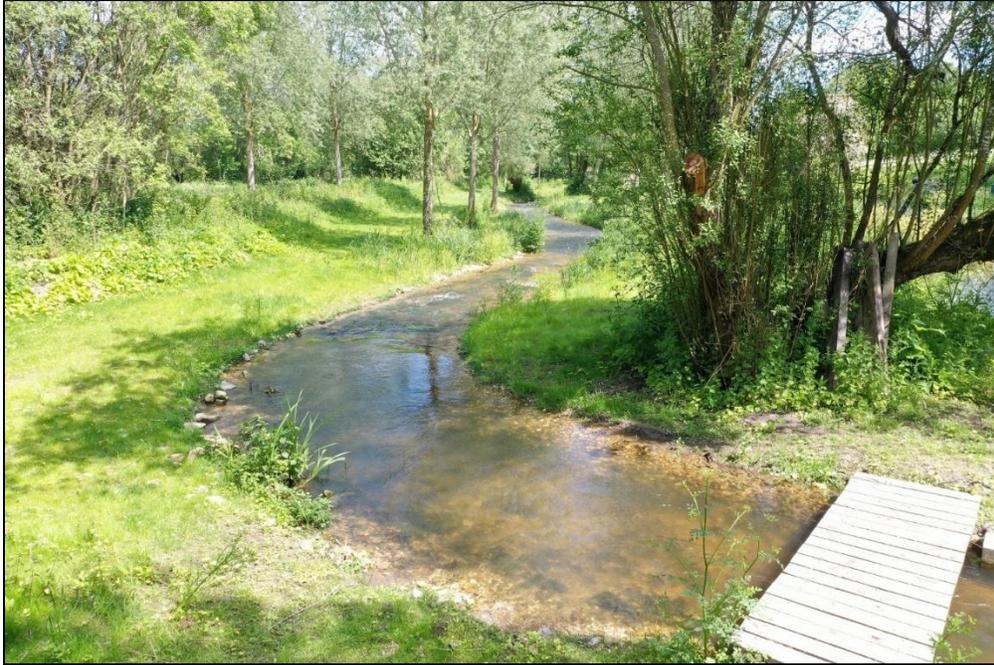
Fig 8. A photograph of a newly created channel with a natural sloping bed.

Ideally all of the sluices would be removed (Listed Building Consent would be required to do this) to re-establish a more natural flow to the river, allowing up and down stream migration of any fish species, and a natural d/s movement of sediment. However as the main channel is artificially high, it would be difficult to improve its morphology, instead a new channel should

be cut through the adjoining land/woodland creating a more sinuous channel with gradual gradient down to below the mill, effectively bypassing all of the mill's infrastructure. (This has been achieved on other rivers, with substantial grant aid available, and the results are tremendous. See fig 8,) This ideal solution would require numerous land owning interests to join forces and agree a change in the river's route, and should be seen as a longer term aim. With the channel redirected the existing mill leat could be retained as a backwater. The new channel could start at NGR SU 73712 40543 as shown in Fig 9.

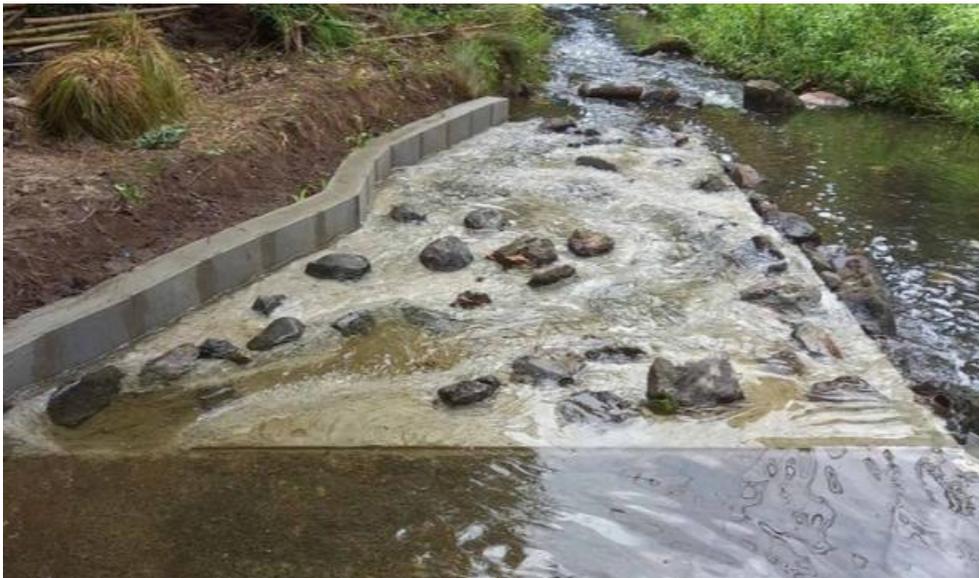
Fig 10, Stones retrospectively fitted to a concrete spill way to create diversity in flow

With the increase in flow, the BPC may need some bank stabilization works, and there is potential in augmenting the existing gravel riffles with more stone. For the lower section of the BPC, installing a series of baffles of wood or stones on the concrete cill would create a variation in flow, aiding fish passage, and they would also enable some gravels to accumulate making a more natural environment. By creating a pinch point at the mouth of the BPC, it will speed up the flow, making it a more desirable route for the fish to follow upstream. See Fig 10
