**WILD TROUT TRUST**  
wildtrout.org

**River Mells and tributaries, near Frome, Somerset**

**Wild Trout Trust report following an Advisory Visit on 28-29 June 2022**

**Undertaken by Theo Pike: [tpike@wildtrout.org](mailto:tpike@wildtrout.org)**

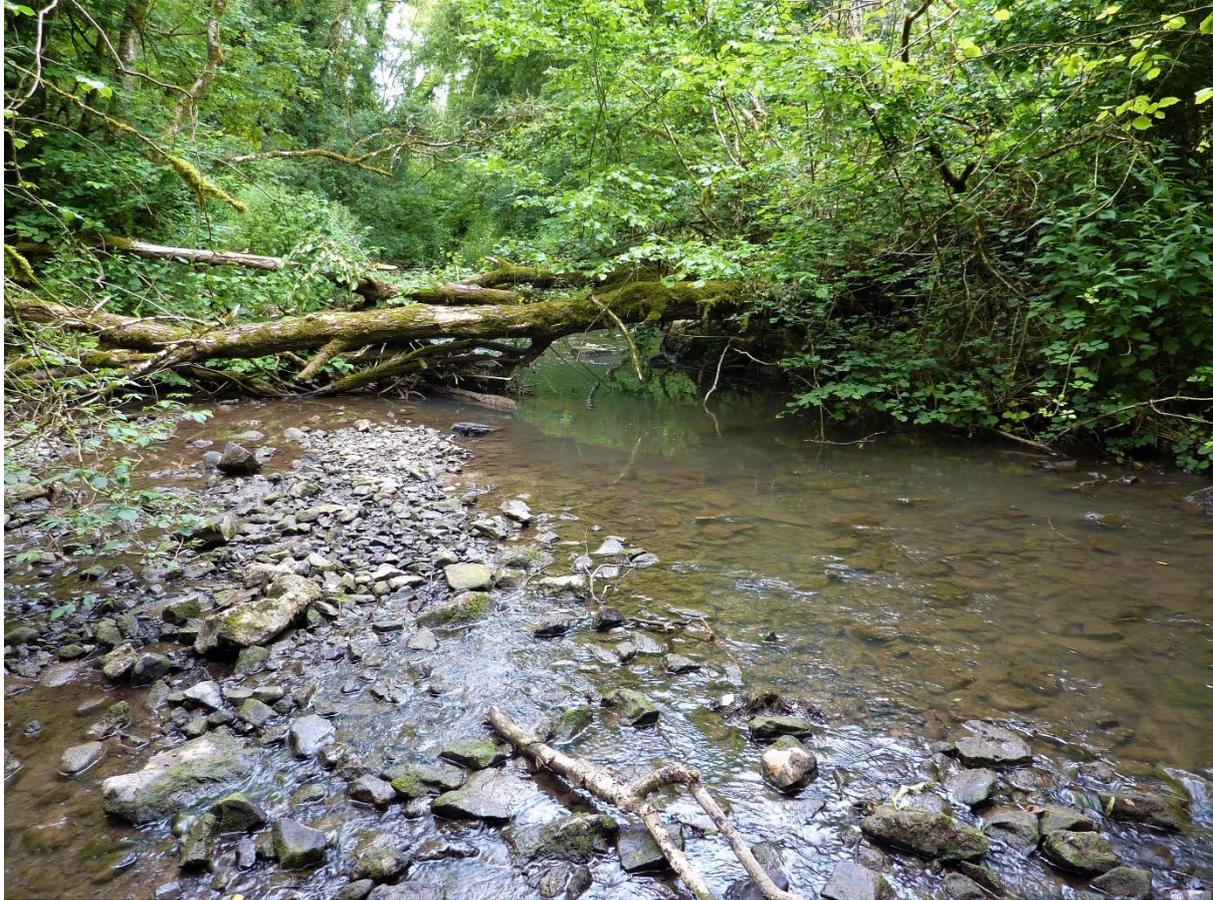
*Figure 6: Naturally-occurring Large Woody Material (LWM) is a huge asset to habitat diversity on the River Mells.*

An exceptionally good example of such beneficial Large Woody Material (LWM) in action is shown in Figure 6 above: a tree has fallen across the full width of the channel, focusing flows towards the LB. Here, a deeper scour has formed under the trunk, with a plume of gravel ejected downstream: the scour has created a refuge for adult fish, even in lower flows, while the gravel plume provides a spawning area. There is also a plethora of low, trailing cover along the LB.

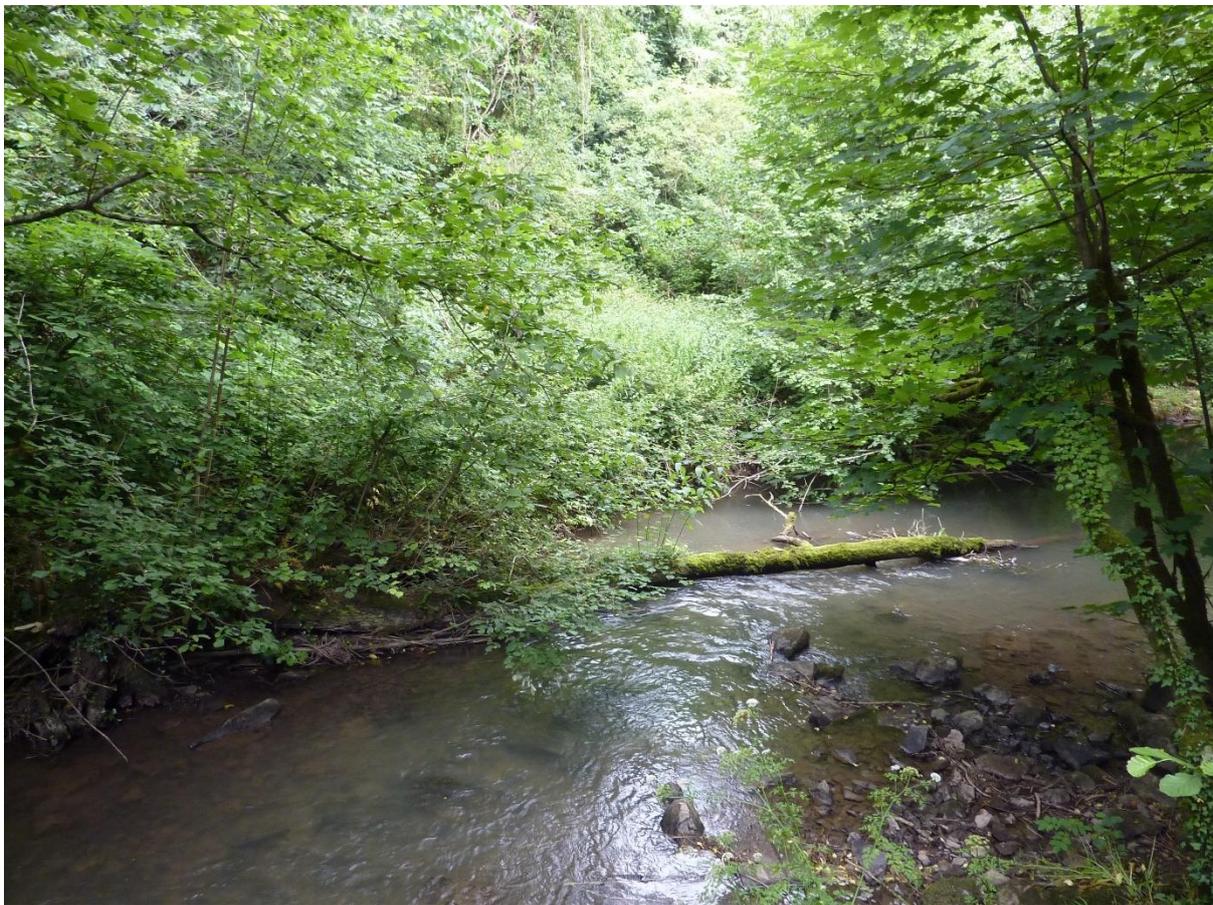
*Figure 11: A stable piece of LWM in a classical 'angle of repose' with root ball upstream and crown downstream.*

Just upstream of the railway bridge, it was also observed that an alder tree, which had fallen into the river several years ago (pers. obs.), had remained in position since that time without showing any signs of moving further downstream.

Some smaller branches had broken off, but the main trunk was still lying in a typical, hydrologically stable 'angle of repose' with the root ball upstream, and the crown downstream. At least one trout was seen moving in and out of its shelter.

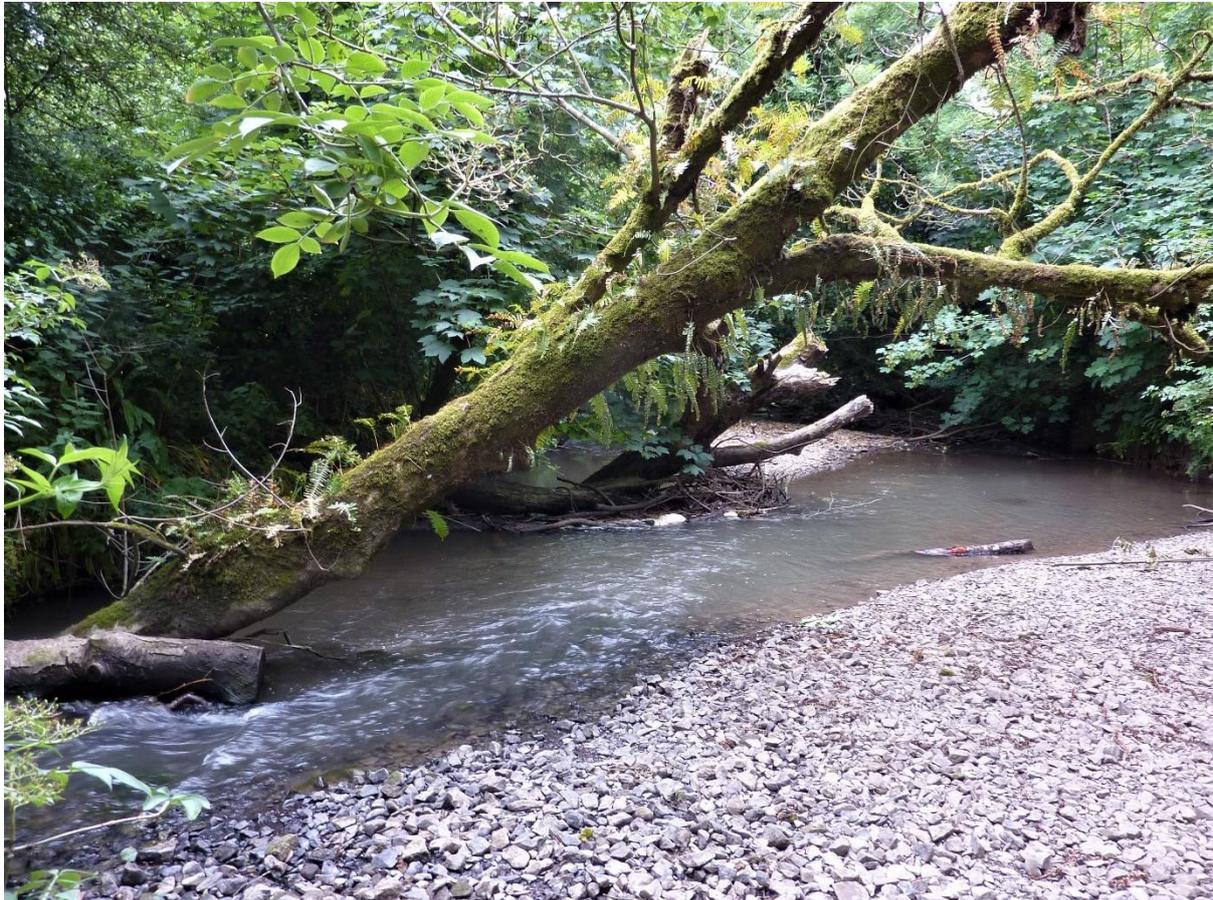
*Figure 14: Further excellent examples of dynamic LWM in action.*

Moving a short distance downstream from the dog dipping bank, more examples of the very positive influence of LWM on river processes were noted. Possibly as a result of historic interruption of sediment transport in this area, significant deposits of gravel were evident, with comparatively deep, narrow, sinuous channels and scour holes created by dynamic accumulations of LWM.

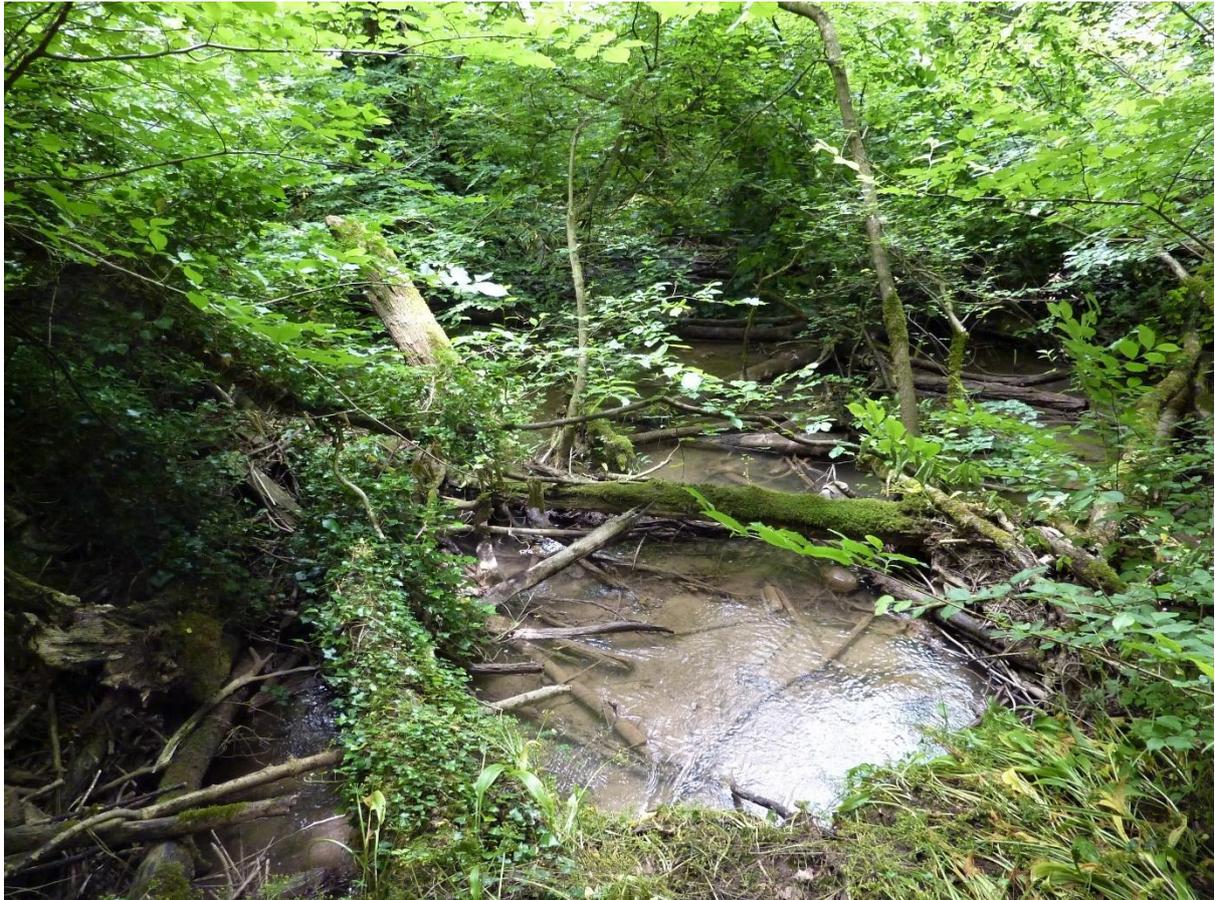
*Figure 22: A highly beneficial accumulation of LWM in the Whatley Brook.*

Further downstream, as the gorge pinches the river more tightly, a much larger and more complex natural accumulation of woody material has formed – offering a wonderful diversity of habitat niches for many different species including birds, insects and fish. It is a feature of LWM behaviour in river channels that the more wood is present, the less likely it is that any single piece will move very far. Impressive accumulations of wood, like this one, are rare in highly-managed UK rivers, and should be cherished for the value that they bring to aquatic ecosystems.

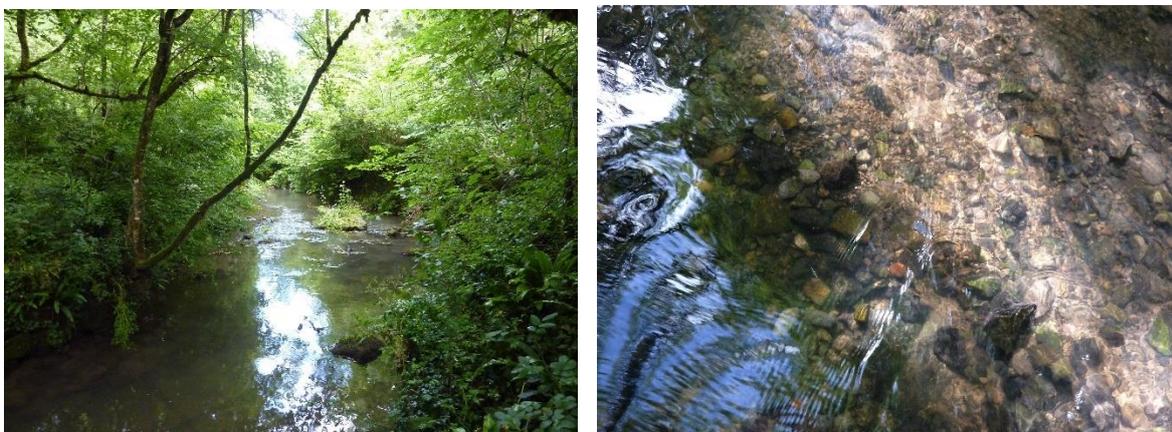
Figure 27: Left, good channel diversity in the Nunney Brook; Right, abundant gravels could provide a valuable spawning area for Mells trout

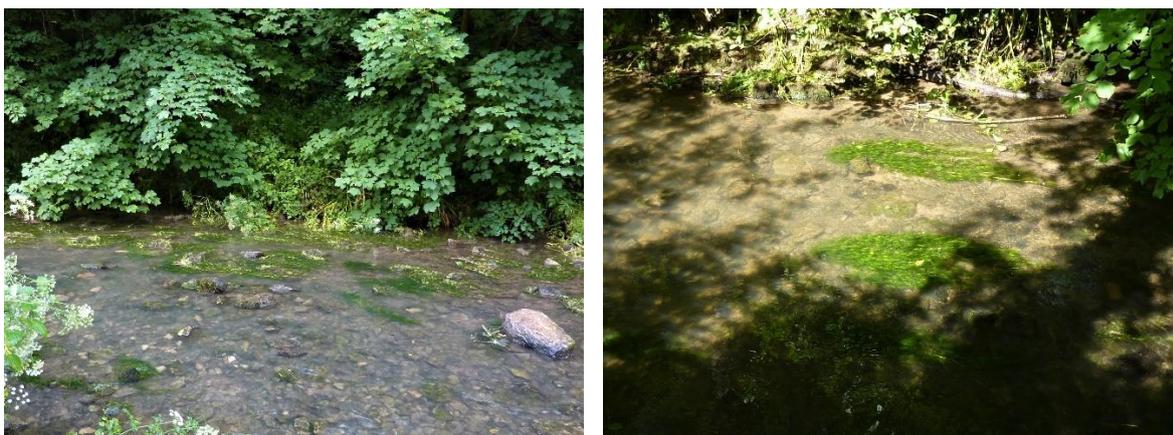
*Figure 31: Water crowfoot growing in skylighted areas of the Nunney Brook.*

The lower Nunney Brook is notably rich in water crowfoot – a beneficial aquatic plant which traps sediment, filters nutrients out of water, oxygenates the water, and provides excellent complex habitat for fish and aquatic invertebrates.
