## WILD TROUT TRUST

### **Advisory Visit**

**River Thet, Manor Farm, Attleborough, Norfolk**

**March 2024**

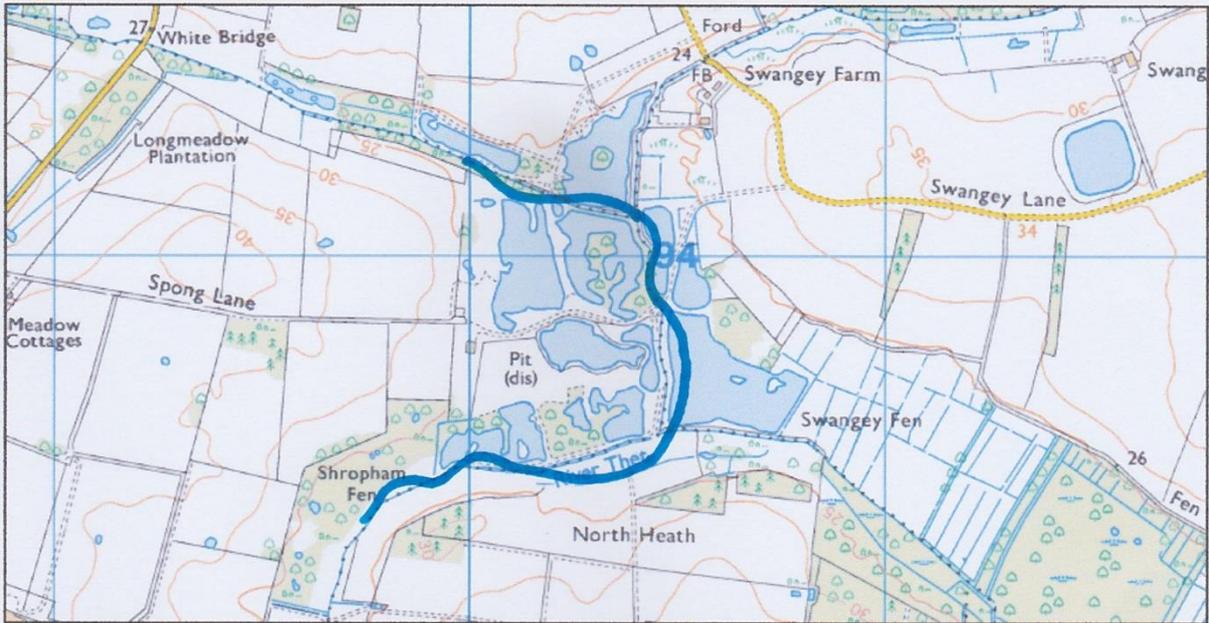
Map 2 – An indicative new route for the River Thet through the site.

Cutting into lakes will clearly require their (partial?) dewatering, and it is quite possible that some cut areas of lakes may require land re-forming to allow a new river course to be created through them. An indicative channel has been added to map 2 below. The current location of lakes should not hinder the proposal of the best and most natural realignment of the river. Landowner negotiations will have to address that, creating the optimum conditions to enable the river to function properly should be the high-level aspiration for Oxygen Conservation at this stage.
