Advisory Visit

River Leen

"Love Your Leen", Nottingham

30/01/2026

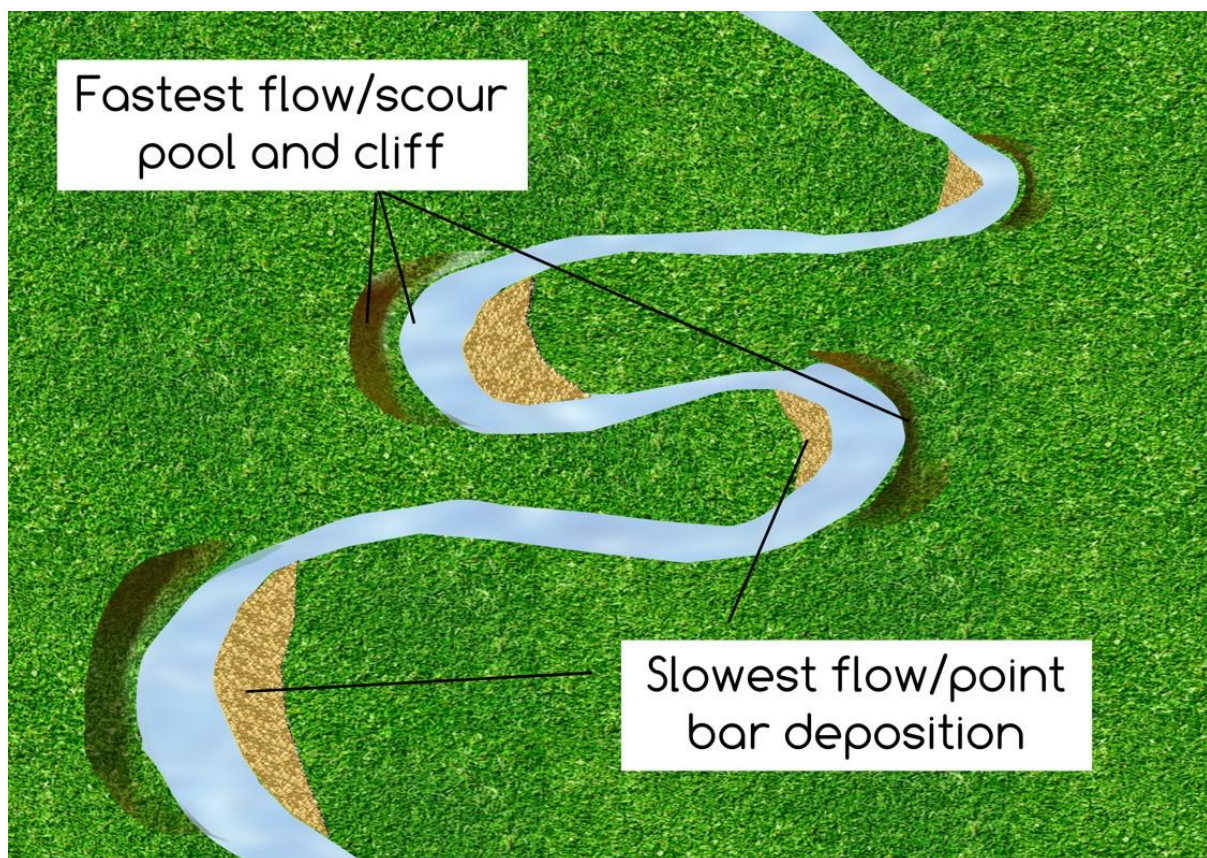
Figure 1: Erosion from the fastest-flowing areas towards the outside of bends provides a supply of substrate that forms both point bar and also mid-channel riffle depositional features.

The artificial banks of the River Leen prevent this natural substrate supply mechanism, creating a system that relies entirely on upstream sediment delivery without the replenishment that bank erosion would normally provide. It should be noted that excessive bank erosion can also be problematic in other contexts and such excess is not being advocated here. The ideal scenario would be, wherever possible, to create an appropriate balance between bank resistance and erosion along with sufficient space for the watercourse to adjust its course within a floodplain. One relatively recent example of removing stone revetments and deliberately reinstating appropriate levels of natural channel material turnover can be found at the

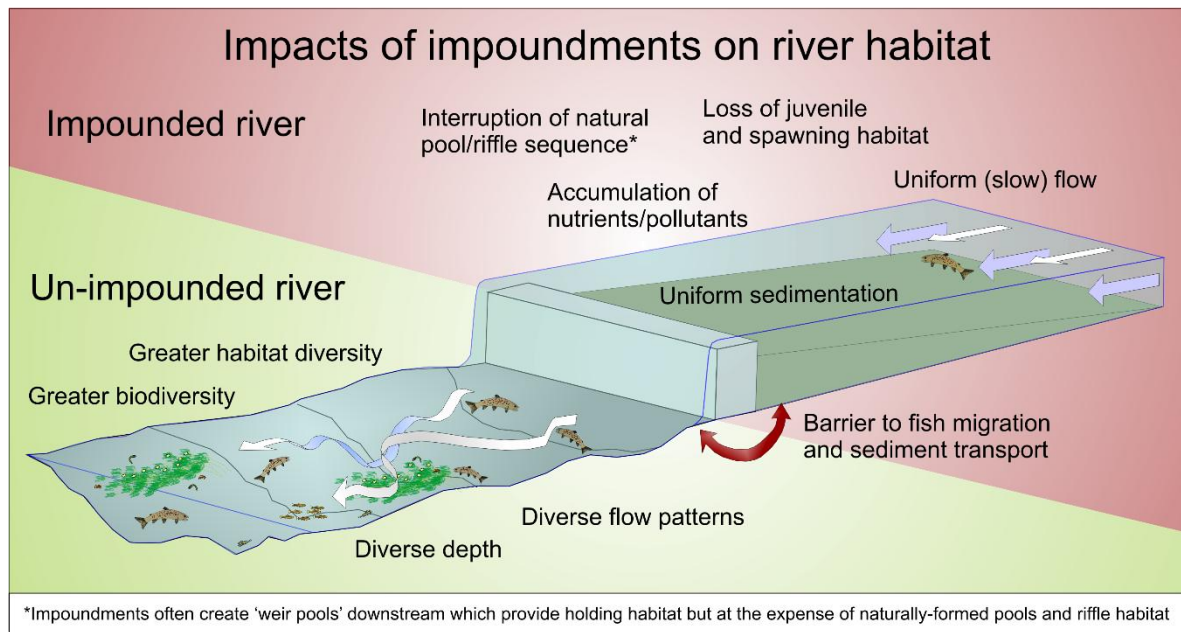
The weirs create barriers to upstream and downstream migration of fish and these also restrict the natural redistribution of substrate that could, otherwise, help to diversify habitat structure. Weirs function as steps in the longitudinal profile of the channel, creating discontinuities in the natural gradient. Upstream of each weir, flow velocities decrease as water backs up against the structure, leading to deposition of sediment belonging to all particle-size fractions from fine silt up to chunks of stonework. This clearly impedes the natural downstream movement of substrate during high flows. In the absence of weirs, substrate would be redistributed to areas of more dynamic flow conditions. That continual redistribution tends to create much more varied habitat features that consist of a wider variety of particle-sizes. Such physical diversity provides the basis for greater biological diversity through the provision of a wider range of available ecological niches.

Due to the vertical offset created by impoundments, flows accelerate over weirs and may scour the bed to create a plunge pool downstream of the structure. While this might seem to create habitat diversity, the abrupt nature of these transitions and the barrier effect they impose on fish movement severely constrains the ecological functionality of the system. There can also be a limit to the depth of such scour pools where the bed is artificially armoured.

Figure 2: A graphical summary of some impacts of weirs on rivers. The depth of any weir-pool will be limited to the level at which the bed is armoured (unless that armouring surface eventually breaks down).

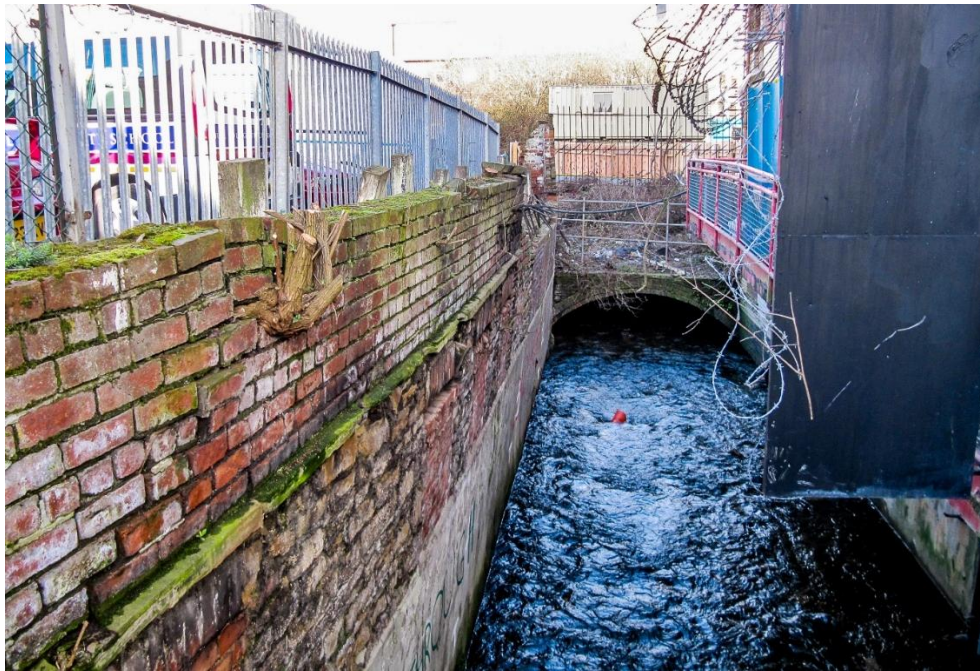
For a relevant precedent, hydraulic and flood modelling of the Porter Brook in Sheffield identified culverts presenting increased flood risk. In line with these findings, the creation of Matilda Street "Pocket Park" on a deculverted section of the Porter Brook (Figs. 3 and 4) provided increased flood

resilience on two fronts. Firstly, the removal of a problematic culvert “bottleneck” (Fig.3) and secondly, the creation of increased flood-water storage capacity within the stepped “amphitheatre” design of the park itself (Fig.4).

Figure 3: Culverted section of the Porter Brook at Matilda Street, Sheffield. Photographed facing downstream from road bridge. After deculverting, a portion of the car park to the left of the frame was converted into a pocket park which also provided additional floodwater storage.

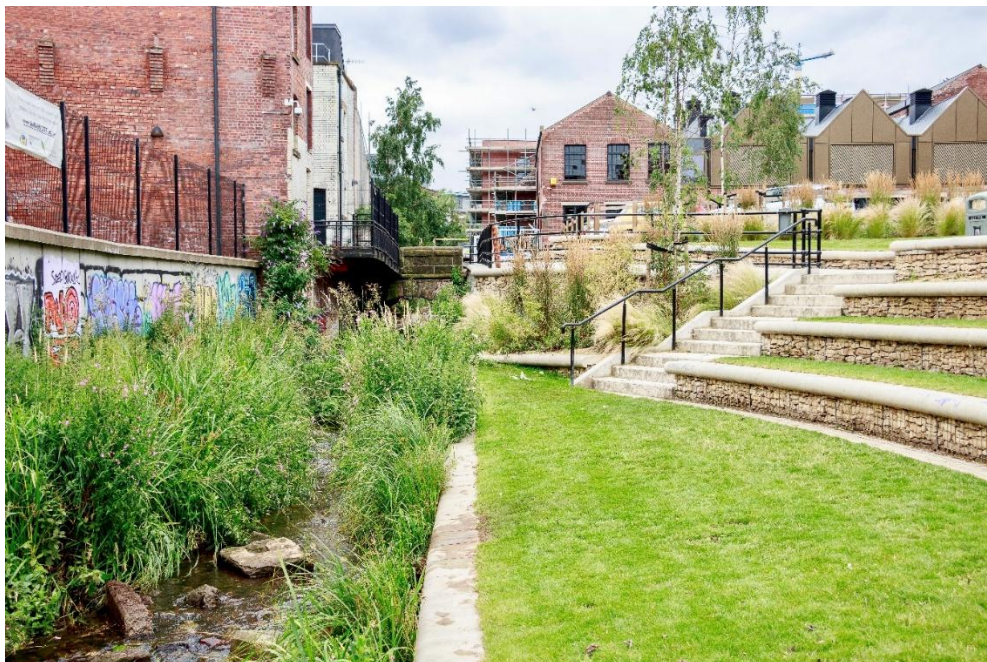
Figure 4: Facing upstream from within the previously-culverted channel and the pocket park. The black gantry attached to the white brick wall on the left (background) is visible in Fig.3 as the red gantry to the right of the frame in that image. In spate conditions, the river now spills over into the stepped amphitheatre.
