WILD TROUT TRUST

Pullaugh Burn and Nick Burn

Galloway Fisheries Trust

23/06/2021

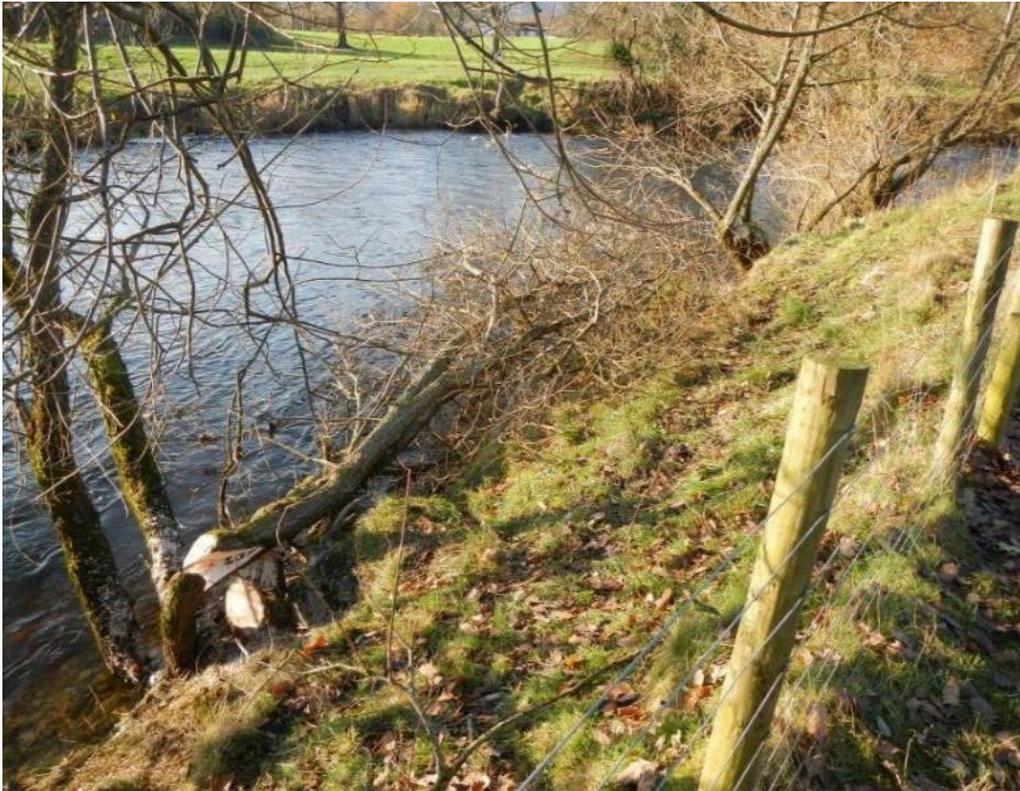
Figure 19. Willow hinged into the river margin to increase cover and structure. The method involves cutting part way through the stem, quickly through the first two thirds, then continuing until it collapses down over the river. The depth of the cut should be limited to only that which is required to bend the stem over, as this will maintain maximum size and strength of the hinge and the health of the tree/shrub.

Where multiple trees of suitable, pliable species are present, the occasional trunk can be cut and used to create a habitat enhancement feature, with no significant detriment to the overall habitat. This could entail partially cutting through the trunk, so that it remains attached and can be laid into or along the channel (Figure 19). The technique works particularly well with willow, elm and hazel, but only willow will thrive with its canopy partially submerged.

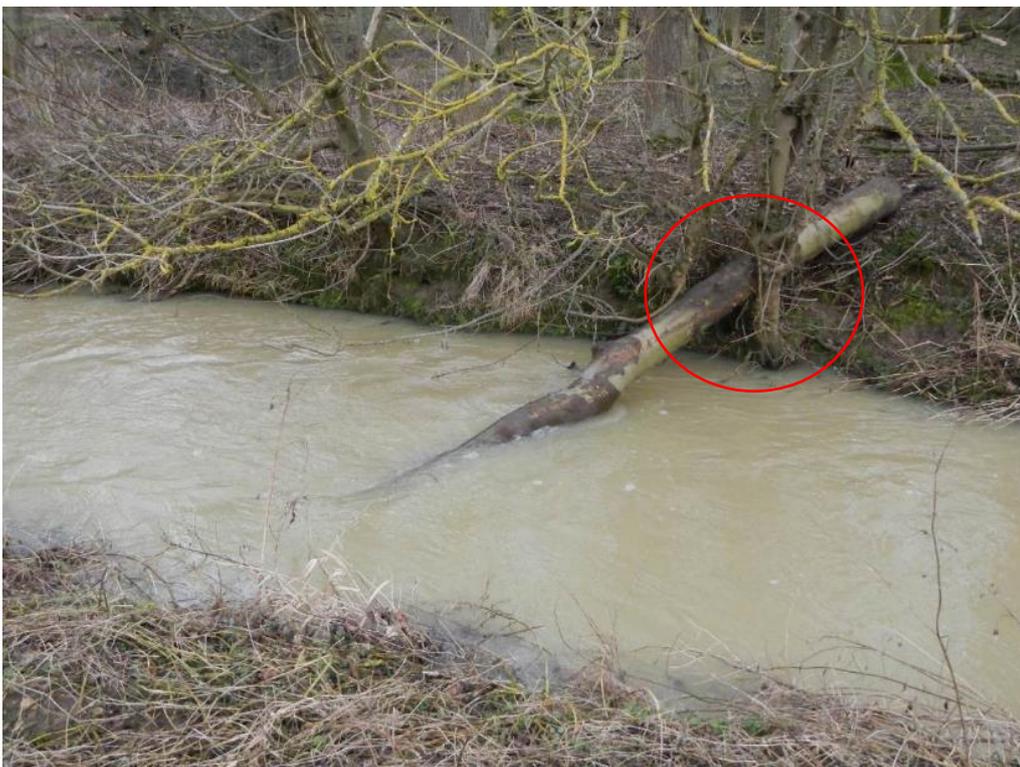
Figure 20. A flow deflector, securely but naturally lodged in place between two upright trees (red circle). The technique can utilise a single pole (primarily to increase scour) or a branched limb (to create greater flow dissipation or diversity, depending upon how it is used). The elevated butt end (bank end) reduces the potential detrimental bank score usually associated with d/s deflectors as a through-flow is maintained along the bank.

Many deciduous tree species can be felled to create a coppice, encouraging low-level regrowth from the stool; in the process, providing material that can be lodged between two or more standing trunks (Figure 20), or hung over another tree if a 'V' branch is available (Figure 21). Again, this should be undertaken very sparingly, to avoid loss of habitat and the creation of a maintenance burden as the bushy regrowth ensues. Owing to the lack of mature trees/shrubs in many areas, this method is limited, but there are areas in which it could be utilised to good effect. These methods can be a great means of kick-starting changes within a channel but have a limited life before they degrade and where possible, willow laying is often a more sustainable technique.

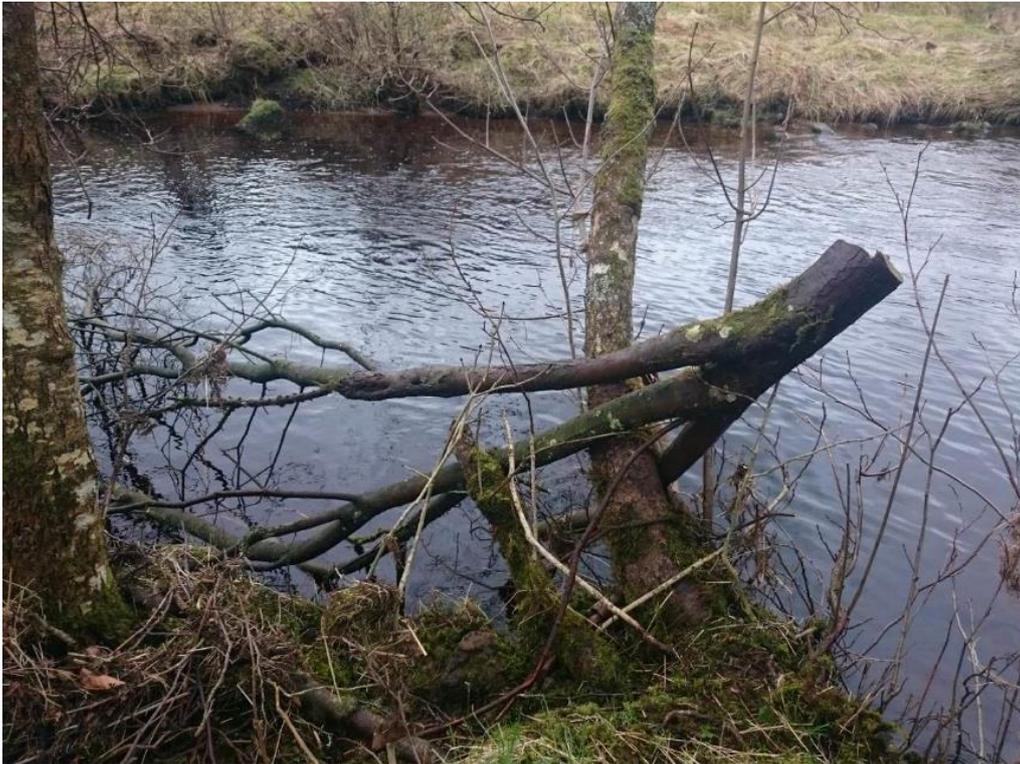
Figure 21. Medium-sized, lodged woody material, securely anchored naturally by the 'V' of the branches against an upright tree.

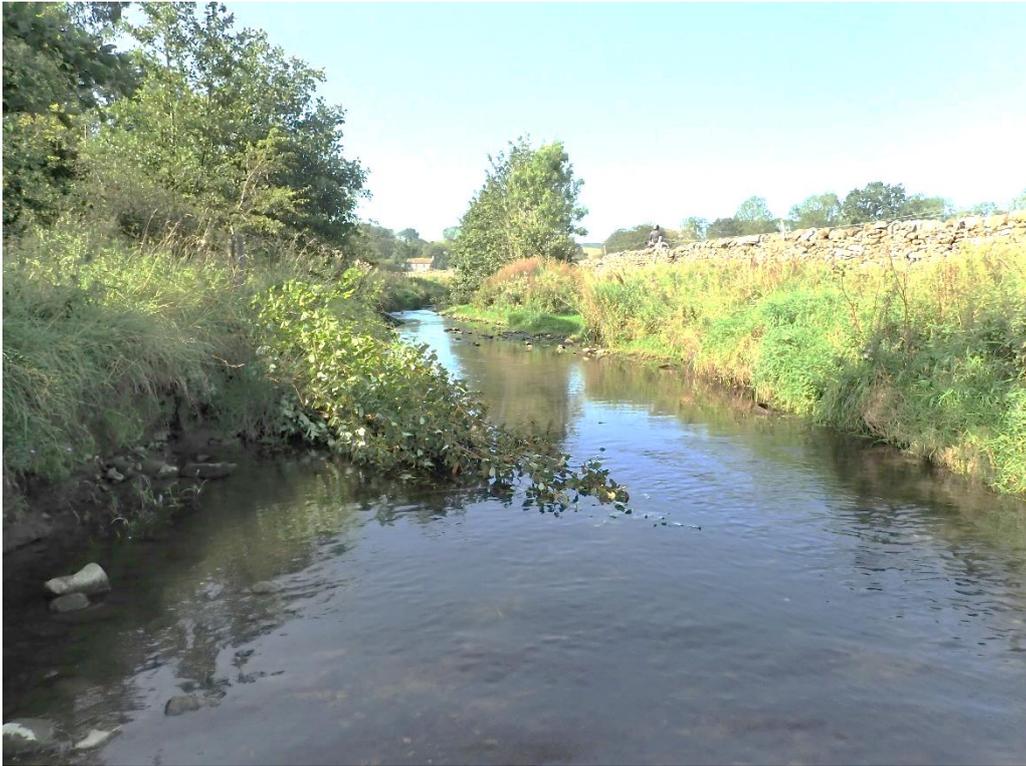
Figure 22 Alder top (canopy) pinned into the river margin to increase flow sinuosity and focus scour on the opposite side of the channel, while also providing valuable in-channel cover and encouraging deposition/substrate retention downstream.

Channel sinuosity can be enhanced through the installation of brush, tree canopies or entire shrubs to the river margin (Figure 22). This technique would be applicable throughout the Pullaugh Burn and Nick Burns where bankside trees and shrubs are absent, but particularly in the downstream sections where gradient decreases. Large trees secured across the channel could also provide a range of benefits from dissipation of peak flow energy through to localised bed scour. The example in Figure 23 is natural, but when engineering such structure, it is generally beneficial to lay them at a more acute angle to the channel, reducing the chances of complete blockage and encouraging lateral erosion to increase channel sinuosity.

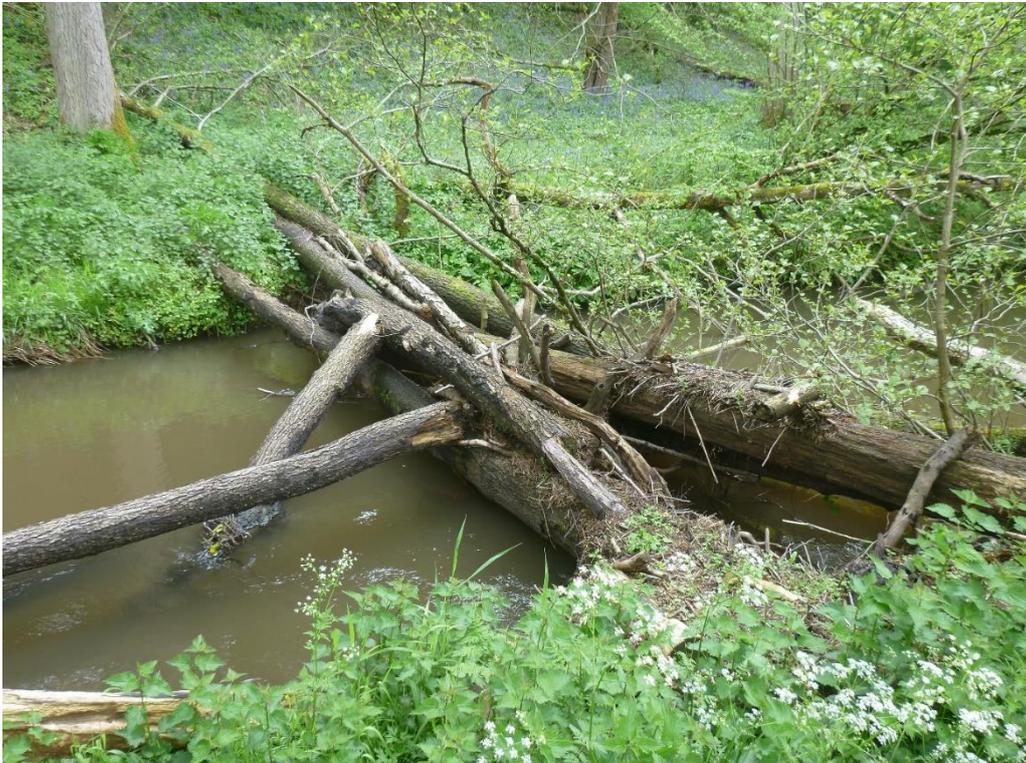
Figure 23. A natural logjam. Engineered stable log jams could be re-created on the burns with large timber sourced from riparian conifers. This would help encourage peak flows out of bank and create additional areas of scour and deposition. When engineering such structures, it is usually better to align them at a more acute angle, to reduce the potential for total blockage (debris will accumulate at the d/s end, not right across the channel) and promote lateral scour.

Longer-term, reconnecting side channels that have been bypassed by straightening and installing much larger woody material into the channel would greatly assist natural recovery. Large conifers could be felled over the channel or ideally even pushed/pulled (excavator or winch) over, with their rootball attached (replicating the occurrence in Figure 5 and Figure 23). The benefit of retaining the rootball is that it acts as an anchor and
