WILD TROUT TRUST

**River Esk Walkover (lower)**

(West Cumbria)

5/02/2021

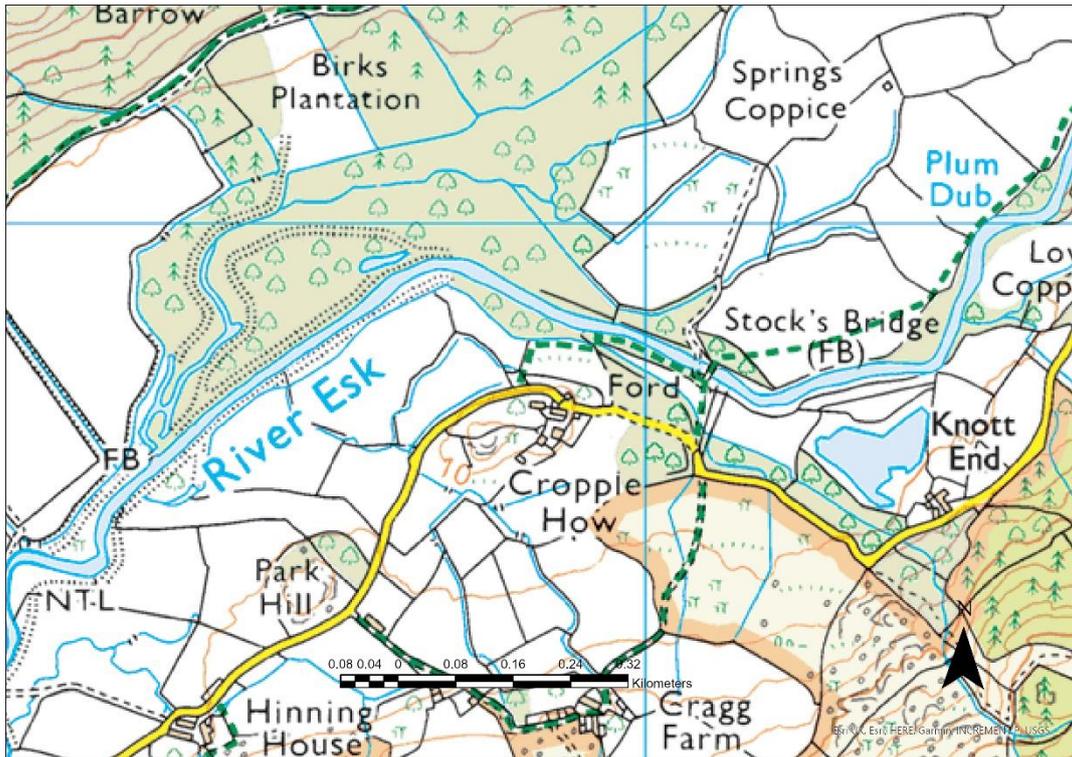
**Figure 14** Shows the current Ordnance Survey 1:25k map and the course of the river.

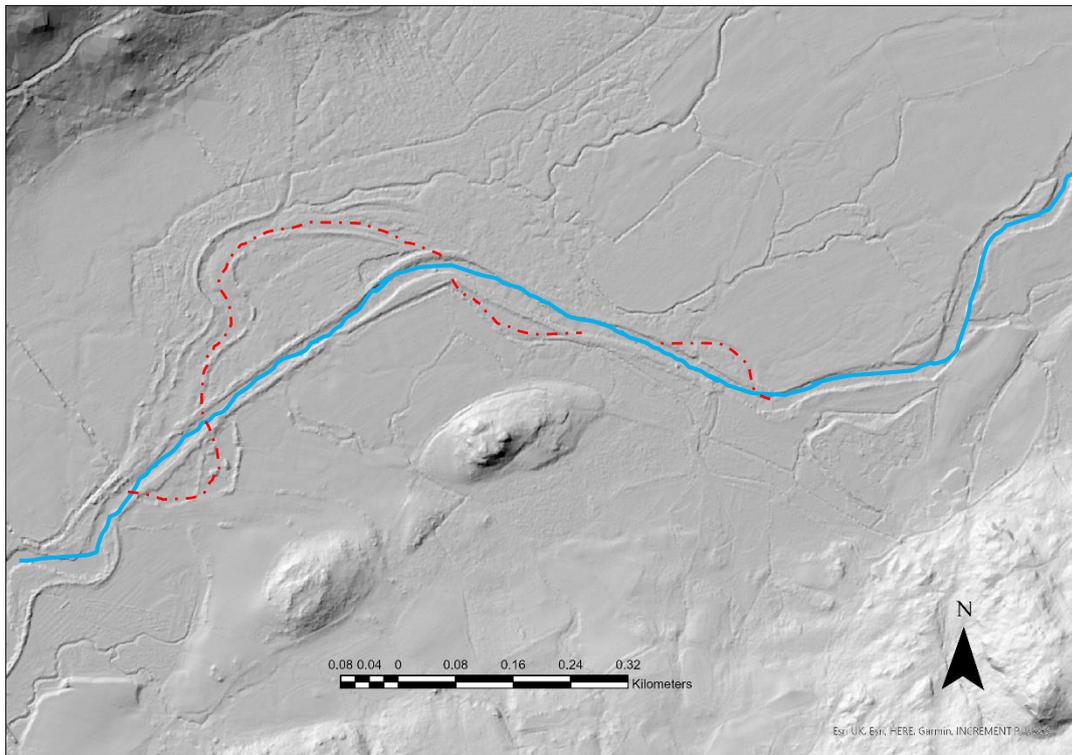
**Figure 15** Shows the Environment Agency's 2019 LiDAR (Light Detection and Ranging) map of the same area as Figure 14. LiDAR is a laser scan of the ground made from an aeroplane which shows the relative level of the ground (and water). This clearly highlights the current, straightened and uniform channel (solid blue line) and the much longer, more sinuous and variable areas of the lost natural course (red dashed line). The potential to reinstate any of these areas could not only increase the availability of habitat, through increased channel length, but also greatly increase the quality of any associated habitat (including areas upstream and downstream).

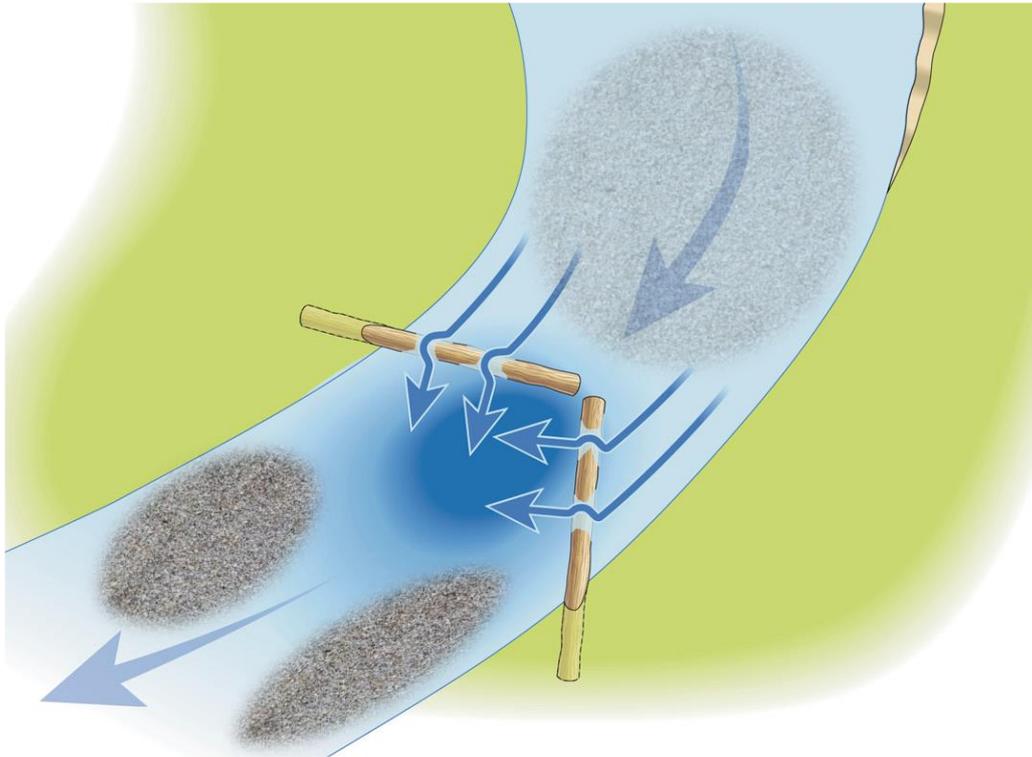
**Figure 24** Shows how full-width structures reduce flow energy, leading to uniform deposition across the pool upstream. Turbulence will create depth immediately downstream of the structure but fails to maintain a natural pool profile with a gradual tail (also reducing the potential for salmonid spawning). Focussing flow into the centre of the channel (through a central notch, upstream 'V' or horseshoe) also reduces flow energy at either bank side downstream, often leading to areas of deposition at either side. These scenarios are not beneficial to the creation of high-quality pool habitat, as the highest velocity flow should naturally pass round the outside bend unimpeded.

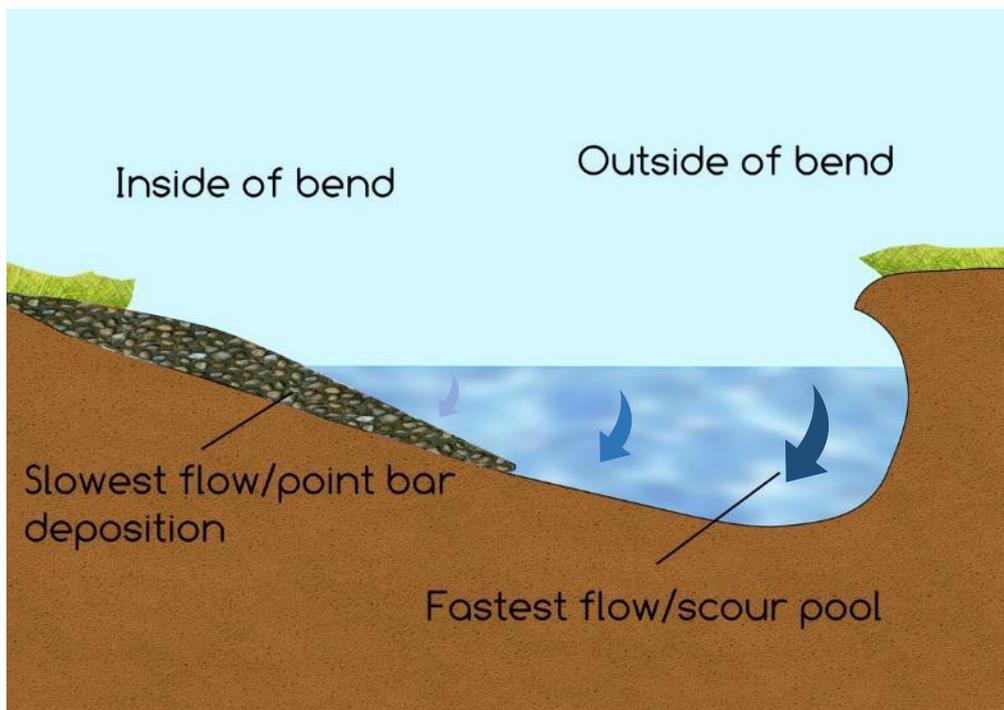
**Figure 25** A natural pool cross-section. Deposition is beneficially on the inside, where it helps to focus flow to the deeper outside bend. A natural pool, on a bend, is therefore self-maintaining through scour. It can adjust to the flows experienced and creates sustained depth, unlike a weir or impoundment that leads to unwanted deposition in the deeper area and shallowing over time. This cross section is also more resilient to low water as flow is always encouraged through the deepest area.

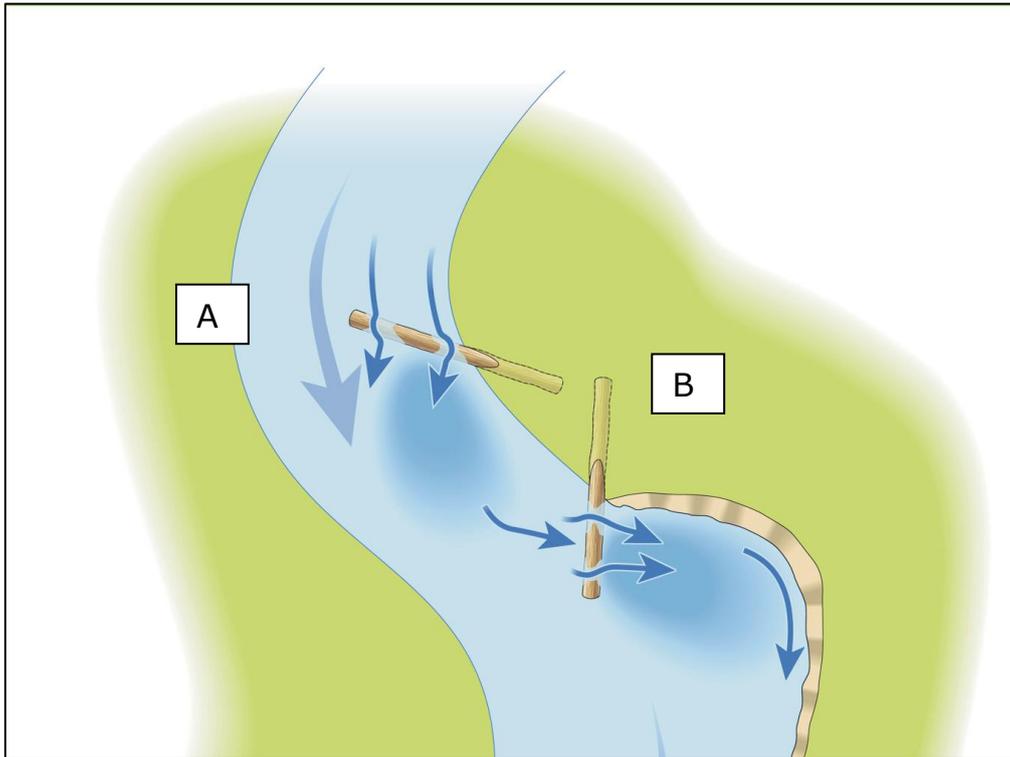
**Figure 32** Shows the impact of upstream and downstream facing deflectors. Note how the upstream deflector (A) turns overtopping flow towards the centre of the channel and the downstream deflector (B) turns overtopping flow towards the bank. In the case of the inside bend at Donald’s Pool, part of the structure is acting as a downstream deflector, causing a portion of the flow to cut the corner. Flow deflectors, though relatively simple are often misunderstood, making them a higher risk management tool than simply installing more diffuse natural features.

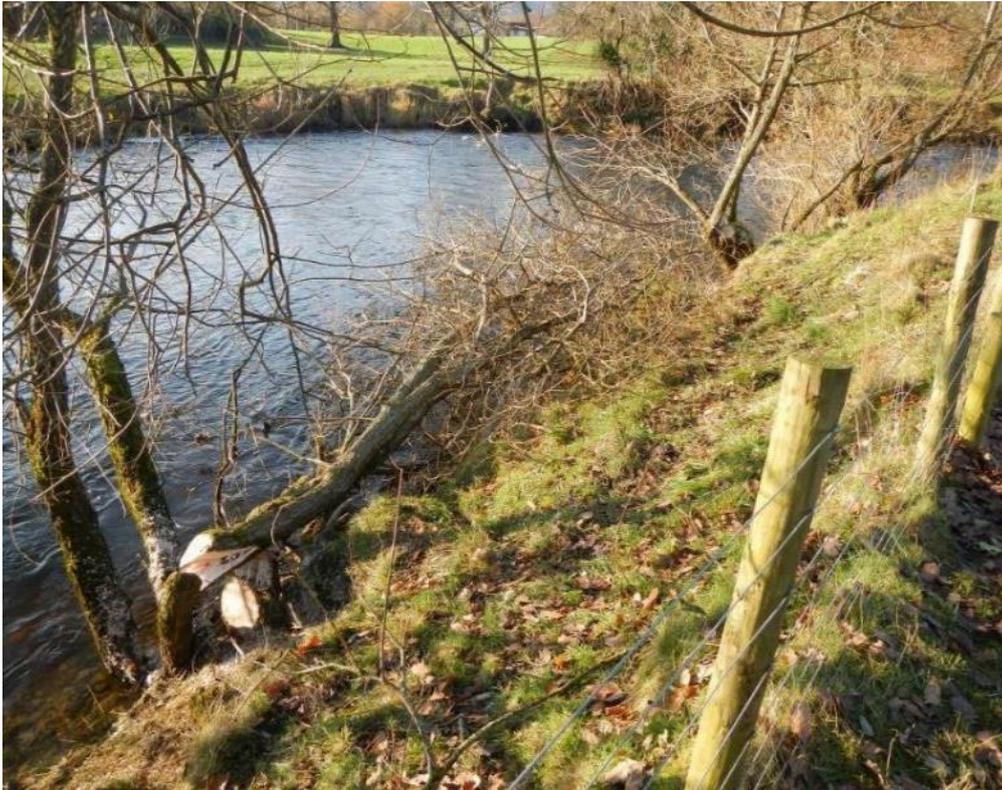
**Figure 33** Willow hinged into the river margin to increase cover and structure. The method involves quickly cutting part way through the first two thirds of the stem, then continuing until it collapses down over the river. The depth of the cut should be limited to only that which is required to bend the stem over, as this will maintain maximum size and strength of the hinge and the health of the tree/shrub.

entail partially cutting through the trunk, so that it remains attached and can be laid into or along the channel (Figure 33).

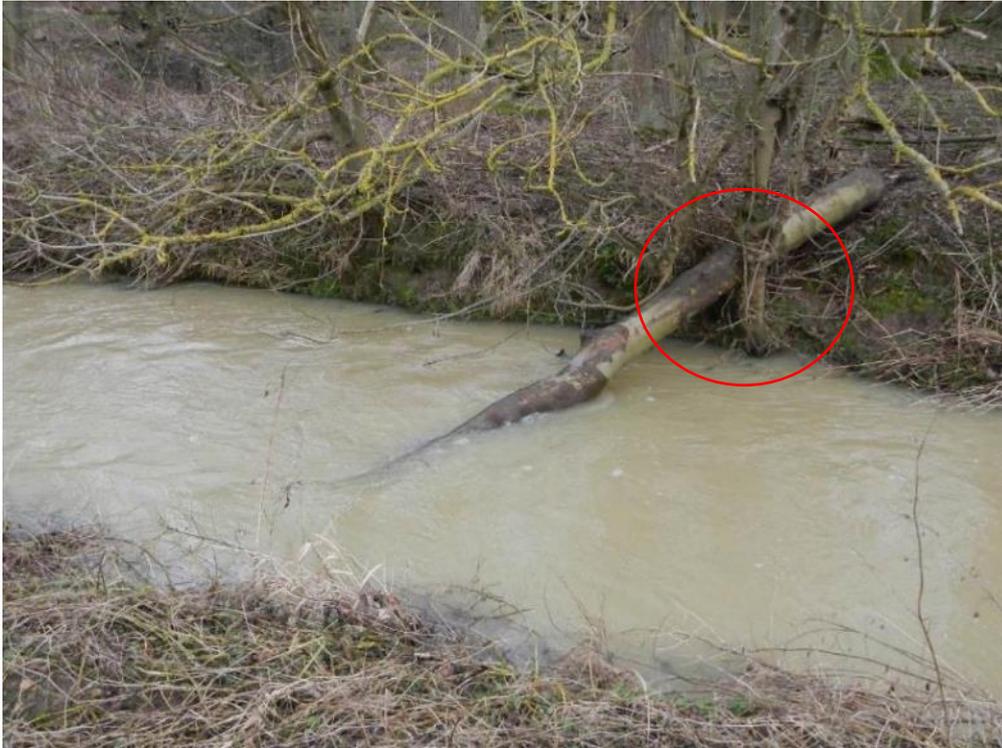
**Figure 34.** A lodged flow deflector: securely but naturally lodged in place between two upright trees (red circle). The technique can utilise a single pole (primarily to increase scour) or a branched limb (to create greater flow dissipation and deposition). The elevated butt end (bank end) reduces the potential detrimental bank scour usually associated with downstream deflectors as a through-flow is maintained along the bank.

Alternatively, a tree can be felled to create a coppice, encouraging low-level regrowth from the stool, providing material that can be lodged between two or more standing trunks (Figure 34), or hung over another tree if a 'V' branch is available (Figure 35). Any felling or cutting of trees should be undertaken under further guidance (possibly through a WTT habitat workshop) as it would be easy to denude areas already lacking cover if the wrong trees were tackled.

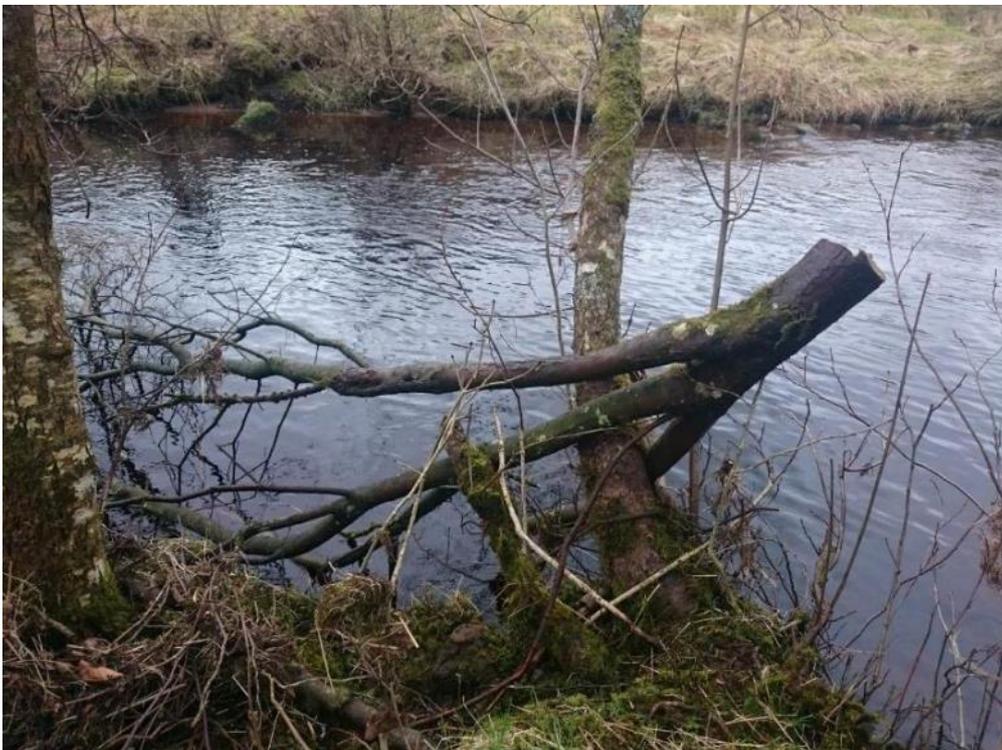
**Figure 35.** Medium-sized, lodged woody material, securely anchored by the 'V' of the branches against an upright tree.

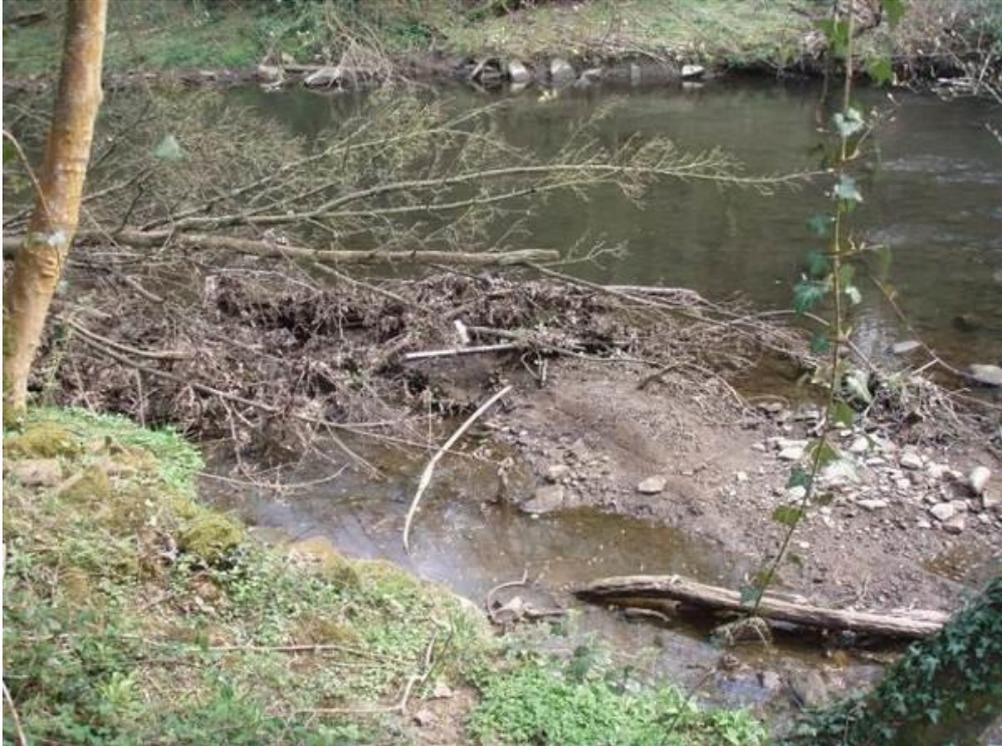
**Figure 36.** A perfect example of how the diffuse canopy of a tree kicker can be employed to diversify flow and increase deposition in the river margin. Here, the structure focusses flow down the far side of the channel, maintaining depth with no negative impact upon the downstream transport of gravel. The structure itself creates valuable high flow refuge for fish. This kind of technique is designed to kick-start processes that will continue to develop long after the initial structure degrades. The same effect can also be achieved with the other techniques for installing in-channel woody material.

Felled trees can also be tethered as downstream facing tree kickers (Figure 36 & Figure 37), where the butt of the tree is attached to its stump with strong cable. This is a highly effective method, but it is generally best to avoid the use of man-made materials, so where possible, the lodged material options may be a more natural choice.

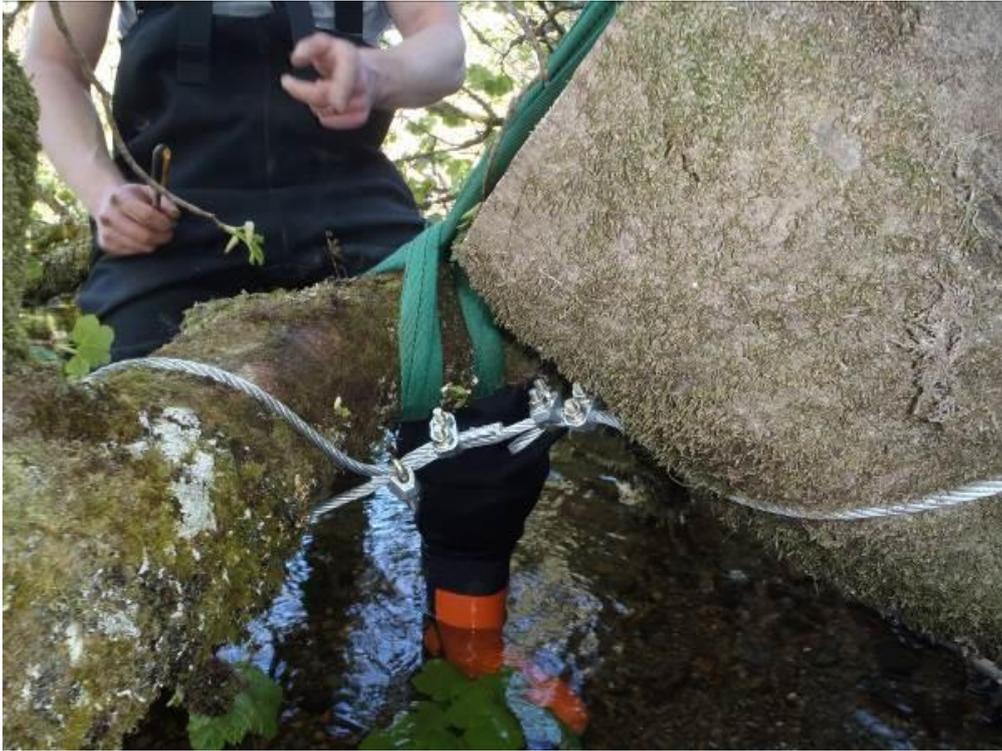
**Figure 37.** A basic tree kicker setup, using 4000 kg breaking strain cable and two pairs of cable clamps. The webbing strap in the background is used to pull the kicker close to the stump for fastening but is removed once the cable is fully fixed in place.
