WILD TROUT TRUST

**River Irt**

Bertol Angling Club

01/10/2020

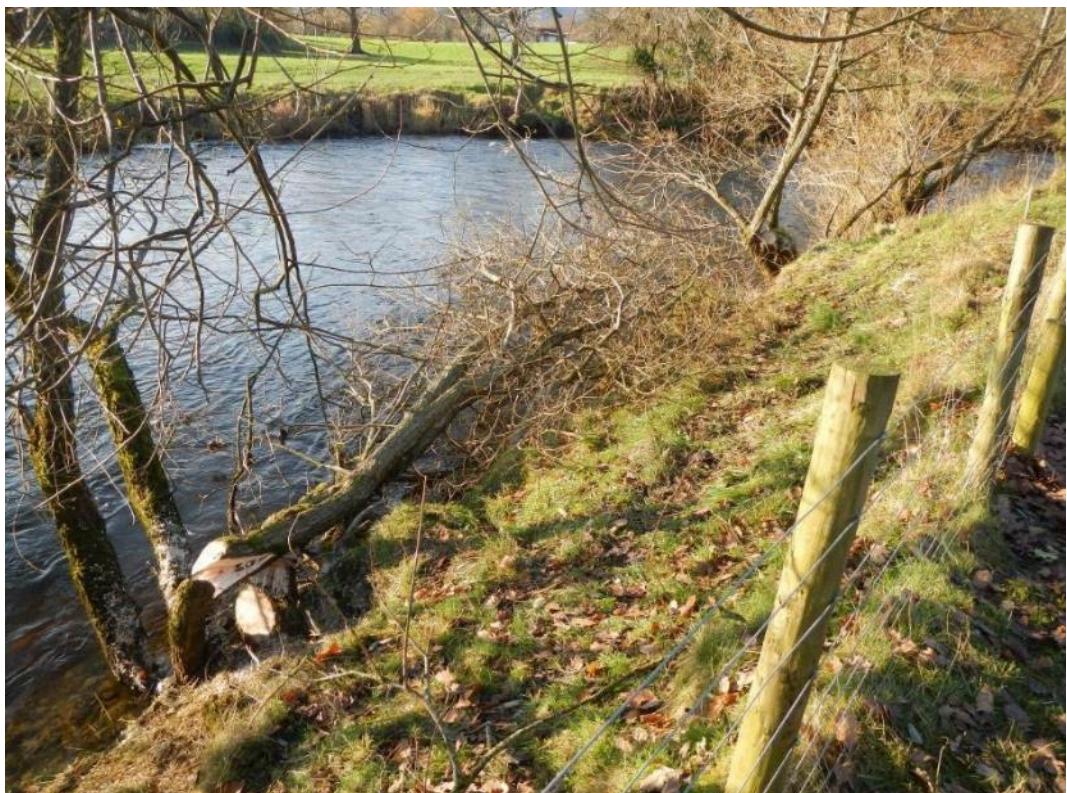
Figure 25. Willow hinged into the river margin to increase cover and structure. The method involves cutting part way through the stem, quickly through the first two thirds, then continuing until it collapses down over the river. The depth of the cut should be limited to only that which is required to bend the stem over, as this will maintain maximum size and strength of the hinge and the health of the tree/shrub.

Where multiple trees are present, the occasional trunk can be cut and used to create a habitat enhancement feature, with no significant detriment to the overall habitat. This could entail partially cutting through the trunk, so that it remains attached and can be laid into or along the channel (Figure 25).

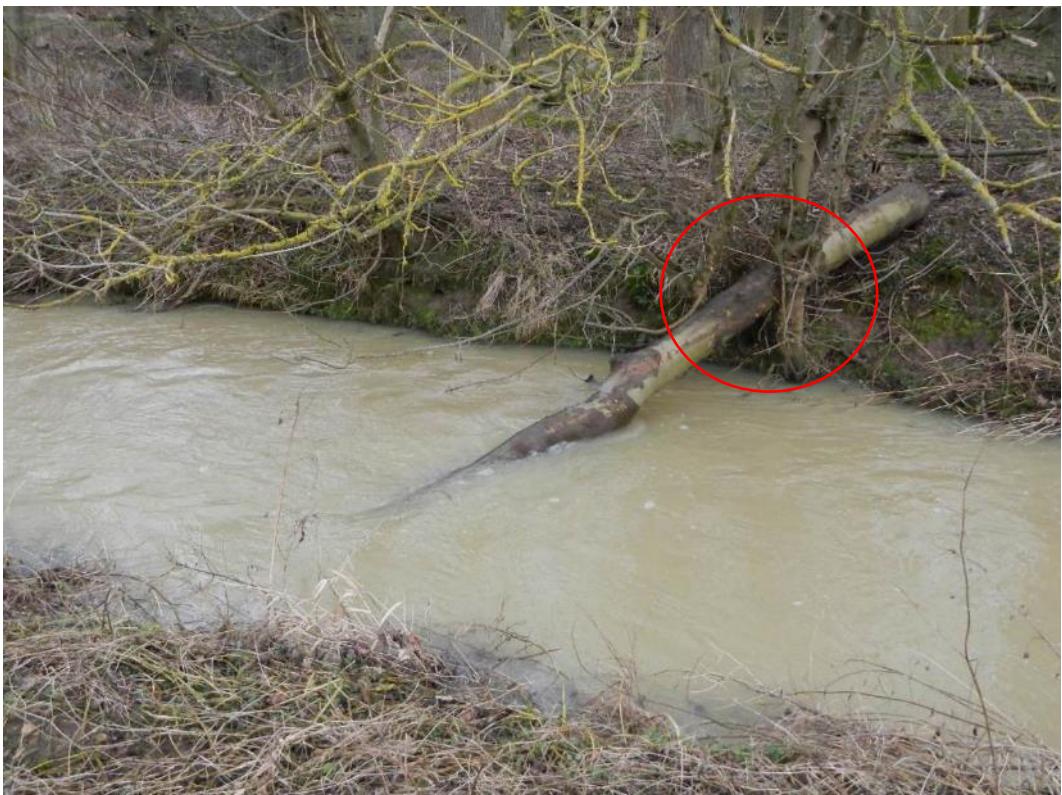
Figure 26. A lodged flow deflector securely but naturally lodged in place between two upright trees (red circle). The technique can utilise a single pole (primarily to increase scour) or a branched limb (to create greater flow dissipation). The elevated butt end (bank end) reduces the potential detrimental bank scour usually associated with downstream deflectors as a through-flow is maintained along the bank.

Alternatively, a tree can be felled to create a coppice, encouraging low-level regrowth from the stool, providing material that can be lodged between two or more standing trunks (Figure 26), or hung over another tree if a 'V' branch is available (Figure 27).

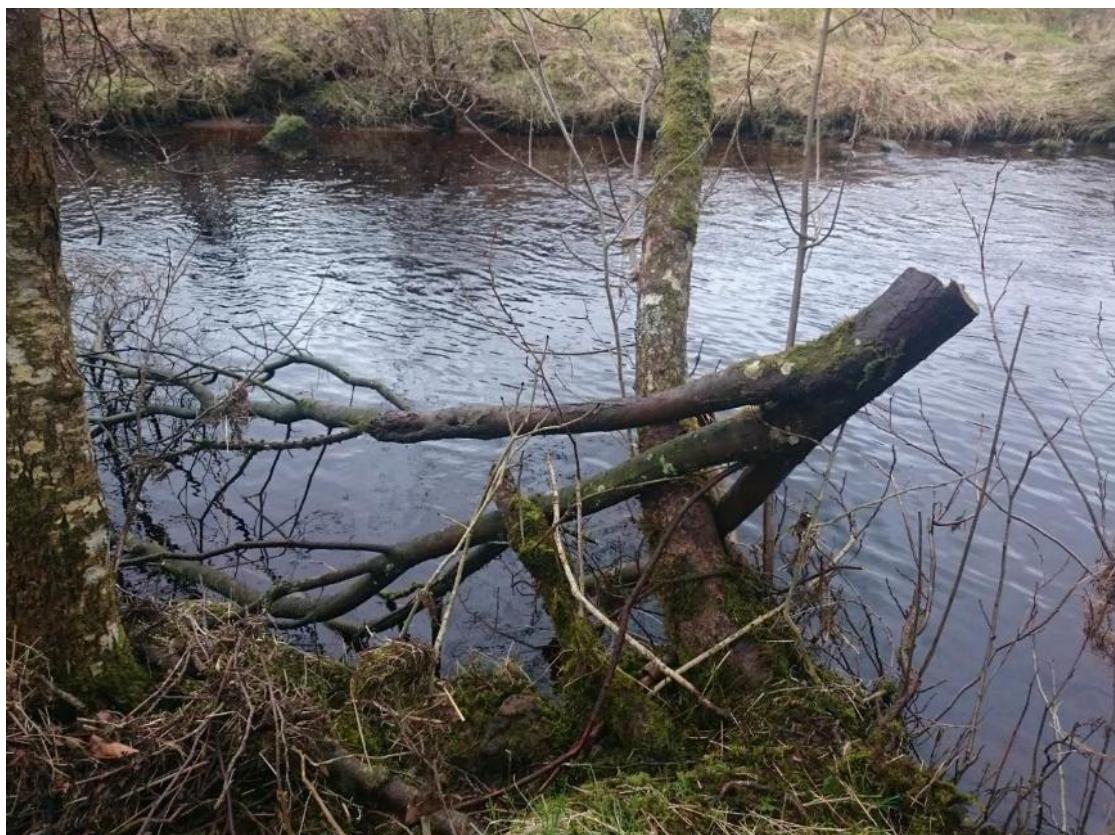
Figure 27. Medium-sized, lodged woody material, securely anchored by the 'V' of the branches against an upright tree.

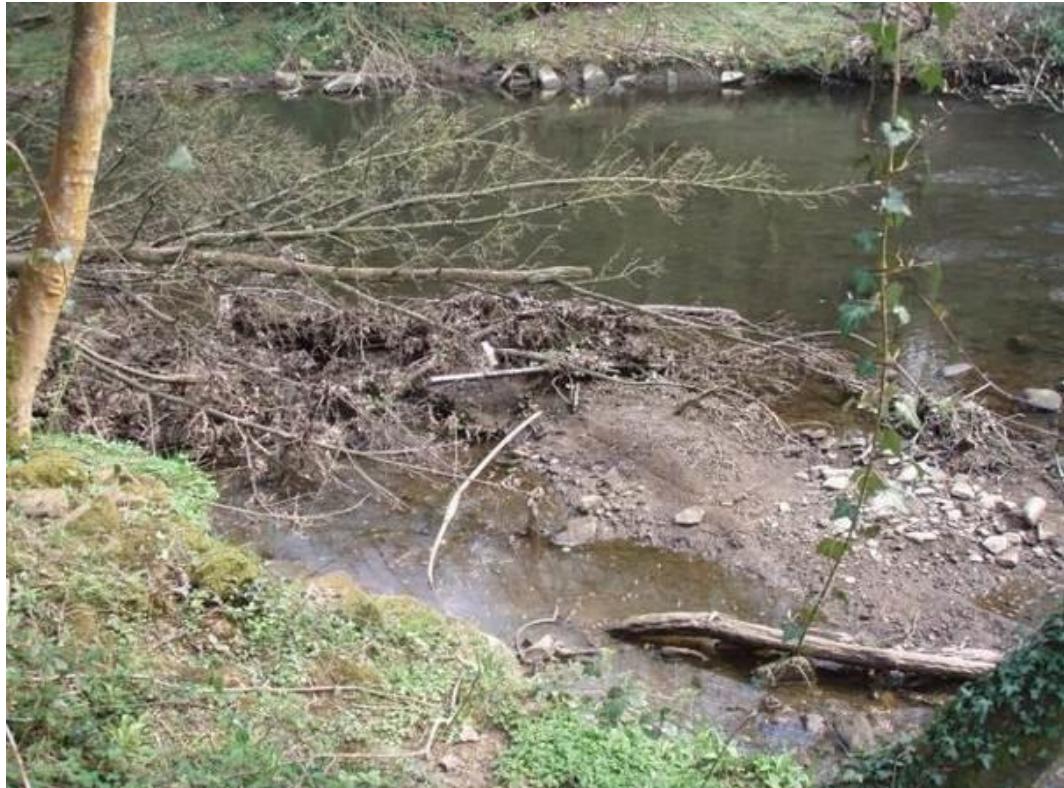
Figure 28. A perfect example of how the diffuse canopy of a tree kicker can be employed to diversify flow and increase deposition in the river margin. Here, that focusses flow down the far side of the channel, maintaining depth there with no negative impact upon the downstream transport of gravel. The structure itself creates valuable high flow refuge for fish. This kind of technique is designed to kick-start processes that will continue to develop long after the initial structure degrades.

Felled trees can also be tethered as downstream facing tree kickers (Figure 28 & Figure 29), where the butt of the tree is attached to its stump with strong cable. This is a highly effective method, but it is generally beneficial to avoid the use of man-made materials, so where possible, the lodged material options may be a better choice.

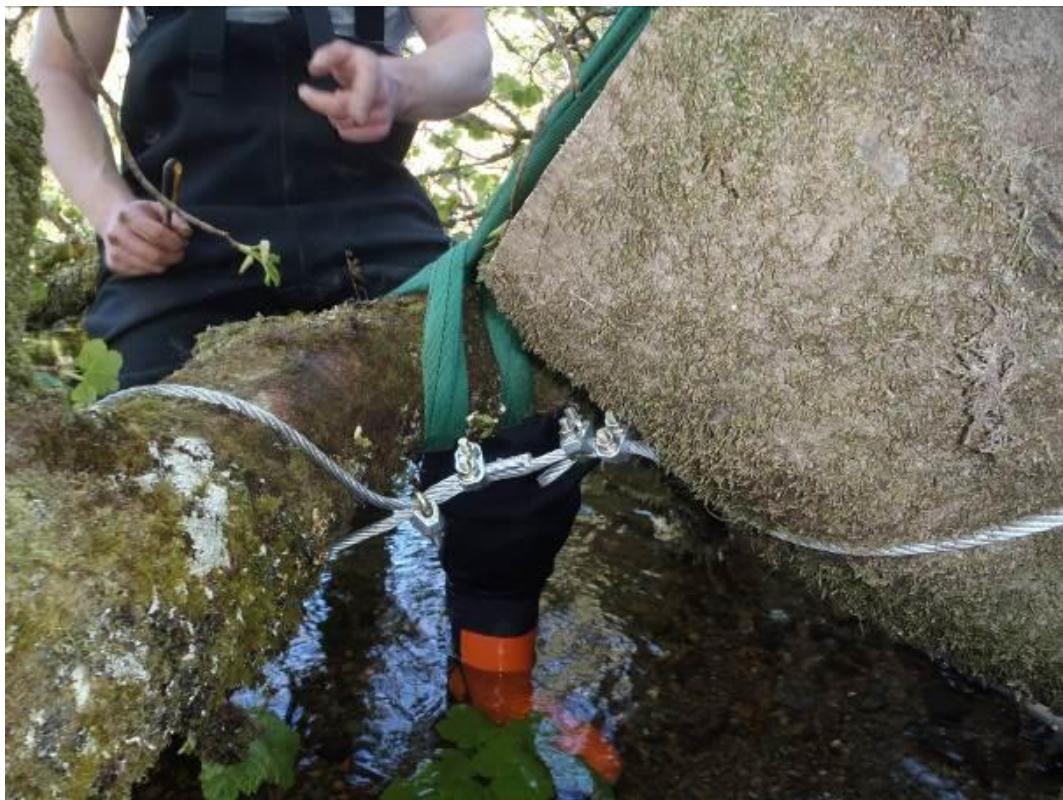
Figure 29. A basic tree kicker setup, using 4000 kg breaking strain cable and two pairs of cable clamps. The webbing strap in the background is used to pull the kicker close to the stump for fastening but is removed once the cable is fully fixed in place.
