WILD TROUT TRUST

River Team
(lower catchment)

March 2021

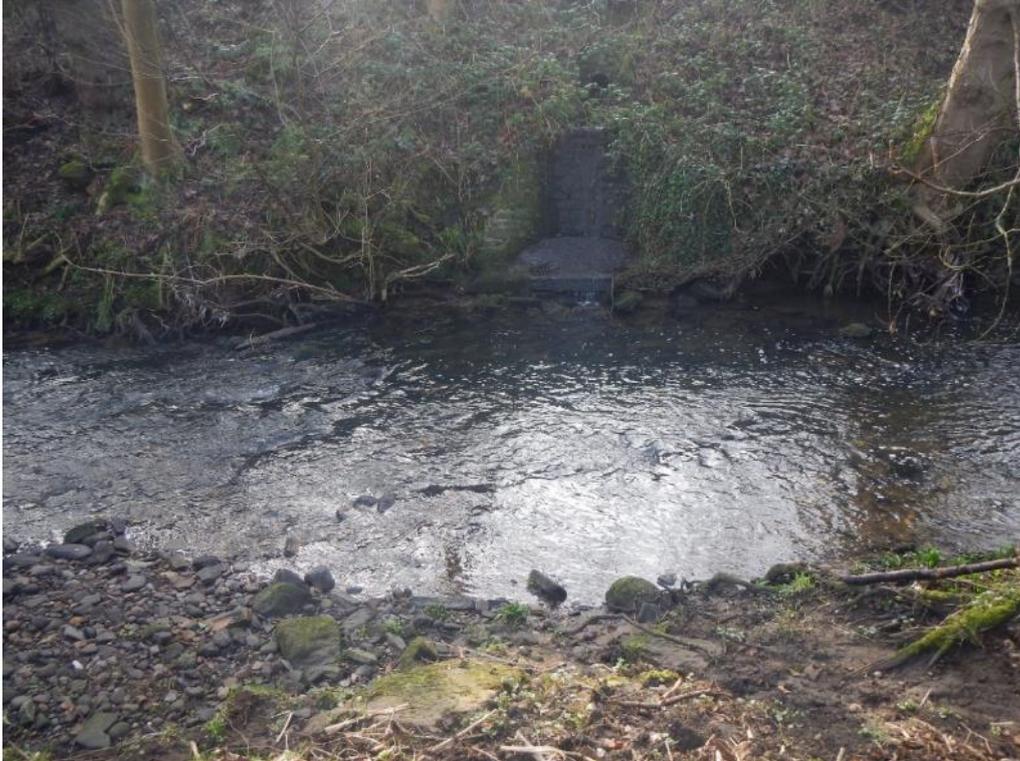
BB60. A small discharge around the upstream limit (NZ 21660 55001). The water appeared relatively clean with no obvious signs of significantly elevated nutrient levels.

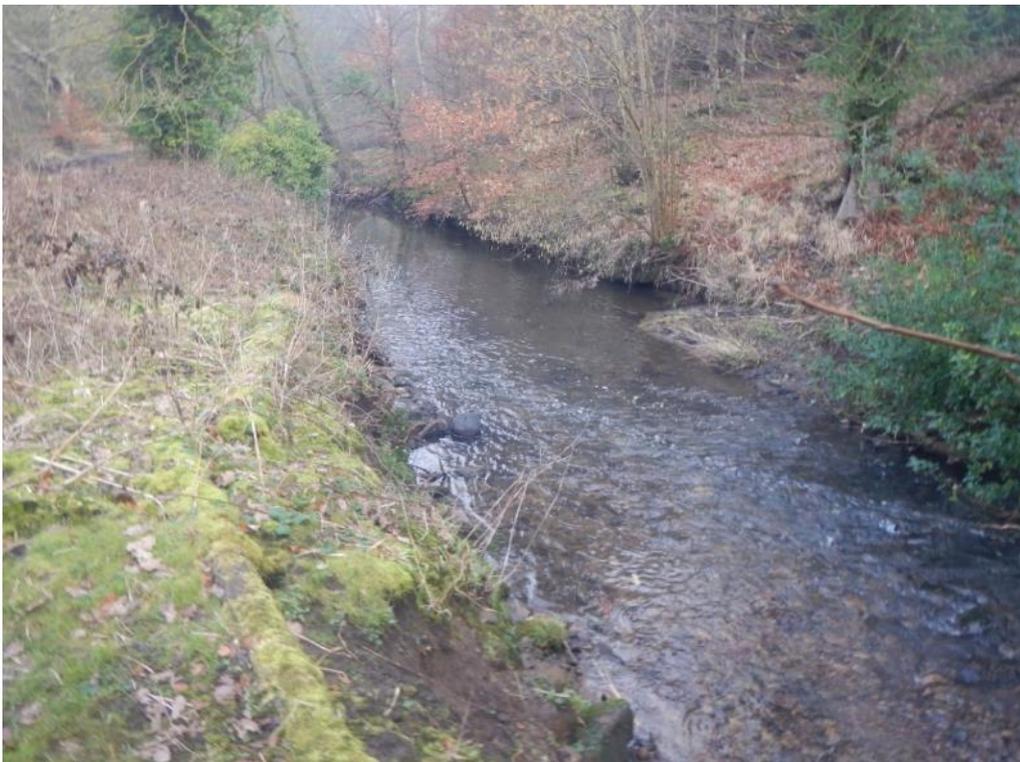
BB62. The straightened nature of this section reduces its habitat value, but the banks are vegetated and bankside trees provide some cover.

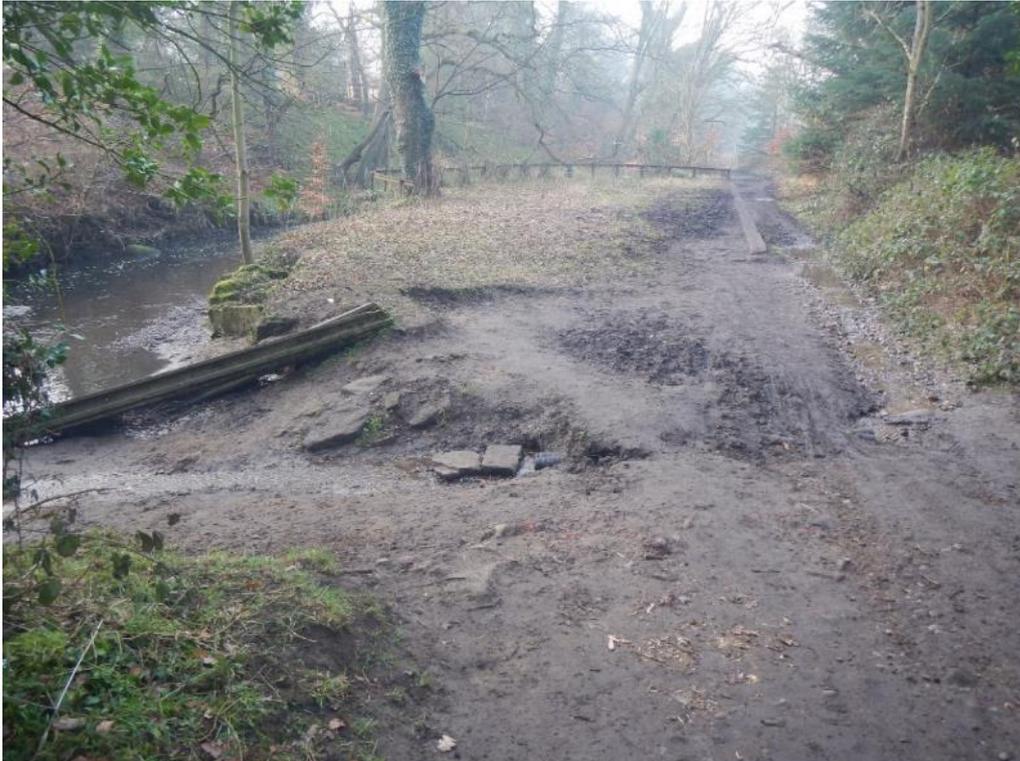
BB66. The track crossing of a small tributary is in a very poor state of repair and contributing significant fine sediment (NZ 21808 55142). This could be solved simply with an appropriately sized sunken pipe.

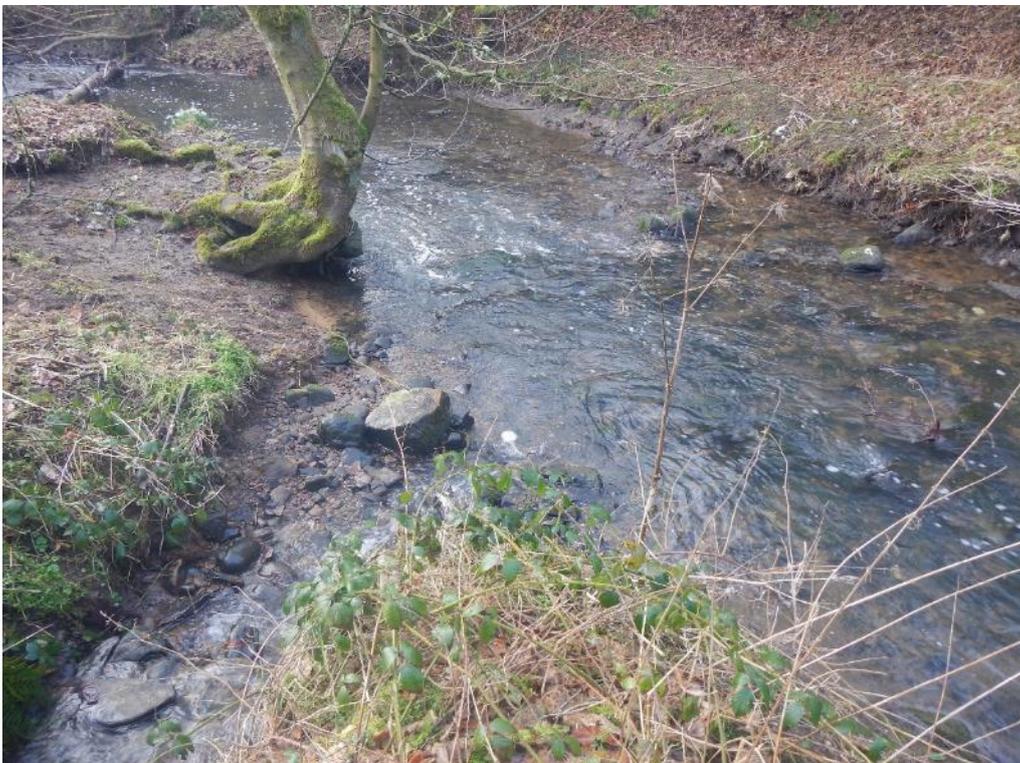
BB69. A small tributary joins the burn (NZ 21882 55123) and supplies elevated volumes of fine sediment, suspected to originate at NZ 21250 56327, where a collapsed field culvert/buried watercourse is visible. Otherwise, the water quality was reasonable, supporting large stone-clinging mayfly nymphs and cases and caseless caddis.

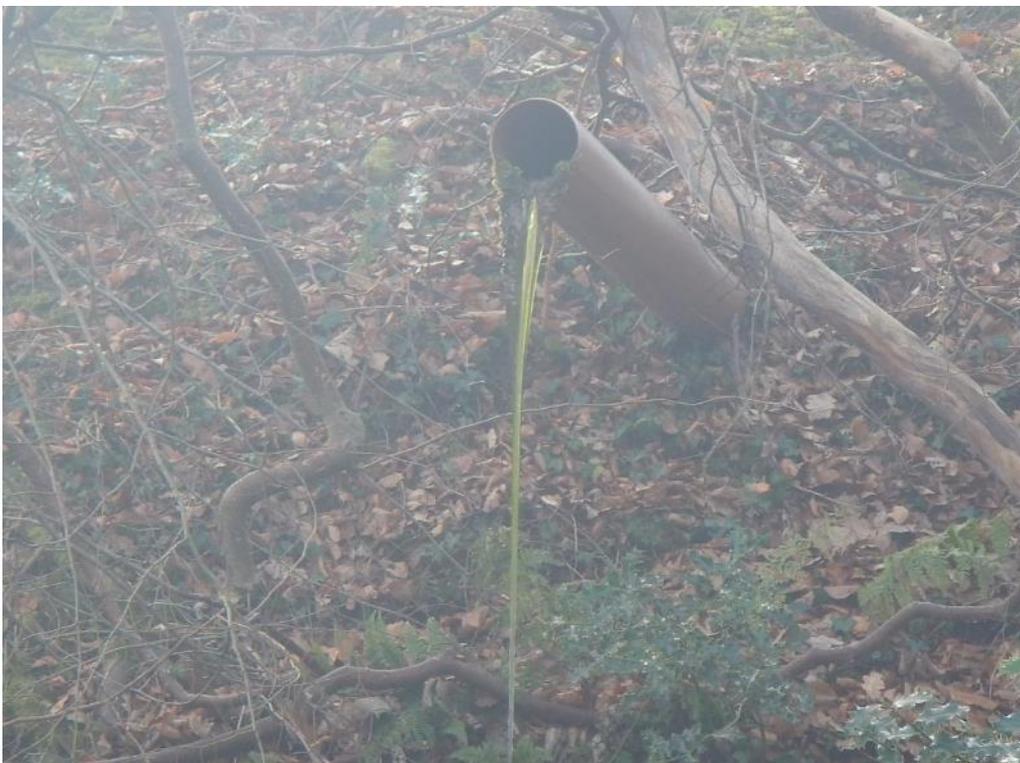
BB78. The streams of algae associated with this discharge from the Beamish Museum site indicate a high nutrient discharge (NZ 21902 55090).

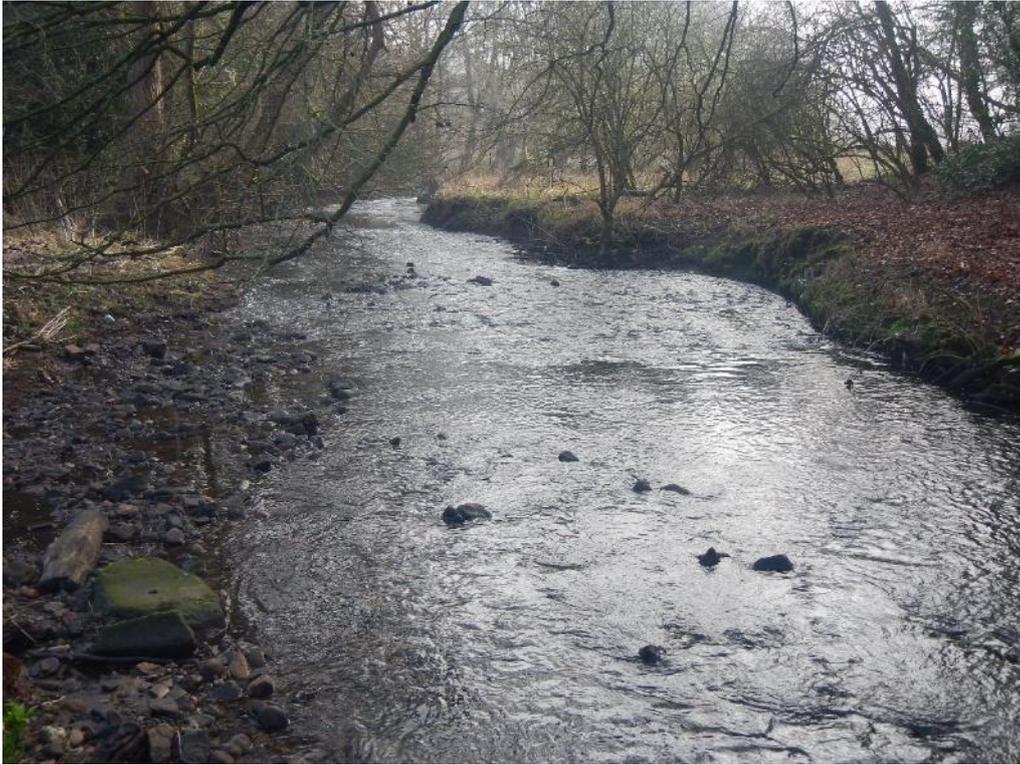
BB78. Generally good juvenile salmonid habitat in the more naturalised areas but would benefit from more woody material within the channel.

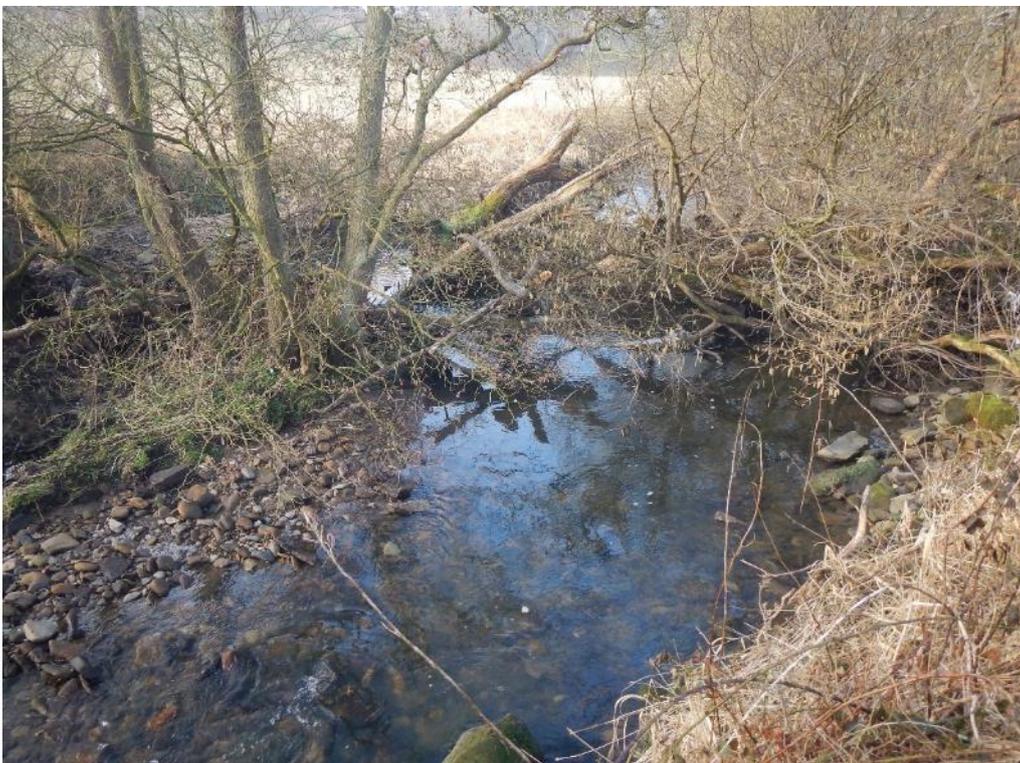
BB83. Scour around bankside alders creates good pool habitat for adult trout, with the associated flow constrictions also providing true Natural Flood Management (NFM) benefits, while maintaining a free channel for fish movement and sediment transport – unlike many fixed, man-made NFM structures.

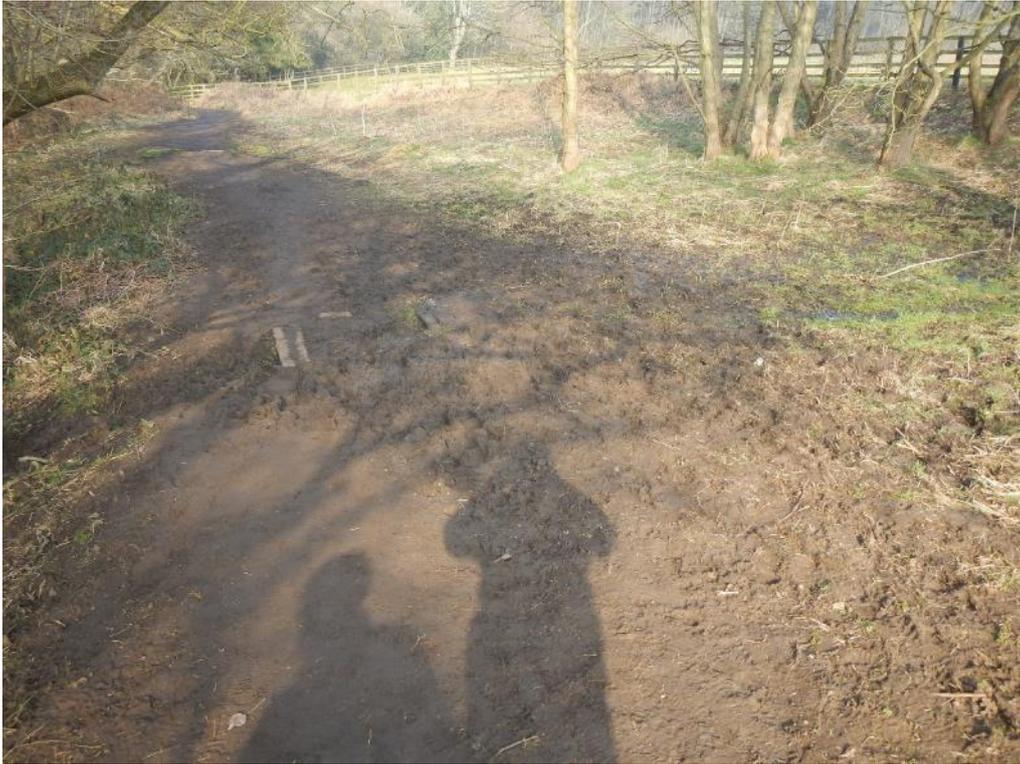
BB85. Springs or possible field drain discharges create boggy areas that, coupled with heavy footfall along the path, increase fine sediment input to the watercourse (NZ 22194 54994). Cheap and simple drainage with an appropriately sized pipe could rectify the issue.

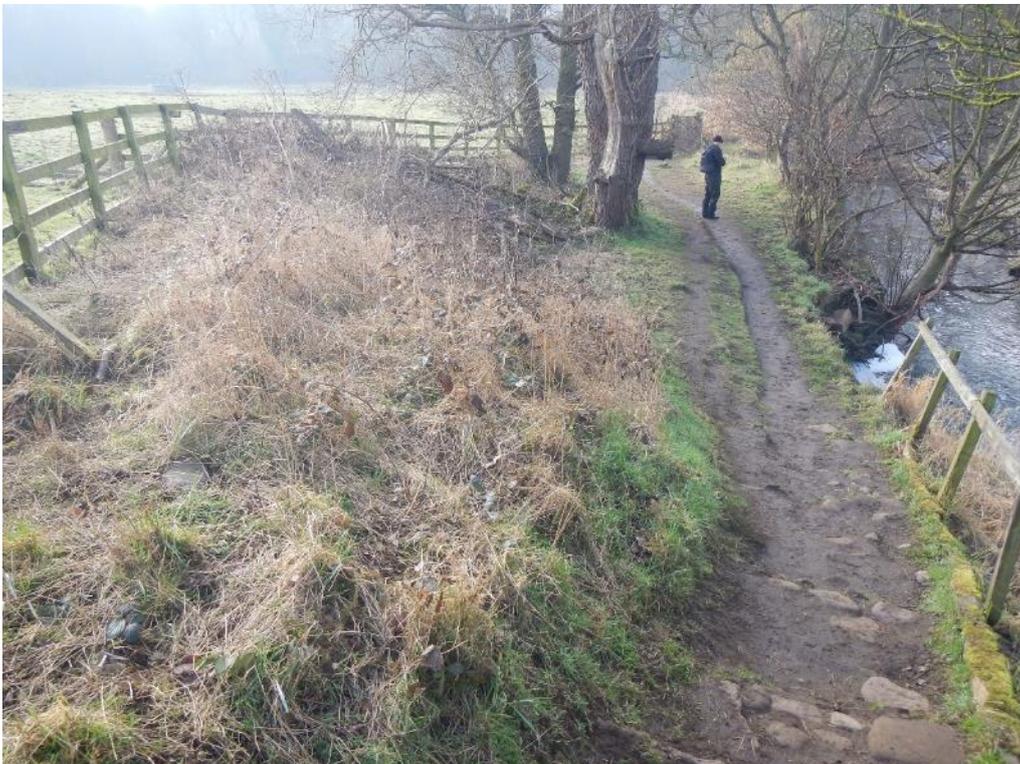
BB86. The path is threatened by lateral channel erosion (NZ 22196 54962). Ideally the path should be moved back to allow the banks to revegetate and stabilise – possibly with the addition of a willow planting or brush bank protection.

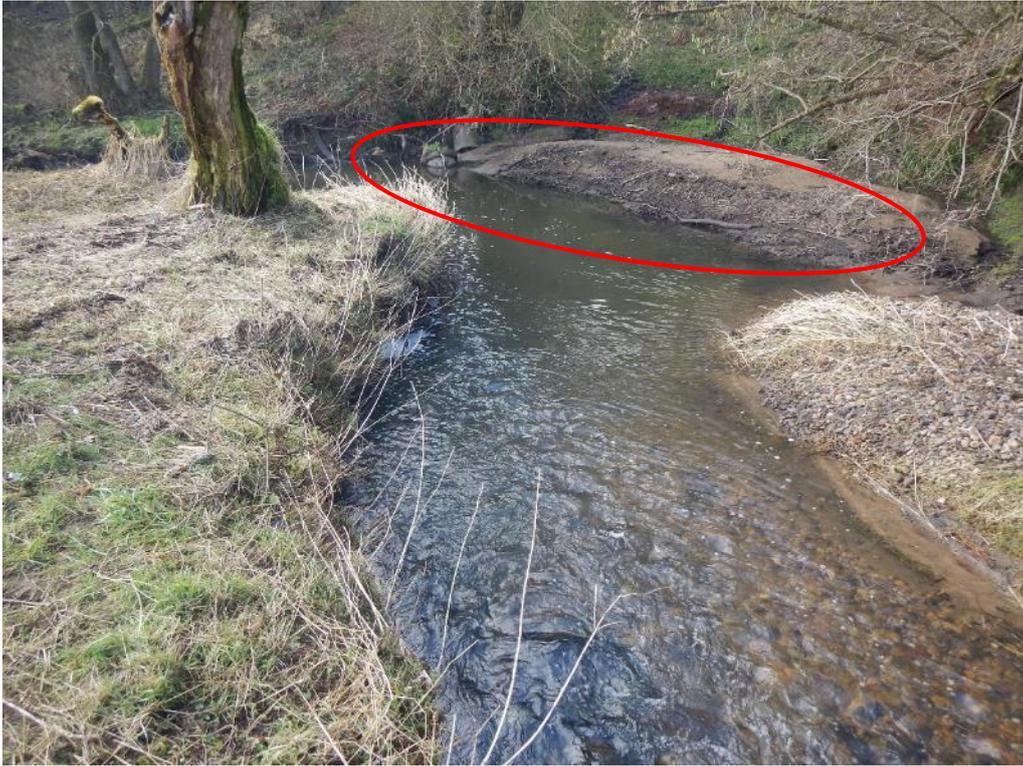
BB90. The more sinuous planform in this area and increased flow diversity allows the development of valuable pool features. However, the considerable fine sediment load clearly visible in lower energy depositional areas (red ellipse).

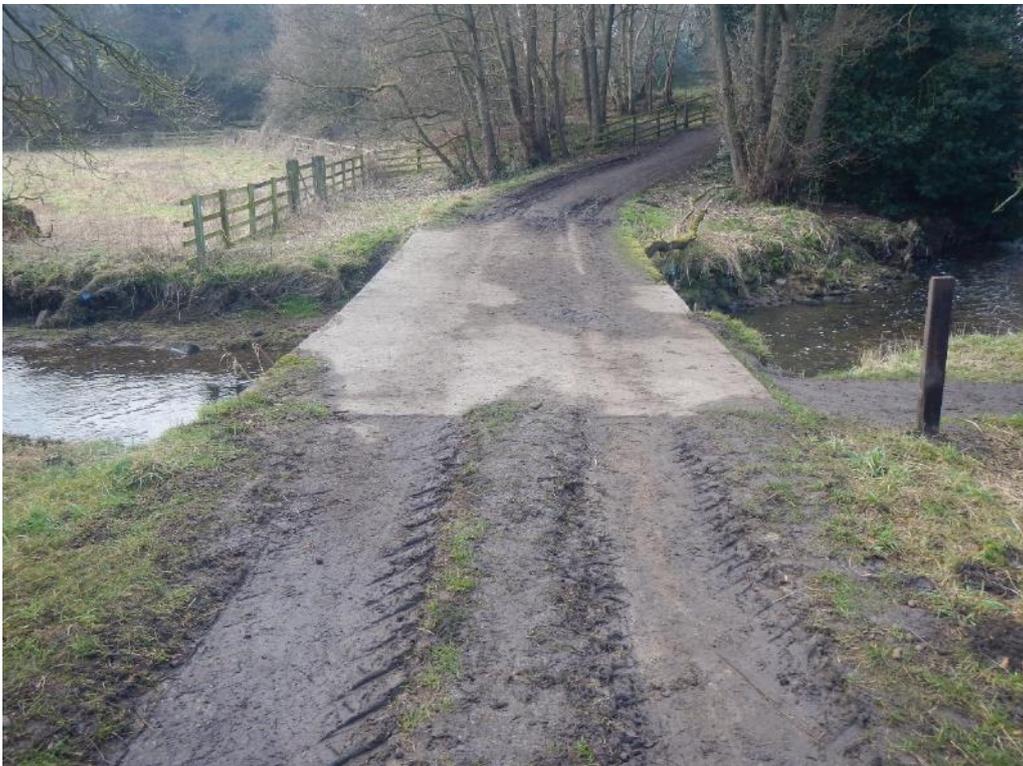
BB96. The track crossing and bridge create a likely source of surface runoff and fine sediment (NZ 22288 54798). Cross drains discharging to rough ground, away from any watercourse, would be beneficial.

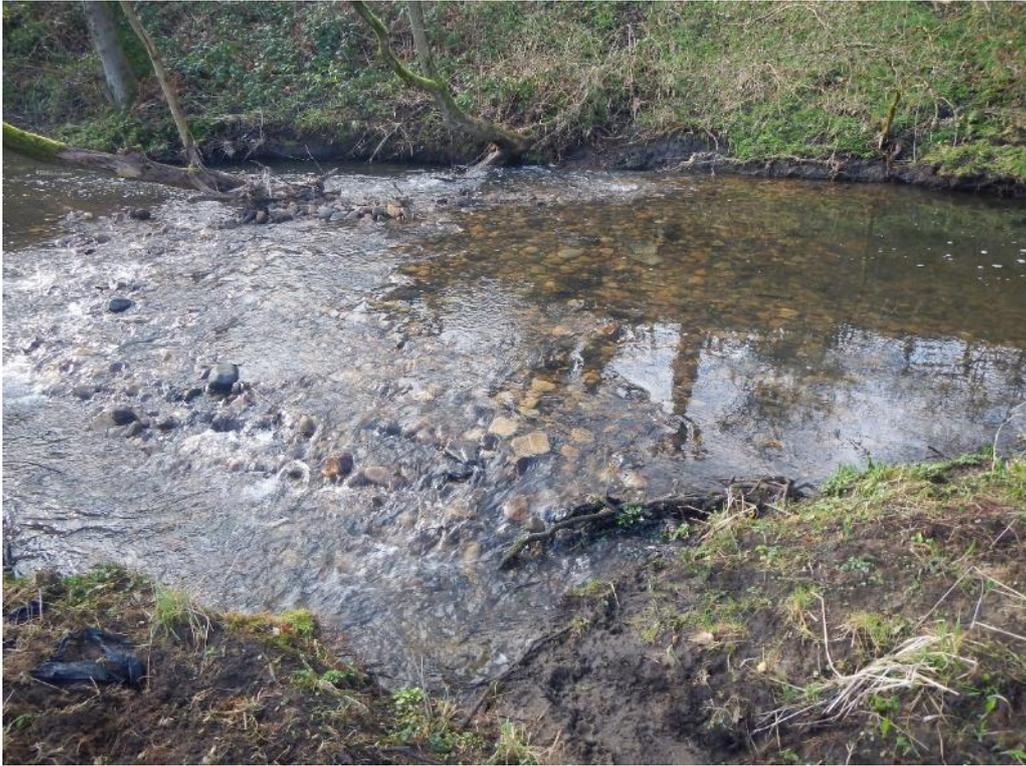
BB93. Where large woody material, or in this case bends, have driven scour into the bed valuable gravel bar deposition can be seen downstream, and the potential quality of salmonid spawning substrate becomes evident (here particularly for larger migratory fish).

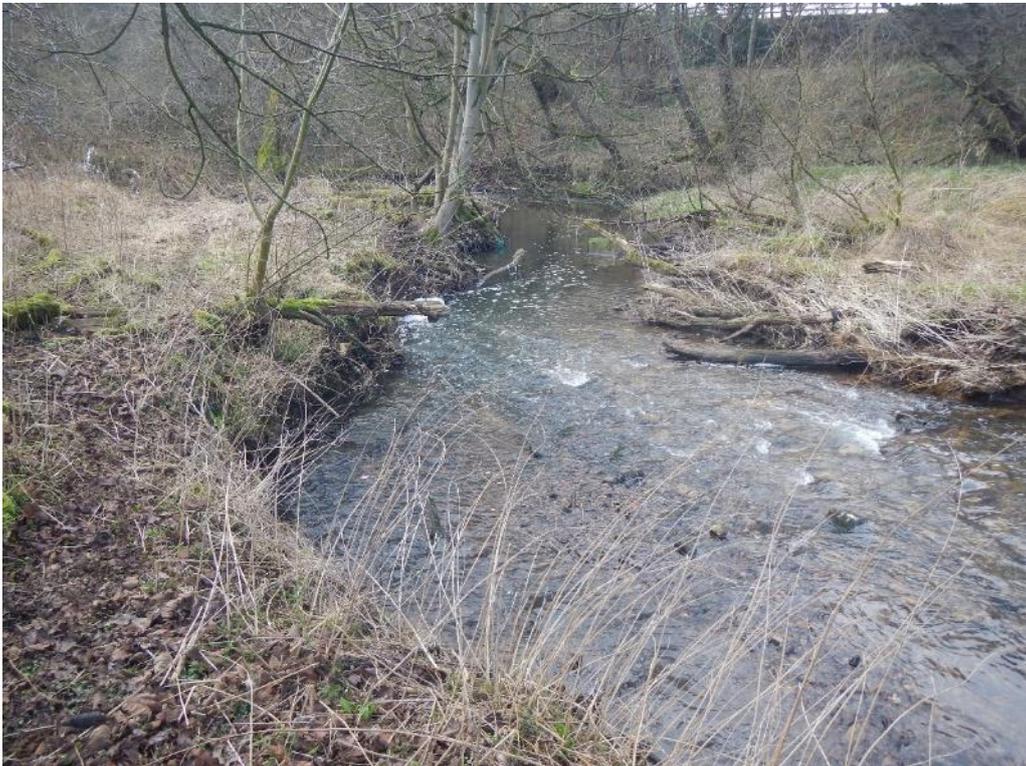
BB106. The basic habitat quality of the area around Beamish Museum remains high, with ample basic habitat to support salmonids.

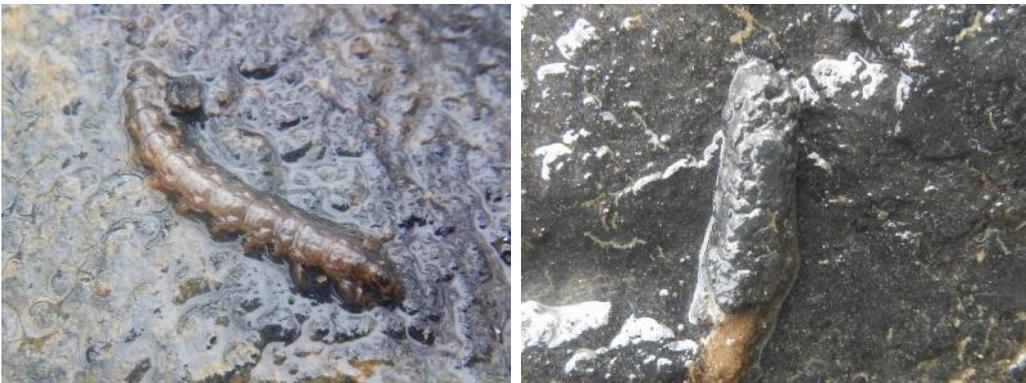
BB108 & 109. Cased and caseless caddis from Letch Burn.

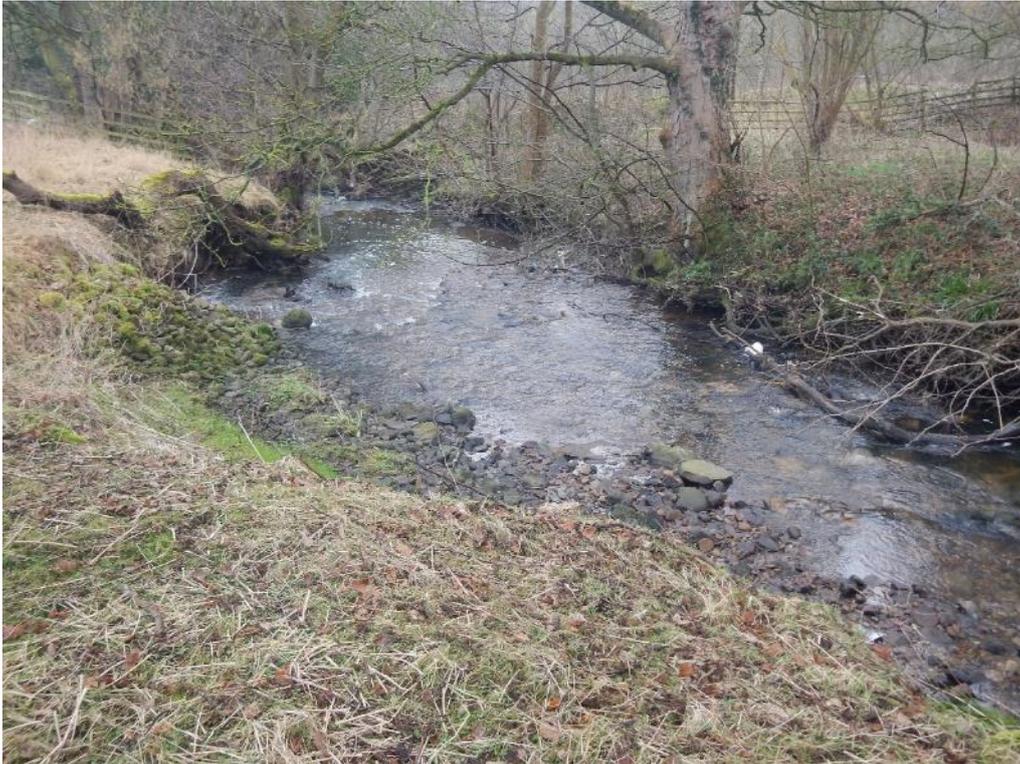
BB111. The physical habitat downstream remains good for salmonids.

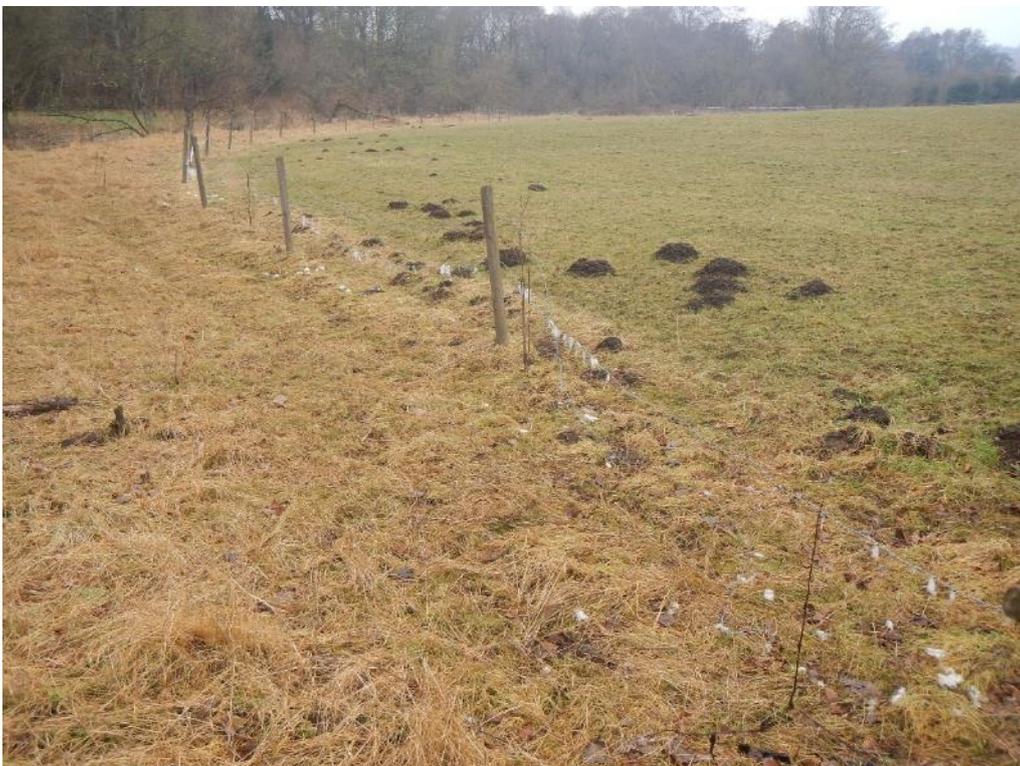
BB114. The field at NZ 22350 54656 appears to be cut for fodder, but then aftermath grazed (as evident by wool on the dilapidated fence). Bankside vegetation and tree regeneration would greatly benefit from reinstatement of a stock proof fence.

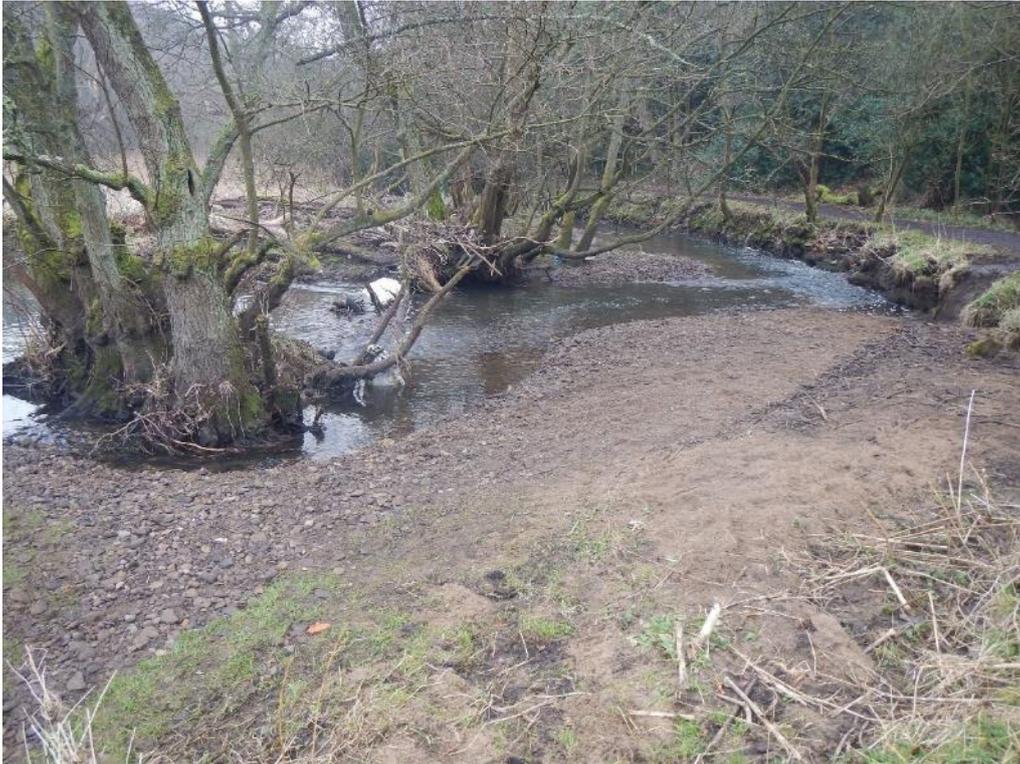
UB2. Increased structural diversity within the channel leading to beneficial substrate sorting. At this sharp bend, the RB is also becoming threatened by erosion (NZ 22586 54454).

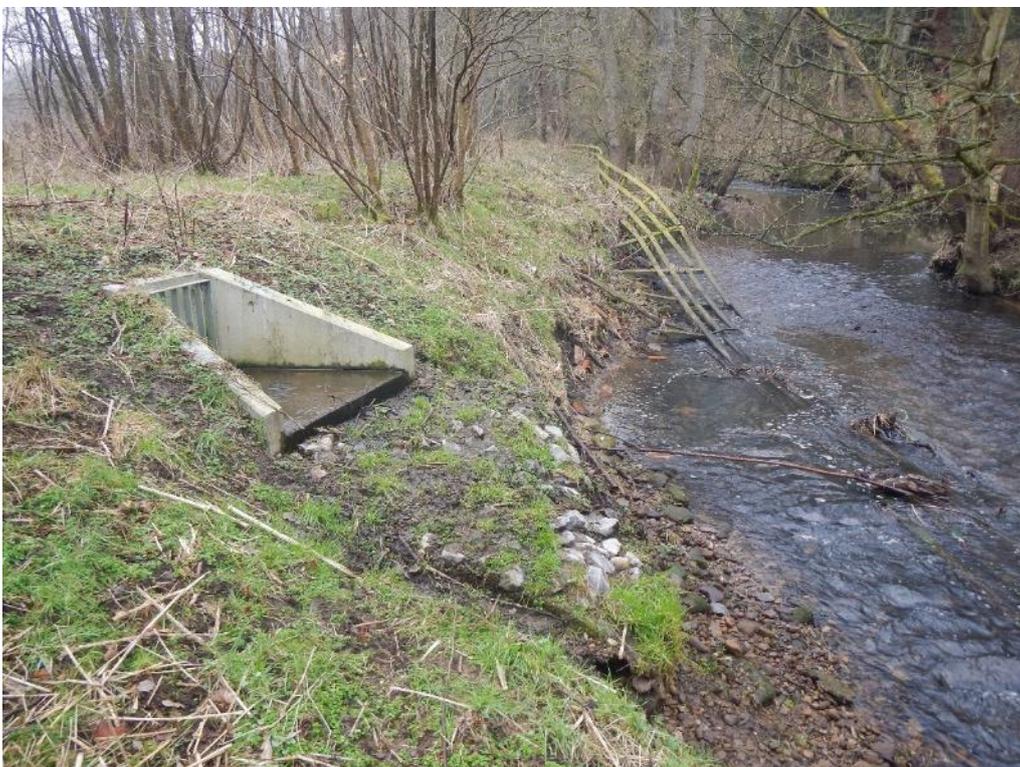
UB6. Further erosion downstream is likely the result of a hard apron inappropriately installed on the riverbank. Ideally this should just be allowed to find a natural equilibrium.

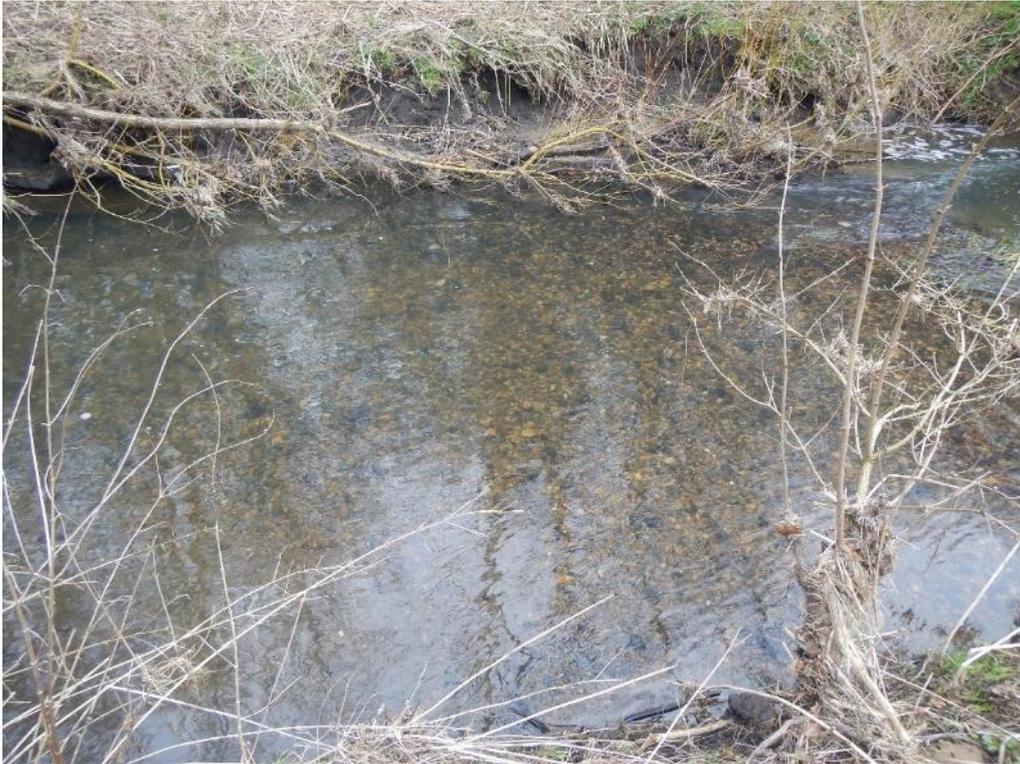
UB8. More potentially high-quality gravels for invertebrates and salmonid spawning – providing the fine sediment and water quality issues can be addressed upstream.

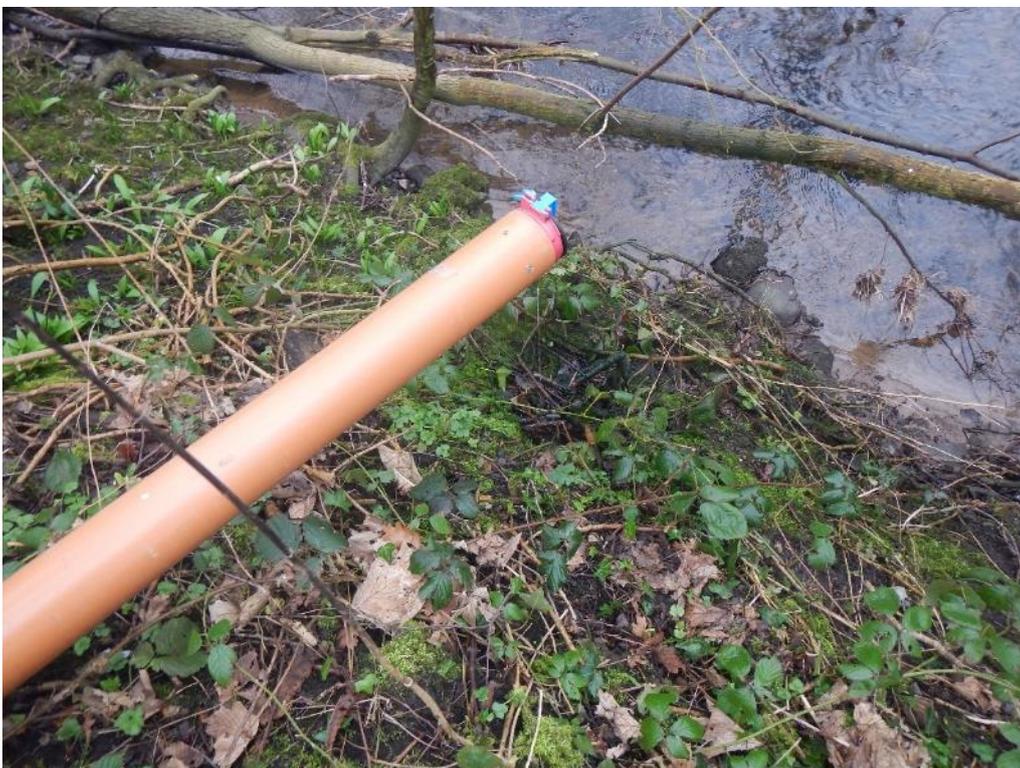
UB9. Discolouration of vegetation at a pipe outfall suggest an elevated nutrient discharge (NZ 22748 54215).

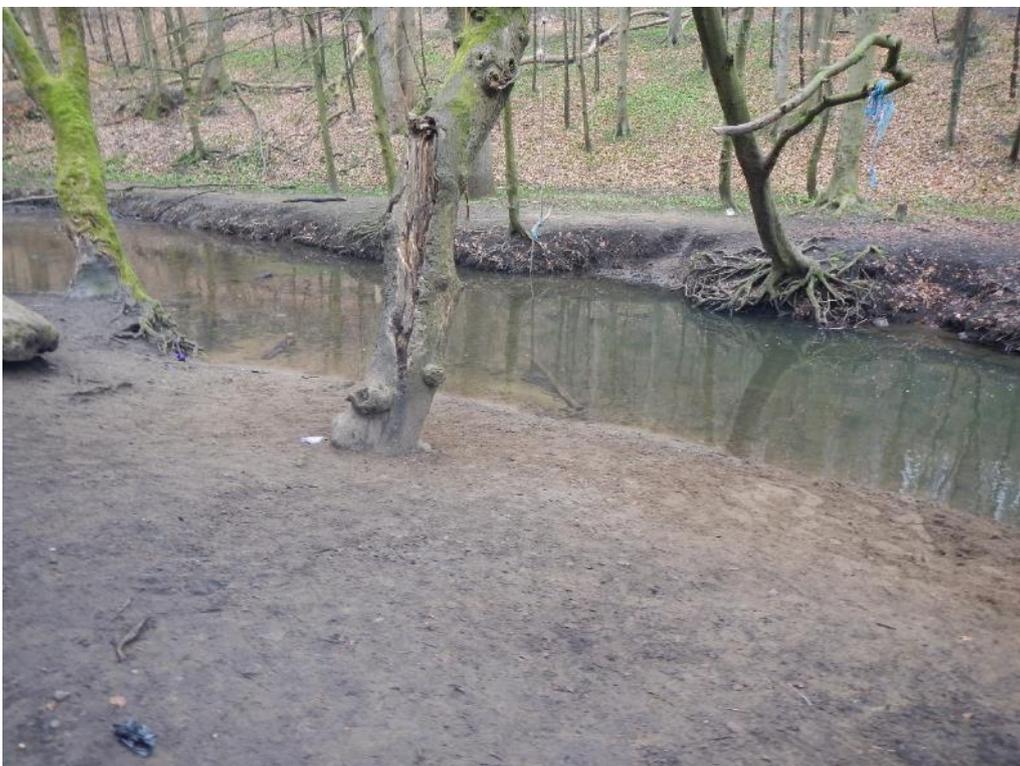
UB20. High footfall of dogs and humans in the area is preventing understory vegetation and creating increased erosion, as evident by exposed tree roots (NZ 22583 54071).

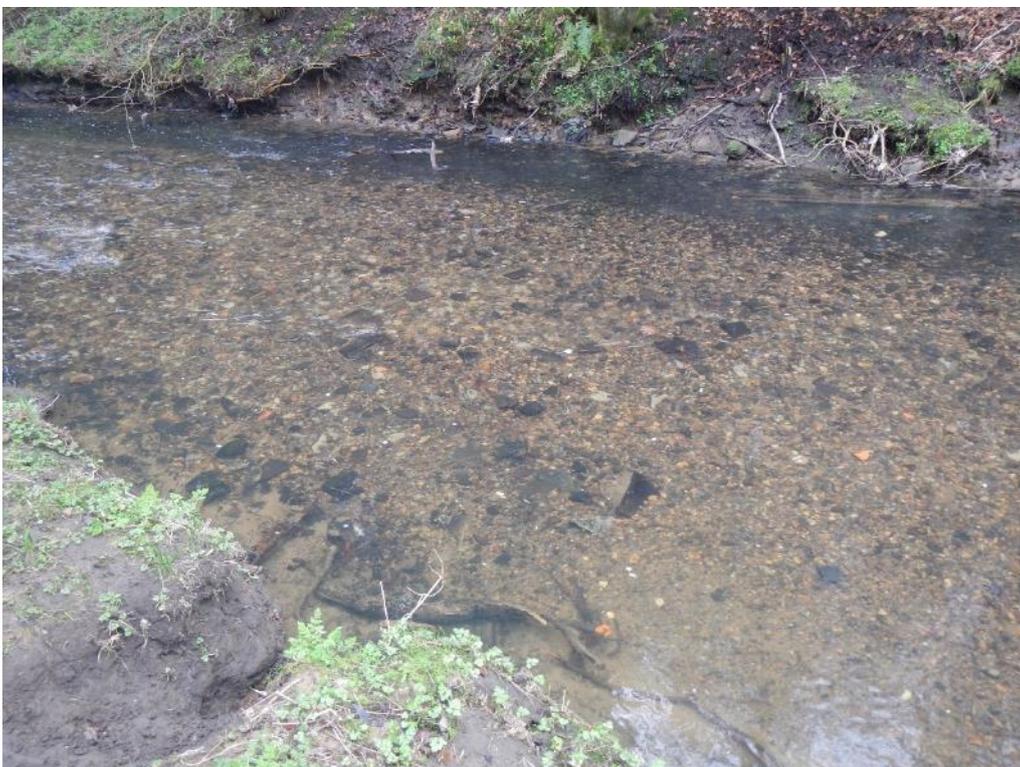
UB37. In wider, lower gradient areas downstream of the gorge, the building impact of fine sediment inputs can be seen in the silt-laden bed.

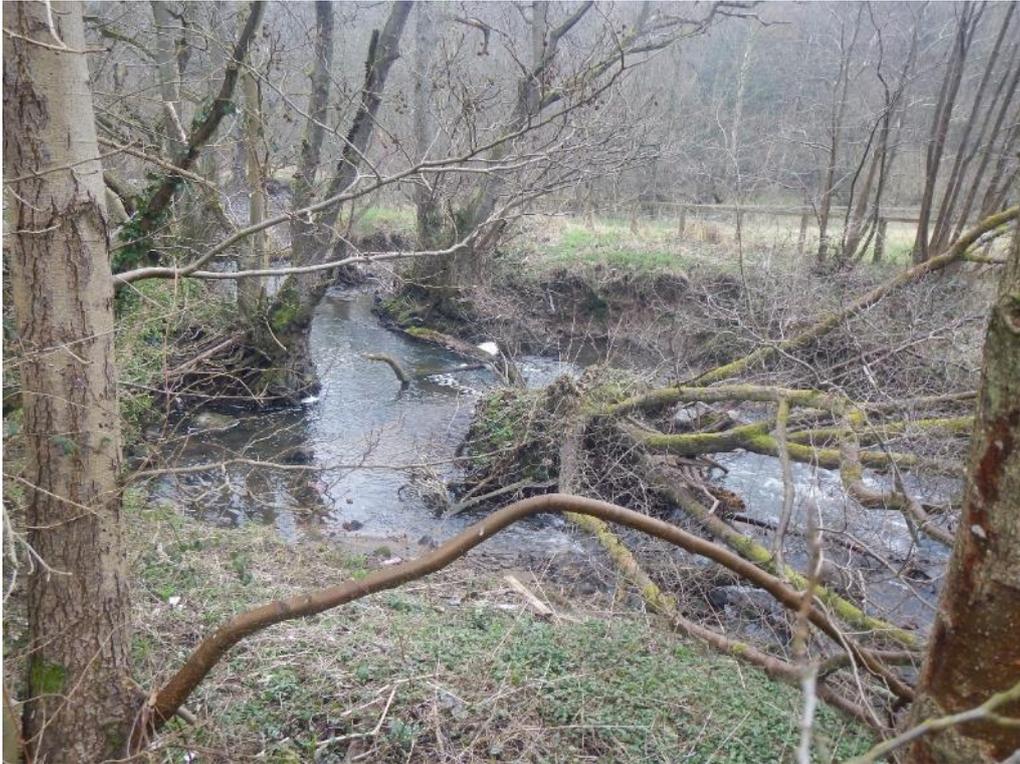
UB58. Downstream, the channel is naturalising nicely. The erosion leading to, and resulting from, tree wash-out is relatively natural and not of concern as the process creates valuable habitat features (pools and in-channel structure). It is the artificially increased erosion rates upstream in the catchment that require action.

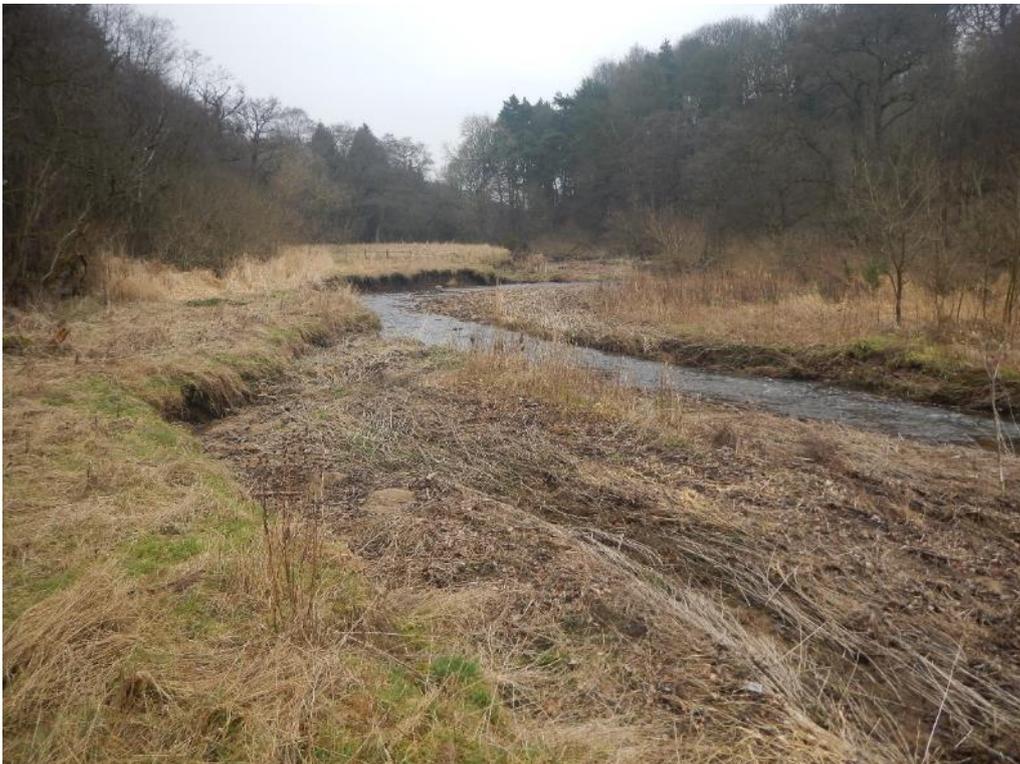
Te1. The valley progressively opens downstream of Urpeth Burn and the River Team develops a lower gradient meandering channel.

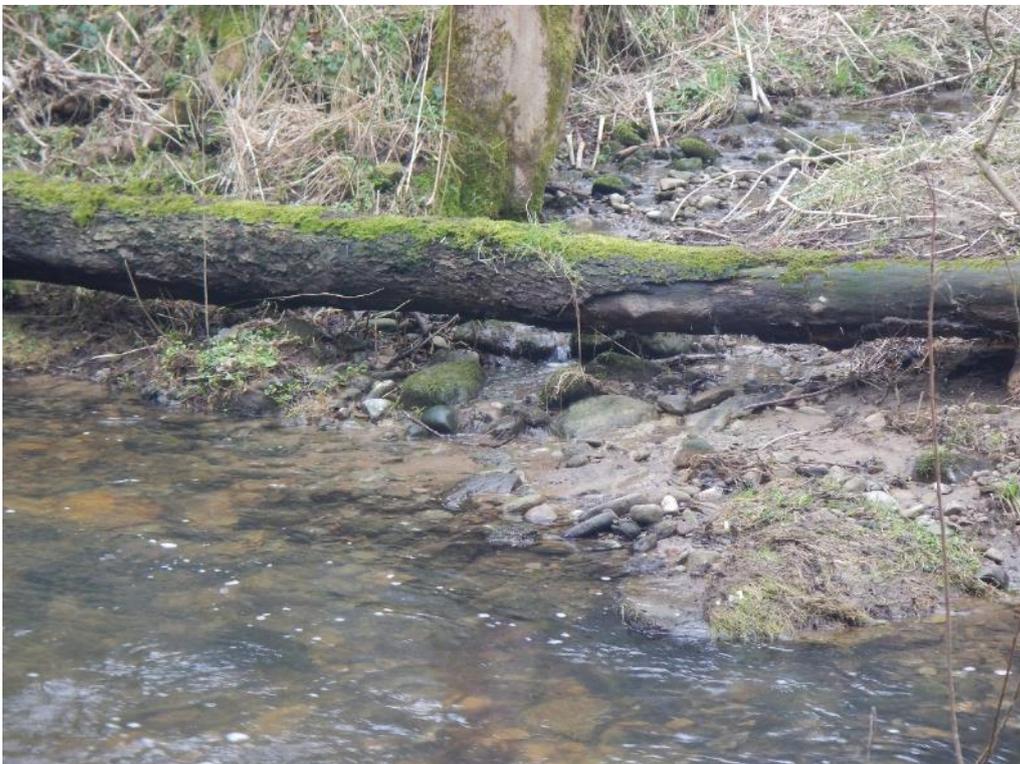
TE8. Fine sediment entering from a small tributary (NZ 23815 54513). While the R. Team catchment is clearly susceptible to issues of fine sediment input, it is invariably inappropriate land use that increases the issue to problem levels.

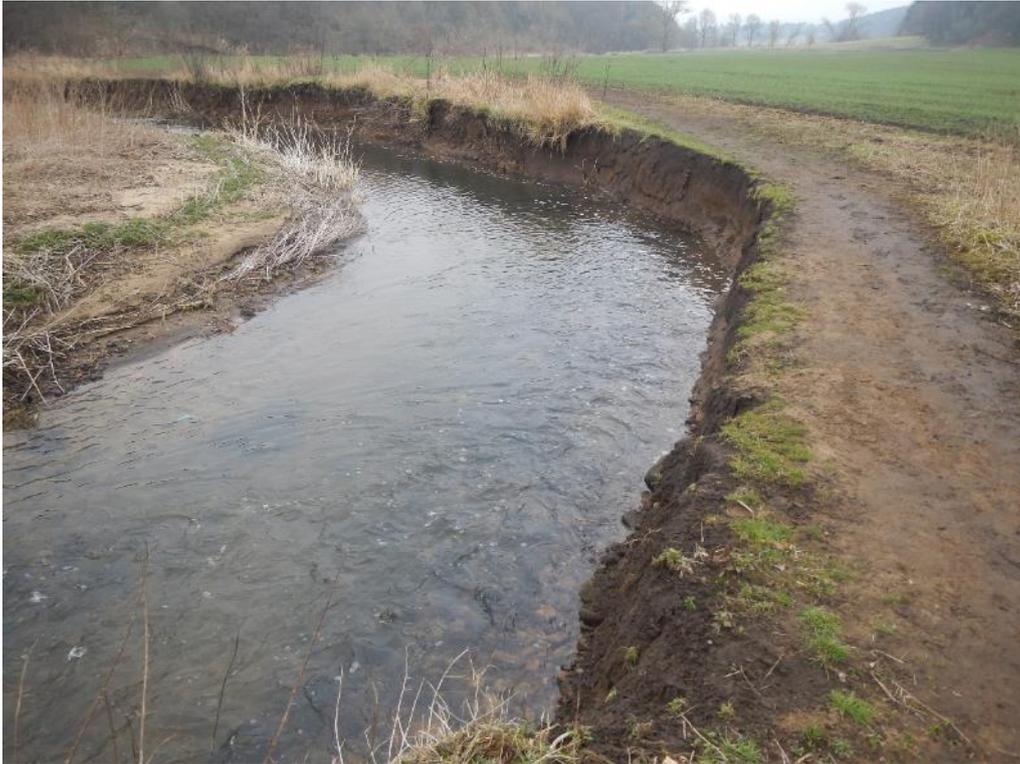
Te13. Lateral erosion threatens a farmer's field (NZ 23964 54558). The river is simply responding to historical straightening (to the left of the floodplain). A lack of trees to consolidate the banks, cultivation too close to the watercourse and the track preventing vegetation growth all further contribute to the erosion here.

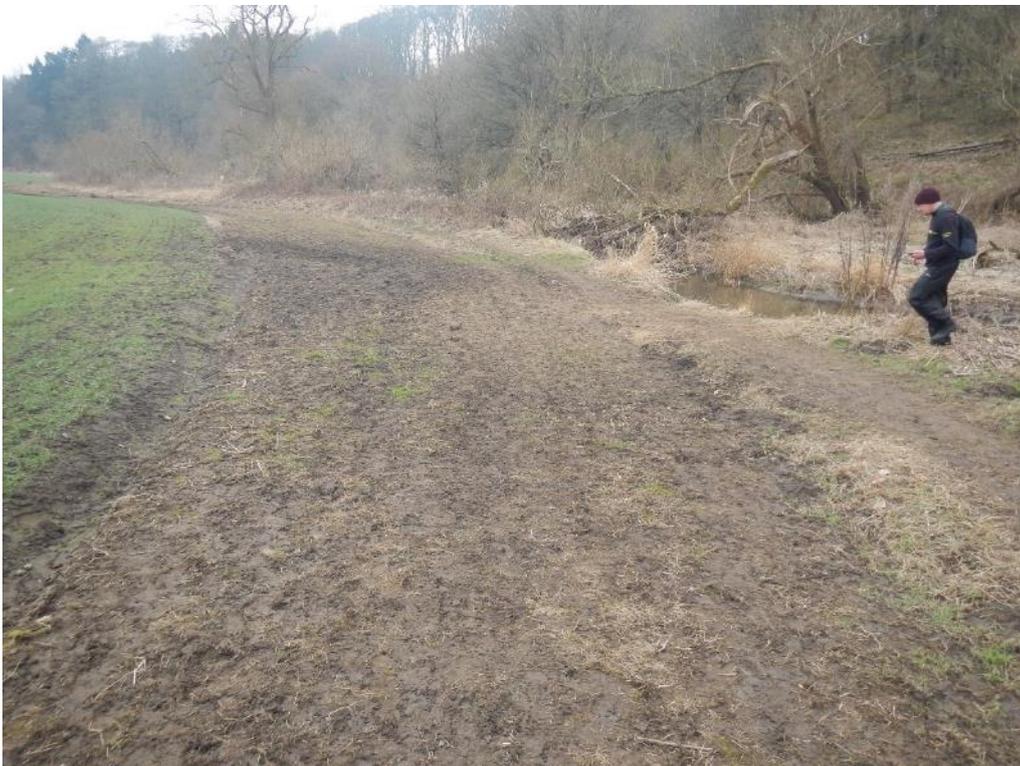
Te18. A similar issue downstream (NZ 24138 54741). A greater buffer has been maintained, but the trampled track and lack of vegetation negate the benefit. The solution here would be to allow a greater buffer and relocate the path back from the watercourse to facilitate planting and allow bankside vegetation to establish.

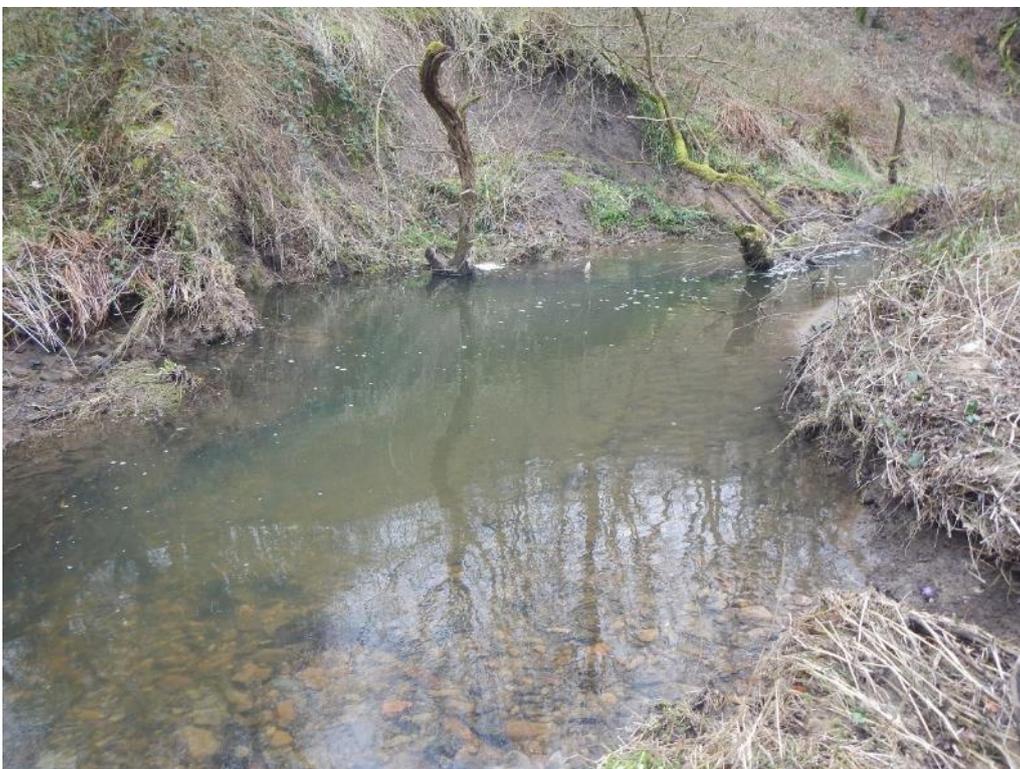
Te23. The general habitat remains capable of supporting salmonids, with some interesting pool and riffle features.
