WILD TROUT TRUST

River Team
(lower catchment)

March 2021

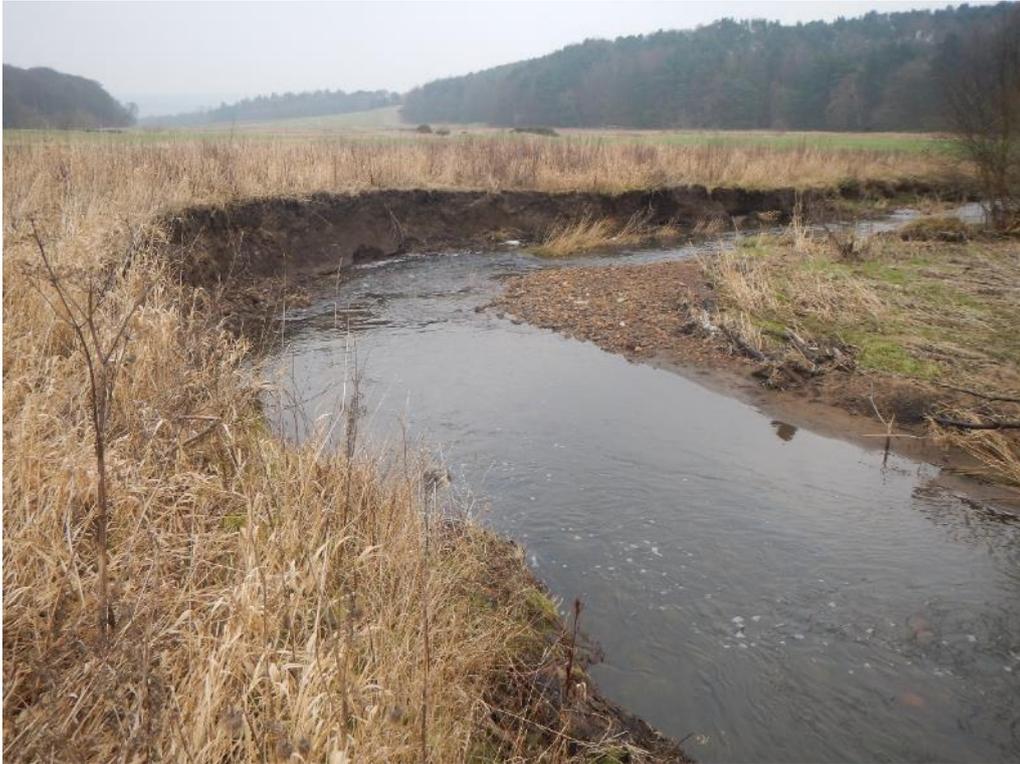
Te25. It would be beneficial to undertake tree planting on the outside bend to manage (not prevent) the rates of erosion (NZ 24395 54815).

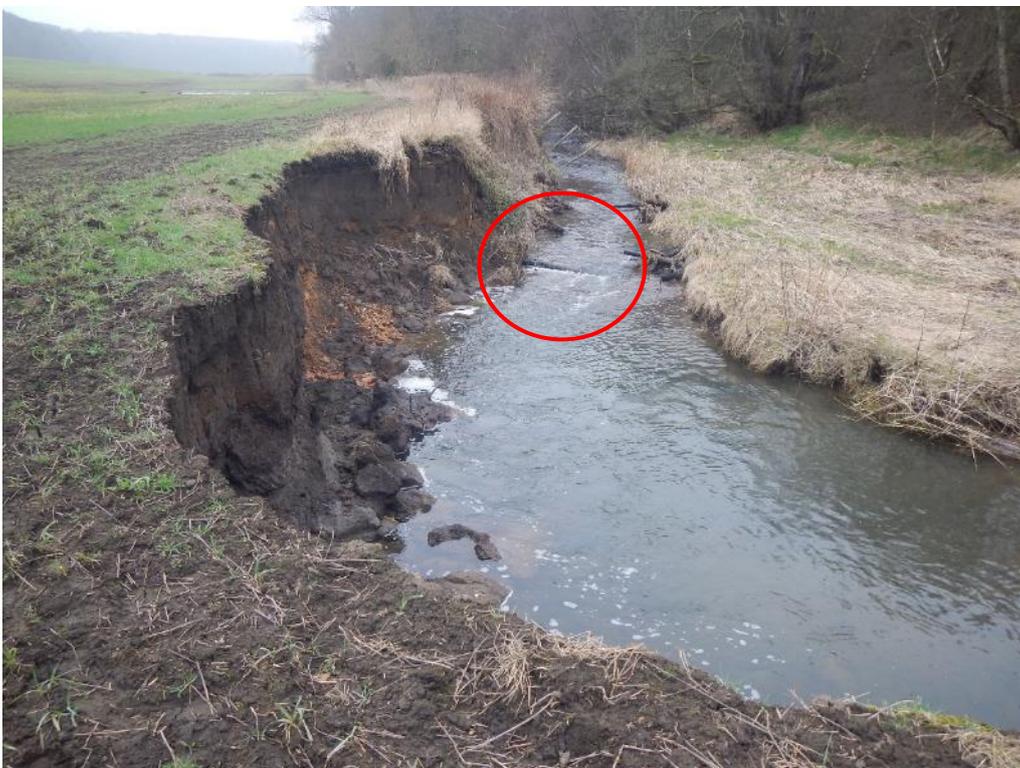
Te51. The river naturally responding to its severely straightened channel, cultivation too close to the banks and a lack of bankside trees. Land drains discharging from the bank also destabilise the soil (NZ 24931 55537). In addition, pipes within the channel are acting as downstream deflectors, directing overtopping flow towards the bank (red circle).

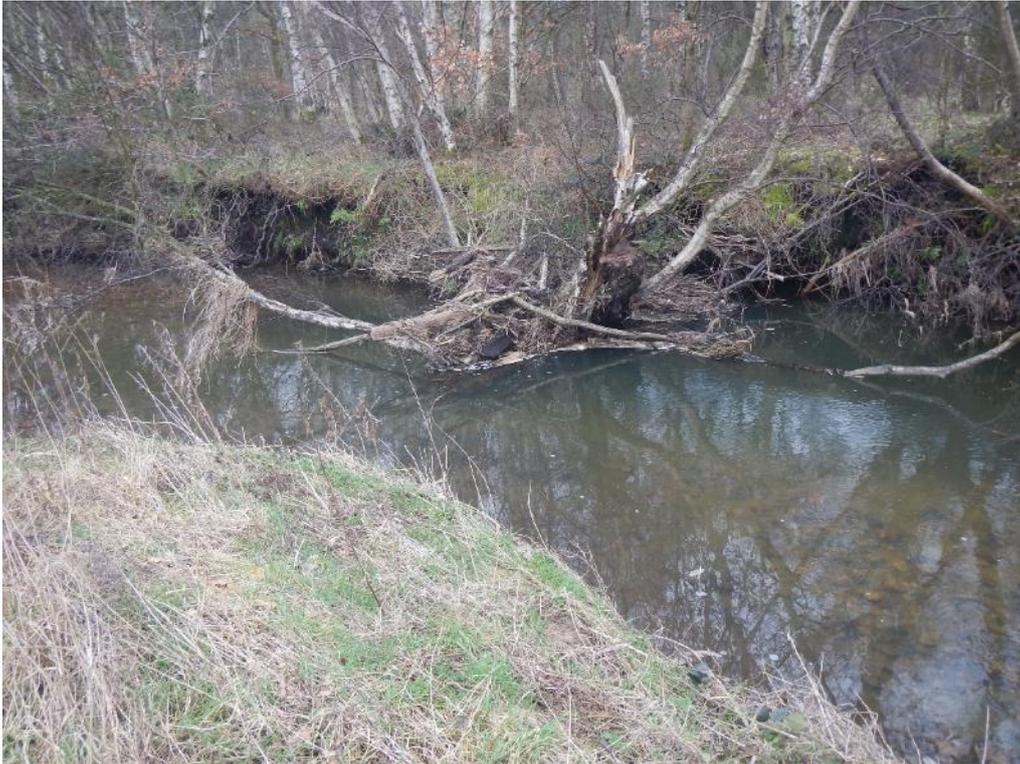
Te63. The river skirts the edge of a deciduous woodland where habitat is generally good, with valuable woody material input.

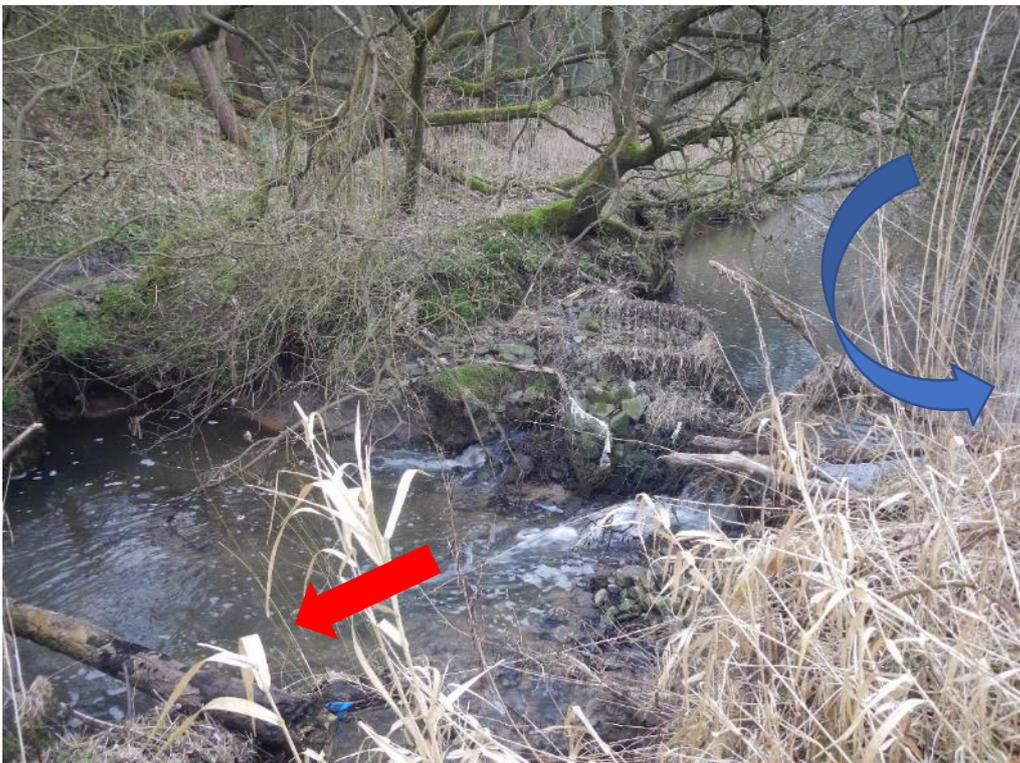
Te68. A bank breach threatens to divert the river down a straight drainage channel (red arrow); NZ 25309 55883). Gabions (failing) have been used inappropriately to protect the bank. A solution could be to roughen the drainage ditch with large woody material (LWM) and laying adjacent willows into the channel, thereby making the main river course (blue arrow) the easiest route flow pathway. This would encourage the ditch to block through natural deposition.

Te69. Although it is generally best to leave naturally occurring woody material well alone, a fallen willow in the pool downstream could be realigned to aid conveyance down the river and reduce pressure at the gabion breach a short distance upstream (**Te68**).

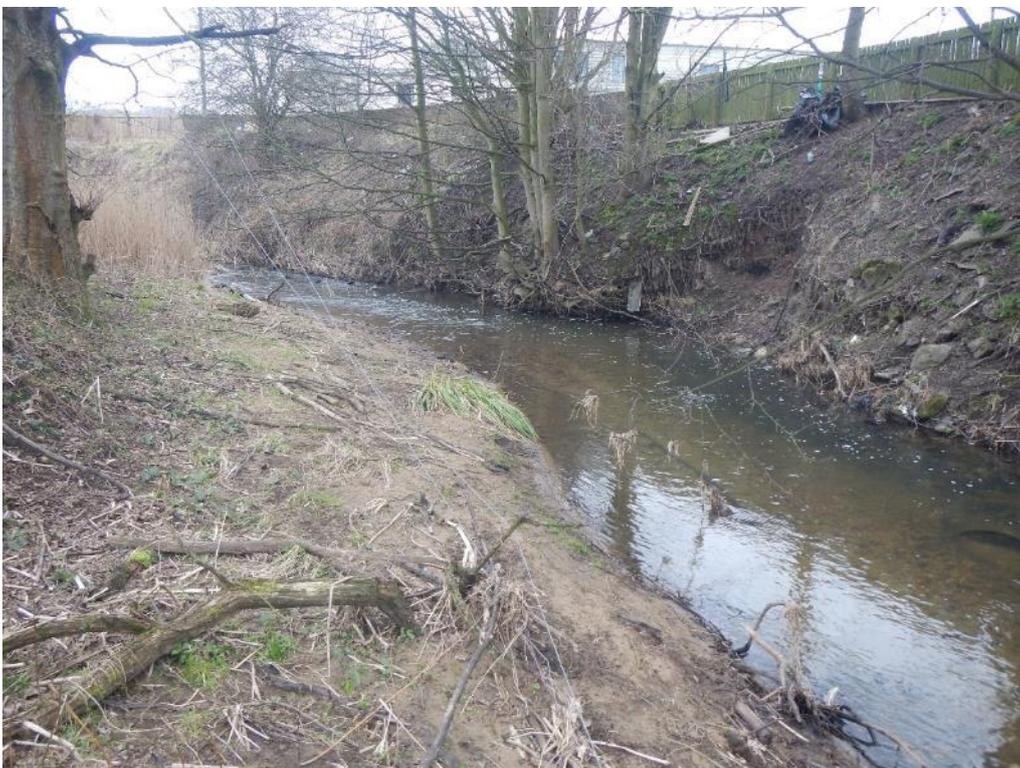
Te71. The river makes several large meanders towards the LB side of the valley bottom creating erosion and potentially threatening the land boundaries (NZ 25278 56026).

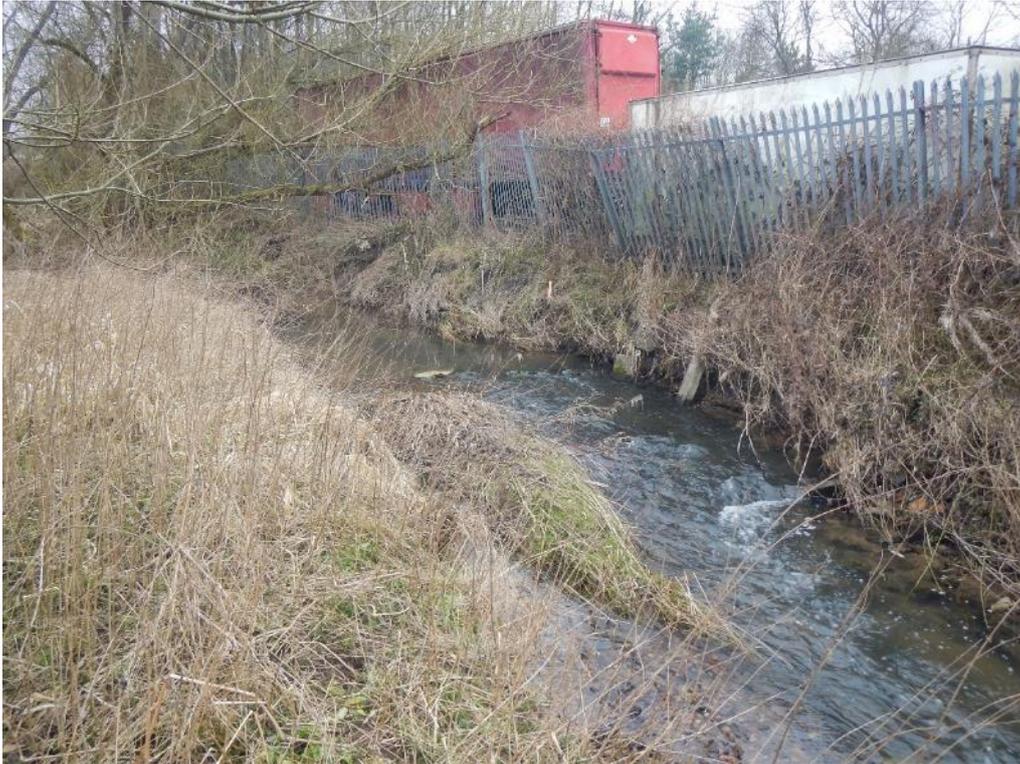
Te80. The river threatening the boundary of the yard downstream (NZ 25475 56062).

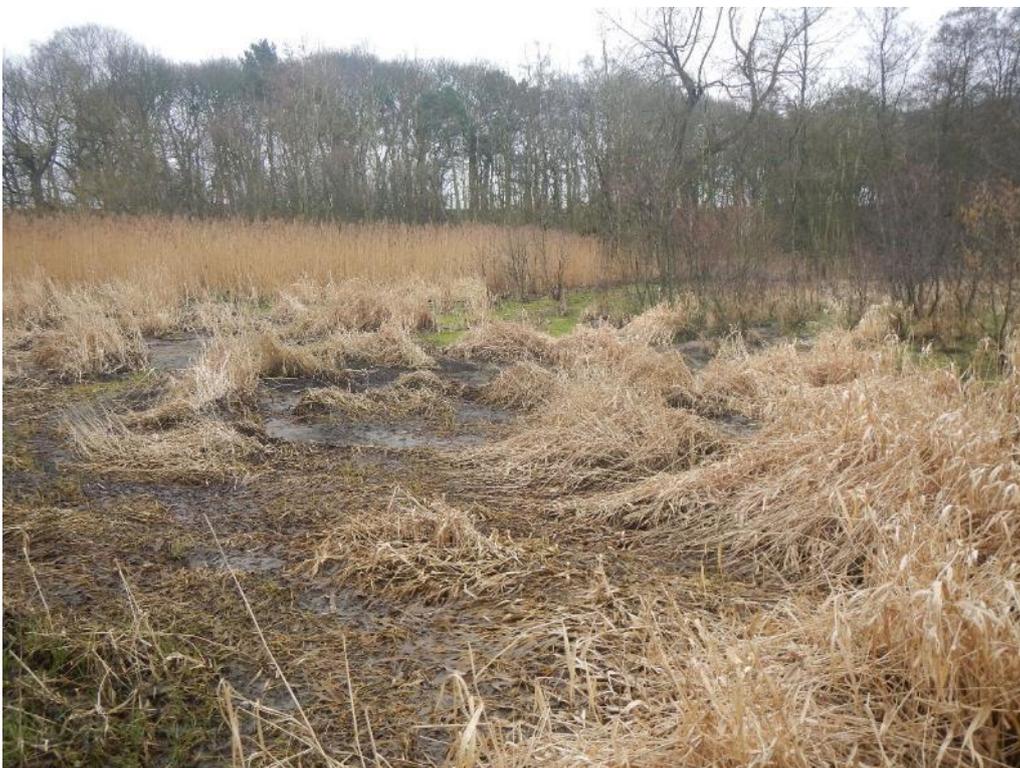
TE78. The RB floodplain is a low, marshy area (contributed to by the drain and lost river flow upstream **Te68**).

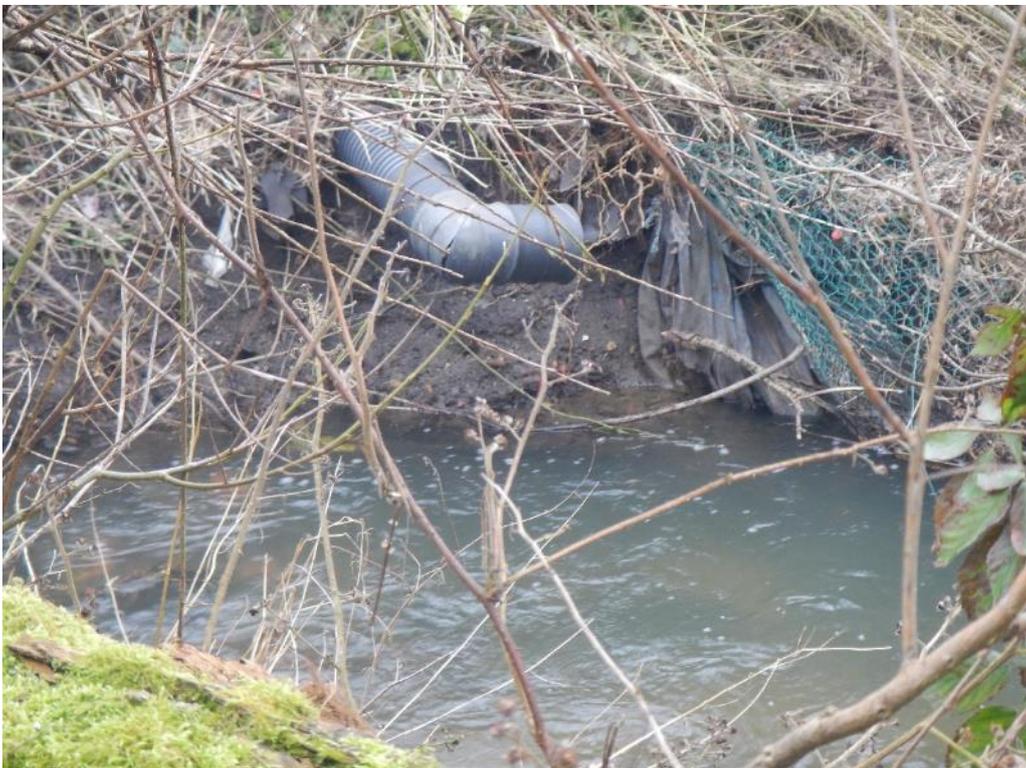
Te85. A large diameter pipe was not discharging at the time of the walkover (NZ 25557 56027).

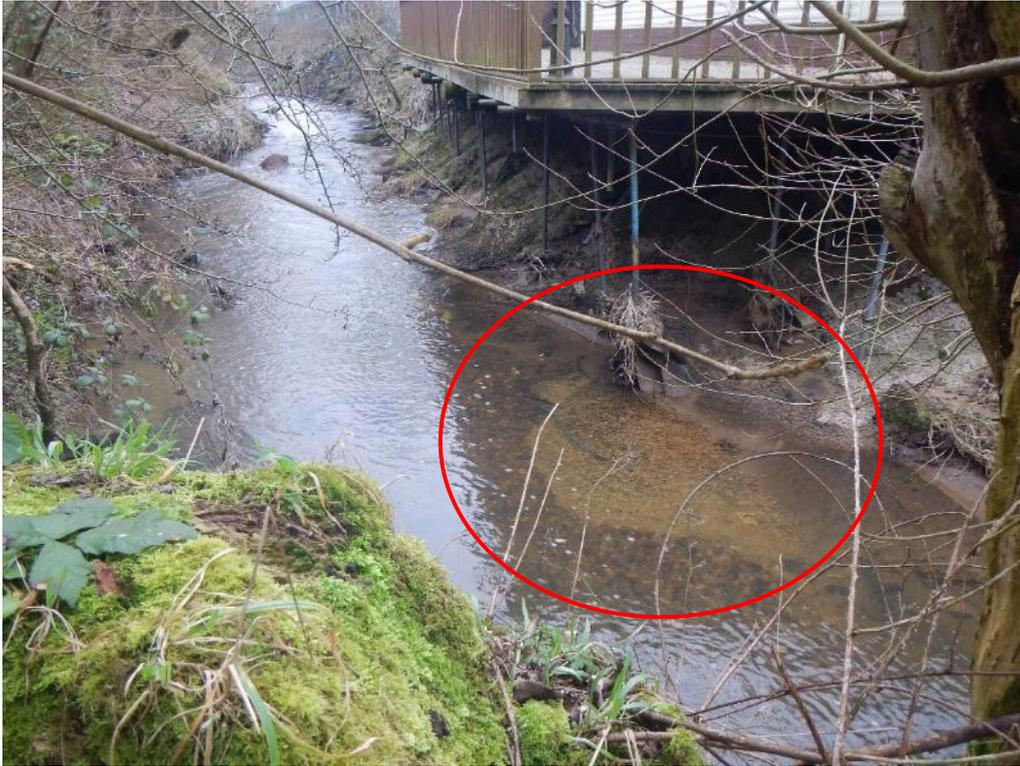
Te86. Highly inappropriate (illegal) bank work has been undertaken to shore up decking along the riverbank (NZ 25620 56036). Concrete has been poured along the banks and even on the bed of the watercourse (red circle).

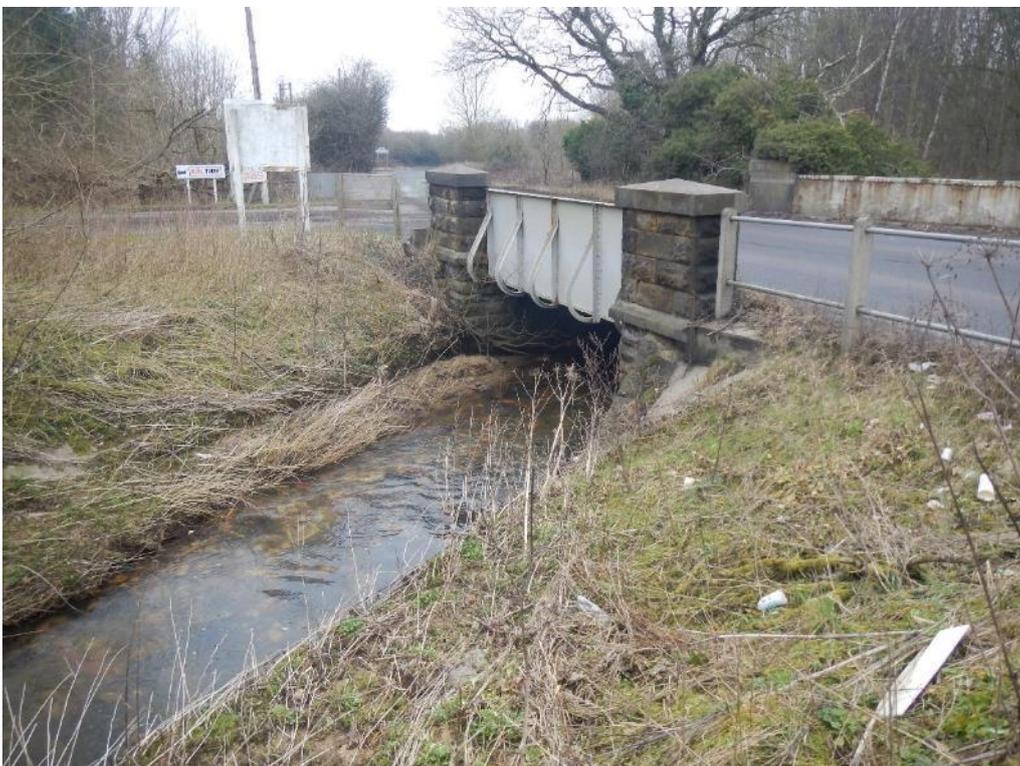
Te90. The Greenford Lane Bridge is a swim-through, posing no issues for fish or sediment movement (NZ 25710 56092).

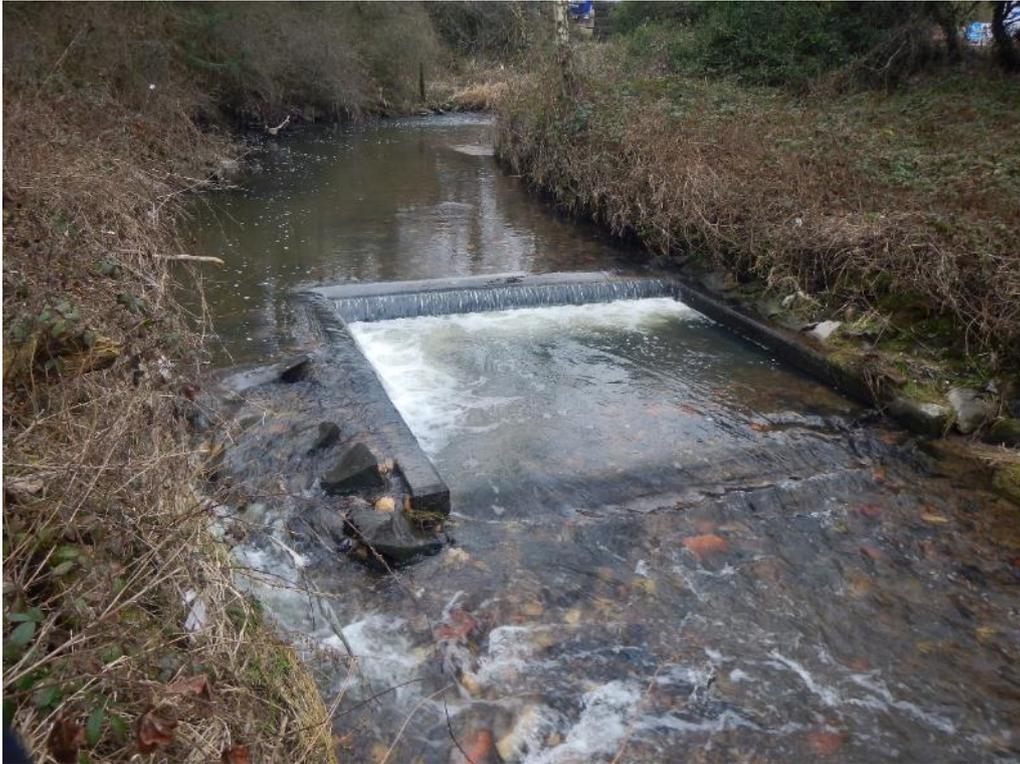
Te92. Downstream of the road, the river runs alongside the now disused Union Brickworks Clay Pit. Four bed-check weirs (NZ 25716 56129; NZ 25753 56239; NZ 25805 56297; and NZ 25858 56349) have been used to mitigate head loss through the re-routed channel. The upper weir has a narrow crest and has been outflanked to the RB side, improving its passability to fish.

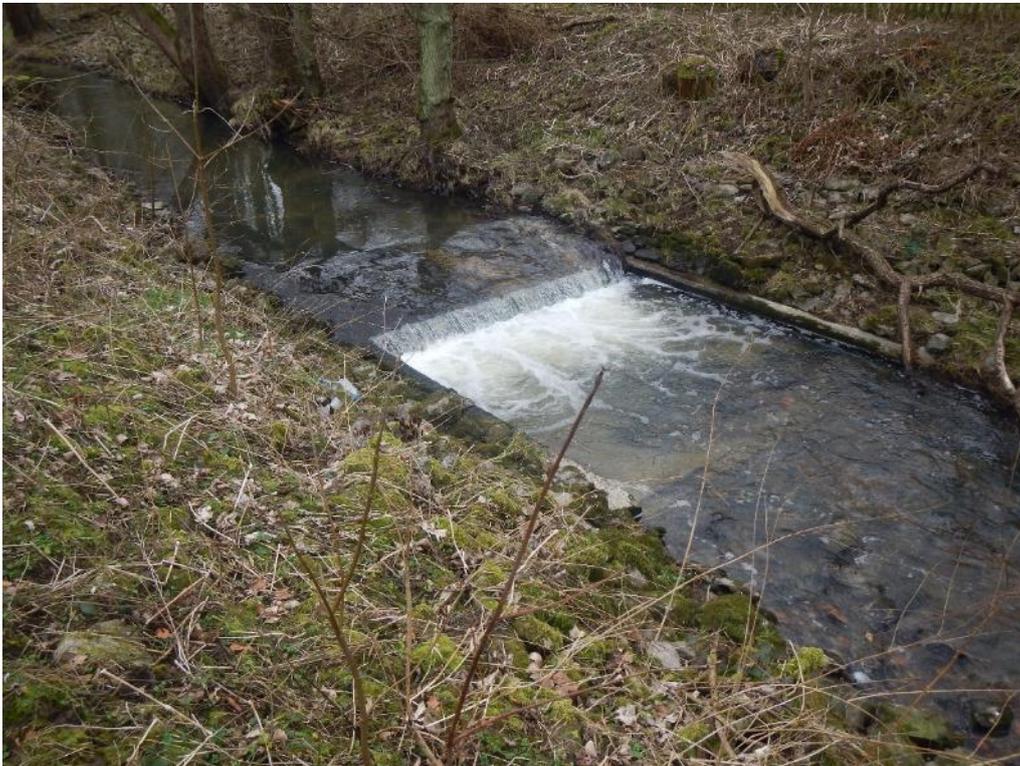
Te99. The two middle weirs are very similar, with a wider crest extending upstream, creating shallow water and high velocities that are more of an issue for fish passage.

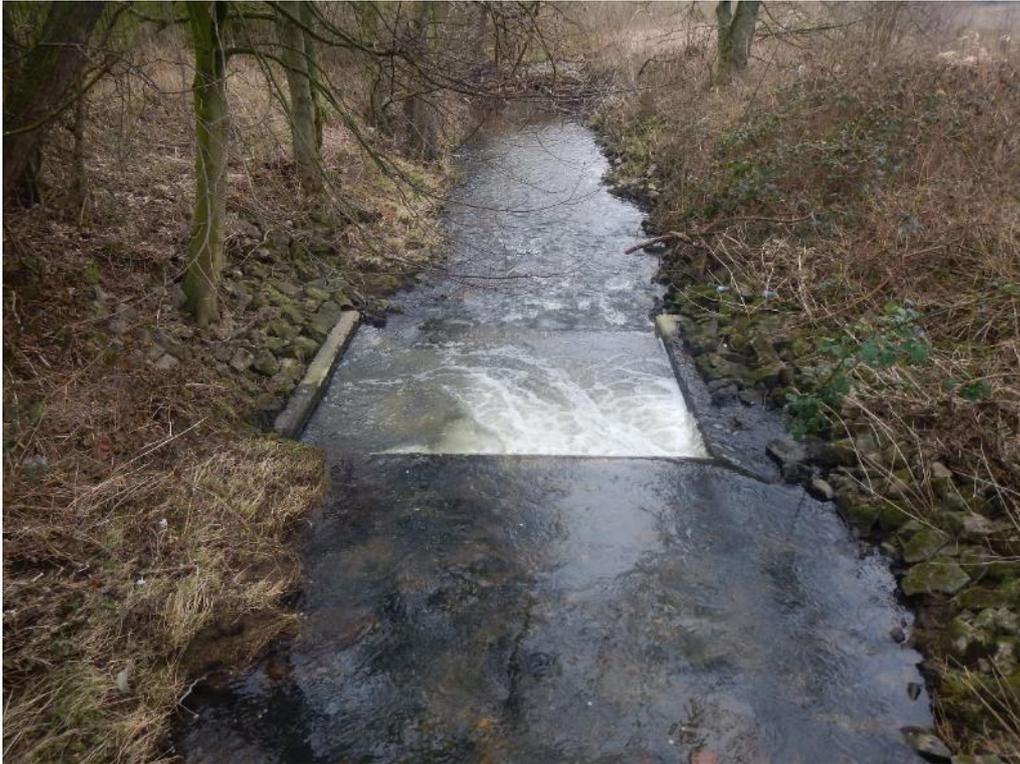
Te101. The furthest downstream weir is similar to the first weir (narrow crest), but is higher and has not been outflanked, so creates more of an obstruction.

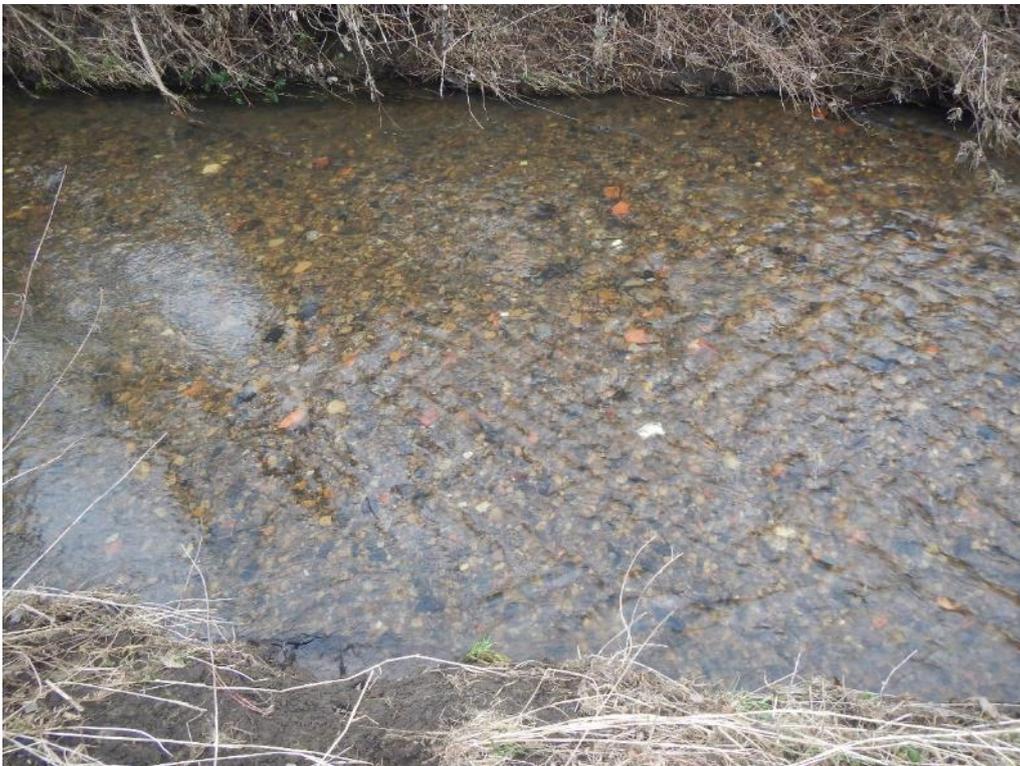
Te102. Deposition immediately downstream of the straightened section (where minimal sediment is retained) provides some potential for spawning (although still greatly compromised by fine sediment). This area has been used for spawning in the past (N Cook, EA, 2021, pers.comm., 2 March).

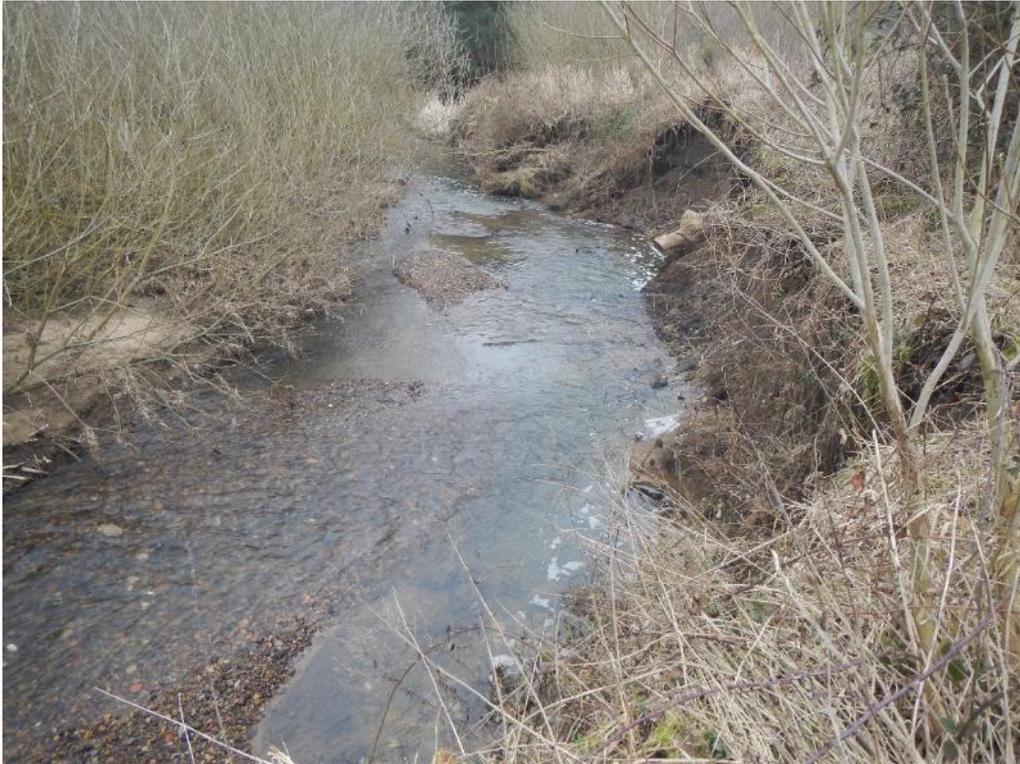
Te103. At several locations along the downstream boundary of the quarry site, the riverbank is precariously close to breaching (10-15 m in places), owing to quarrying having been undertaken far too close to the watercourse. Should the bank breach, the watercourse would be lost ~20m down into the quarry bottom.

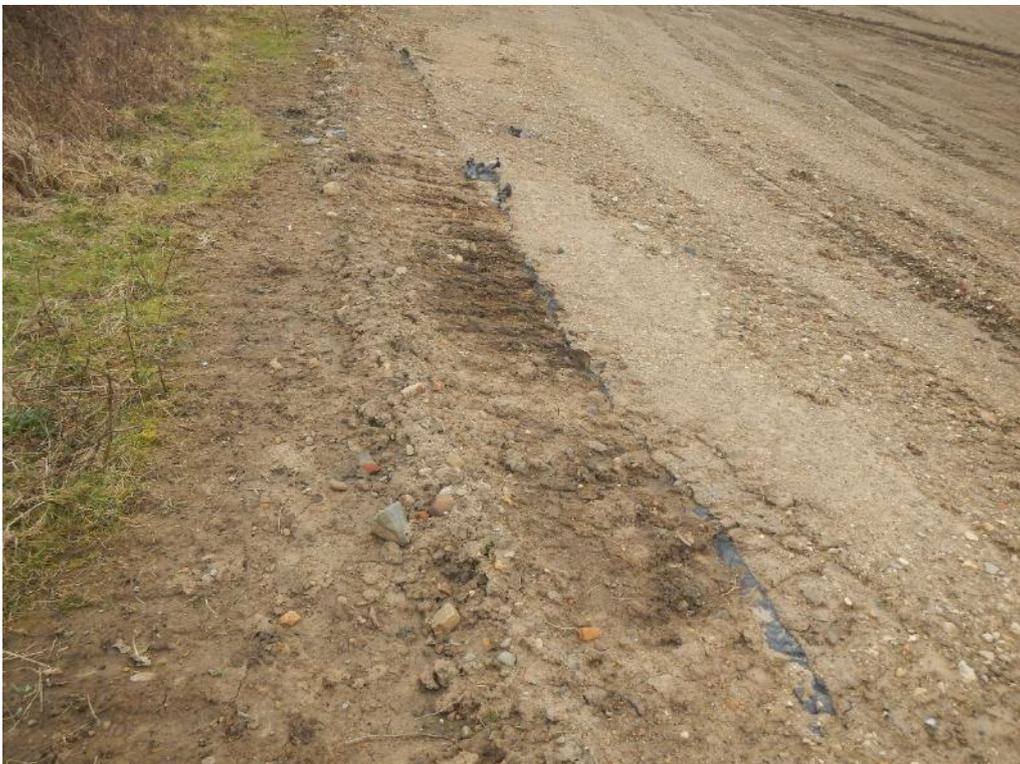
Te105. A membrane appears to have been installed to stem seepage to the quarry (and presumably increase bank stability), but this cannot mitigate the lack of space afforded to the river. As a bare minimum, reparation of the quarry should have reinstated a far greater bank area between the quarry and watercourse.

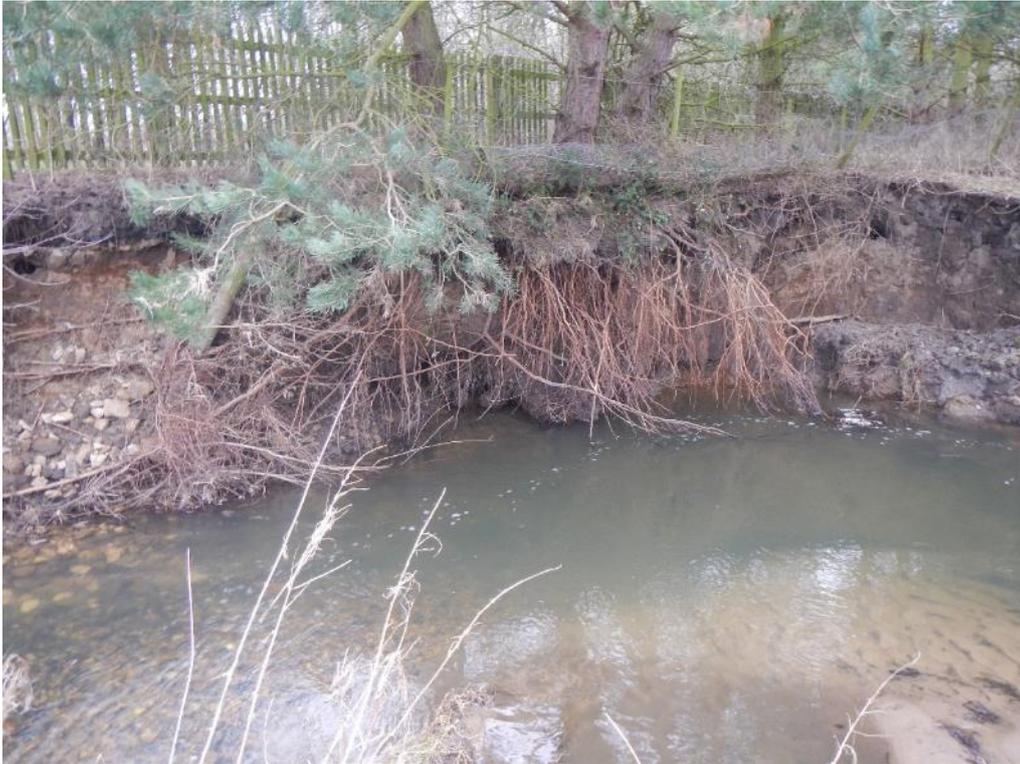
Te107. The river threatens a LB land boundary, with the erosion likely to be exacerbated by shading and lack of understory beneath the pine trees. The pool provides good holding water for adult trout.

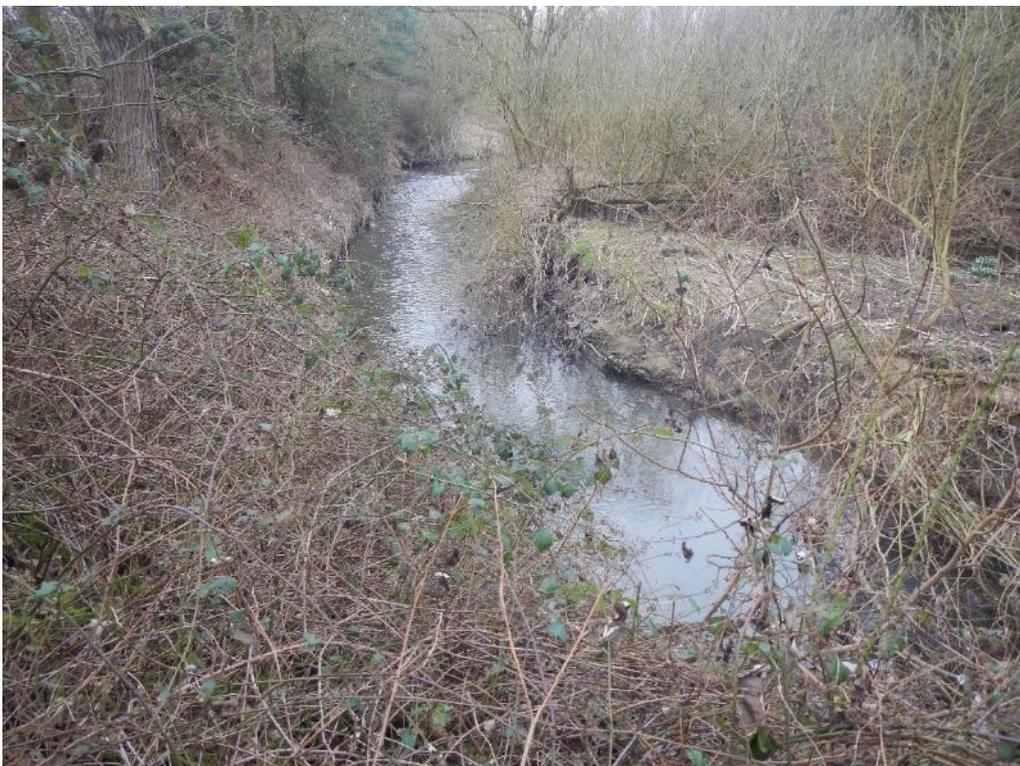
Te110. Although clearly realigned, the in-channel habitat quality is recovering and is relatively good.

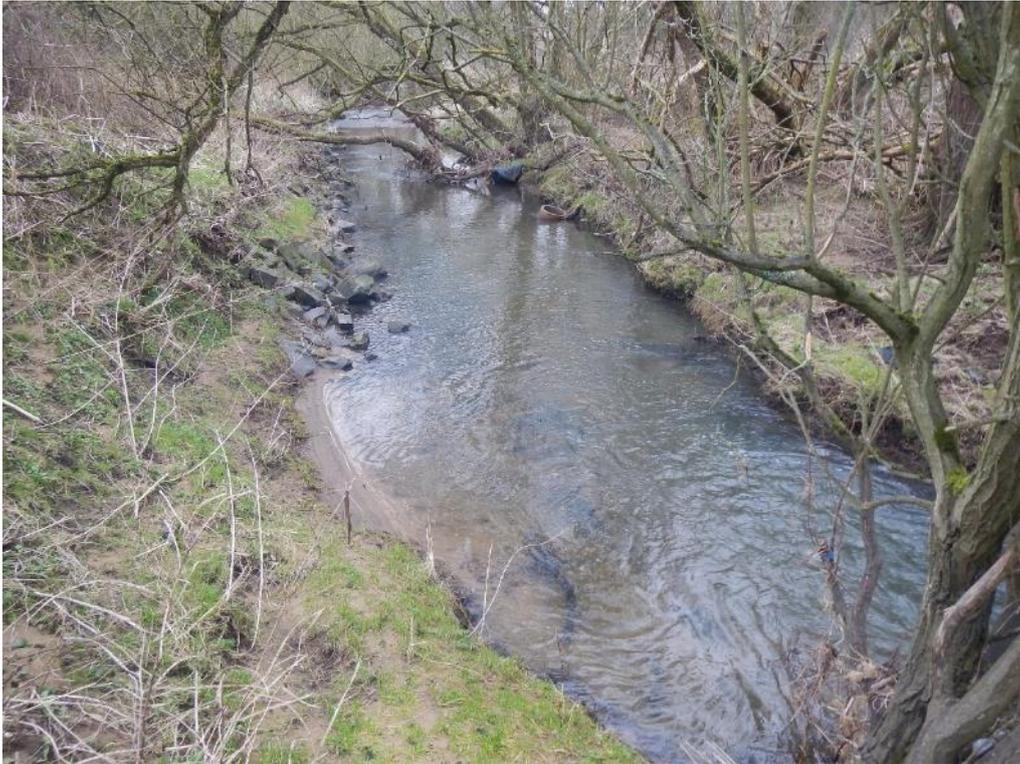
Te118. Deeper pools provide potentially good habitat for coarse fish and larger trout in the straightened section downstream to the sewage treatment works (STW) discharge.

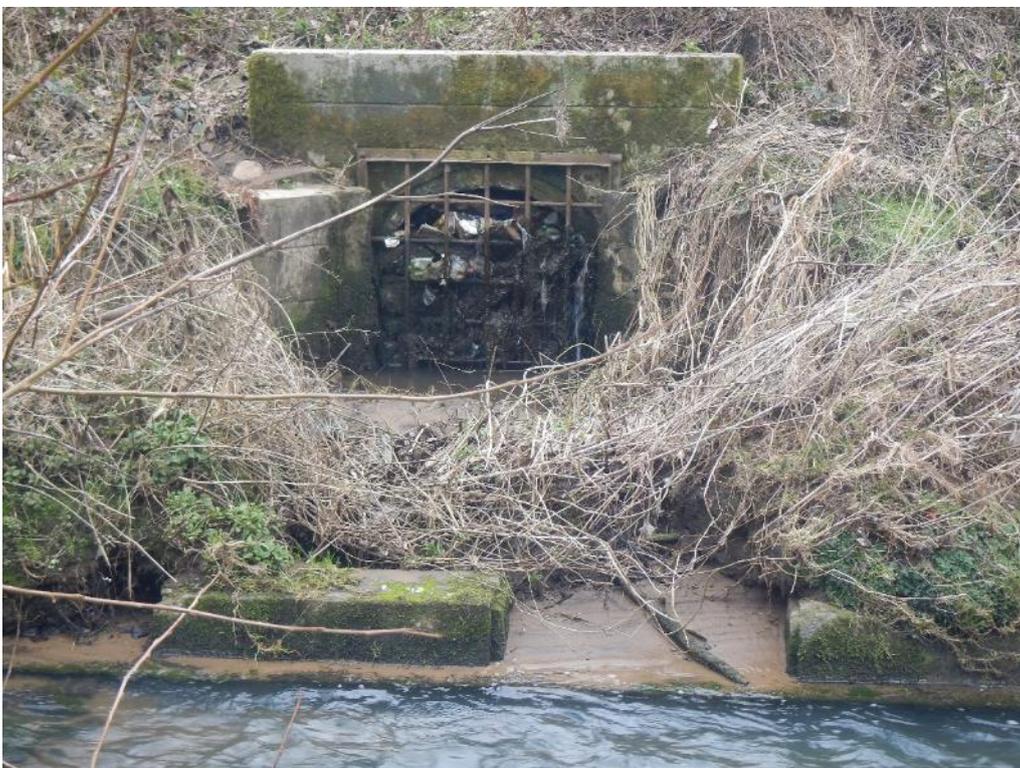
Te134. Unmaintained culvert screen (NZ 25912 56864). It would be expected that such waste should have already been intercepted before the discharge point to the river, suggesting additional issues further up the system.

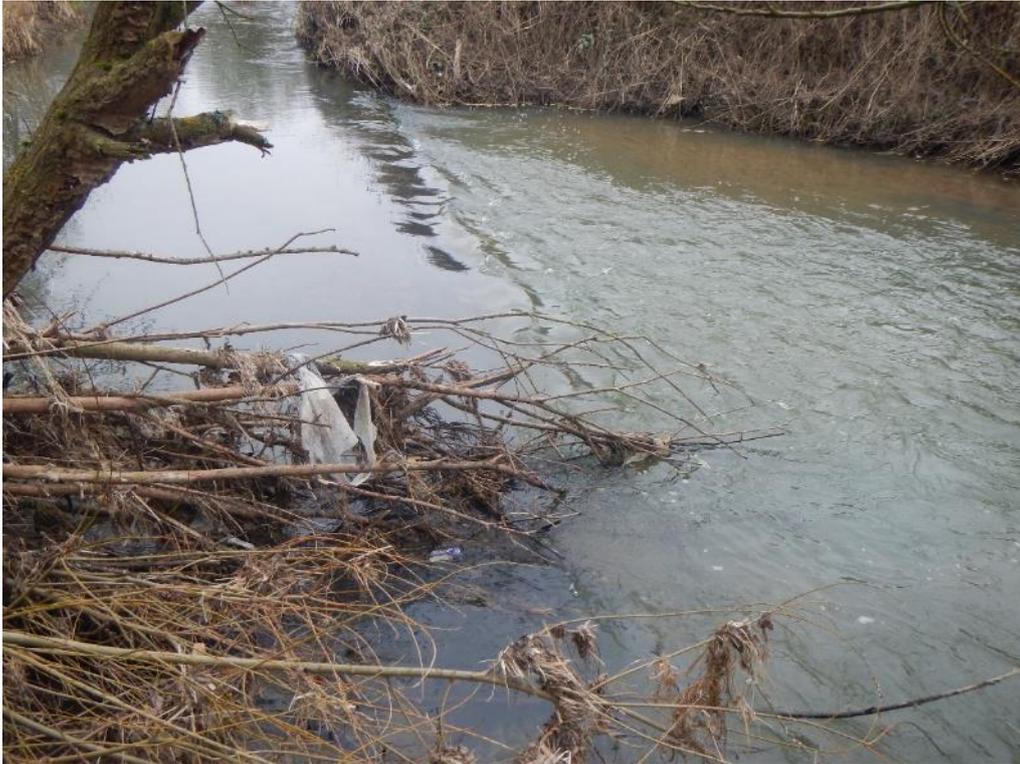
Te137. A small weir/possible encased pipe creates a small obstruction (NZ 25869 56939). Investigate whether the weir protects an asset and if not remove it.

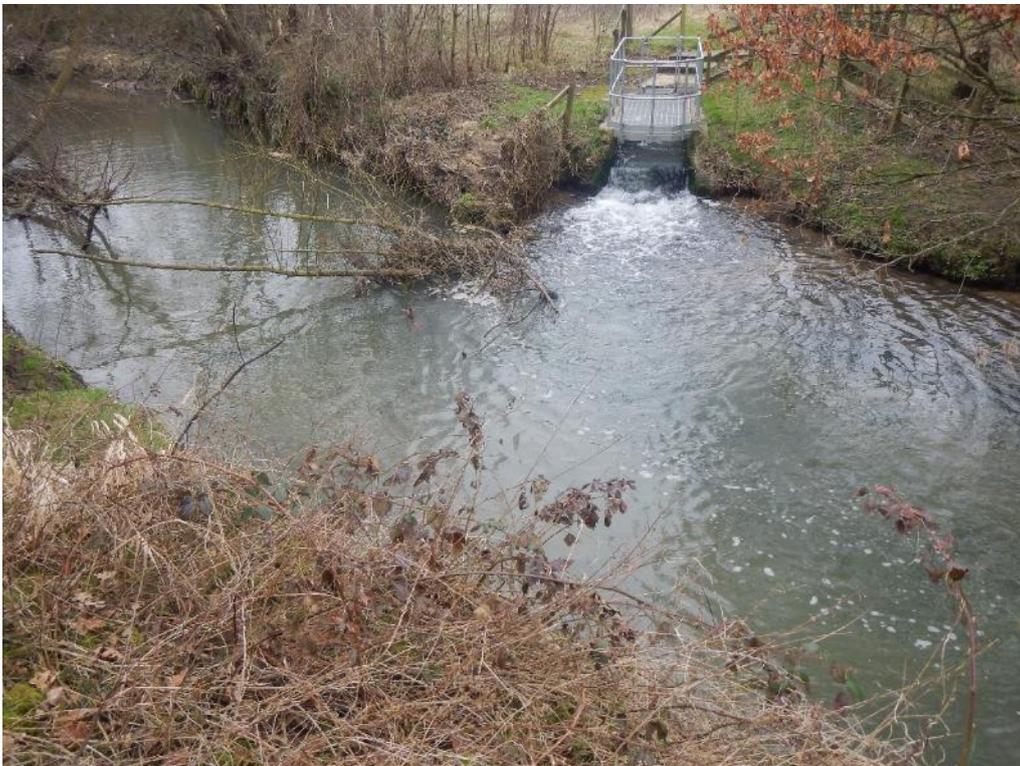
Te140. The second main STW discharge appeared to be clearer and had a reduced odour compared to the discharge further upstream (NZ 25846 56995) - perhaps through the benefit of additional reedbed filtration.

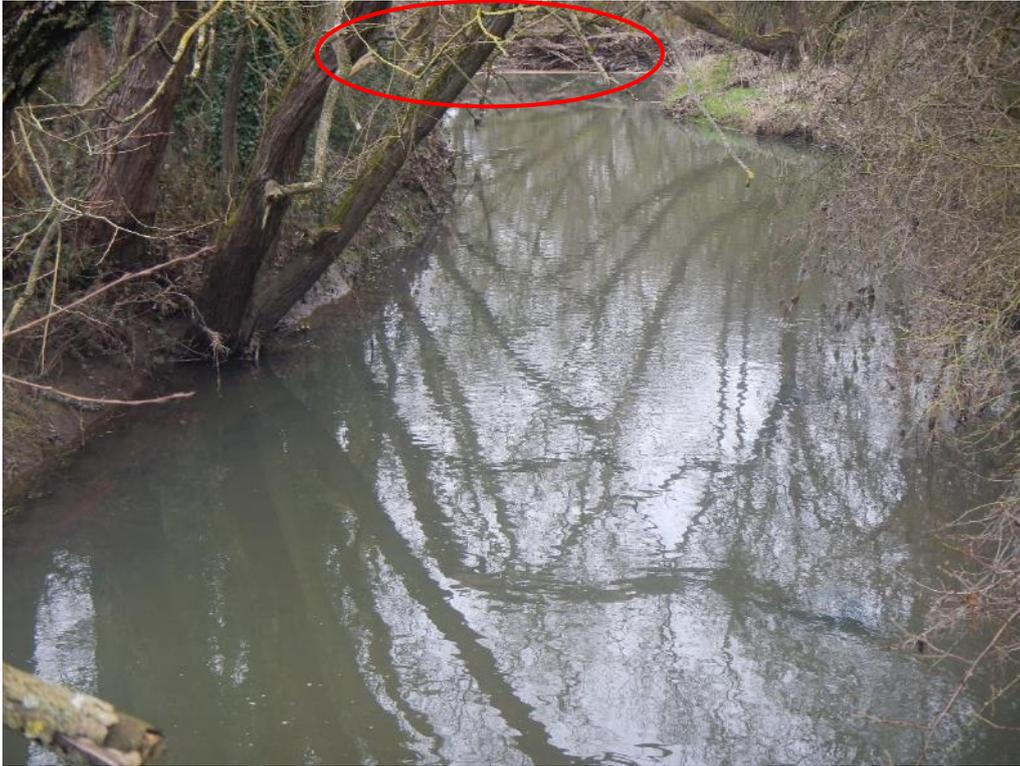
Te141. Looking downstream from Moor Mill Ln Bridge: deeper pools continue to provide good potential coarse fish habitat, although it is not known how limiting the STW discharges are upon water quality. The trash dam in the background (red ellipse) was drowning the bridge footings at the time of the walkover.

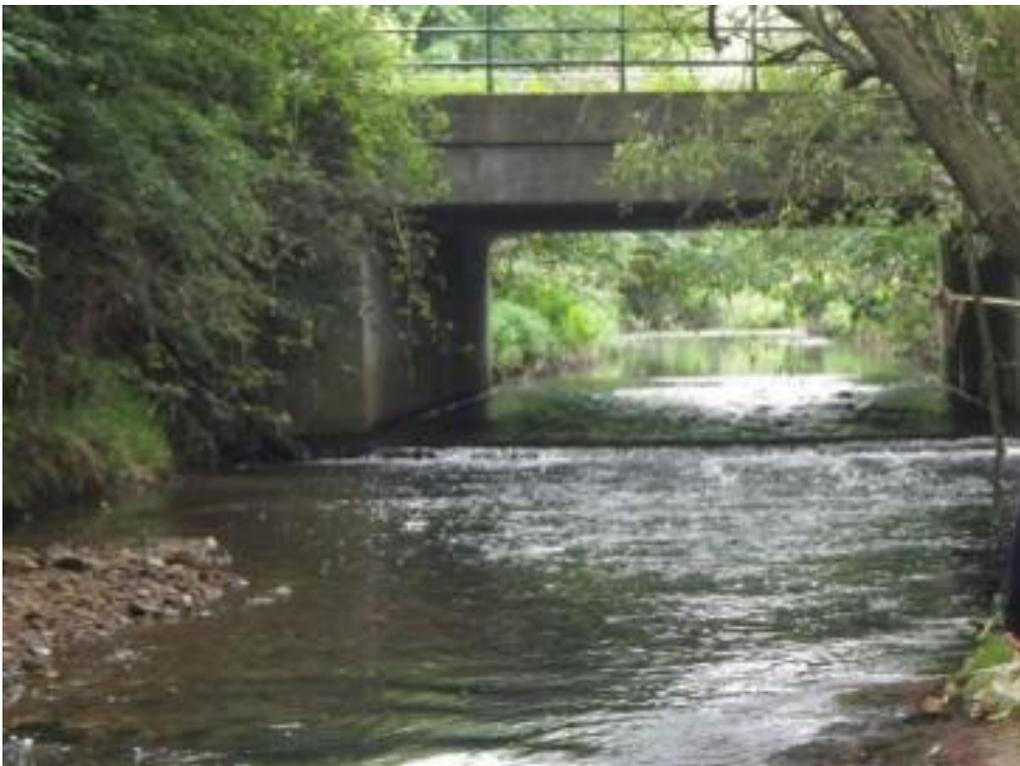
Te142. The perched footings of Moor Mill Ln bridge: photo taken by the EA before the trash dam d/s established (NZ 25802 57027). These footings were clearly an obstruction previously. If the trash dam (**TE141**) is removed, the structure will require reassessment for passability, owing to the step and shallow water.

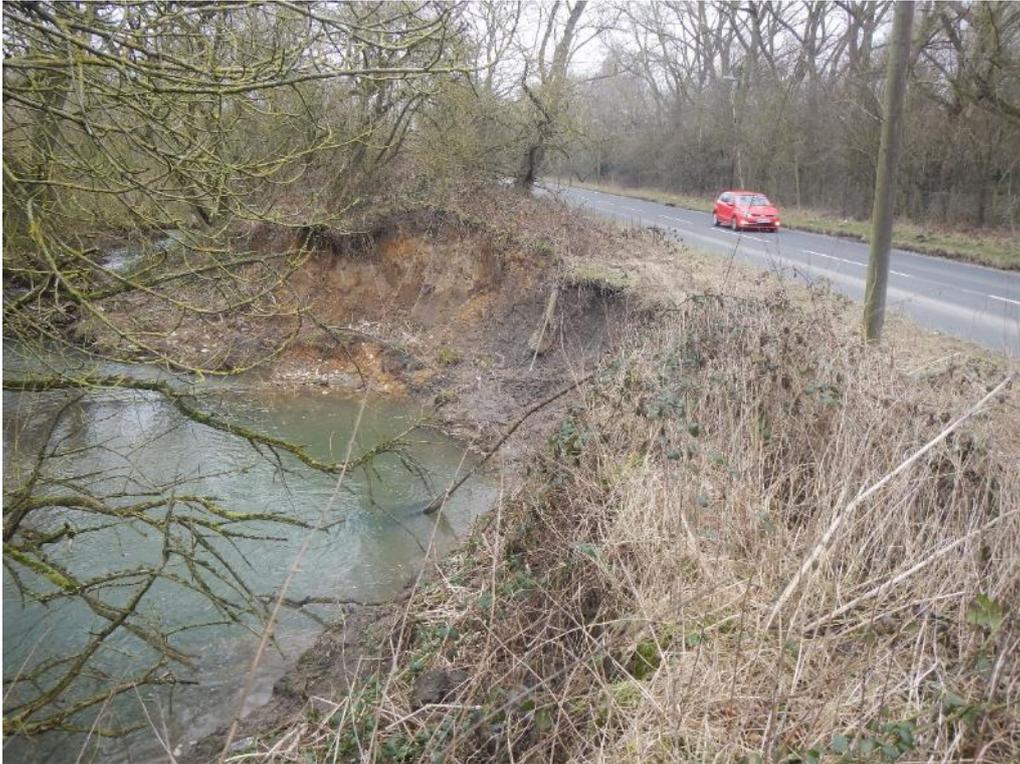
Te146. At several points, the river is getting precariously close to the main Lamesley Road (NZ 25721 57188). Any bank protection work should seek to maintain in-channel structure and use green/soft engineering techniques.

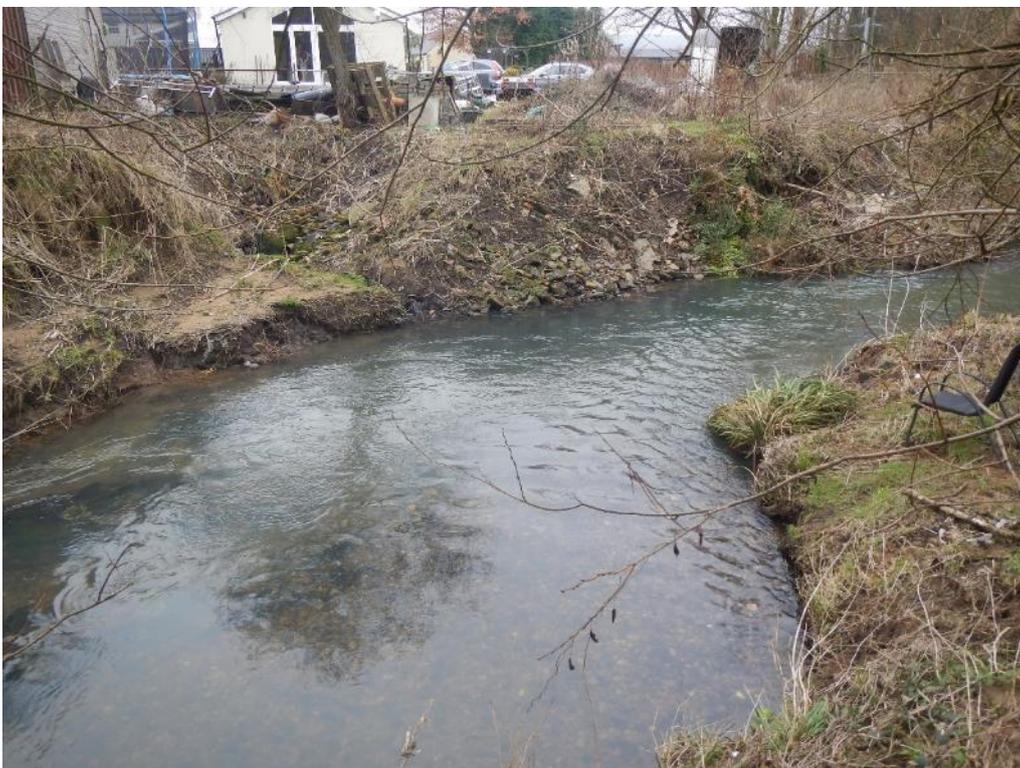
Te150. Erosion around a small tributary/ditch, exacerbated by dumping of waste material and garden waste on the riverbank (NZ 25661 57236).

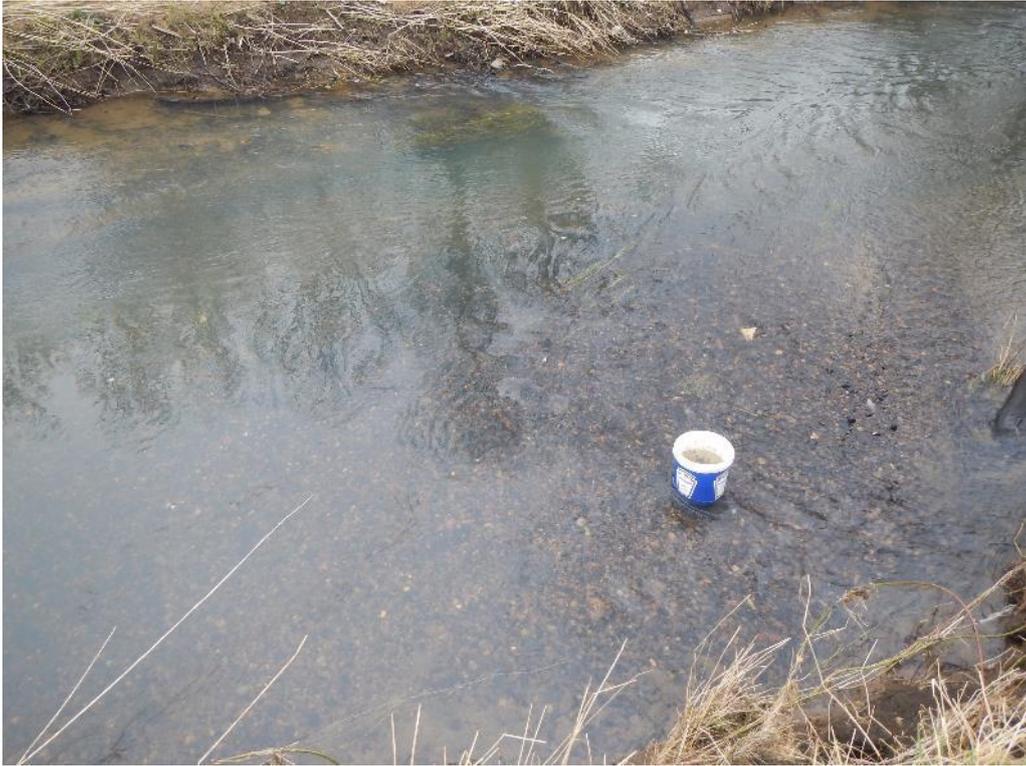
Te157. The substrate in this area could potentially be suitable for coarse fish spawning (fine sediment remains an issue), but the naturally reduced gradient and flow velocities in these lower reaches would not usually be expected to support salmonid spawning.
