WILD TROUT TRUST

River Team
(lower catchment)

March 2021

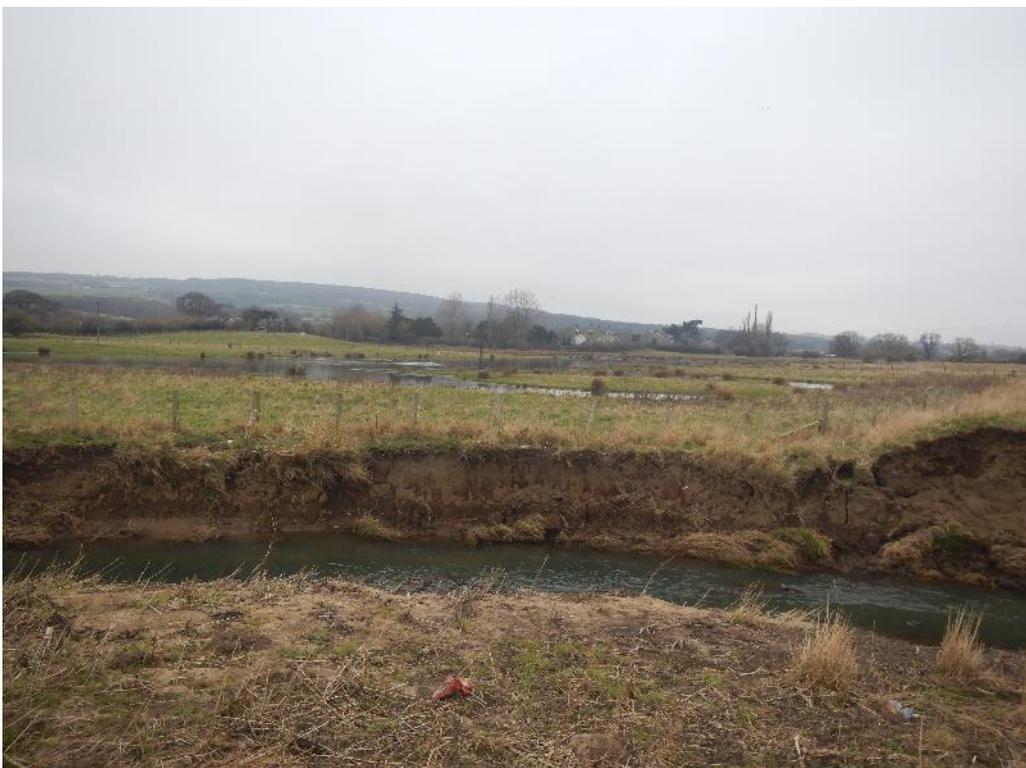
Te160. Much of the river through Lamesley Meadows has been straightened and dredged. The channel is flanked in areas on the LB by a flood bund. The river's paleochannels are visible as wet areas in the LB side fields (NZ 25409 57520).

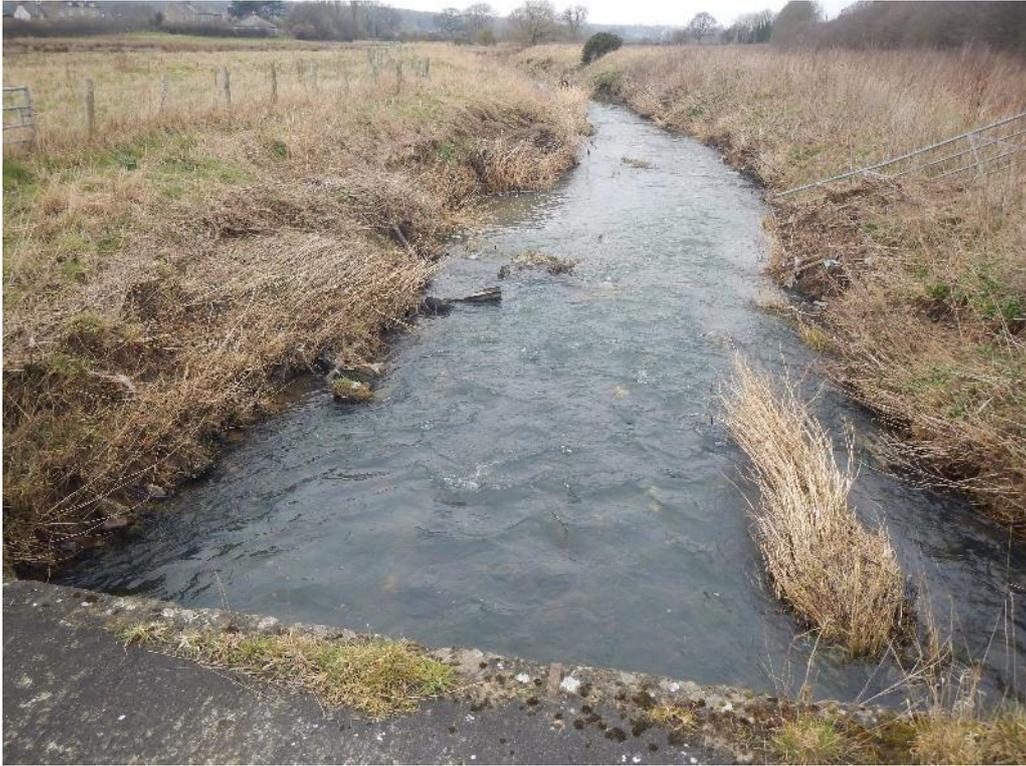
Te162. Although straightened many areas of the in-channel habitat is capable of supporting trout, although it appears better suited to coarse fish. The RB appears un-grazed and the LB is largely un-grazed (with buffer fencing).

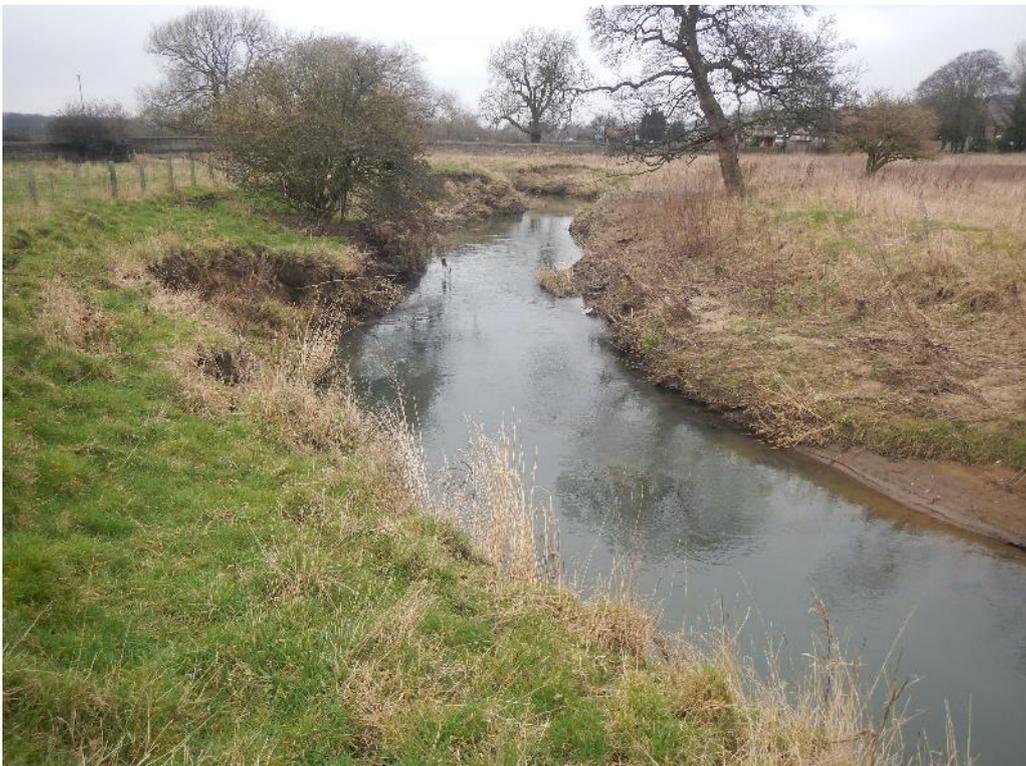
Te170. The lower end of buffer strip (field upstream of Hags Ln) did appear to have been grazed more recently on the LB (NZ 25108 57889).

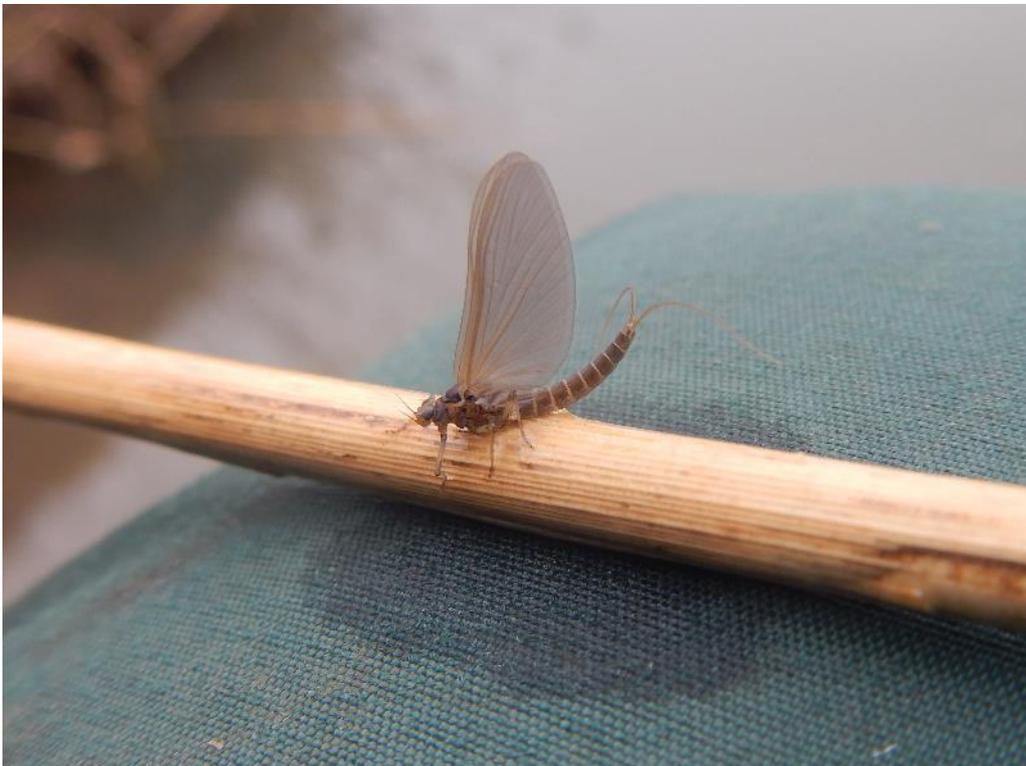
Te173. A reasonable hatch of large dark olive myflies - *Baetis rhodani* - (a species relatively tolerant to pollution) was observed through the meadows.

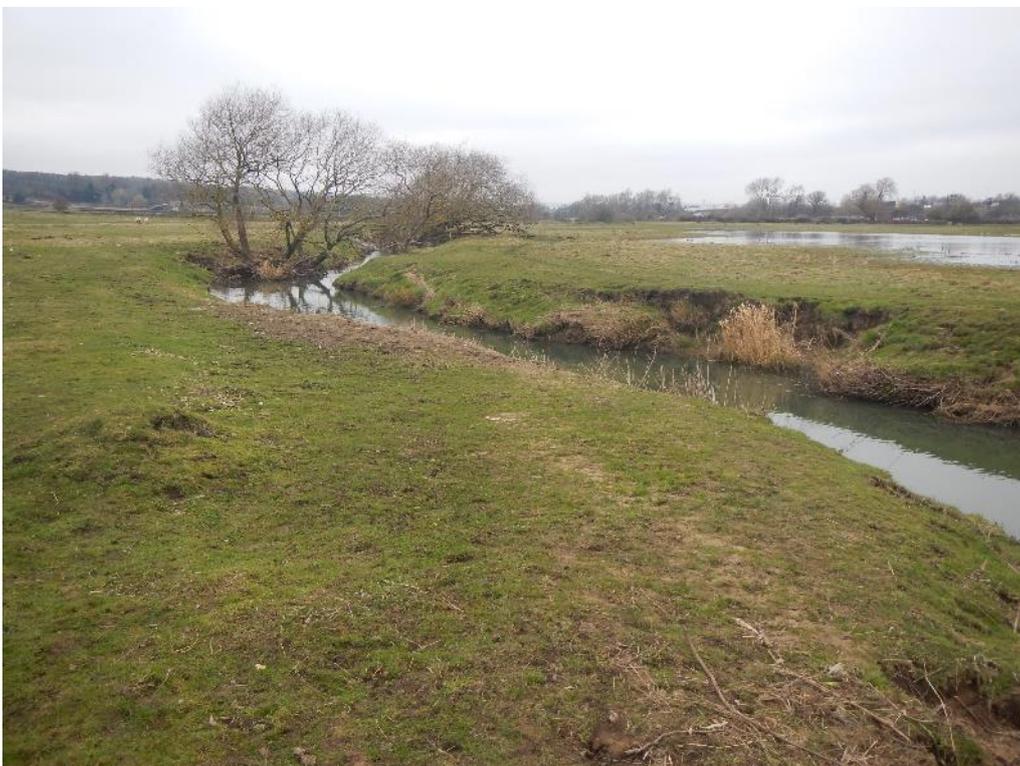
Te179. The fields on both banks downstream of the bridge are heavily grazed, with a lack of bankside vegetation and tree regeneration (NZ 25031 57964 & NZ 25080 57986). Buffer fencing would be beneficial.

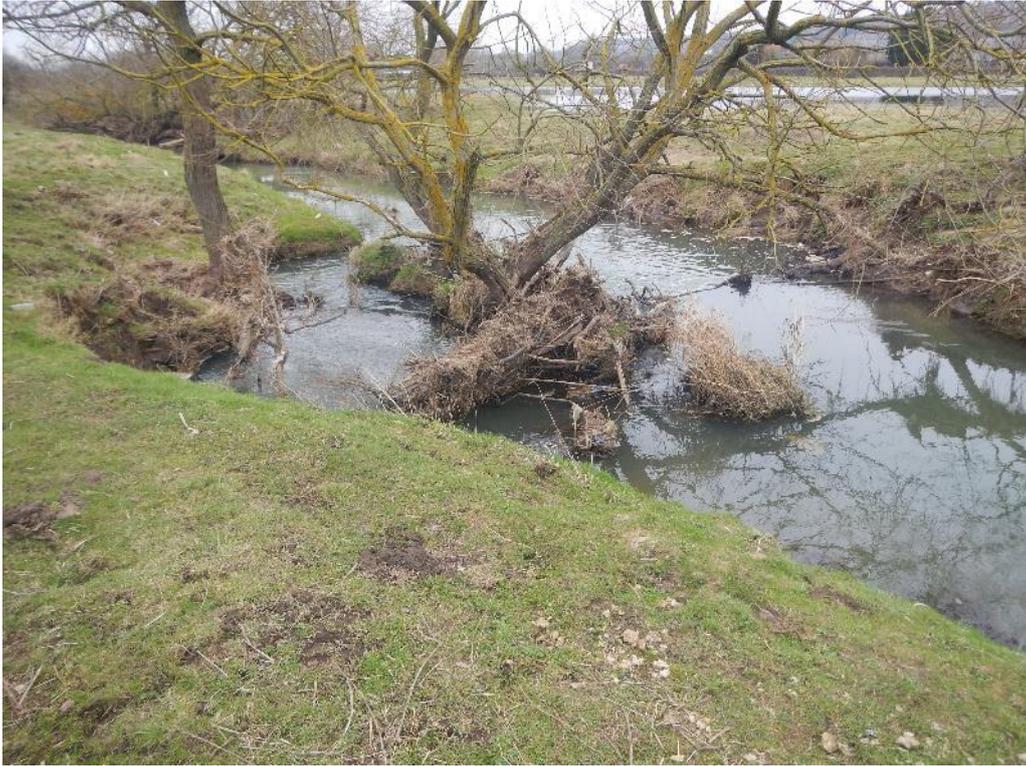
Te181. Areas of in-channel habitat are greatly enhanced again in this reach by trees and large woody material.

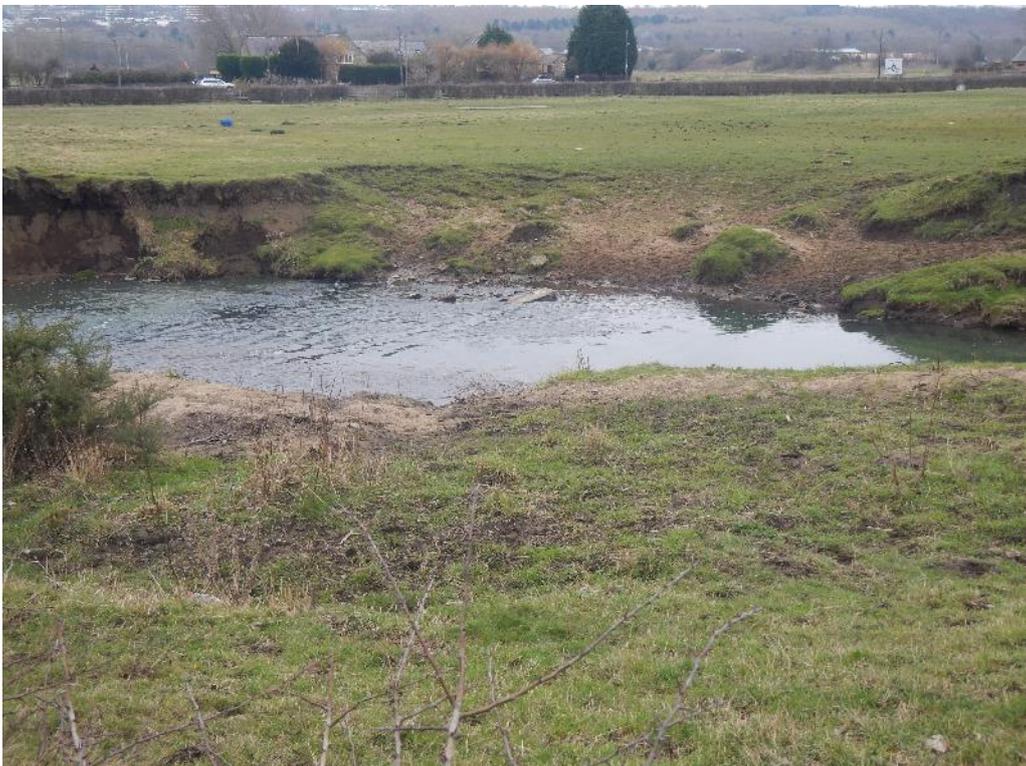
Te187. A drinking point/ford creates a particular hot spot for bank erosion (NZ 24989 58164). Buffer fencing and alternative watering required.

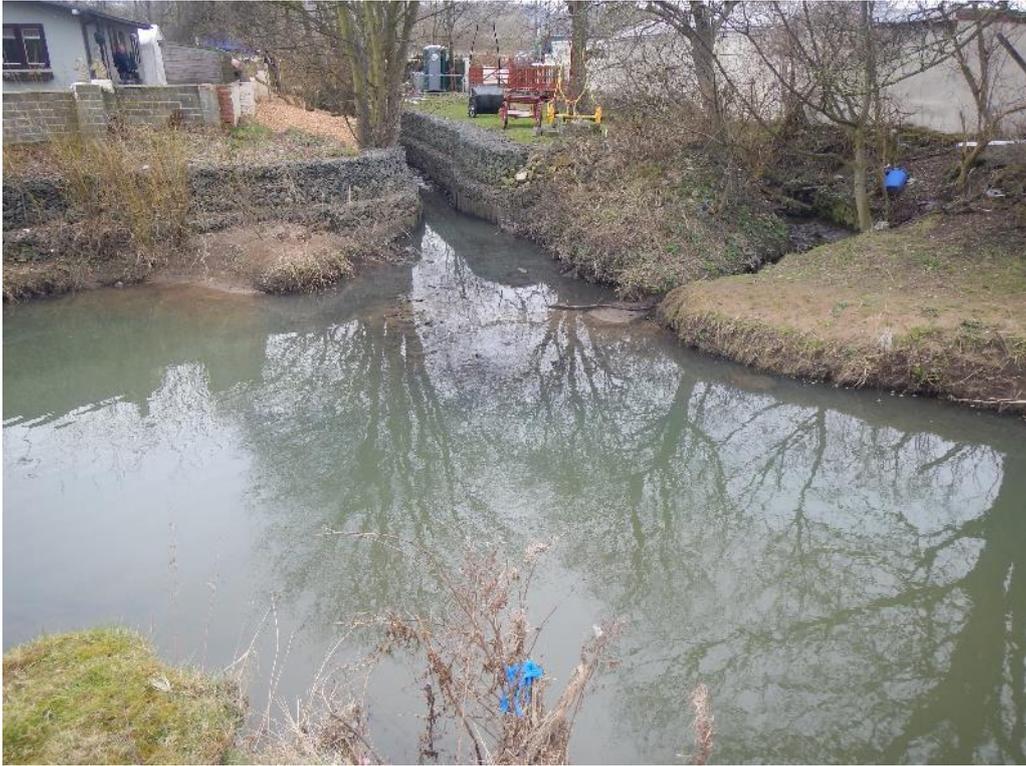
Te198. Two small watercourses join at a sharp bend upstream of Lamesley Roundabout but appear to be of low ecological quality and potential, both from the fine sediment they discharge, and the extent of culverting and realignment further upstream (NZ 25012 58395).

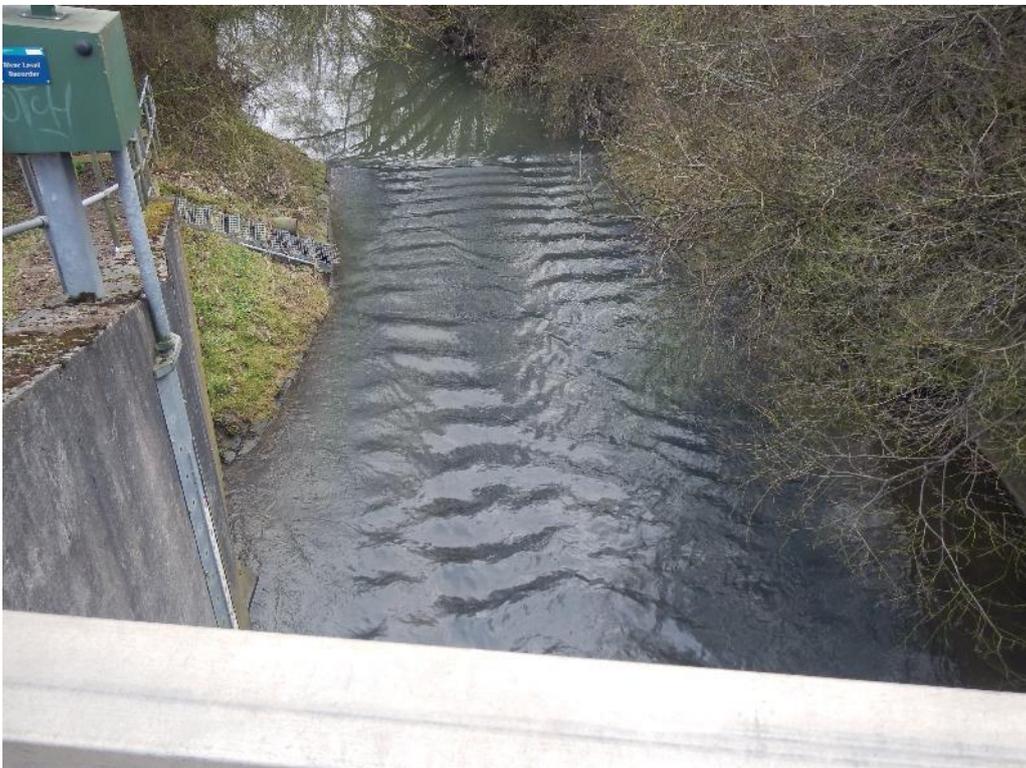
Te200. EA gauging station at the Lamesley Roundabout culvert 1. Here the shallow, high velocity water across the base of the culvert creates an obstruction to fish passage (NZ 24957 58482).

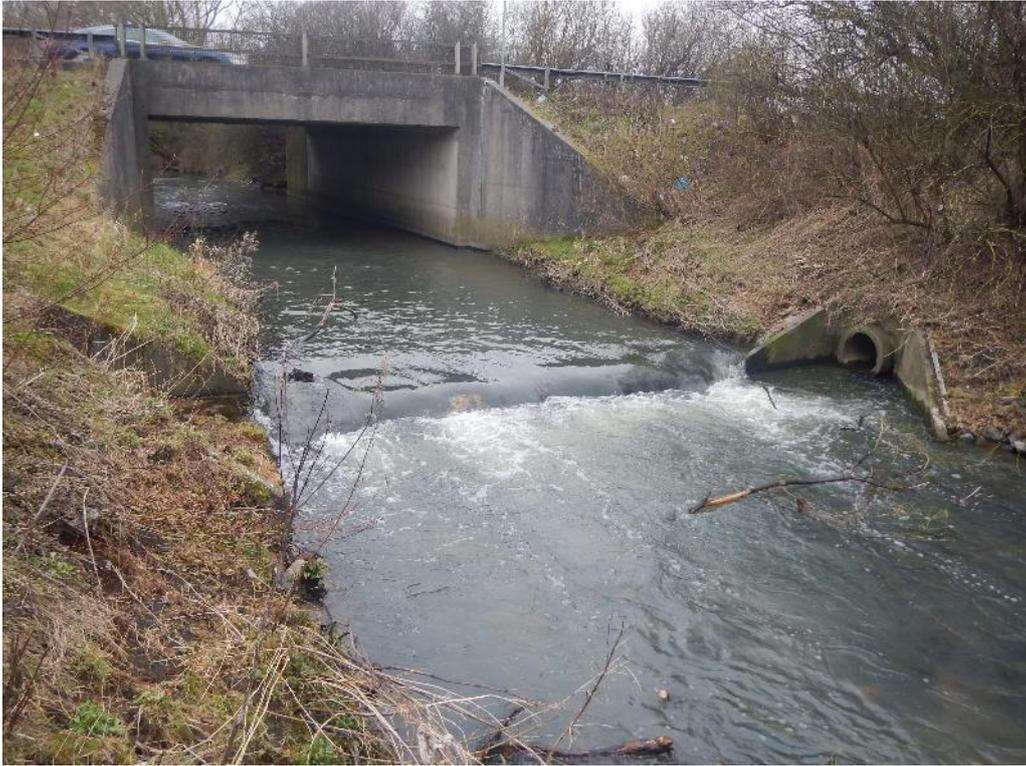
Te201. There is a distinct step just downstream of the culvert that creates a further issue. It is understood that fish passage at this culvert will be investigated as part of upgrades to the A1 road (N Cook, EA, 2021, pers.comm., 2 March).

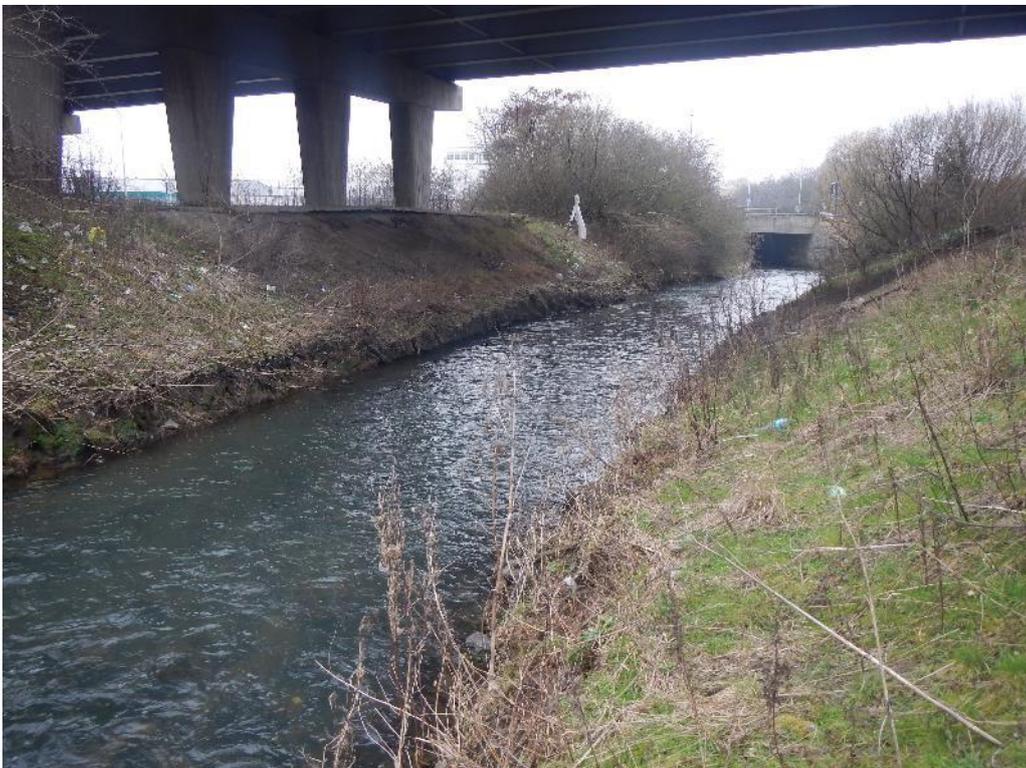
Te205. The river beneath the A1 is highly modified, straightened and fast-flowing.

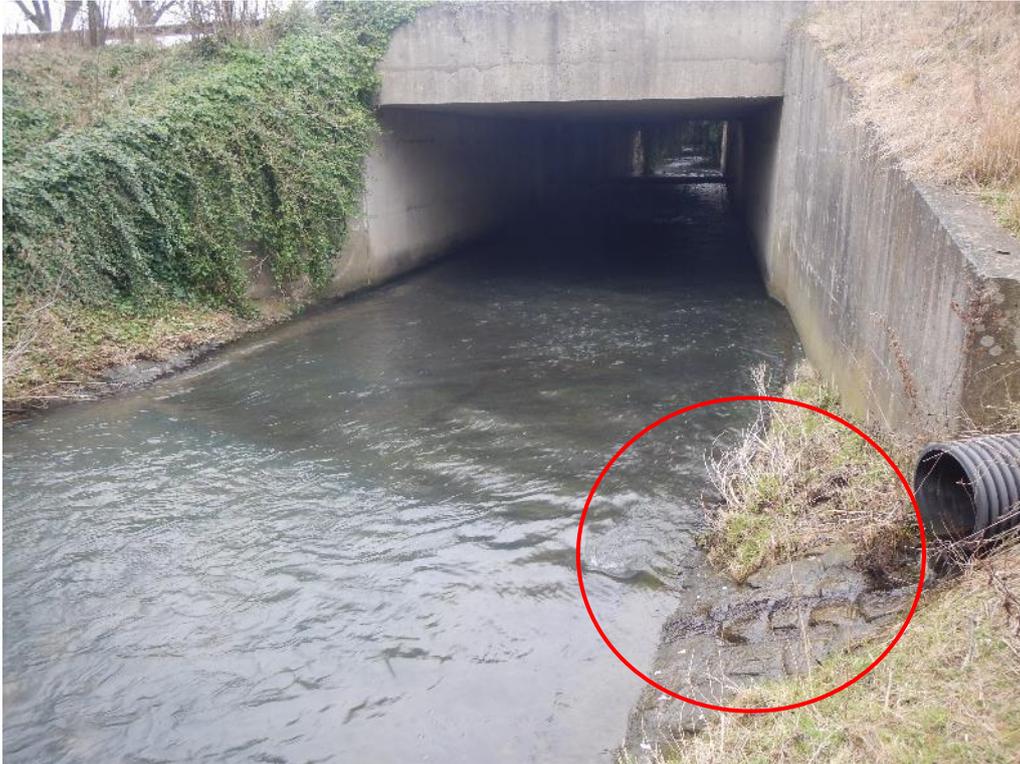
Te207. Lamesley Roundabout culvert 2 marks the start of a ~ 1.4 km culvert beneath Team Valley Trading Estate (NZ 24939 58607). The issue here is high velocity flow and limited water depth. An elevated nutrient discharge (as identified by increased brown algal growth) also discharges at the upstream end (red circle).

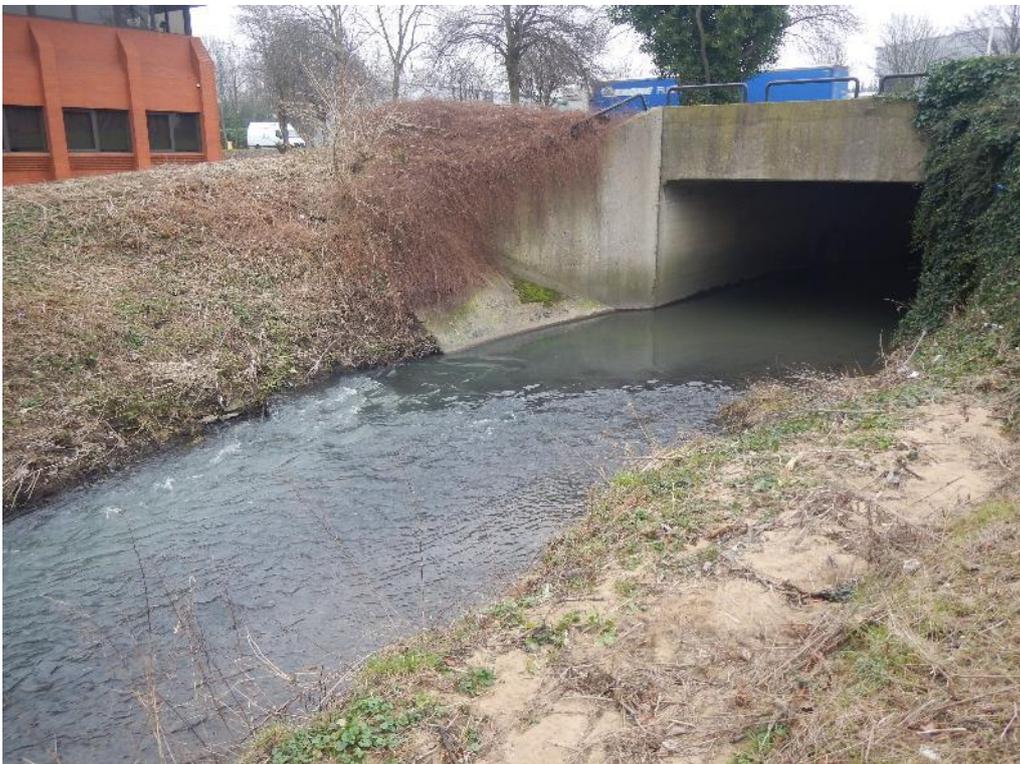
Te210. The river was next inspected ~ 1400 m downstream, at the end of the culvert, which was encouragingly sunken below bed level (NZ 24637 59882). If flows can be slowed through the rest of the culvert and water depths increased, fish passage could be greatly improved.

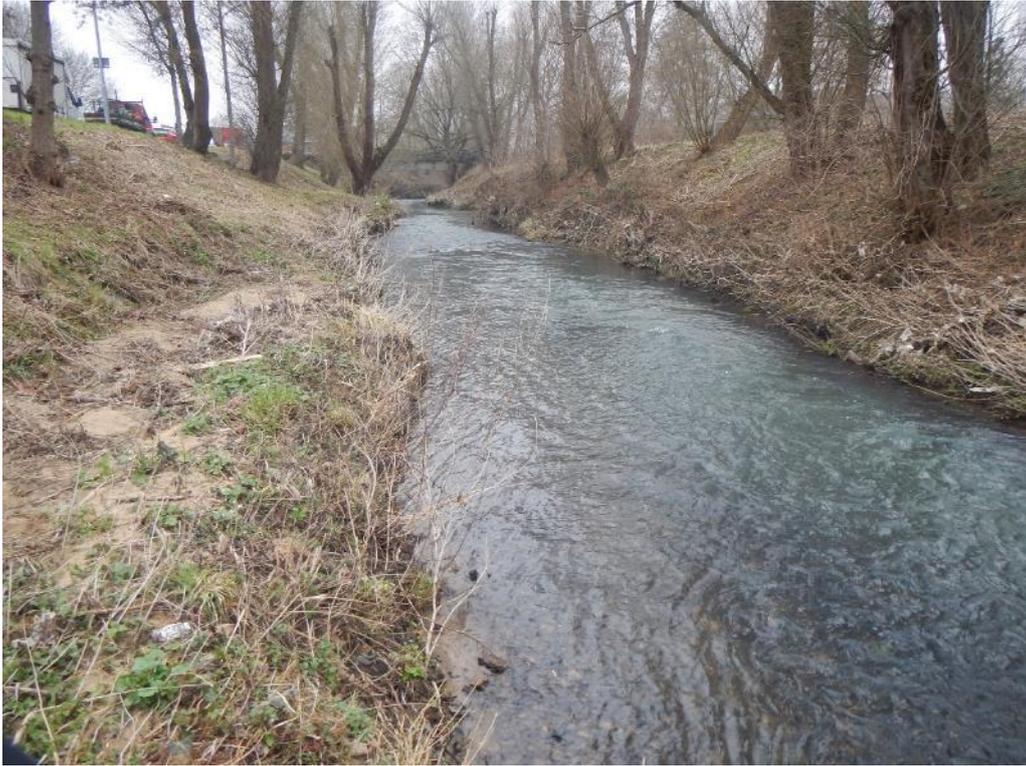
Te212. The river downstream is of reasonable quality for a straightened channel, aided particularly at this point by a slight inset berm. Sewage litter in the bankside vegetation could suggest combined sewer overflows (CSO) discharge within the culvert upstream.

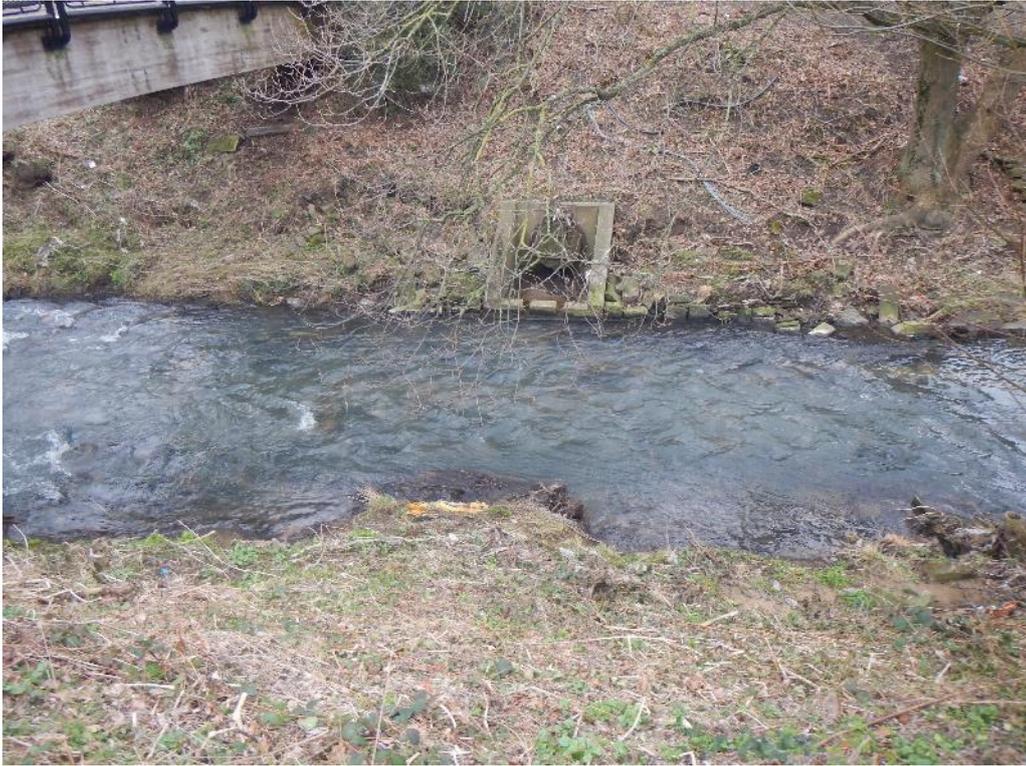
Te216. A large outfall was observed at NZ 24606 59978.

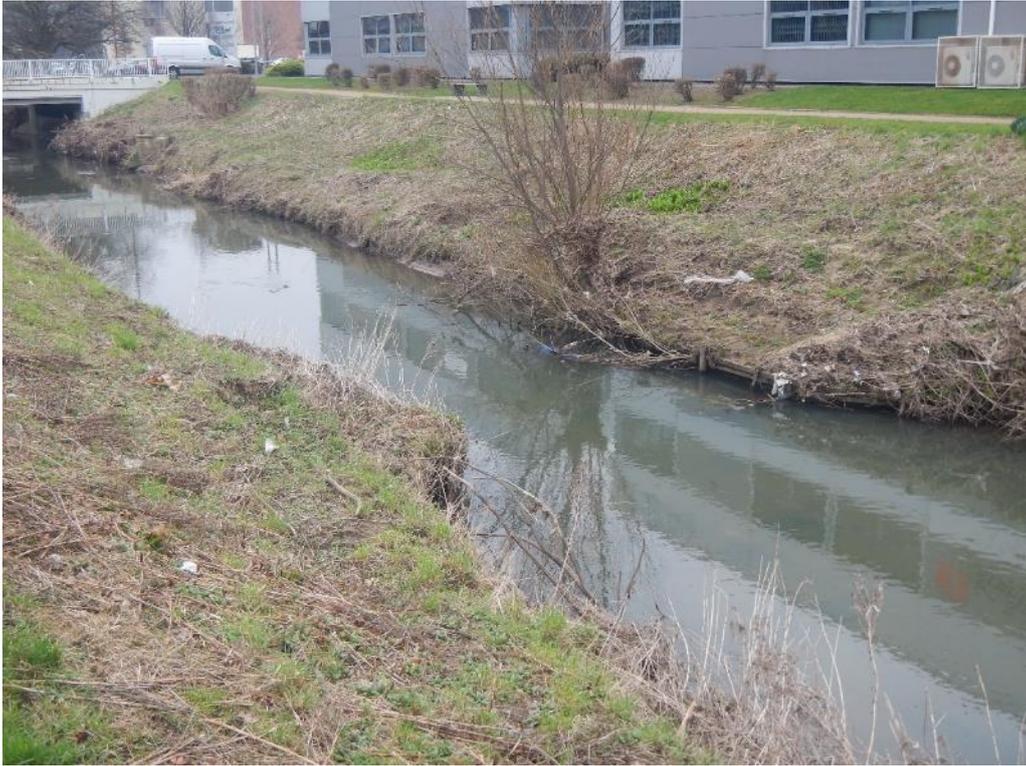
Te227. At several points, paired berm/pinch-points have been installed, providing variability in channel width and no doubt contributing to riverbed diversity through scour. Some areas are further improved with willow trees; tree and scrub cover should be allowed to develop further. Ideally, flow would be deflected from one bank side to the other, but in this urban setting, central pinch-points at least provide some improvement, with reduced risk of increasing bank erosion.

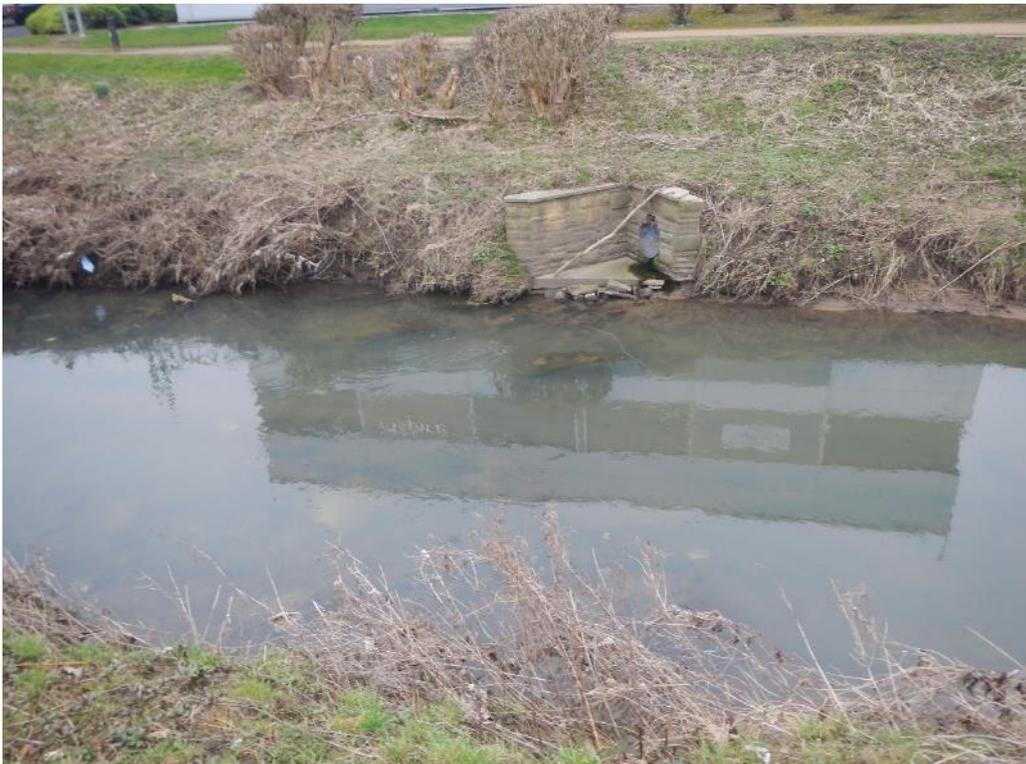
Te229. Discharge on the RB (NZ 24483 60542).

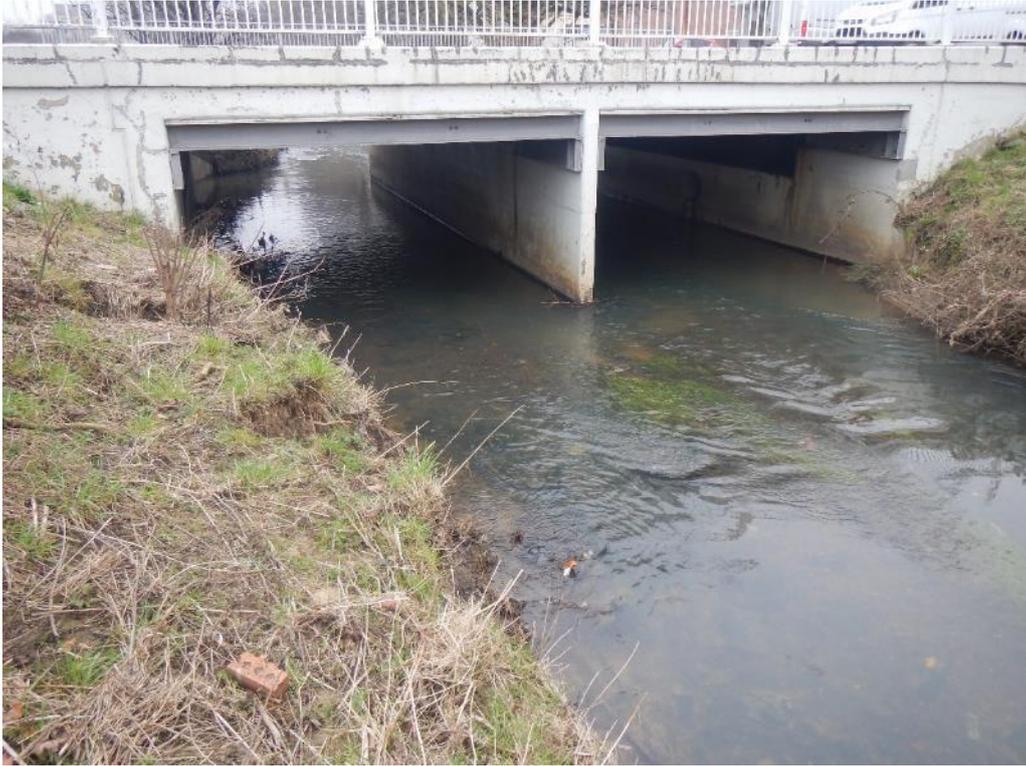
Te231. Of the numerous bridges/road crossings, most posed no issues for fish or sediment movement. Note the aquatic weed (suspected to be water crowfoot) that was present in the few areas where gravel deposition created shallow riffle habitat.

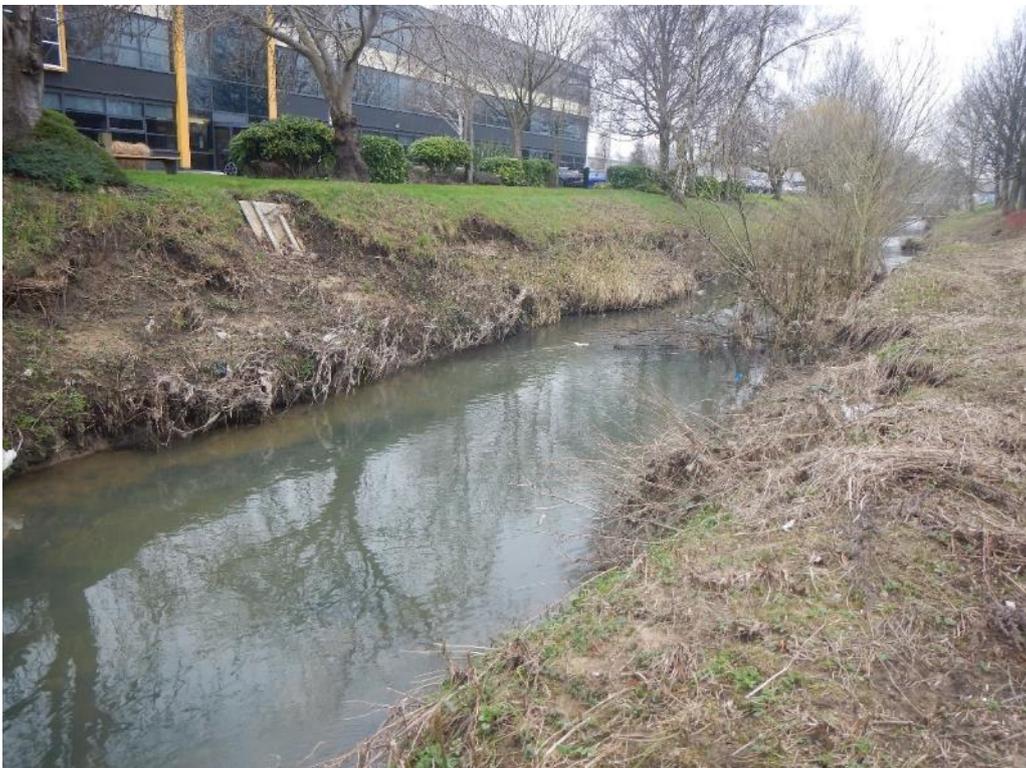
Te236. In several areas, bankside vegetation clearance could be leading to increased bank instability and erosion. Maintaining and increasing bank roughness is likely to reduce the erosive forces acting upon them.

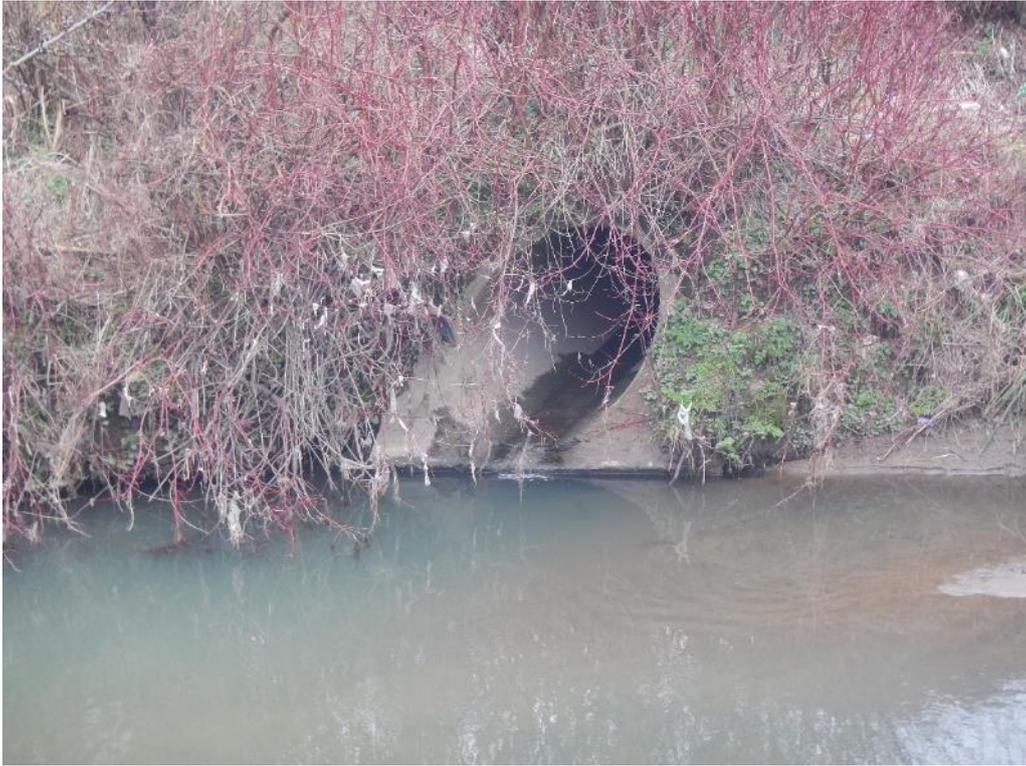
Te243. A RB discharge (NZ 24328 60978). As with most of these structures through the Team Valley, likely to be surface water/road drainage.

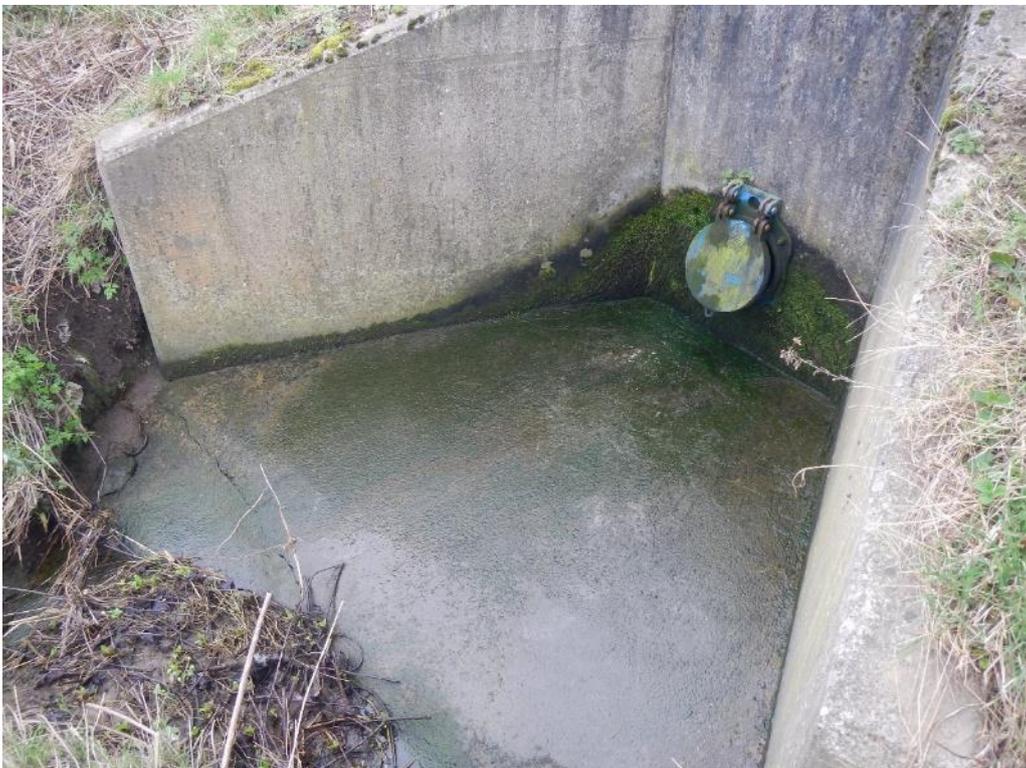
Te245. Outfall on the LB (NZ 24287 61062).

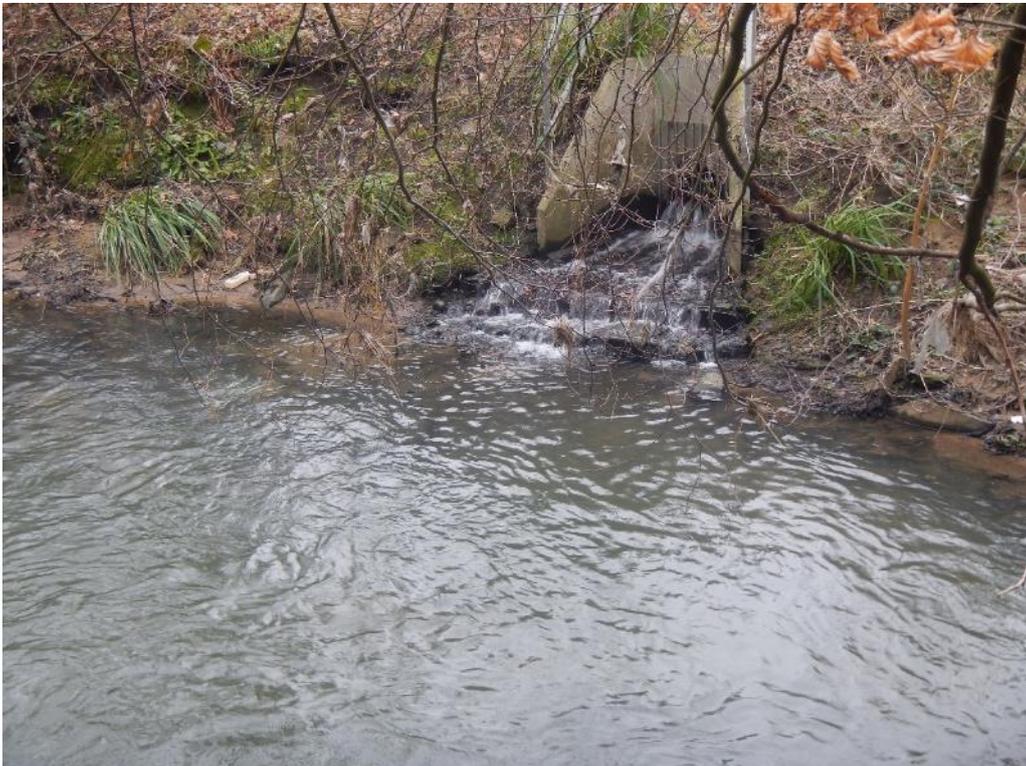
Te253. LB discharge (NZ 24079 61379).

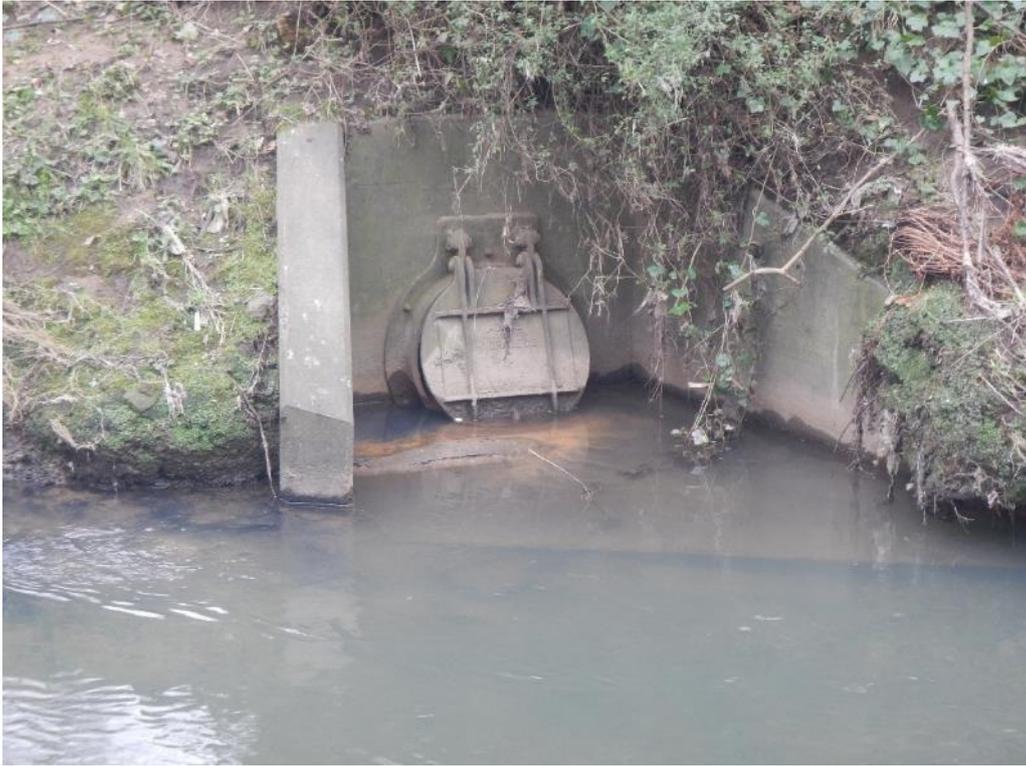
Te245. LB discharge supplying excess fine sediment and elevated iron (NZ 24051 61388).

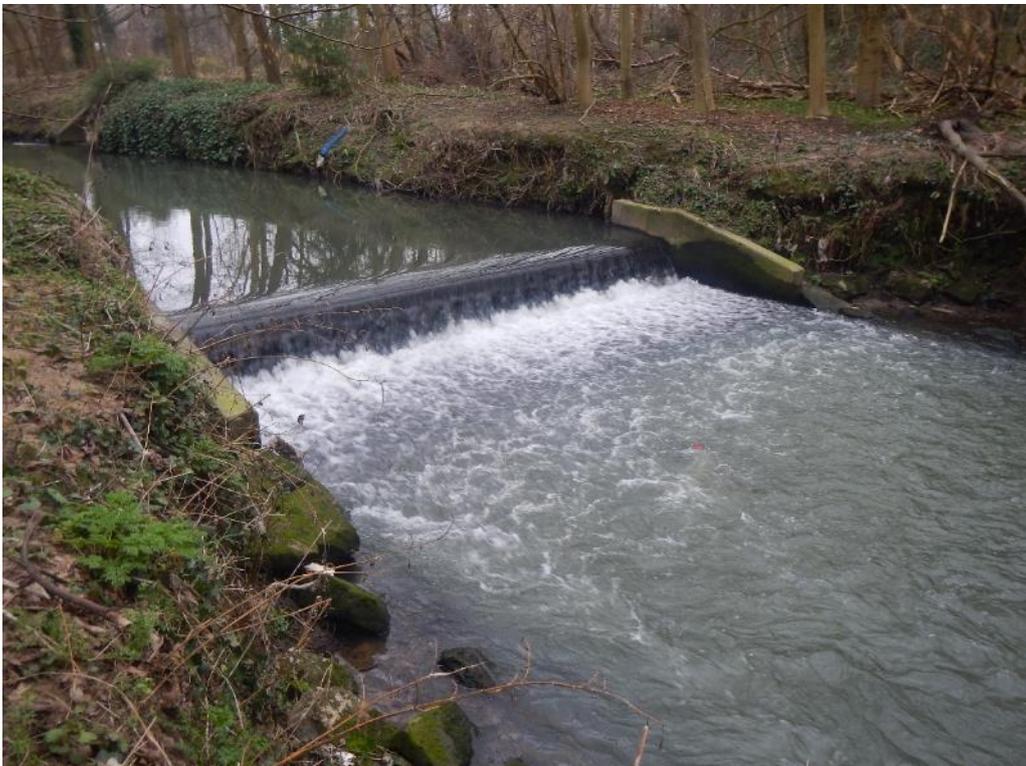
Te257. A weir at the downstream end of the section of River Team creates a major obstruction to most species, with a significant step and shallow fast flow - as well as increased erosion on the LB (NZ 24025 61405).

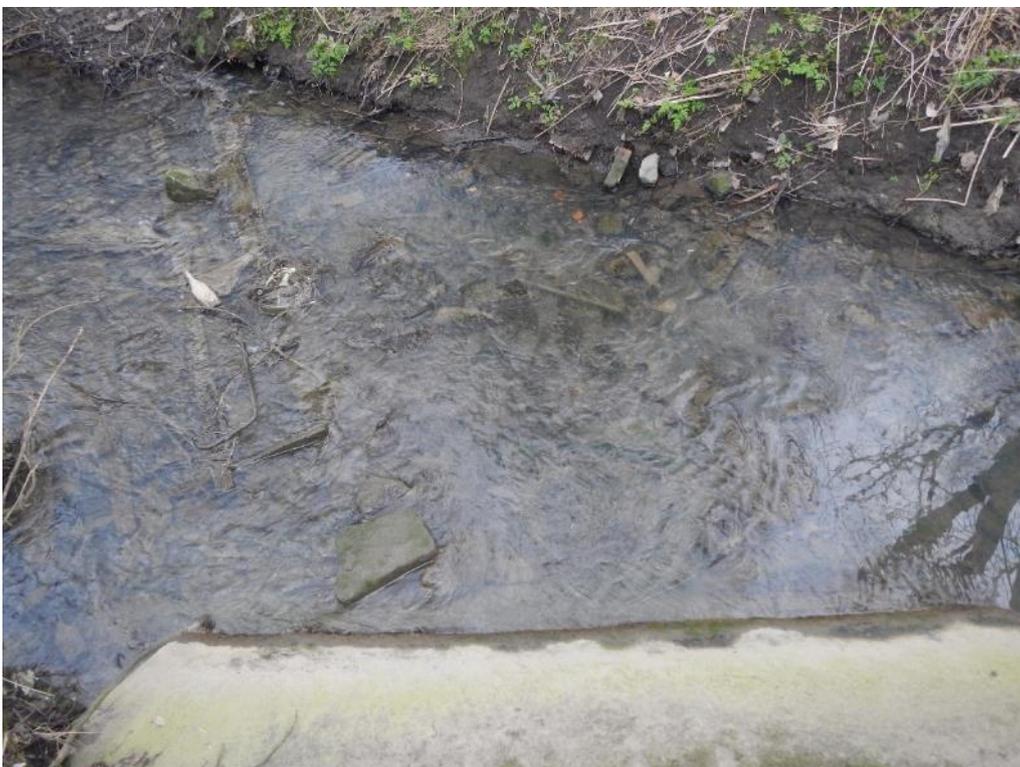
RoB4. Observation of the bed revealed a significant smothering of biofilm and grey sediment, symptomatic of enrichment and surface/road drainage (NZ 26842 55047).

<p style="text-align: center;">RoB4</p>	1	Upstream of NZ 26842 55047	Further investigation of the potential water quality issues in the upper areas of Rowletch Burn.

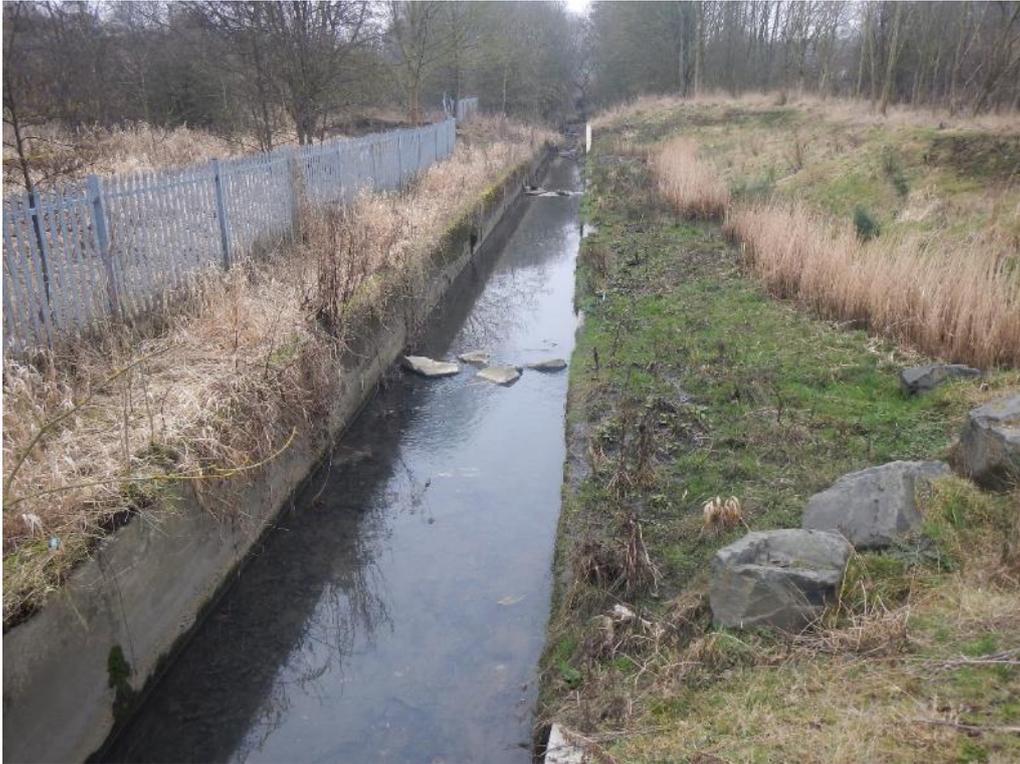
RoB8. What appears to have been a reed (suspected to be a filter for leachate from the adjacent land) bed has been infilled with fine sediment (NZ 26828 55153). The efficacy of the reedbed could be improved through maintenance. Boulder features installed within the channel cannot mitigate the poor water quality and concrete lined channel.

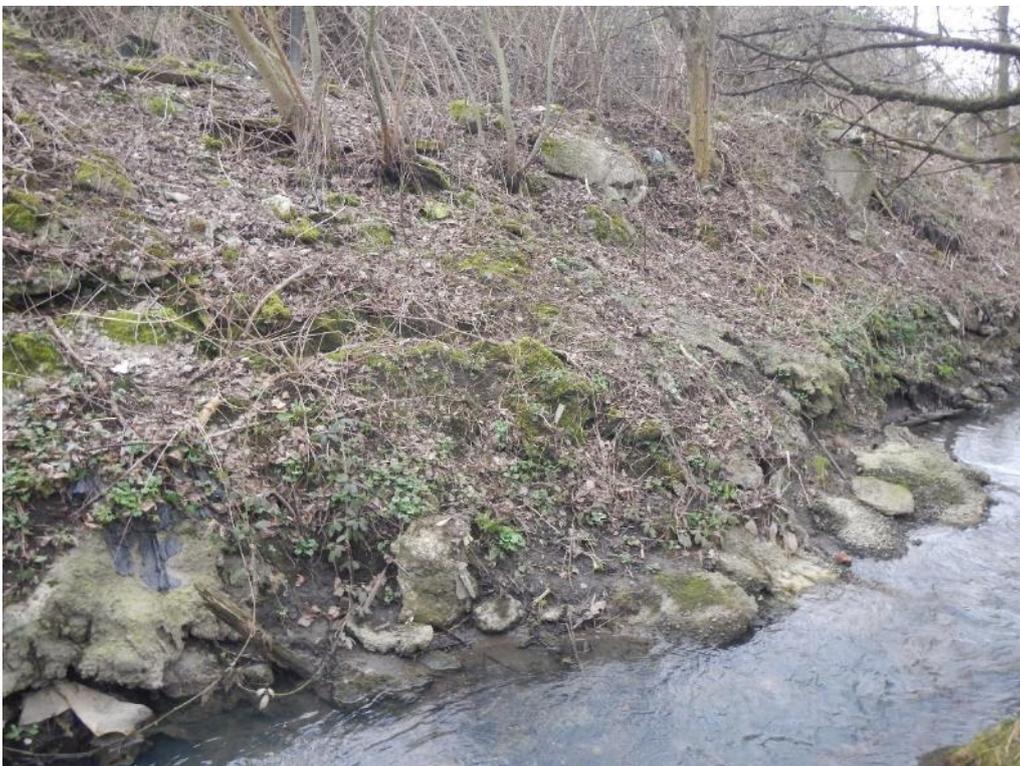
RoB20. Wet (at the time) concrete appears to have been discarded down the bank on numerous occasions, sometimes reaching the watercourse (NZ 26714 55500).
