WILD TROUT TRUST

River Team
(lower catchment)

March 2021

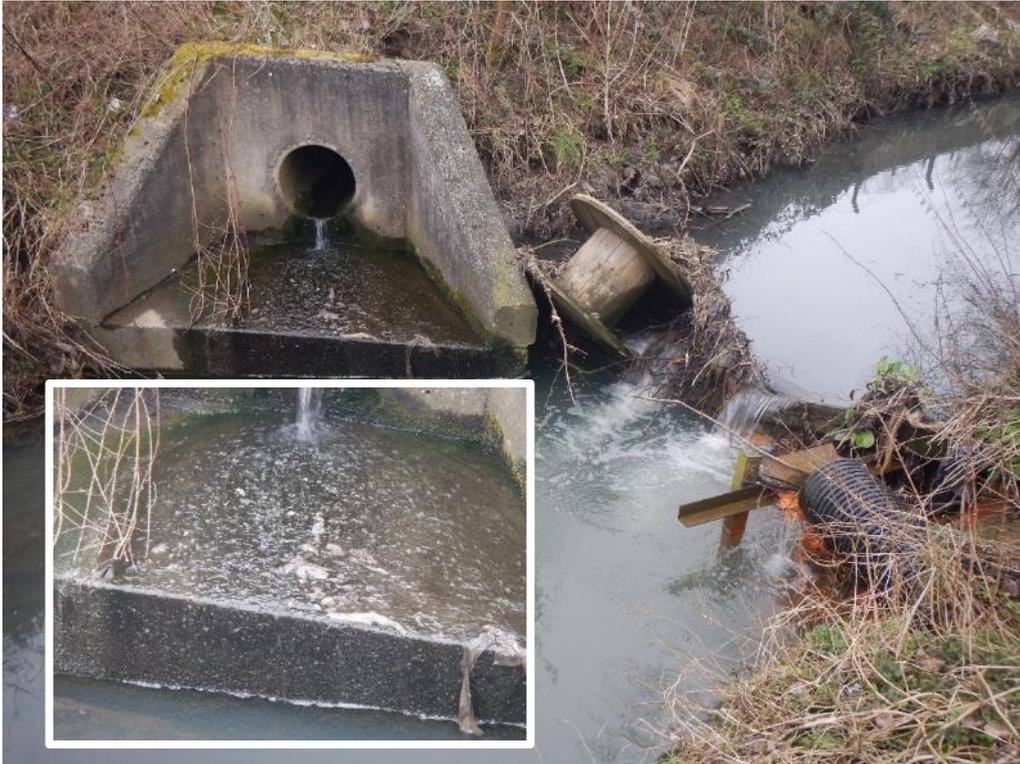
RoB24 & 25 (inset). Outfall discharging what appeared to be domestic water, including solids, adjacent to a seemingly purposeless weir (NZ 26564 55586).

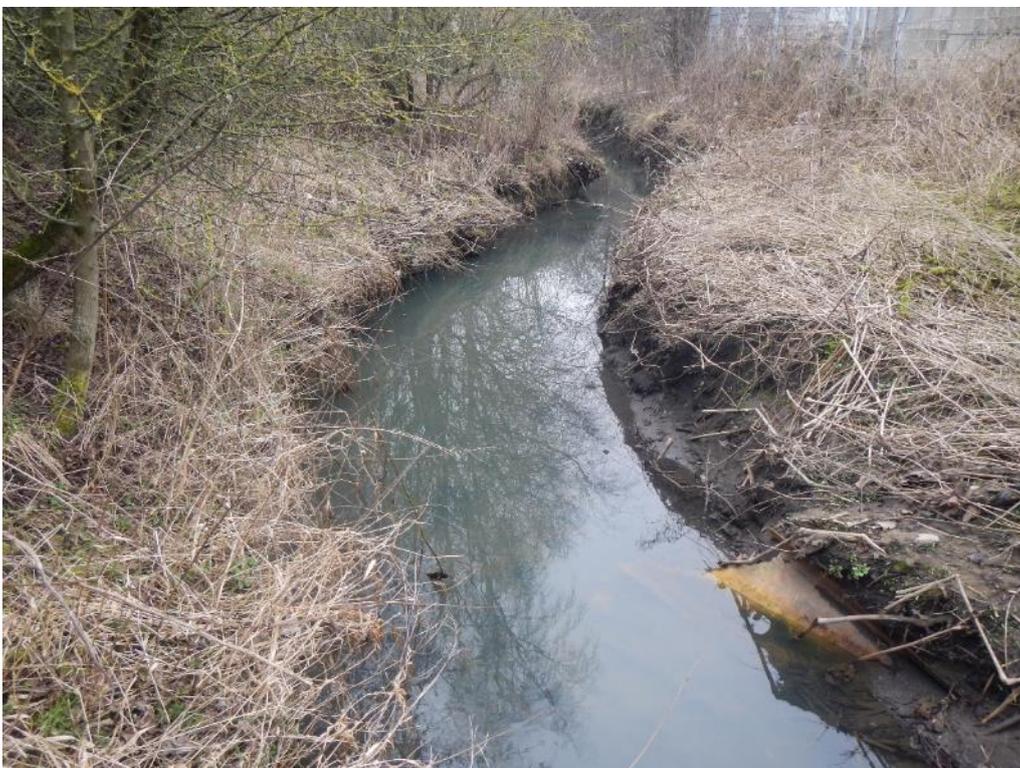
RoB32. Progressing downstream, the channel is dredged and over-capacity.

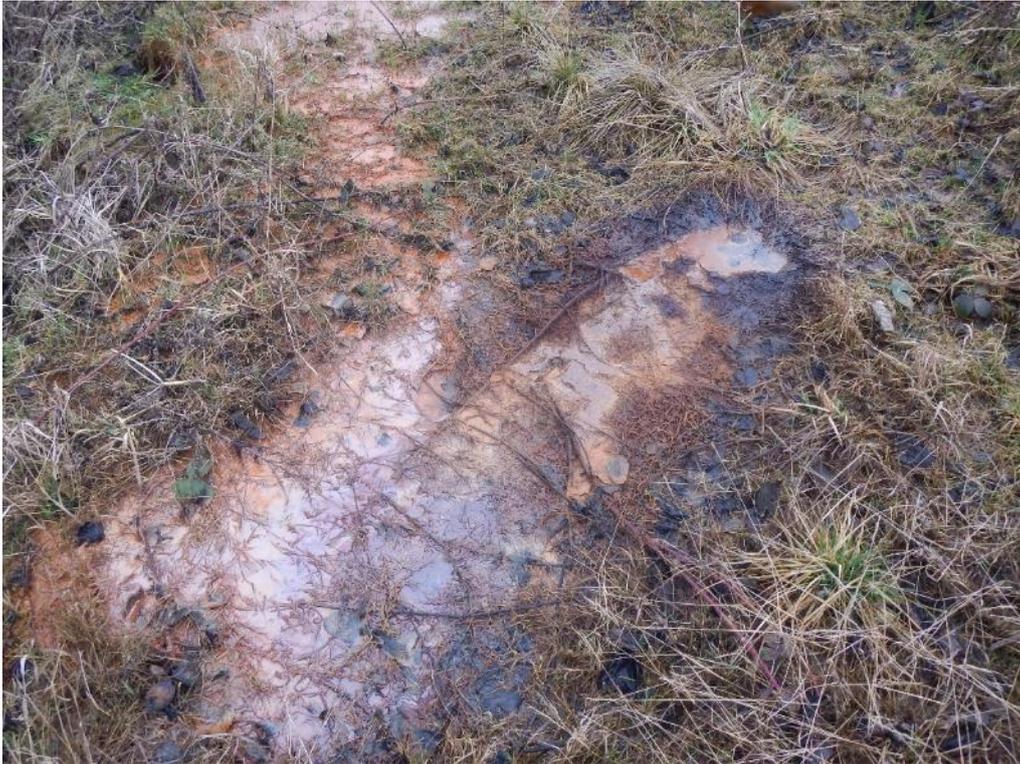
RoB33. Leachate from the LB ground into the watercourse (NZ 26433 55731). The iron content is clearly elevated but other contaminants are suspected, owing to the opaque nature and oily residue. Purely Iron-laden water is usually vividly clear owing to the removal of fine particulates as the iron oxidises and precipitates out of solution.

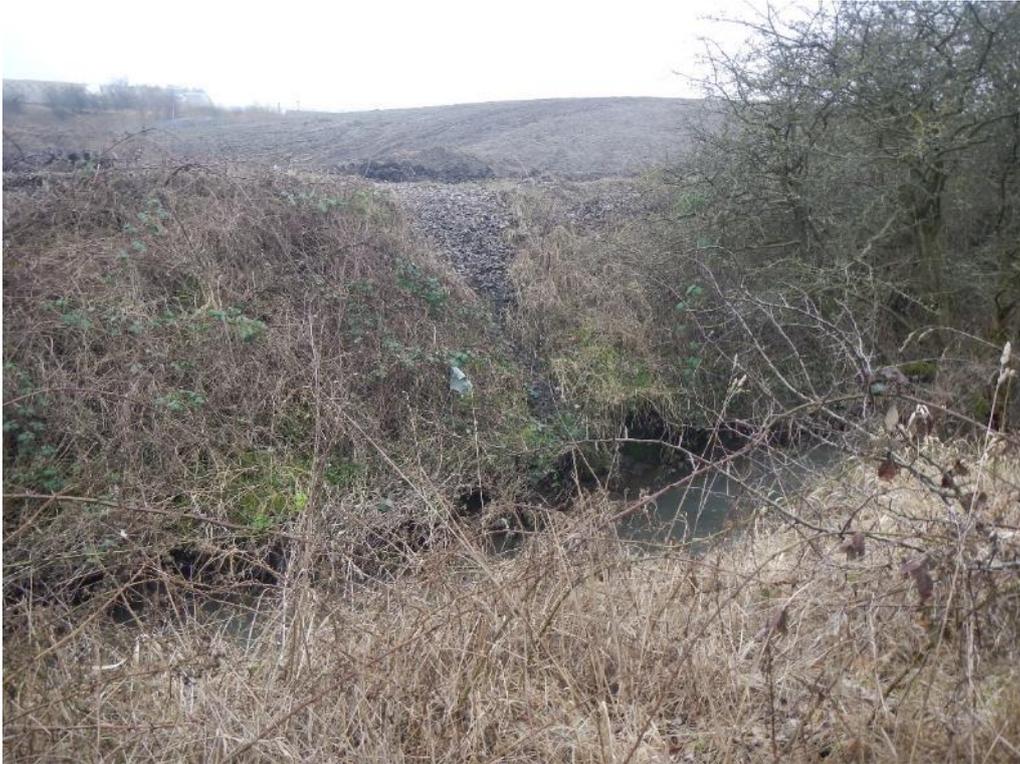
Rob44. A hole in the site bund appears to have been plugged with gravel but demonstrates the potential risk of materials washing out of the site into the watercourse.

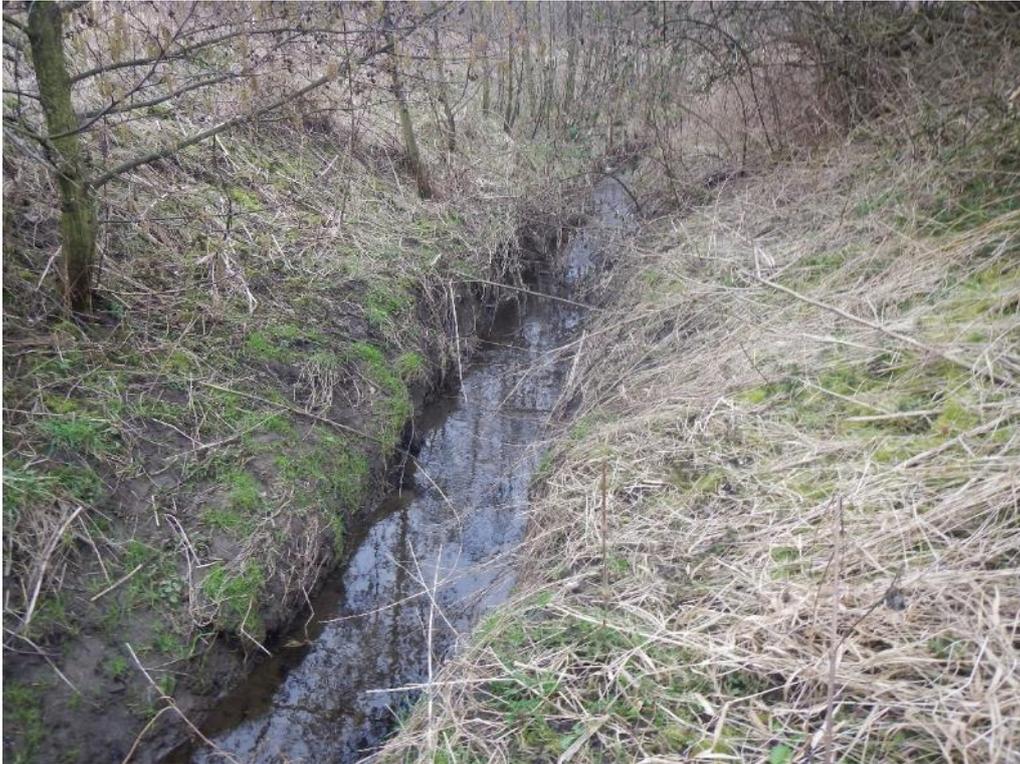
RoB49. A small LB tributary/ditch supplies what is suspected to be higher quality water (NZ 26283 56125).

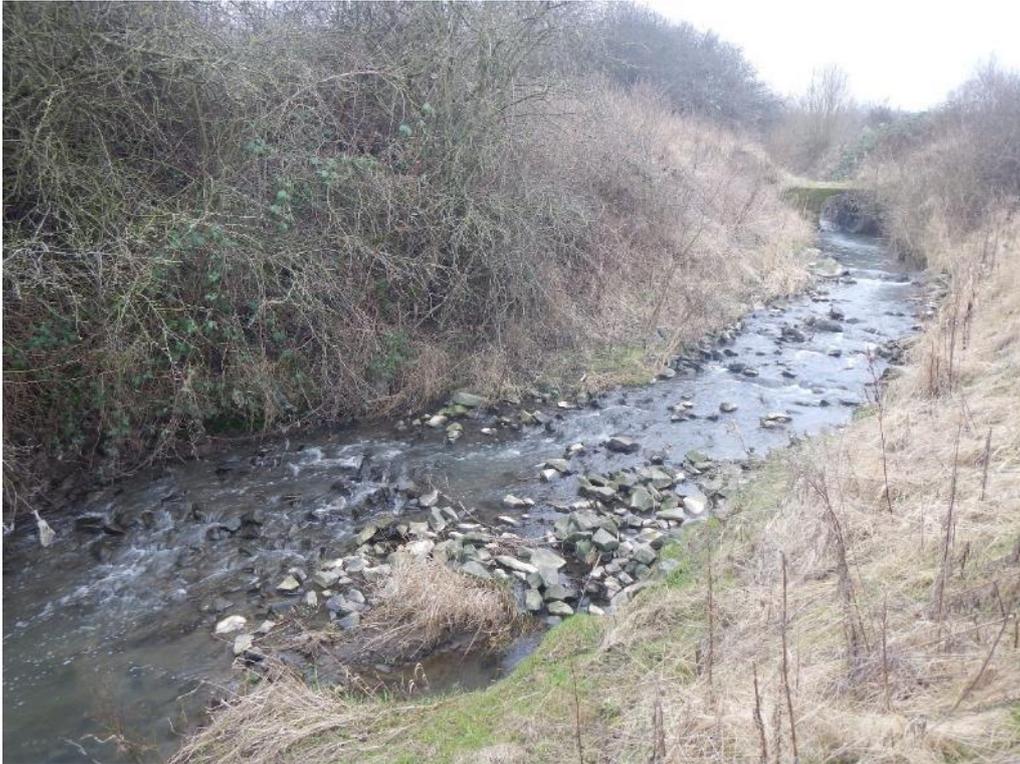
RoB59. Ironically, in a degraded and probably fishless burn, an excellent example of a naturalistic rock ramp fish easement was observed – presumably installed to drown out the culvert a short distance upstream. This design would serve as an excellent template for other small watercourses.

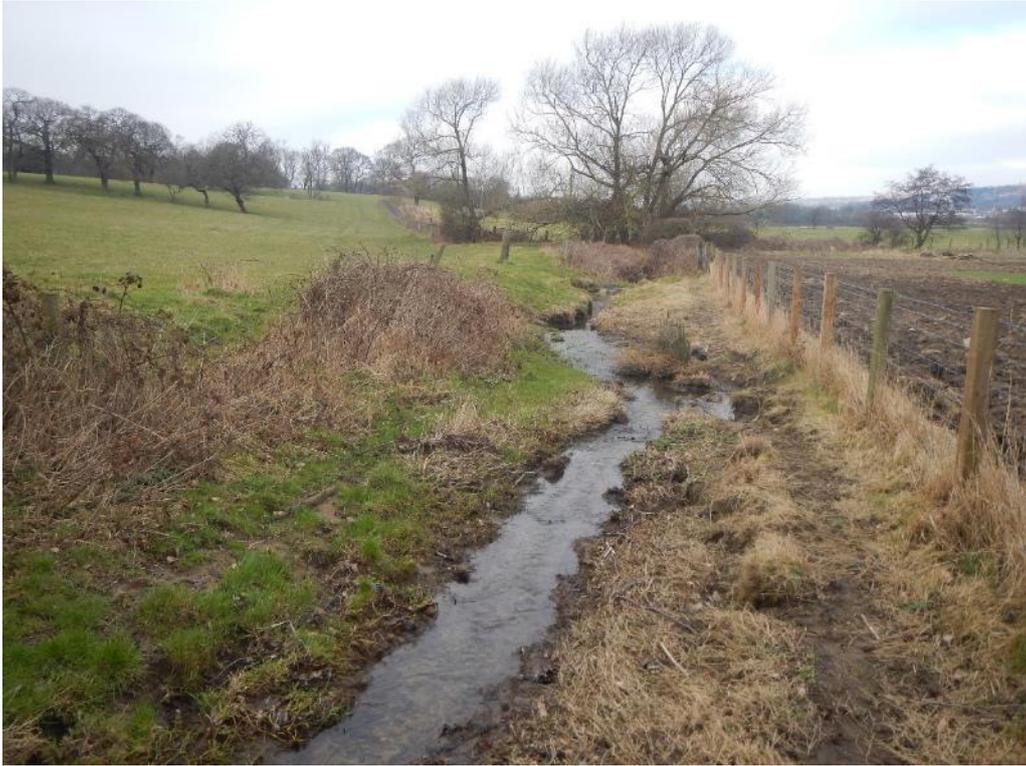
SB6. Livestock access and associated erosion, and runoff from RB arable field (NZ 24487 57756).

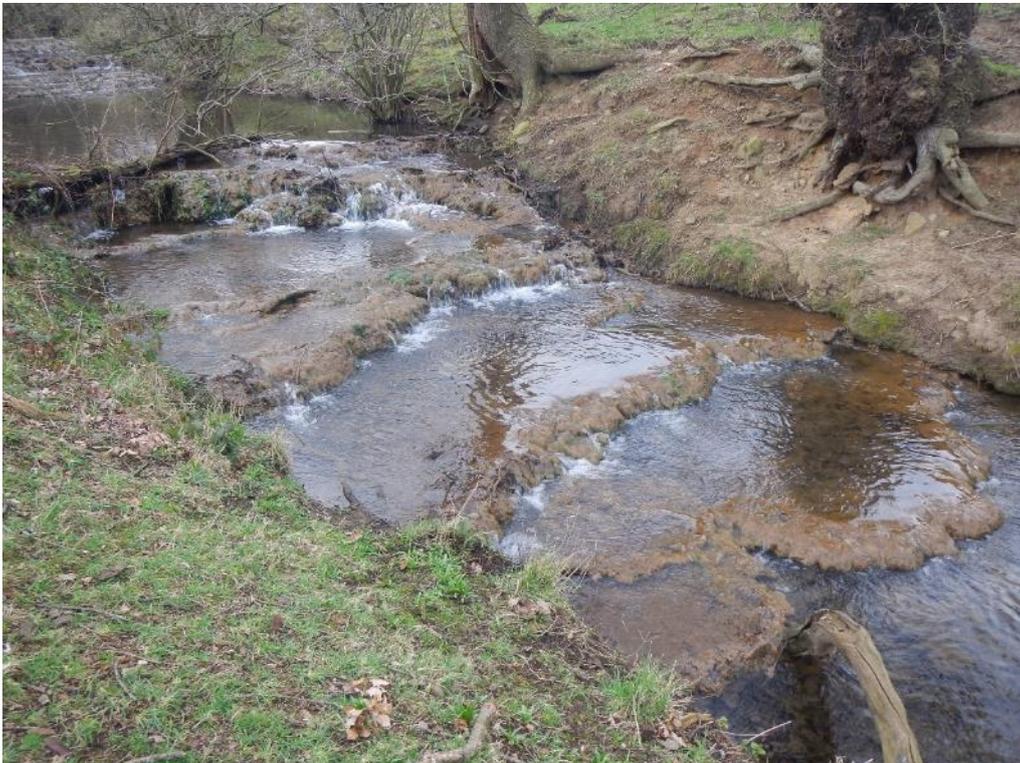
SB28. Active tufa growth, forming barrages (natural calcium carbonate weirs) within the channel that naturally reduce fish access, but certainly do not preclude their presence (NZ 24346 57937). This demonstrates a particularly high alkalinity and potentially high productivity of the watercourse.

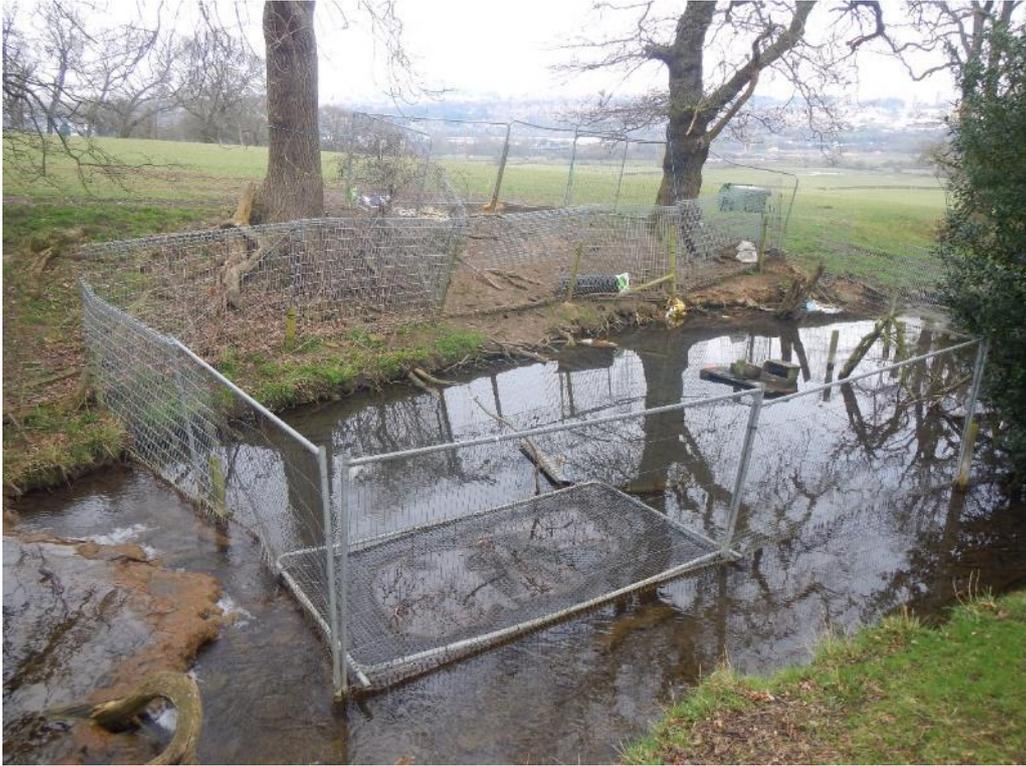
SB29. Inappropriate use of the watercourse for rearing wildfowl, creating increased fine sediment input and almost certainly elevated levels of nitrate and phosphate (NZ 24323 57941).

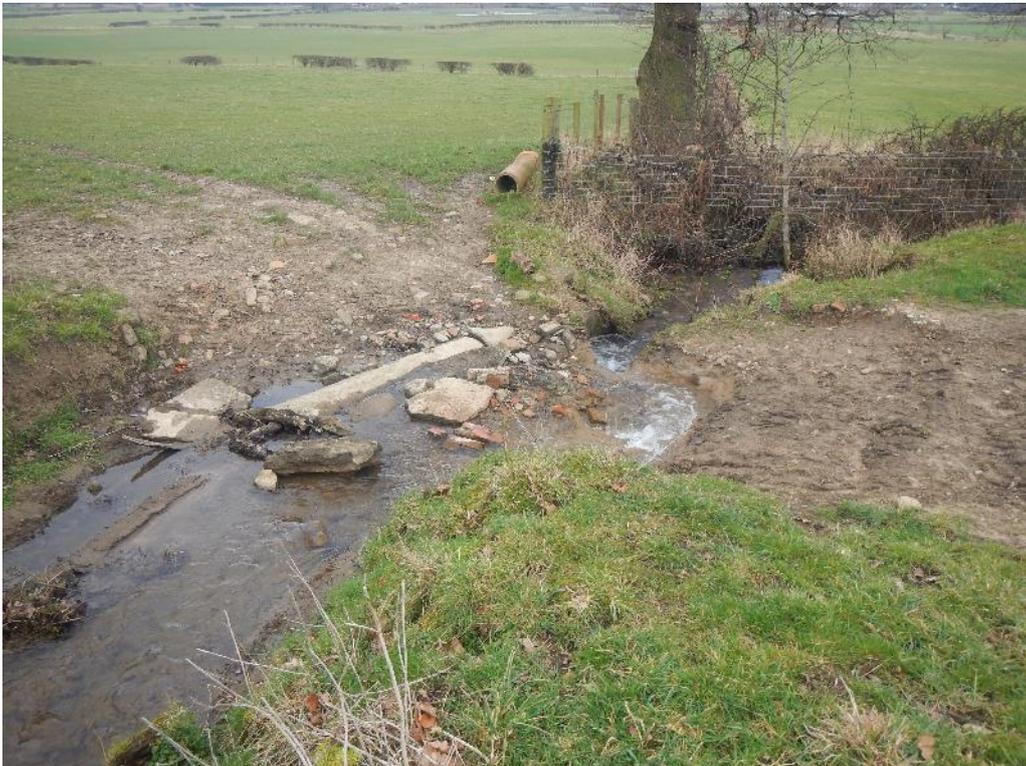
SB35. Track crossing and significantly increased erosion, along with a partial barrier (NZ 24427 57939).

<p style="text-align: center;">SB35</p>	<p>1</p>	<p>NZ 24427 57939</p>	<ol style="list-style-type: none"> 1. Buffer fencing 2. Replacement of the outflanked culvert pipe with a clear span bridge or an appropriately sized sunken pipe (set at a level gradient)
<p>Straightened channel</p>

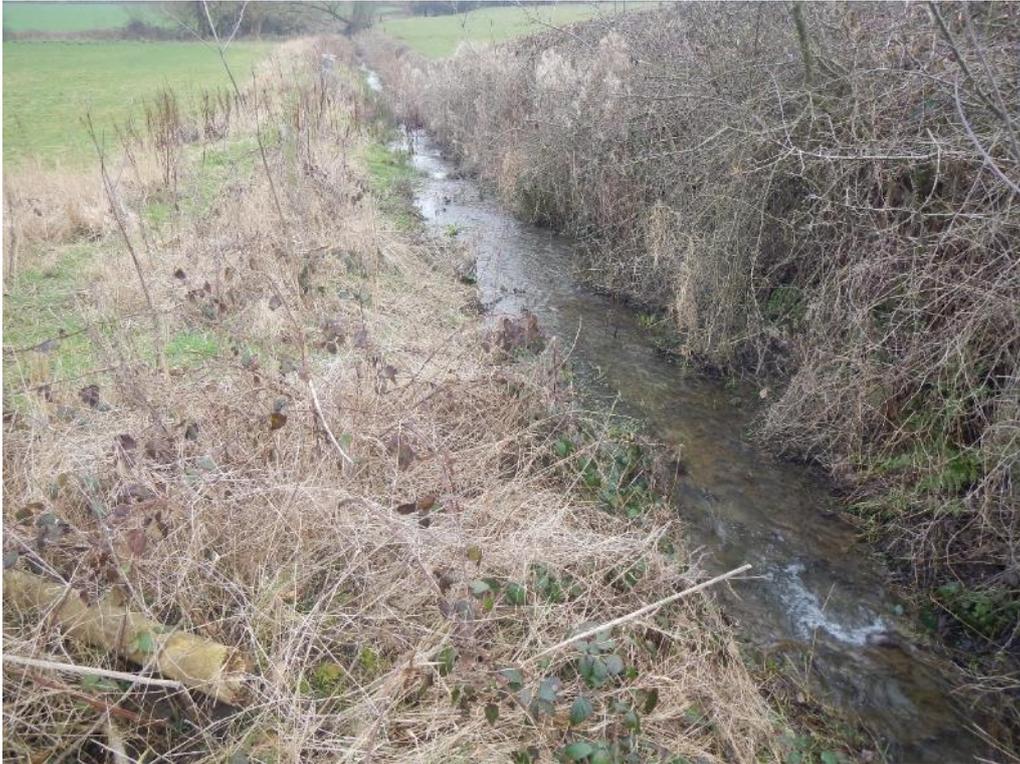
SB36. The final straight downstream to the Strandy Burn is protected by a rough buffer, resulting from mowing not having been undertaken too close to the watercourse. However, the channel is very poor habitat quality. This potentially high-quality watercourse would really benefit from channel restoration to a more sinuous course. Paleochannels of this tributary are also present in the adjacent fields (NZ 24434 57939).

<p style="text-align: center;">SB36</p>	<p>2</p>	<p>NZ 24434 57939</p>	<p>River restoration from here, and downstream. This watercourse and the Strandy Burn are so realigned there are a range of options potentially worth investigating, allowing that their small size may limit the overall catchment benefit.</p>

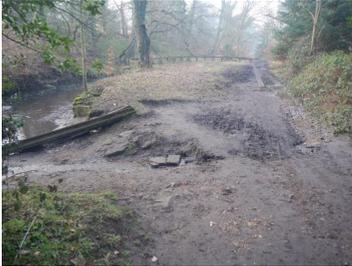
<p style="text-align: center;">BB66</p>	1	NZ 21808 55142	Install sunken pipe to separate the track from the watercourses.
Small tributary with elevated fine sediment load

Observation	Photo (If required)	Priority (1-3)	Location	Proposed action
Tributary crossing in poor state of repair

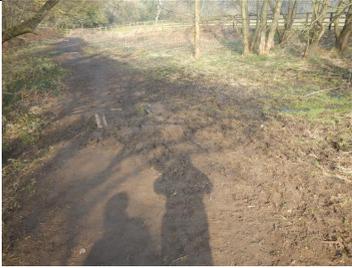
<p style="text-align: center;">BB85</p>	2	NZ 22194 54994	Install sunken pipe to separate the track from the watercourses.
Threat to the path through erosion

Spring/track crossing

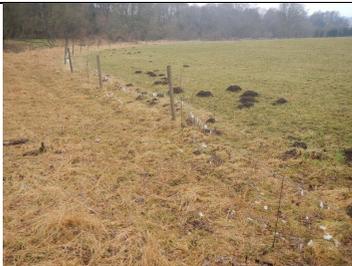
<p style="text-align: center;">BB114</p>	2	NZ 22350 54656	Install appropriate (sheep-proof) buffer fencing.
-----------------------------------	---	---	----------------	---

Livestock access to the riverbank

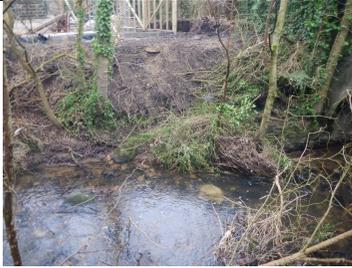
<p style="text-align: center;">UB10</p>	<p style="text-align: center;">2</p>	<p style="text-align: center;">NZ 22748 54215</p>	<p>Advice to the property owner.</p>
<p>Small weir</p>

<p>Inappropriate management of the riparian area</p>

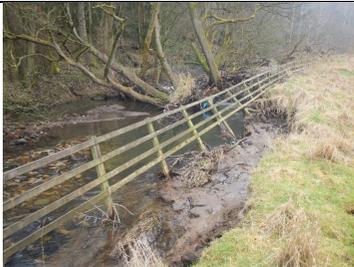
UB51	1	NZ 22987 53841 - NZ 23497 54220	Accommodate lateral erosion to allow natural channel recovery wherever possible.
Pipe crossing and associated protection

UB51. In response to the historical straightening, the burn is now starting to win back some sinuosity through lateral erosion (assisted by valuable inputs of large woody material). This should be facilitated wherever possible.

Bank erosion through a straightened reach

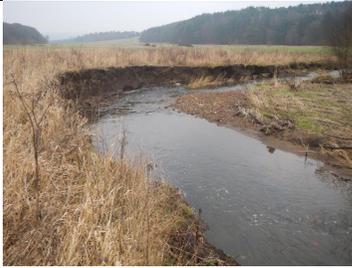
<p style="text-align: center;">Te25</p>	<p style="text-align: center;">2</p>	<p style="text-align: center;">Around NZ 24395 54815</p>	<p>Tree planting to manage erosion rates.</p>
<p>Leachate from the redundant refuse site & Japanese knotweed</p>

<p>Semi-natural bank erosion</p>

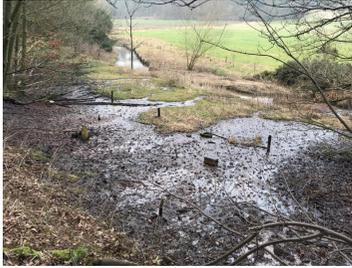
Te33. Leachate from the historical High Urpeth landfill is entering the watercourse and should be addressed (NZ 24532 54759). Japanese knotweed was also observed here, but not noticed in the many kilometres of suitable areas upstream during the 'River Team walkover'. All knotweed should be treated with herbicide by a licenced operative to eradicate it before it spreads and caused further issues, including increased bank erosion.

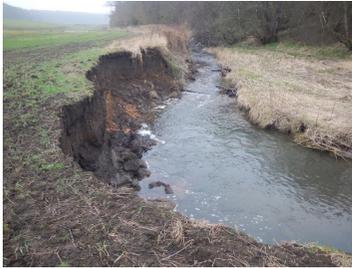
Bank erosion

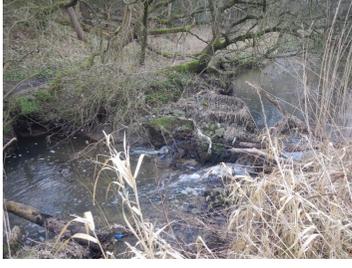
Te68. A bank breach threatens to divert the river down a straight drainage channel (red arrow); NZ 25309 55883). Gabions (failing) have been used inappropriately to protect the bank. A solution could be to roughen the drainage ditch with large woody material (LWM) and laying adjacent willows into the channel, thereby making the main river course (blue arrow) the easiest route flow pathway. This would encourage the ditch to block through natural deposition.

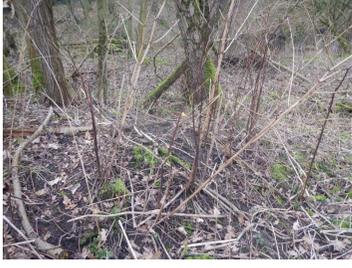
<p style="text-align: center;">Te83</p>	1	NZ 24931 55537	Treat with herbicide.

Te83. Further stands of Japanese knotweed were observed on a track in the riverside wood (NZ 24931 55537).

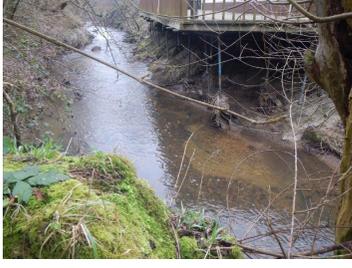
Concrete work on the banks and within the channel

<p style="text-align: center;">Te86</p>	1	NZ 25620 56036	<p>This work is almost certainly illegal, so action should be taken by the EA and/or Local Authority.</p>

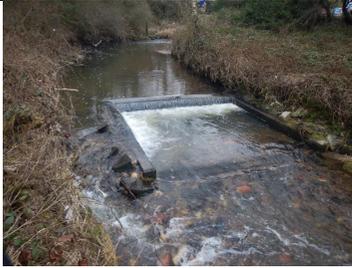
Weirs

<p style="text-align: center;">Te92</p>	2	NZ 25716 56129; NZ 25753 56239; NZ 25805 56297; and NZ 25858 56349	These weirs should be removed or eased. One option could be to replicate the situation occurring at the first weir TE92 , but bypassing the weir to the LB side, away from the clay pit. Alternatively, rock ramps/engineered riffles could be used to replace the weirs.
Large capacity pipe/discharge

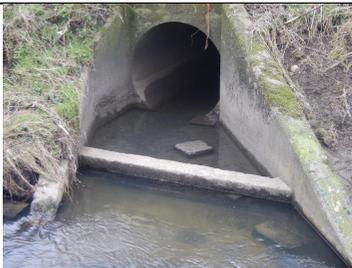
Te121. Observed from the far bank, a large capacity culvert on the LB was not discharging at the time of the walkover. A greyish biofilm / sewage fungus on the bed suggests it may discharge poor quality water at certain times - likely associated with the STW (NZ 25998 56723).

<p style="text-align: center;">Te121</p>	1/2	NZ 25998 56723	Potential poor water quality discharge from the STW.
Significant discolouration from the 1 st STW discharge

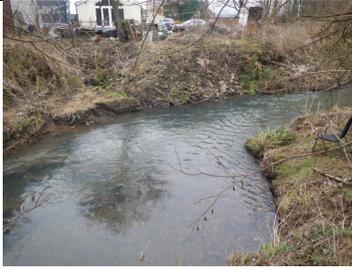
<p>inappropriate dumping of waste and spoil on the riverbank</p>

<p style="text-align: center;">Te150</p>	<p style="text-align: center;">2</p>	<p style="text-align: center;">NZ 25661 57236</p>	<p>Stop the inappropriate dumping of material which is contributing to bank instability by preventing vegetation growth.</p>
<p>Livestock access</p>

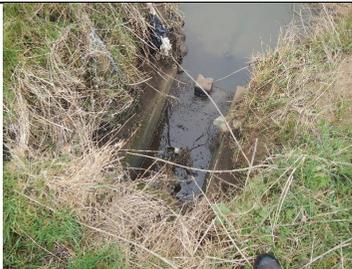
Te169. A small outfall was observed at, which appears to discharge slightly elevated levels of fine sediment – possibly road drainage (NZ 25173 57788).

<p style="text-align: center;">Te169</p>	<p style="text-align: center;">2/3</p>	<p style="text-align: center;">NZ 25173 57788</p>	<p>Road drainage is difficult to deal with, but should ideally discharge to soak-away, well away from a watercourse.</p>

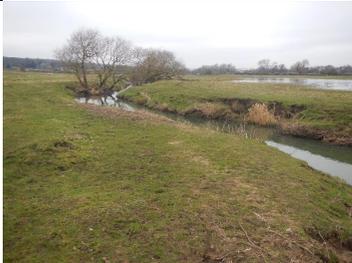
Livestock grazing

<p style="text-align: center;">Te179</p>	1/2	NZ 25031 57964 & NZ 25080 57986	Install buffer fencing – this could facilitate planting and natural regeneration.
Obstruction at footpath bridge

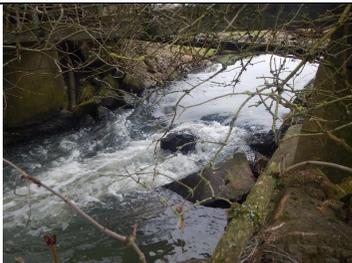
Te189. The footings of the dilapidated footpath bridge create an obstruction to fish movement through elevated flow velocities (NZ 25040 58245). This should be replaced with a more appropriate, larger, clear-span structure when the crossing is next maintained.

<p style="text-align: center;">Te189</p>	2	NZ 25040 58245	Replace with larger, completely clear span structure.
Further increased grazing pressure in the final two fields upstream of Lamesley Roundabout.

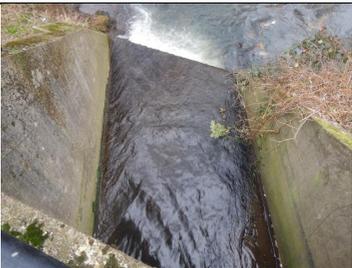
Te215. Black Burn joins via a culvert (NZ 24603 59967), limiting its potential, although poorly accessible from the main river it is possible that there are areas of higher quality habitat upstream. The water appeared to be of a reasonable quality.

<p style="text-align: center;">Te215</p>	<p style="text-align: center;">2/3</p>	<p style="text-align: center;">NZ 24603 59967</p>	<p>Further investigation of the habitat potential and accessibility of the burn upstream.</p>
<p>Elevated levels of fine sediment from a culver</p>

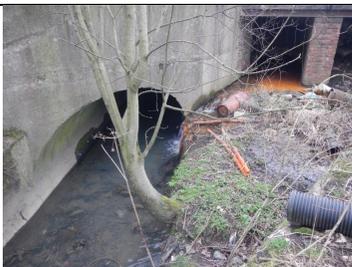
RoB1. Rowletch Burn was walked from NZ 26842 55047, where it emerges from a culvert. Significant seepage of iron-laden water was observed from the LB. Rubbish appears to be escaping from the adjacent compound.

<p style="text-align: center;">RoB1</p>	1	NZ 26842 55047	Further investigation to identify the source.
Poor water quality

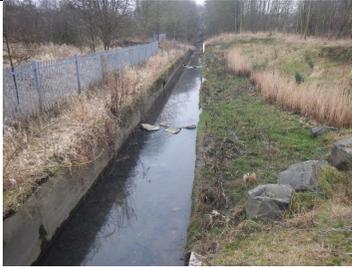
Reedbed in need of maintenance

<p style="text-align: center;">RoB8</p>	2	NZ 26828 55153	Undertake maintenance to ensure that leachate does not reach the watercourse untreated.
Concrete discarded down the bank

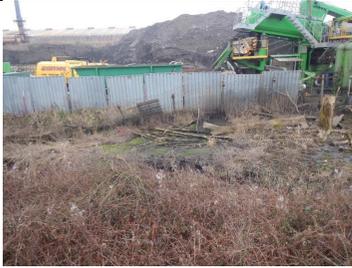
RoB37. Clears signs of material washing out of the site compound into the burn (NZ 26413 55811).

<p>Fine sediment and waste escaping from the adjacent refuse site</p>

<p>RoB37</p>	<p>1</p>	<p>NZ 26413 55811</p>	<p>Enforcement by the EA.</p>
<p>Japanese knotweed escaping from the refuse site</p>

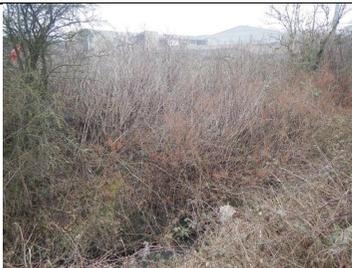
RoB40. Japanese knotweed may have escaped from the site as it was not observed further upstream (NZ 26360 55964).

<p>RoB40</p>	<p>1</p>	<p>NZ 26360 55964</p>	<p>Advice to treat the infestation and/or Enforcement by the EA.</p>
<p>Small weir</p>

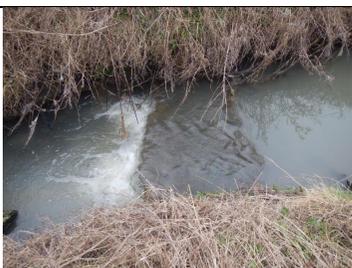
Rob46. A small concrete weir would pose an obstruction to fish, but the burn is unlikely to support any in its current state (NZ 26295 56119).

<p>Rob46</p>	<p>2/3</p>	<p>NZ 26295 56119</p>	<p>This weir would be a higher priority for removal if other improvements could help the burn to support fish.</p>
<p>Track crossing to Union Brickworks Clay Pit creates more fine sediment input and obstruction.</p>

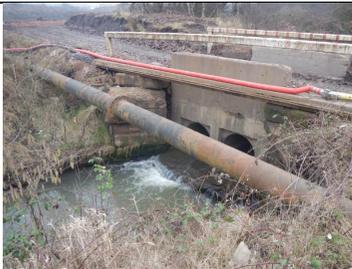
RoB51. The track crossing to the disused Union Brickworks Clay Pit (now decommissioned) creates another fine sediment input to the burn, particularly after heavy rain (NZ 26286 56152). The raised footings and twin pipes of the bridge also create an obstruction.

<p>RoB51</p>	<p>1/2</p>	<p>NZ 26286 56152</p>	<ol style="list-style-type: none"> 1. Seek better maintenance of the track (free from mud) and install cross-drains to discharge to soak-away. 2. An easement would be beneficial if the burn can be brought up to a standard that supports fish life.

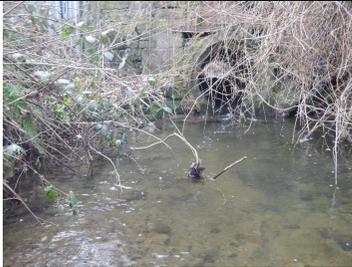
SB1. A perched culvert with a blocked grid at the upstream limit of the Strandy Burn section walked (NZ 24475 57682).

<p style="text-align: center;">SB1</p>	2	NZ 24475 57682	<p>Removing the screen would improve the situation but ideally the culvert should be partially sunken below bed level. This would be a higher priority if electrofishing showed fish to be present.</p>
Erosion and runoff

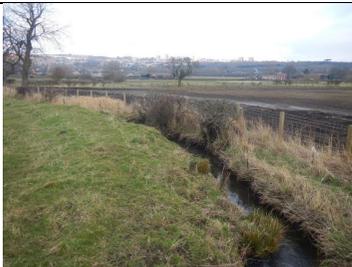
SB16. Suspected signs of the burn's pre-straightening paleochannels in the adjacent field. Note how they are still wet, being the natural low point in the floodplain. These channels could be restored to naturally improve land drainage (NZ 24704 57922). Buffer fencing would also be beneficial on one or both banks from here, downstream to the River team.

<p style="text-align: center;">SB16</p>	2	Throughout the section of Strandy Burn walked.	<ol style="list-style-type: none"> 1. Potential for channel restoration to improve habitat quality and land drainage throughout. 2. Buffer fencing from here to the River Team.

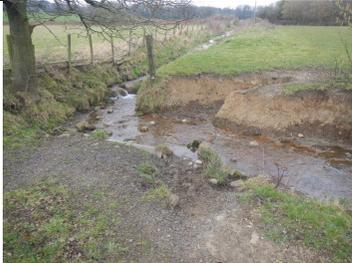
SB25. Livestock access and significant poaching/erosion at the furthest point upstream that was inspected (NZ 24217 57926). Note that although being the unnamed tributary of Strandy Burn, this watercourse supplied the majority flow.

<p>Poaching / erosion</p>

<p style="text-align: center;">SB25</p>	<p>1</p>	<p>NZ 24217 57926</p>	<p>Install buffer fencing.</p>
<p>Inappropriate wildfowl enclosure</p>

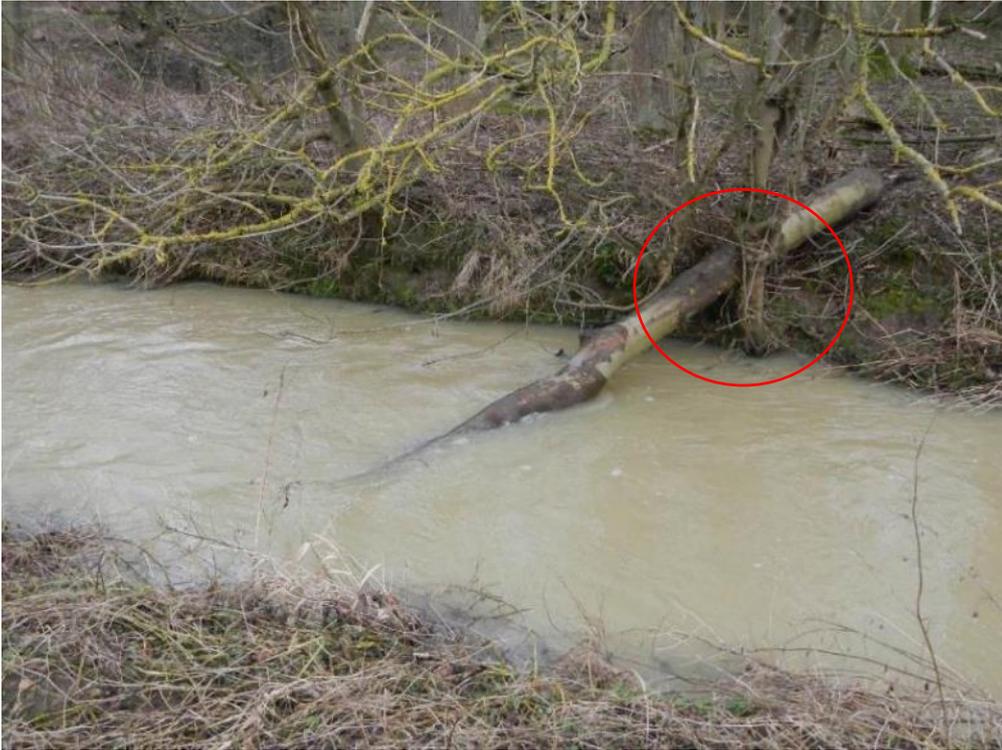
Figure 2. A lodged flow deflector securely but naturally lodged in place between two upright trees (red circle). The technique can utilise a single pole (primarily to increase scour) or a branched limb (to create greater flow dissipation and deposition). The elevated butt end (bank end) reduces the potential detrimental bank scour usually associated with downstream deflectors as a through-flow is maintained along the bank.

Alternatively, a tree can be felled to create a coppice, encouraging low-level regrowth from the stool, providing material that can then be lodged between two or more standing trunks (Figure 2), or hung over another tree if a 'V' branch is available (Figure 3). Again, this technique could be employed to encourage further accumulation of woody material within the straightened drainage ditch that is fed by the bank breach on the River Team (Te68). That increased roughness should encourage flow down the main channel, rather than the breach (where increased sediment deposition should then occur).

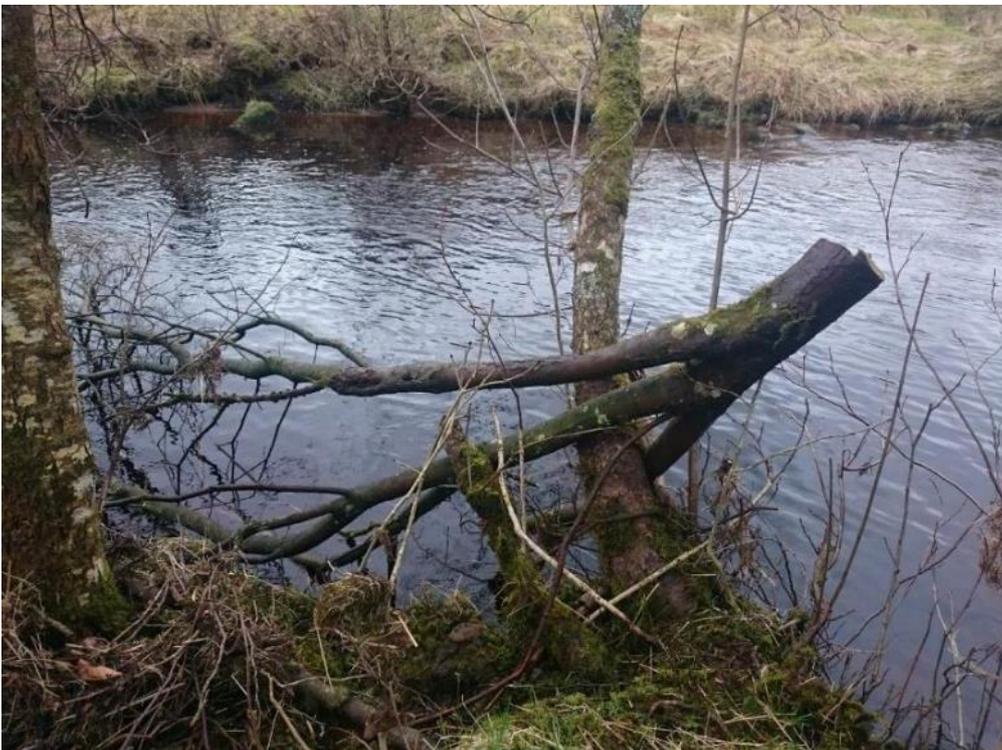
Figure 3. Medium-sized, lodged woody material, securely anchored by the 'V' of the branches against an upright tree.
