## WILD TROUT TRUST

**Follow up Advisory Visit / Project Proposal:**

**R. Ure, Tanfield Angling Club ([GB104027069461](mailto:GB104027069461))**

**Prof J Grey ([jgrey@wildtrout.org](mailto:jgrey@wildtrout.org)); April 2026**

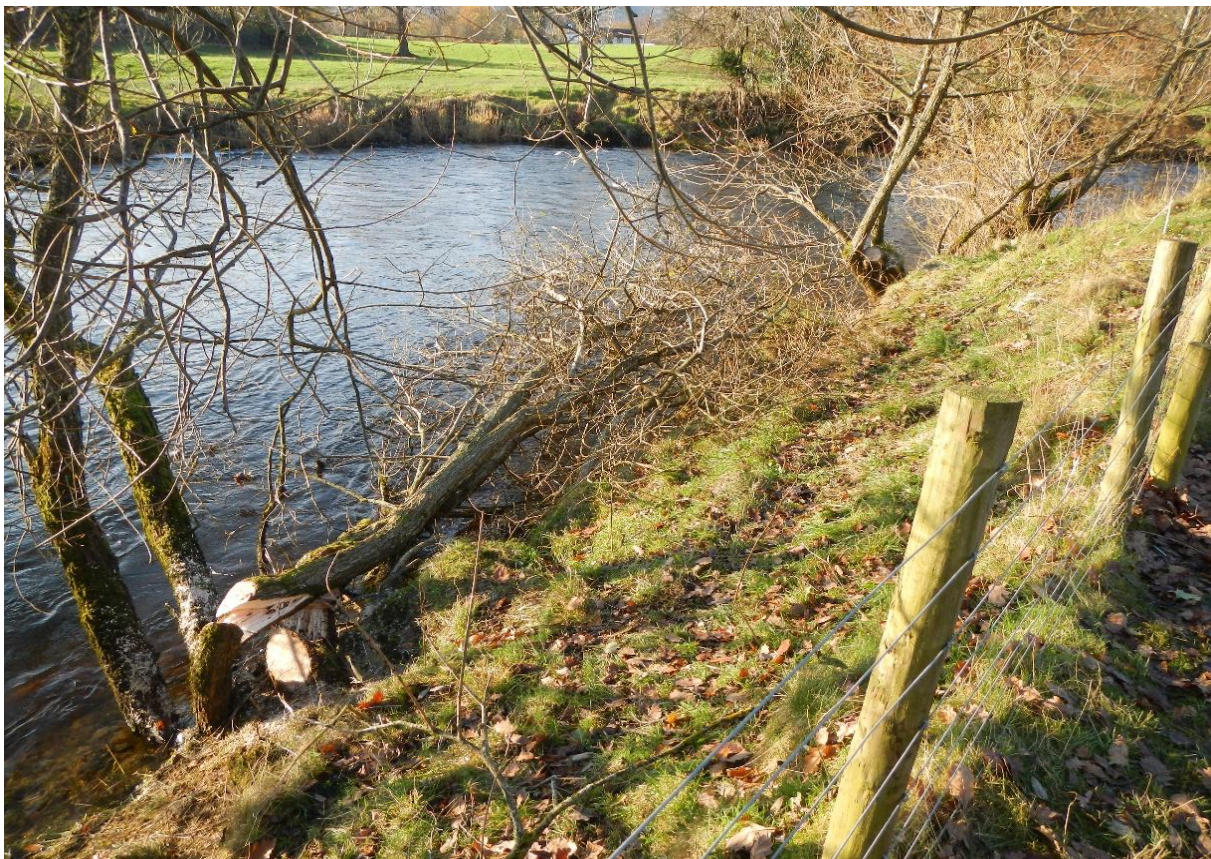
**Fig 15. Two stems from a previously coppiced and hence multi-stem crack willow laid into the channel and aligned close to the bank to provide low / submerged cover. The living upright stems on the u/s side protect the hinge.**

Tree-kickers simply emulate the fall and retention of natural woody material but can be used where there has been historic removal or where a river system has been too heavily modified to retain material safely (ie risk of dislodged material blocking man-made pinch-points like bridges). It is a step further than simply laying or hinging stems into the channel whereby the material is retained via a living hinge (Fig 15). This can be done with pliant, living species, but larger and/or dead trunks and many species are not suitable.

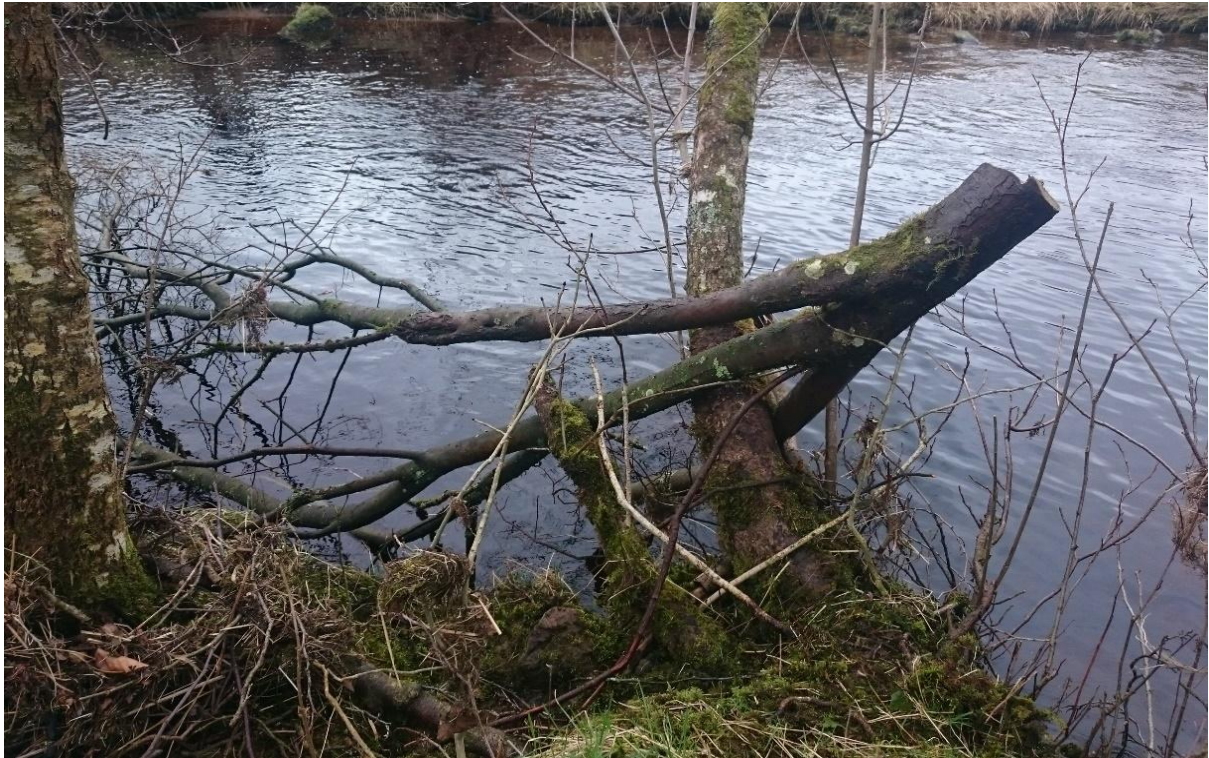
**Fig 16.** Simple lodging of material if there is the structure, in this case the fork, to make it work.

Ideally, if the trunk can be retained without a tether, eg by lodging around or opposing forces between living trunks (Fig 16) as a tree-hanger, then that reduces the amount of non-natural material used. If not, or to minimise risk, appropriate gauge stainless steel cable (10 or 12mm equivalent to 6.5 or 9.4 tonne breaking strain) and wire rope clamps should be used (Fig 17).

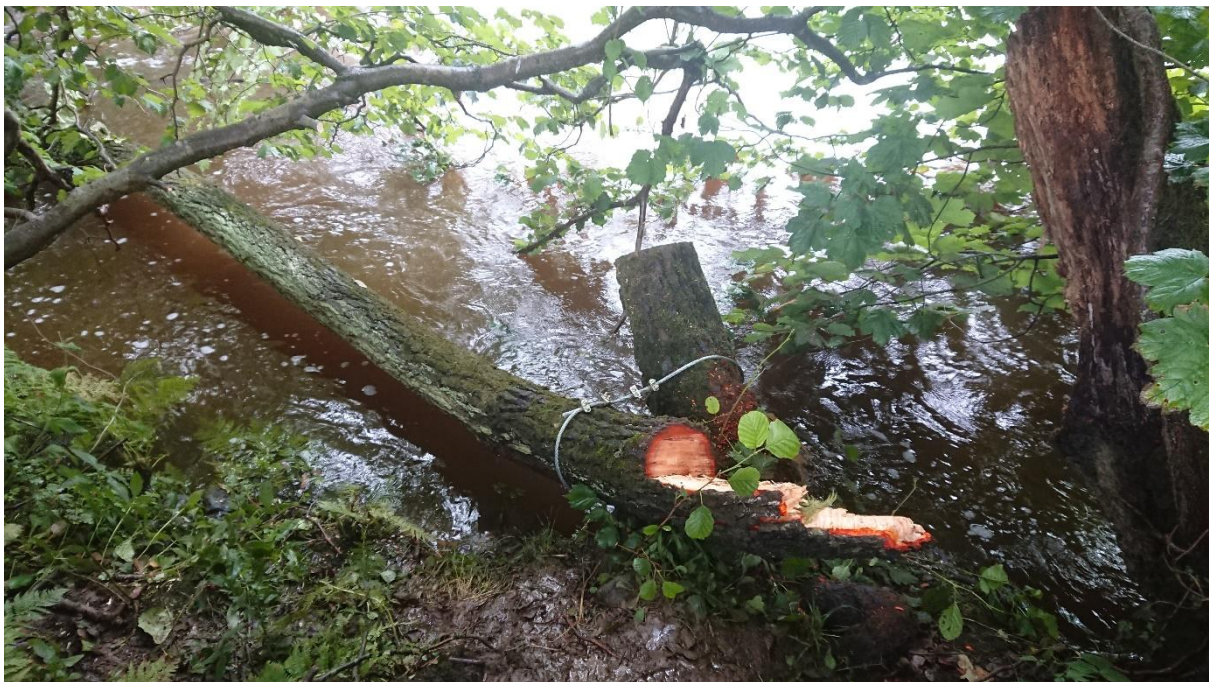
**Fig 17.** Alder of ~350mm girth felled and cabled back to the living stump as a tree-kicker. The coppiced stump will regrow vigorously, providing further low cover and screening of the cable.

Uprooted trees or individual trunks can be retained *in situ* or nearby by winching and cabling to an appropriate living anchor. If none are nearby, consider the use of a ground anchor, eg <https://platipus-anchors.com/>
