**Advisory Visit**

**River Ivel, Radwell, Herts**

**March 2021**

**Rob Mungovan**

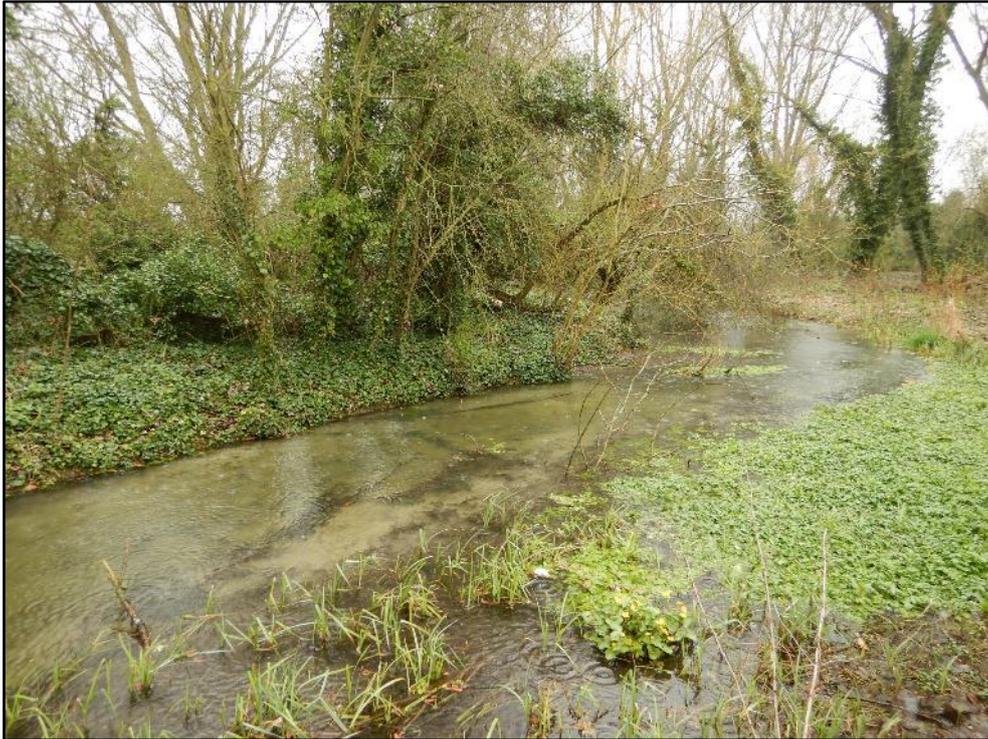
Pic 23 – The river has a meandering profile through the woodland.

The river has extensive damp margins which provide habitat for a variety of marginal plants. Extensive watercress growth is already visible. Cress will provide cover and natural channel narrowing as the year passes. Starwort is the dominant aquatic plant, with water crowfoot still strangely absent.

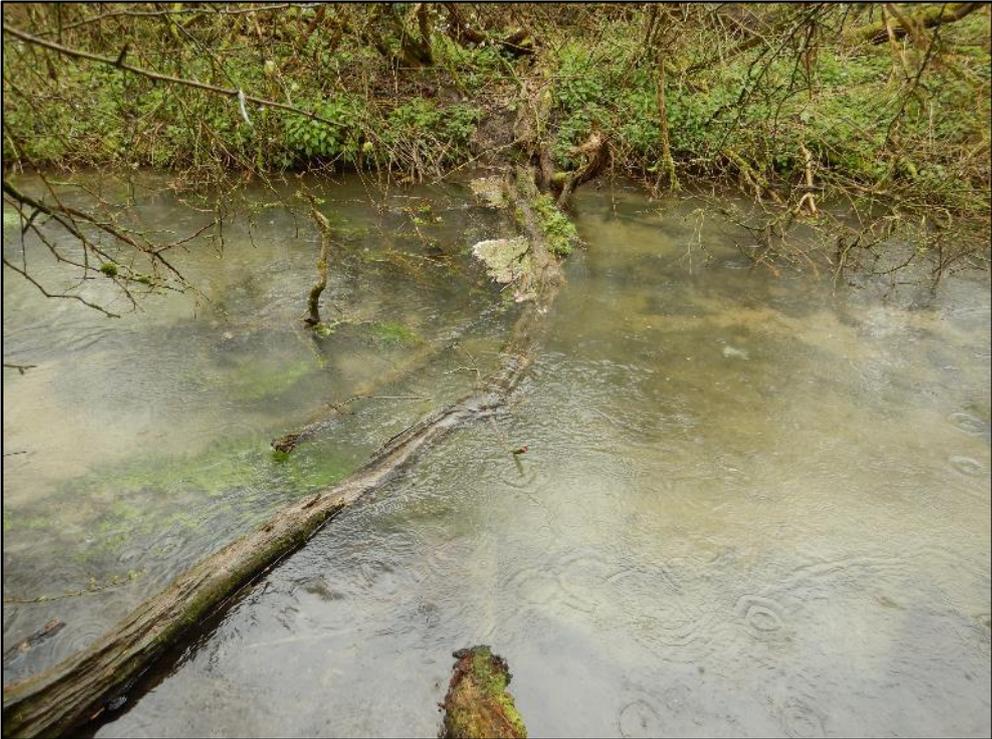
Pic 26 – Occasional limbs across the river provide important habitat features giving cover and flow diversity.

In other situations, the presence of fallen branches may require some adjustment (pic 25) to prevent impoundment and siltation upstream. In this case branches can be pulled back towards the bank to provide natural flow deflection and marginal cover. Similarly, the occasional branch across the river provides flow diversity and cover for fish (pic 26) without creating an impoundment. Each piece of fallen LWM should be assessed on a case-by-case basis, with the default position for it to be retained in situ.

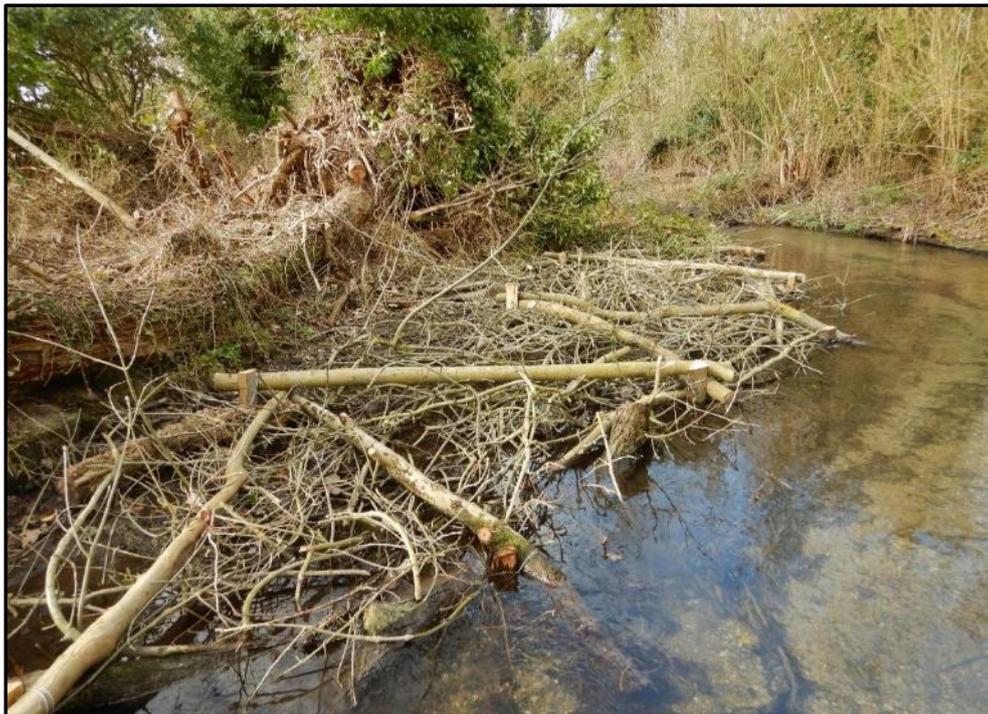
Pic 29 – A low-level brash berm created following tree thinning. They can be particularly effective for enhancing low-flow rivers.

- Brash berms (pic 29): these features can be created following tree works. A brash berm provides complex cover at, and below, water level. Brash from tree thinning is pinned against the bank in alternating directions or increasing stem thickness, and is securely wired down or held with battens. The brash lattice provides niches for invertebrates and small fish, aids silt entrapment and provides a rooting substrate for plants to establish. In time (~3yrs) the brash will become a vegetated berm if exposed to full sunlight.

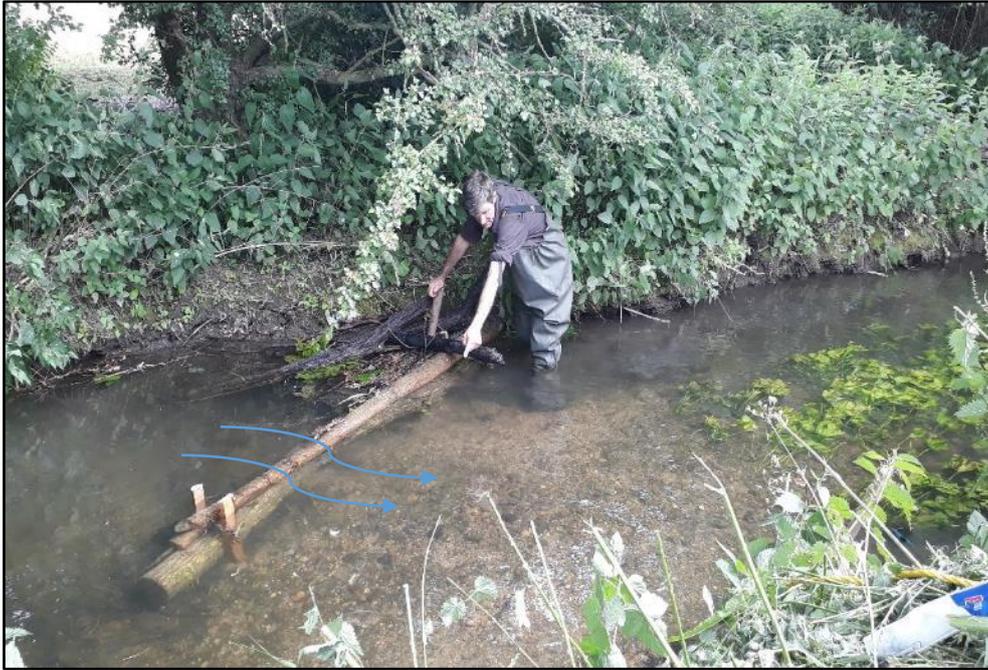
Pic 30 - A flow deflector used to focus flow and scour into the centre of a river.

- Flow deflectors (pic 30): these features can be used to increase flow diversity and bed scour. They can be simple log deflectors or tethered tree stems. The complex flow that arises creates depth variation, cover and aids sediment sorting. Flow deflectors should not impound the reach above them.

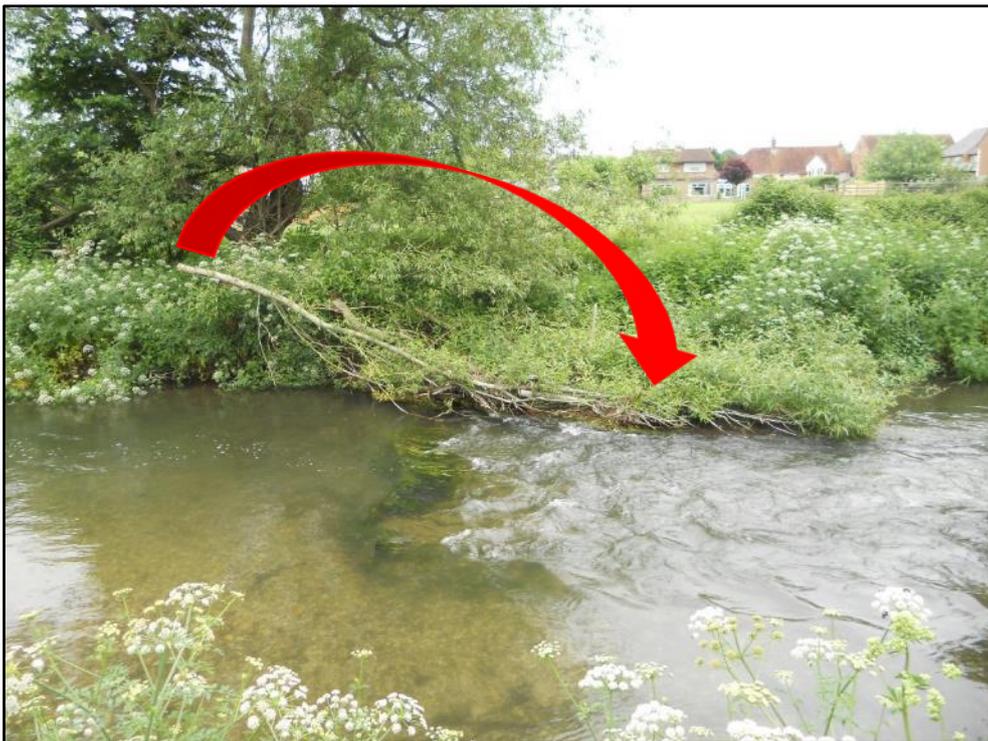
Pic 31 - An example of tree hinging increasing cover at, and below, water level.

- Tree-hinging would be a simple first approach to managing some of the tree stock whilst providing cover at water level (pic 31).

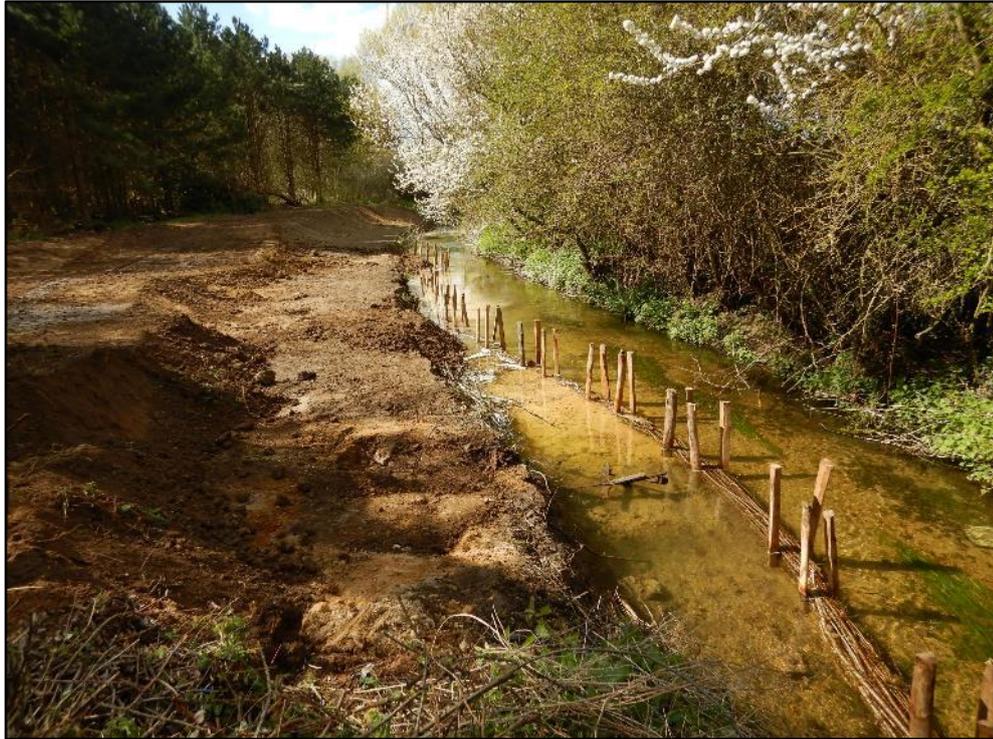
Pic 32 – Channel narrowing using faggots. A new sinuous bank line has been established and is being backfilled.

- Channel narrowing use hazel faggots: A double layer of faggots is held between a double line of stakes to create a new bank line. The void behind the faggots can be filled with brash to retain sediment or it can be backfilled with spoil to provide instant bank establishment.

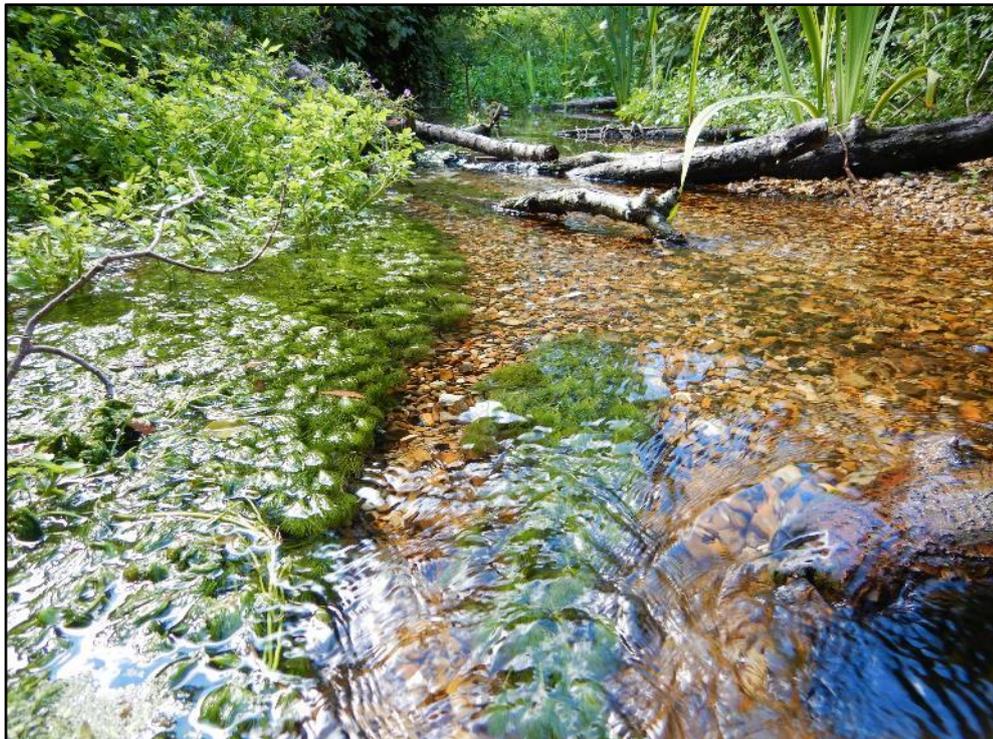
Pic 33 – Gravel placed in the River Mel has been planted with water crowfoot along with pinned LWM. 2 months later the reach has naturalised.

- Creation of new riffles and gravel bars: This sees the introduction of 10mm to 40mm gravel placed to replicate missing river features.
