River Don Walkover
(River Tyne Catchment)
29th & 30th November 2016

Undertaken by Gareth Pedley, Wild Trout Trust

1.0 Introduction

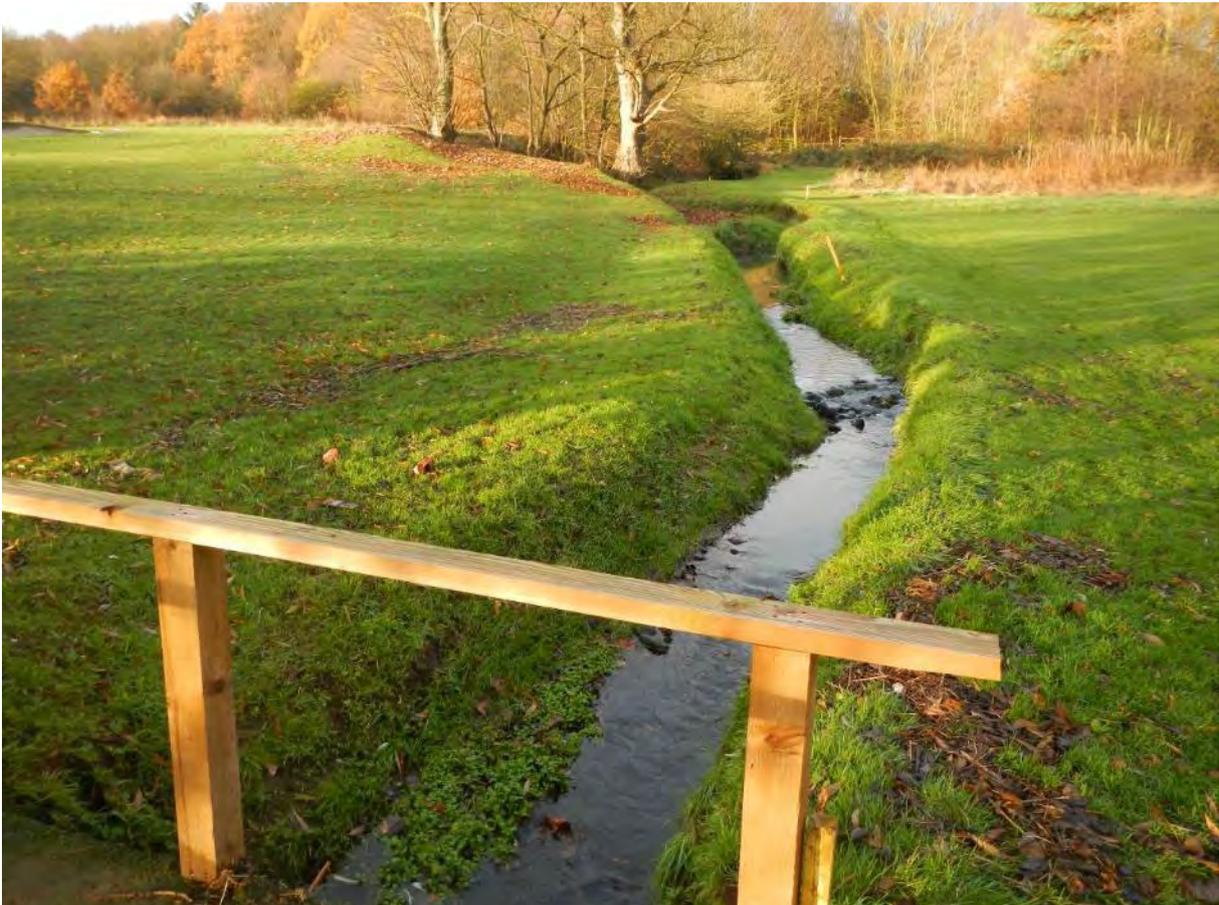
Photo DSCN4980. Modified channel through the golf course.

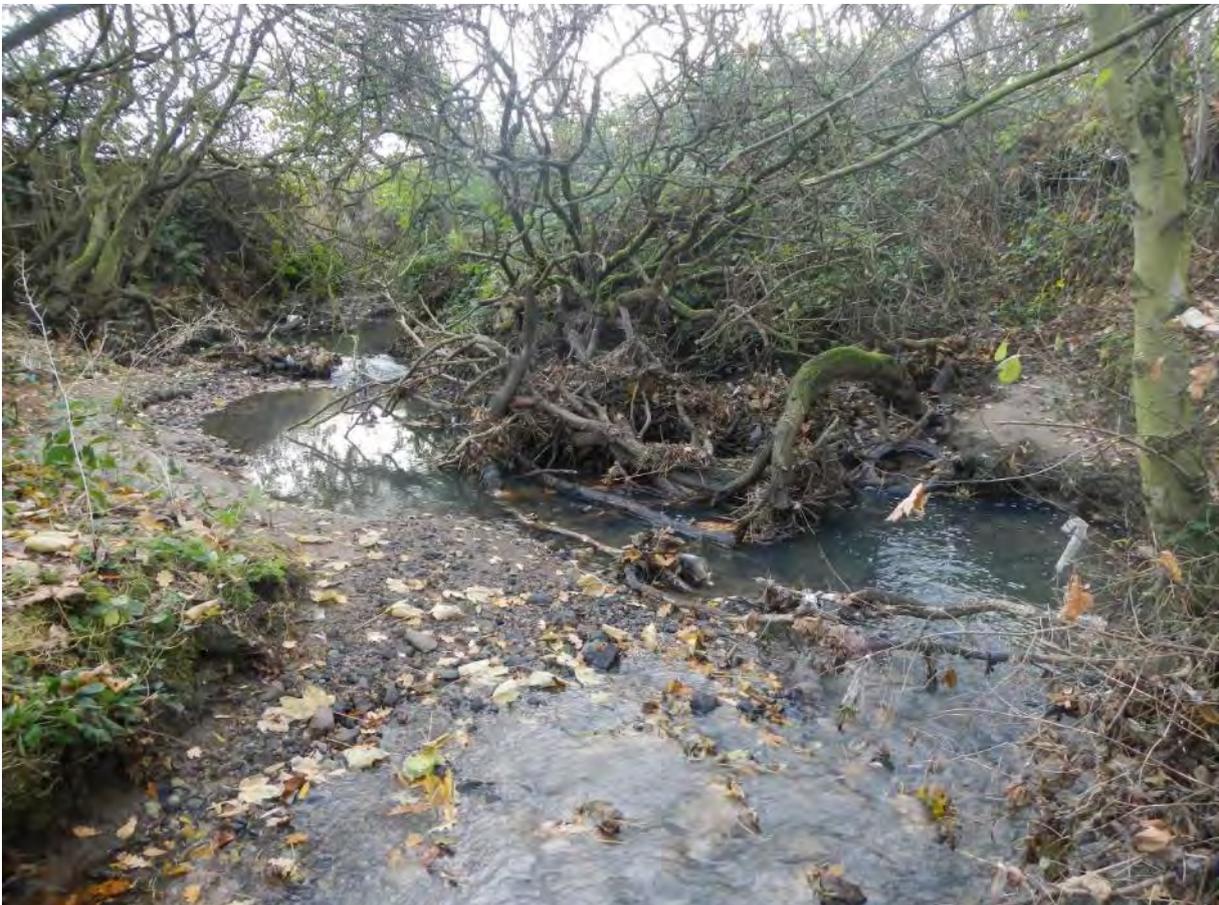
Photo DSCN5027. Tree encroachment and woody material greatly enhance habitats in the area u/s of the railway culvert – excess fine sediment remains a major issue.

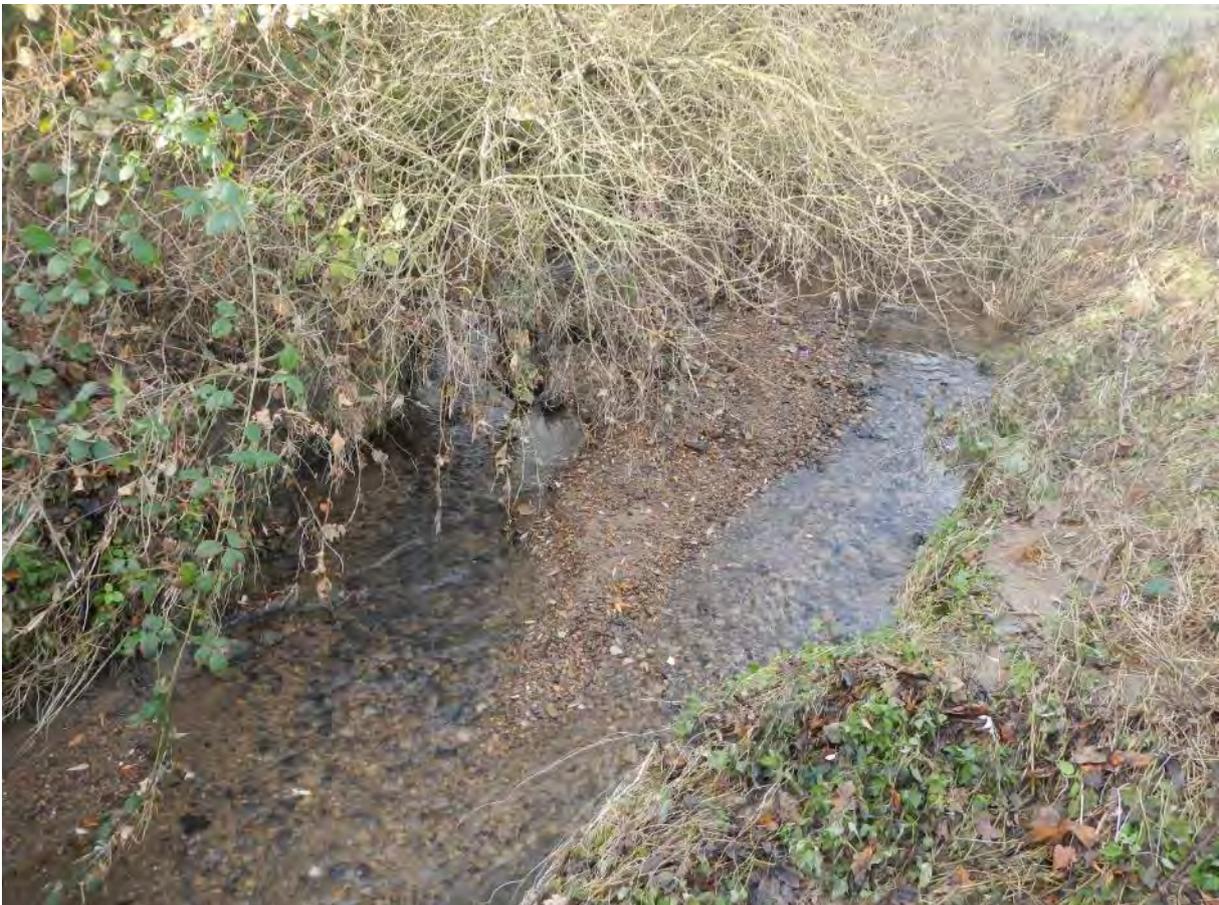
Photo DSCN5044. Bed and bank scouring has accentuated a small bend, scoured greater depth and facilitated retention of valuable gravel bar (improved invertebrate and salmonid spawning habitat). Fine sediment remains a major issue.

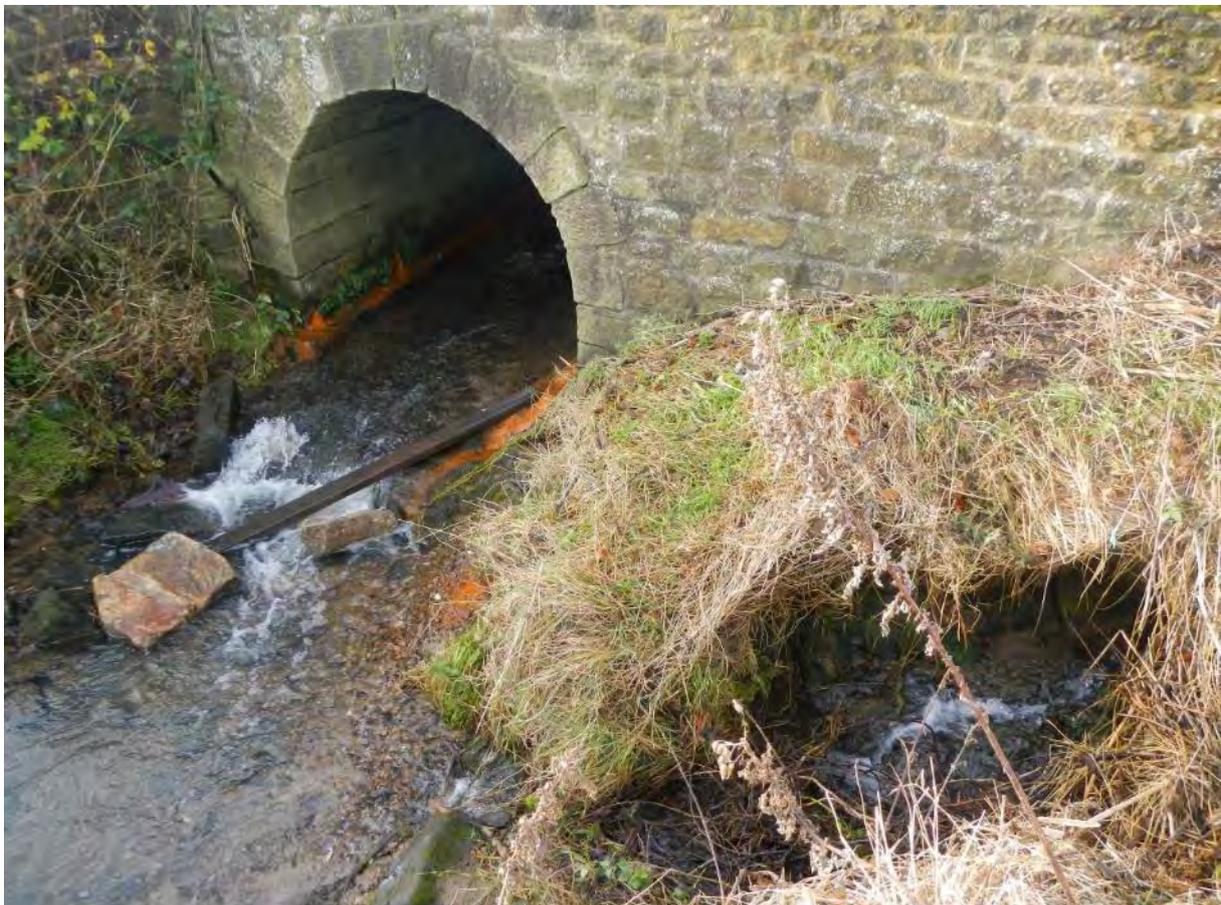
Photo DSCN5049. Another impediment to fish passage (NZ 31926 59688), although a slightly lesser issue than the two u/s in Reach 6.

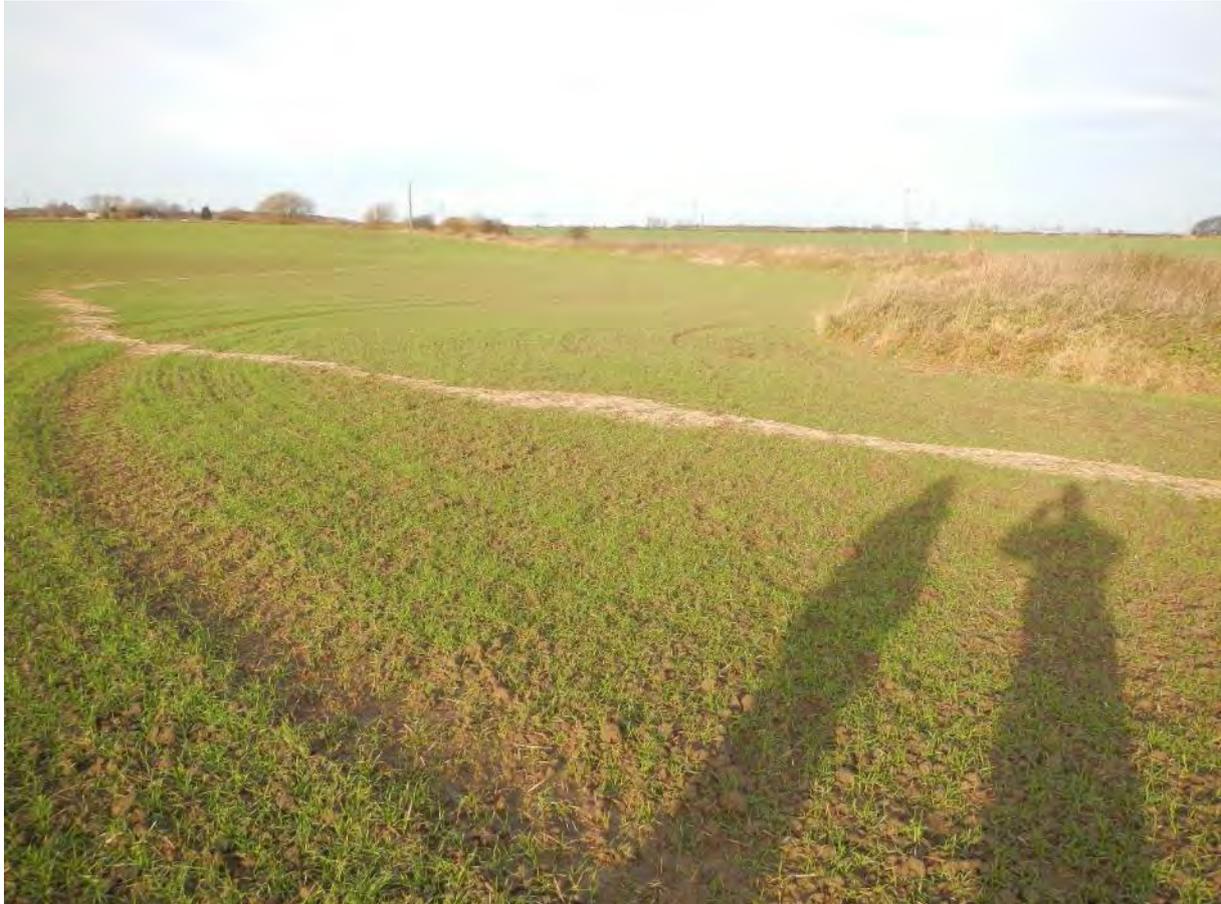
Just u/s of a tributary, the channel becomes less incised but is then flanked by flood banks (Photo DSCN5084). These are clearly retaining out of bank flows on the field, inhibiting water from receding to the channel as river levels drop.

Photo DSCN5084. Debris line within the field, showing the extent of water that will be trapped behind the flood banks at out of bank flows. The River Don flows along the field boundary (line of rough vegetation) and the tributary is located behind the photographer.

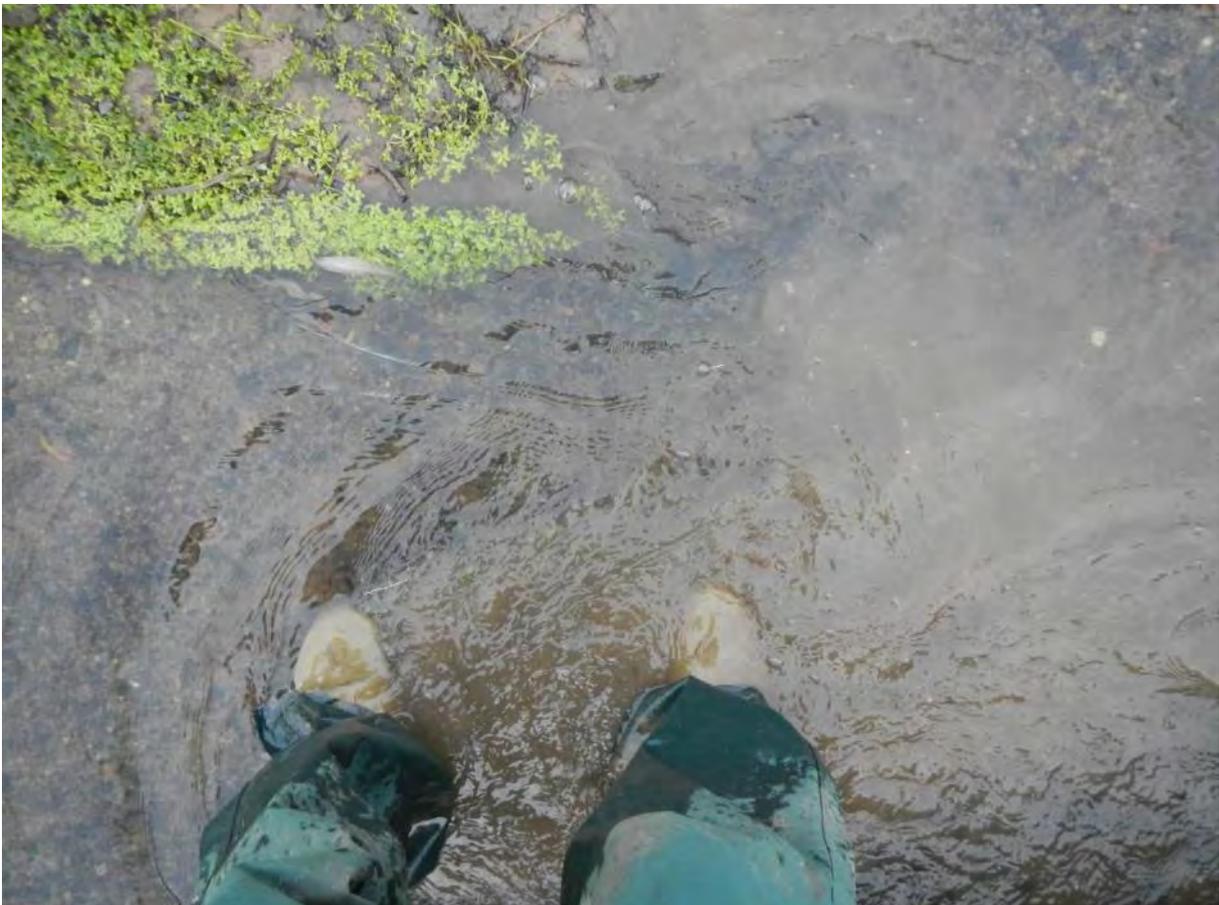
Although less incised, recent dredging of the tributary is clearly inhibiting its natural recovery (Photo DSCN5089). Fine sediment input And a lack of bed sorting is clearly an issue in what could, potentially, recover or be restored to much higher quality salmonid habitat (Photo DSCN5093).

Photo DSCN5093. Dredged areas of the tributary where coarser, gravel substrate is being supplied but a high proportion of finer material limits its quality as invertebrate and spawning habitat.

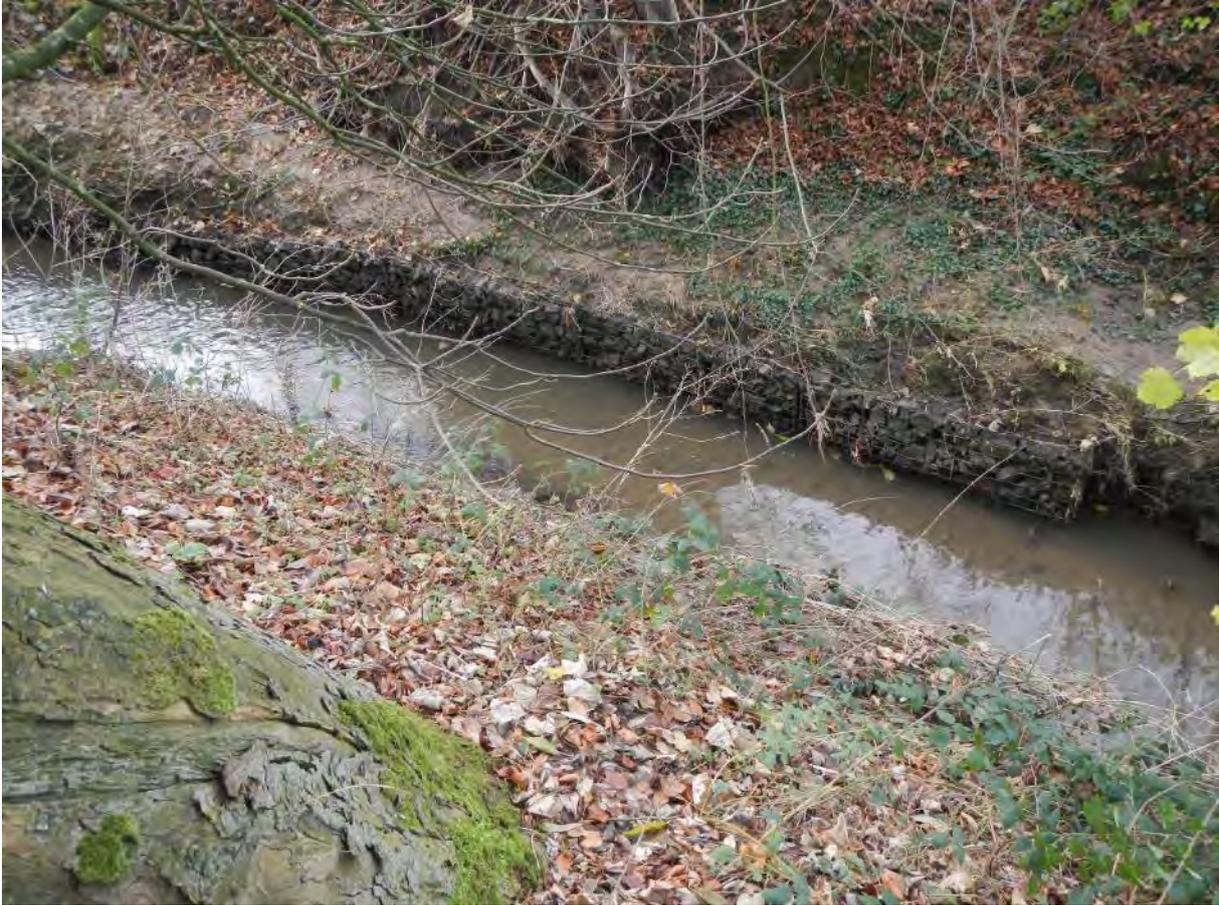
Photo DSCN5109. The channel d/s of Hylton Bridge is incised between high banks and is uniformly over-capacity. Note the bed smothering with sand and fine sediment.

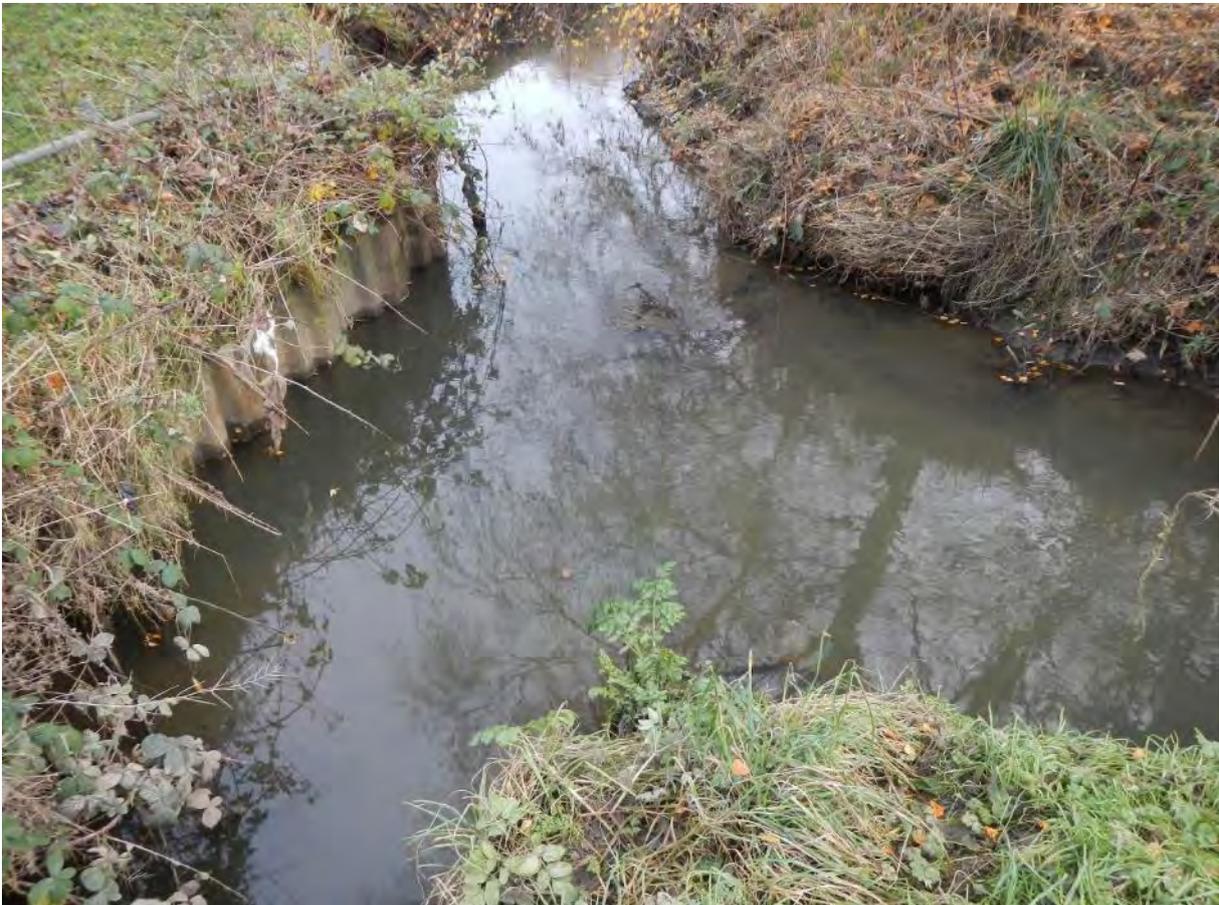
Photo DSCN5186. The suspected source of a light oil slick on the water surface.

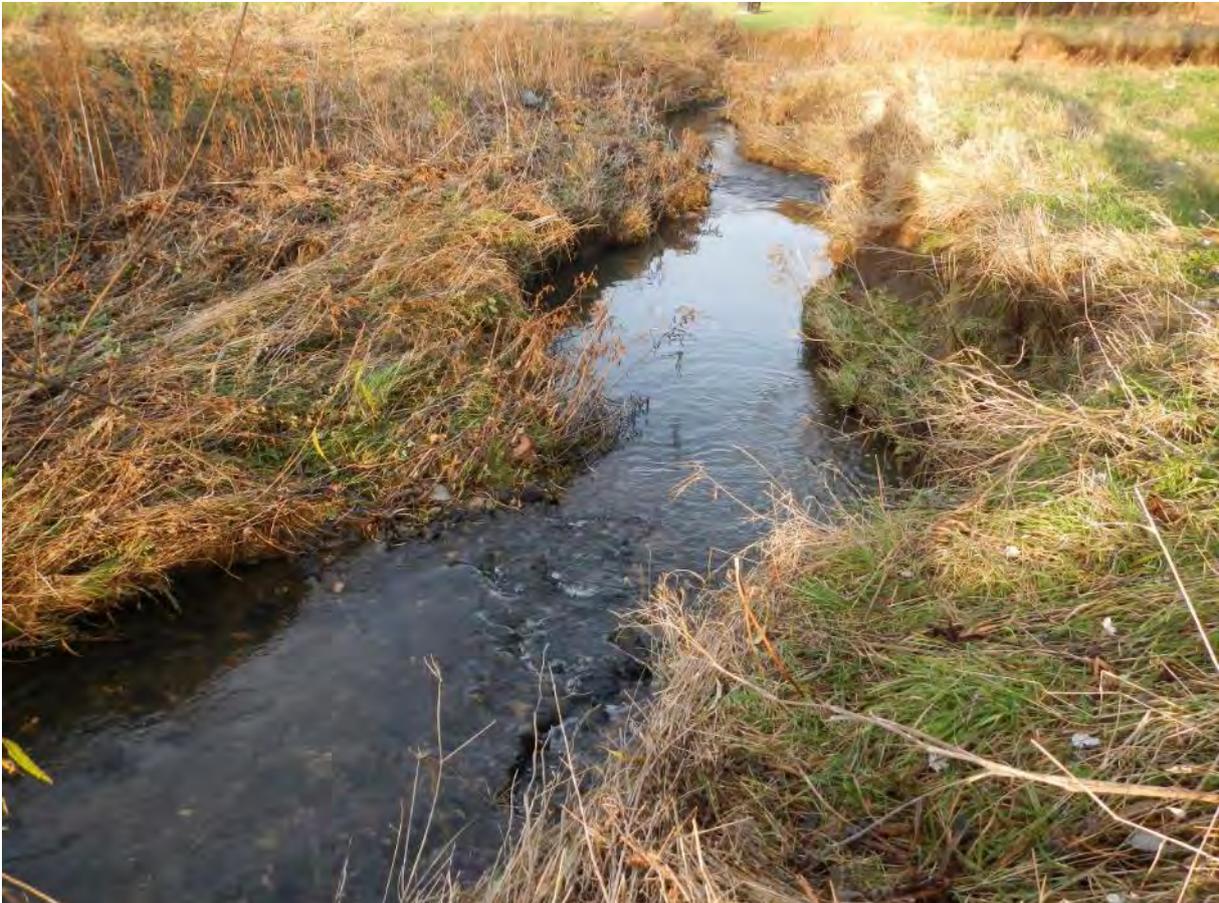
The lesser degree of straightening and bed lowering (and greater width variation) has preserved some degree of substrate retention and sorting (Photos DSCN5201 & Photo DSCN5213). This provides valuable areas of gravel, on which trout (Photo DSCN5244) were observed to be spawning (Photo DSCN5254). This is the only Reach with multiple fish sightings.

Photo DSCN5213. The lack of (or reduced occurrence of) recent dredging and ongoing maintenance has allowed the retention/development of a more natural channel (although clearly modified in places).

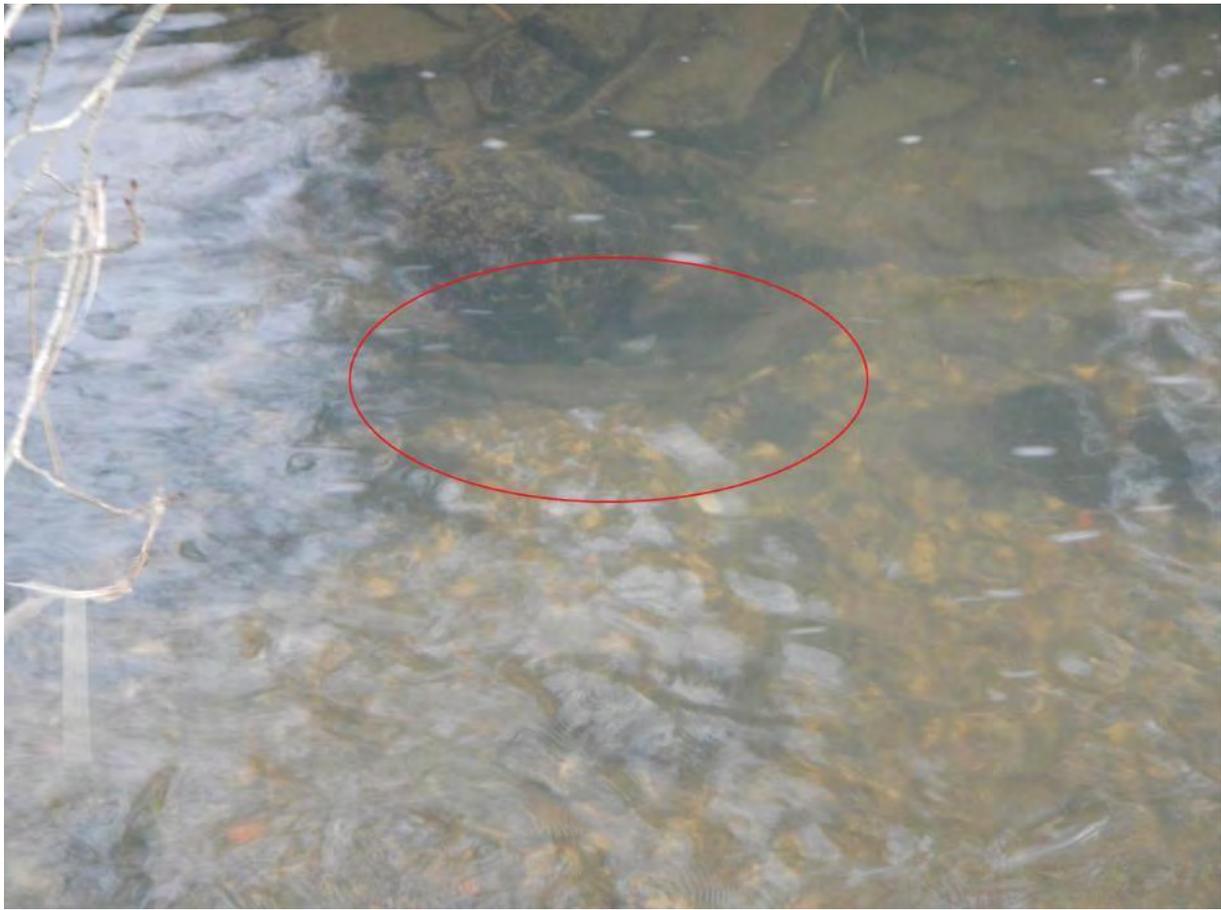
Photo DSCN5244. A c. 250mm brown trout (circled red).

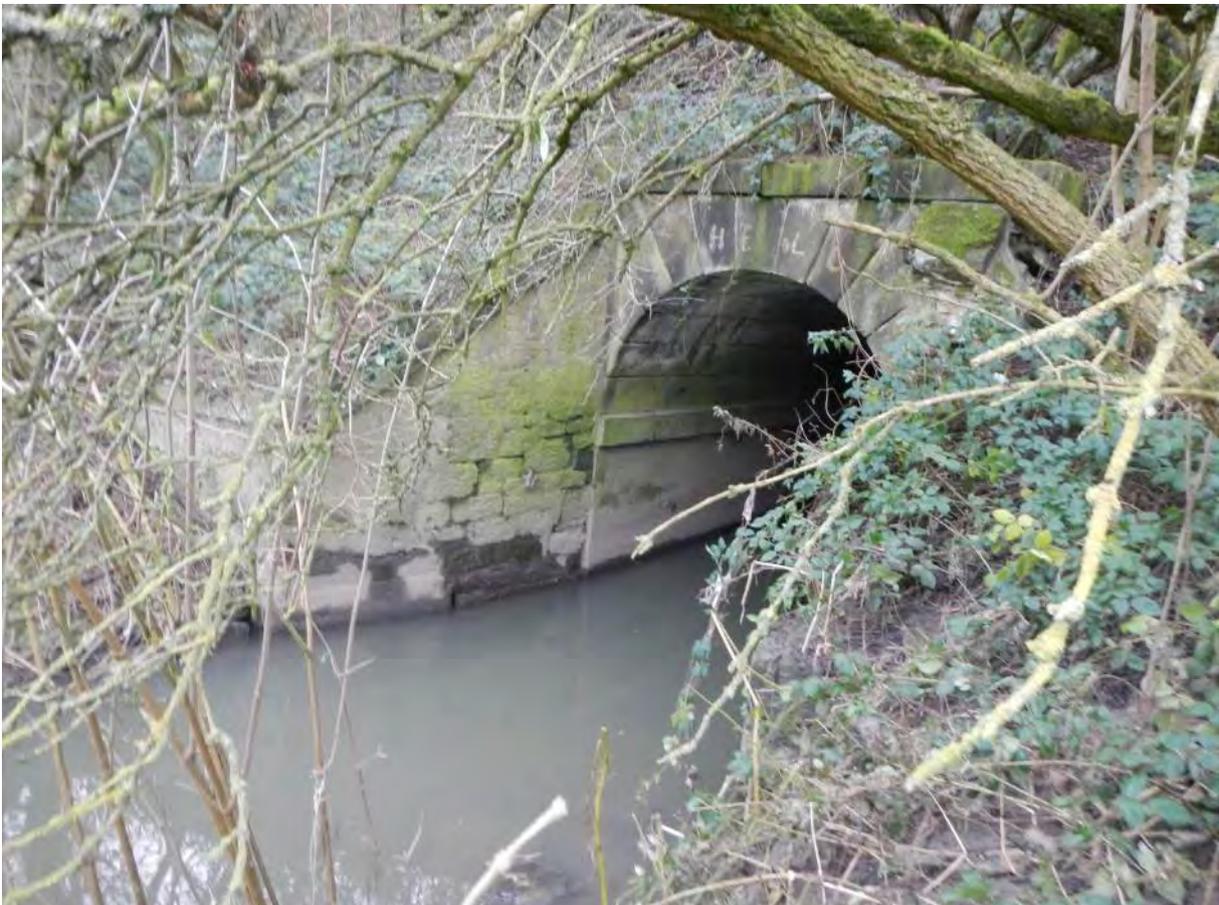
Photo DSCN4829. The old railway culvert u/s of Newton Garth Farm (NZ 35520 62534). Deep water and natural substrate though the culvert pose no issues for fish passage.

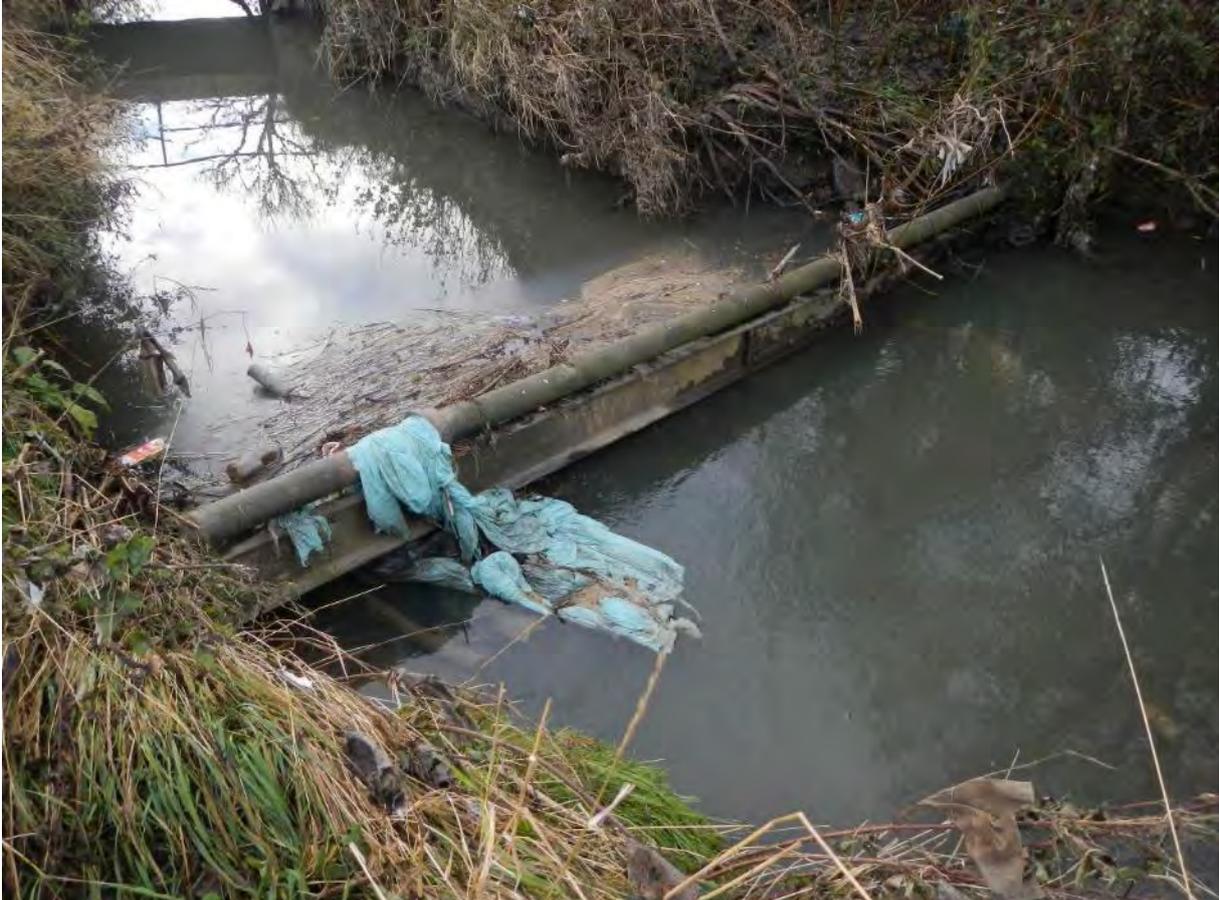
At Newton Garth Farm, habitat quality is further degraded by a lack of buffer fencing and livestock (horse) access to banks (Photo DSCN4831), where further fine sediment inputs result (Photo DSCN4836). Adjacent to the farm, a pipe crossing creates a potential impediment to fish passage and increased flood risk (Photo DSCN4835).

Photo DSCN4835. A pipe crossing at Newton Garth Farm (NZ 35408 62585) poses a potential issue for channel blockage, fish passage, flooding and possibly pollution, should it break.

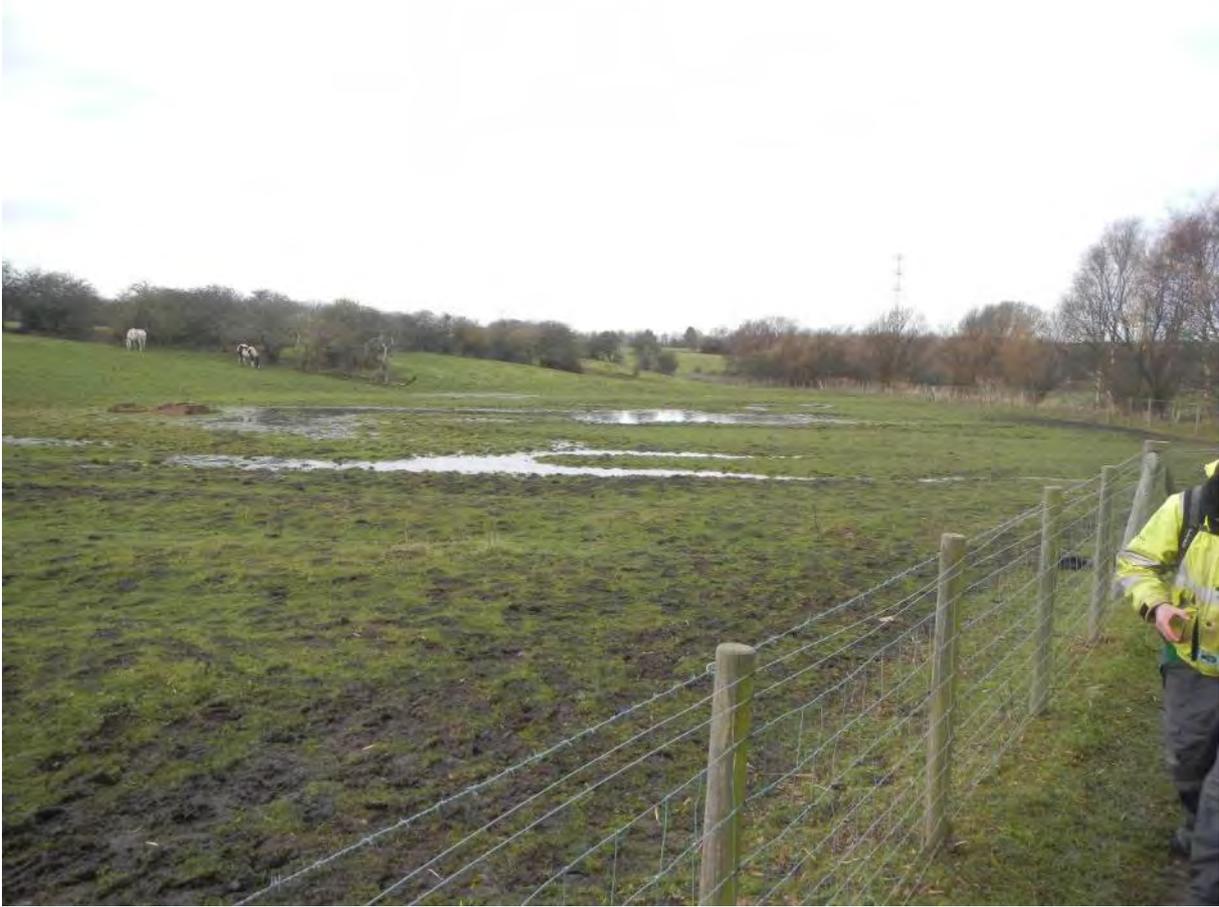
Photo DSCN4839. Paleo-channel on the LB (NZ 35187 62680).

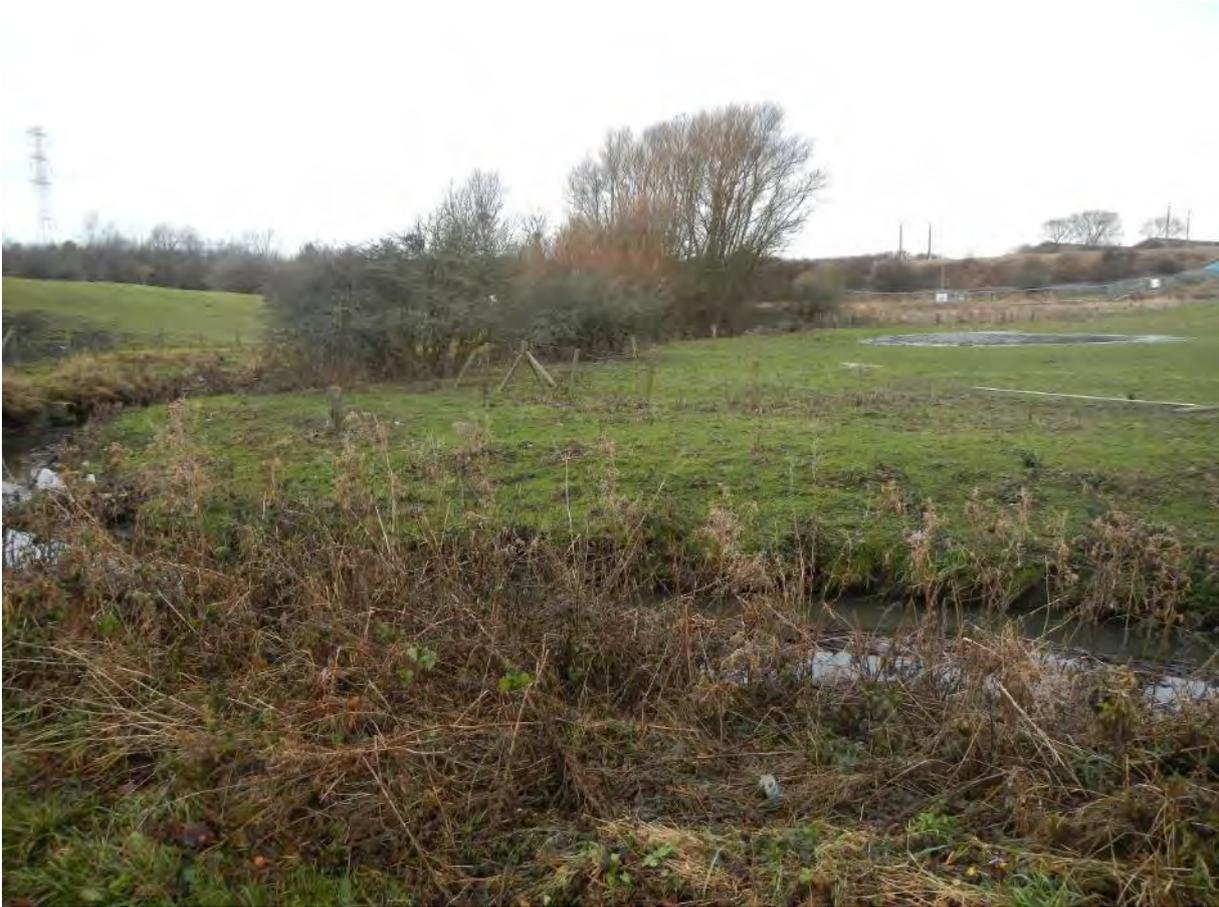
Photo DSCN4843. Paleo-channel on the RB.

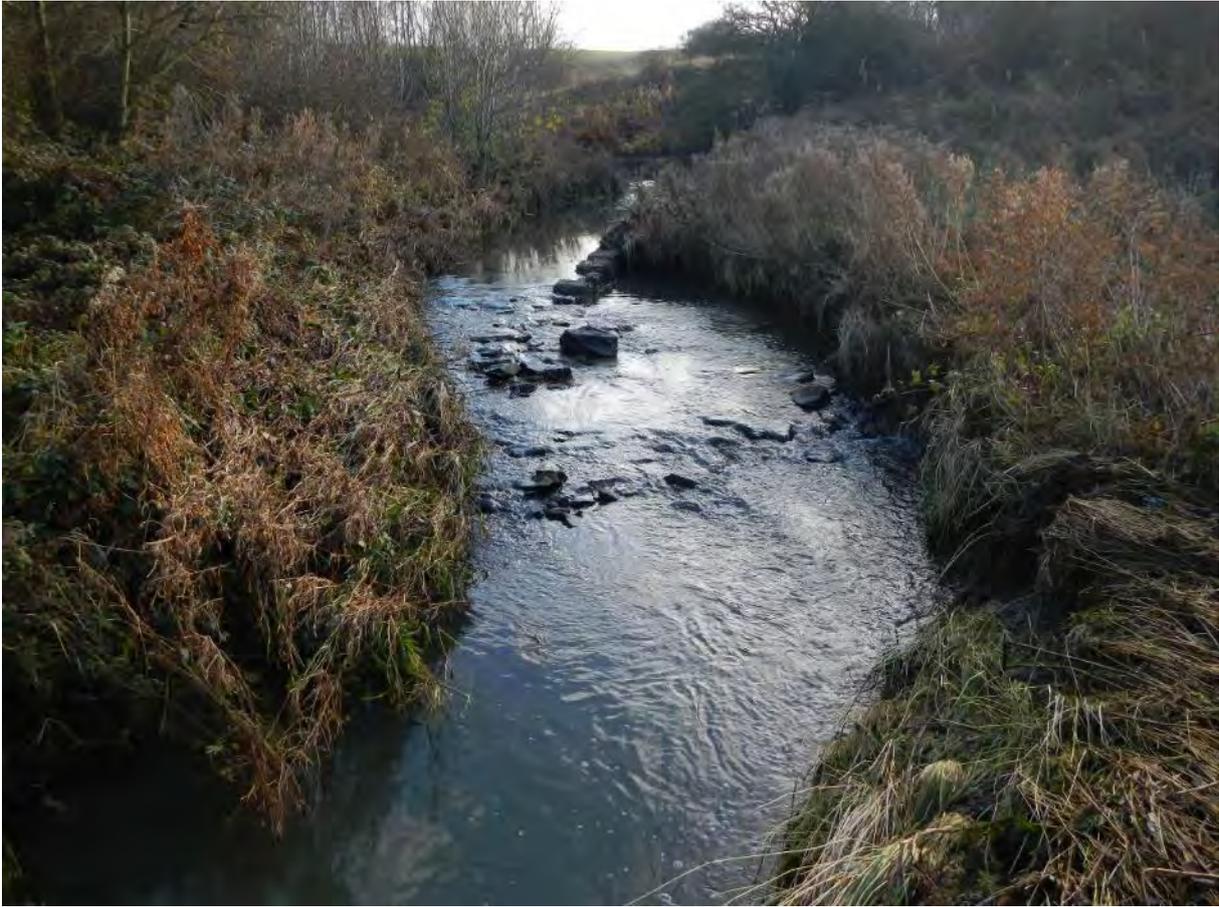
Photo DSCN4863. The remains of an old weir now poses no major issue to habitat, fish passage or sediment transport.

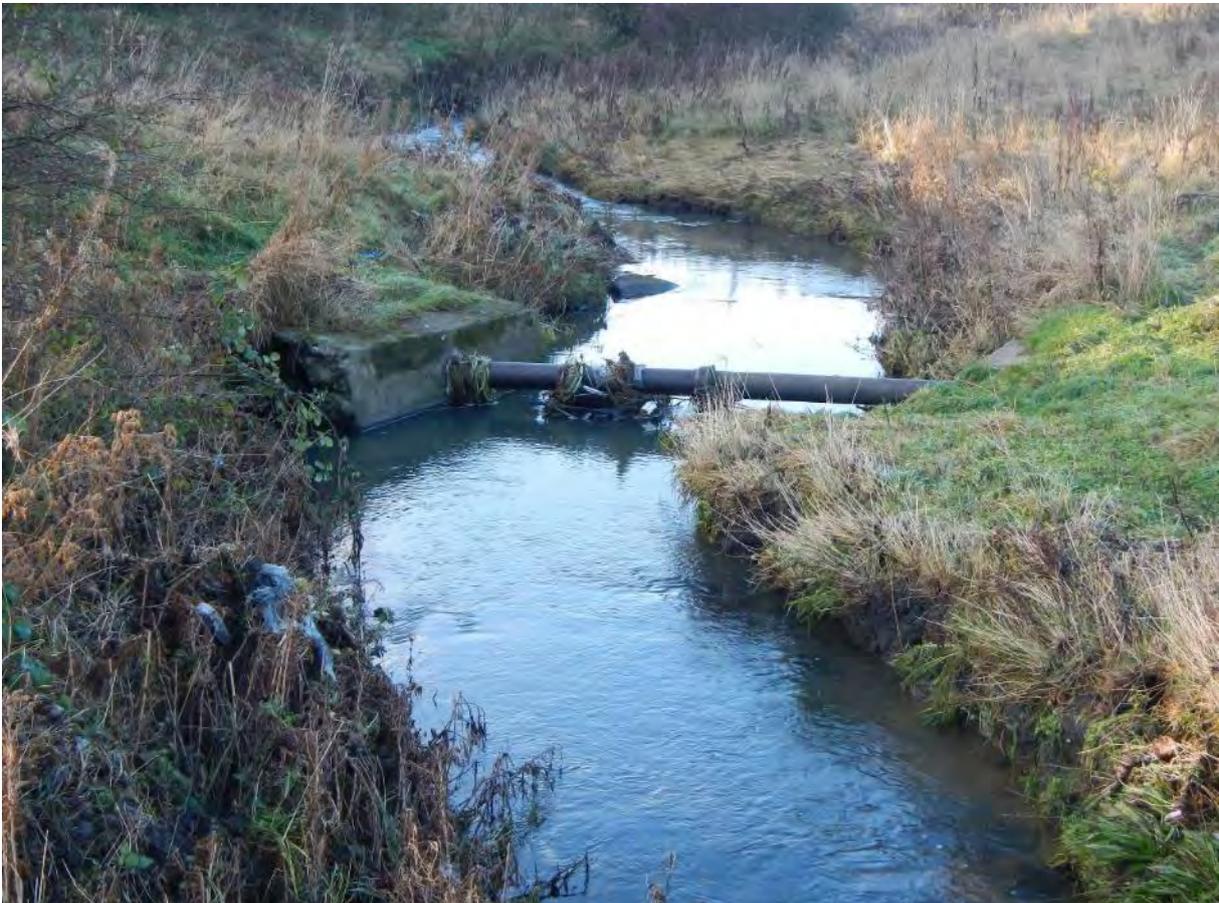
Photo DSCN4865. A series of pipe crossings start at the d/s end of Reach 3a. This one poses no real issues at low flows (unless it is breached) but is likely to have potential for blockage with debris at higher flows.

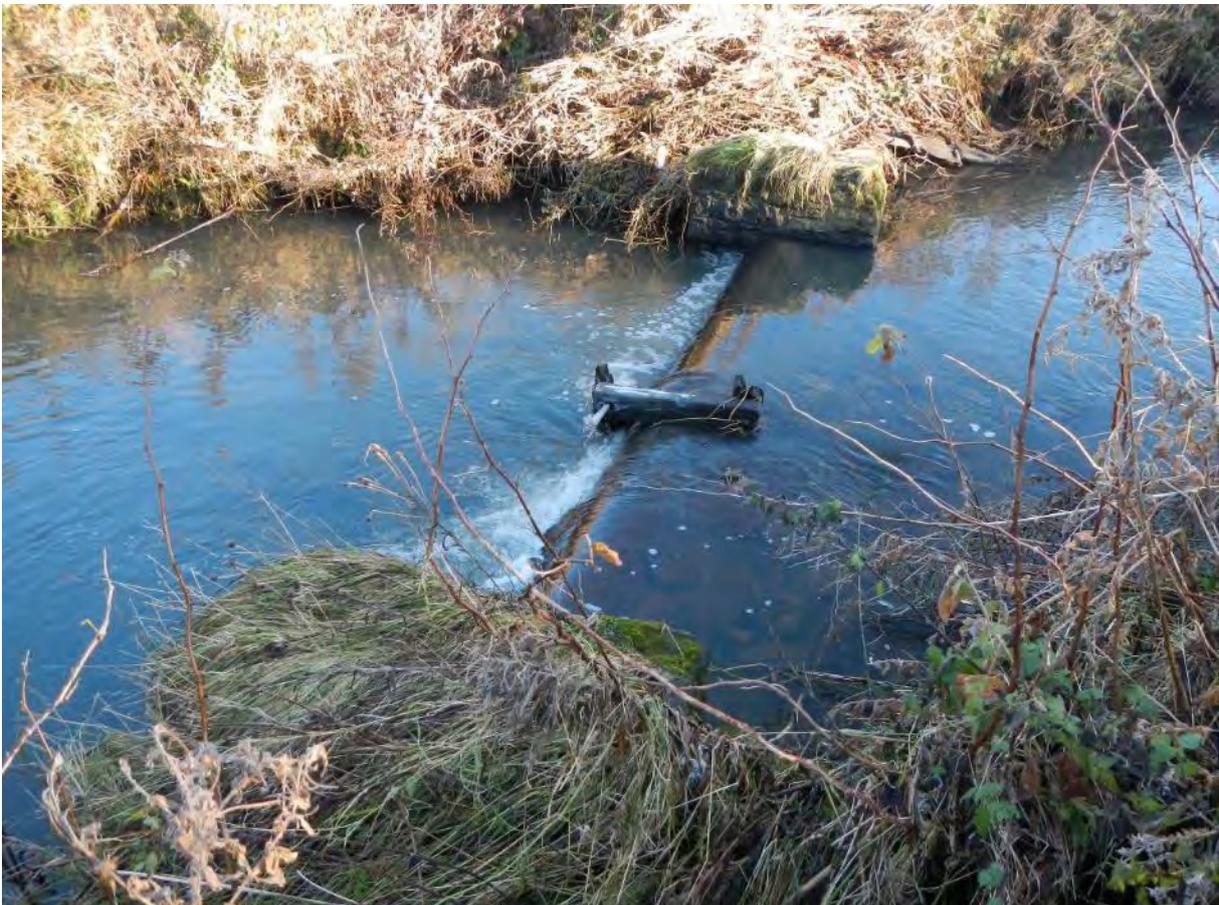
Photo DSCN4873. Small impoundment and minor issue for sediment and fish passage.

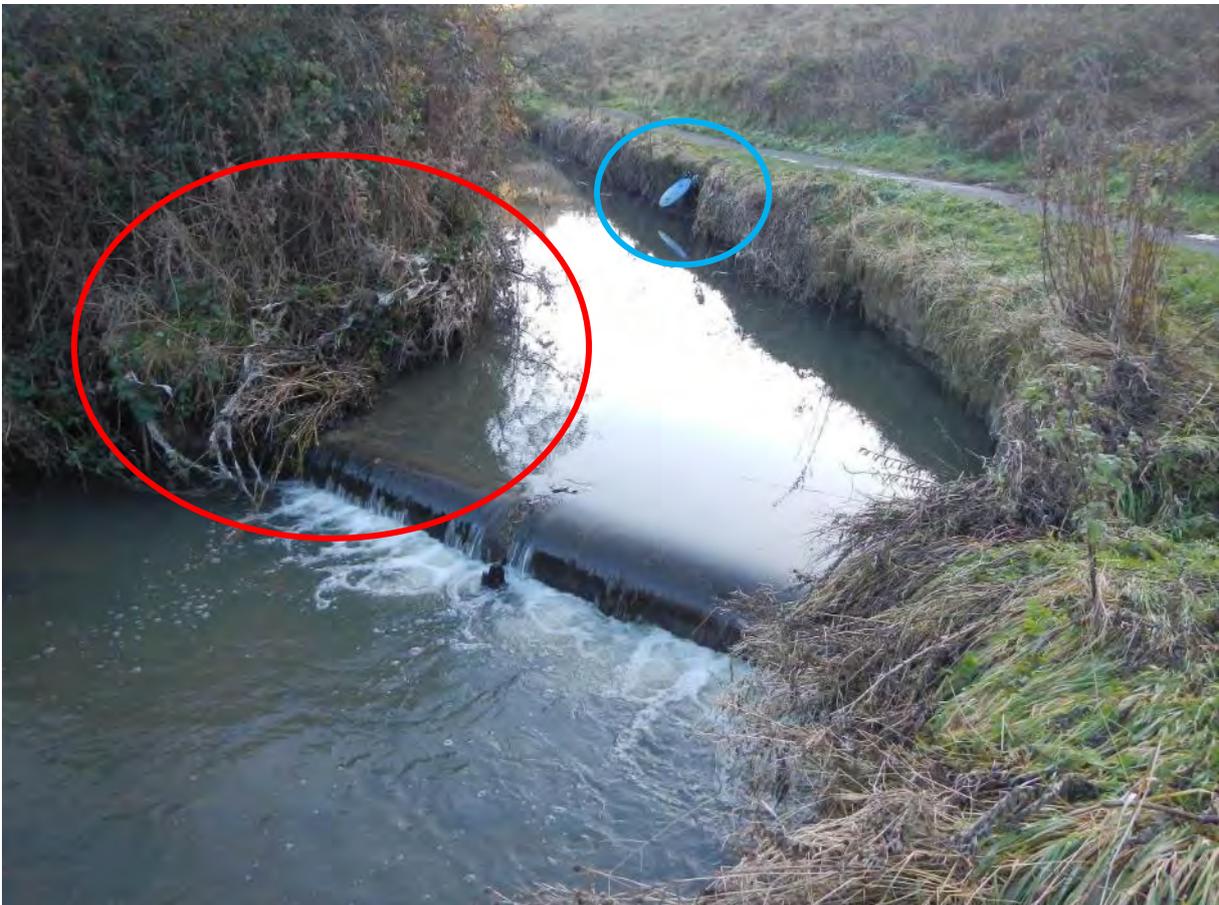
Photo DSCN4878. Small impoundment and issue for sediment and fish passage. Note the blue flap-valve in the background (blue circle) and sewage litter d/s on the far bank (red circle) that appeared to increase from this point.

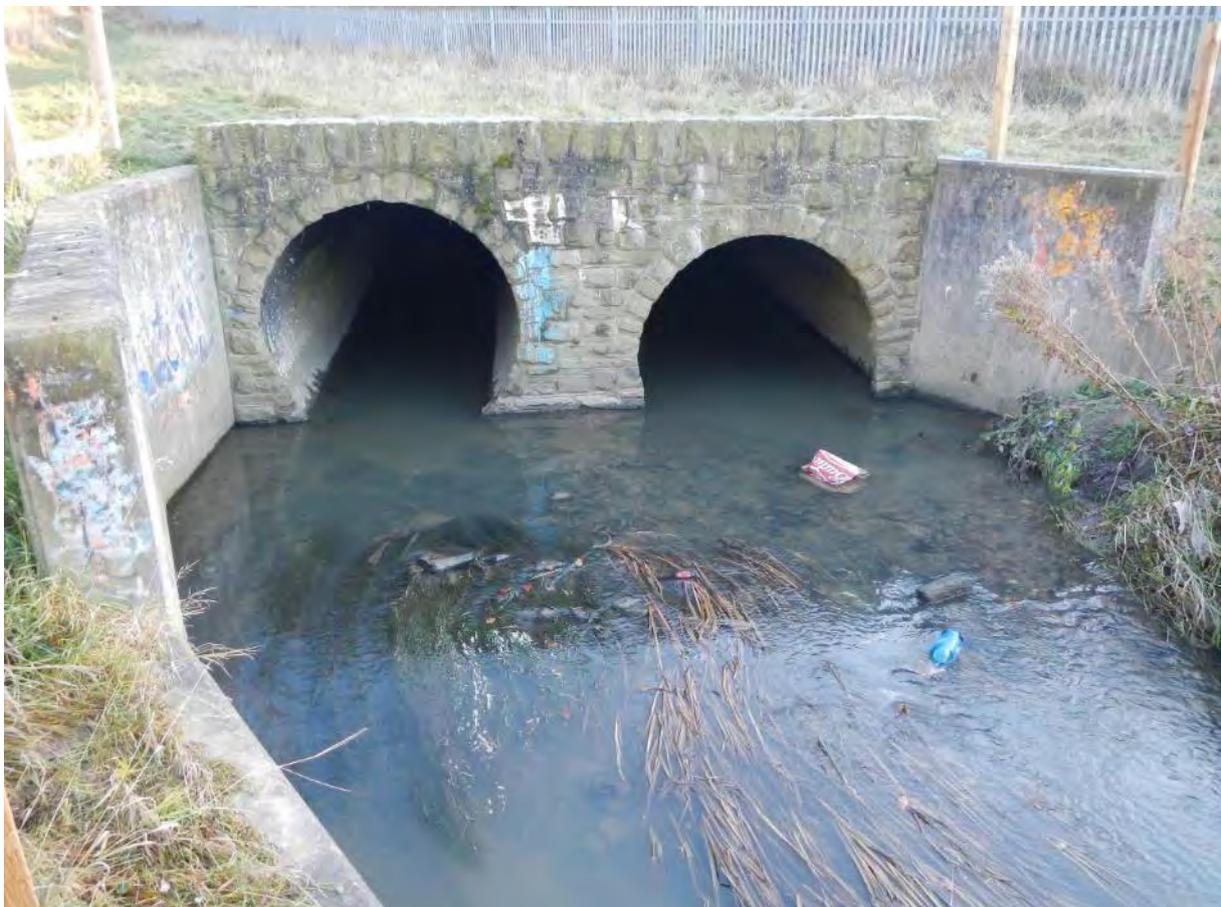
Photo DSCN4882. The partially sunken nature of the culvert appears to pose no problem to fish passage or sediment transport.

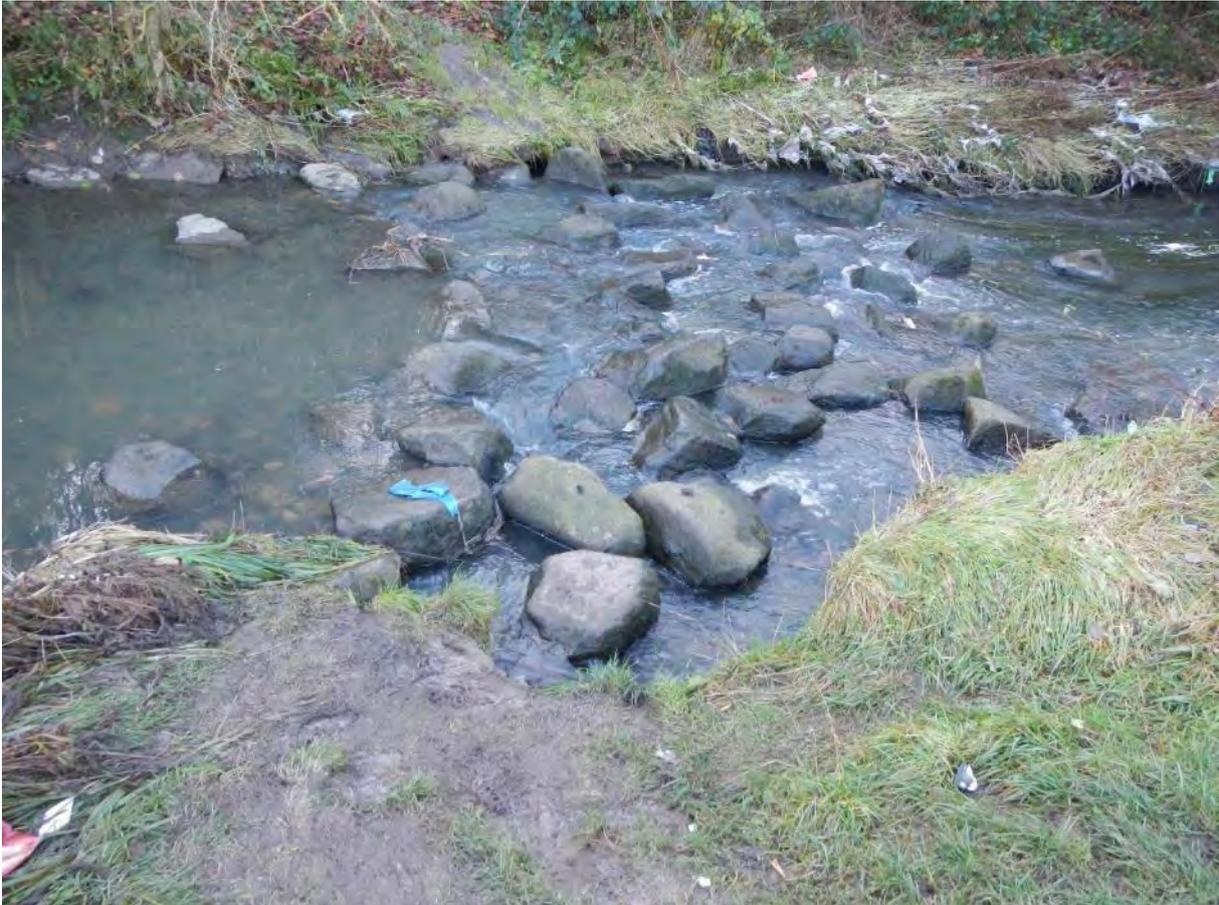
Photo DSCN4886. Small rock ramp that is relatively passable to fish but creates a small impoundment u/s.
