River Don Walkover
(River Tyne Catchment)
29th & 30th November 2016

Undertaken by Gareth Pedley, Wild Trout Trust

1.0 Introduction

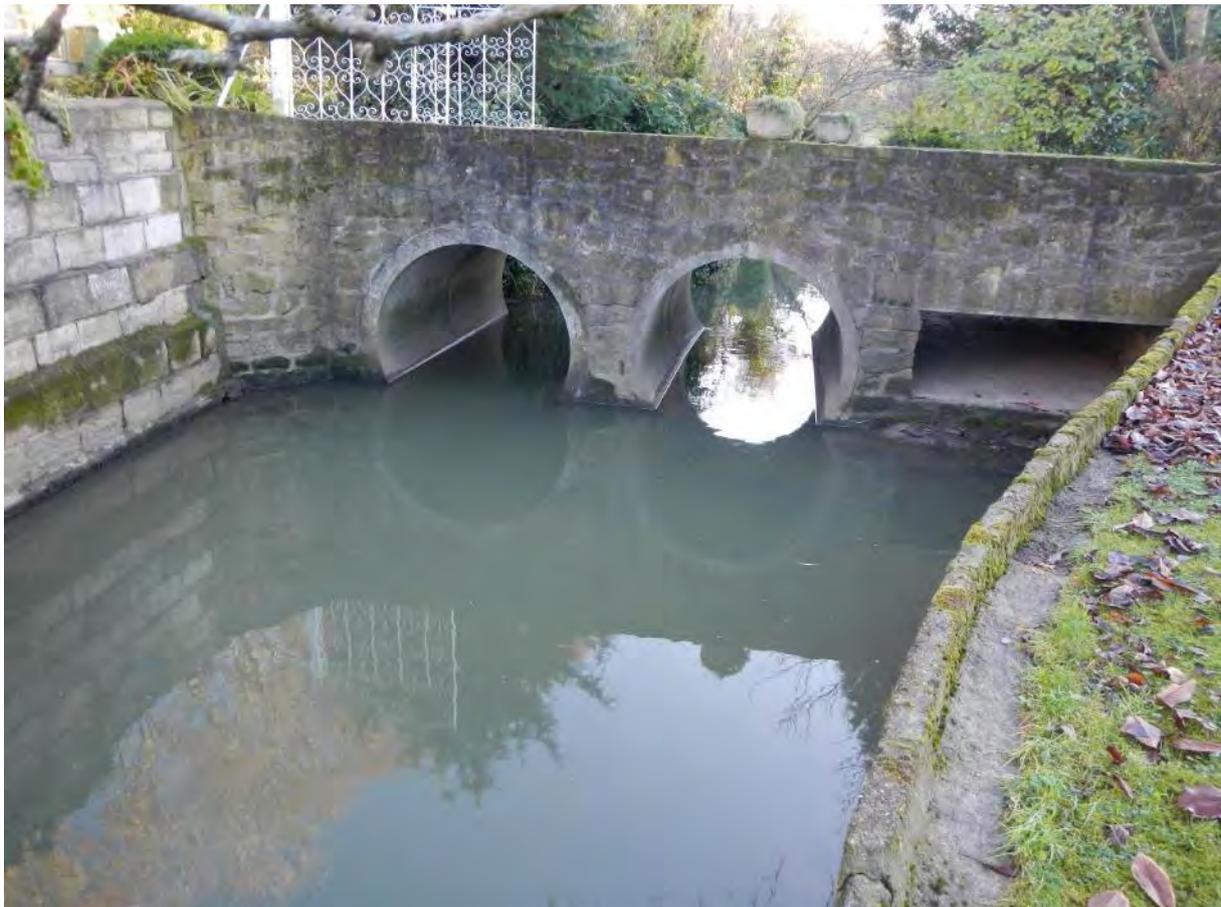
Immediately u/s of Headworth Lane, the river flows through gardens, within a walled channel. A partially sunken pipe culvert poses no issue to fish passage but is likely to restrict high flows and sediment transport (Photo DSCN4905). Three weirs within the gardens also create obstacles to fish passage and sediment transport. The first is relatively passable (Photo DSCN4906), but the next has collapsed and blocks the channel (Photo DSCN4911); the final weir/possible pipe crossing creates an obvious step above relatively shallow water and is a major issue for salmonid and eel passage, particularly at lower flows (Photo DSCN4909). Headworth Lane road culvert d/s of the gardens poses no issues (Photo DSCN4908).

Photo DSCN4905. Partially sunken pipe culvert posing no issues.

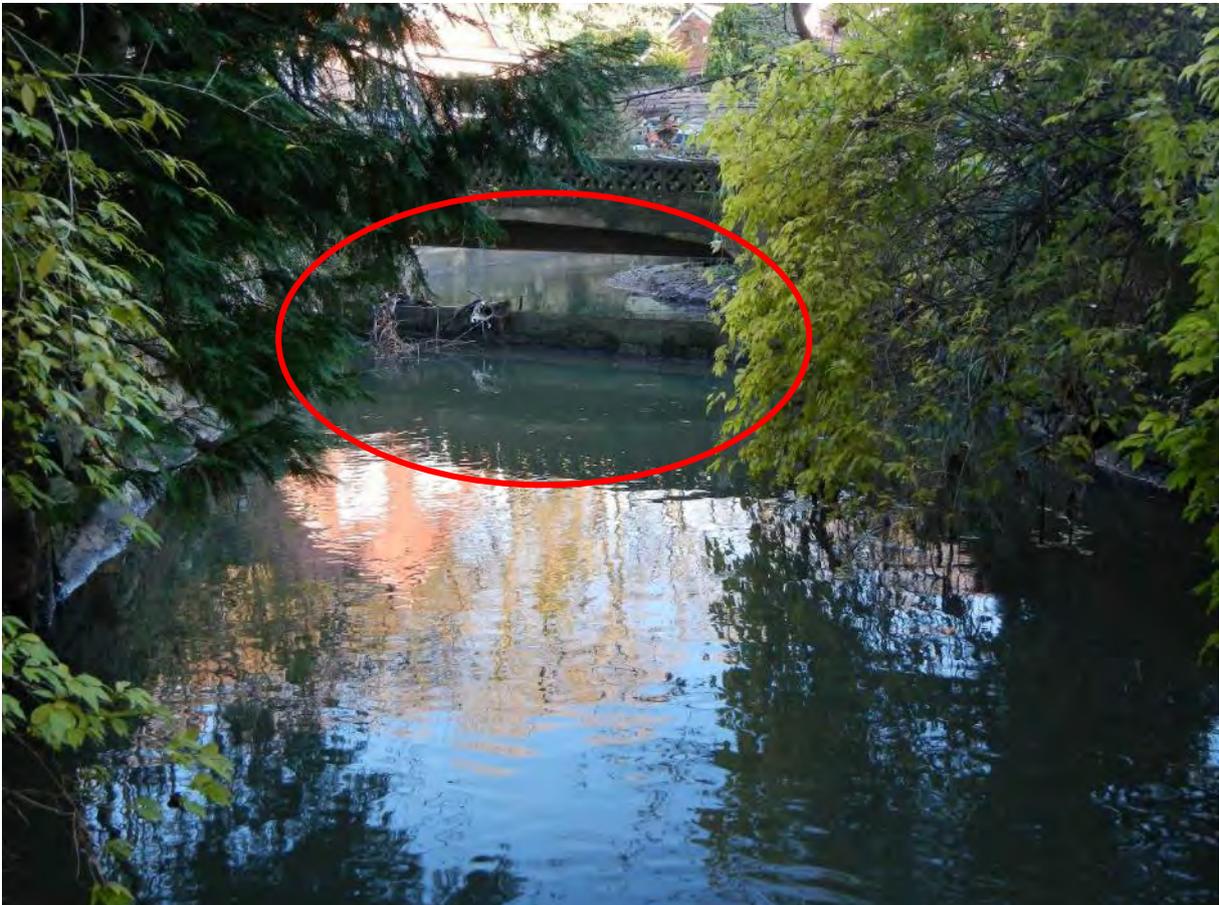
Photo DSCN4911. Collapsed weir partially blocking the channel (red ellipse). The extent of the obstruction could not be ascertained without further inspection (requiring waders).

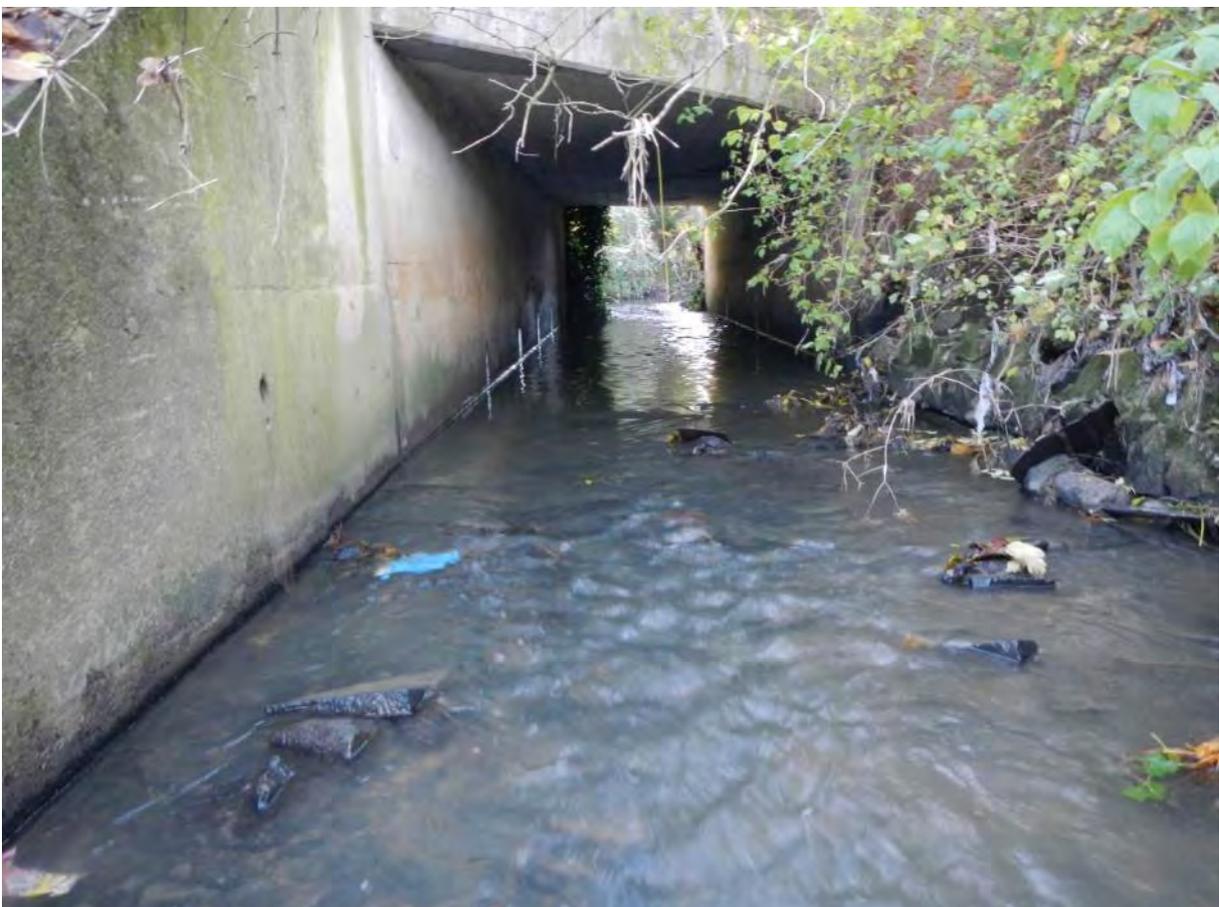
Photo DSCN4908. A sunken road culvert with natural bed poses no real issues for fish or sediment movement.

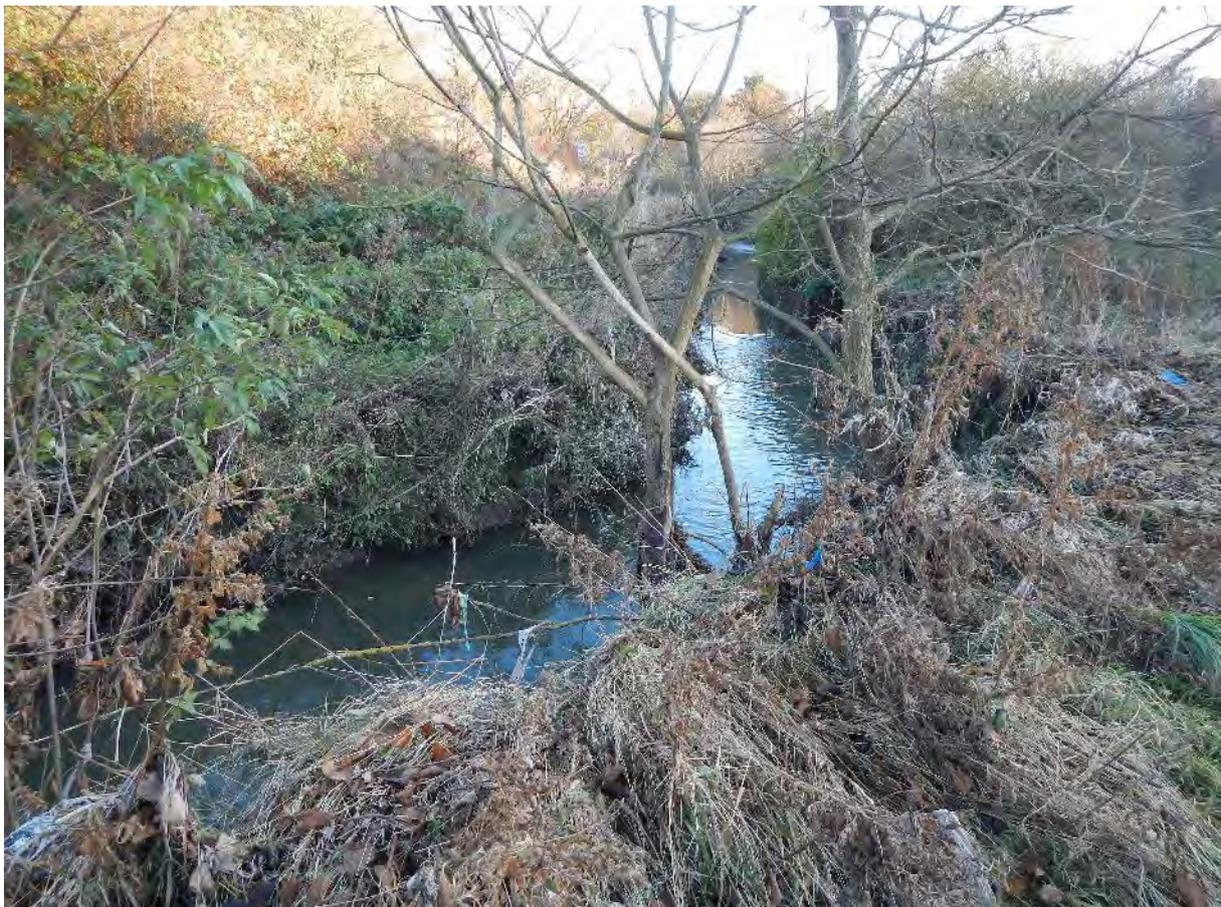
Photo DSCN4912. Modified, straightened channel but some meanders remain.

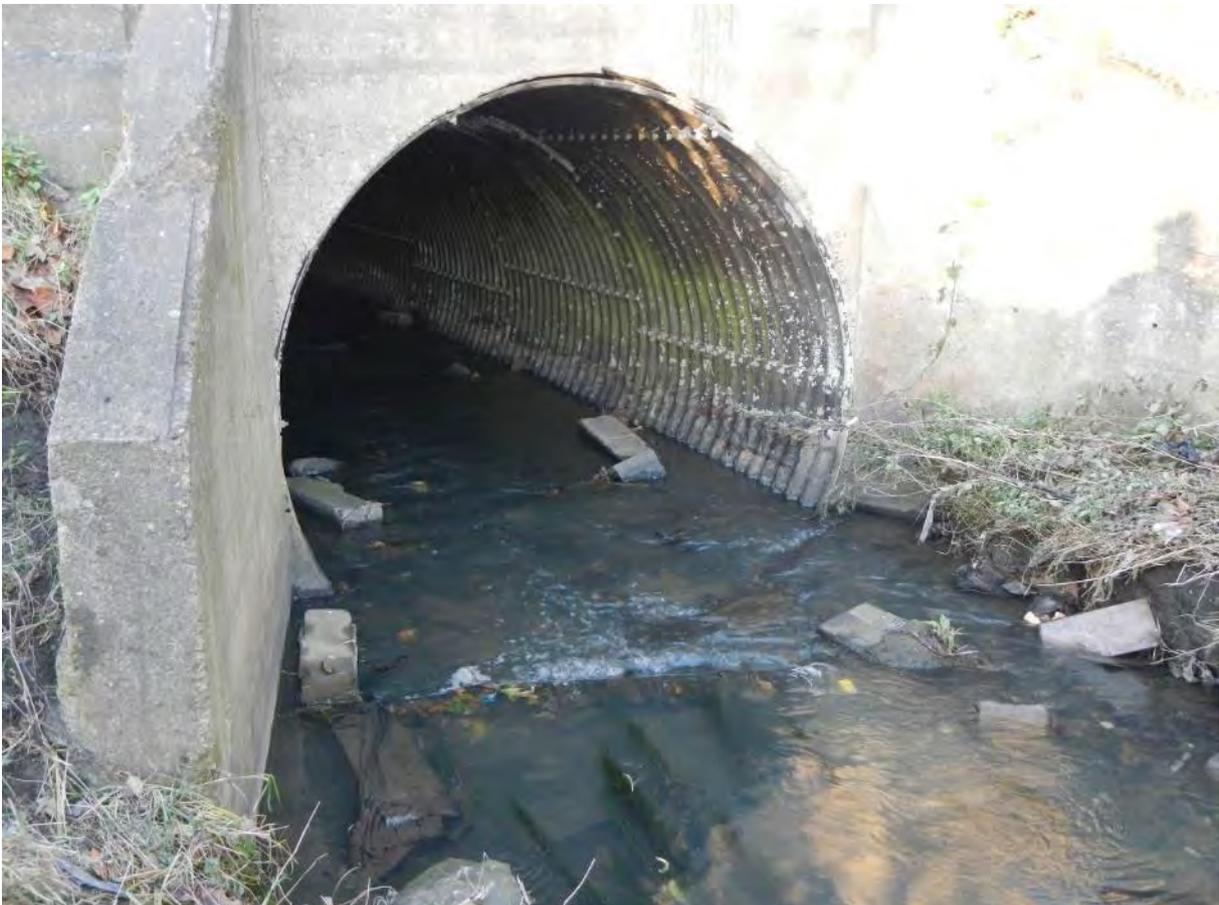
Photo DSCN4918. Natural bed material at the u/s end of the A194 culvert.

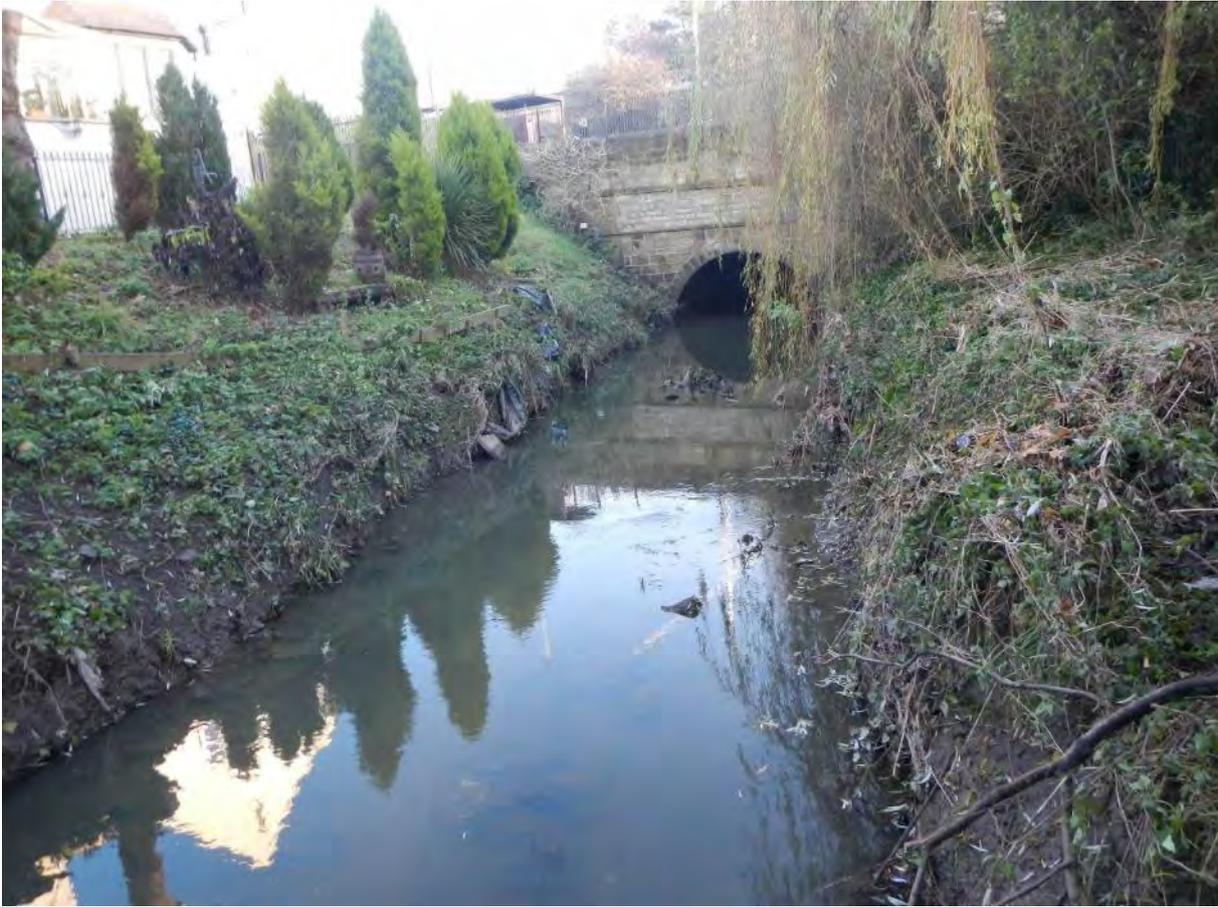
Photo DSCN4920. The well-sunken d/s end of the A194 culvert.

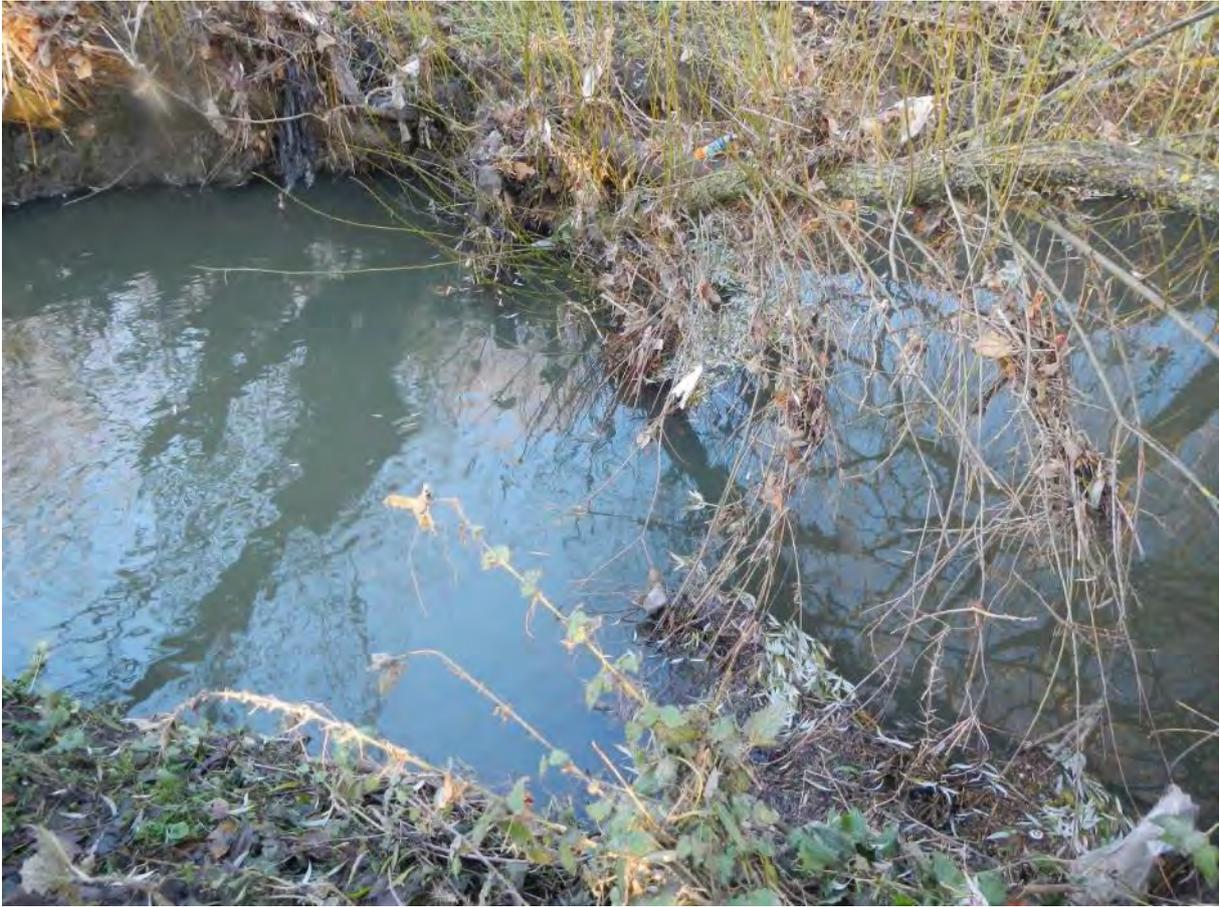
Photo DSCN4925. Occasional willows provide some cover but are insufficient to improve flow diversity.

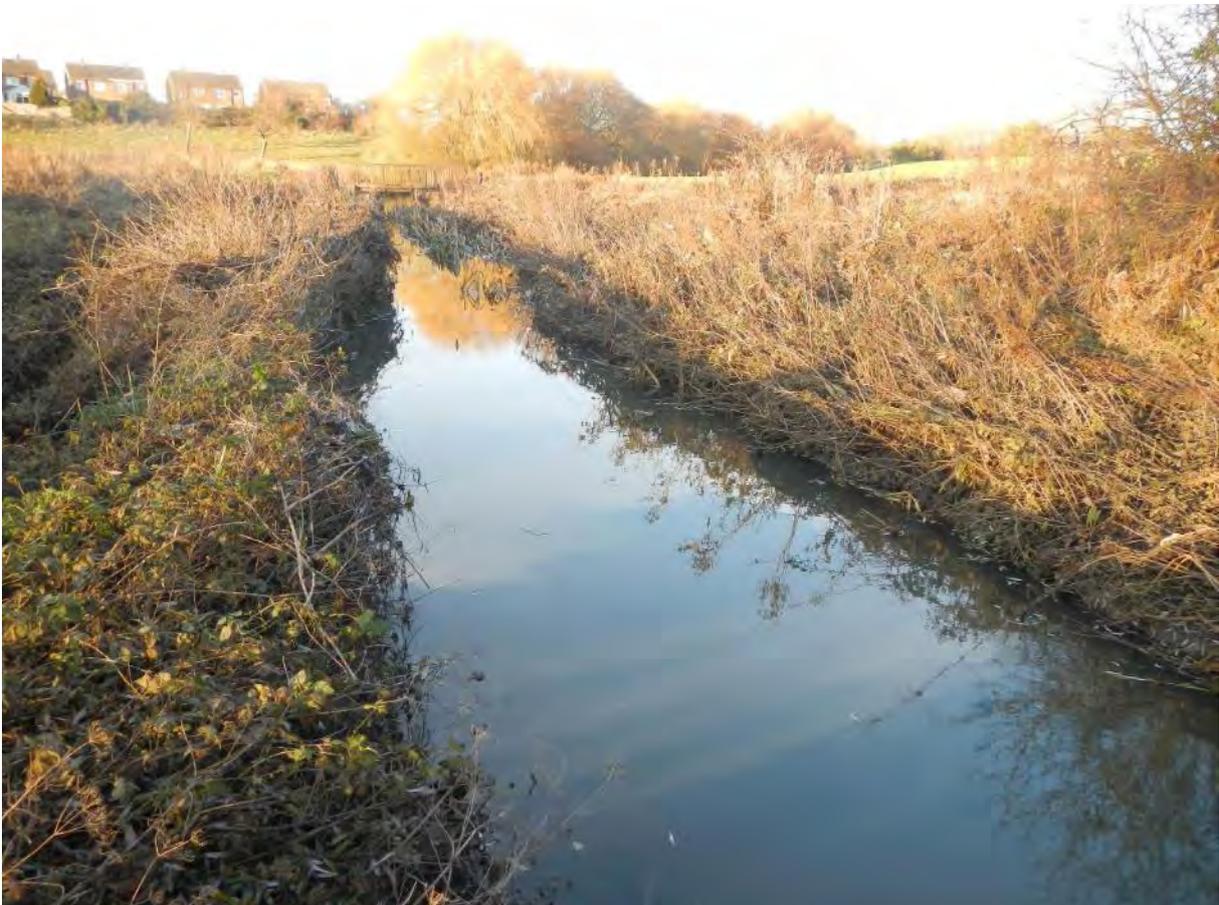
Photo DSCN4926. Typical channel and lack of flow within much of the upper section of Reach 1.

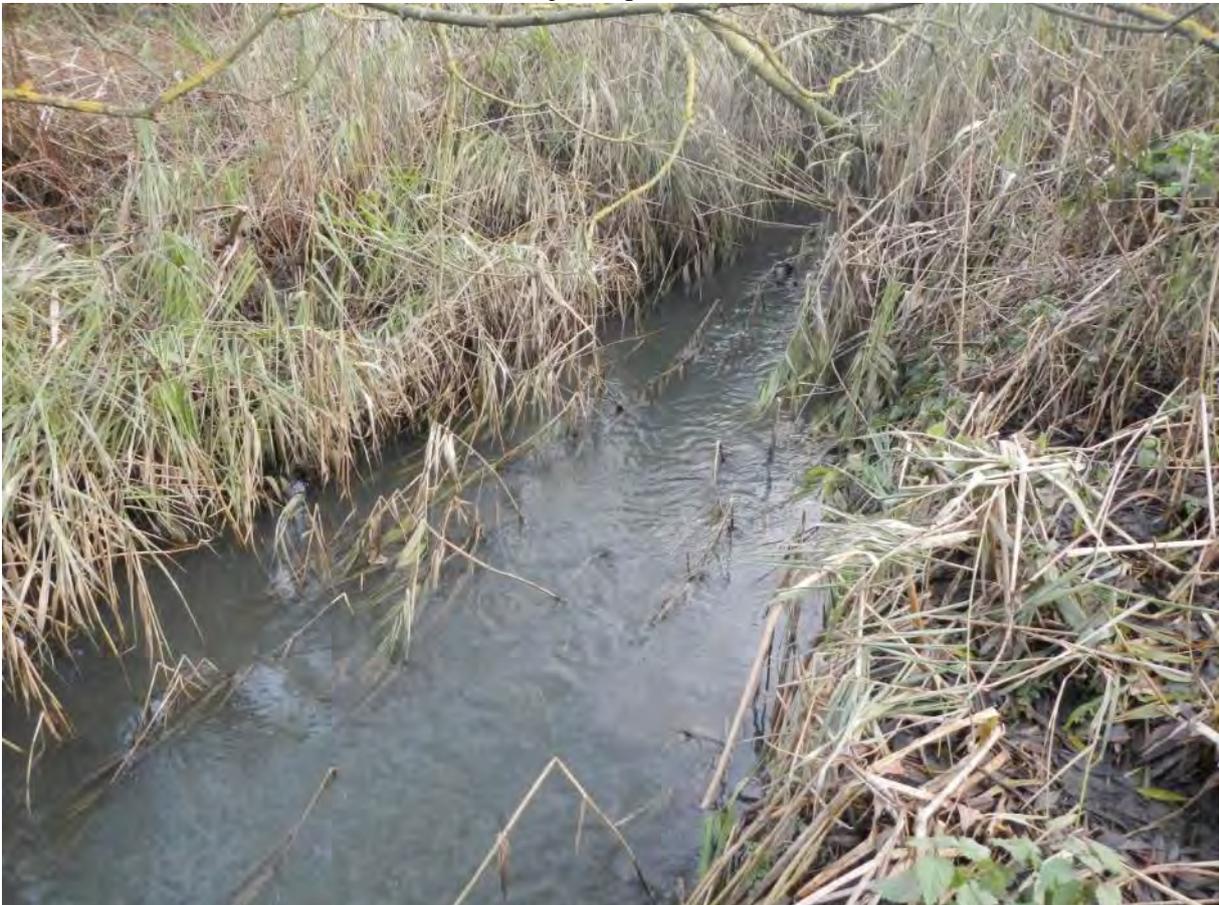
Photo DSCN4940. Overly deep and narrow channel resulting from past re-sectioning and realignment.

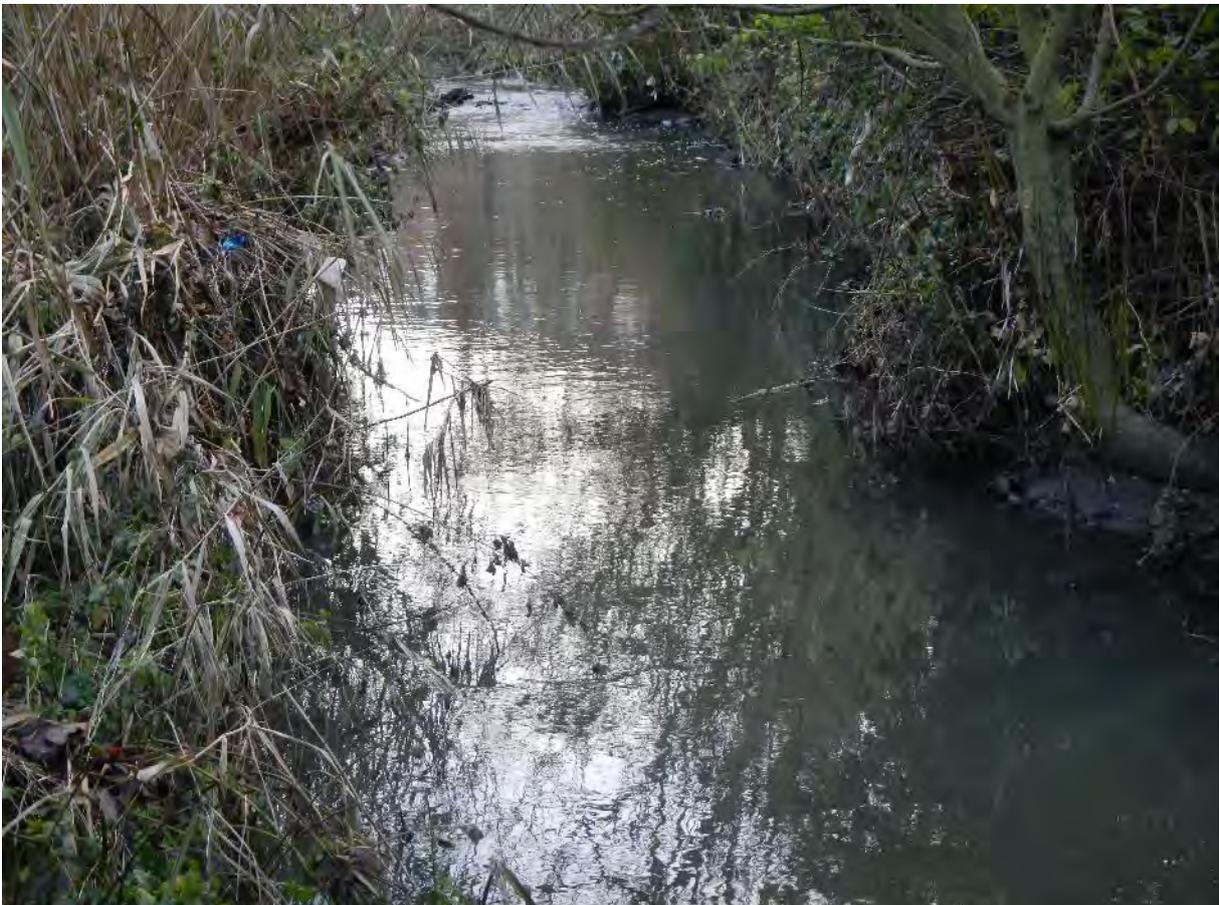
Photo DSCN4953. Outside the influence of the raised bed sections habitat improves a bit, although the channel is still straightened.

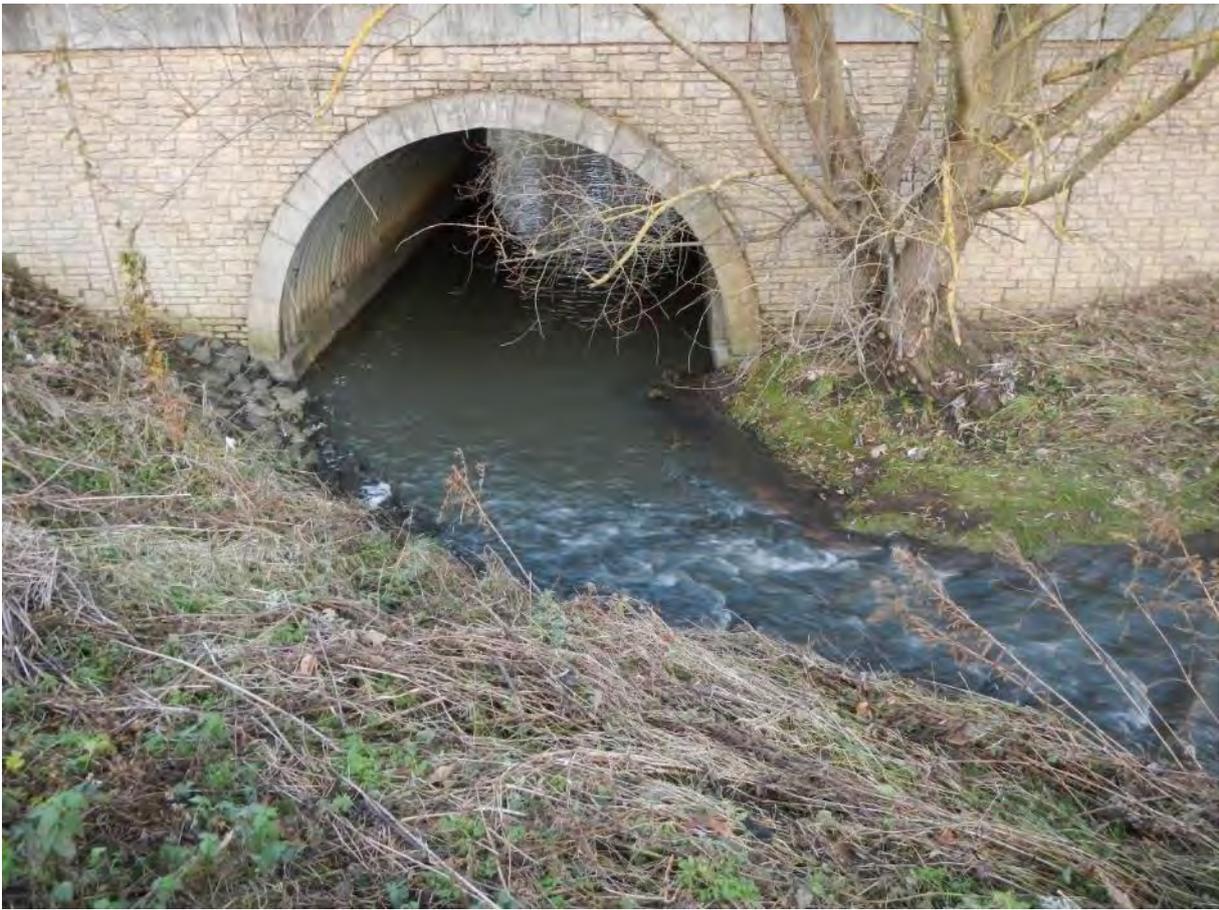
Photo DSCN5958. Cemetery Road culvert – no issue for fish or sediment movement.

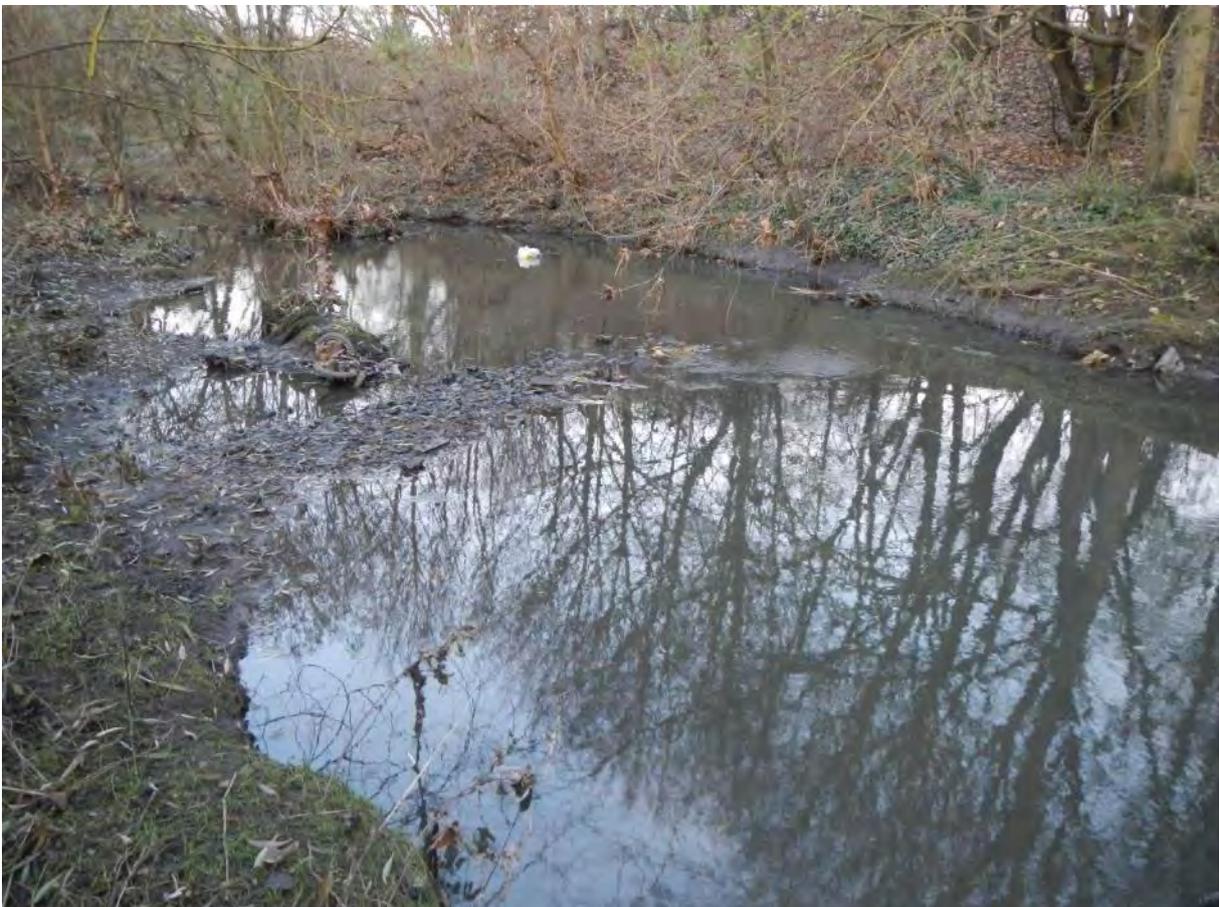
Photo DSCN4960. Area of scour d/s of Cemetery Road culvert that has facilitated formation of a gravel bar.

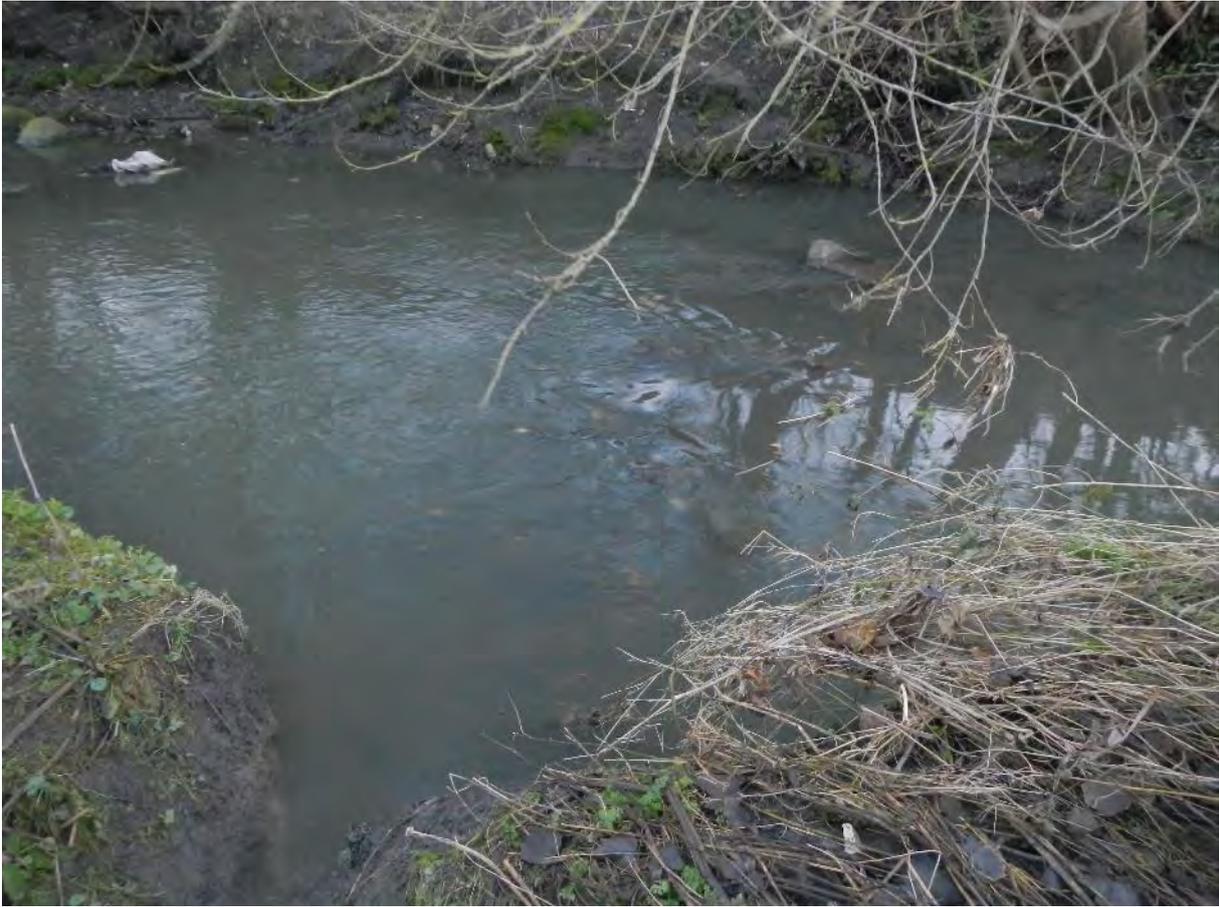
Photo DSCN4965. A slightly raised area of bed/coarse substrate; one of very few features in the lower section of Reach 1.

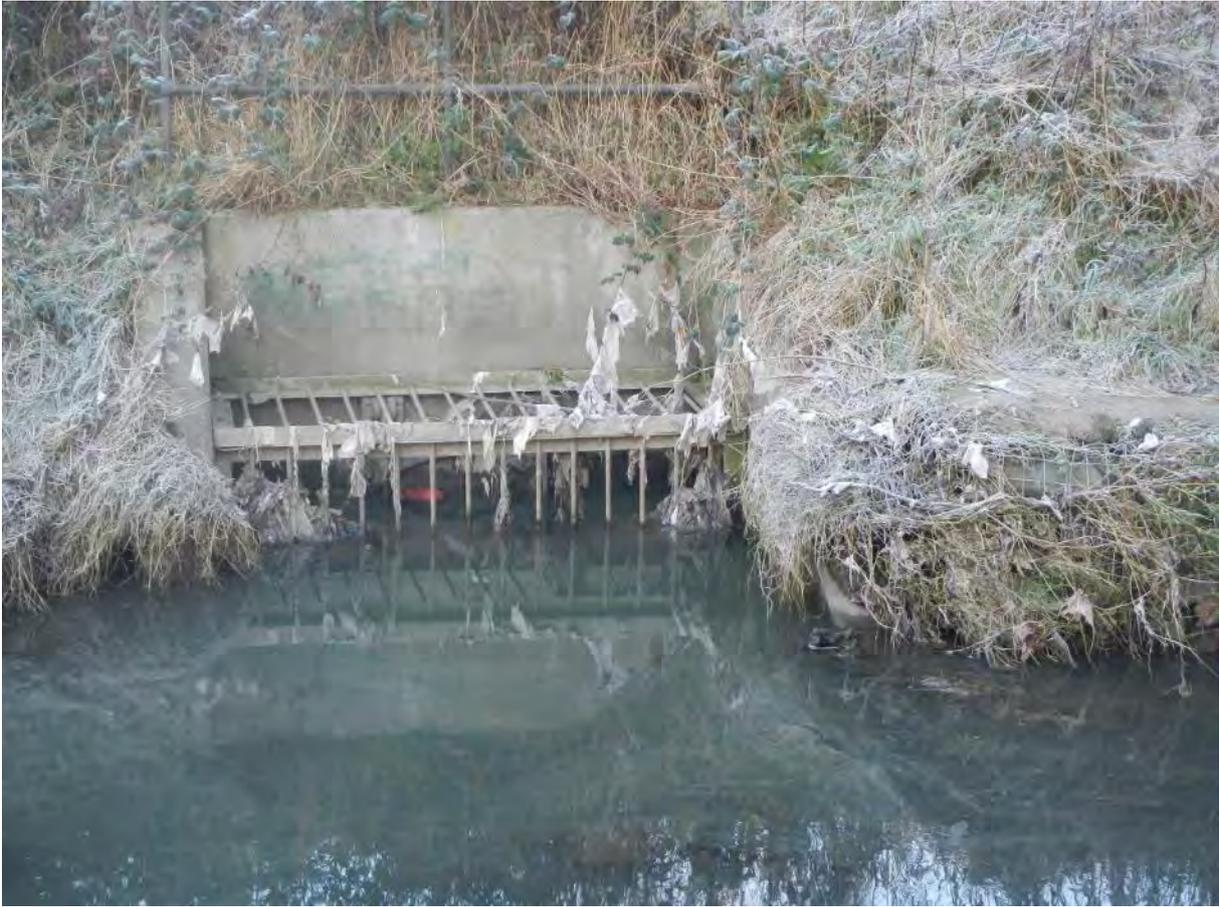
Photo DSCN4802. Yet another large CSO that clearly discharges unscreened waste into the river (NZ 33436 64685).
