Skitter Beck Walkover Survey

September 2015

1.0 Introduction

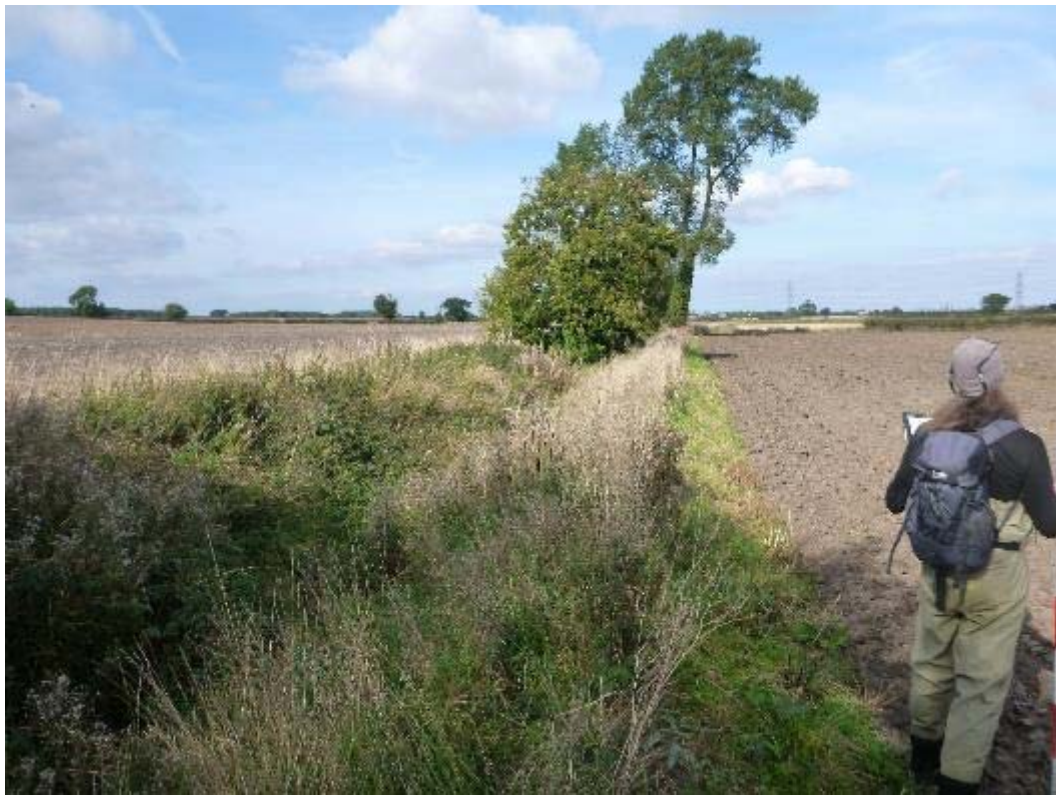
Photo 3 More open section of Keelby arm (TA1545011609).

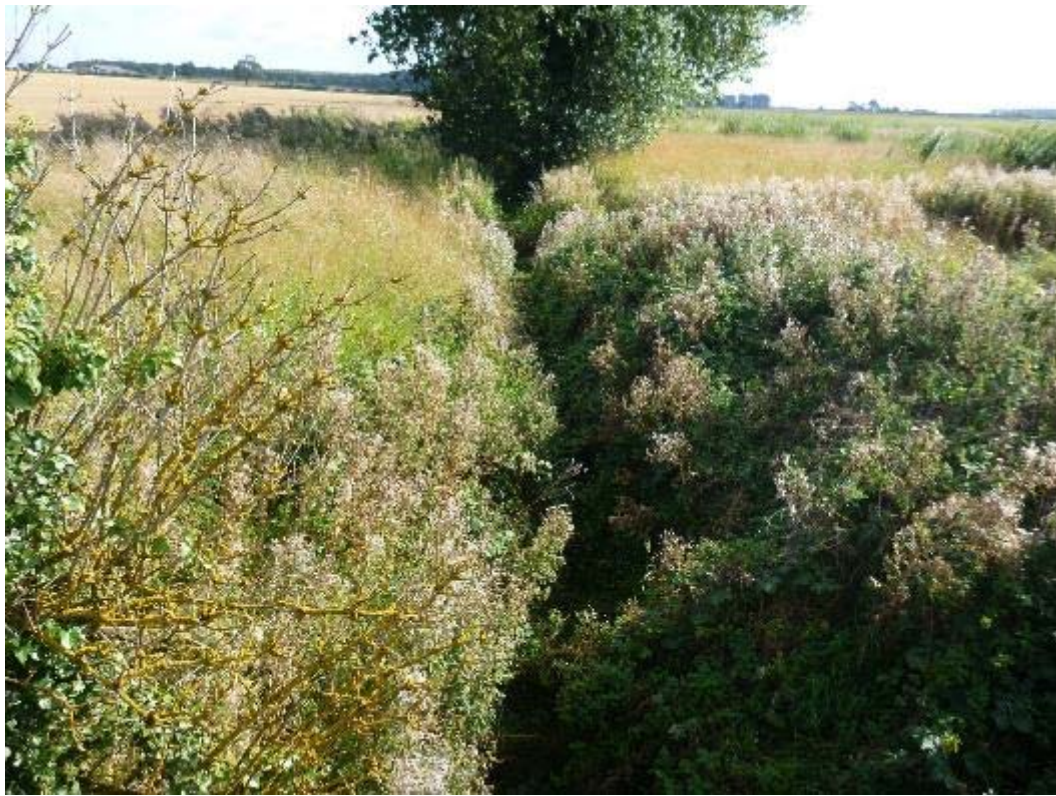
Photo 5 View upstream from Brocklesby Road bridge (TA1461112726). Wet area on true LHB (right of picture).

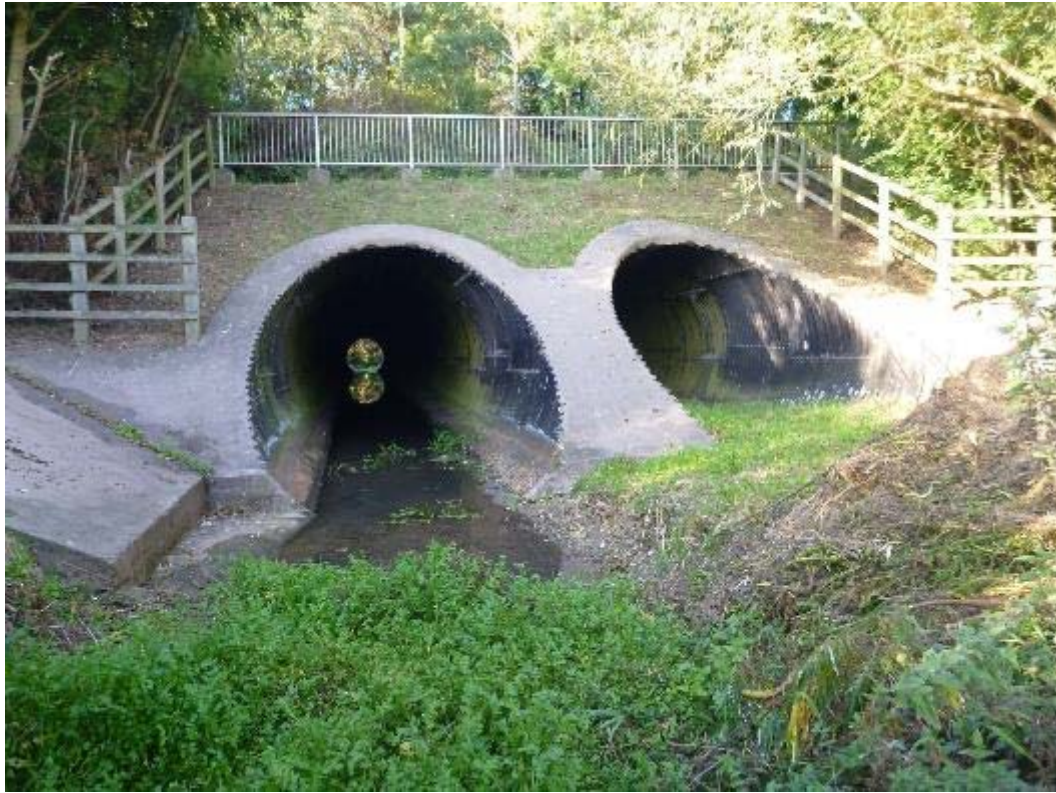
Photo 11 A180 road culvert (TA1258614401).

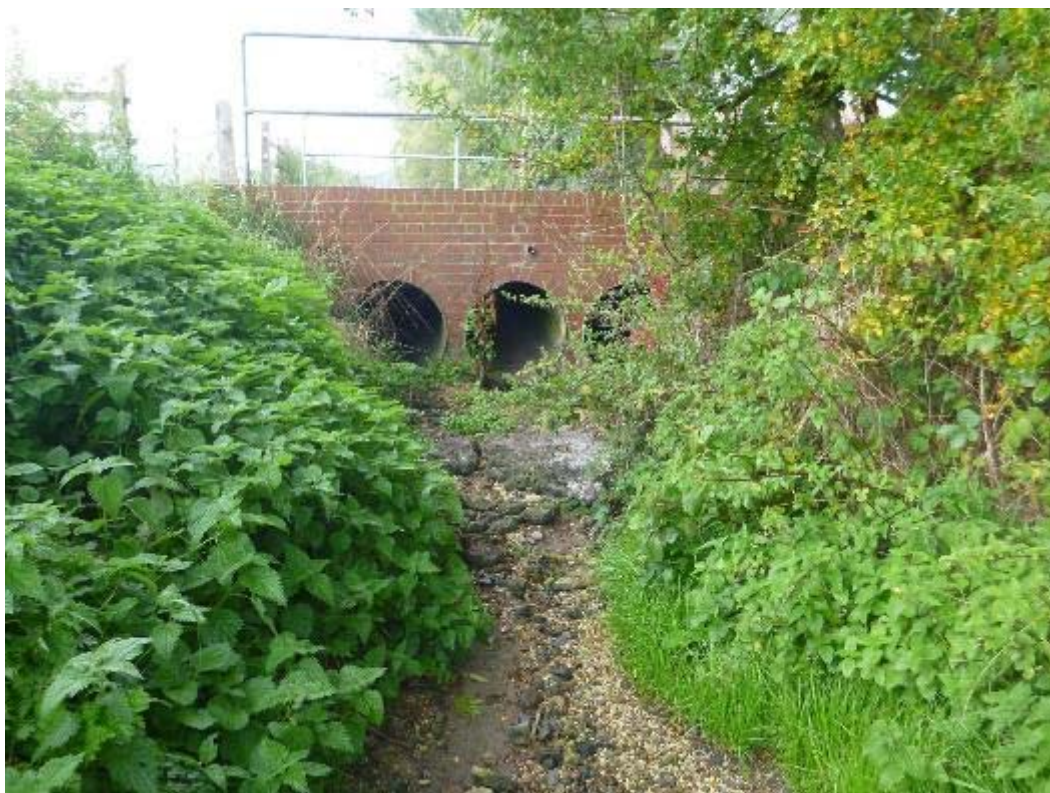
At Kirmington, the channel was dry apart from some standing water ponded above the pipe culvert under the track to the house alongside the AW sewage pumping station (TA1086811176). Downstream of this point the Beck was dry (Photos 12 -15) until approximately TA1106911570 where a trickle of water enters on the LHB. Pools of standing water were present

Photo 12 Culvert under track to house adjacent to Kirmington East End sewage pumping station (TA1087211178)

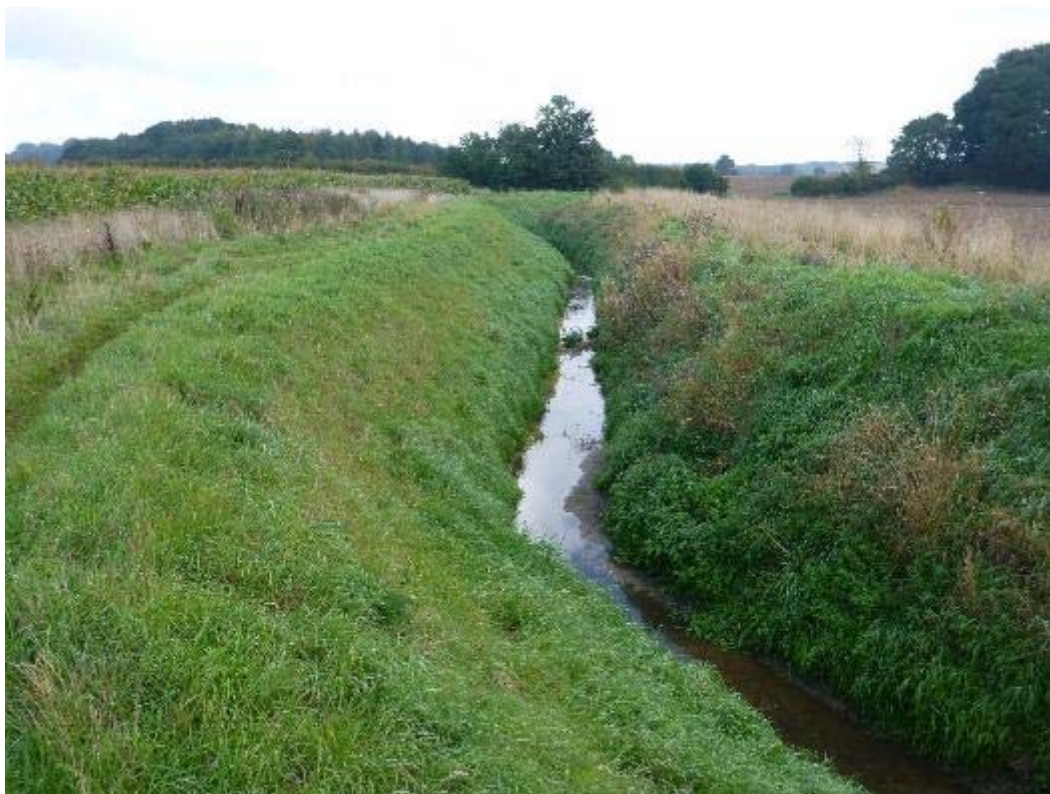
In common with the previous section, the channel is engineered and maintained for land drainage, being straight, steep-sided and lacking any variation in depth (Photos 18 – 20, 23). Bed substrate is largely gravel, with fine sediment accumulations upstream of culverts as noted above. Aquatic vegetation is sparse and the banks are open throughout this reach from Kirmington to the culvert at Brocklesby Junction (TA1193413453), probably reflecting the channel maintenance regime here. Between Brocklesby Road and the railway crossing (TA1228913762) the channel is heavily shaded by hawthorn, blackthorn, elder and brambles (Photo 24).

Photo 18 Section of Kirmington arm (TA1119311861).

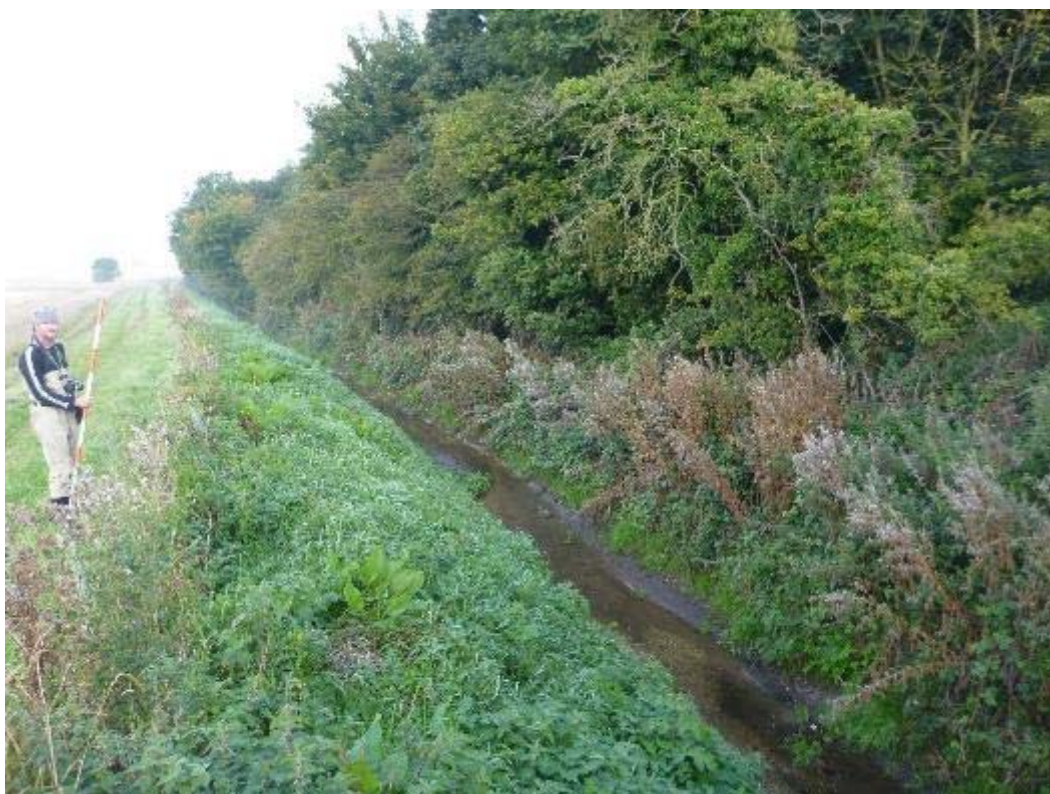
Photo 19 Section of Kirmington arm, Horns Wood (TA1130812153).

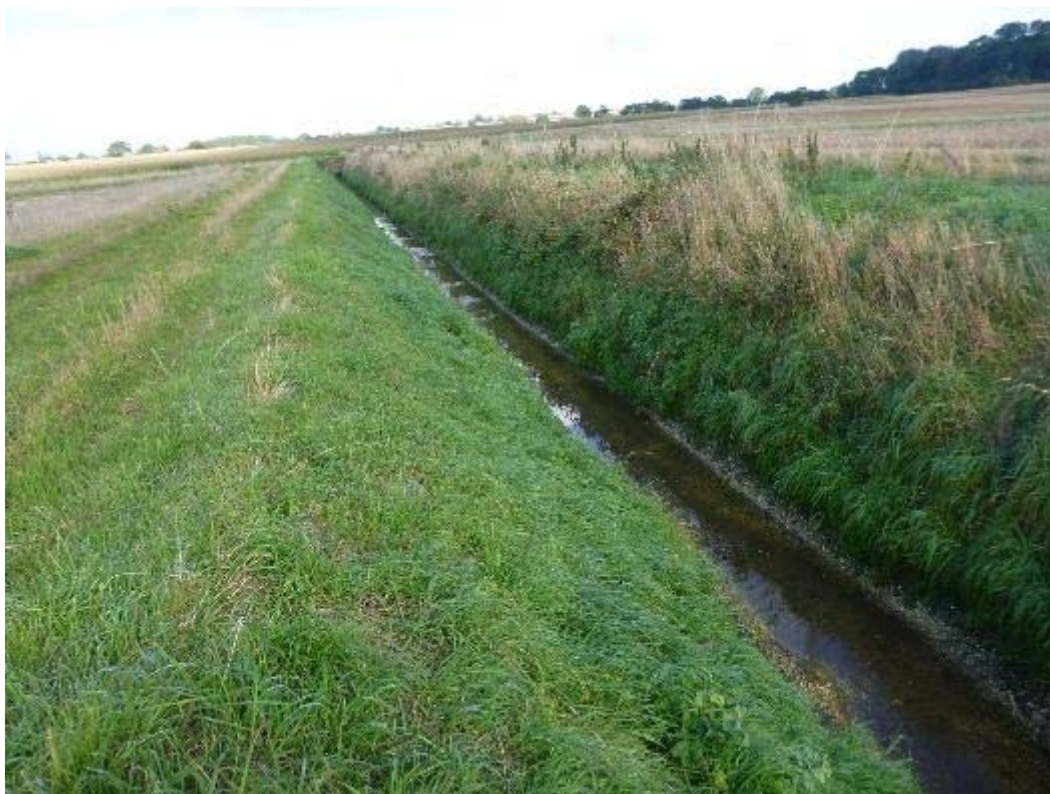
Photo 20 Section of Kirmington arm (TA1129712268).

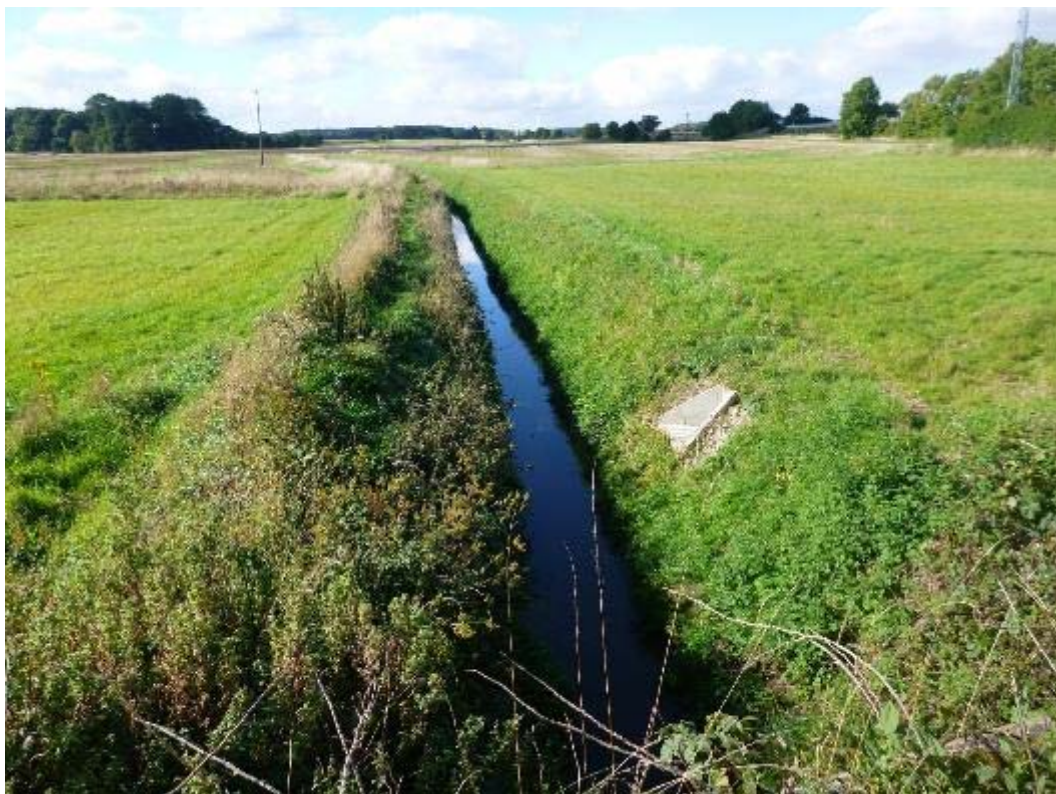
Photo 23 View upstream from upstream of Brocklesby Road culvert (TA1193513451).

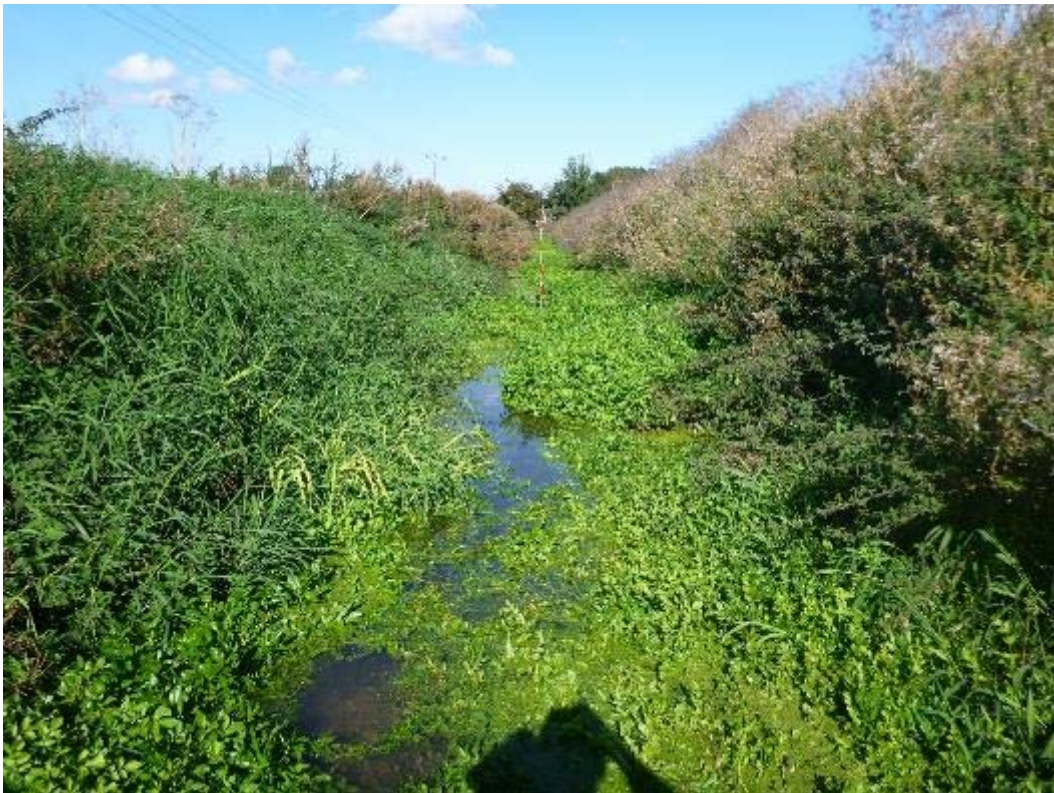
Photo 31 Upstream of Ulceby Skitter, showing gravel bed under fools' water cress (TA1244814740).

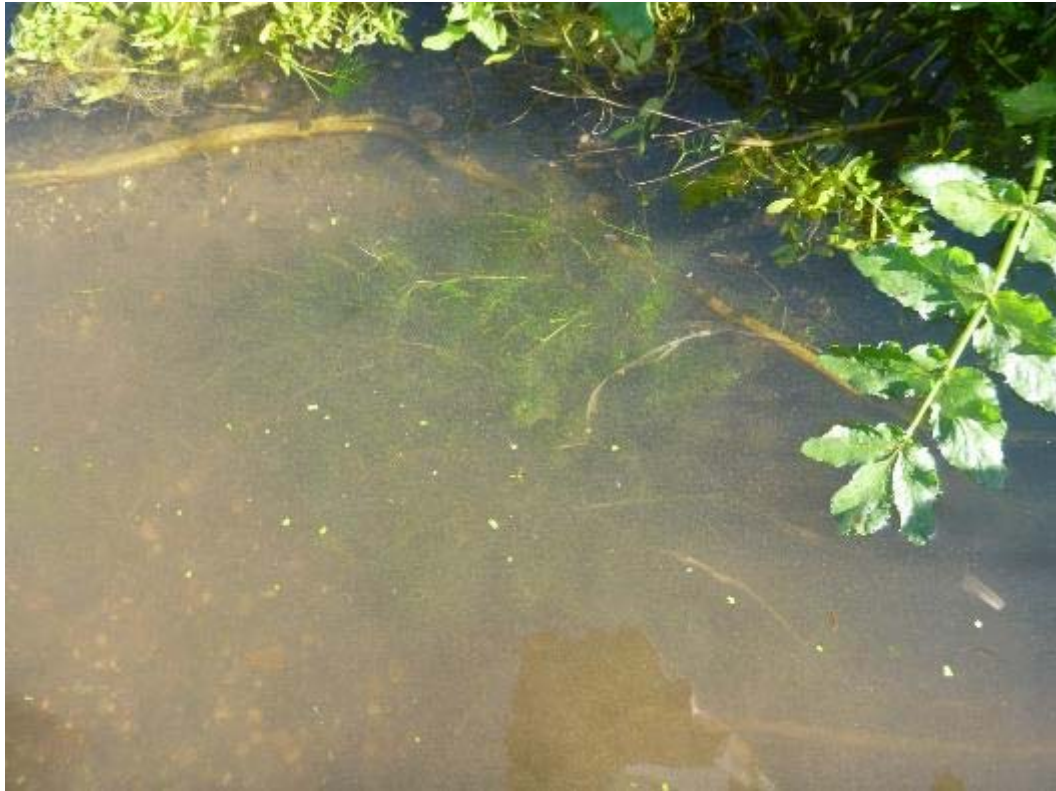
Photo 32 Water crowfoot (Ranunculus sp.) in clear spot between fools' water cress (TA1240214821).

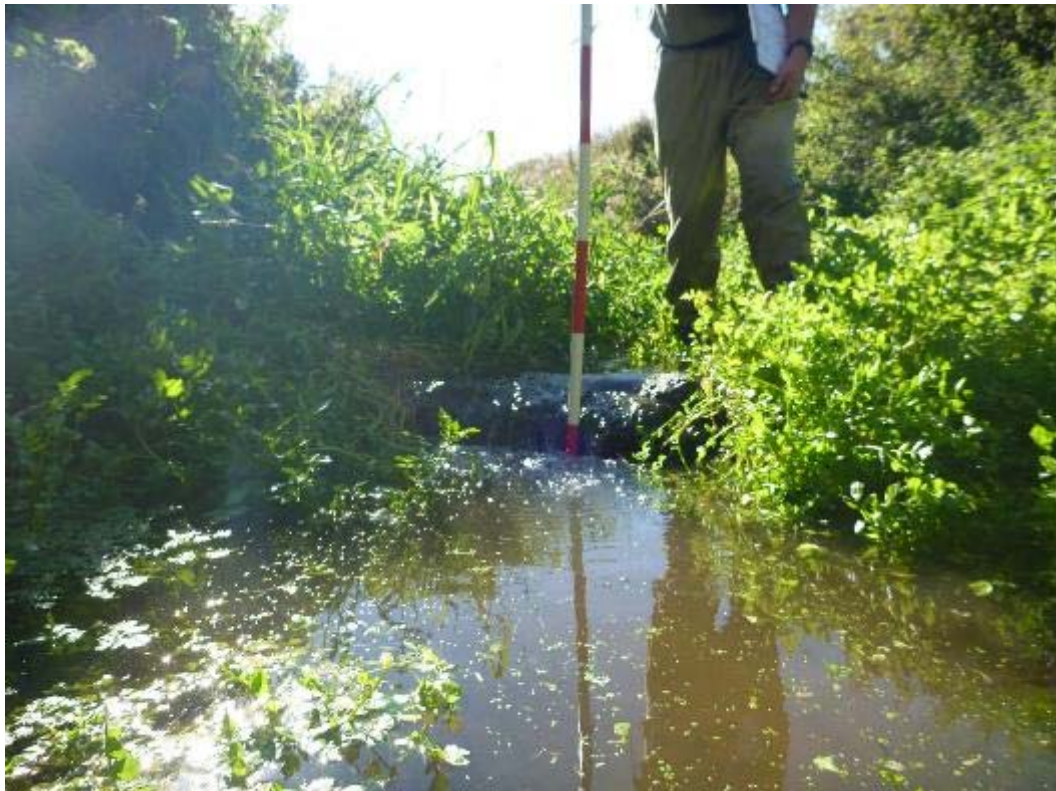
Photo 33 Step weir immediately upstream of Ulceby Road (A1077) bridge (TA1234514944).

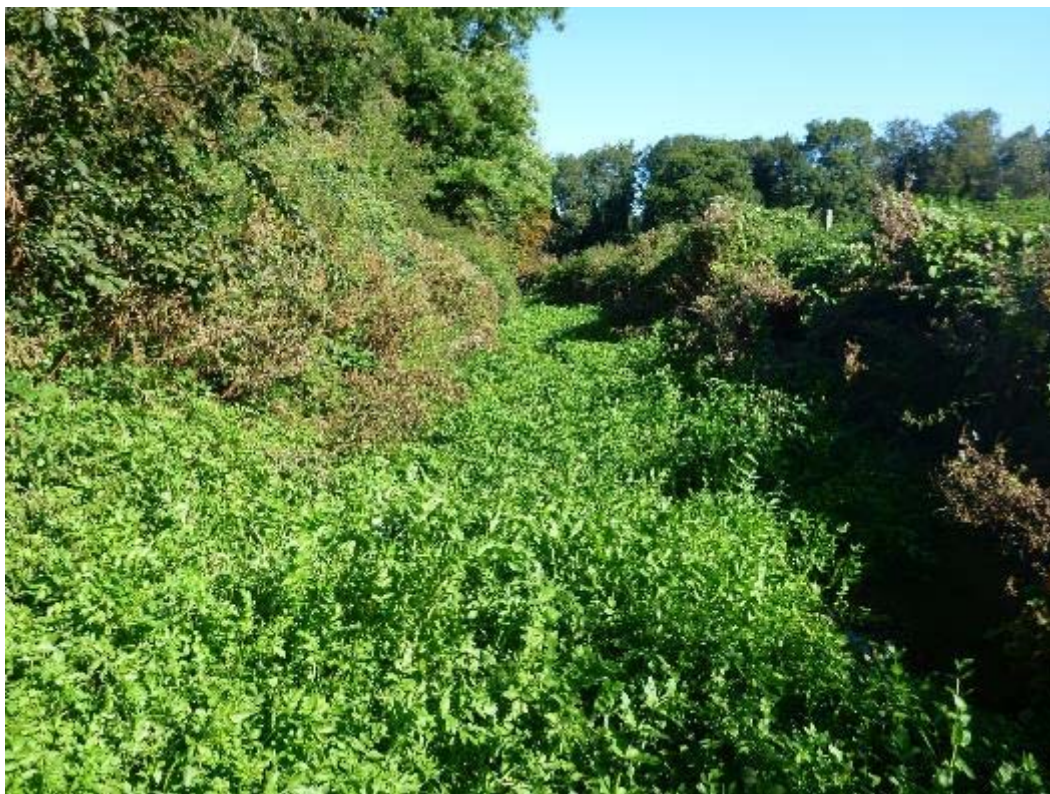
Downstream of the road bridge, the Beck runs alongside gardens of houses on the LHB until it reaches another railway culvert at TA1241915162. There is a mixture of tree-shaded and open sections here, with corresponding in-stream vegetation ranging from relatively open channel to one choked with *Apium*. The channel is wide (approximately 4m) and shallow (<0.2m) along this reach, apart from one deep hole (approximately 1m deep) which appears to have been scoured by a fallen tree (now removed). The flow appears to be lower than normal, as indicated by exposed river bed in the margins (Photos 34 – 36).

Photo 34 Downstream of Ulceby Road (A1077) bridge (TA1234514944). Unshaded section.

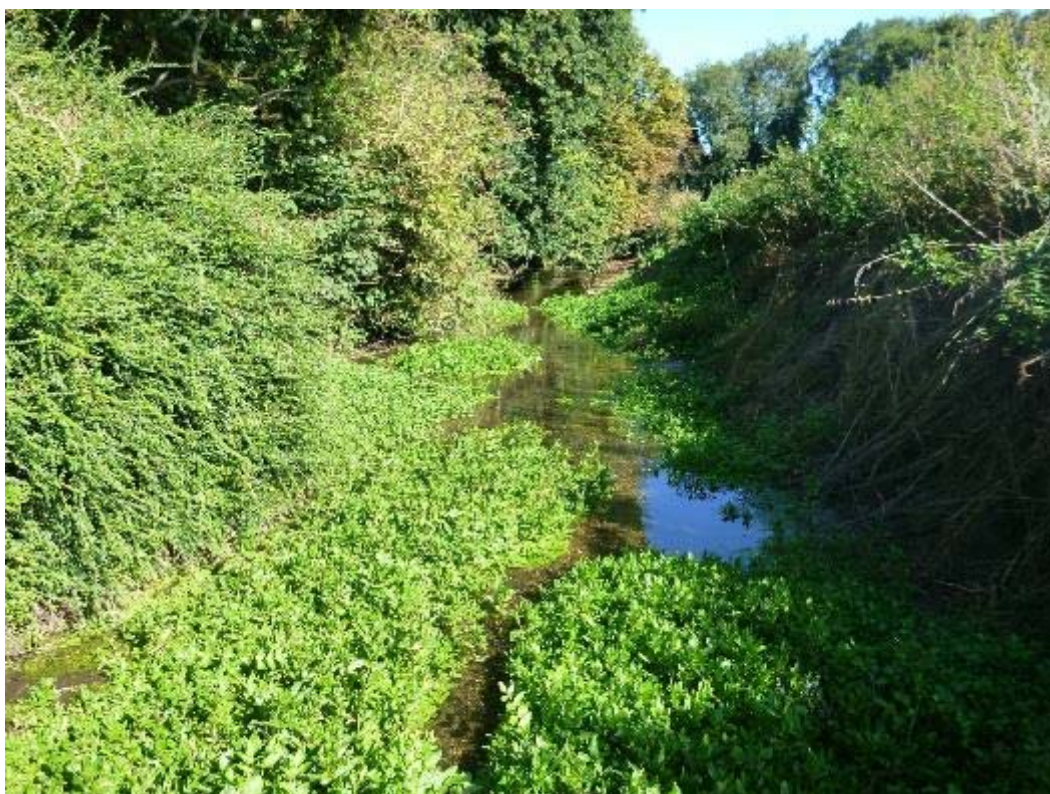
Photo 35 Downstream of Ulceby Road (A1077) bridge (TA1234514944). Partially shaded section.

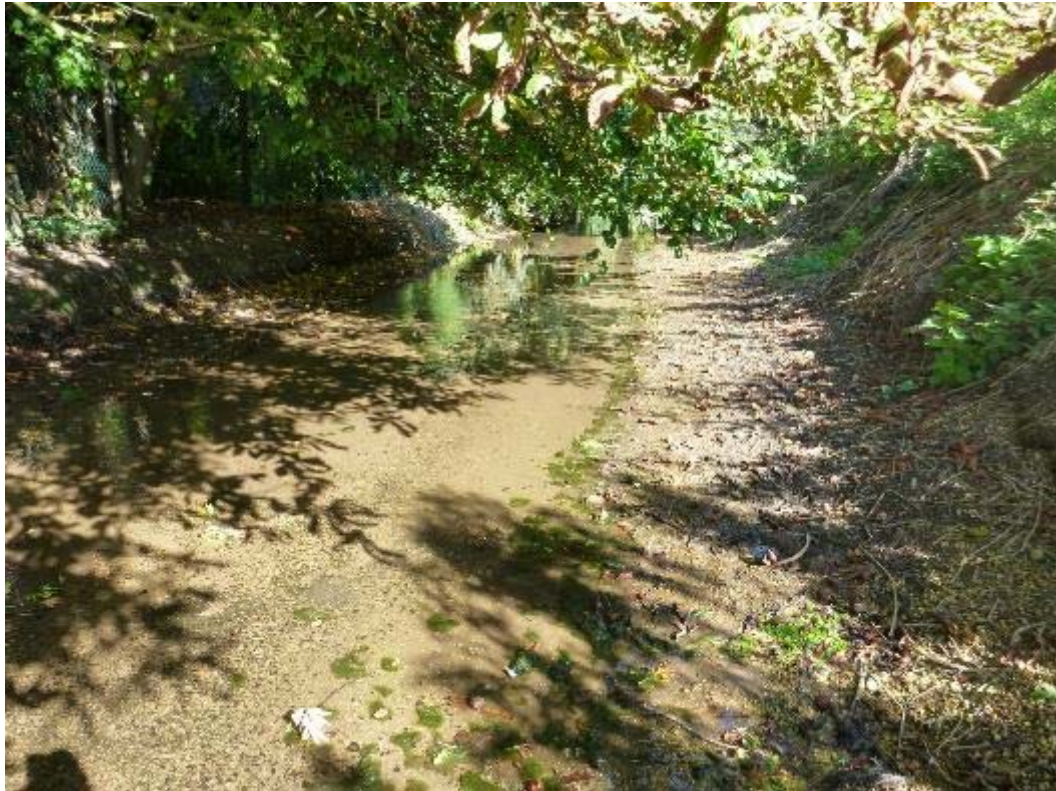
Photo 36 Downstream of Ulceby Road (A1077) bridge (TA1234514944). Shaded section.

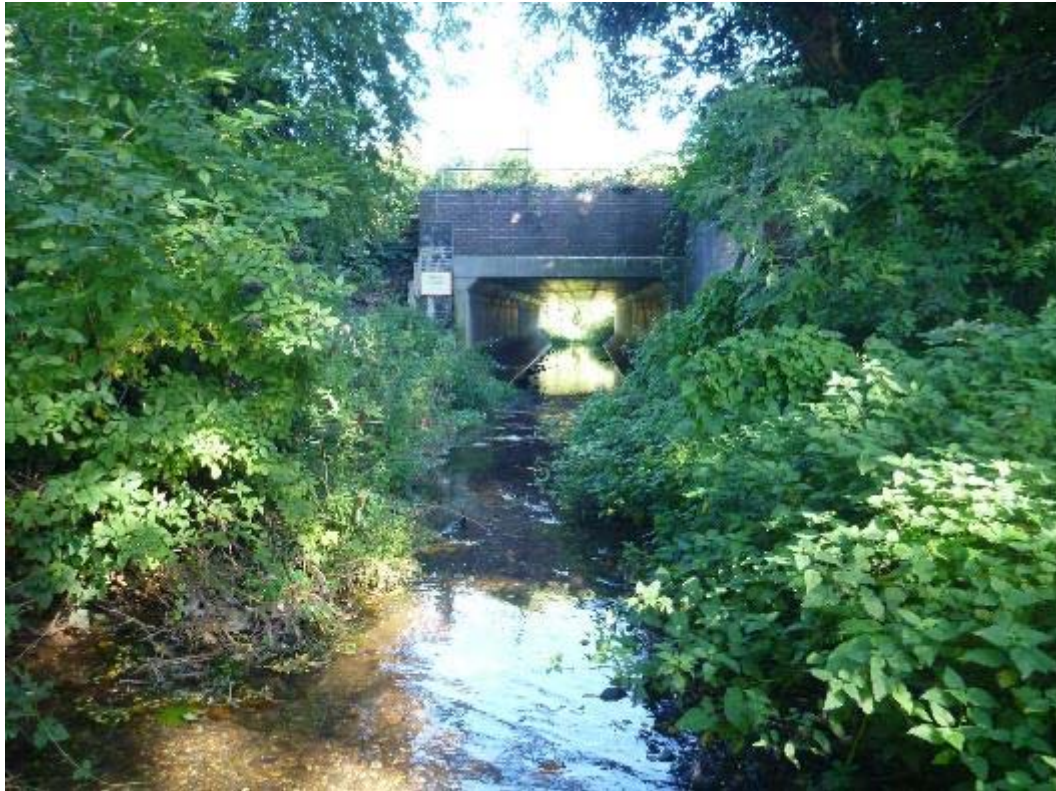
A kingfisher was observed flying through the railway culvert (TA1241915162)(Photo 38). Downstream of this point the channel has varying levels of shade from riparian trees and bushes which influences the abundance of aquatic vegetation in the beck (predominantly *Apium*). The channel form remains straight, incised and trapezoidal in cross-section with no depth variation; the only exception is a deeper scour pool against the LHB where a pipe drains to the Beck from a height of approximately 2m above water level (dry at the time of the survey). With progress downstream towards another railway culvert (TA1252915742) the channel becomes more open and the bed of the Beck is filled with *Apium*. Very occasional clear patches were observed where starwort and water-crowfoot were present (Photos 40 - .42).

Photo 38 Railway culvert at TA1241815165.

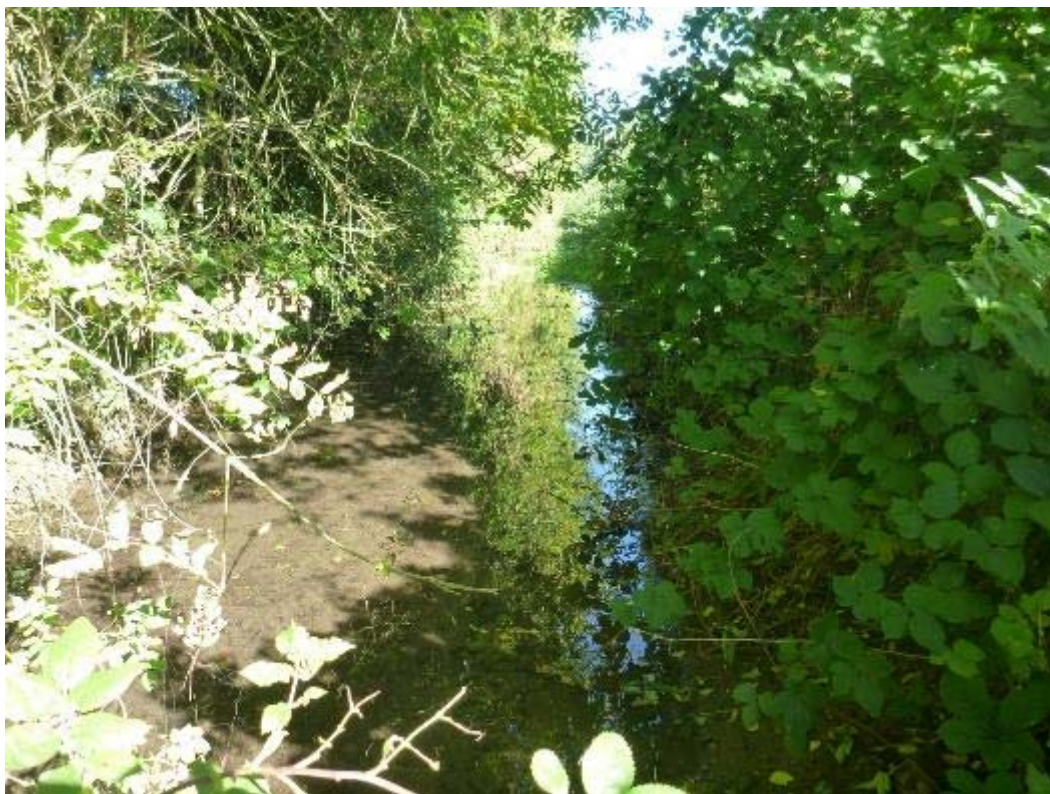
Photo 40 Between railway culverts at TA1241815165 and TA1253115744. Shaded area.

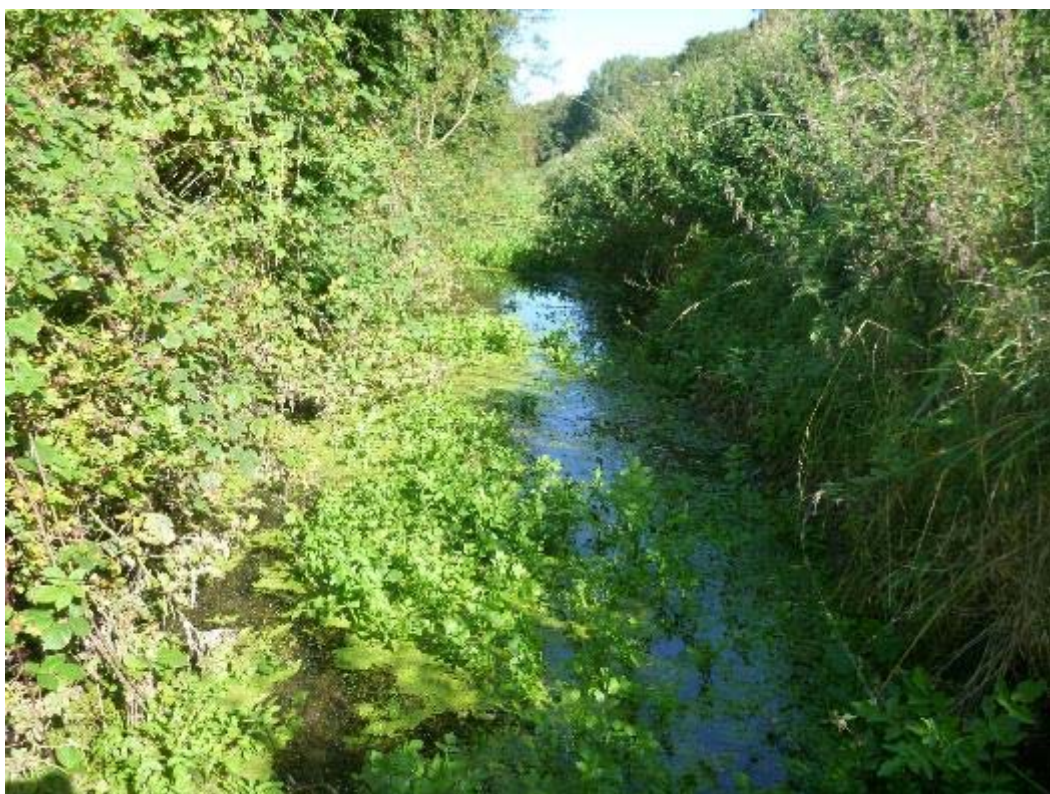
Photo 41 Between railway culverts at TA1241815165 and TA1253115744. Partially shaded area.

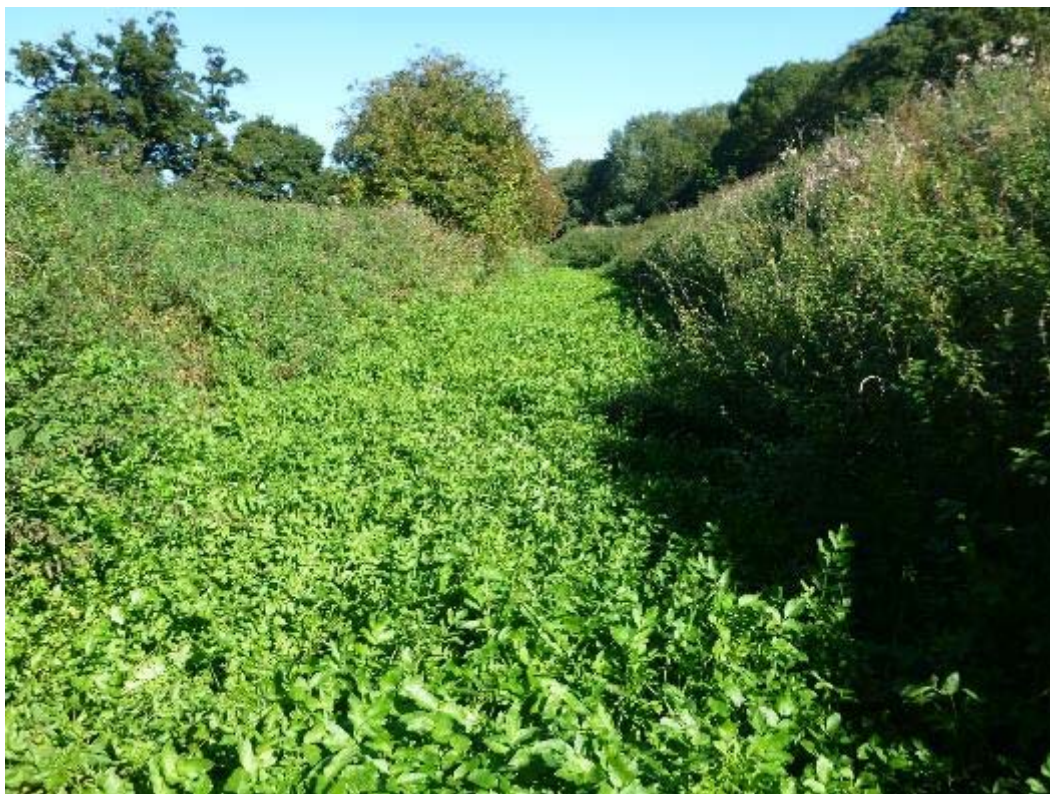
Photo 42 Between railway culverts at TA1241815165 and TA1253115744. Unshaded area.

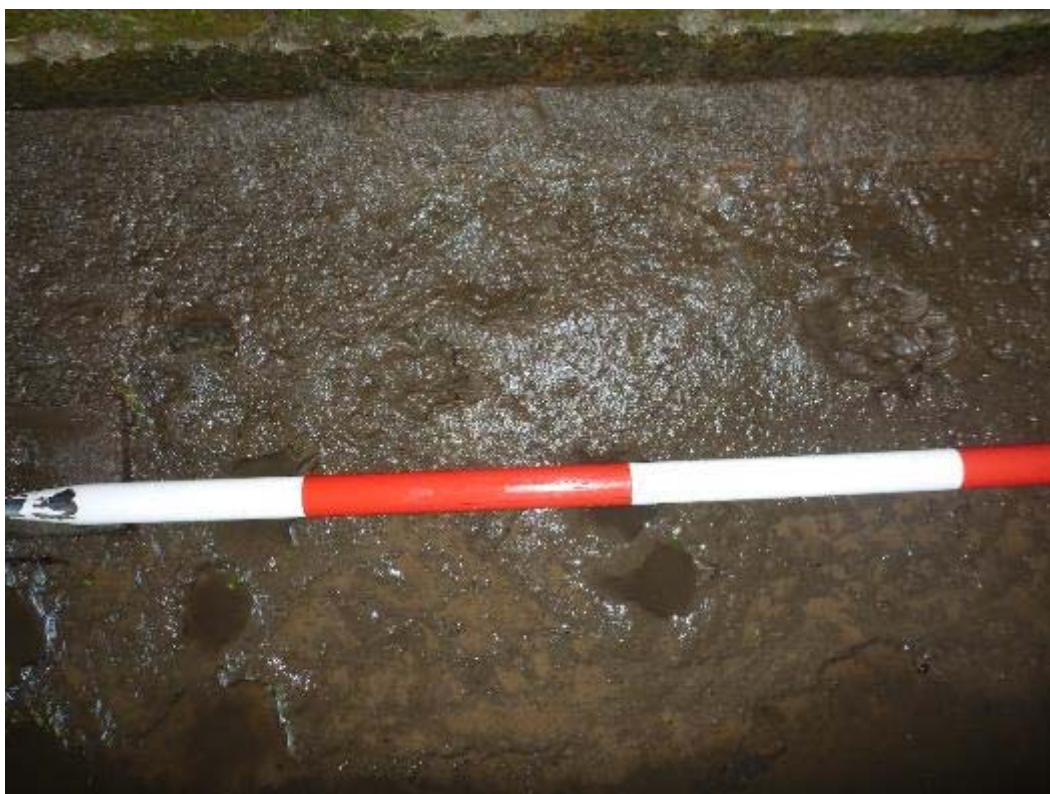
Beneath the railway culvert (TA1252915742) otter footprints were seen in the mud (Photo 43). These were seen in other locations, but no spraints were observed throughout the survey. Downstream of the culvert, the Beck enters a 1.2-km long, straight reach called Ulceby Carr. The Beck here is bordered by narrow grass fields on each bank which appear to be permanent pasture. The Beck is dominated by the growth of *Apium* which completely fills the channel. Occasional clear spots have some starwort, but also extensive growth of filamentous algae on the bed. A field drain enters from the LHB which was carrying fine sediment and discolouring the Beck at the time of the survey (TA1192216977). The LHB is lower than the RHB, probably because the latter is where spoil is dumped from channel maintenance. Short sections of the LHB are lower and less steep than the remainder of the bank (Photos 44 – 47).

Photo 43 Otter footprints in mud under railway culvert. Increments on ranging pole are 0.2m. (TA1253115744).

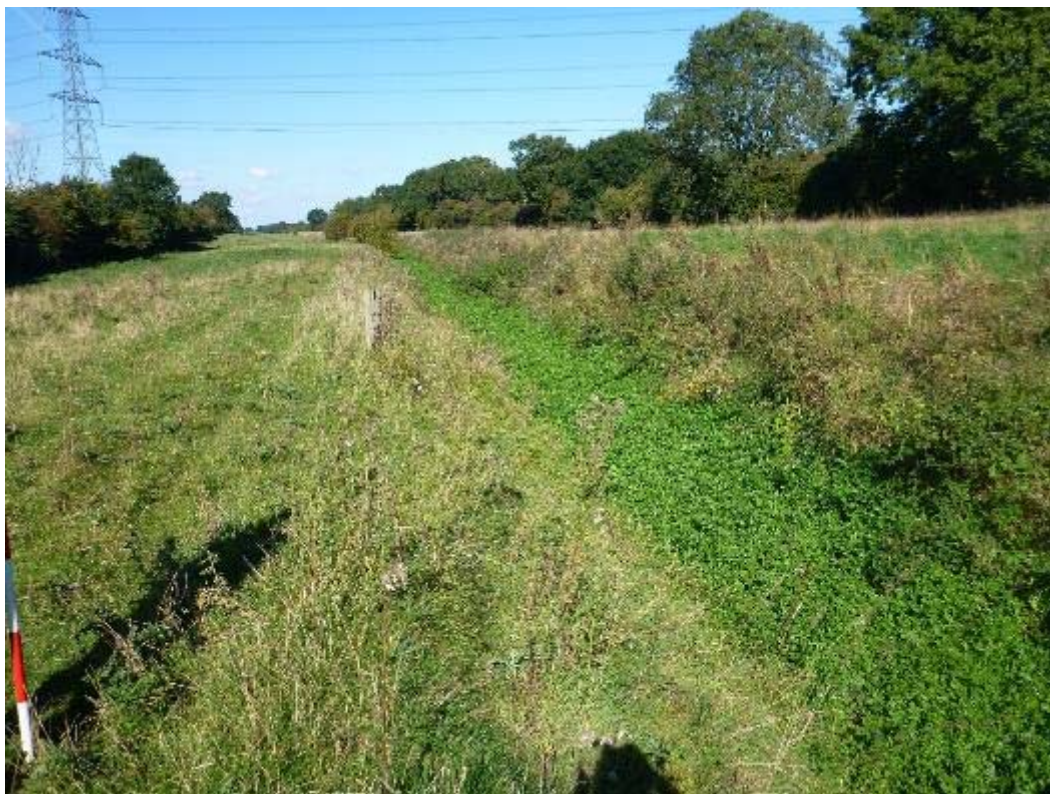
Photo 44 Ulceby Carr section (TA1233716172)

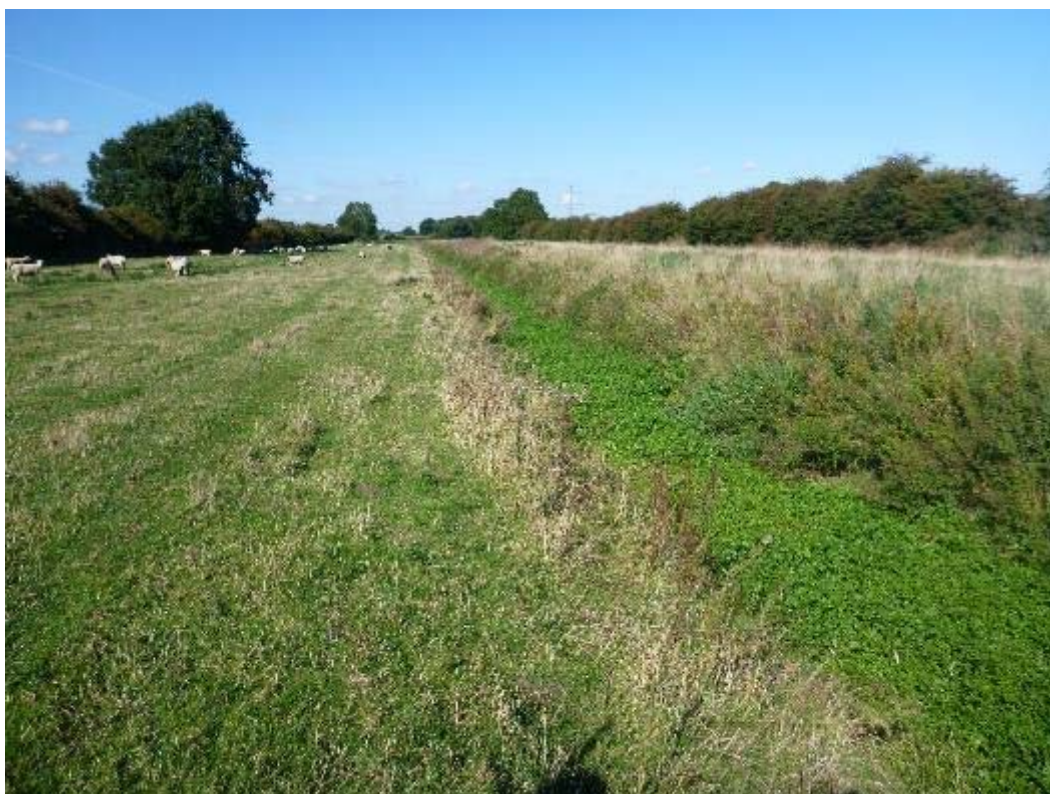
Photo 45 Ulceby Carr section (TA1213516569).

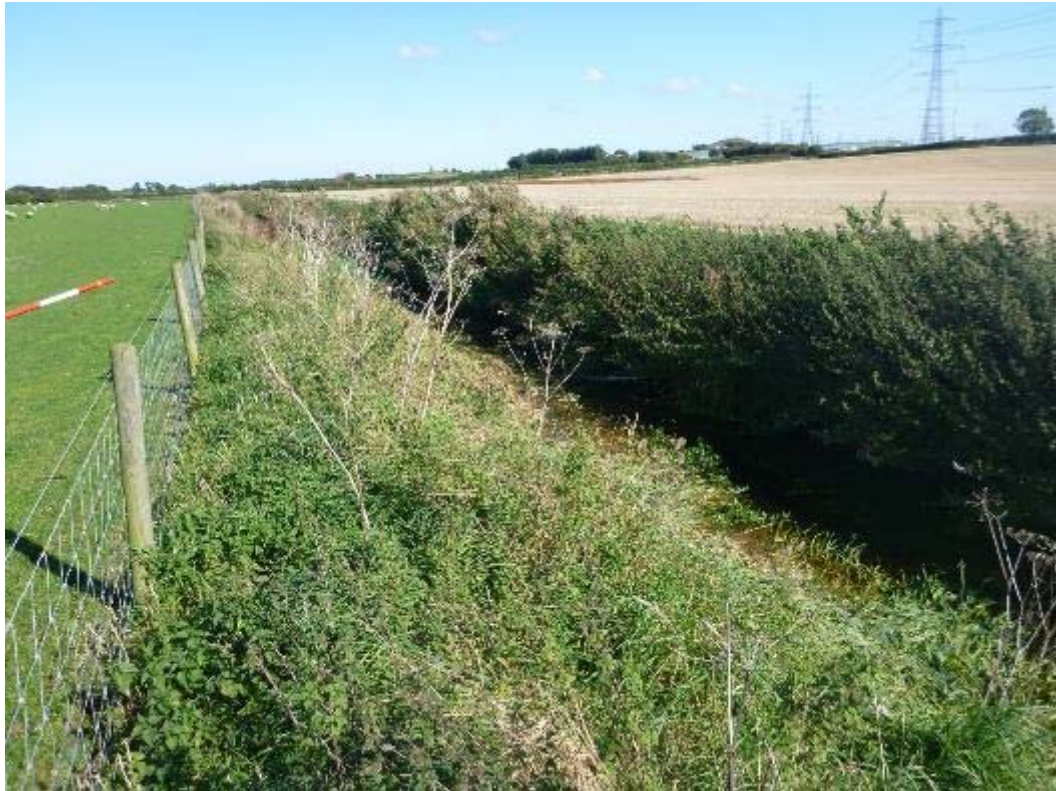
Photo 48 (TA1202317499)

At the downstream end of Ulceby Carr, the grass field margins give way to a grazed field (sheep) on the LHB and an arable field on the RHB, both being fenced alongside the river (Photo 48). A recently cleared ditch enters from the LHB (TA1199117430). The vegetation on the banks of the Beck is longer here (tall grasses, nettles) in the absence of grazing. *Apium* becomes

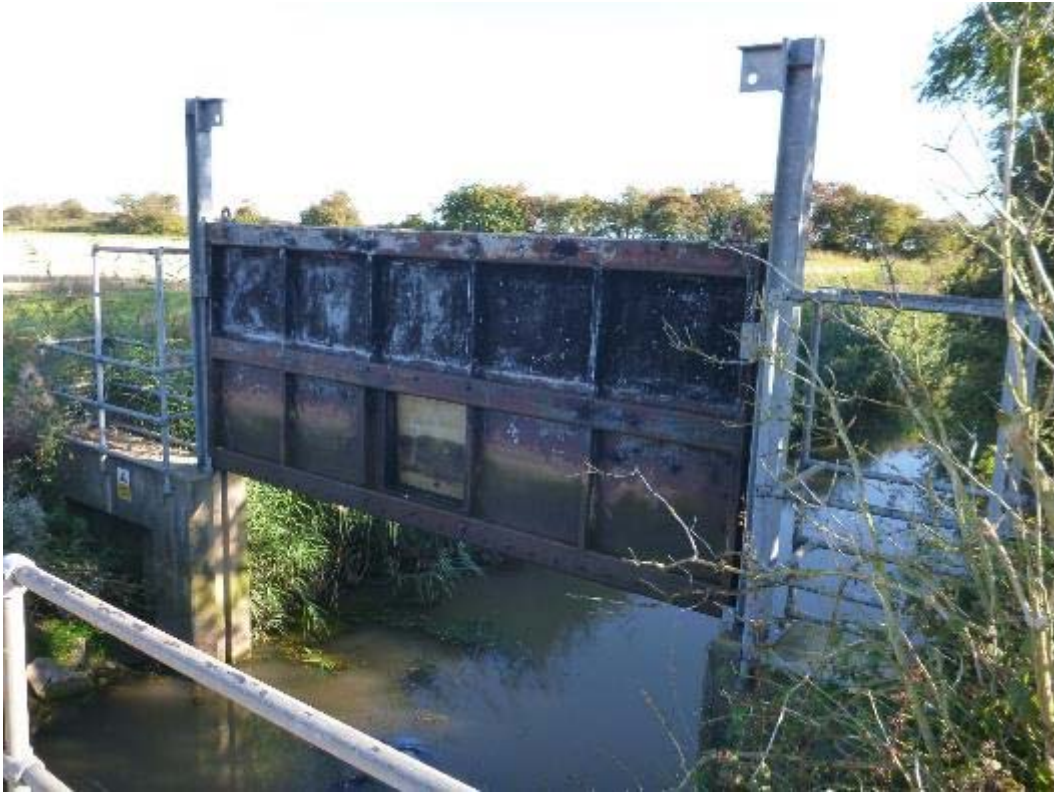
Photo 57 Skitter Beck Flushing, an EA structure probably used intermittently to impound water and flush silt out of the lower beck (TA1396822628).

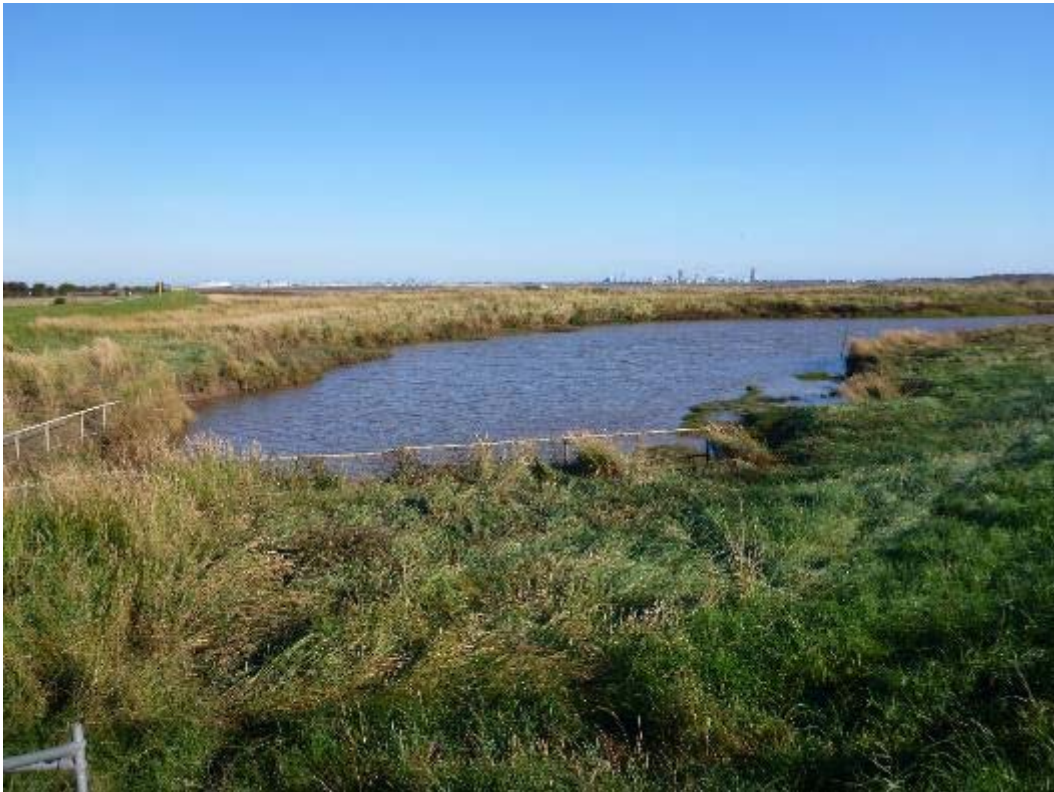
Photo 58 Sea side of Skitter Beck outfall, tide in and gates closed, 10.00hrs 30/09/2015 (TA1439822885).

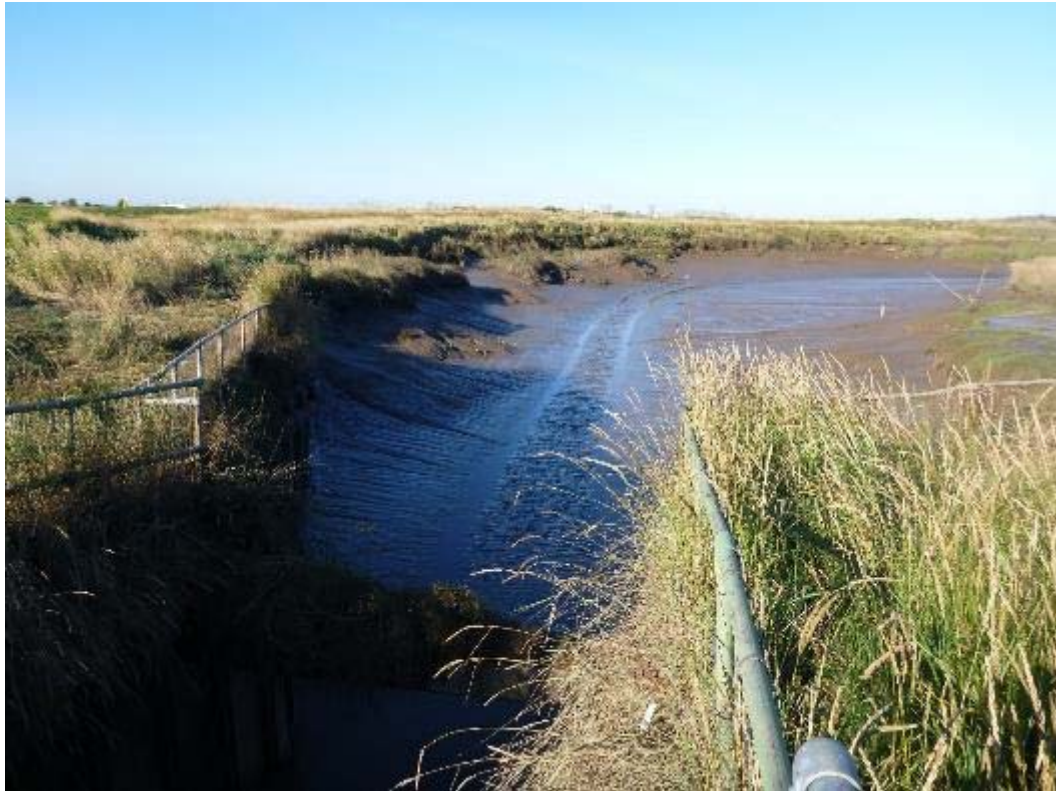
Photo 59 Sea side of Skitter Beck outfall, tide out and gates open, 16.15hrs 30/09/2015 (TA1439822885).
