Skitter Beck Walkover Survey

September 2015

1.0 Introduction

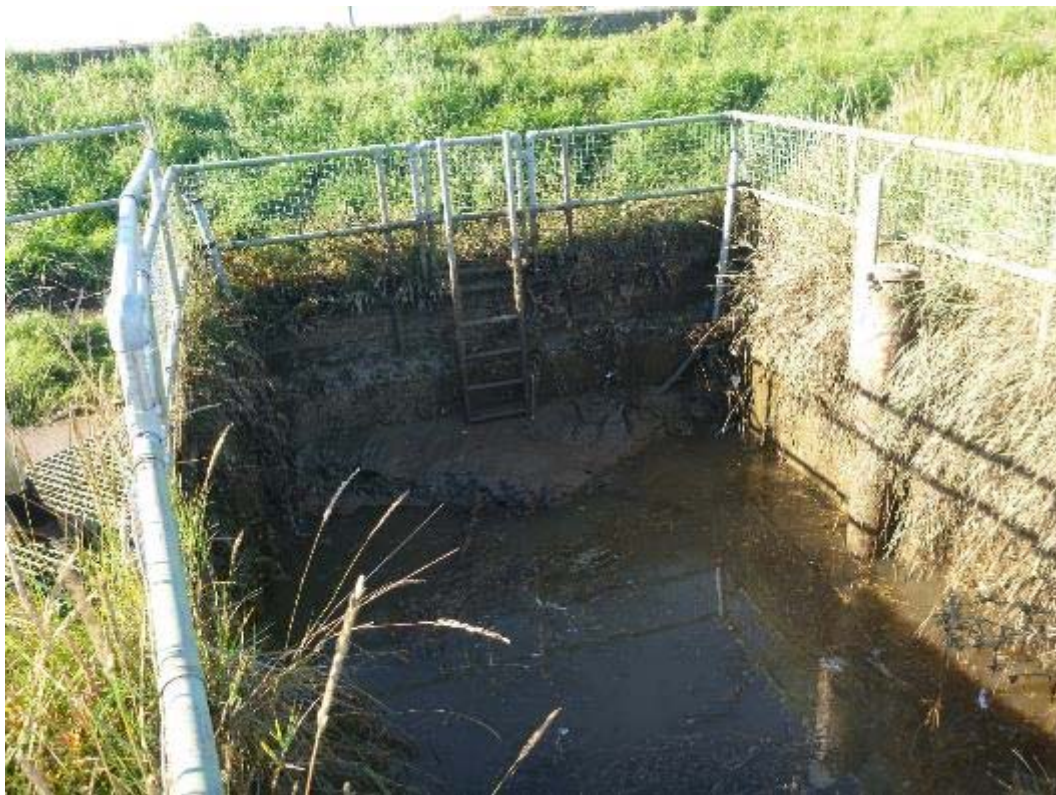
Photo 60 Sea side of Skitter Beck outfall, tide in and gates closed 10.00hrs 30/09/2015 (TA1439822885).

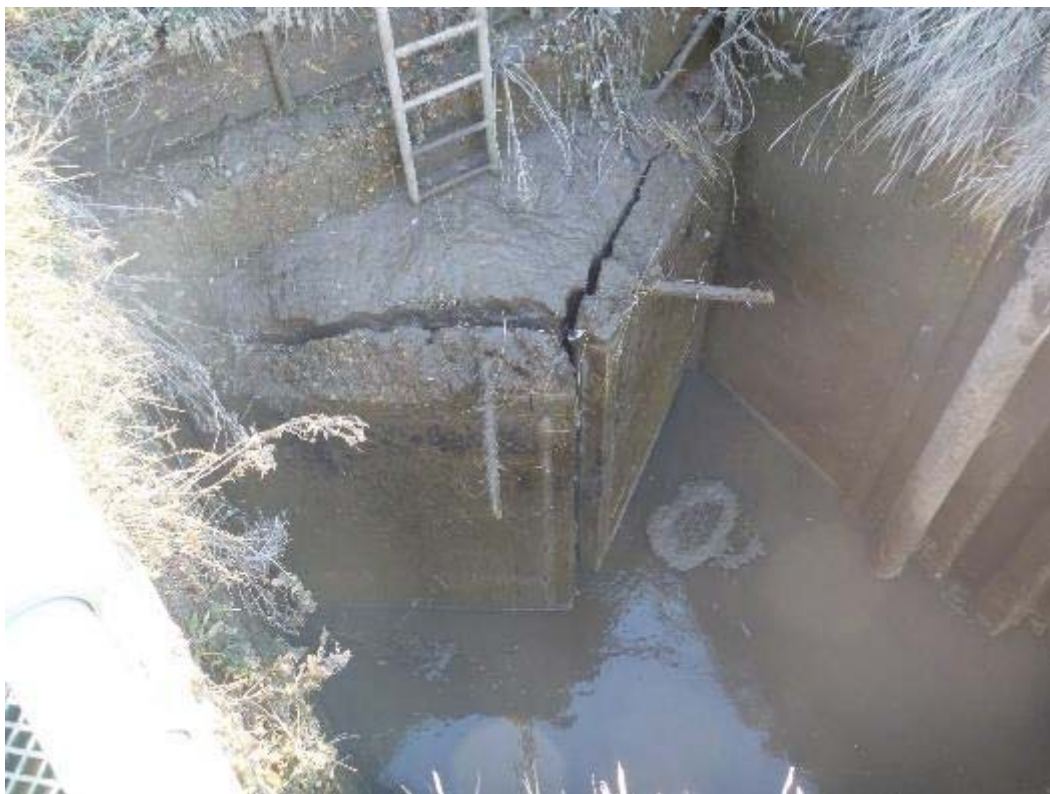
Photo 61 Sea side of Skitter Beck outfall, tide out and gates open 16.15hrs 30/09/2015 (TA1439822885).
