Advisory Visit / Walkover Survey

River Tean Staffordshire

February 2016

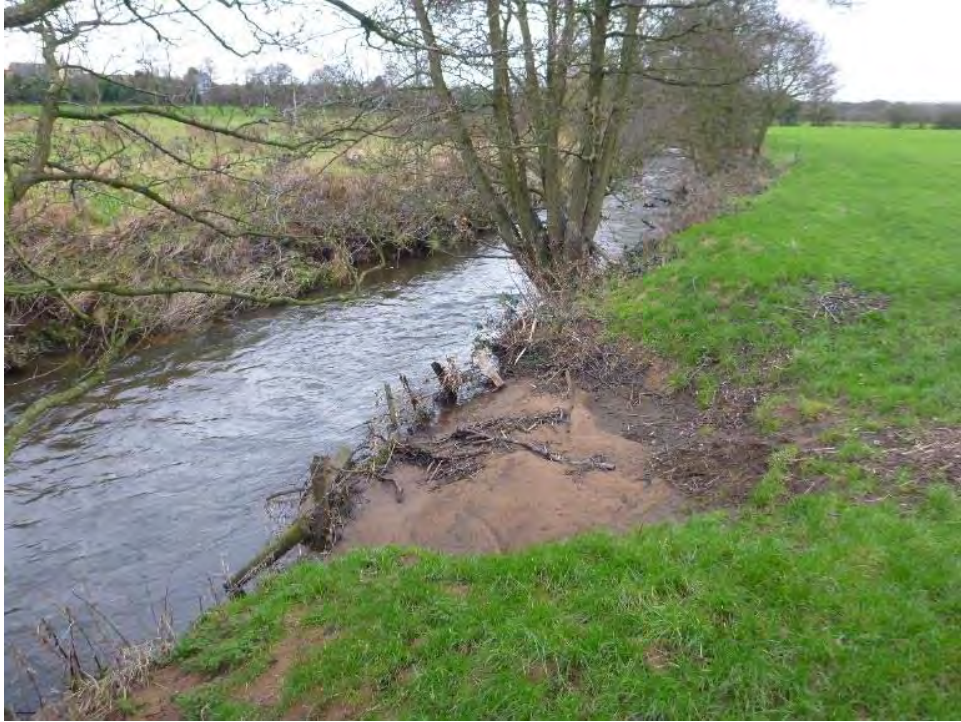
Photo 19 Straight section of river upstream of A518 Ashbourne Road.

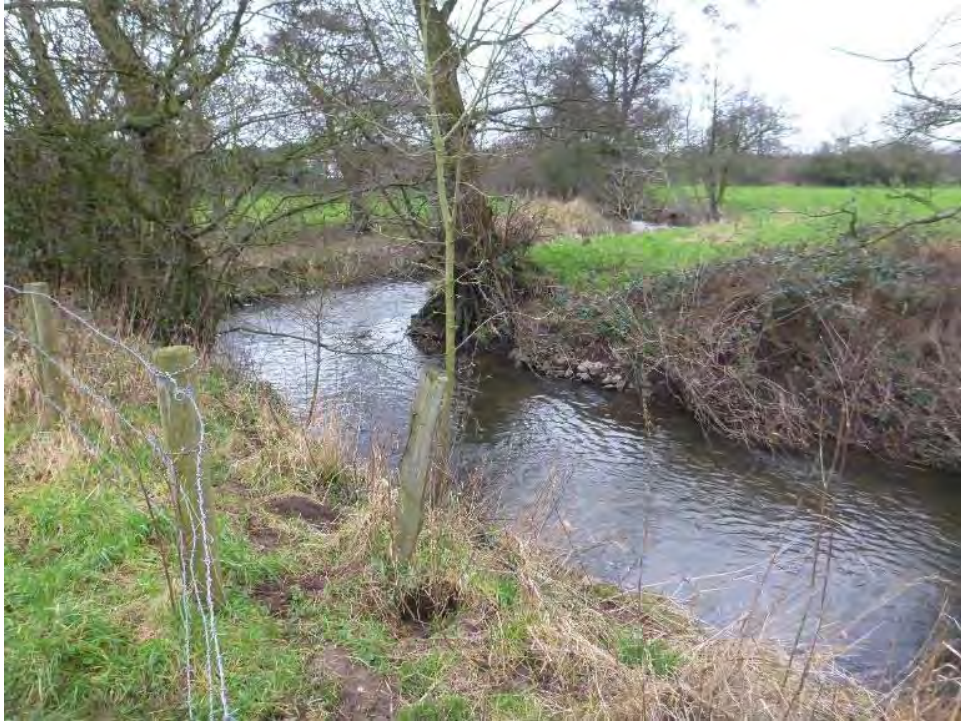
Photo 21 Meandering sections retain a pool-riffle structure.

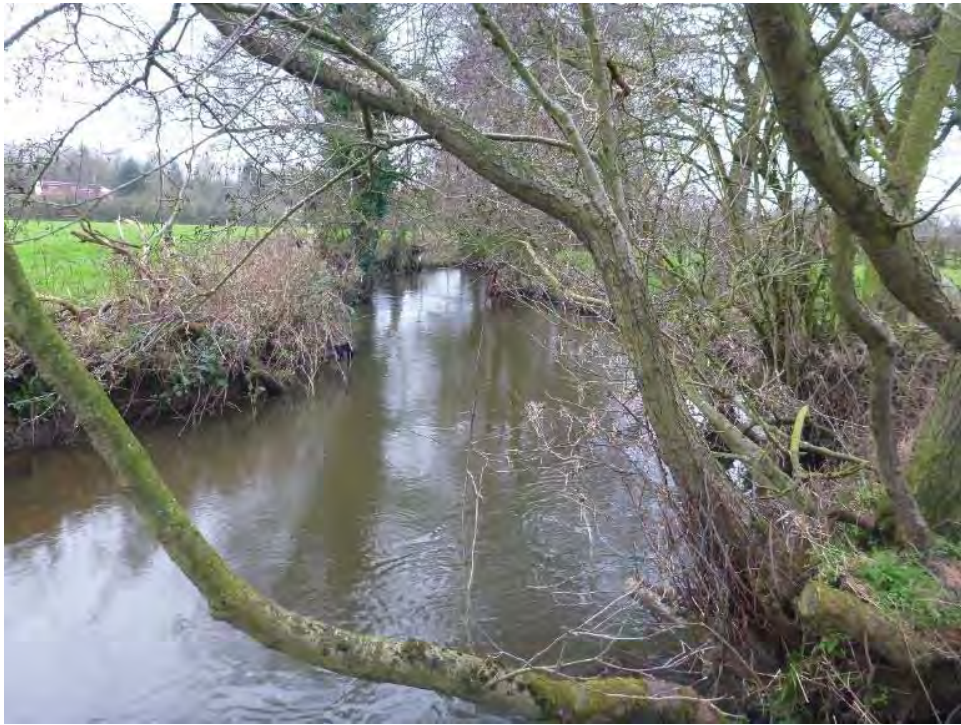
The channel remains incised and a blockstone toe is present throughout most of the section, indicating past channel engineering (bed lowering). In some areas, the stone toe has blown out and bank erosion is occurring at accelerated rates, especially where trees are absent and where woody debris accumulations have promoted bank scour. There is some LWD present, but also evidence of recent removal (e.g. SK0838134800, Photo 20), probably prompted by the above-noted tree loss, stone toe blowout and increased bank erosion rates. Tree succession is not occurring because of grazing, which is a cause of concern for future bank stability and channel shading. Selective coppicing, stock fencing and tree planting would benefit this part of the river (Photos 22 – 25).

Photo 23 More stable, wooded banks.

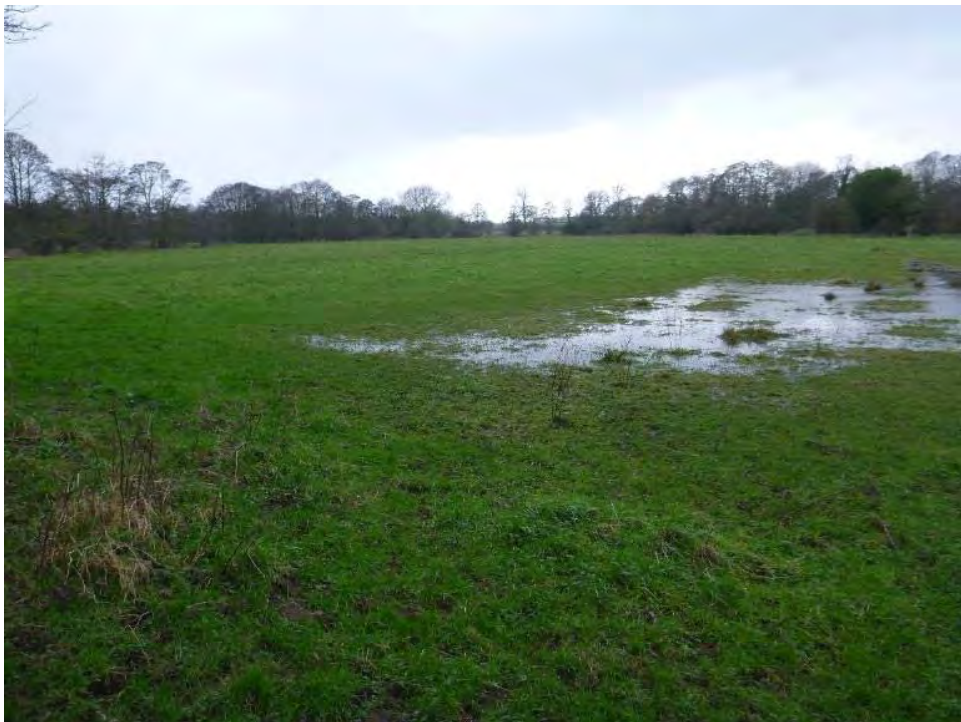
Photo 24 Possible paleo-channels in LB fields.

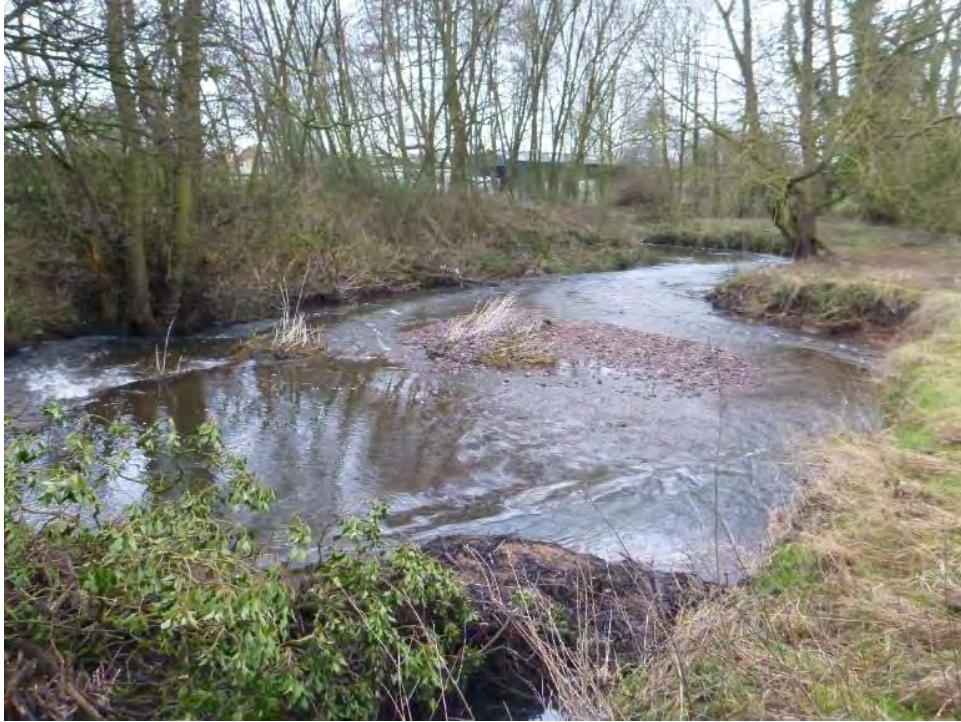
The section of river upstream and downstream of the stables (SK0749735143) comprises good in-stream habitat with a mixture of natural habitat features including a meandering plan-form, pool-riffle sequence, point bars, gravel shoals and river cliffs. Some sections have blockstone armouring, but this is one of the most natural sections of river seen during the walkover. There are some issues with stock access close to the river, but these are relatively localised and minor impacts (Photos 27 -30).

Photo 27 Good in-stream habitat, upstream of Anfield Livery Stables

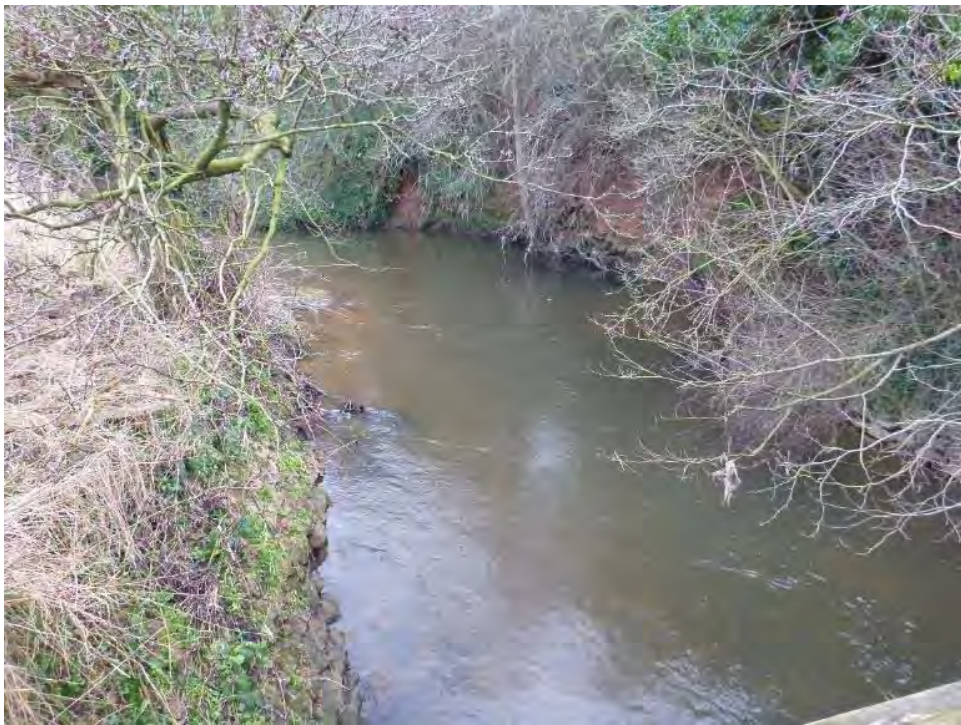
The section of river from the upstream boundary of Saracen's Head fishery to the road bridge at SK0723835496 is less meandering, but retains some good in-stream habitat (pool-riffle sequence). There is evidence of recent LWD removal at one location and the backfilling of a scour hole in the bank. The remains of an old weir are present (just side walls; no obstruction to fish passage), along with an old headwall and very uneven ground in the field on the RB, possibly industrial archaeology associated with the former mill upstream (Springfields / Mill Farm). Some tree coppicing has been carried out in recent years along this section (Photos 28 – 30).

Photo 28 River cliff feature, upstream of Anfield Livery Stables

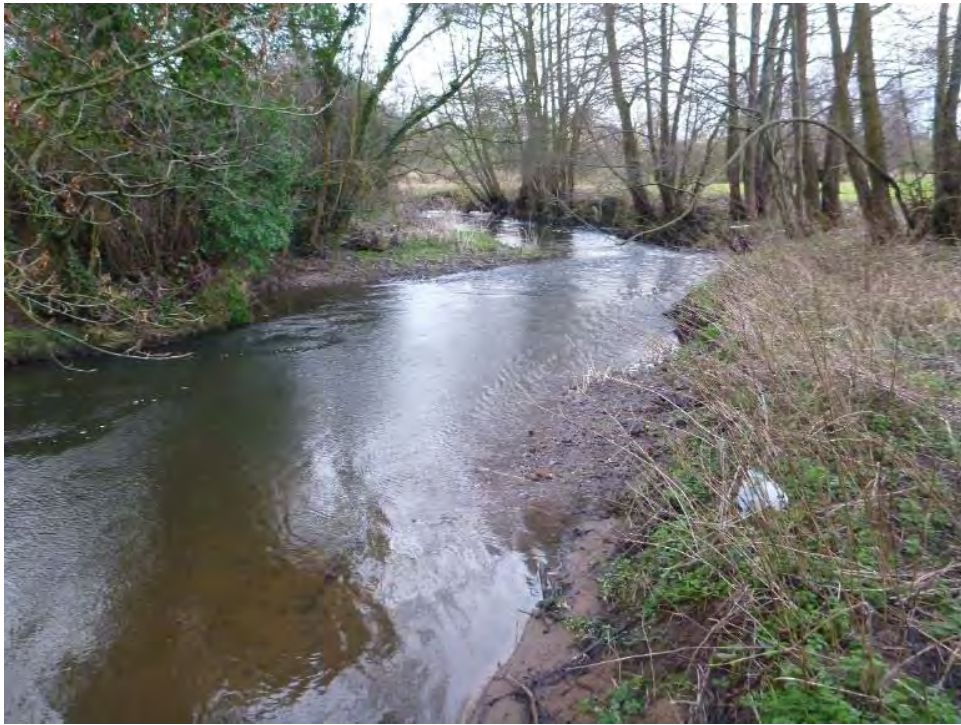
Photo 29 Good in-stream habitat.

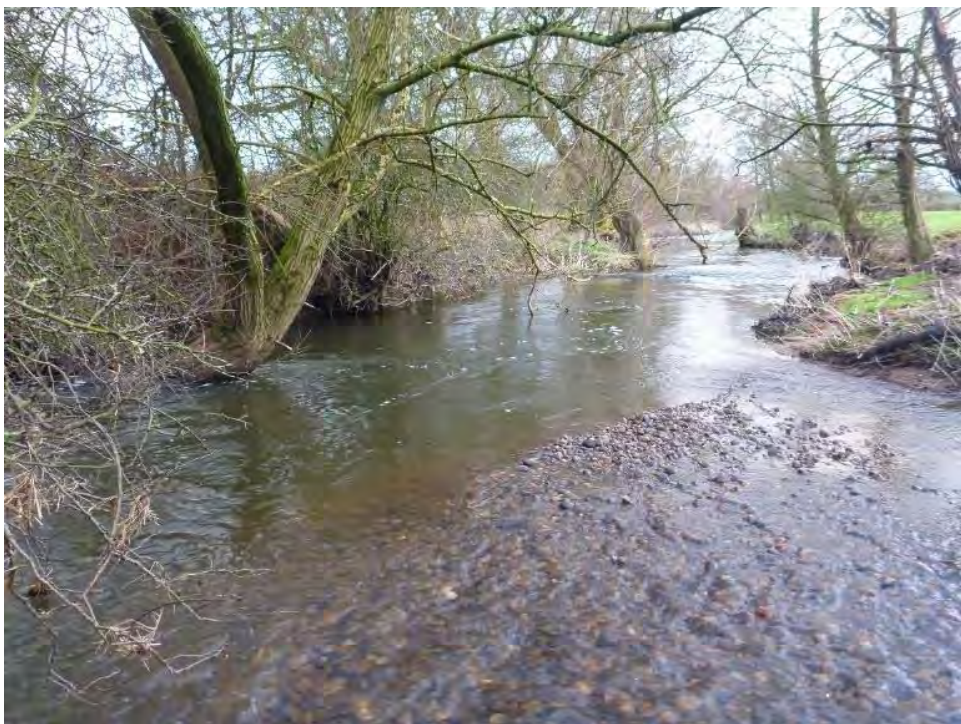
Photo 32 Good in-stream habitat downstream of road bridge SK0704235723.

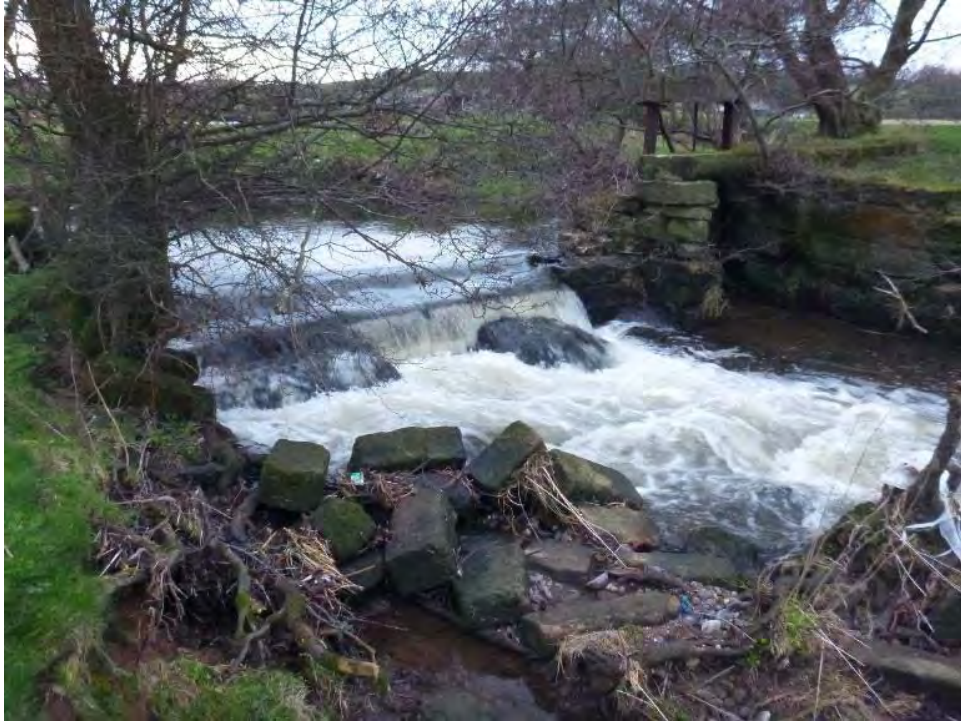
Above the weir, there are some deposits of coarse sediment forming mid-channel shoals, probably as a result of interrupted sediment transport by the weir (Photo 34). The channel plan-form is meandering and the LB has few trees, with accelerated rates of erosion evident on the outside of bends

Photo 35 Weir at SK 06761 35807

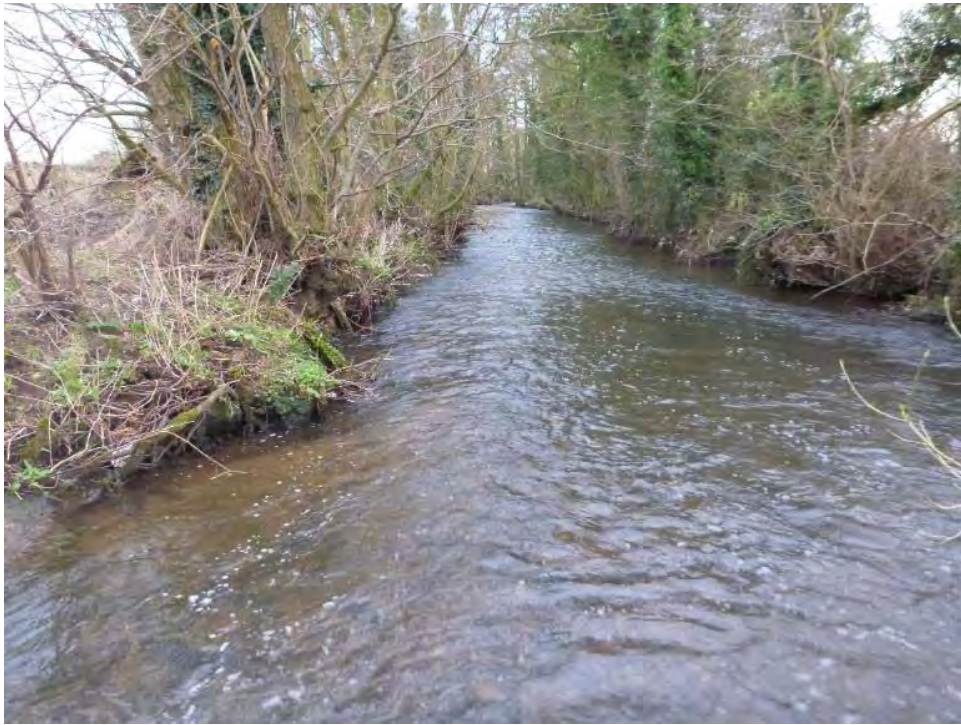
Photo 40 Straight, shallow section alongside the A522

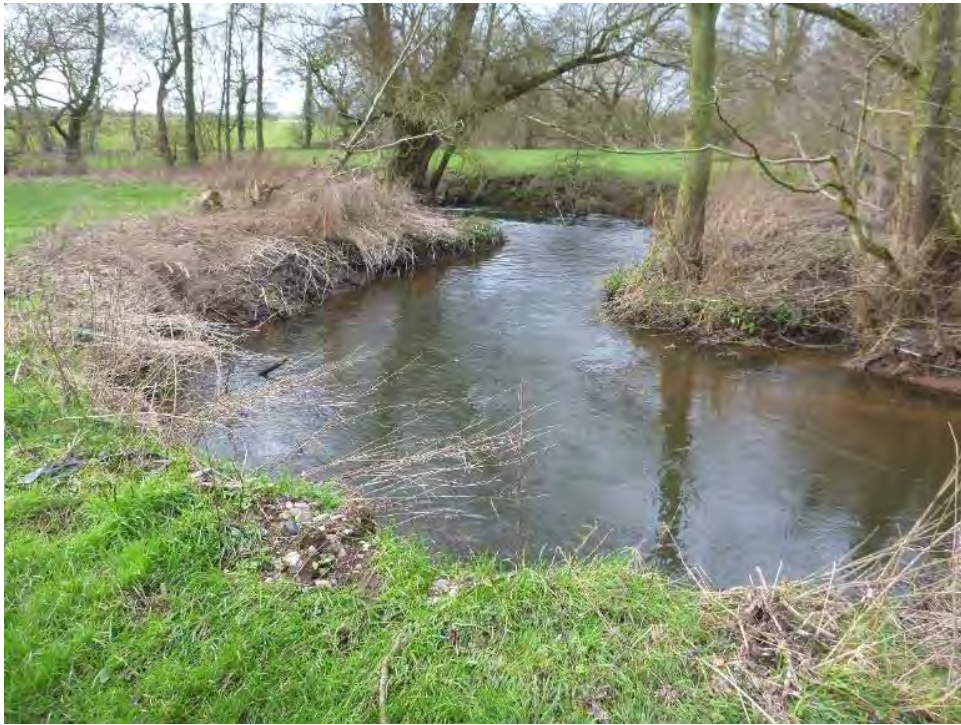
Photo 44 High quality habitat provided by the meandering river course.

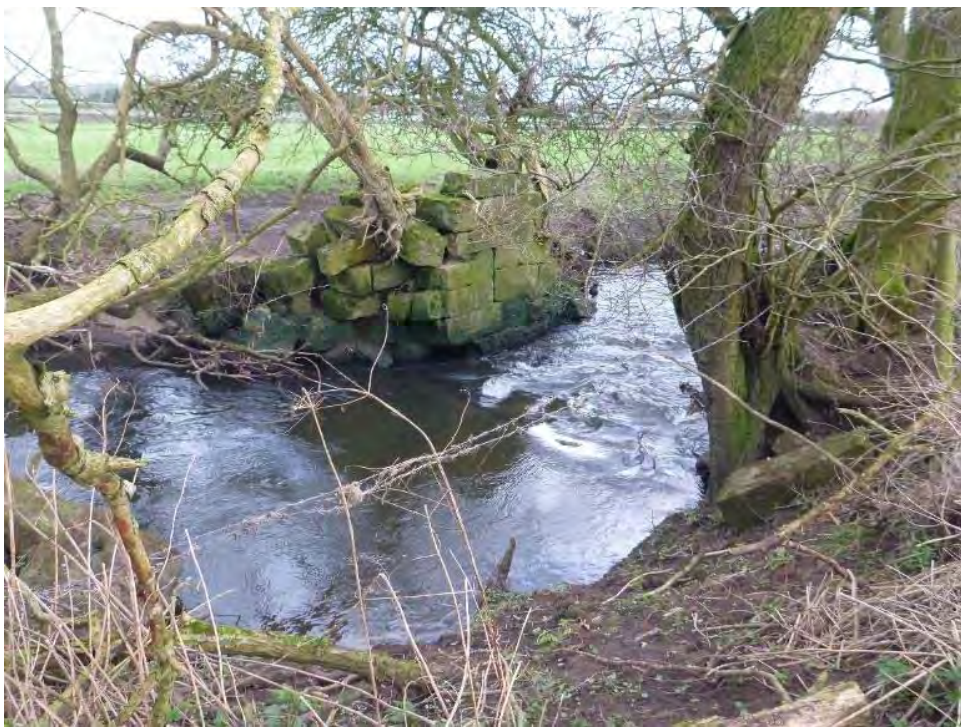
Photo 45 Former weir

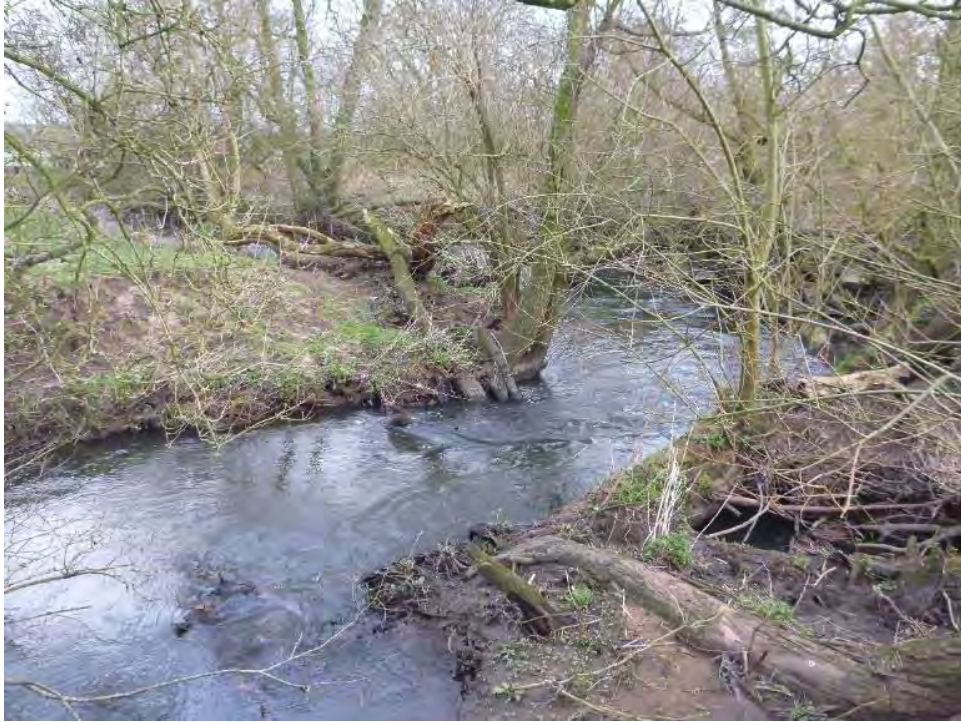
Photo 46 Good in-stream habitat

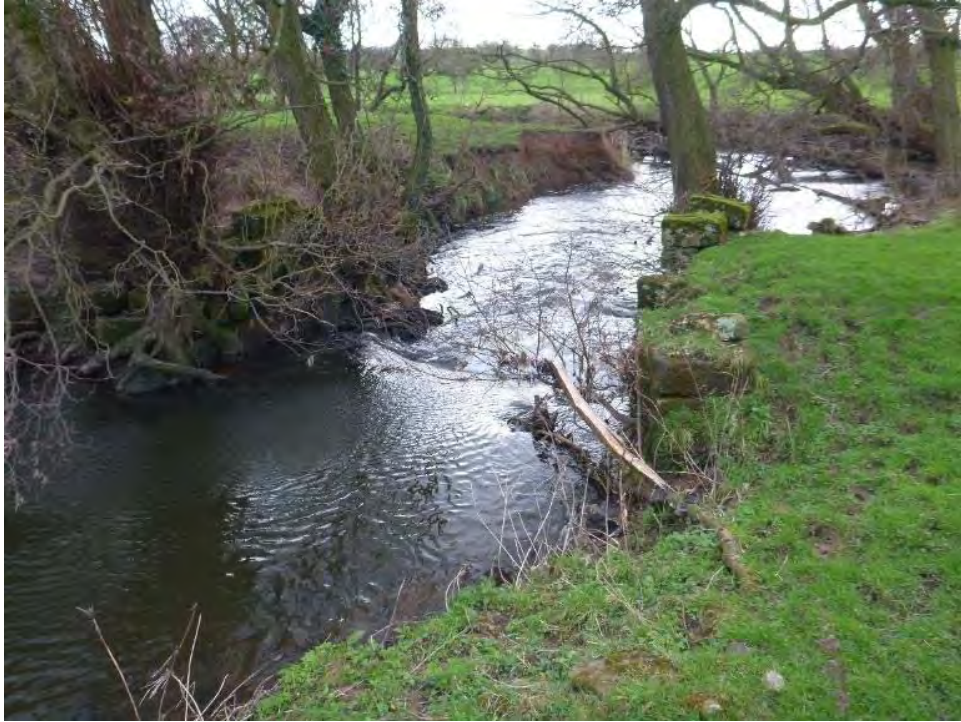
There are two former weir structures at SK0518436540 and SK0476636900 of which only the stone wing walls remain and they are no obstacle to fish migration. At the upstream extent of this section, the river is in two channels (see Section 4) which rejoin just downstream of Fole Bridge (SK0451637147).

Photo 48 Former weir

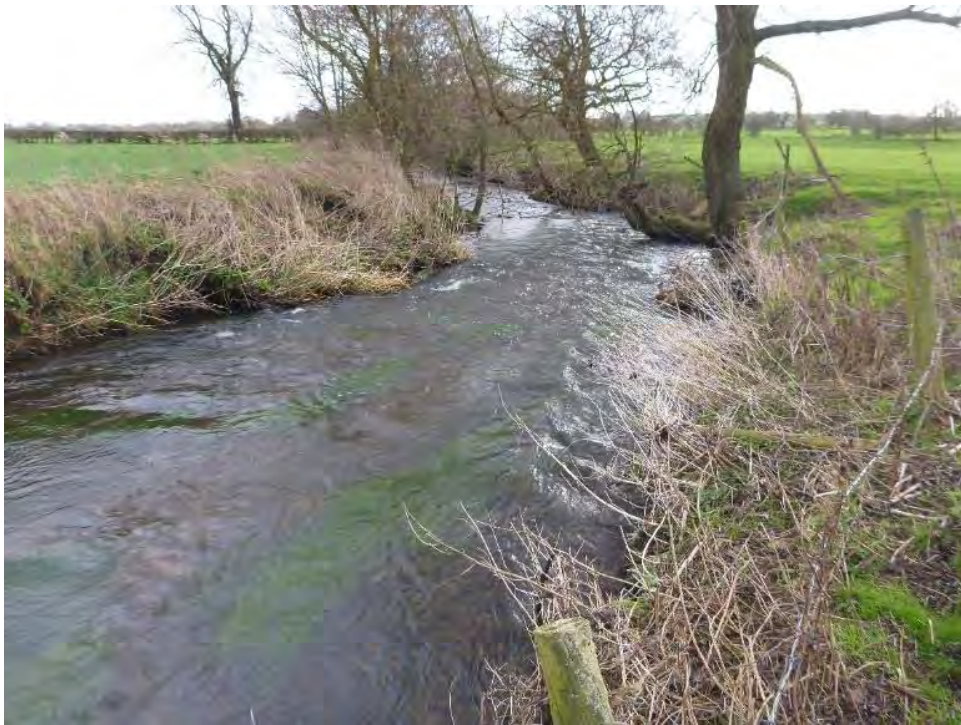
This upstream part of this section is fished by Hanley Angling Society. This part of the river is straighter than the downstream section and hence has fewer pools. Tree cover is lighter, especially on the LB.

Photo 49 More open upstream part of the section

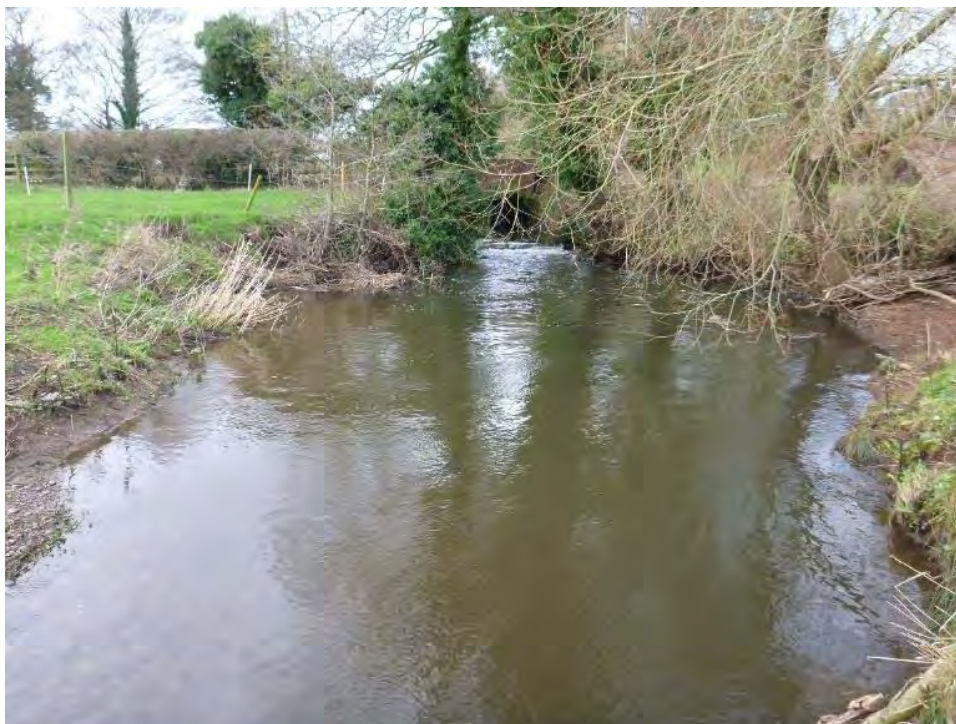
Photo 52 Upstream view of bridge and culvert apron on RH channel. The larger road bridge over the LH channel is visible to the right of the picture.

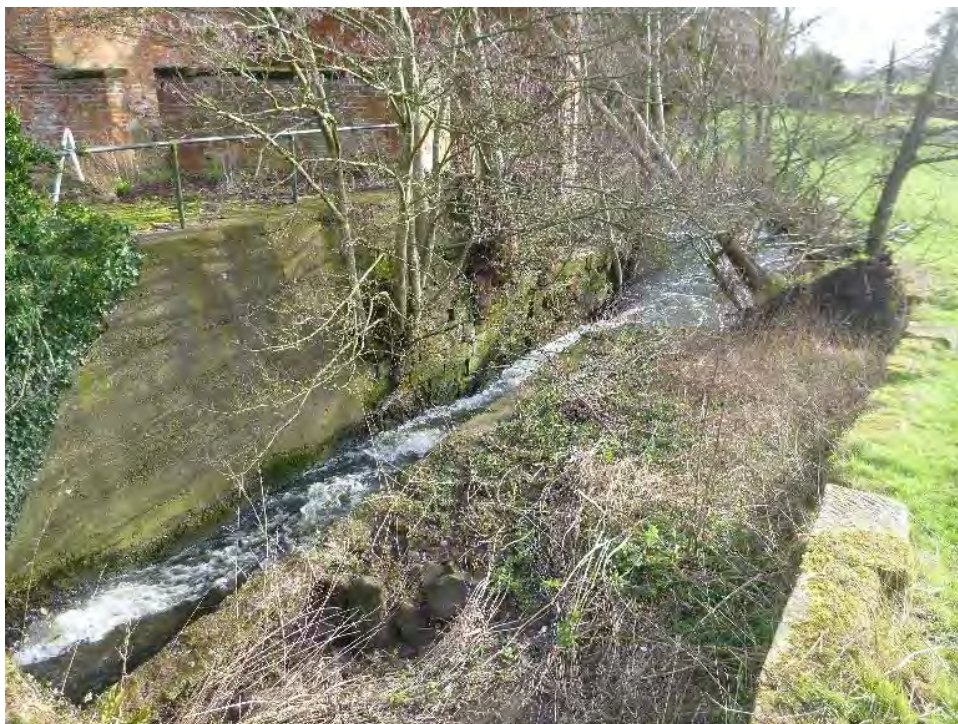
Upstream of the redundant sluice (Figure 1-c), the RB is embanked with evidently lower-lying land beyond. A man-hole cover is present here indicating the possible presence of underground services. The channel is steep, shallow and swift-flowing with a gravel bed and bordered by crack willows. The LB is a stone or concrete wall for the length of the former dairy site, extending upstream to beyond the pipe crossing (Figure 1-e).

Photo 54 Former mill sluice structure (c in Figure 1).

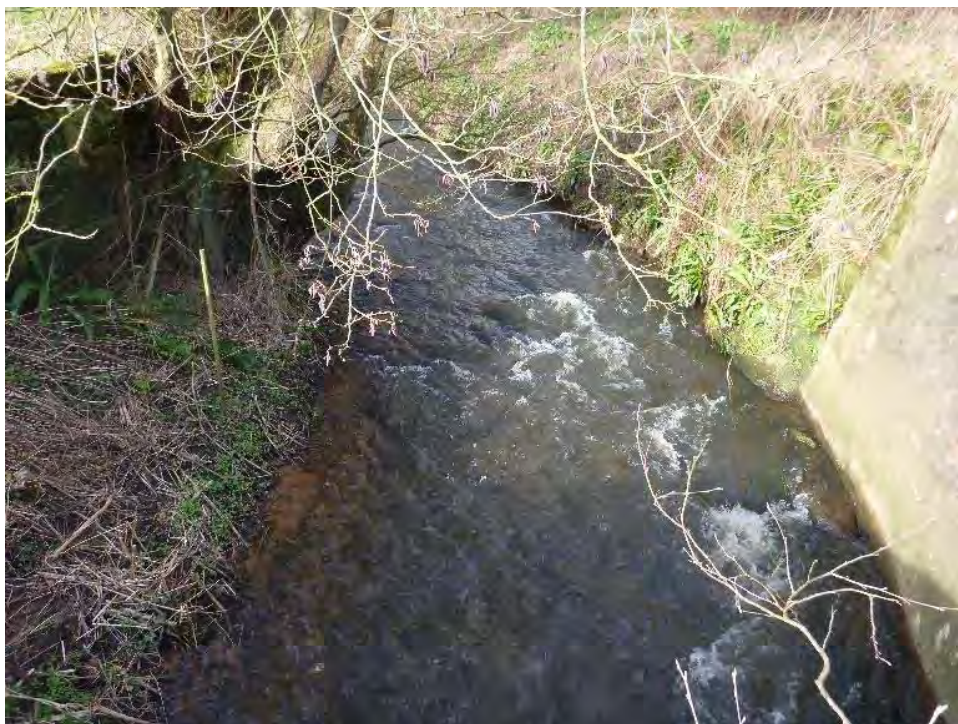
Photo 56 Immediately upstream of Photo 55

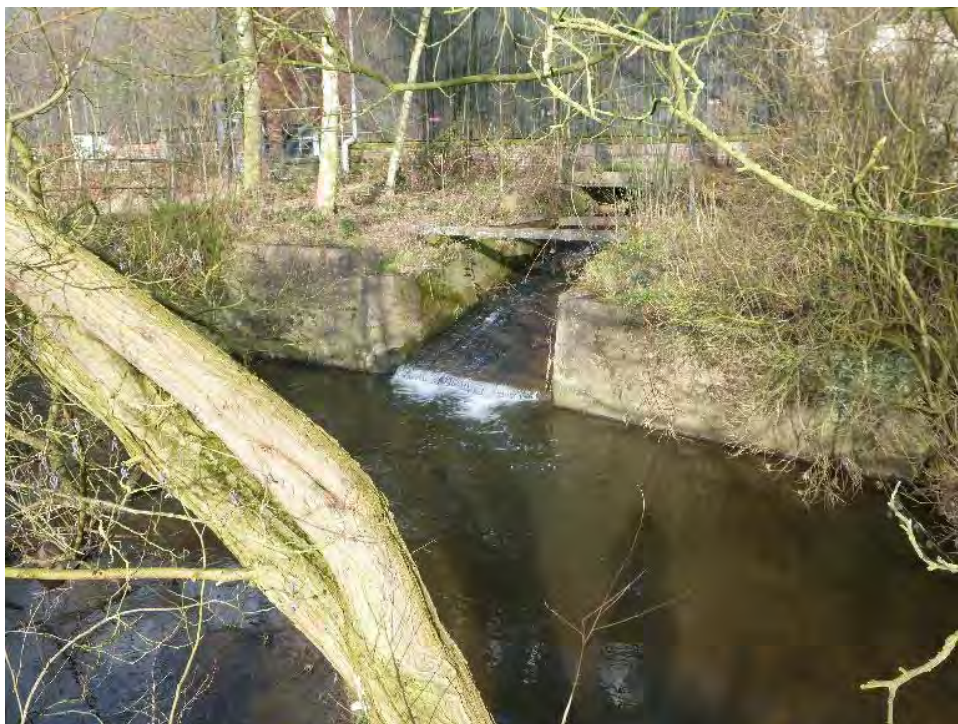
Photo 58 Broadgatehall Brook confluence with the Tean.

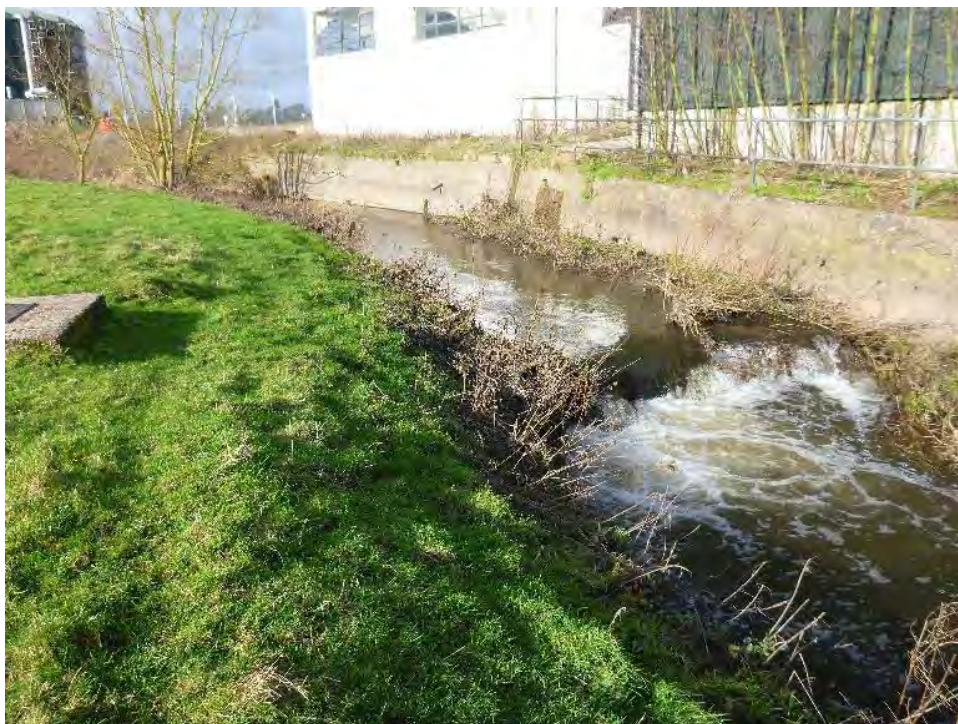
Photo 60 Pipe crossing weir.

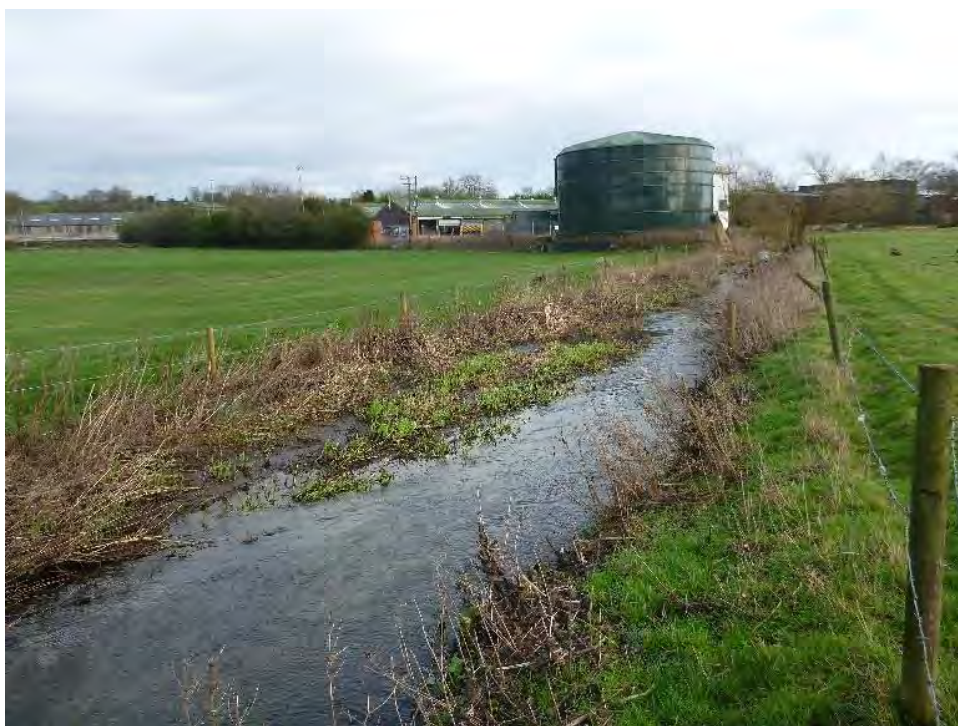
Photo 61 Northern channel upstream of Fole dairy site (downstream view).

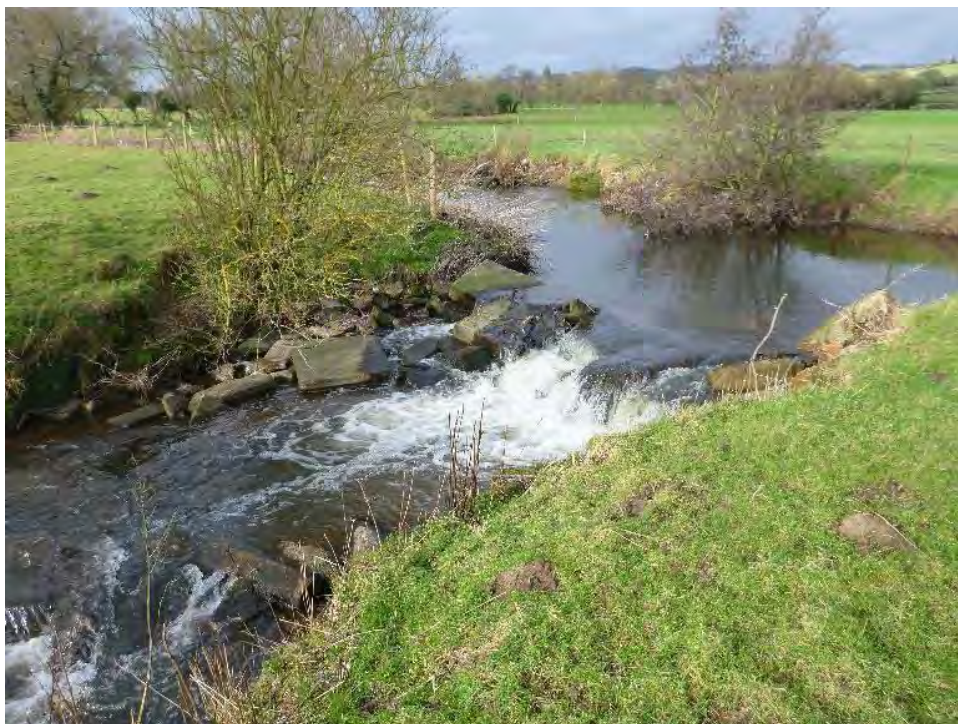
The weir at the channel split (Figure 1-a) formerly had sluice gates, but now the relative flow down each channel is determined by the fixed crest height of the weir. The weir is in a poor state of repair and the landowner has introduced concrete blocks to maintain the crest height and flow split. Bank erosion on the southern channel is a concern for the landowner and many areas on the outside of bends have been reinforced with rubble.

Photo 62 Split in channel at SK0395937238 (Figure 1 - a).

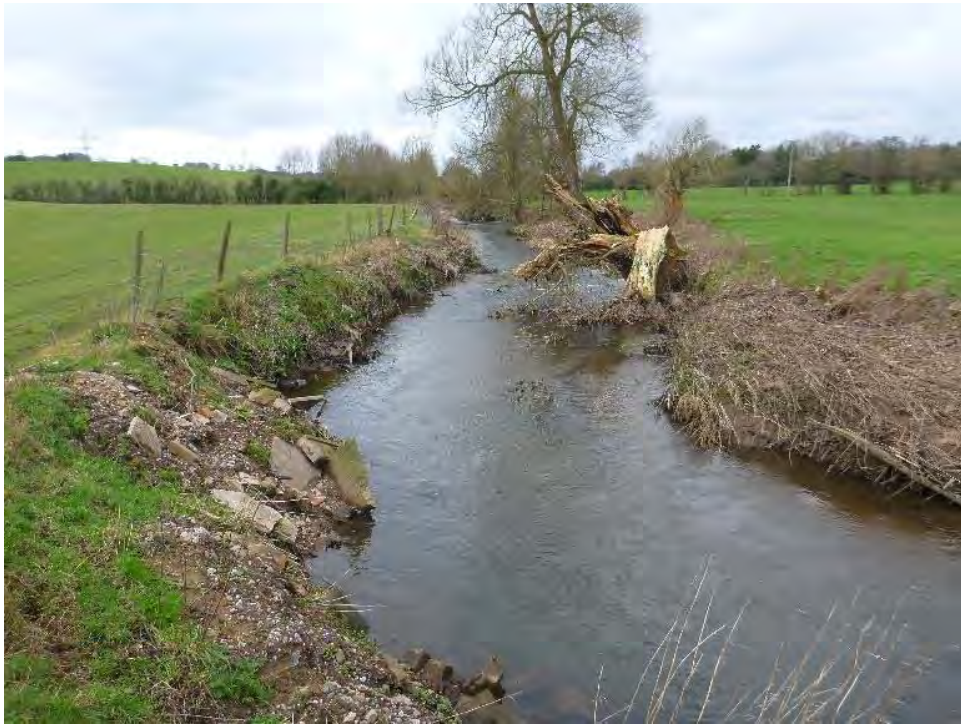
Photo 66 Upstream view towards Checkley STW

- Establishing a more natural river channel around Fole Mill, for example by utilising the course of the existing southern channel and creating new connections at the upstream and downstream ends. Potential benefits include designing a channel according to geomorphological principles to reduce the tendency for bank erosion, improve in-stream habitat, remove barriers to fish migration and reduce flood risk.
- Fencing and tree regeneration to reduce erosion rates.
- Re-meandering the river alongside Checkley STW where it is currently artificially straight.

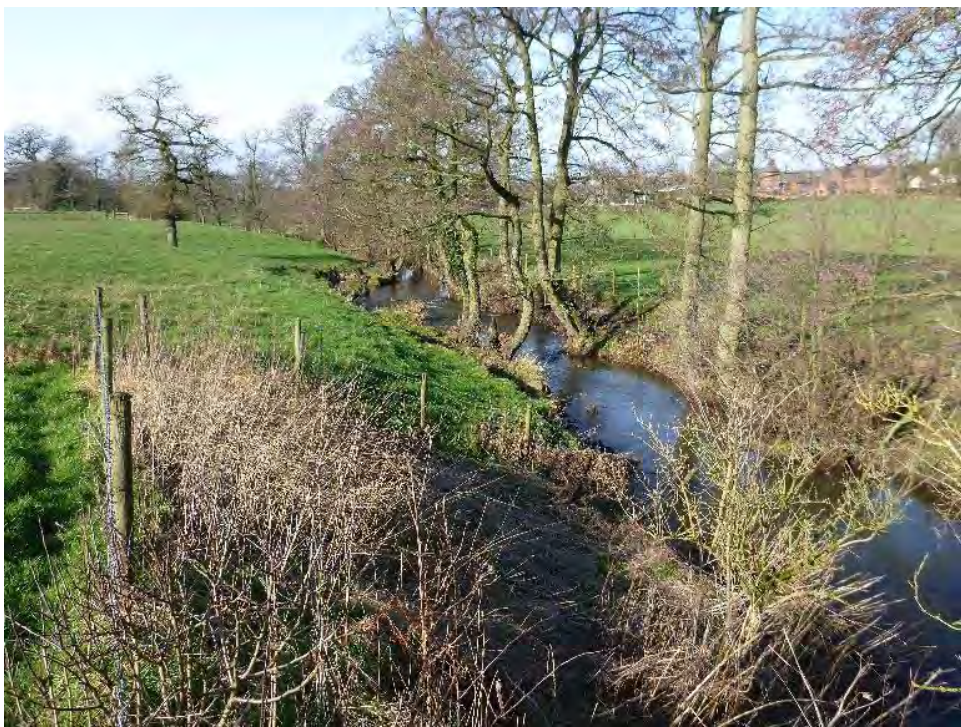
Photo 71 River upstream of Hey Bridge.

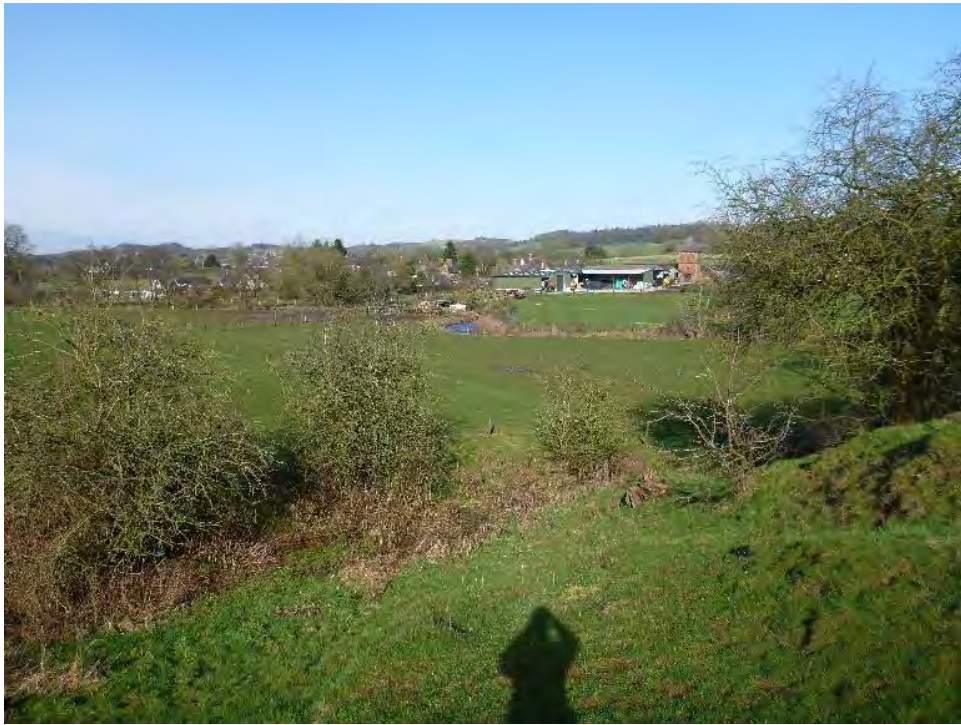
Photo 72 View towards Heybridge Farm, a more open section of the river.

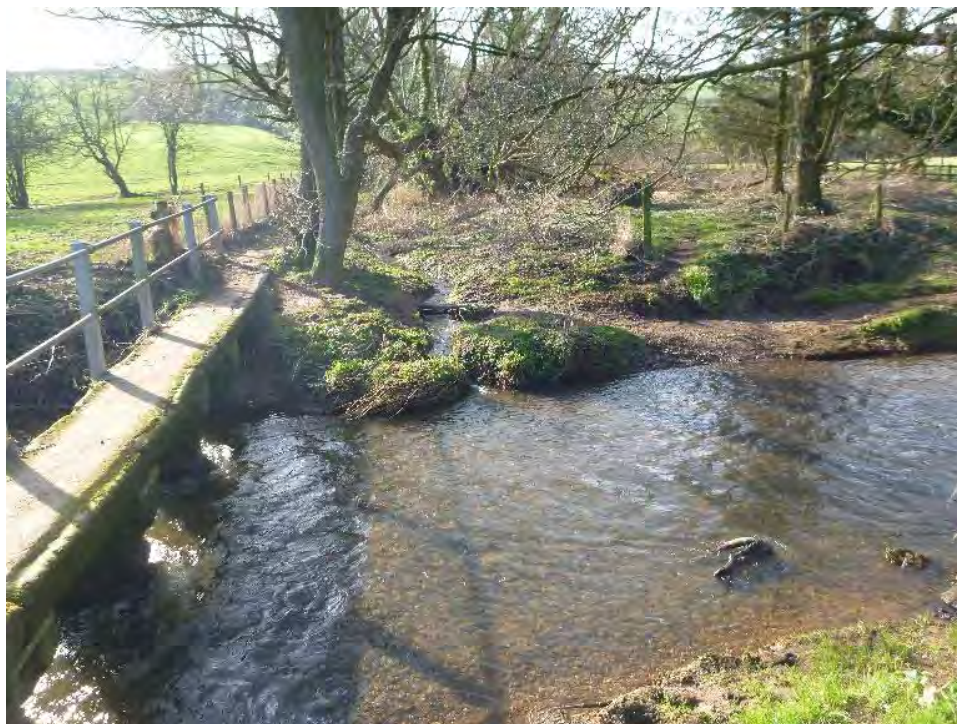
Photo 74 Footbridge at Mill Lane,, with former river channel entering river on far bank (RB).

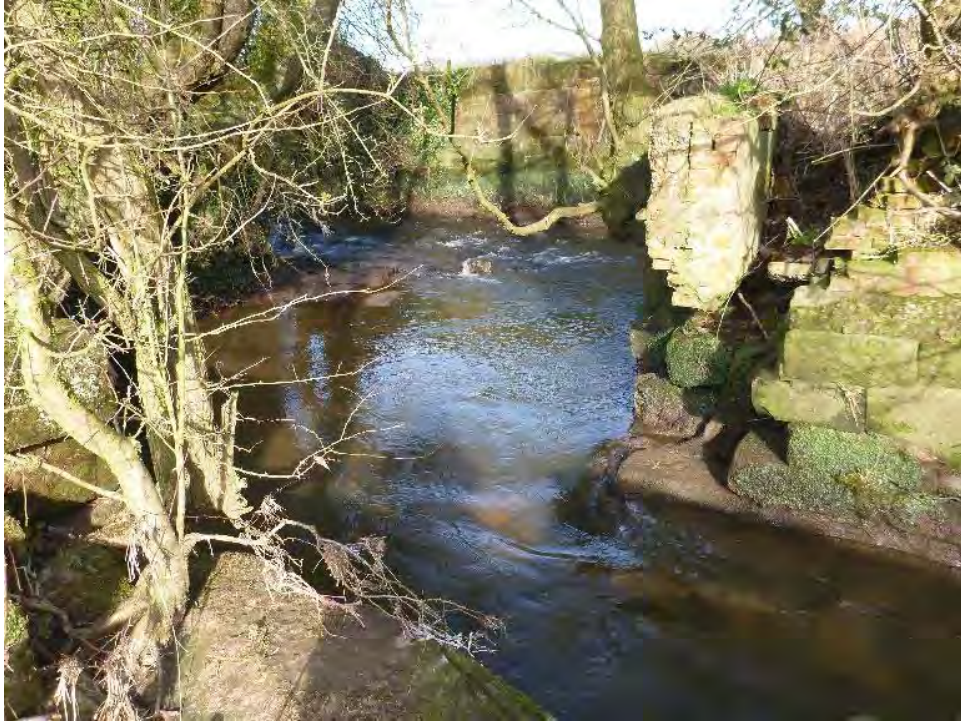
Photo 76 Mill Lane sluice (middle section).

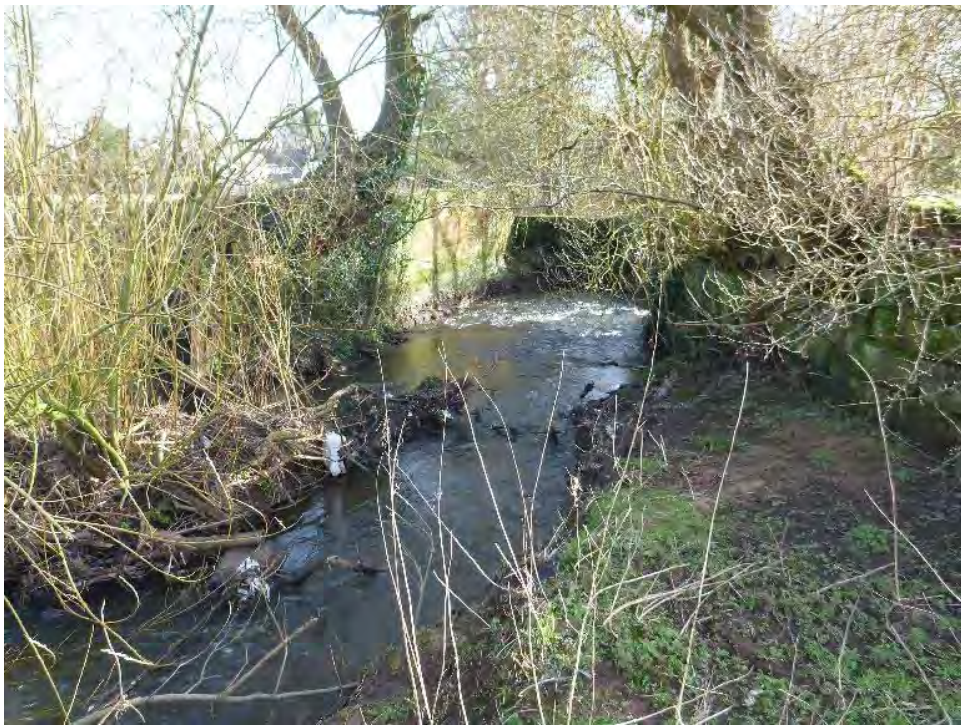
Photo 77 Upstream of Mill Lane sluice

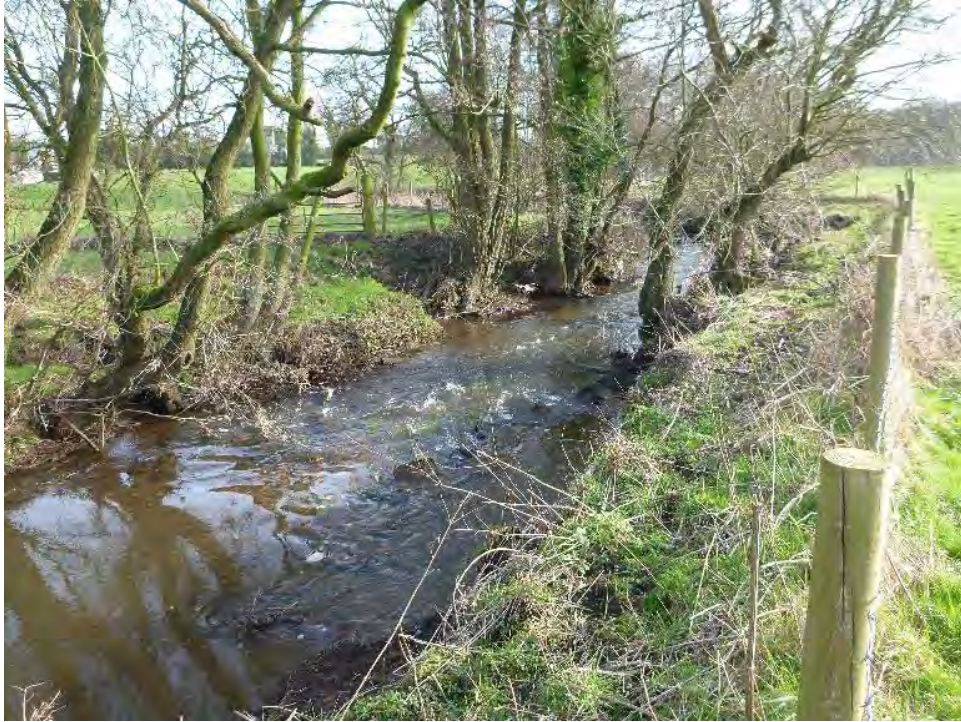
Upstream of Hall Green Farm, the river course is sinuous but becomes less so past Midway Farm and into the outskirts of Upper Tean; this may again be because of former channel alteration for milling, as two possible collapsed weir structures were observed on this section, neither an obstacle to fish migration. Most of the channel is tree-lined, although the LB becomes less so as Upper Tean is approached. In the village, the river channel is heavily modified, with a wide cross-section, walled banks and a uniformly shallow, riffle-glide instream habitat.

Photo 80 Fenced and tree lined reach of section 6 near Midway Farm.

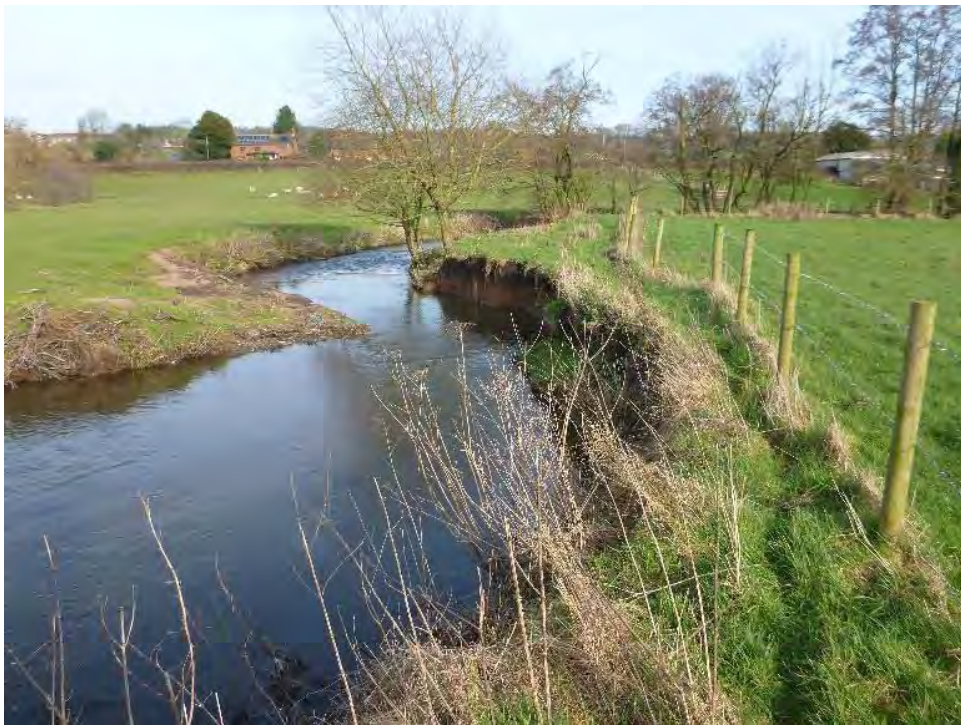
Photo 81 More open reach of Section 6.
