Advisory Visit / Walkover Survey

River Tean Staffordshire

February 2016

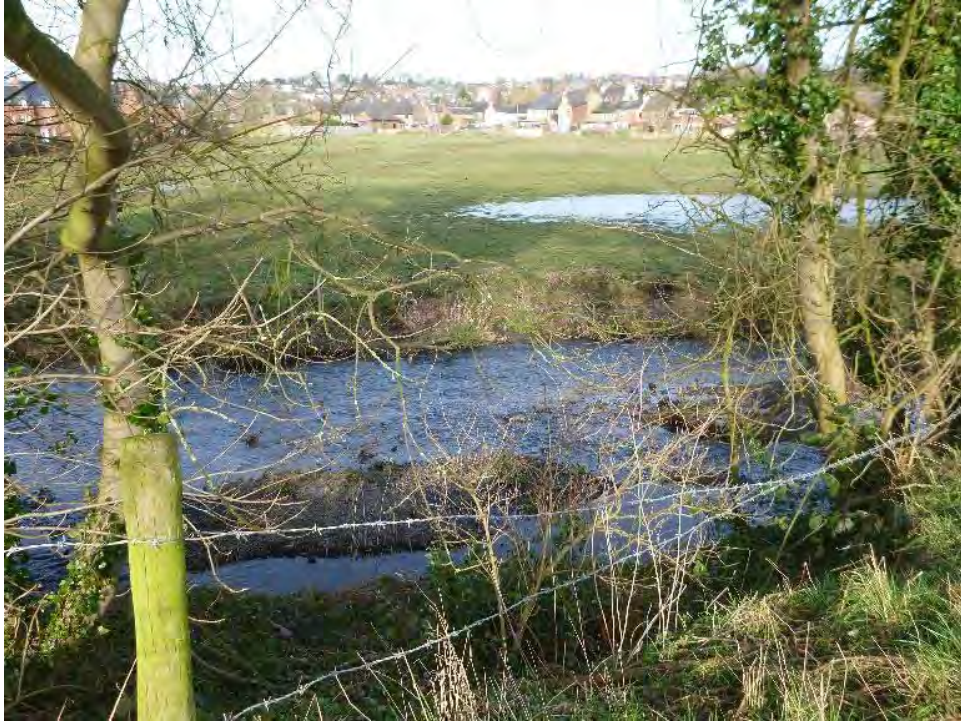
Photo 82 River to the south east of Upper Tean.

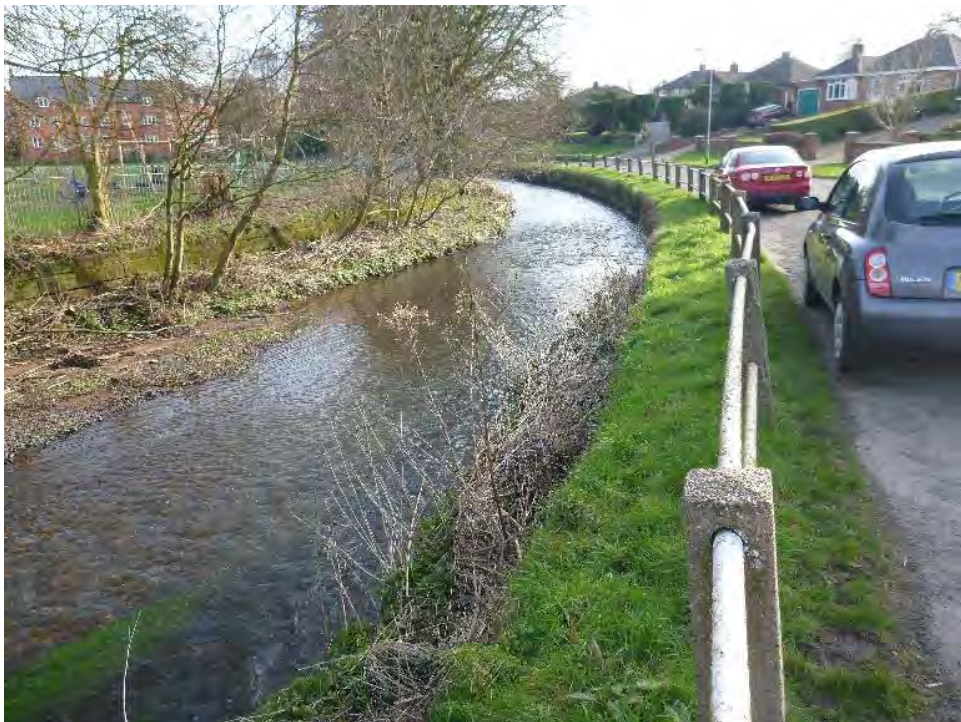
Photo 83 River in Upper Tean.
